# 14 Stewart Street, Portgordon, Moray Historic Building Recording Report

AOC Project: 70540

*January 2021*

## Historic Building Recording Report

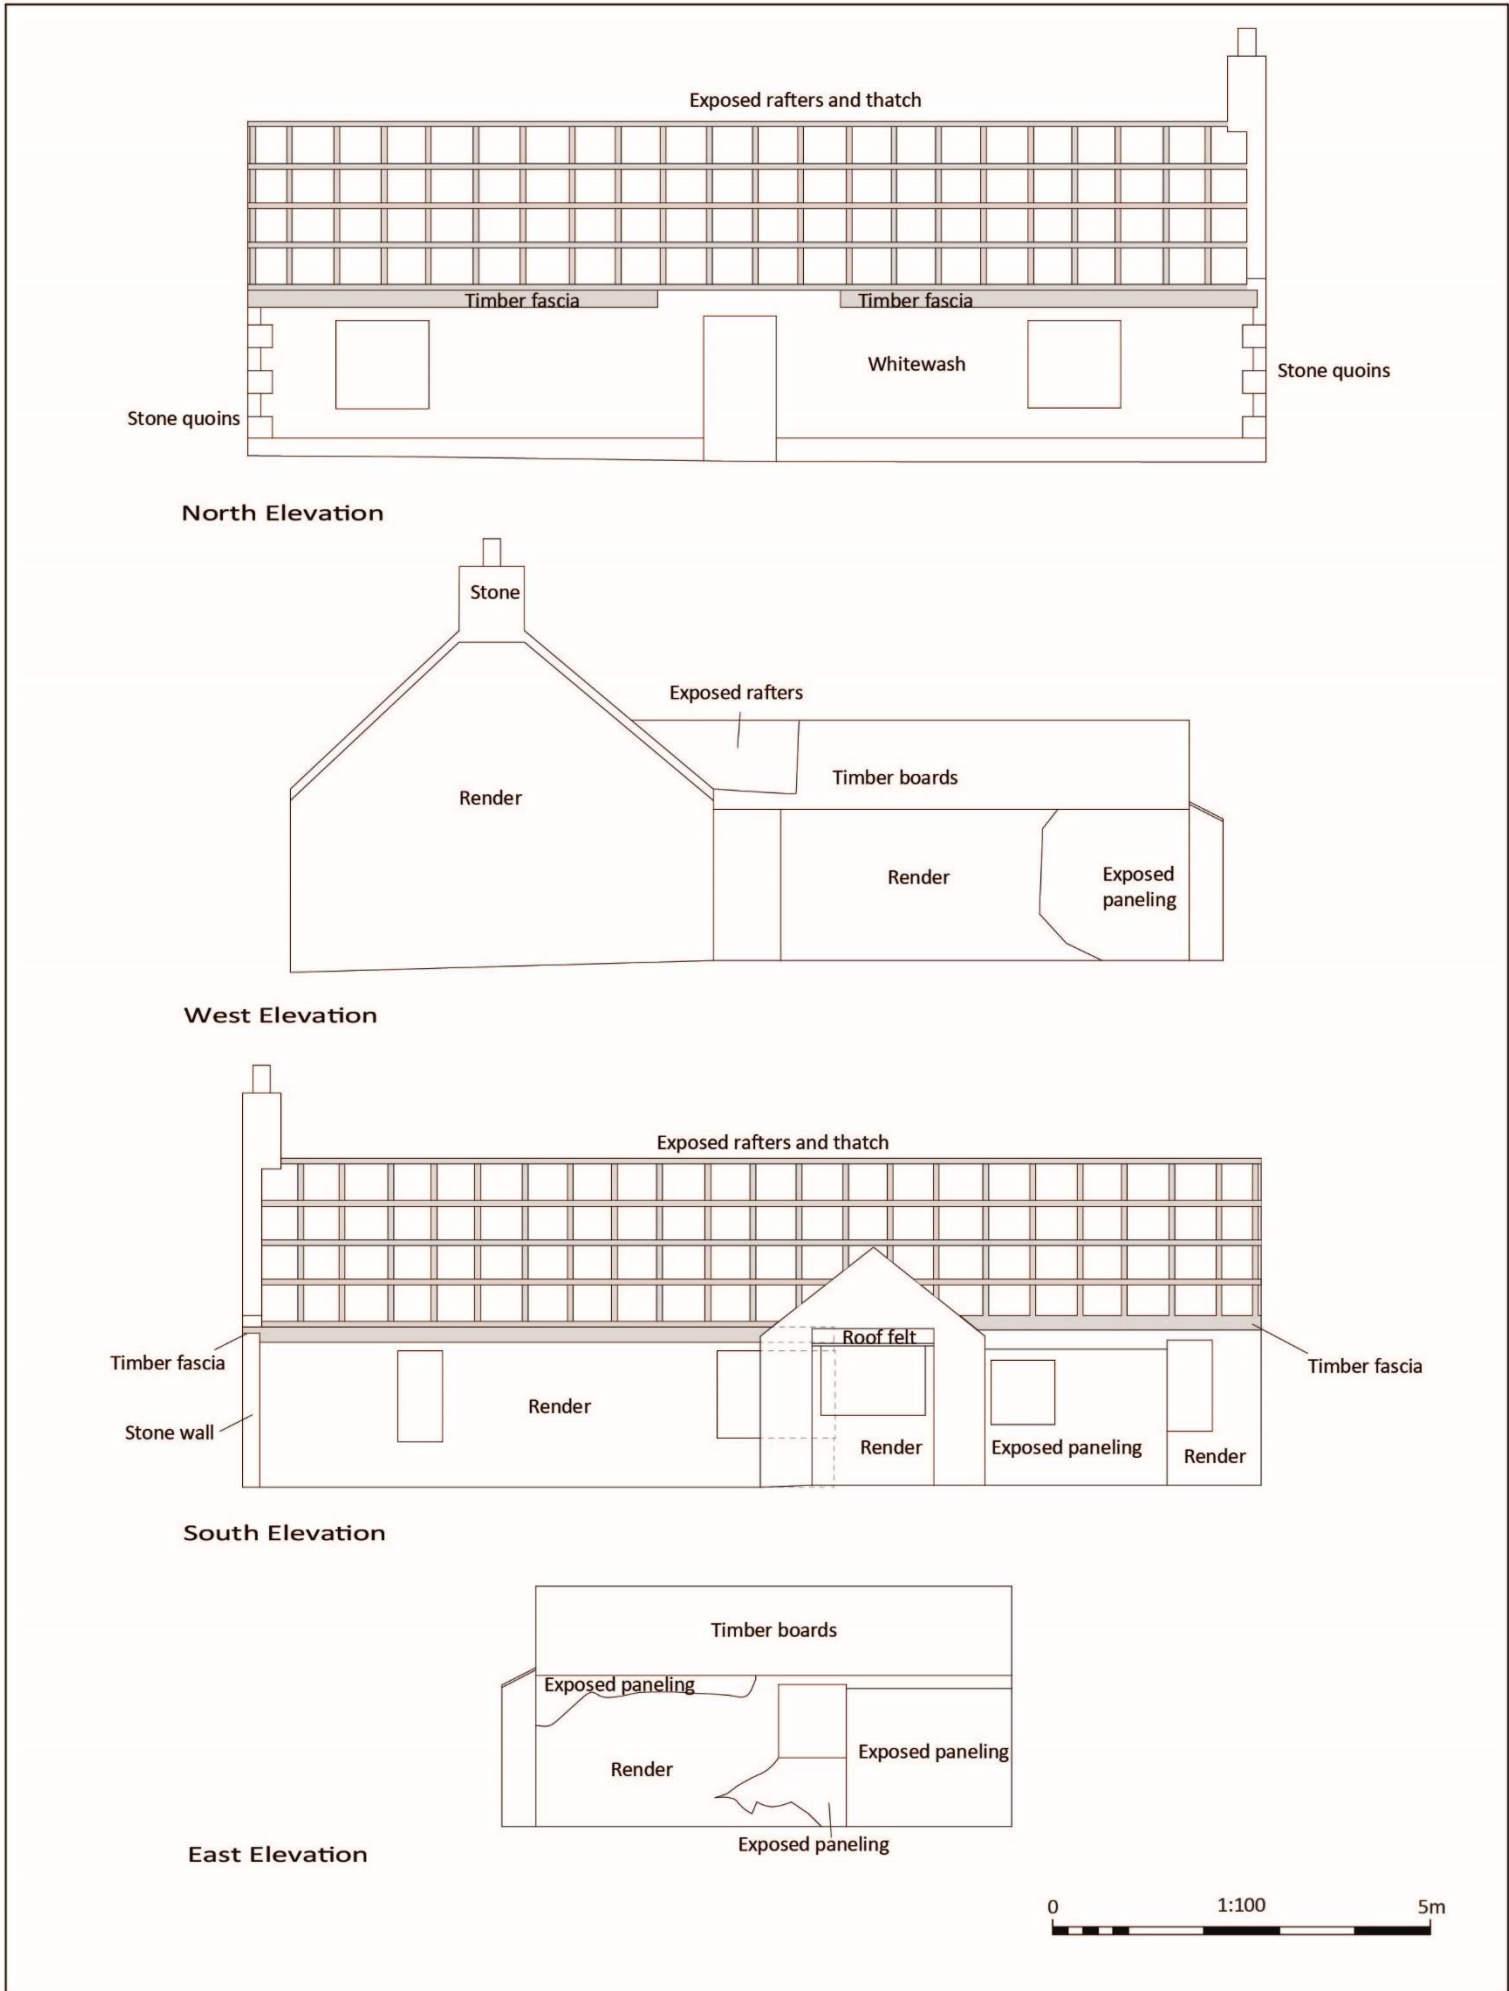
Figure 6: Elevations

The north elevation is the principal elevation of the building, fronting Stewart Street (Figures 6 & 7; Plates 1 – 2). It consists of an off-centre door opening (013) with windows to the east (010) and west (019), there is inconsistent placement of the windows, it is possible that this relates to the original structure of the building being the end of a terrace. The stonework has been covered in a whitewash render with stone courses highlighted. There is a stone skirt visible at the base of the elevation. The quoins at the east and west of the building along with window surrounds have been highlighted in a mustard paint (Plates 1 & 7-8).

The east elevation consists of a rendered gable end to the north, along with the rendered extension to the south (Figures 6 & 7). The gable end has one central chimney stack visible and the wall has been stone capped. The gable is abutted by a tall stone wall to the south with entranceway into the rear garden (Plates 10-12).

The extension found to the south consists of an opening for the rear entrance (003) into the building and the side of wall of a bay window to the rear of the property. The timber panels beneath the render have been exposed to the south of the elevation. There is a pitched roof constructed of timber panels and roofing felt, the north end has been exposed to the elements (Plate 3).

The south elevation forms the rear of the property (Figures 6 & 7; Plates 3 & 5). The main linear building can be seen to the west and east ends of the elevation and is stone rendered (Plates 13 & 14). There are two windows visible to the west, a single width sash window to the west (017) and a double with sash window (016) that is partially obscured by the extension. To the west there is a single sash window (008) abutted by the modern extension. All windows have stone surrounds in keeping with the north elevation. The roof consists

The modern extension is seen off centre to the main building and consists of rendered gable end with bay window (001) with a flat roofed structure to the east (Figures 6 & 7; Plates 6 & 15). The bay area consists of a sloped felt roof and timber lined picture window with top awning. The flat roofed structure to the east has no external wall coursing visible and has been stripped back to the wall studs and insulation. There is a single top awning timber framed window visible (005). The roof is covered in roofing felt.

The west elevation shows the modern extension to the house. To the north a featureless timber panel structure is seen that abuts the main building, the external face of the structure has been removed revealing internal stud walls. The roof is flat and covered in roofing felt. To the south is the single pitch rendered structure. The render has been removed in places to reveal timber panelling, there is a triple pane timber framed window (002) abutting the north section. There is overlap between this window and that on the south section of the flat roofed structure suggesting that the flat roof structure may be a later addition to the extension (Figures 6 & 7; Plates 16 & 17).

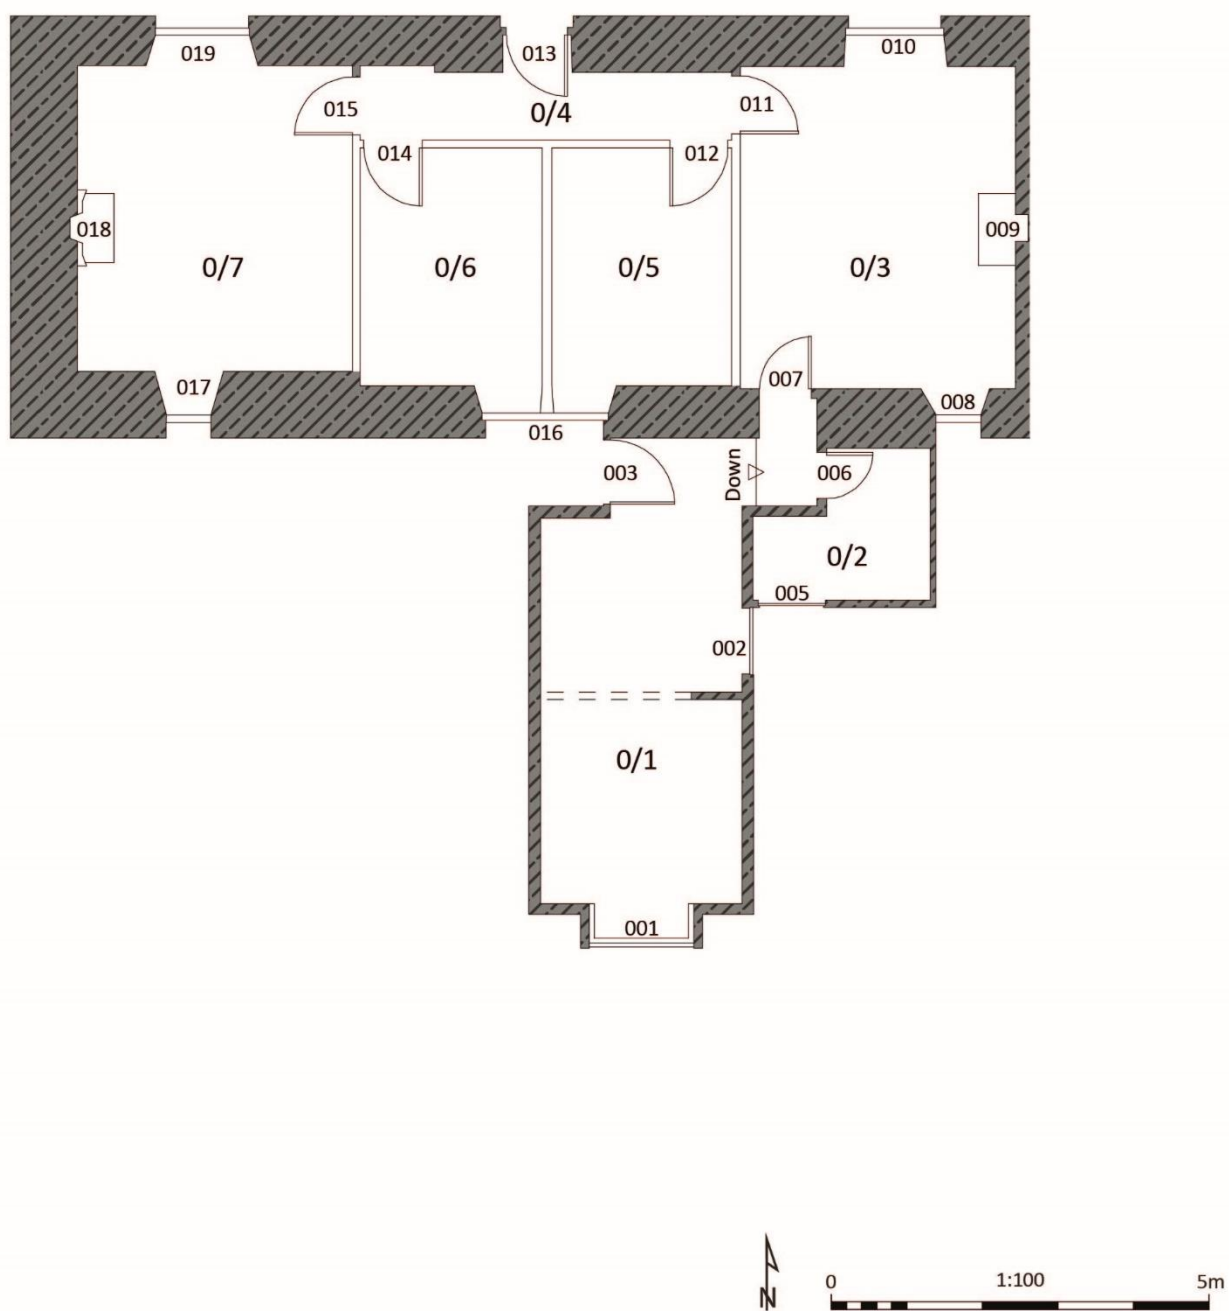
Figure 7: Ground floor plan

There are seven rooms (including one hallway) on the ground floor of which three can be found within the extension to the rear. All rooms within the main building are carpeted and wallpapered with timber panel doors (Figure 7). The partial collapse of the north wall in Room 0/3 revealed the main house construction material to be a red sandstone (Plate 18).

Room 0/3 is thought to be the living room area of the house. There has been considerable damage in the N/E corner of the room where the ceiling has collapsed and the north wall corner exposed due to roof damage (Plate 28). It has a tiled fireplace (009) on the east wall, the surround of which has collapsed on the floor (Plate 29 & 30). There is a double sash window (010) on the north wall and a single sash window on the south wall (008). Both windows are set back into the wall within angled edge plasterboard recesses with painted timber sills (Plates 31 & 32). The ceiling is a partially sloped plasterboard ceiling (Plate 33). The room is accessed by two doorways, to the south is a hollow timber panel doorway leading to the extension (007) and to the north west there is door frame for a missing door (011) leading to Room 0/4.

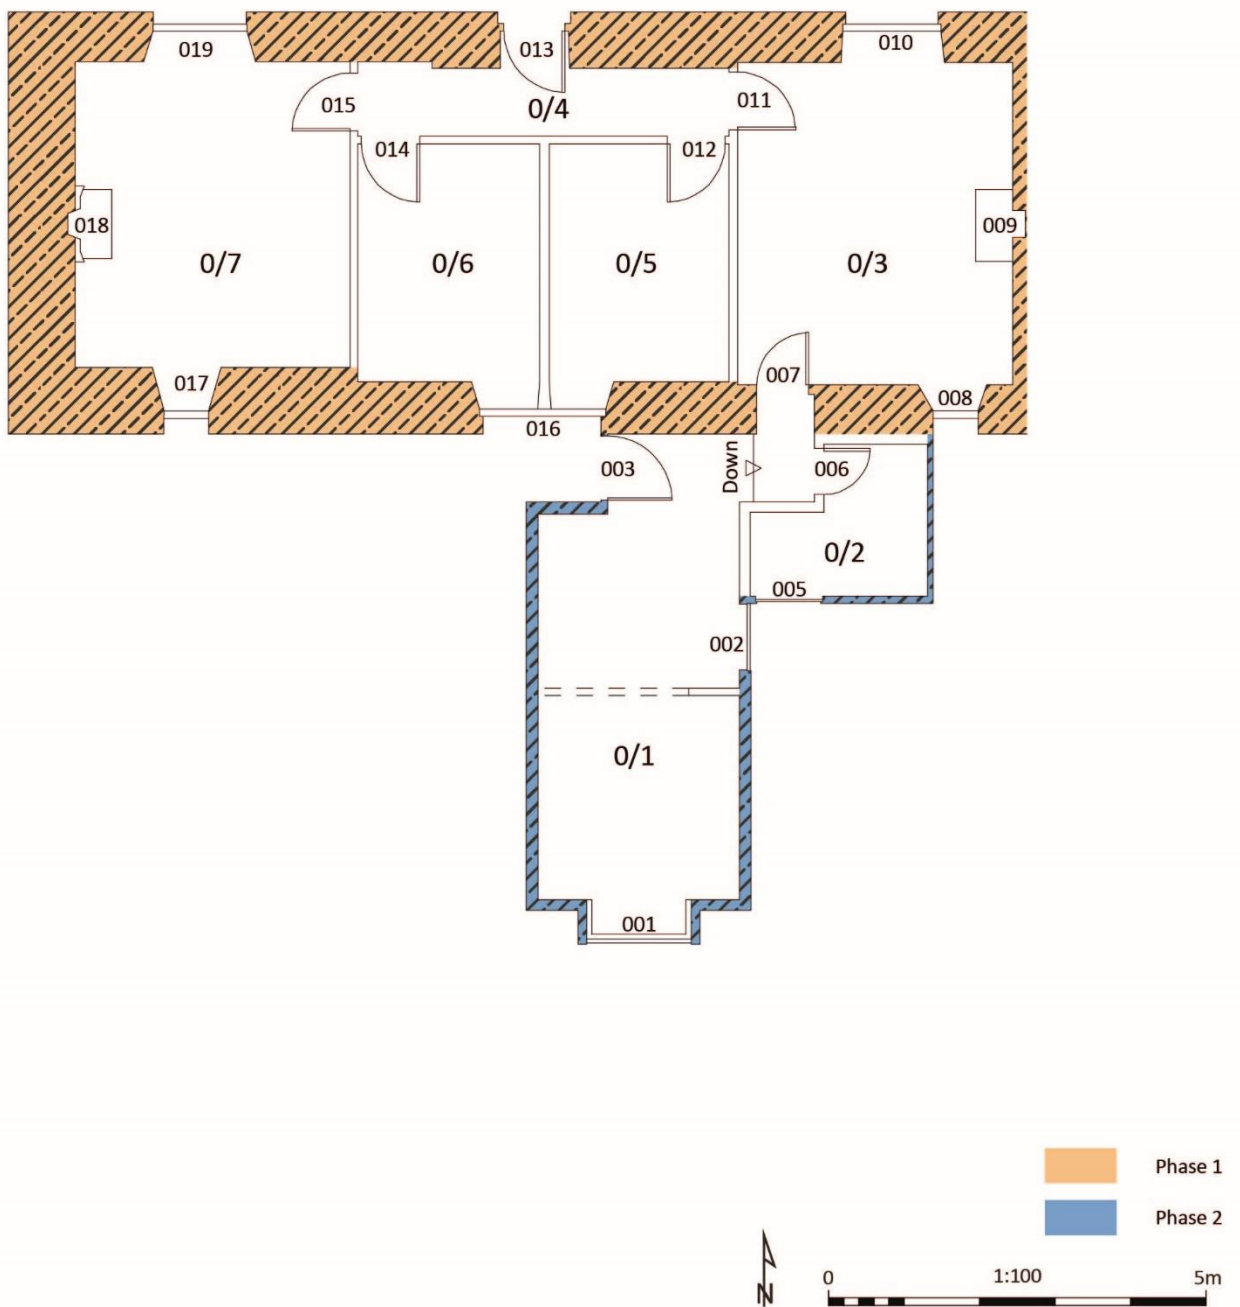
Figure 8: Site plan showing construction phases

- 6.2 The structural evidence suggests that current building layout can be separated into two phases. The initial stone building running E/W to the north of the site is part of the original stone building as depicted in the early maps whilst the timber extension to the south is a modern addition. It is unclear whether the kitchen area (Room 0/1) is a later addition to the bathroom area (Room 0/2). The changes in floor level, ceiling height and the abutment of windows (002) and (005) suggest that creation of its current state may have occurred over several phases (Figure 9).
