# Alum Scar Bridge, Samlesbury Bottoms, Lancashire Historic building survey and watching brief report

### Historic Building Report

AOC Project No: 51018

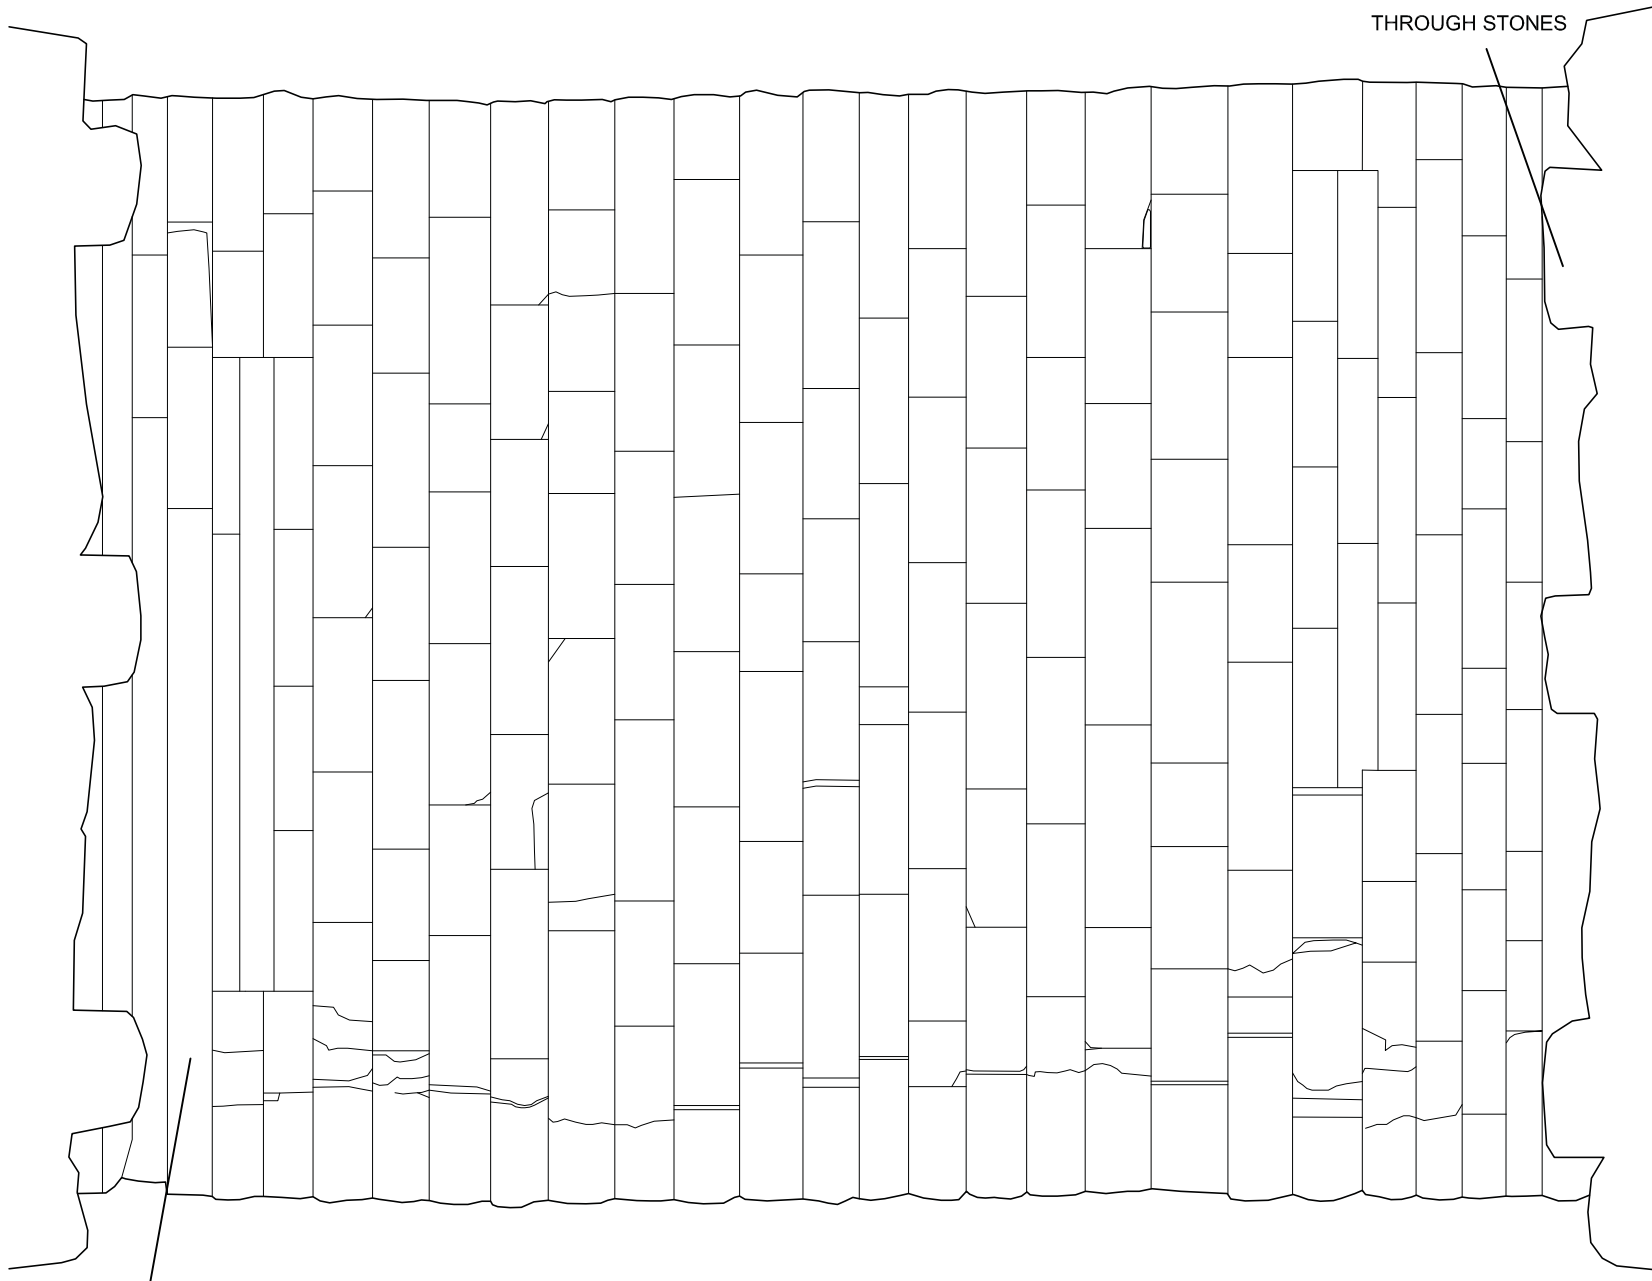
STONES DIFFICULT TO DISTINGUISH DUE TO DAMP STAINING

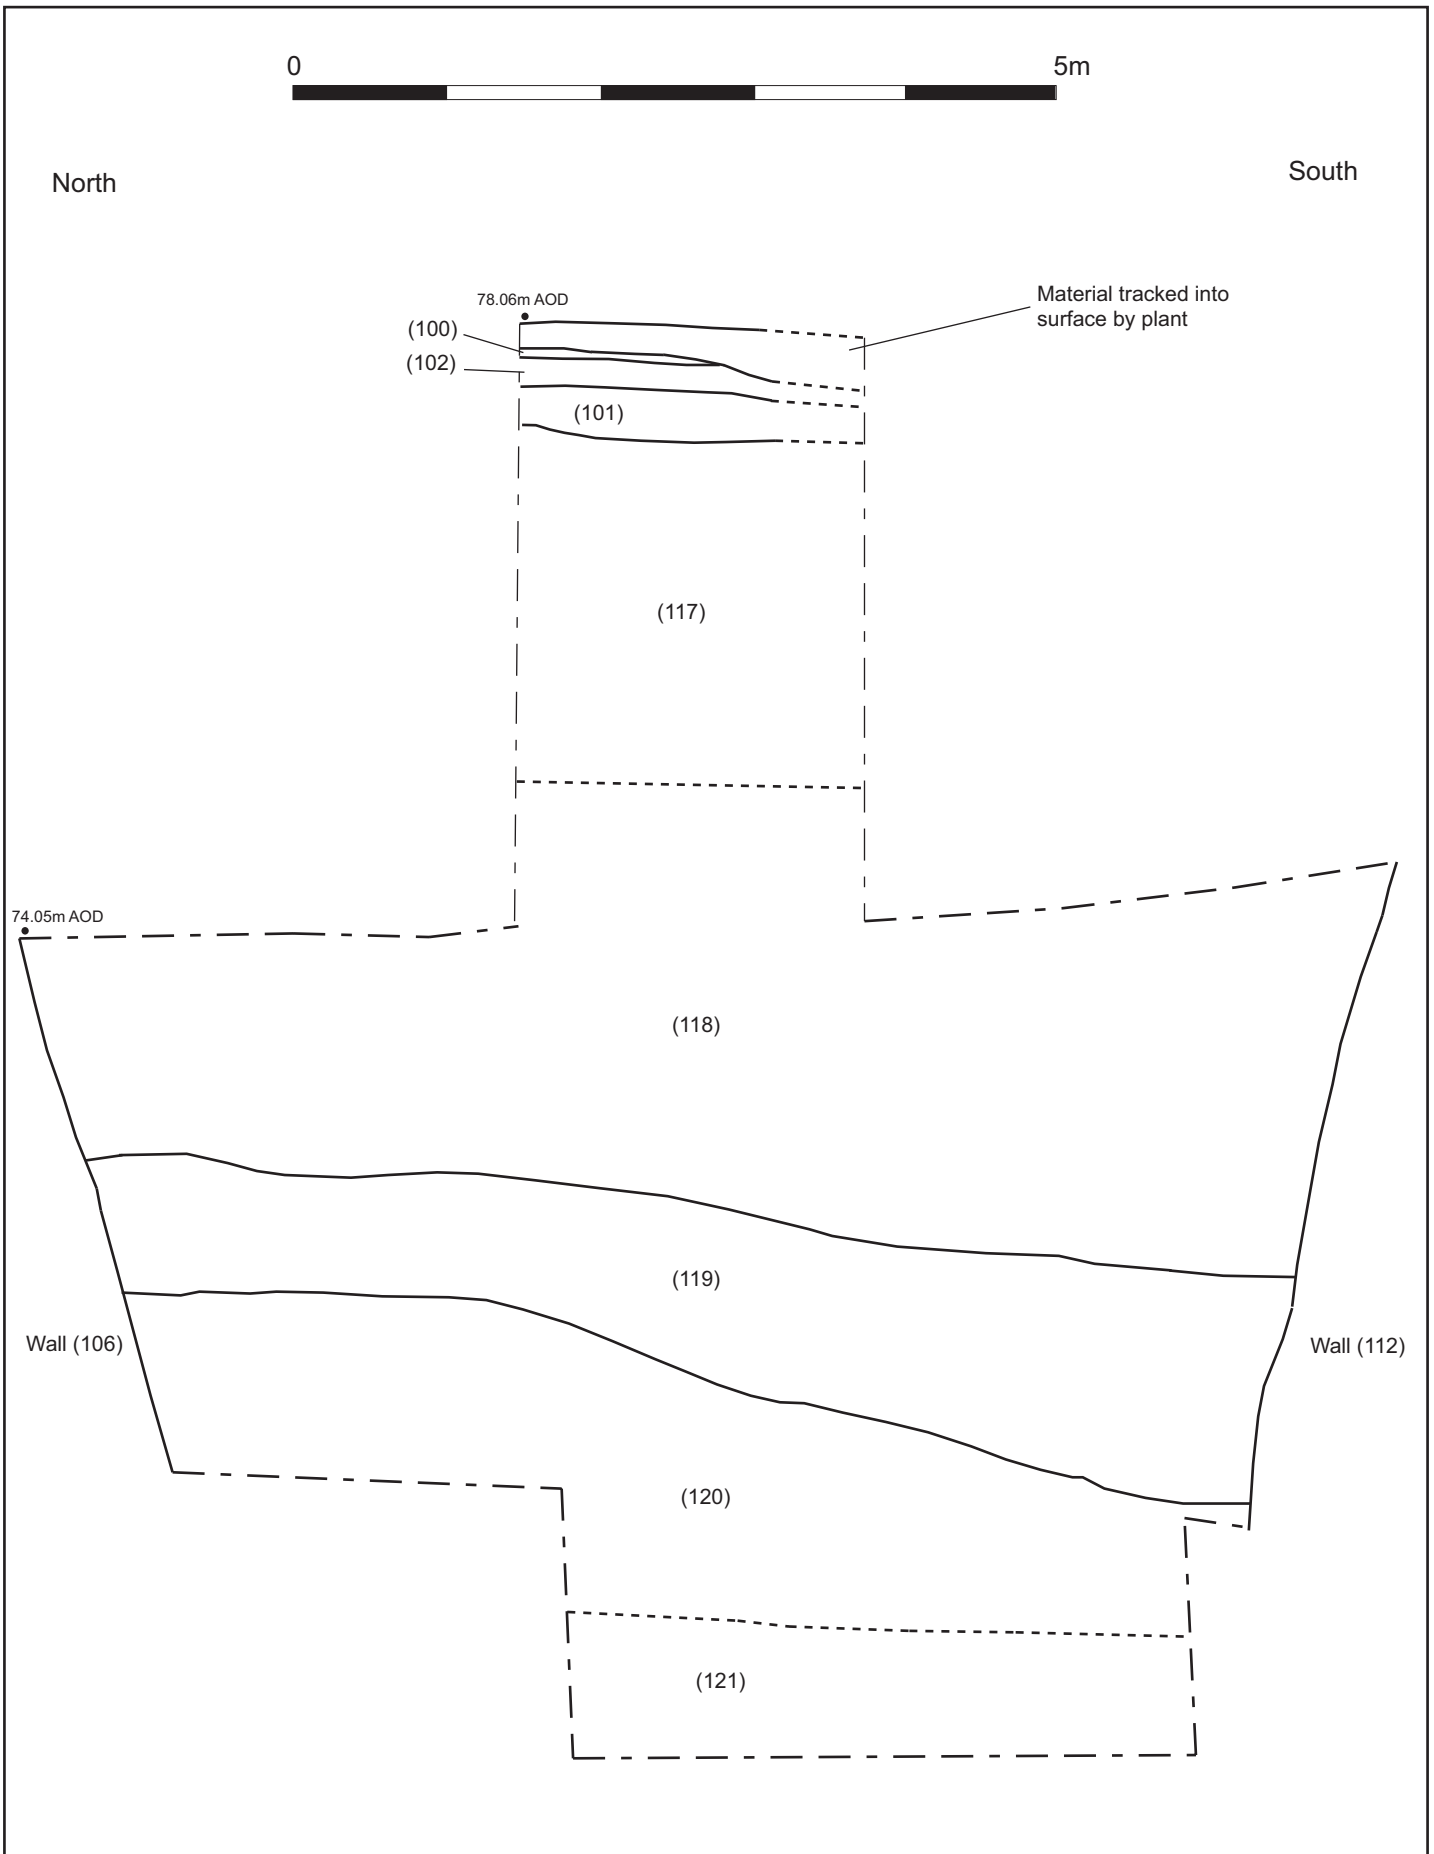
Figure 35: Reconstructed west-facing section through deposits within bridge structure

- 6.2.2 The natural bedrock was only observed on the western limit of excavation where a construction cut for the bridge was visible in the south-facing elevation (context 122; **Plate 16; Figure 35**). The bedrock consisted of abundant medium-large platy, angular stones in a silty/clayey soil matrix (context 123).

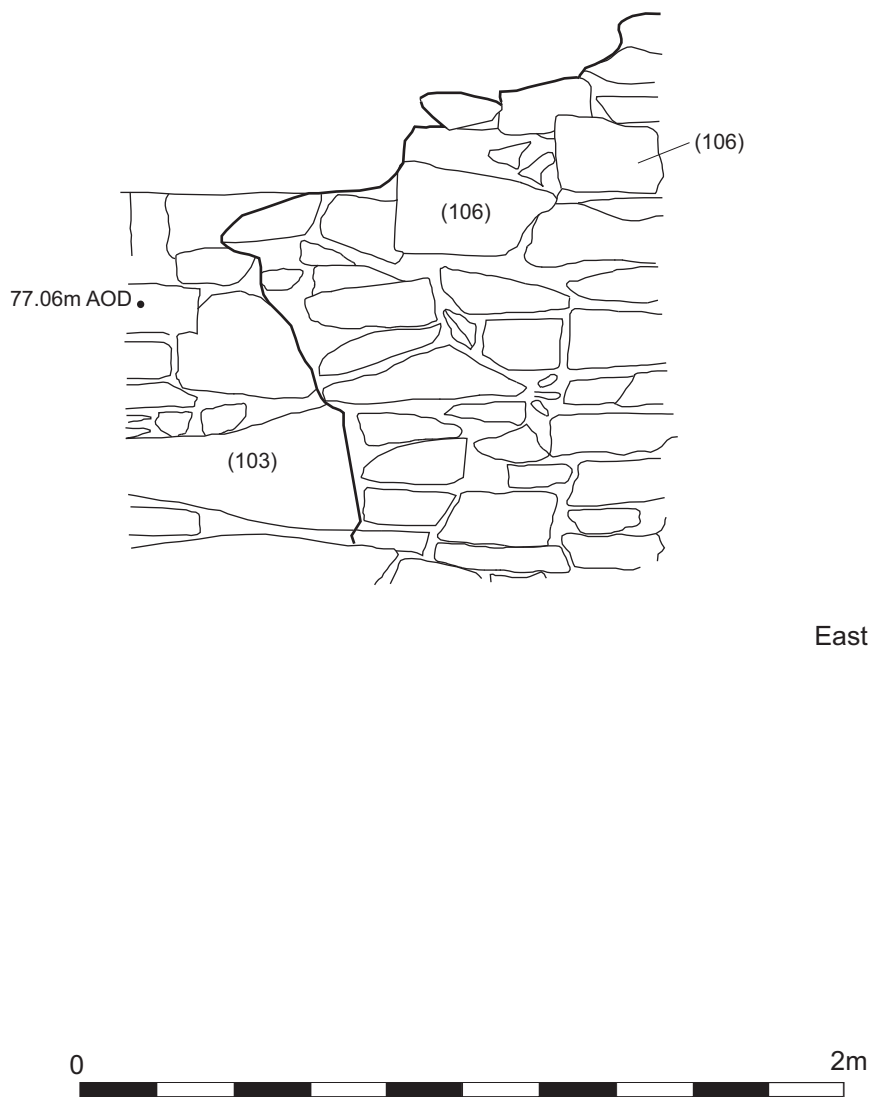
Figure 39: South facing elevation showing possible phase break between walls 106 and 103, Alum Scar Bridge

- 7.1.2 The north and south elevations of the bridge show clear vertical 'phase breaks' or straight joints between the central sections of dressed masonry and the rubble wing walls. During the watching brief it was possible to examine these relationships both in plan and on the internal elevations. No definitive evidence of phase breaks in the rubble backing was observed: the rubble backing to the wing walls and to the dressed masonry appeared to be of one build (**Plates 14 & 27**).
