# Montrose Swimming Pool Watching Brief: Data Structure Report

# Montrose Swimming Pool, Watching Brief

## Data Structure Report

**AOC Project No:** 21343

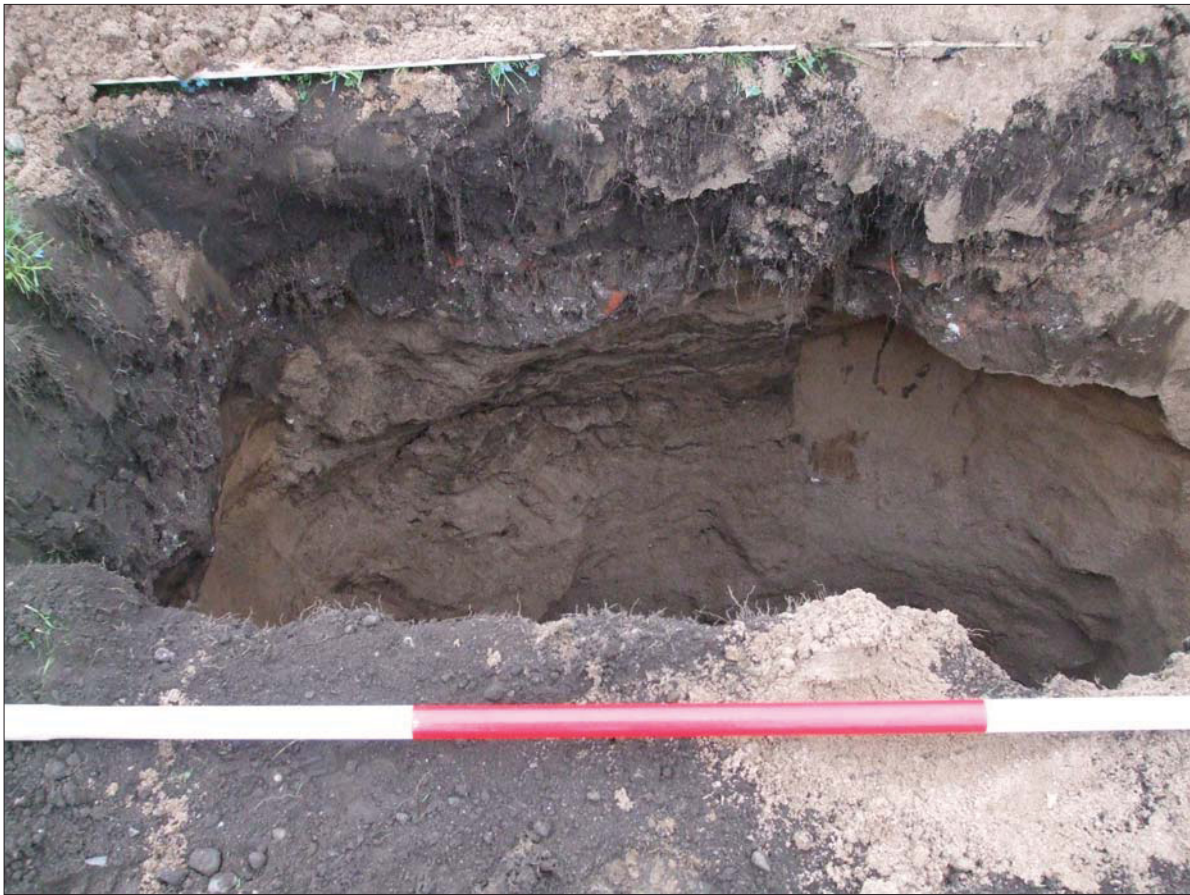
6.5.1 A rectangular trench measuring 2.6 m long x 0.6 m wide x 2.9 m deep, aligned N-S was cut through a layer of landscaping topsoil [300], this overlay a layer of demolition debris [301] comprising unfrogged brick and brick fragments in a degraded mortar matrix. This was found overlying clean pale brown natural sand [302]. A very steep sided, flat bottomed, U-shaped linear cut [303] aligned E-W was visible, cut into the natural sand at the north end of the trench. This measured 0.8 m wide, (excavated) and continued under the north trench edge, by 0.6 m deep. This was filled by pale brown sand with frequent, discontinuous horizontal lenses of brown silt [304].

- 7.2 The cut features unearthed in TP03 and TP06 cannot be assigned a period or function. The buried improved sand horizon which was evident across the entire site may be associated with agricultural use of the site prior to development.

Plate 1: Cut 303 in the west facing section of TP 03

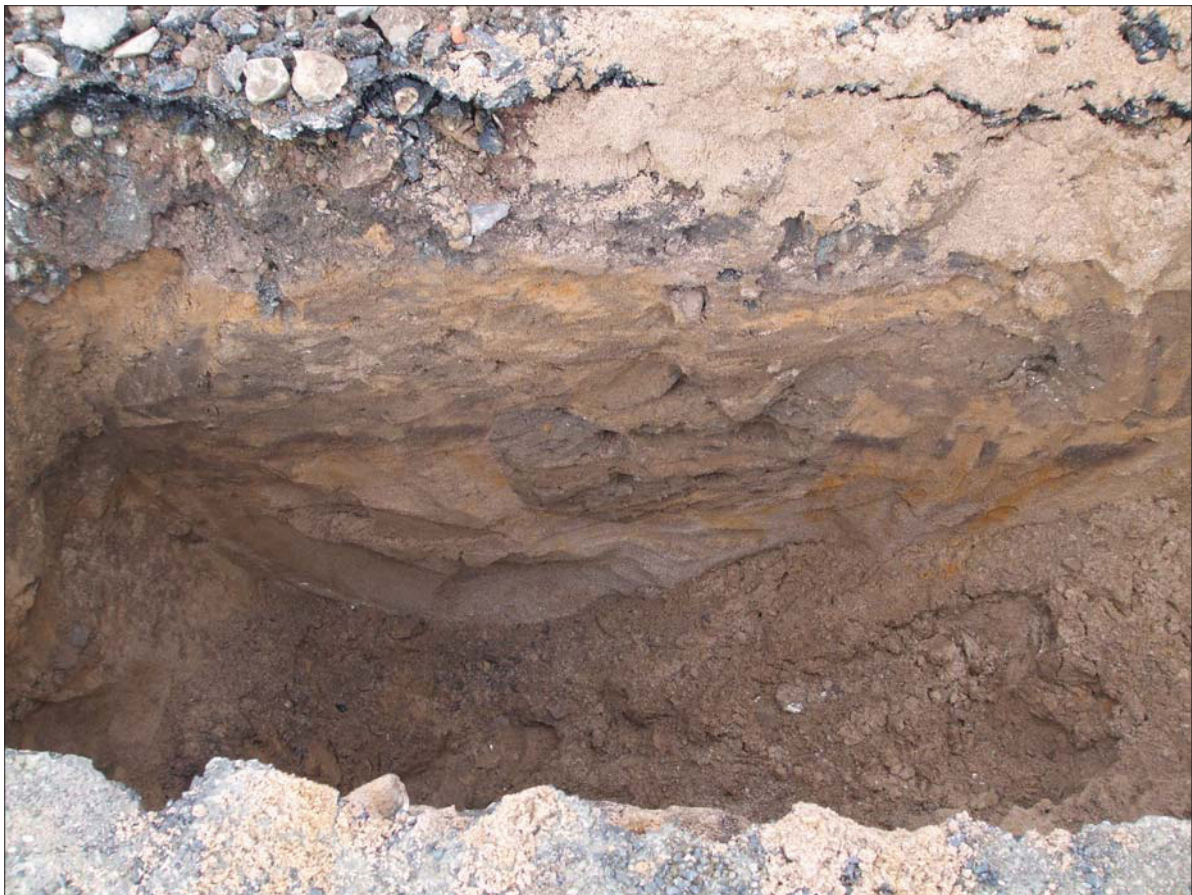
6.8.1 A rectangular trench measuring 2.6 m long x 0.6 m wide x 2 m deep, aligned N-S was cut through a layer of tarmac [600], this overlay a layer of gravel fill or leveling [601] which overlay a layer of rounded gravel in a dark brown silt [602] which probably formed a surface before the tarmac was laid. Below this a thin layer of clean sand [603] was visible overlying a layer of small to medium sized sandstone fragments in a degraded lime mortar matrix [604]. Beneath this natural sand [605] was encountered. The east facing section of this trench revealed a similar sequence of deposits although the crushed sandstone layer [604] was not visible. Below the clean sand deposit [603] a mottled brown orange sand [606] was recorded, at the base of this layer a discontinuous band of dark brown silt was visible [607] overlying natural sand. A rounded U-shaped cut [606] was visible cut into the natural sand in this section. It measured 0.5 m wide by 0.3 m deep. During further excavation of the test-pit this section edge collapsed and what remained of the feature had disappeared

Plate 2: Cut 608 in the east facing section of TP 06

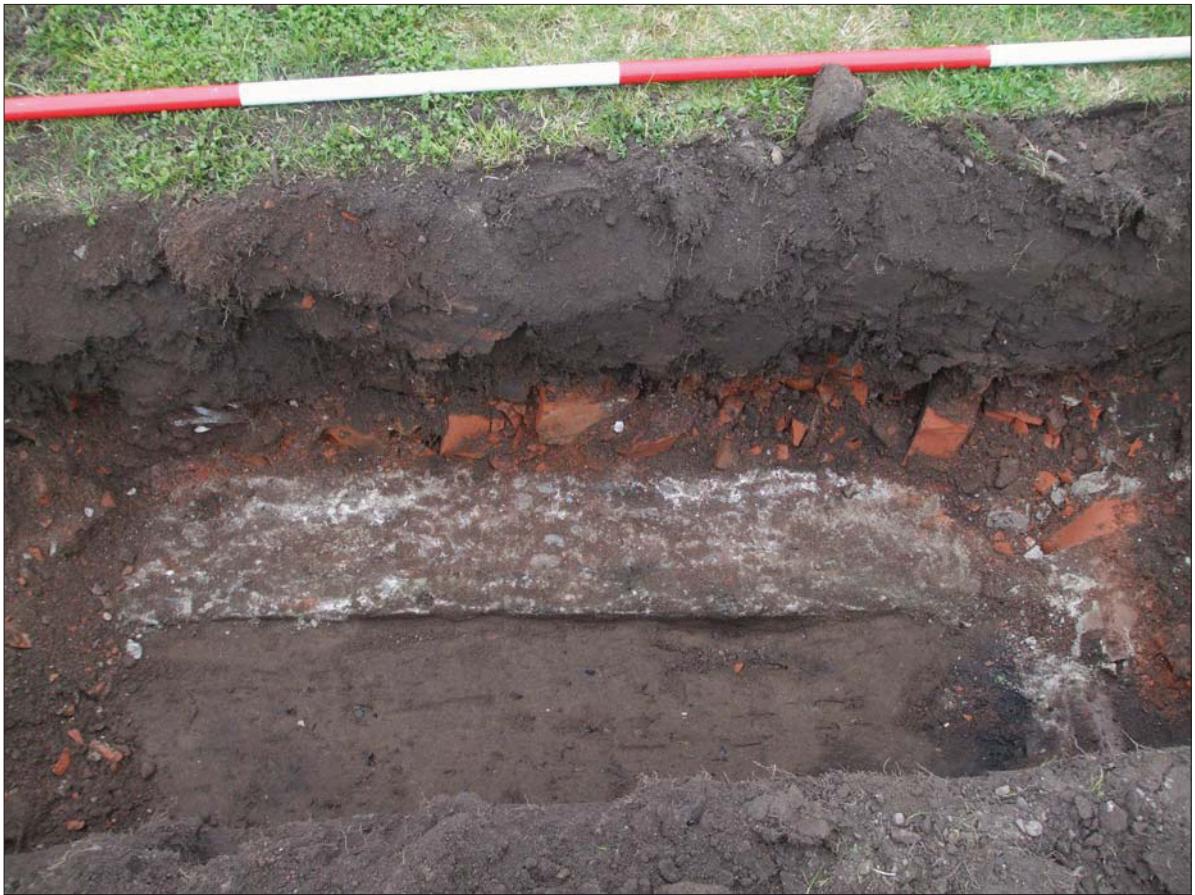
6.6.1 A rectangular trench measuring 2.6 m long x 0.6 m wide x 2.7 m deep, aligned N-S was cut through a layer of landscaping topsoil [400]. This overlay a layer of brick [401] comprising unfrogged brick set on edge bound by a cement mortar. This was aligned N-S with an eastern return at the north end of the trench and found built off a concrete foundation [402] which projected into the trench beyond the base of the brick structure. This feature continued below the west and north trench edges. Below this a layer of brown, improved sand [403] was visible which overlay clean pale brown natural sand [404].

Plate 3: Brick wall remnant 401 and concrete foundation 402 in TP 04, from the east

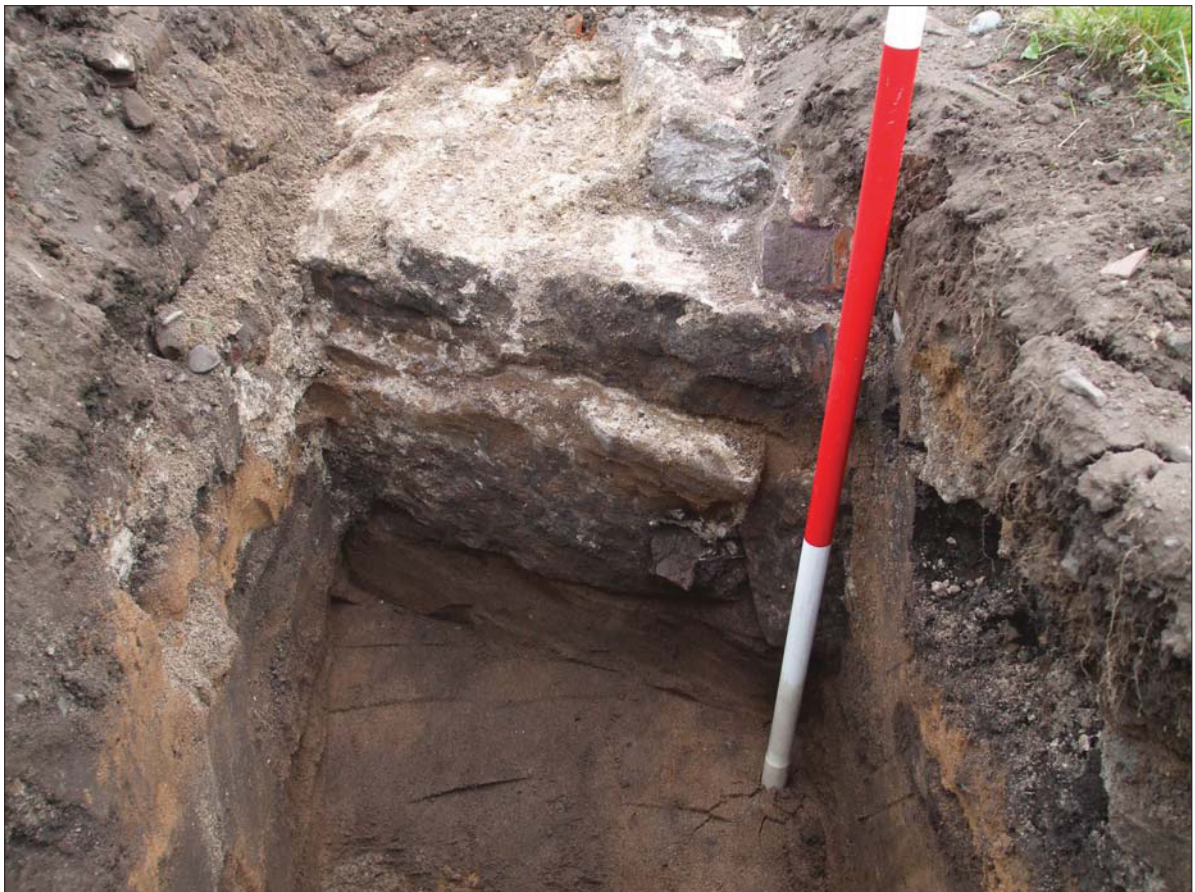
6.11.1 A rectangular trench measuring 2.4 m long x 0.6 m wide x 2.6 m deep, aligned N-S was cut through a layer of topsoil [900], this overlay a layer of brown improved sand [901] which lay directly over clean pale brown natural sand [902]. At the southern edge of the trench a wall [903] was found. This was built from red roughly dressed sandstone bound by a pale grey lime mortar, aligned northwest to southeast built off a foundation course which protruded 0.12 m below the base of the wall which including the found survived to three courses in height. The wall was partially obscured by the southern trench edge.

- 7.1 The watching brief determined that various elements of previous occupation of the site survived below a layer of landscaping material. Some of these features can be assigned interpretations with a degree of confidence. The sandstone wall uncovered in TP09 probably represents part of the building forming a railway siding associated with a timber yard depicted on the map of Forfarshire published in 1903. Similarly the cinder and mortar surfaces may be associated with buildings forming part of the timber yard from this period. The concrete and brick wall recorded in TP04 could also perhaps be attributed to structures depicted on this map, alternatively they may be associated with part of the Montrose Academy, depicted on the OS map published in 1991, which occupied part of the development site until as recently as 2000.

Plate 4: Sandstone wall 903 in TP 09, from the north

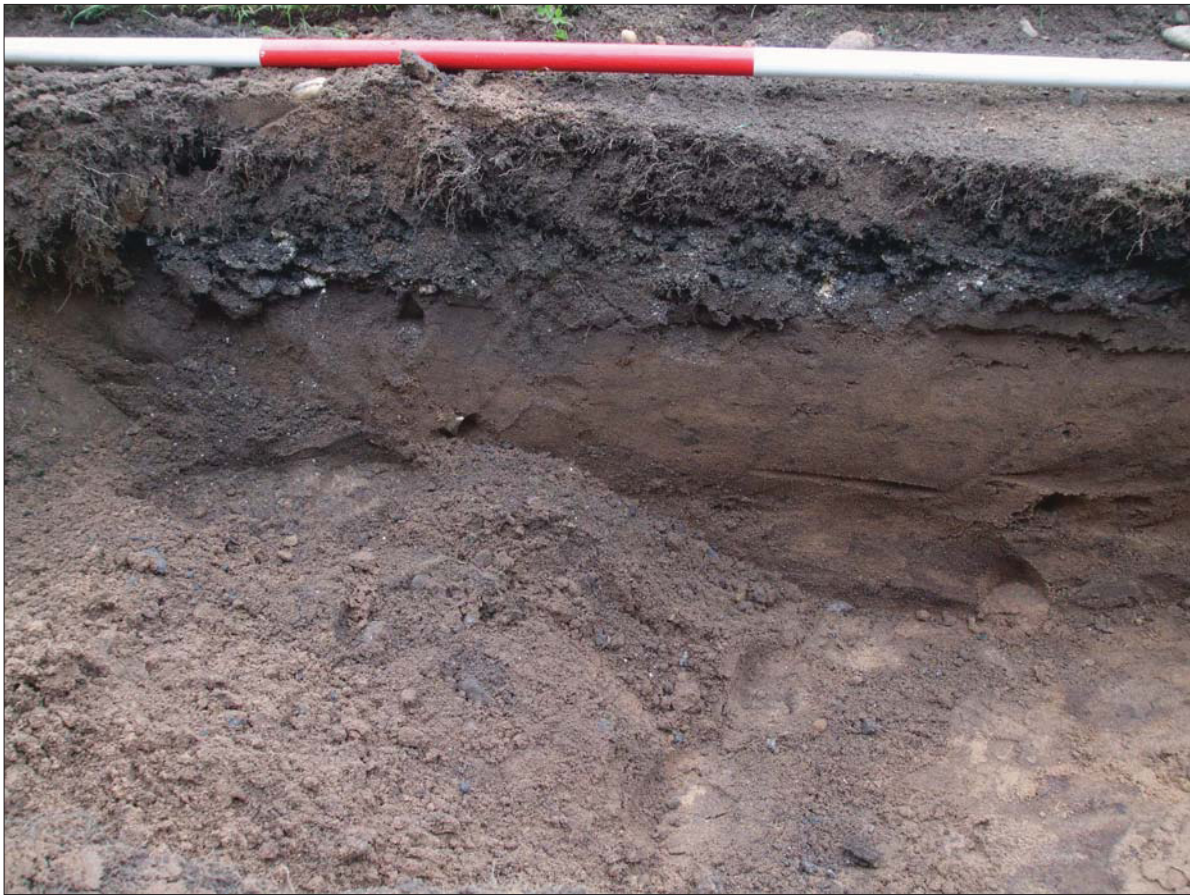
6.7.1 A rectangular trench measuring 2.6 m long x 0.6 m wide x 2.6 m deep, aligned N-S was cut through a layer of landscaping topsoil [500], this overlay a layer of compact cinders in an ashy matrix [501]. Below the cinders a layer of brown improved sand [502] was recorded, this lay directly over clean pale brown natural sand [503].

Plate 5: Landscaping deposit 500, cinder deposit 501 and improved sand 502 in TP 05

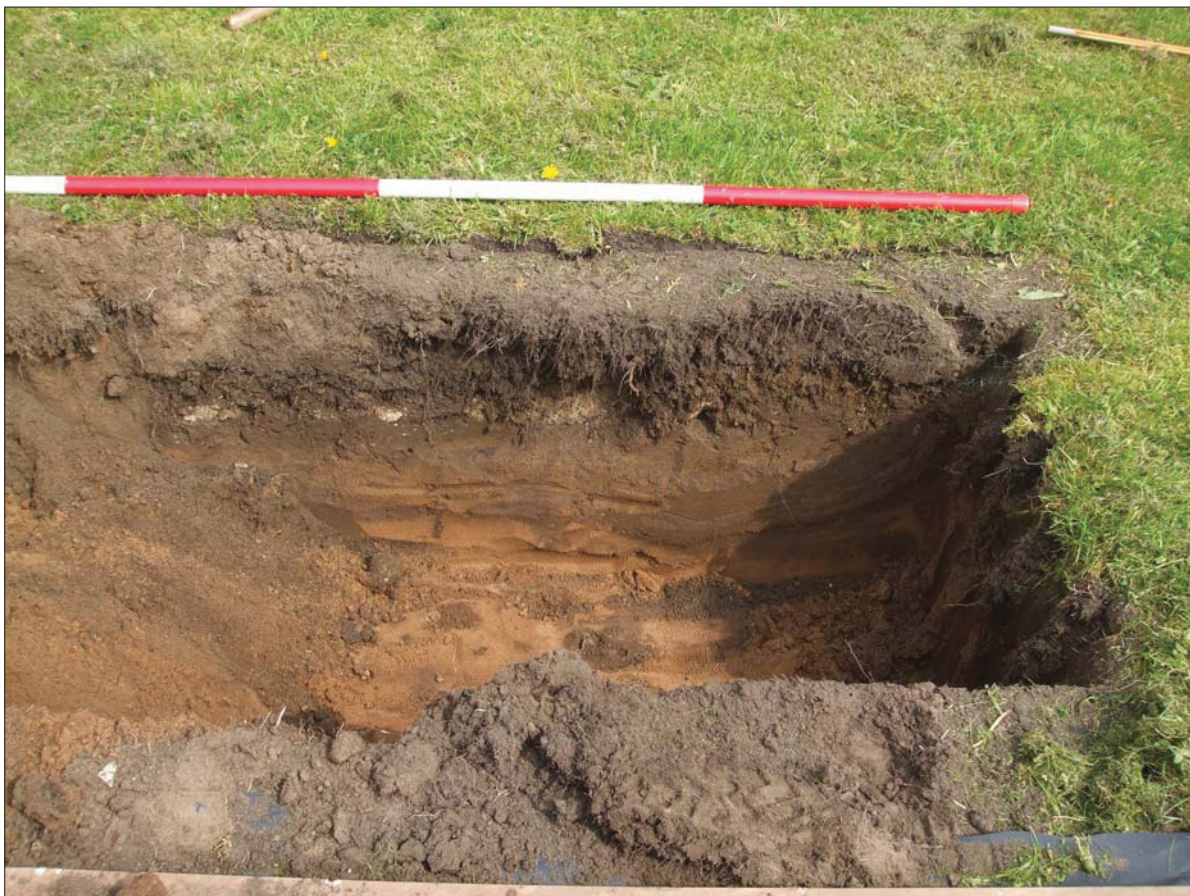
6.10.1 A rectangular trench measuring 2.6 m long x 0.6 m wide x 2.8 m deep, aligned N-S was cut through a layer of topsoil [800], this overlay a thin layer of degraded lime mortar [801]. Below this a layer of brown improved sand [802] was recorded, this lay directly over clean pale brown natural sand [803].

Plate 6: Landscaping deposit 800, mortar deposit 801 and improved sand 802 in TP 08
