North Berwick Harbour Wall Archaeological Watching Brief: Data Structure Report

AOC 21577
25th June 2010

North Berwick Harbour Wall Watching Brief:

Data Structure Report

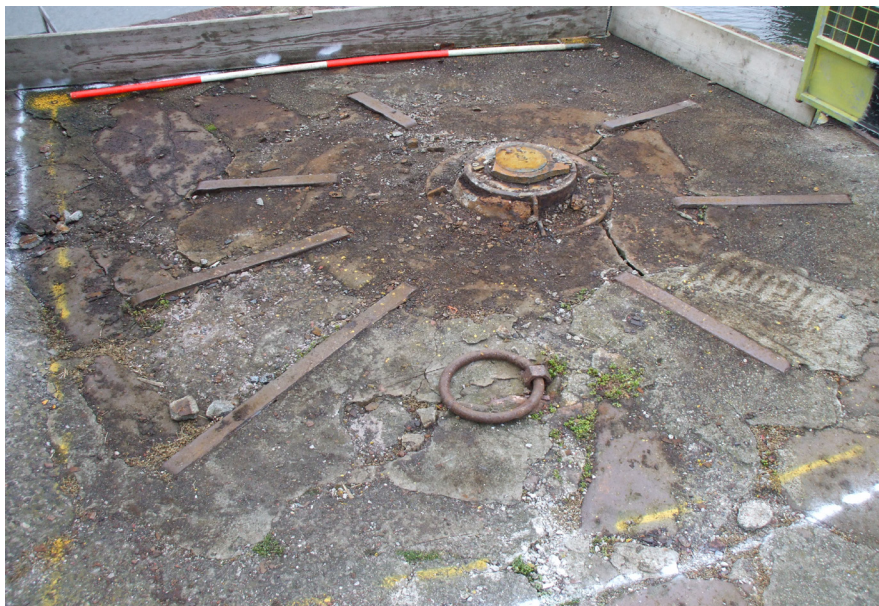
PLATE 1 Old crane base *in situ* prior to works starting

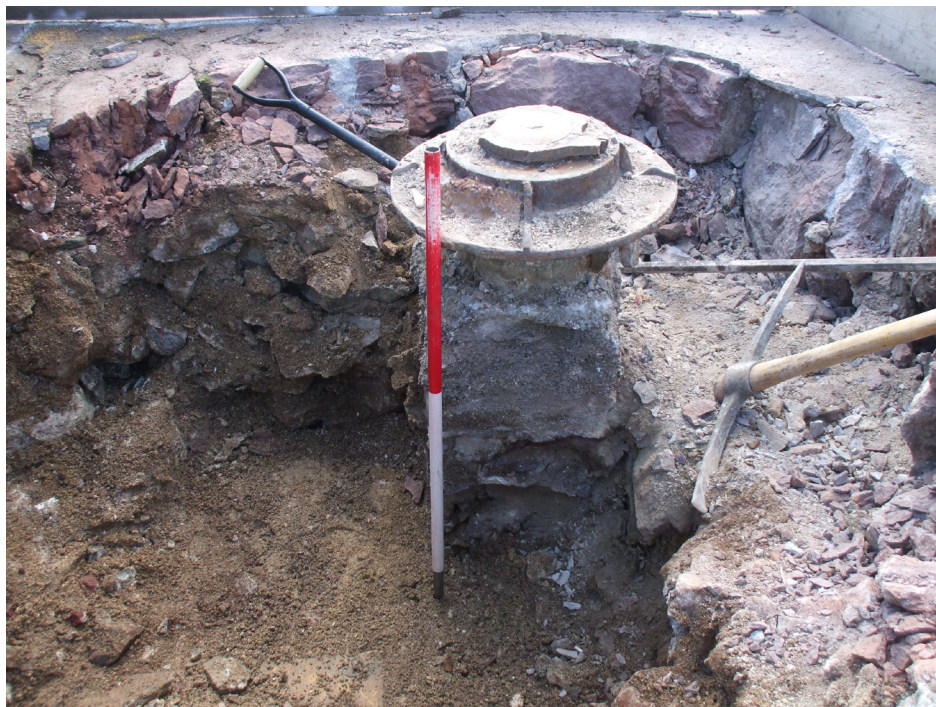
PLATE 2 Old crane base *in situ* prior ready for removal

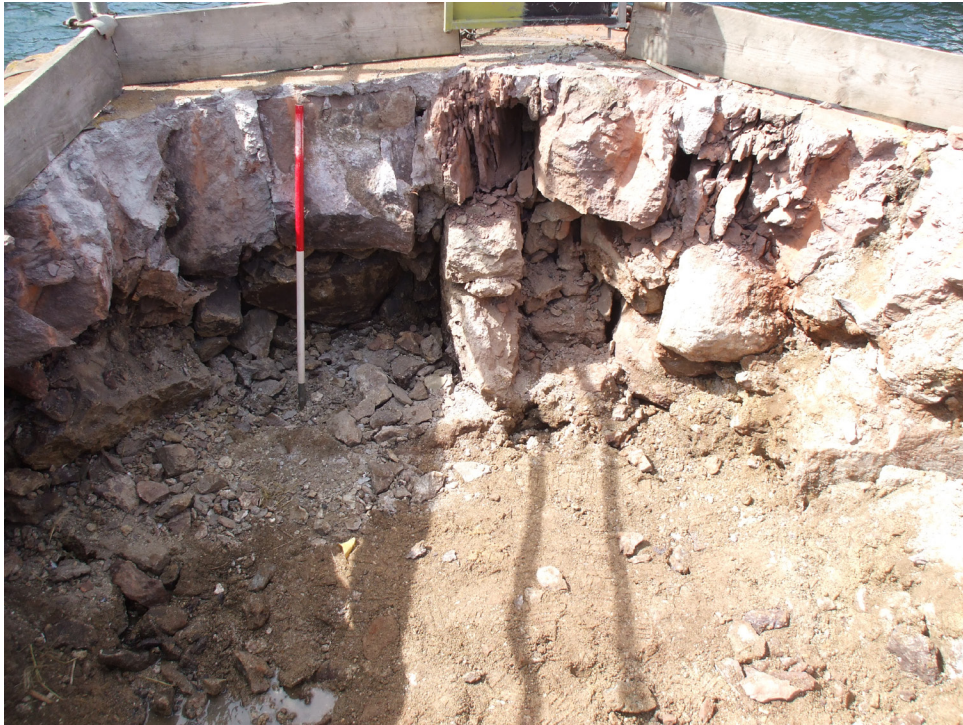
PLATE 3 Concrete layer over sandstone surface over fractured rubble fill with rough blocks, to right of photograph, indicating the original harbour wall construction

- 4.2.2 The surface area around the *in situ* crane pillar comprised a 0.2 m thick slab of concrete. Moving away from the central pillar this concrete surface was much shallower, only 0.03 m thick and directly overlay an earlier upper surface of sandstone blocks, 0.4 m thick, which was missing immediately around the crane pillar. The sandstone blocks/concrete both overlay a mixed rubble deposit consisting of a light yellow/brown coloured sand matrix dominated by small (<0.1 m) to large (up to 0.5 m) sized stone fragments including granite, ironstone and sandstone. This infill deposit was at least 0.90 m deep continuing to the limit of excavations. Rare later 20th century artefacts such as metal cans were apparent within the infill.

- 4.2.3 In the right of Plate 3 you can see the larger *in situ* harbour wall blocks. These form the main structure of the harbour wall, with the fractured infill around the crane pillar representing broken out pieces of the original harbour wall disturbed when the pillar was inserted. These blocks are roughly hewn and larger than the blocks making up the upper surface. They measured between 0.5 m and 0.7 m in size and were bedded in a mortar rich light coloured yellow gritty sand with occasional irregular small stones used as packing.
