# Highwood Hospital, Brentwood, Essex: A Historic Building Record

Planning Application: BRW/201/2010 and BRW/CAC/1/10

AOC Project No: 30947

Date: August 2011

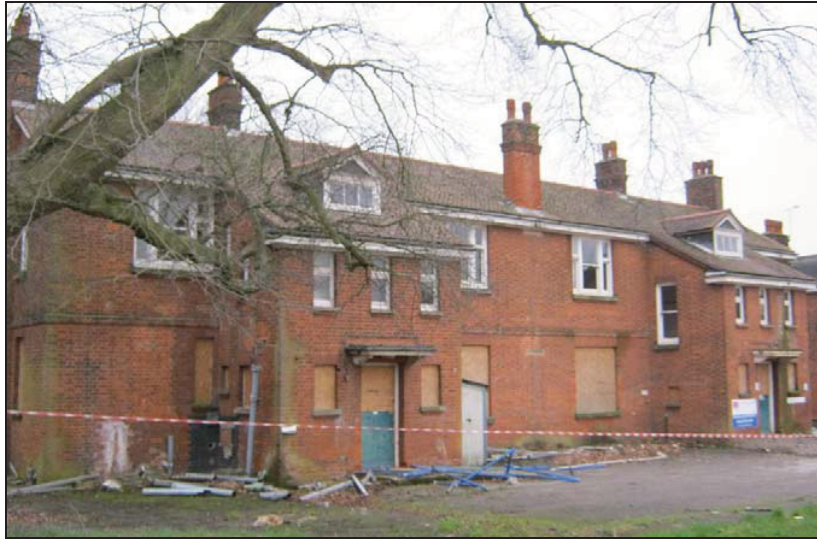
Plate 20: Building EHW 4, Looking West

- 8.3.19 Each windowsill is sandstone, with marks from machine-saws clearly visible. The sandstone is beginning to degrade, particularly on the northeastern face. Each opening is topped by a flat brick arch. The principle entrance is on the southwest side, with a slate lean to roof over a wooden framed porch. The porch floor is pale grey terrazzo, facing the ward EHW1, although there is also a door in the southeast side with an attractive brick arch, and another door in the northeast face. The Etwein Bridges Plan (Etwein Bridges 2005) defines the room beyond the arch as a chapel, but this is unlikely to be the original use.

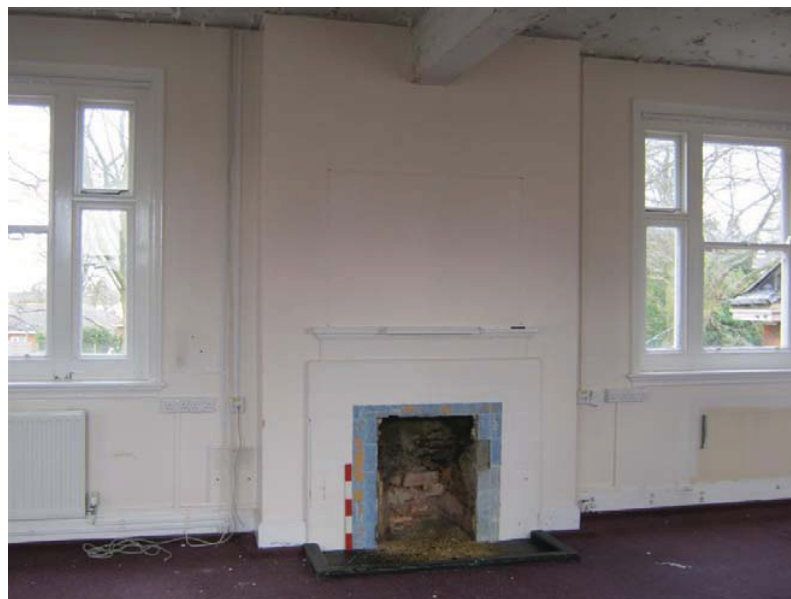
Plate 48: Room 7 Showing Disrepair
