**Outbuilding at  
Moneypot Farm,  
Redgrave, Suffolk  
RGV 048**

**Heritage Asset Assessment**

**April 2011**

## **Heritage Asset Assessment**

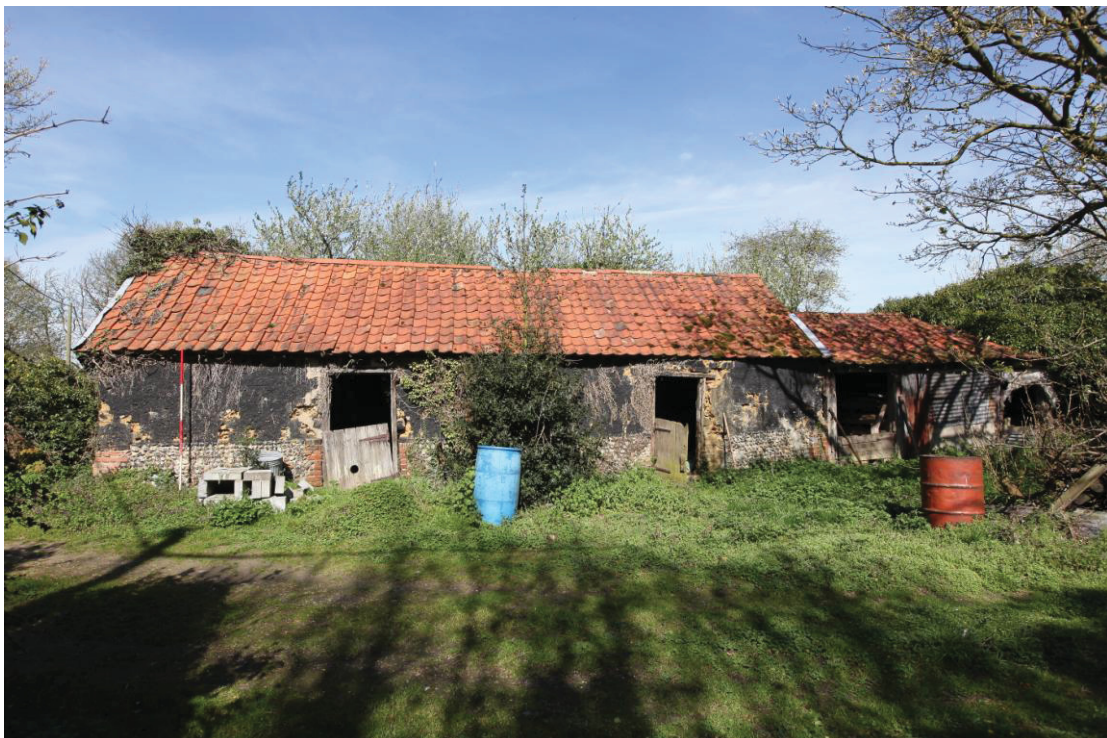
**Illus. 2** The southern exterior of the outbuilding showing the clay-lump shed (1) to the left and the boarded shed (2) to the right, both with two entrance doors and pantiled roofs.

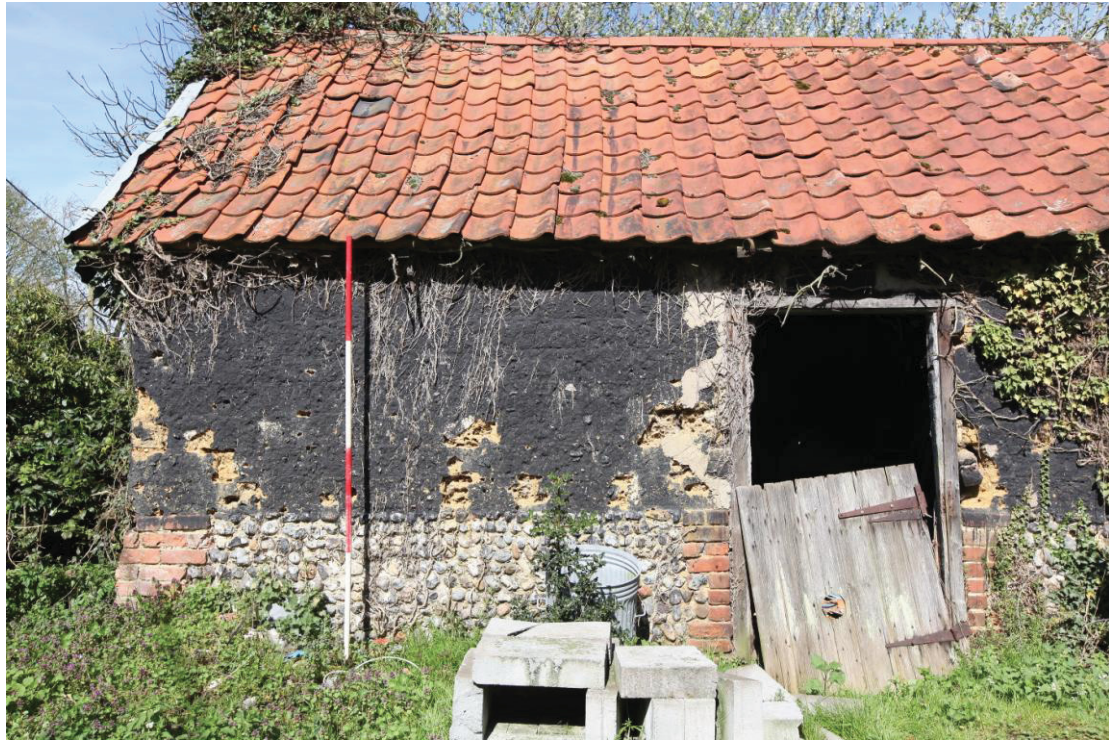
11. Detail of flint plinth and tarred daub to western end of southern exterior (1a) showing invasion by bees.
12. Eastern end of southern exterior of clay-lump shed (1b) showing original doorway with red-brick dressing to flint plinth.

**Illus. 3** The western end of the southern exterior of the clay-lump shed (1) showing the original doorway to the western compartment (1a) with red-brick dressing to the flint plinth. The clay-lump fabric has suffered damage from tunnelling bees where the tar is lacking.

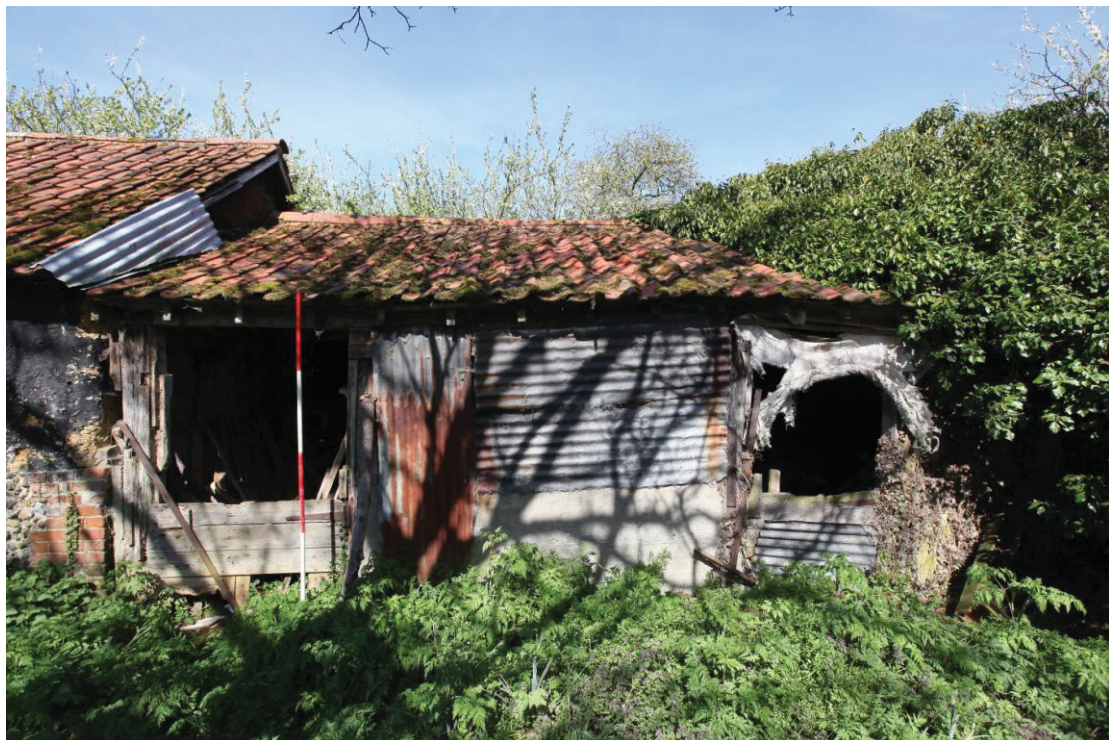
**Illus. 4** The southern exterior of the boarded shed (2) showing the 20th century corrugated iron cladding to the western compartment (2a) and the entrance to the eastern compartment (2b) to the right.

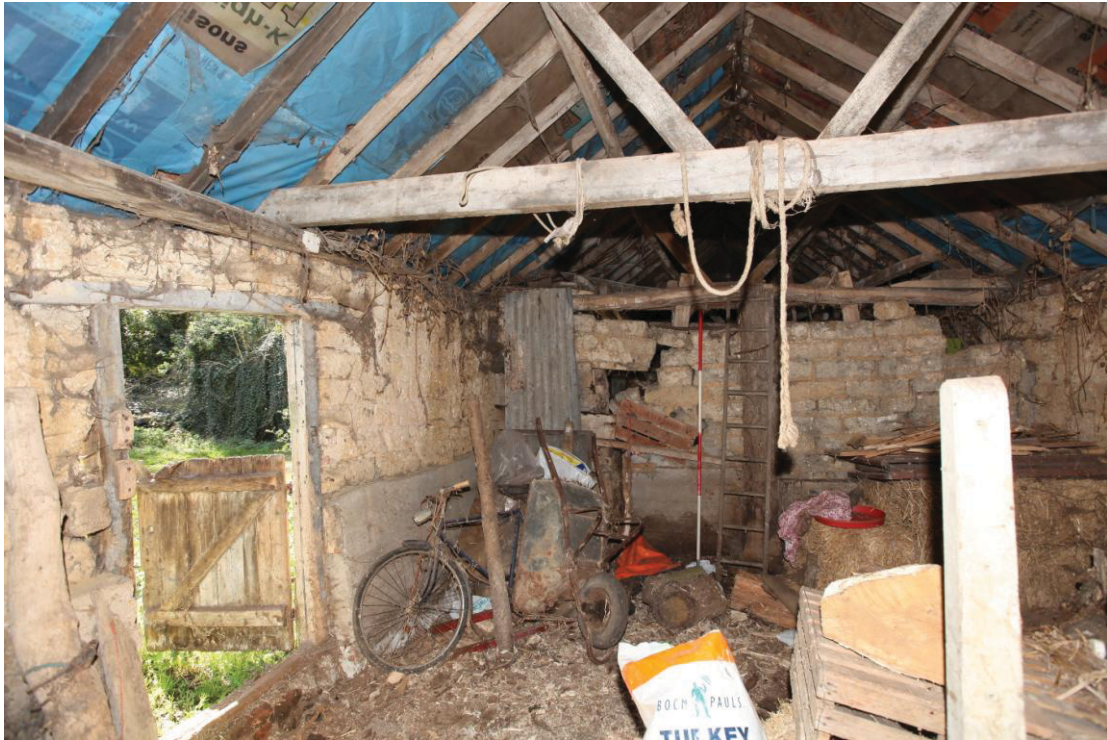
**Illus. 7** The interior of the eastern clay-lump shed (1b) from the east showing its southern entrance to the left and the clay-lump internal partition to the western shed in rear (the latter rising only the tie-beam).

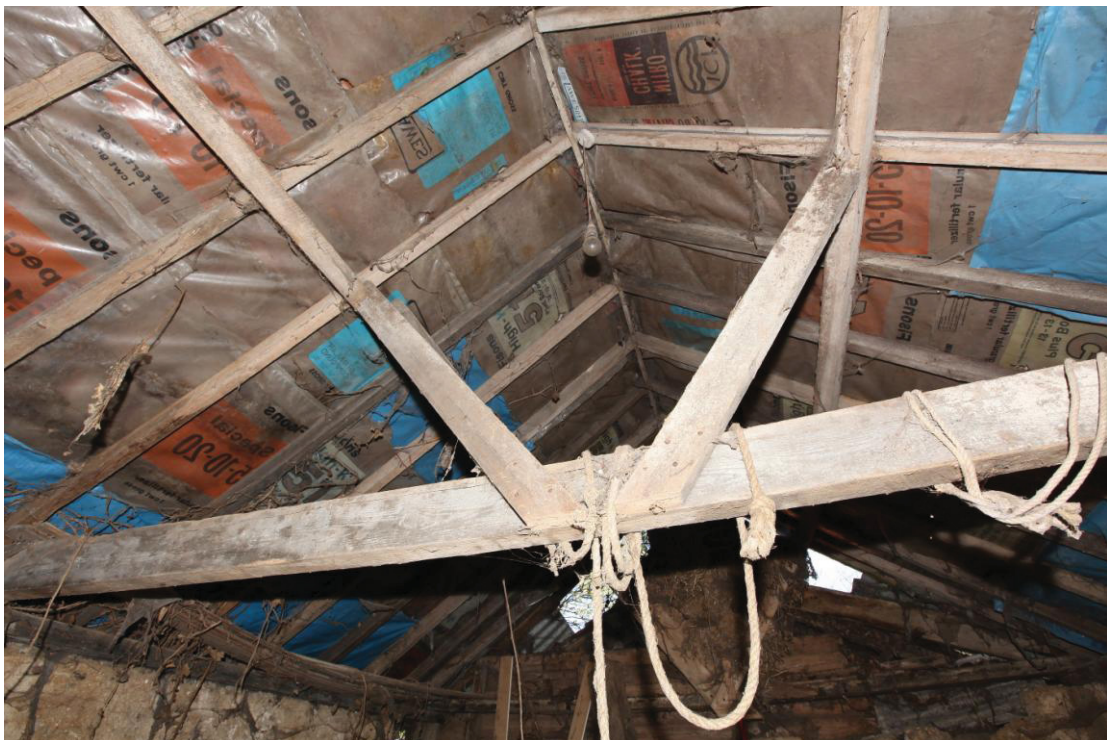
**Illus. 8** Detail from the west of the rebuilt 20<sup>th</sup> century roof structure in the eastern clay-lump shed (2b) showing its crudely nailed softwood struts and tie-beam.

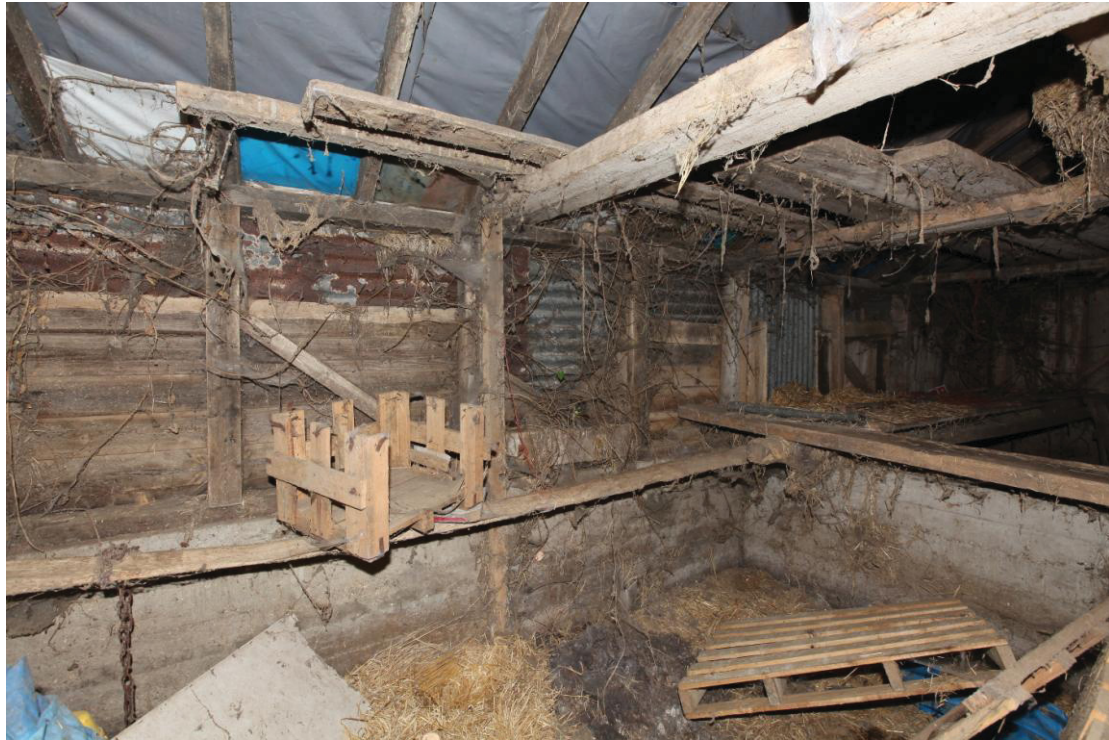
**Illus. 9** The northern interior of the boarded shed (2) from the south-west showing the internal storage shelf and horizontal external weatherboarding beneath the later cladding of corrugated iron.

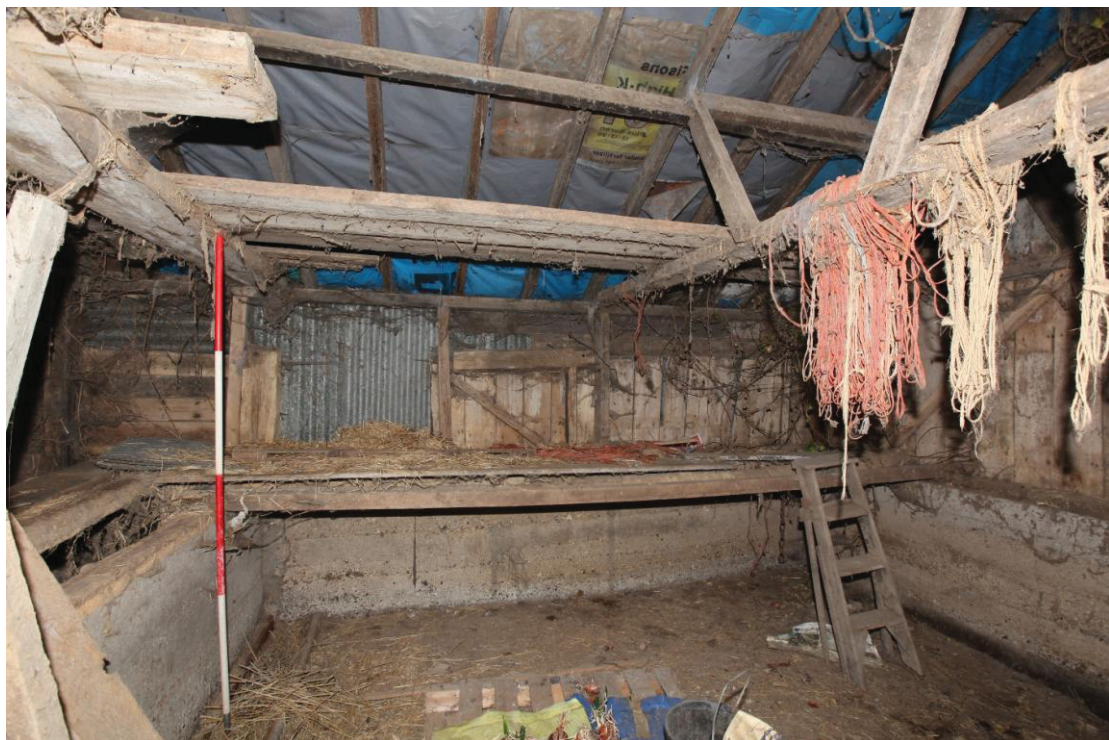
**Illus. 10** The northern interior of the eastern boarded shed (2b) showing the storage shelf and a possible blocked doorway adjoining the low internal partition of shuttered concrete to the left.
