**The Church of St. Mary, Friston (FRS 007),
Report of Archaeological Recording.
SCCAS Rpt No. 2005/141, Oasis No.Suffolkc1-10256**

Introduction

A program of works aimed at alleviating the problems with damp and salt crystallisation on the internal walls of the nave and, particularly, the chancel involved the removal of the bottom two metres of external render on the chancel east wall and c.1.1 metre on the nave north wall. A condition of the faculty grant required that archaeological recording of the exposed wall fabric be undertaken.

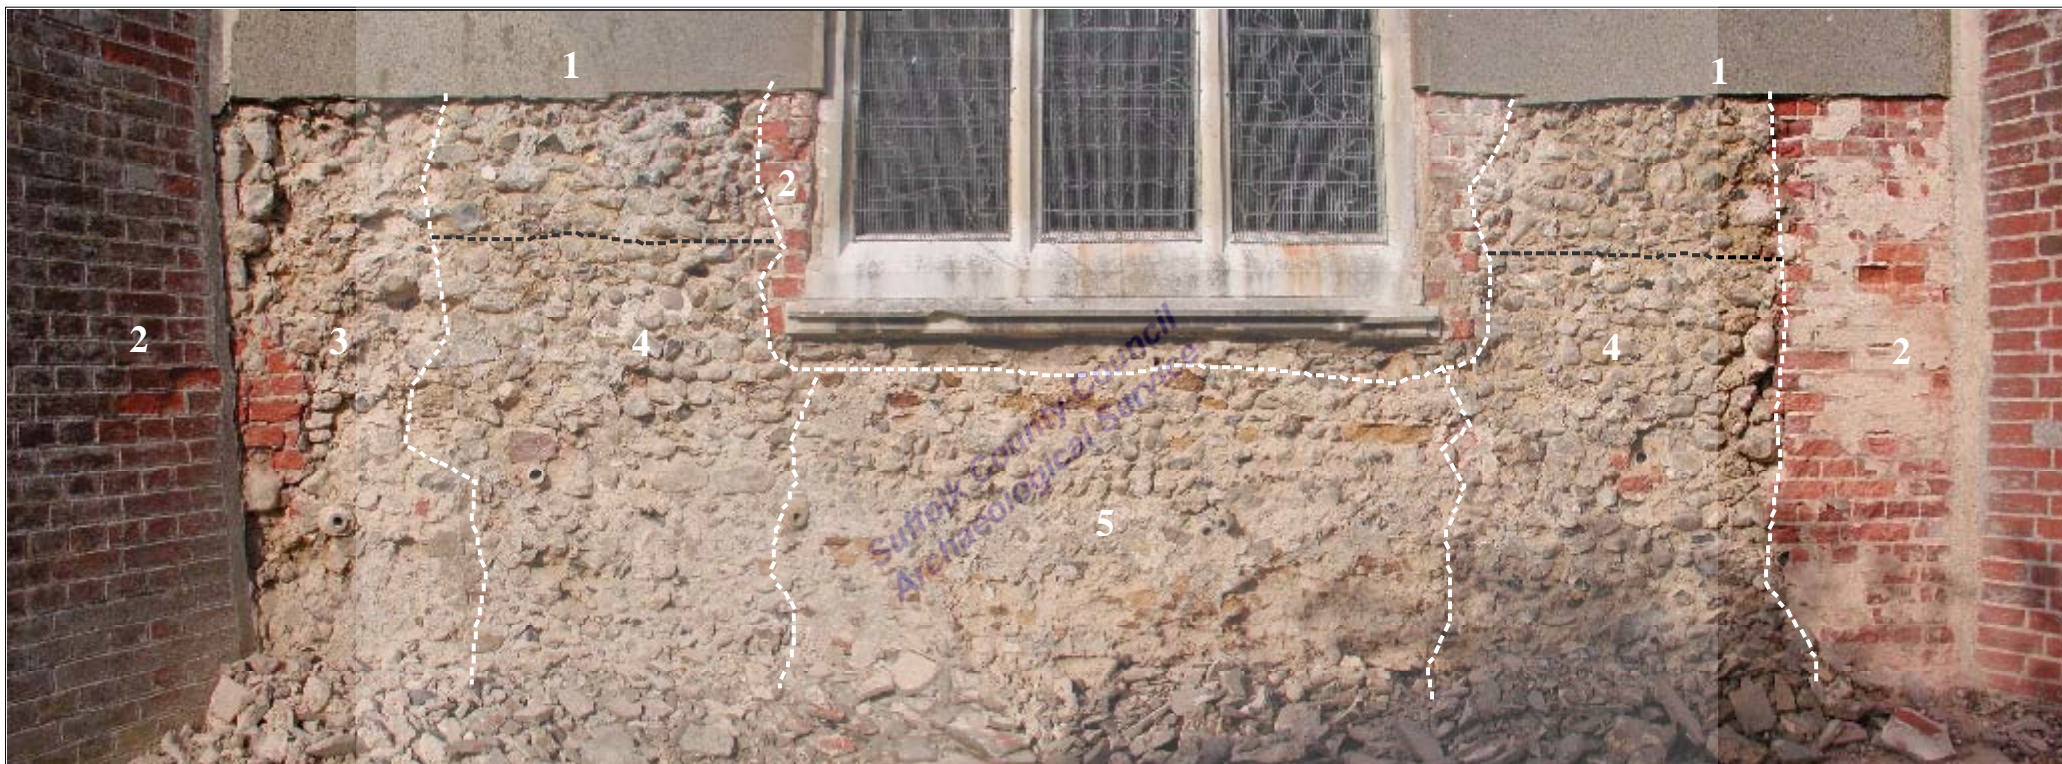
Plate 1 Chancel East Wall

Located in a narrow, 0.75 metres, wide strip at the southern end of the east chancel wall bounded by ***Fabric 4*** to the north and ***Fabric 2*** to the south and included a small area of ***Fabric 2*** brick work (Plate 1).

Comprised predominantly of roughly lain flints and included a moderate number of irregular limestone fragments. The lime mortar matrix was relatively unconsolidated and had been extensively pulled away when the render was removed.

Recorded as two c.1.25 metre strips in the eastern wall of the chancel (Plate 1).

Comprising randomly lain cobbles, predominantly of unknapped flint with some ferruginous sandstone, set in a buff coloured lime mortar with frequent chalk lumps. One constructional lift-line was visible at the same level on either side of the window and is shown as a black dotted line on Plate 1.

Located in a c.2.25 metre wide vertical strip below the east window of the chancel (Plate 1).

This fabric comprised poorly coursed, predominantly unknapped flints with approximately 20% fragments of Chillisford crag. The lime mortar bonding was of a lighter colour than that in the adjacent ***Fabric 4***.

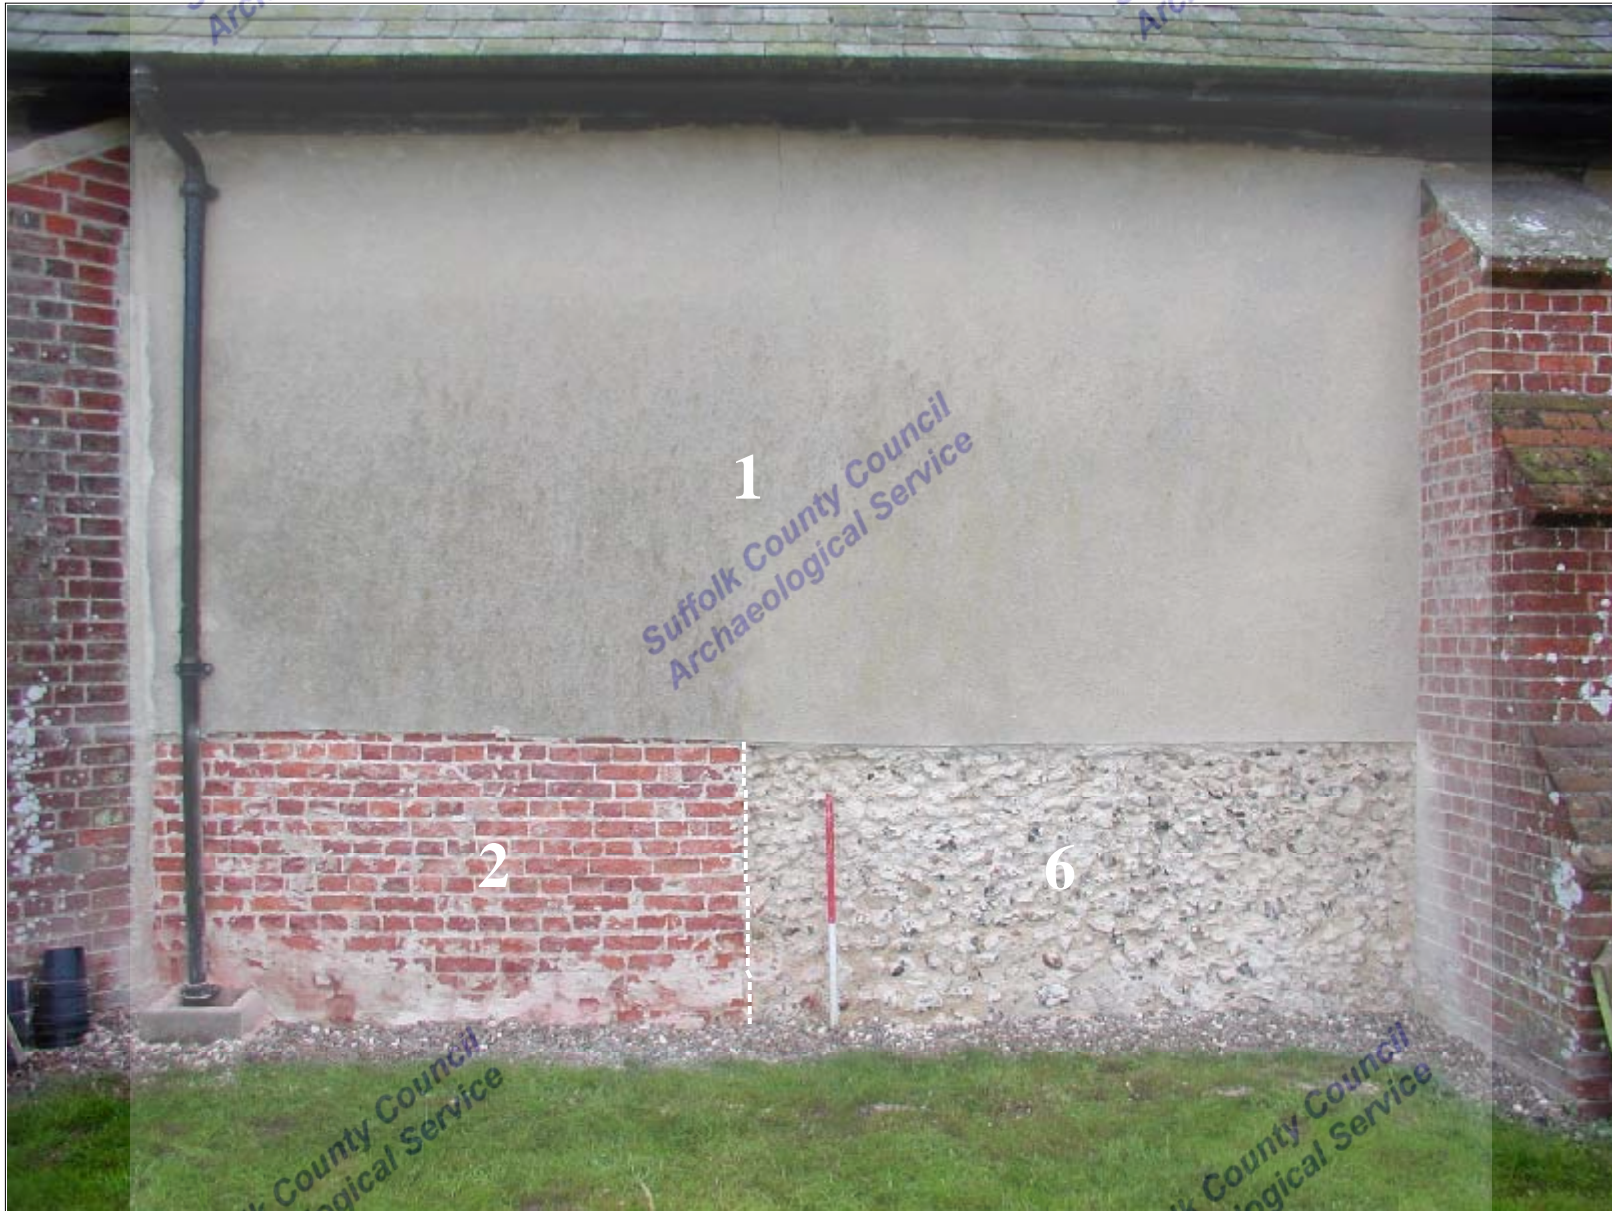
Plate 2 Chancel North Wall

Recorded at the western end of the chancel north wall (Plate 2).

Comprised relatively randomly lain unknapped flint cobbles, with just a hint of coursing, set in a cream/buff coloured lime mortar with common chalk inclusions.

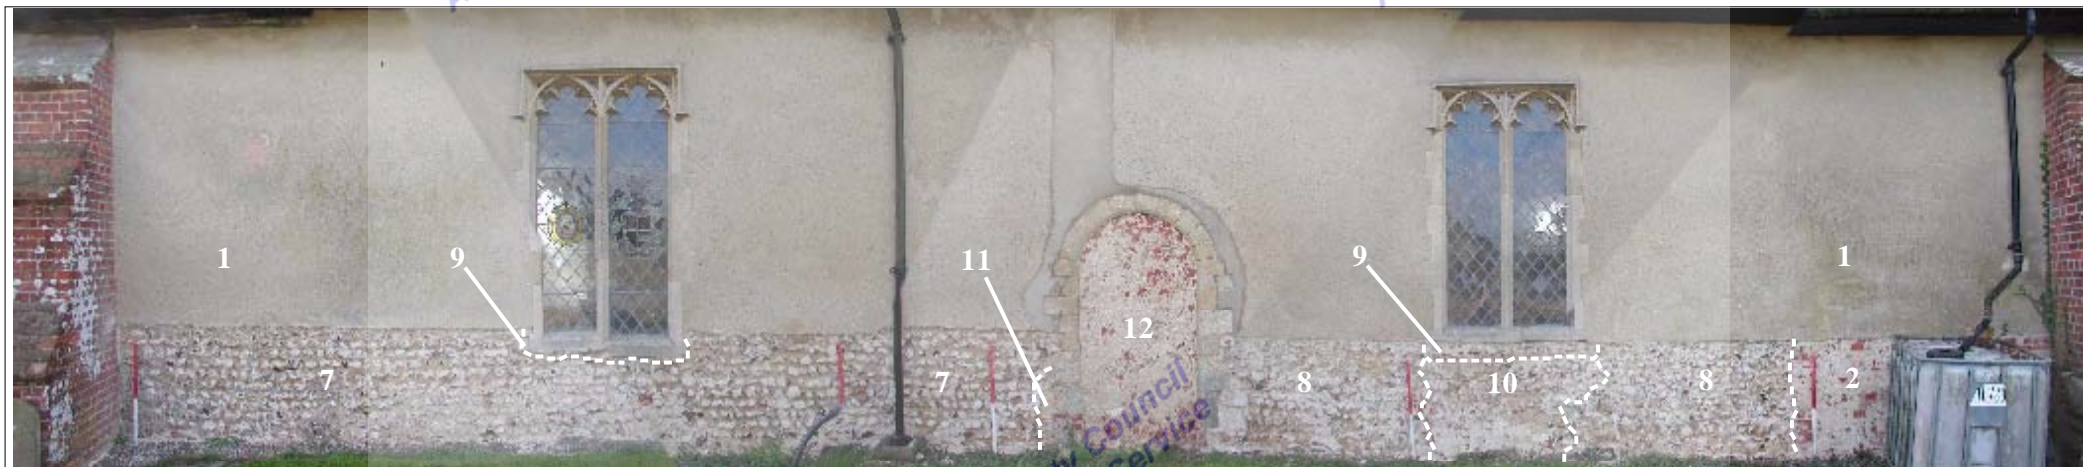
Plate 3 Nave North Wall

This fabric represented the majority of the nave north wall fabric from the eastern side of the doorway to the buttress at the junction with the chancel (Plate 3).

Recorded as two separate areas to the west of the north nave doorway (Plate 3), this fabric was initially thought to be different to ***Fabric 7*** to the east. However, on closer examination it became clear that similar horizontally coursed flint cobbles were present but had been partially obscured by later surface treatment.

This fabric effectively represented the insertion packing around the windows in the north nave wall (Plate 3). In the case of the west window this fabric may have been contemporary with ***Fabric 10*** below.

Located below the westernmost of the two windows in the north wall of the nave (Plate 3), this patch of fabric may have been contemporary with ***Fabric 9*** surrounding the inserted window.

Recorded filling the nave north doorway (Plate 3), this fabric comprised fragments of red brick, similar to those of ***Fabric 2***, set in a hard lime mortar.

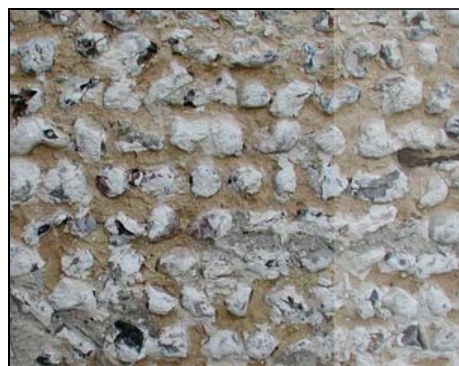
Detail of Fabric 7

Consisting of well coursed, unknapped flint cobbles set in a course brown lime mortar. Any constructional lift-lines that were present had been obscured by later repointing or surface treatment.

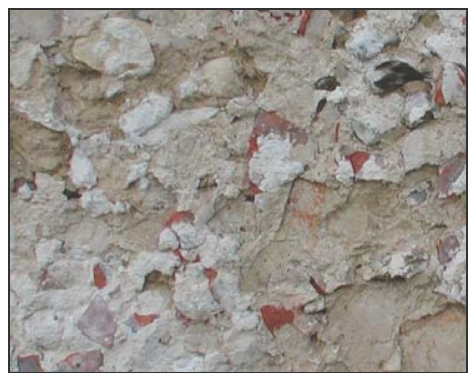
Detail of Fabric 10

The fabric comprised randomly lain flints with fragments of red brick and roof-tile set in a hard lime mortar.

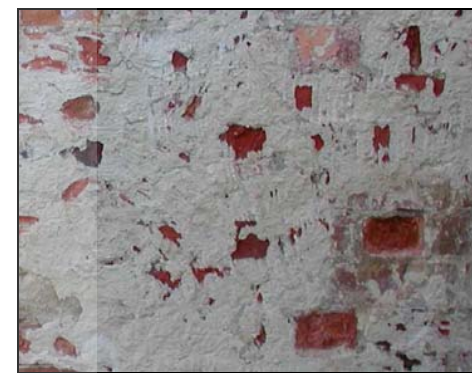
Detail of Fabric 2

The bricks measured 23 x 10.5 x 7 centimetres (9 x 4¹/₄ x 2¹/₂ inches) and were bonded with a relatively hard lime mortar.
