**Barn at Pond Farm,
Thrandeston,
Suffolk
TDE 022**

Heritage Asset Assessment

June 2011

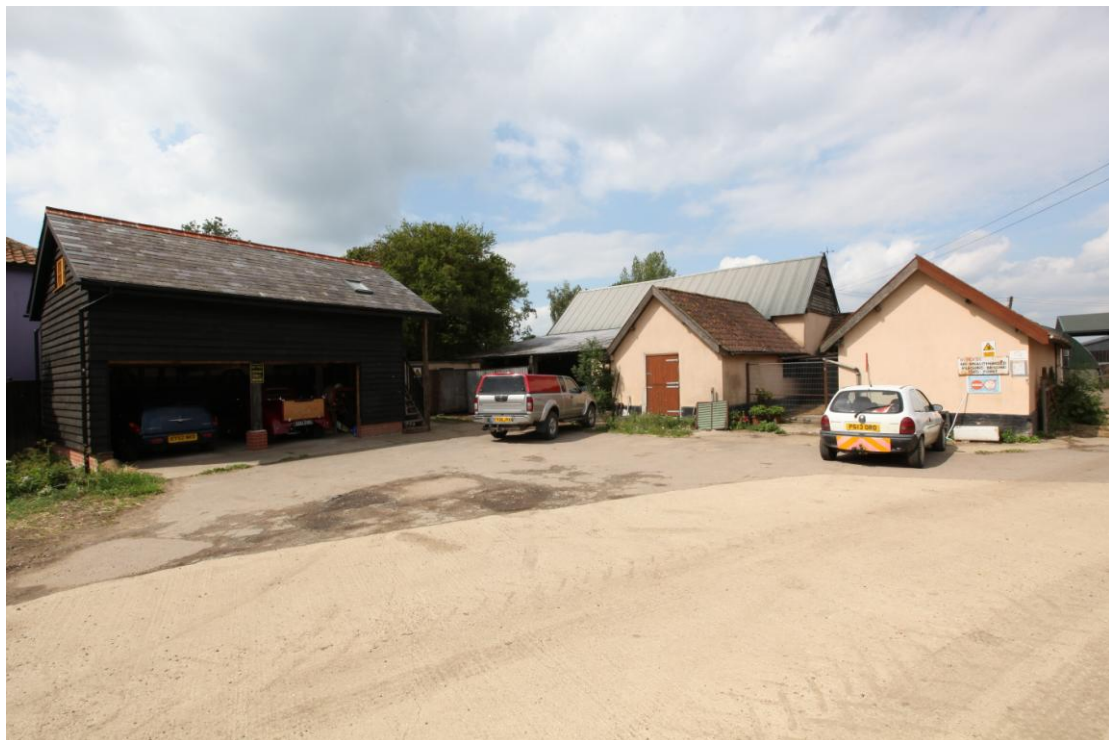
Illus. 2 The Farm complex from the eastern yard flanked by the farmhouse and the previously converted cart lodge and granary shown to the left. The eastern gables of the 19th century clay-lump shelter shed (6) and wood shed (7), now largely cement-rendered, are visible in the foreground with the 16th century timber-framed barn (1) in the rear.

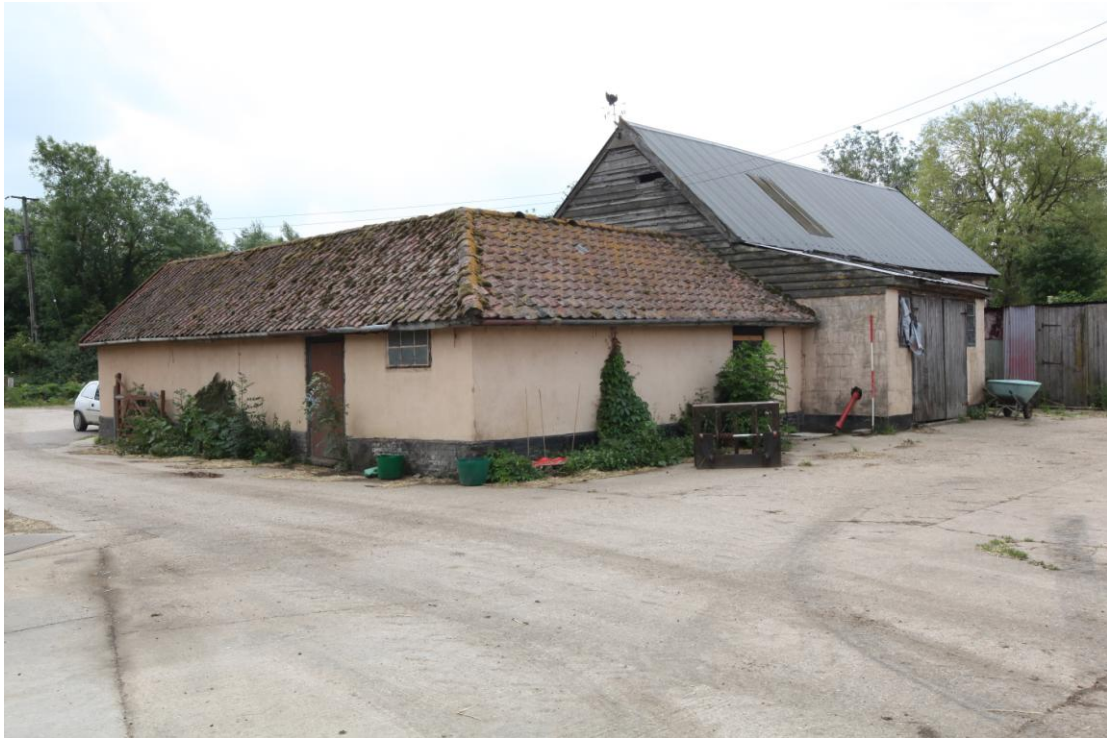
Illus. 3 The farm complex from the north-west showing the 19th century clay-lump former stable (4) and wood shed (7) in the foreground with the 16th century timber-framed barn (1) in the rear to right.

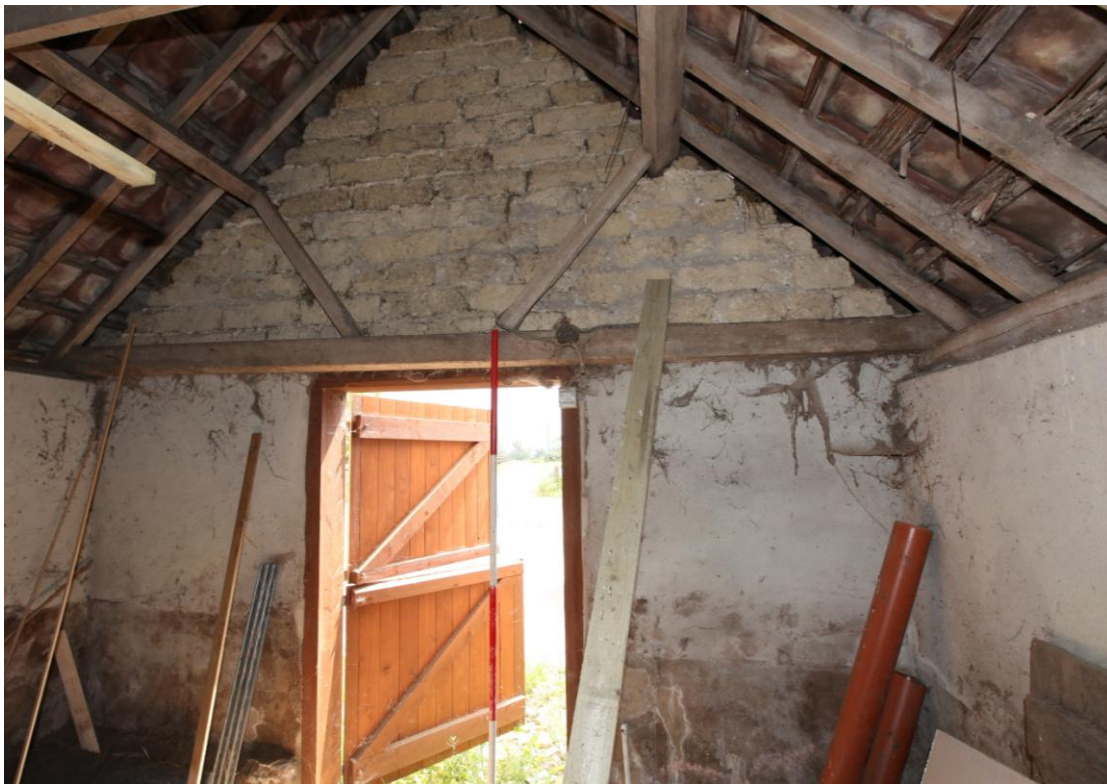
Illus. 4 The internal eastern gable of the clay-lump shelter-shed (6) showing its exposed original clay-lump fabric above the tie-beam and modern door.

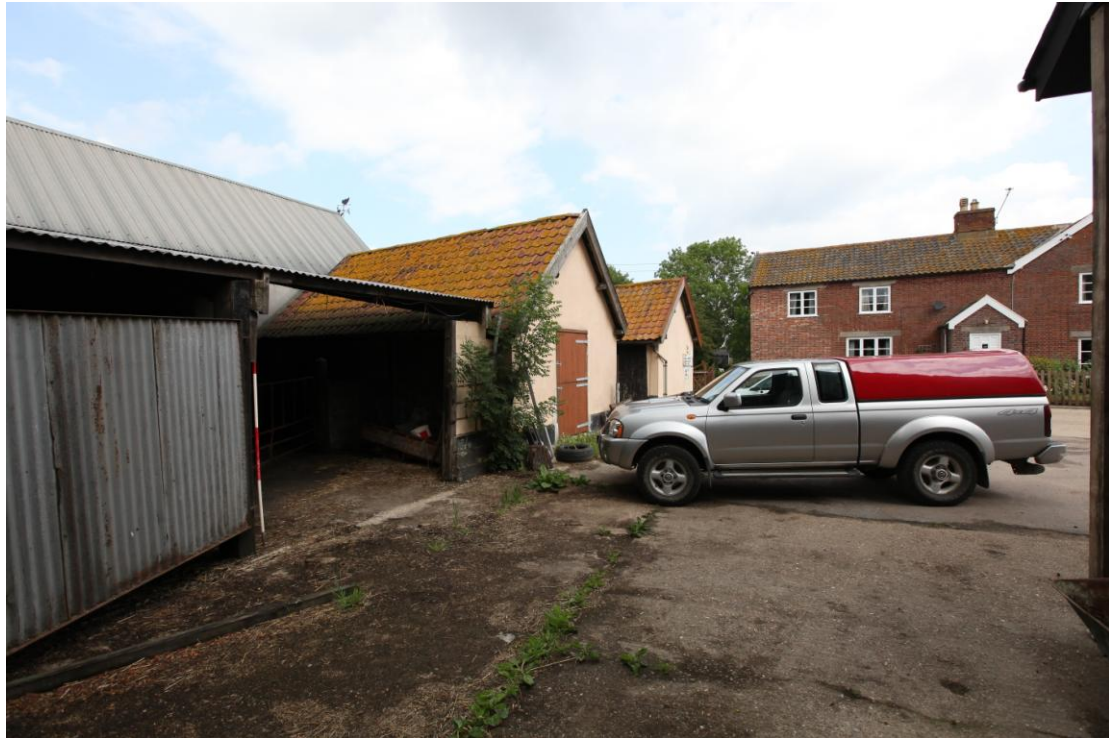
Illus. 5 The eastern exterior of the covered cattle yard (5) from the south-east (left) showing the clay-lump sheds (6 & 7) in the centre and the 18th century farmhouse with 19th century brick cladding in the rear to right.

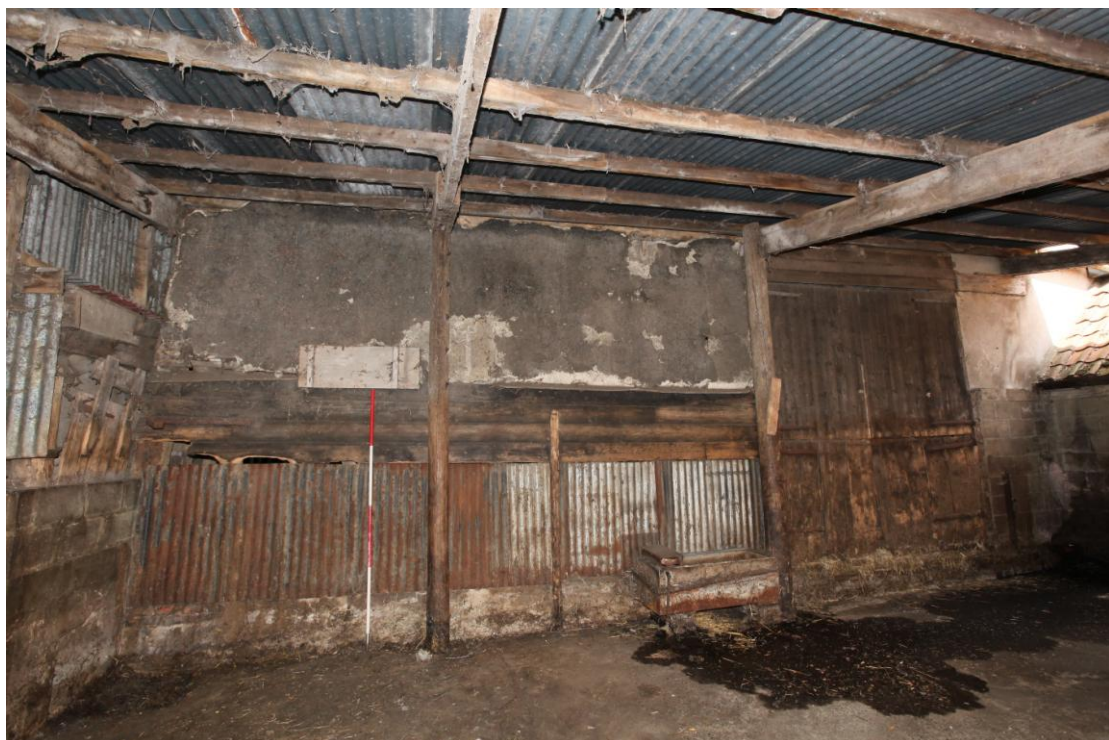
Illus. 6 The eastern exterior of the barn (1) from the covered yard (5) showing its early-19th century two-tier cladding of tarred lath-and-plaster above weatherboarding and corrugated iron. The 20th century half-hung doors of the original entrance bay are shown to the right.

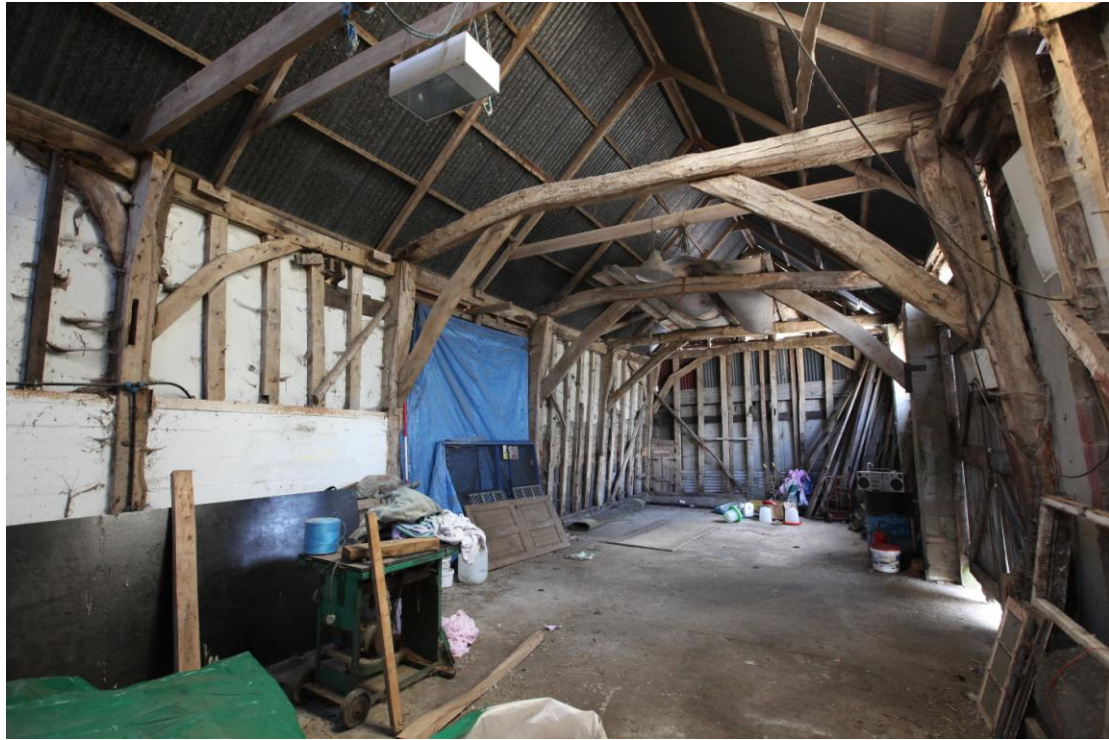
Illus. 7 General view of interior of barn (1) from north showing the largely intact timber frame with original tie-beams and arch-braces but with a 20th century roof structure. The northern gateway (1a) is shown to the left.

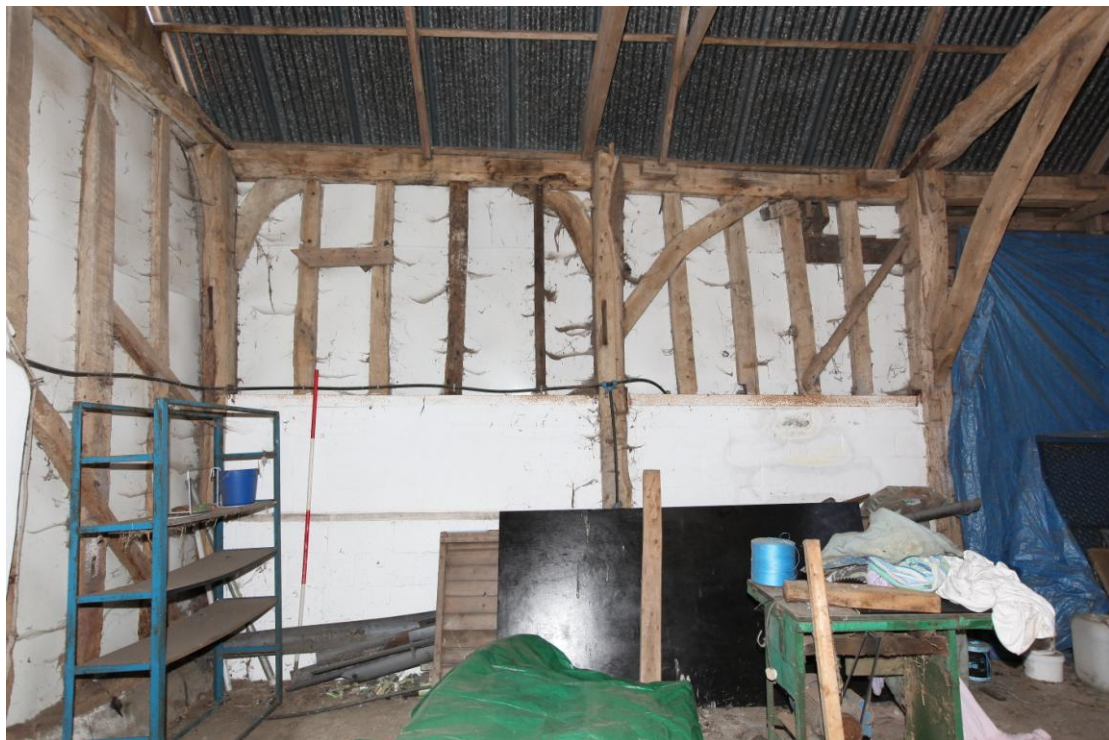
Illus. 8 The eastern interior of the barn (1) showing the original corner brackets and later studs of northern gateway (1a) to the left and the main entrance to the threshing barn behind the blue tarpaulin to the right. The arched gateway was divided by the barn by a missing partition at the central post from which the studs and tie-beam have been removed, and contained a high loft as indicated by joist mortises in the gable tie.

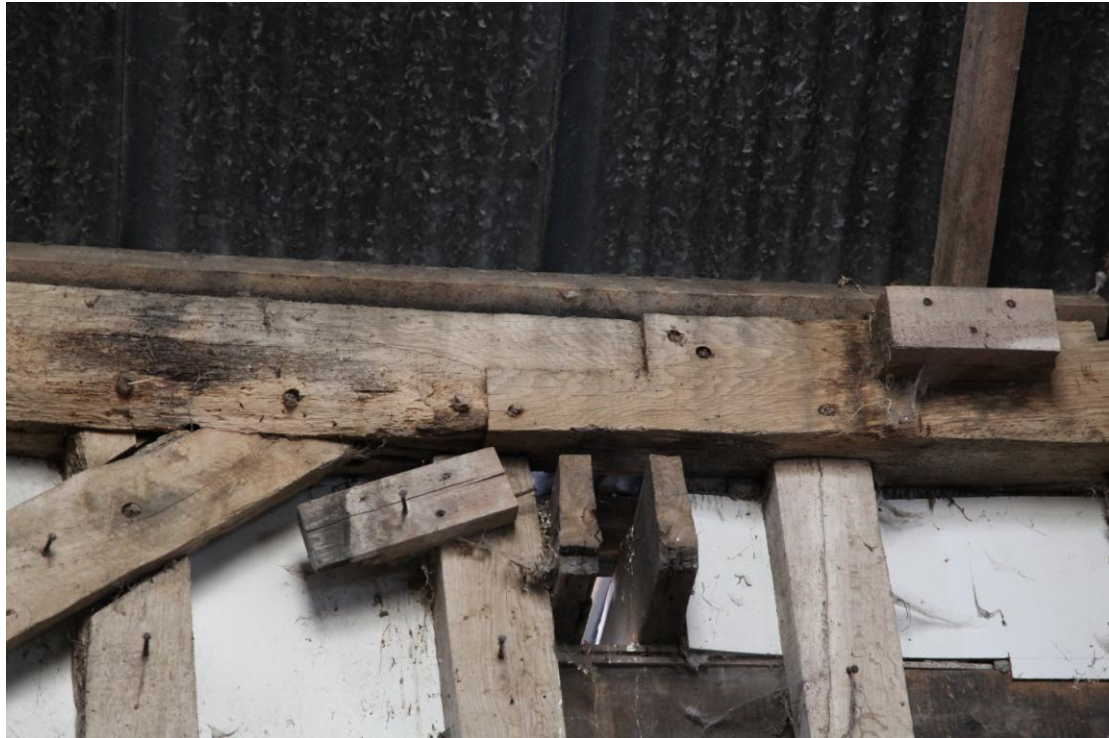
Illus. 9 Detail of the 16th century type edge-halved and bridled scarf joint in penultimate bay of the eastern roof plate of the barn (1) as shown to the right in illus. 8 above.

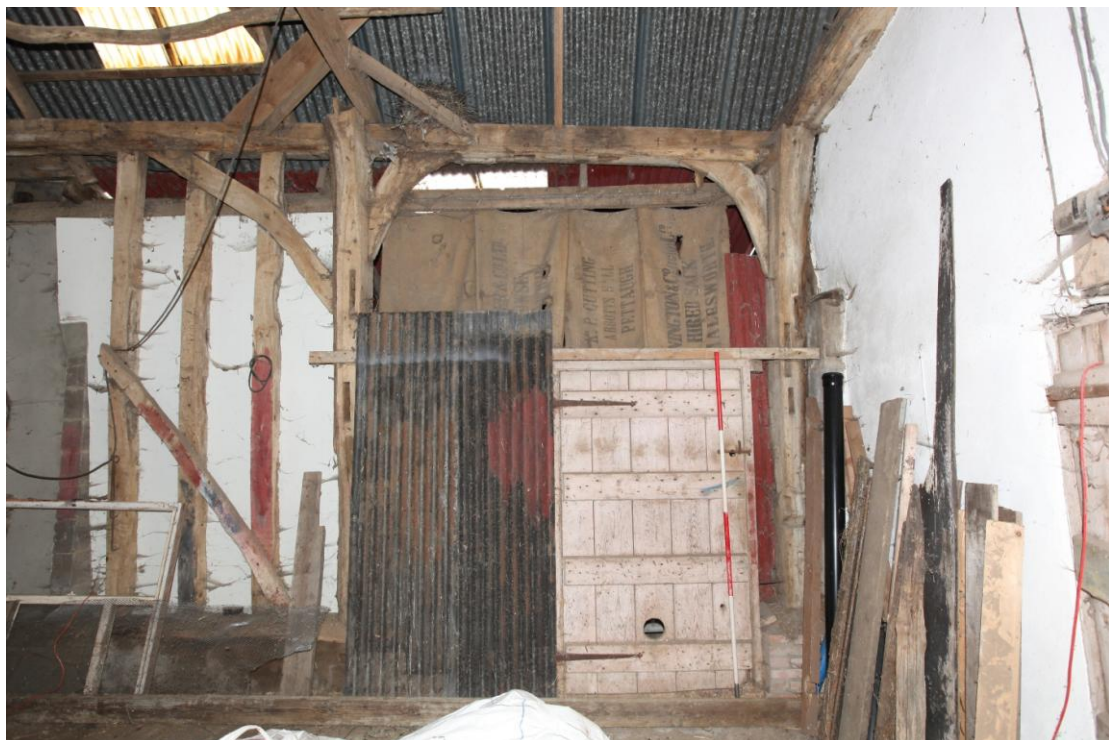
Illus. 10 The western interior of the original gateway (1a) at the northern end of the barn (1) showing the mortise of a wall brace belonging to the missing internal partition in the storey post to the left. The western end of the tie-beam to the right lacks stud mortises and overlapped a pre-existing structure which no longer survives.

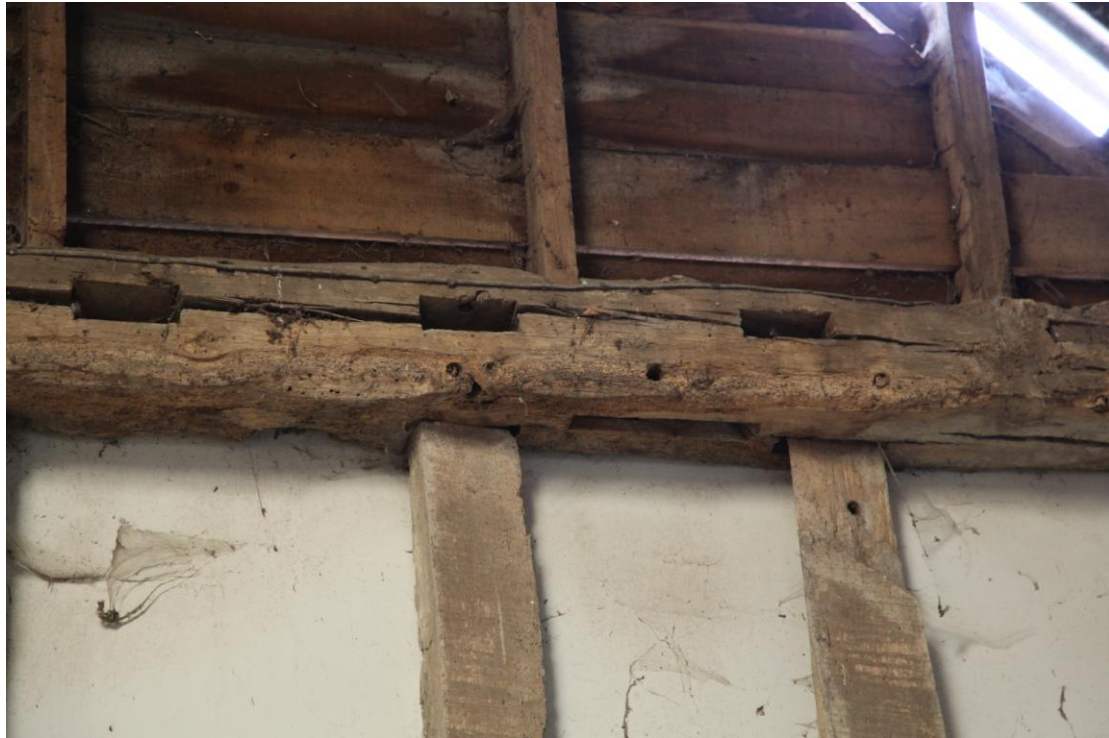
Illus. 11 Detail of the tie-beam of the northern gable of the barn (1) showing a series of 11 original pegged mortises for the missing joists of a loft above the gateway (1a). The studs are also original, with an empty mortise and trench for an internal wall brace.

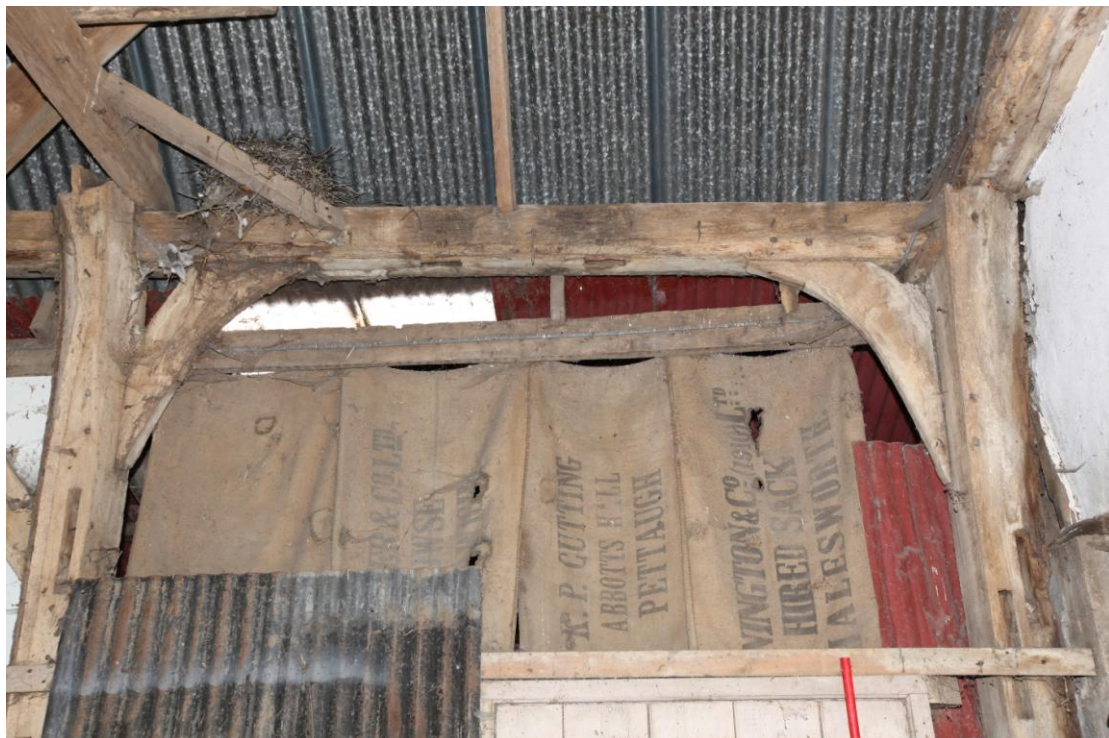
Illus. 12 Detail of the western roof-plate of the gateway (1a) showing its original corner brackets (fully tenoned and pegged to the frame) with a series of mortises for later studs which have since been removed.
