**Outbuilding at  
Valley Farm,  
Coddtenham, Suffolk  
CDD 076**

**Historic Building Record**

# **Outbuilding at Valley Farm, Blacksmith's Lane, Coddendam, Suffolk**

## **Historic Building Record**

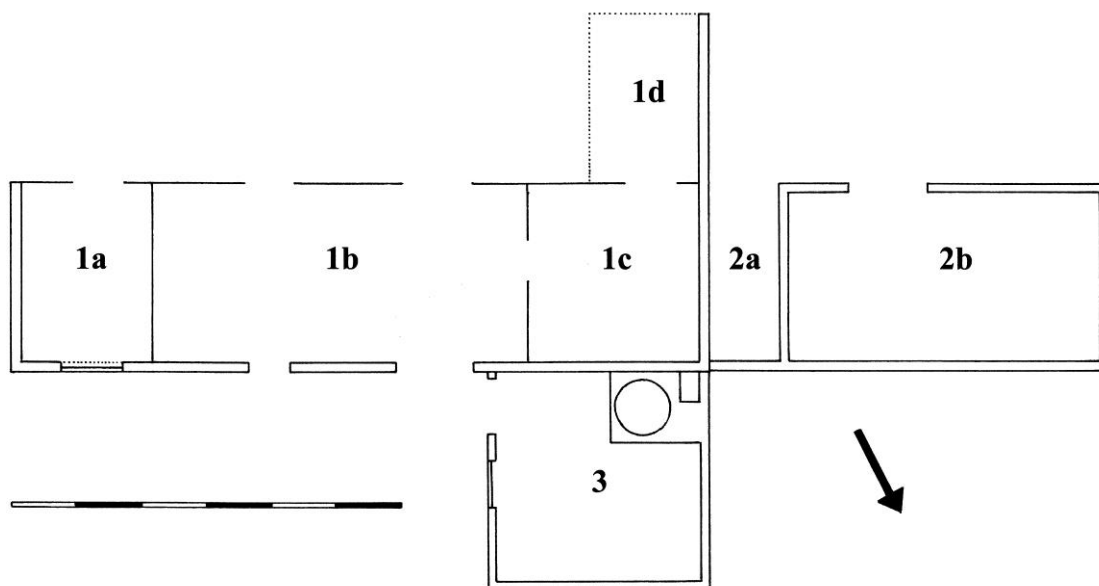
**Figure 6**  
Ground plan of the outbuilding, numbering the key sections for ease of reference in the text and photographs. Scale in metres.

- 1.** Original early-19<sup>th</sup> century pantiled, single-storied flint-rubble shed with red brick dressing. Timber-framed and weatherboarded southern elevation facing farmhouse. Now divided into three compartments but with evidence of four entrances to the south and two to the north. An integral yard wall projects from the south-western corner. Probably designed as a dog kennel or pig sty.
- 2.** A mid-19<sup>th</sup> century flint-rubble extension containing a late-19<sup>th</sup> or early-20<sup>th</sup> century chicken coop.
- 3.** A mid- 19<sup>th</sup> century extension containing a copper and used as a brew-house and (probably) a wash house.

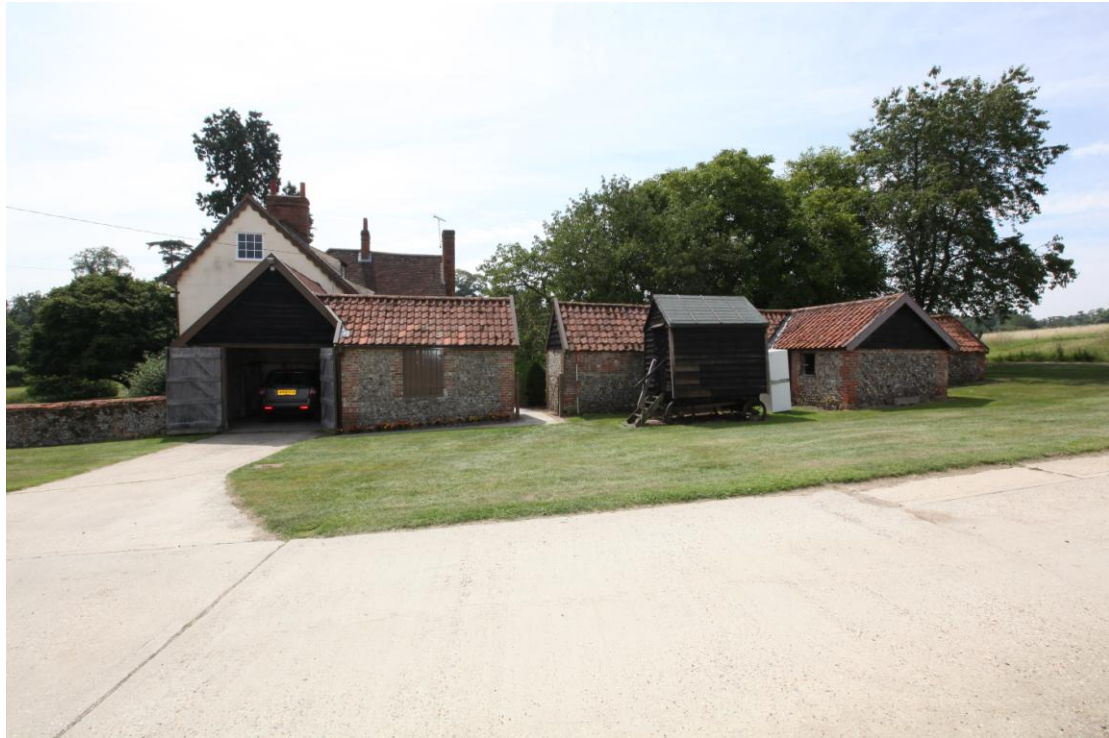
**Illus. 3** General view from the north-east showing the single-storied flint-rubble outbuilding (1, 2 and 3) to the right divided by a narrow access (leading to the rear yard and door of the house) from a similar structure with a hinged hatch to the left which lies outside the survey area.

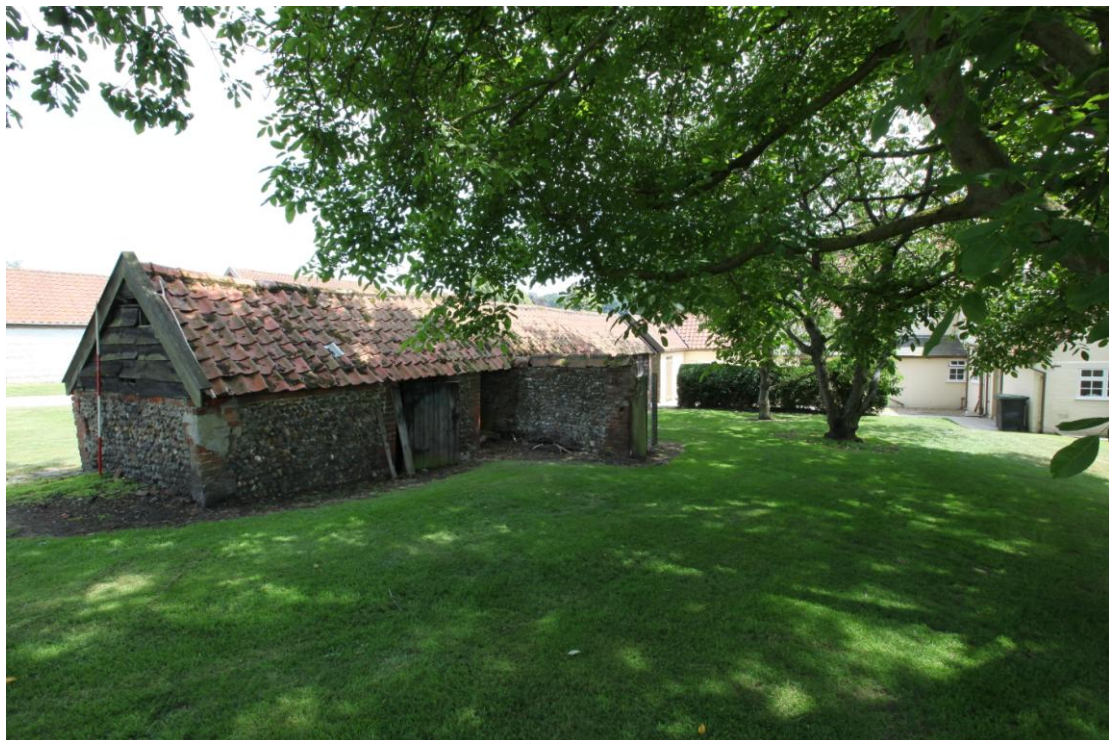
**Illus. 4** The exterior from the west showing the later flint-rubble extension (2) to the left with the service yard of the farmhouse in the rear to the right.

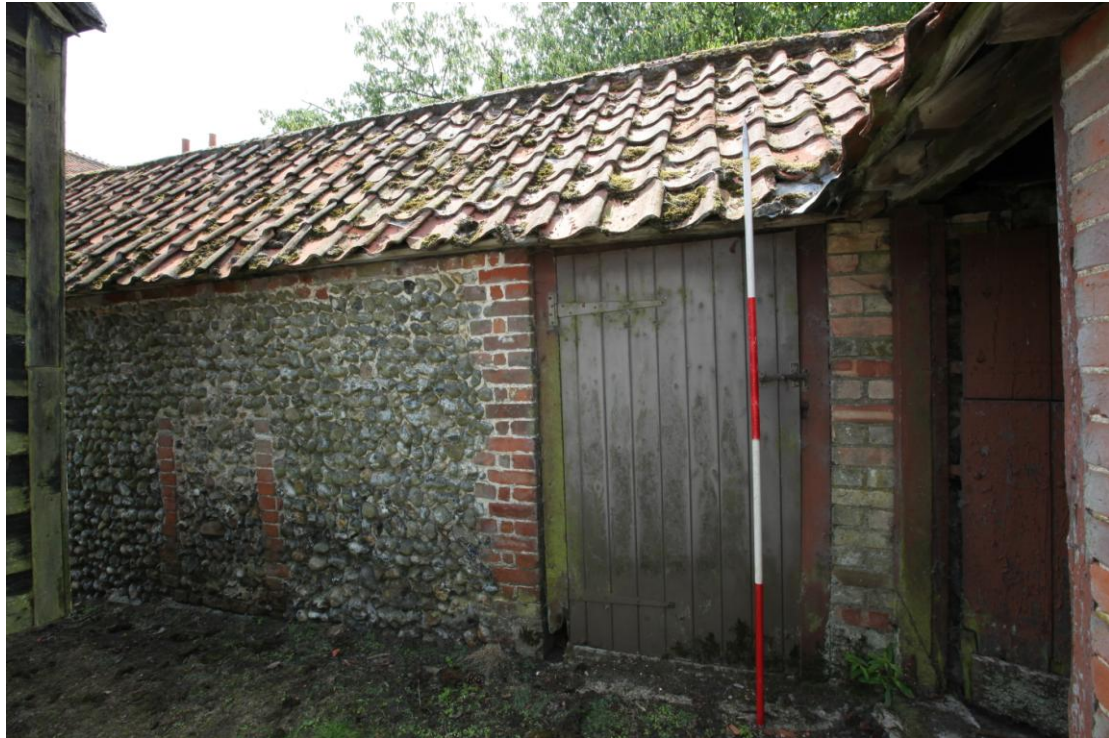
**Illus. 5** The northern exterior of the original shed (1) showing the original doorway opening onto the central area (1b) with the door of the later brew-house (3) to the right and the brick jambs of a blocked narrow entrance (just 2 ft wide by 3.5 ft high) to the left.

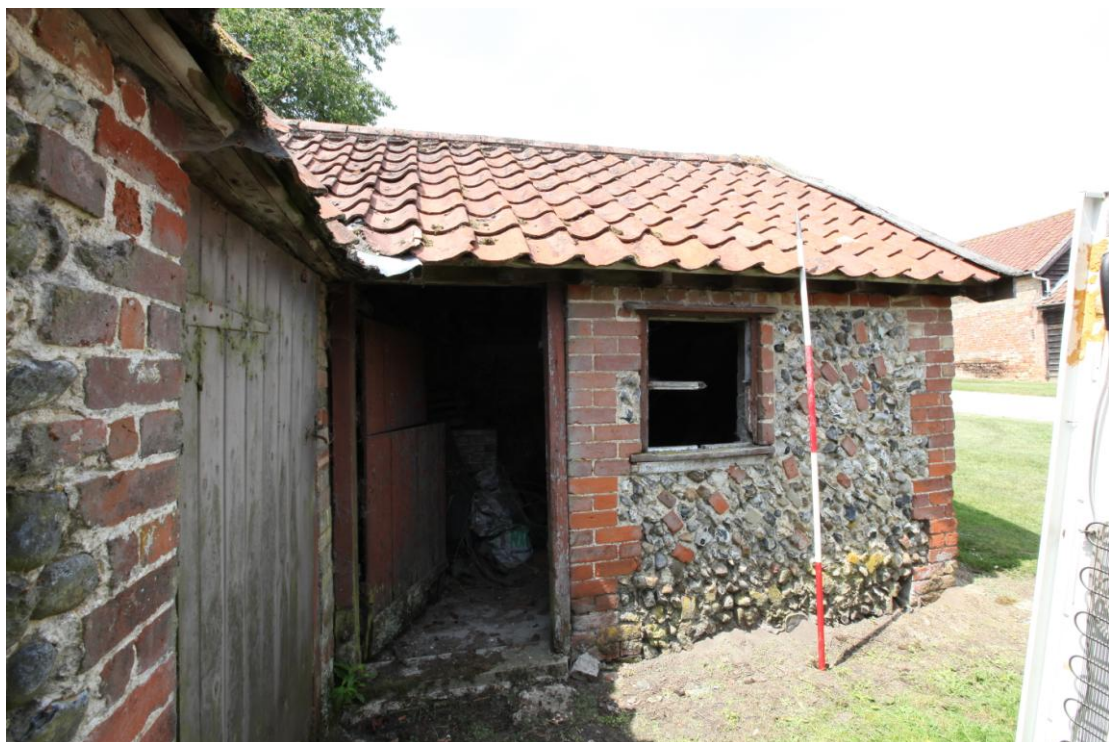
**Illus. 6** The eastern exterior of the secondary brew-house (3) showing its original half0hung door and window with the original shed (1) to the left. The letter 'W' is twice boldly incised into the brick dressing to the right of the door.

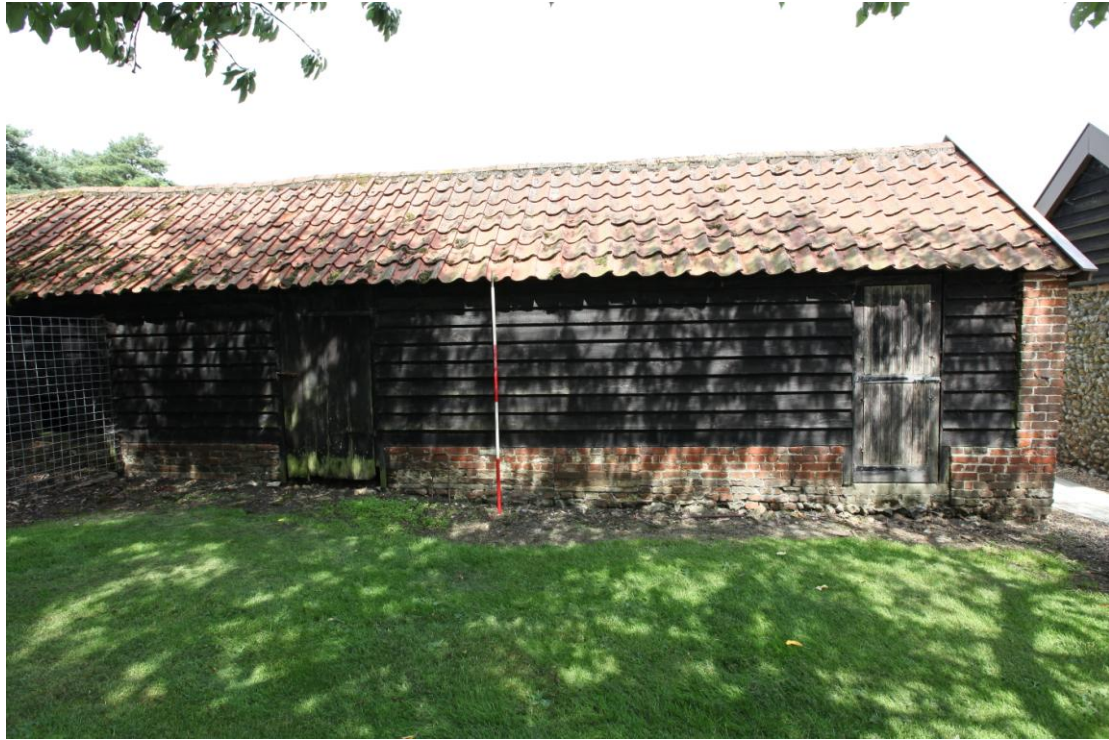
wood shed (1b). There is evidence, however, of no fewer than four original doorways in the southern elevation as shown in figure 6 (indicated by pegged jambs), and the original layout has been altered. The eastern compartment was lit by a blocked window to the north and entered by its present southern door of 0.9 m in width (3 ft). The central compartment is now entered by opposing doors of 1 m in width (40 ins) at its western end but formerly possessed another pair of opposing doors to the east and was clearly sub-divided: these additional doors are now blocked and were unusually narrow at just 0.6 m or 2 ft to the north and 0.75 m or 2.5 ft to the south. The northern door appears to have risen to just 1.1 m in height (3.5 ft) and its southern counterpart was probably similar. The western compartment contained a single southern door without a window, and its entrance too was narrow (at 0.75 m) and probably low. An integral (i.e. contemporary) wall projects at right-angles by 2.5 m (8.5 ft) from the building's south-western corner and terminates in an original brick pier. It is capped with large coping tiles and evidently formed the side of a small enclosed yard much as it does today. A second yard adjoining the narrow door to the east is shown on the Ordnance Survey of 1884 (figure 3), and the building was clearly designed – at least in part – to accommodate animals. It is highly likely to have formed a pair of dog kennels, perhaps for hunting hounds, with feed stores to the east of each, but it may also be interpreted as a pig sty.

**Illus. 7 The weatherboarded southern exterior of the original shed (1) showing evidence of four original entrances.**

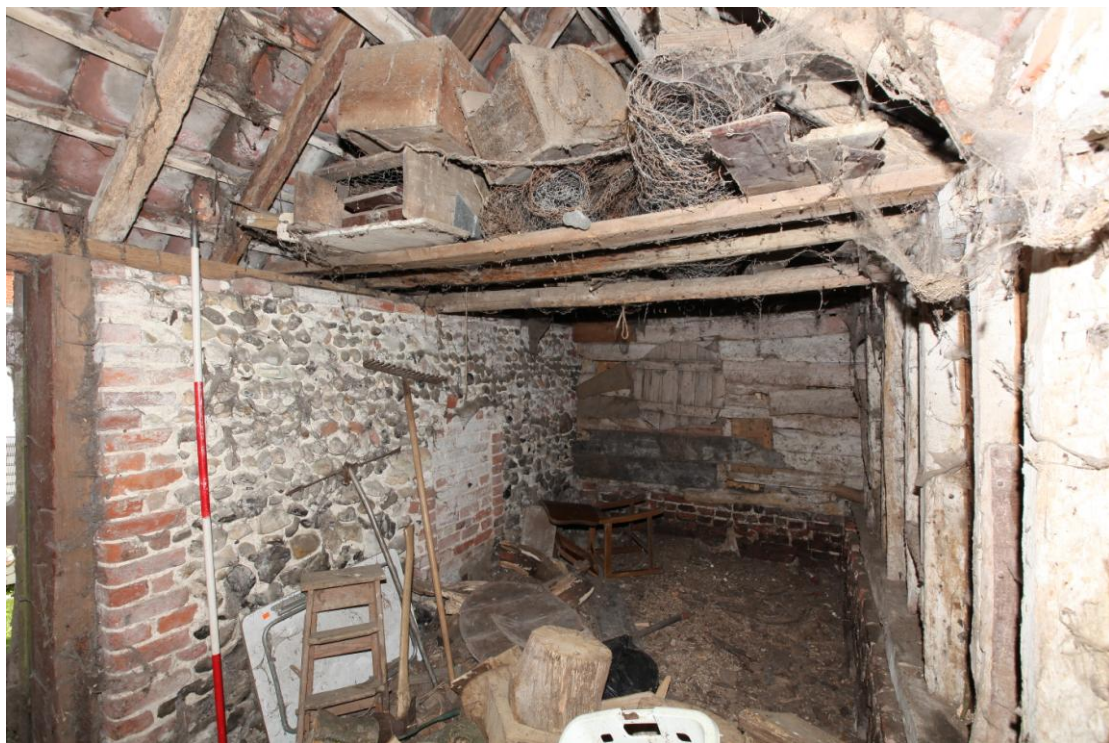
**Illus. 8 General internal view of the central shed (1b) from the west showing its original cross-entry in the foreground and the opposing small doorways (now blocked) in the rear. The boarded partition to the eastern shed (1a) includes a re-used circular copper lid.**

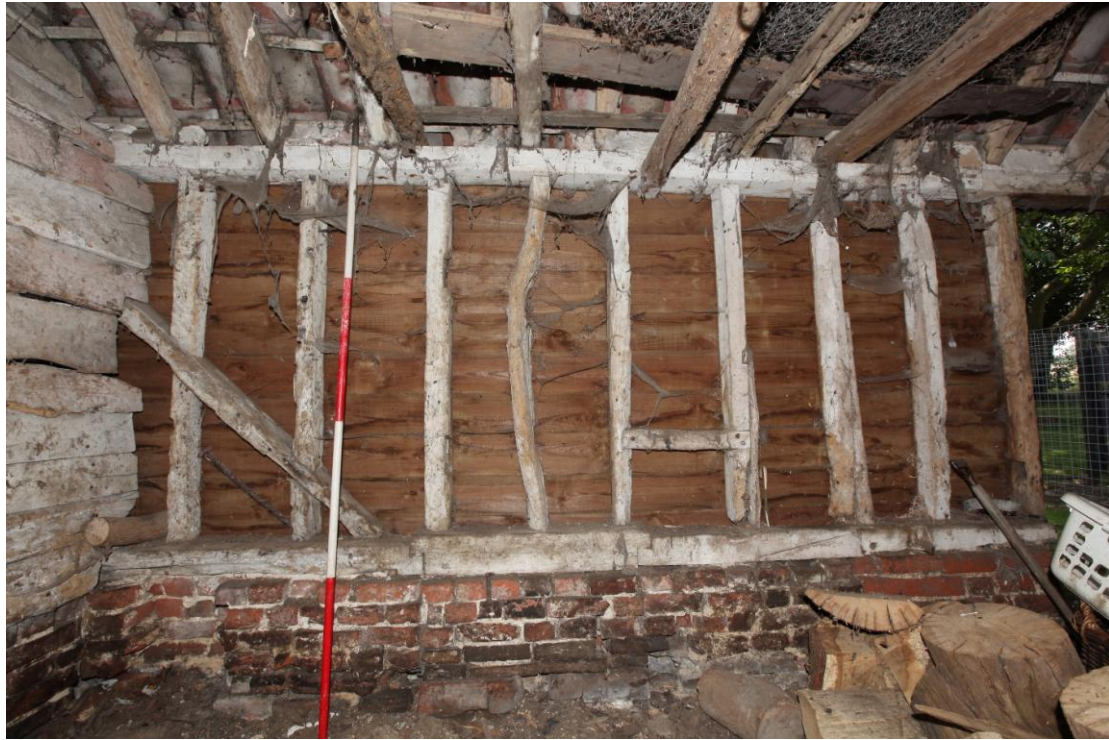
**Illus. 9** The southern interior of the central shed (1b) showing its original studwork with a later stud blocking the original narrow entrance (indicated by the crooked secondary stud in the centre and by corresponding straight joints in the brick plinth).

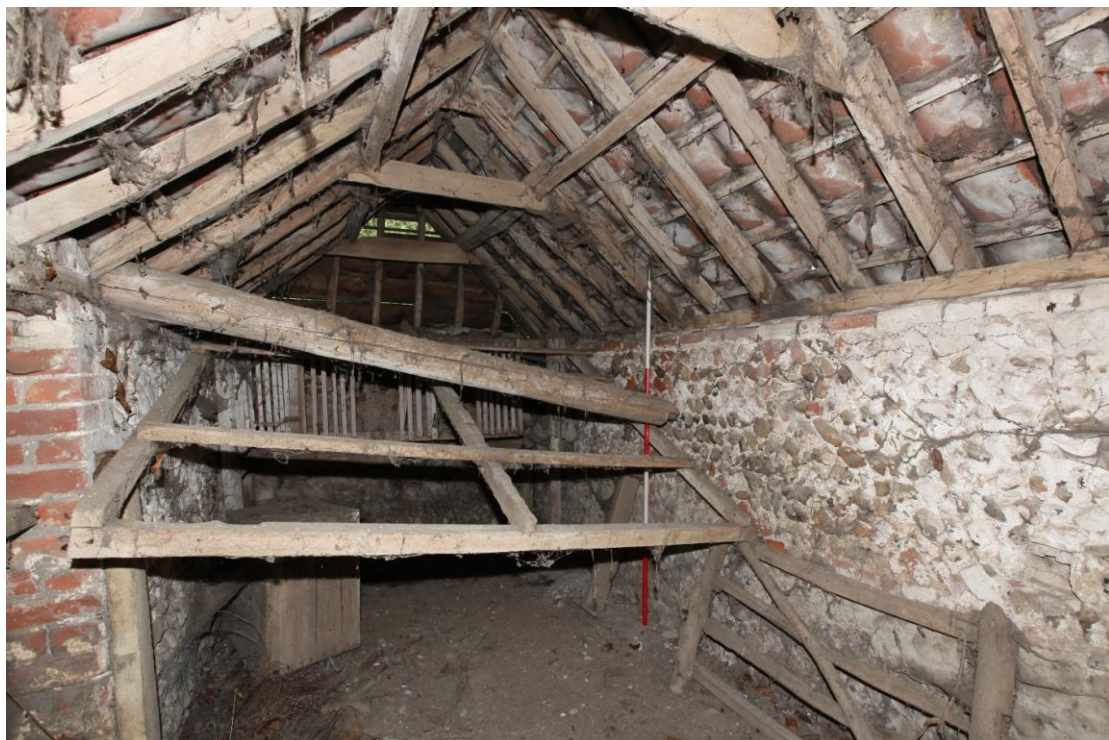
**Illus. 10** The interior of the later flint-rubble extension (2b) seen from the east, showing its collapsed tie-beam and joists with a slatted chicken coop attached to the western gable in the rear.

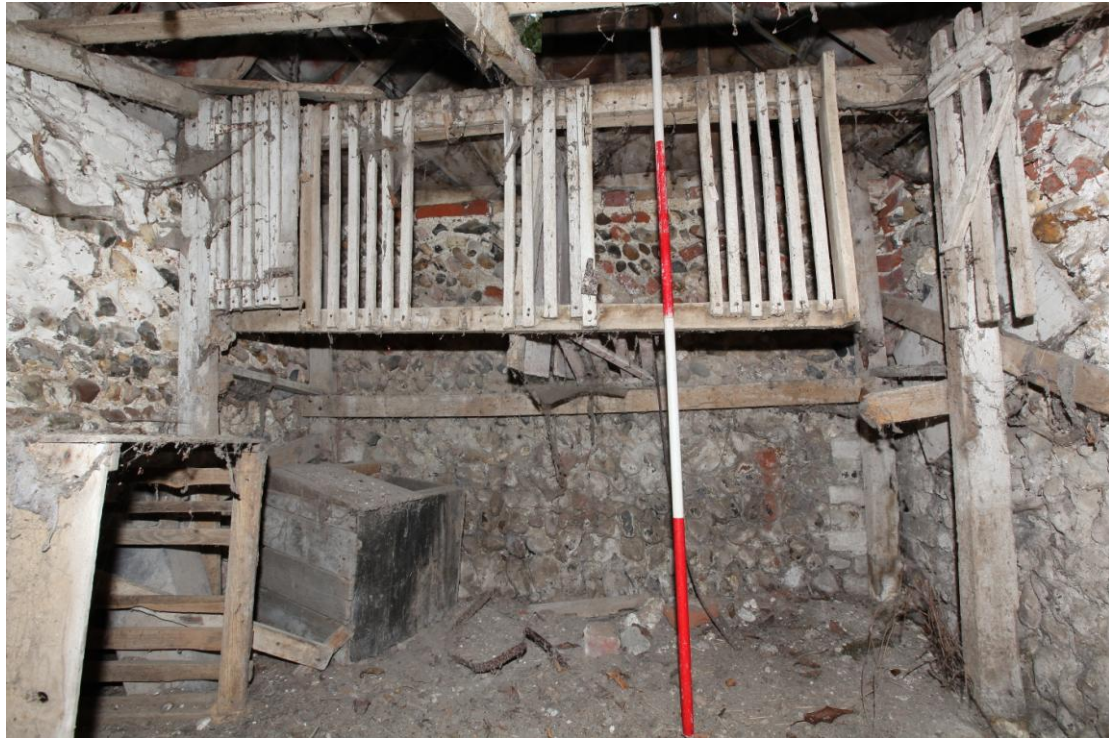
**Illus. 11 The good late-19<sup>th</sup> or early-20<sup>th</sup> century chicken coop of nailed wooden slats with hinged doors attached to the western internal gable of the extension (2b).**

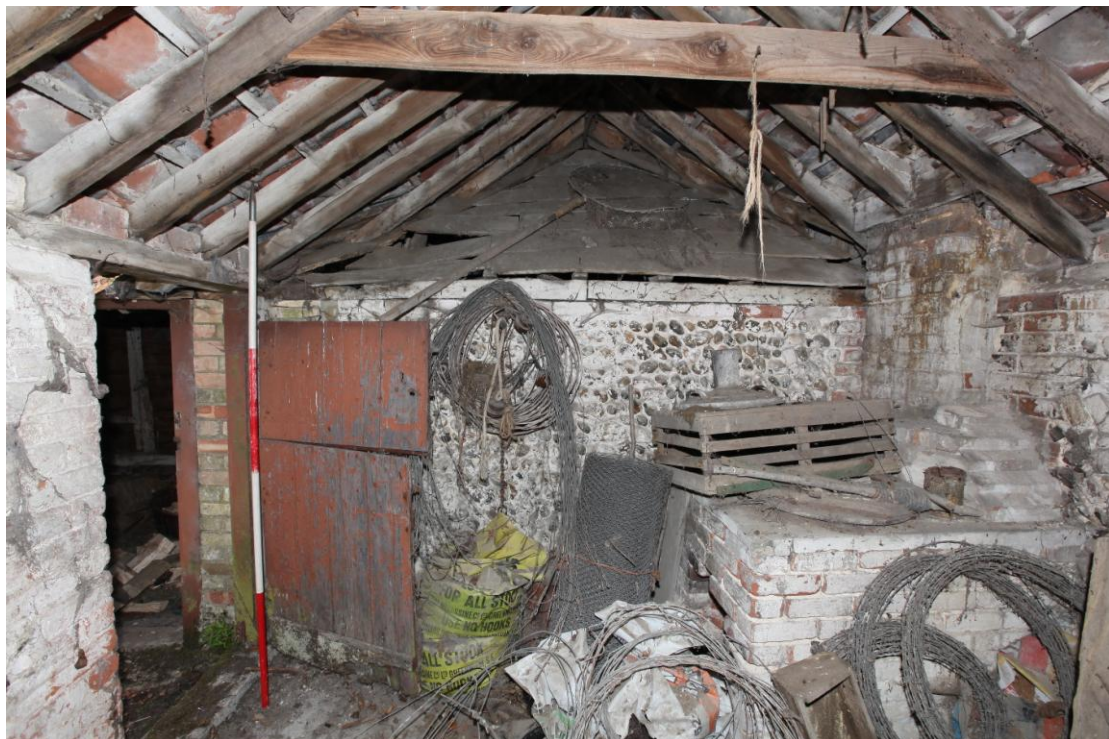
**Illus. 12 The southern interior of the brew-house (3) showing the flint-rubble wall of the original shed (1) in the rear with its copper and chimney to the right and half-hung entrance door with red/brown paint to the left. The copper retains its circular boarded lid.**
