**Barn at
Barrow Hall Farm,
Barrow, Suffolk
BRR 049**

Heritage Asset Assessment

Barn at Barrow Hall Farm, Church Road, Barrow, Suffolk

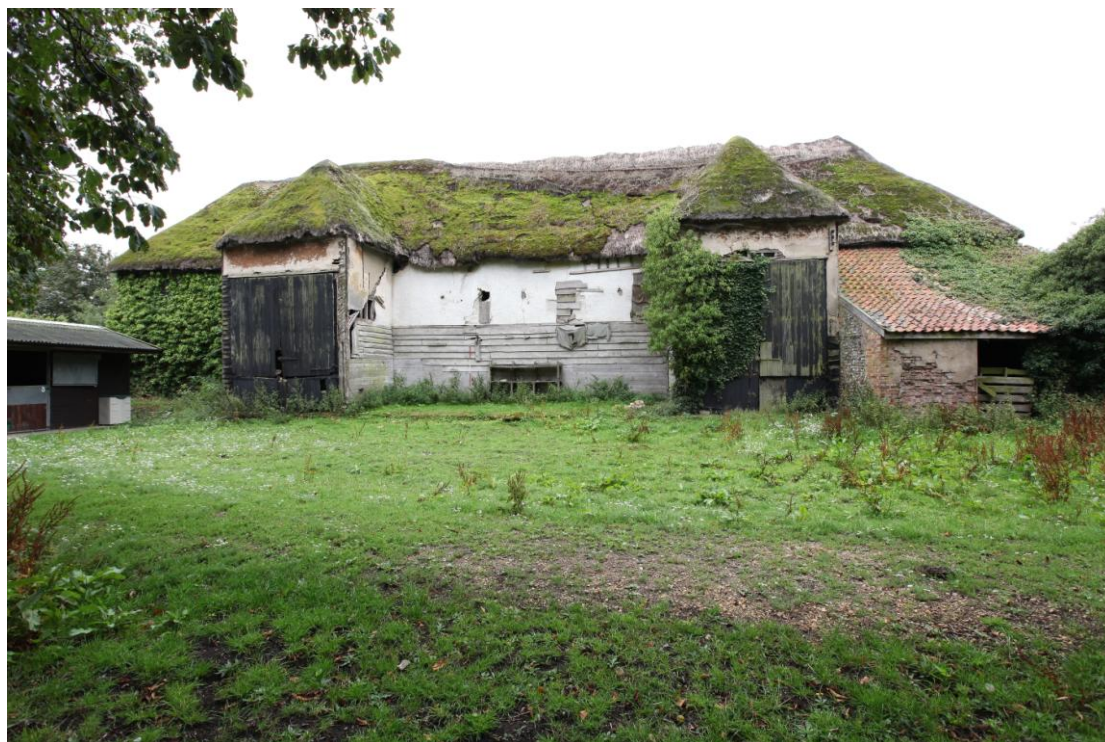
Illus. 2 The northern facade of the barn showing its original 'two-tier' cladding of render above horizontal boarding and thatched roof with twin hipped porches (1a and 1b) to left and right respectively. The secondary pantiled flint-rubble lean-to (2) is visible to the extreme right. A similar lean-to between the porches has been demolished.

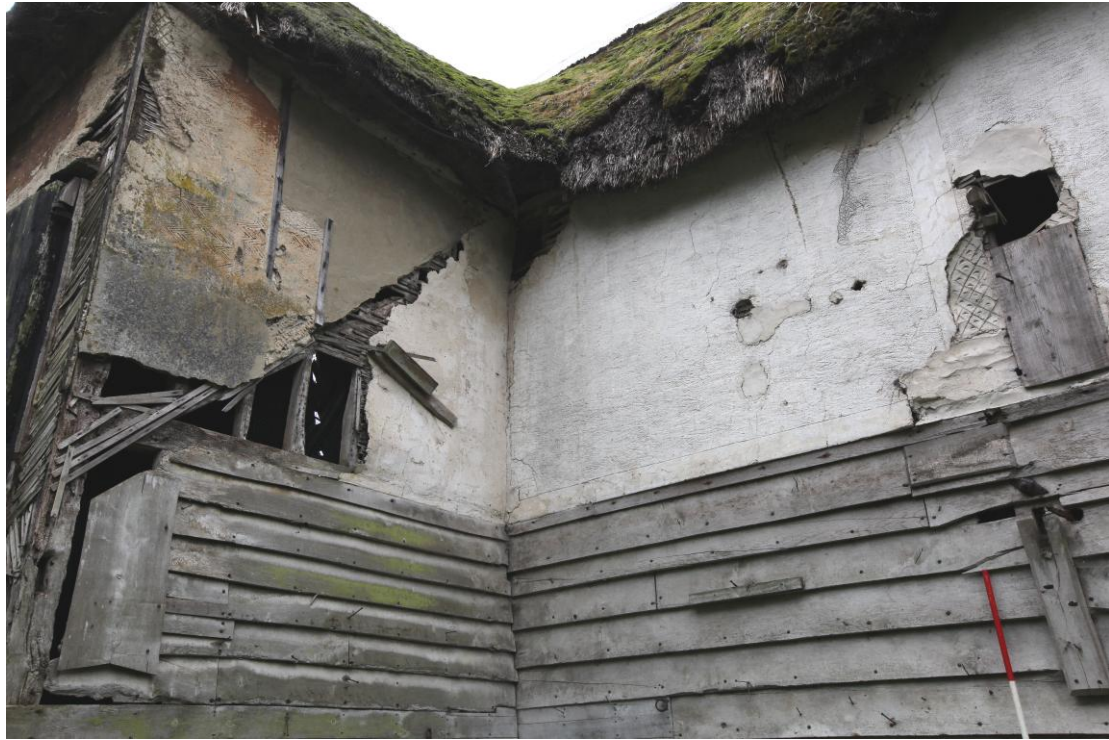
Illus. 3 Detail of the eastern porch (1a) from the west showing the red-ochre pigment above the scar of the demolished lean-to (left) and the herringbone pargeting to the original unpainted lime plaster of the barn to the right. The absence of pargeting beneath the scar on the porch indicates the porch and lean-to were contemporary additions to the earlier barn.

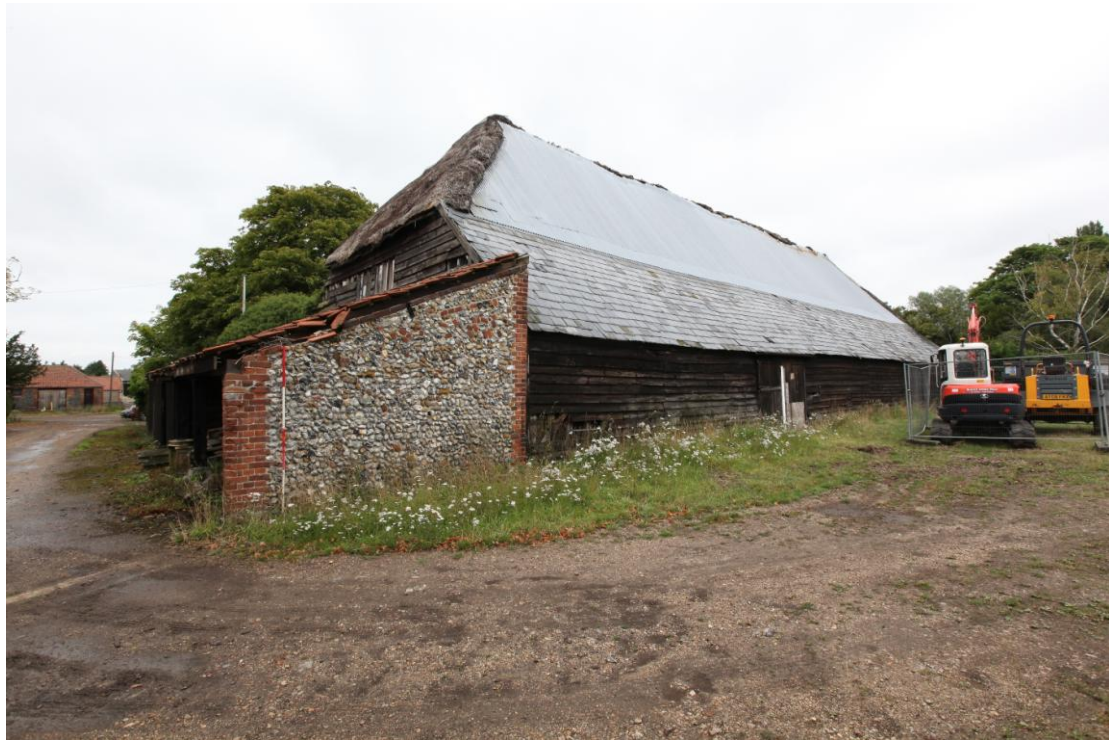
Illus. 4 The exterior of the barn from the south-west showing the flint-rubble lean-to (3) to the left and the slate roof of the rear (southern) aisle beneath the modern corrugated metal which has replaced the thatch to this elevation.

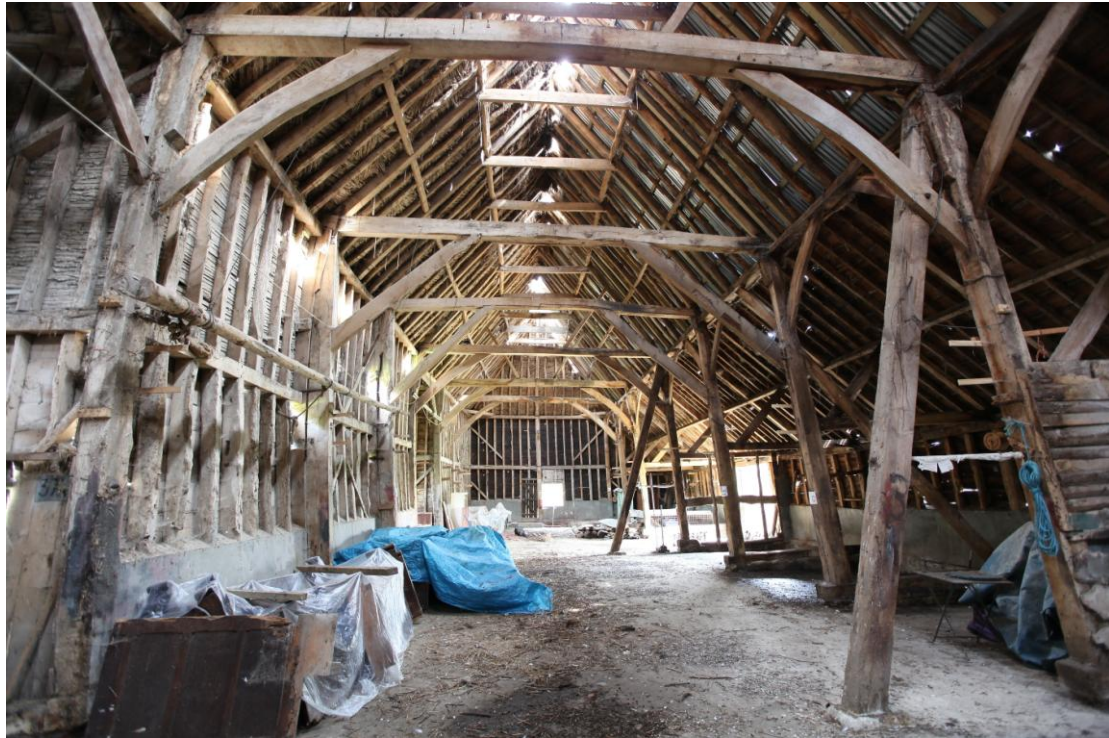
The building appears to have suffered some movement during the 19th century and a series of struts have been inserted to counter lateral racking to the arcade plates, aisles and roof. Several additional earth-fast posts have been set within the original storey posts of the northern elevation to the same purpose, and the associated tie-beams and arch-braces have been renewed accordingly. The aisle trusses have been much altered but originally contained straight braces beneath the aisle ties linking the storey posts to the ground sills on both sides of each threshing bay but none elsewhere; all the storey posts contain empty mortises above the aisle ties, presumably for struts in the original (missing) aisle roof.

Illus. 5 A general view of the barn interior from the west showing its largely intact roof structure and arch-braces with the original rear aisle to the right. The diagonal props are secondary insertions, as are the inner storey posts of the northern elevation to left.

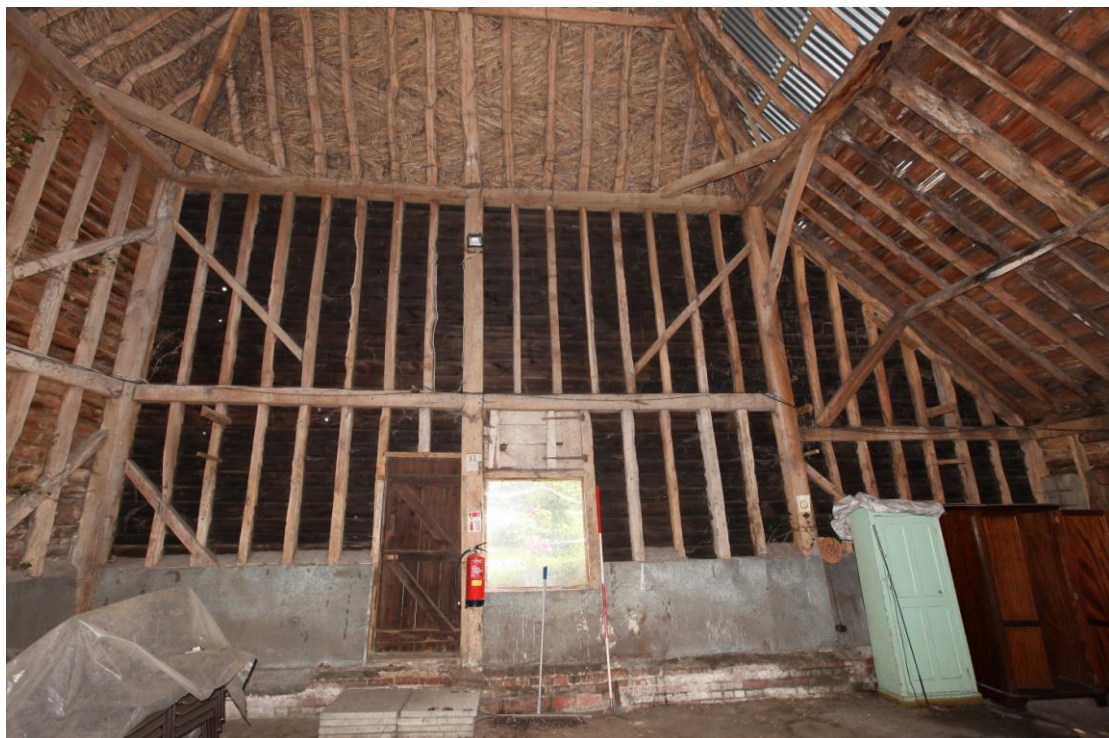
Illus. 6 The internal eastern gable showing its nailed primary wall braces (interrupting the narrow unpegged studs) with the rear aisle to the right. The tie-beam abuts the wall-plate and arcade-plate in a manner not found before the 19th century - before which the tie-beam would have been dovetailed to the respective plates above jowled corner posts. The door is secondary but the ventilation hatch above the modern window is original.

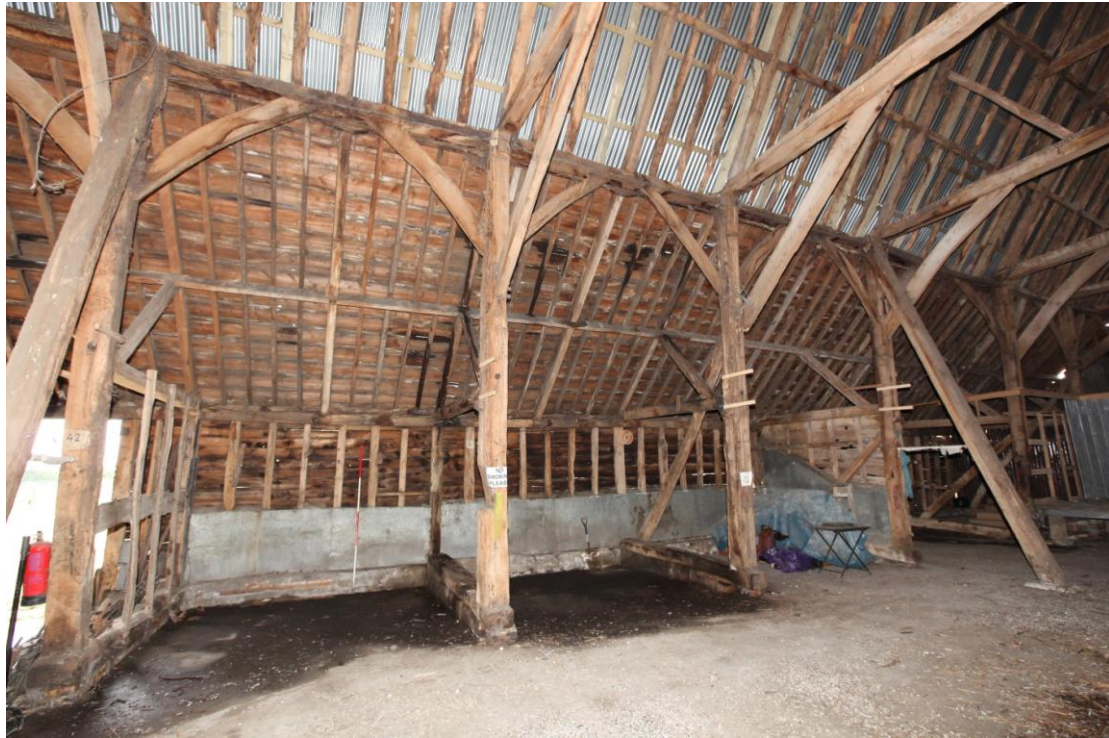
Illus. 7 The central bays (D, F and G) of the southern aisle showing the intact arch-braces to the arcade plate and the renewed tall-sectioned softwood rafters of the aisle roof.

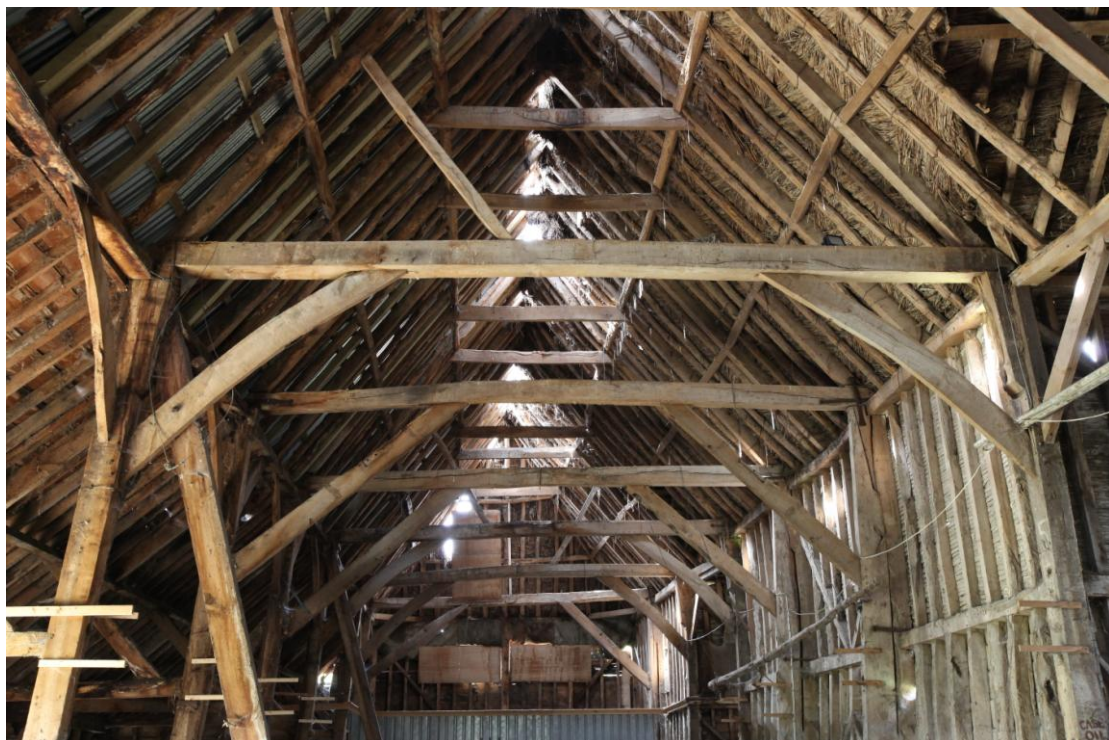
Illus. 8 The roof structure from the east showing the poor quality rafters supported by clasped-purlins with a lower tier of butt-purlins and a mix of original and replaced tie-beams with pegged and unpegged braces respectively.

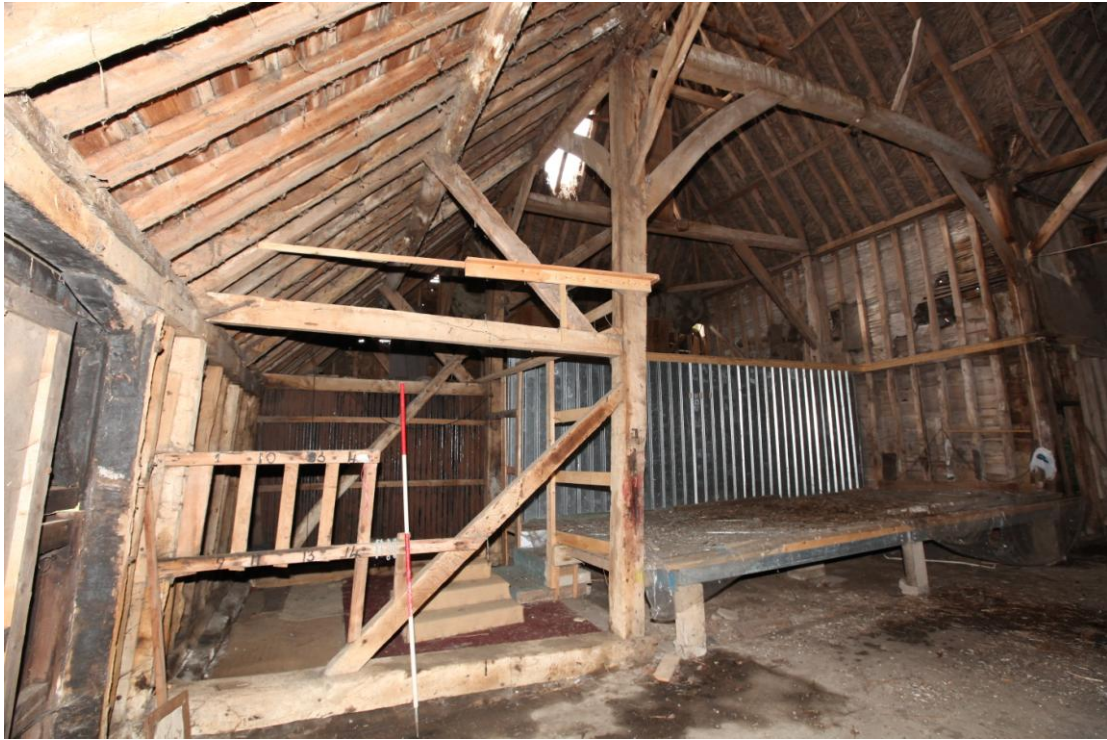
Illus. 9 The well-preserved lateral truss to the west of bay H showing an original down-brace in the foreground and a secondary strut in the rear.

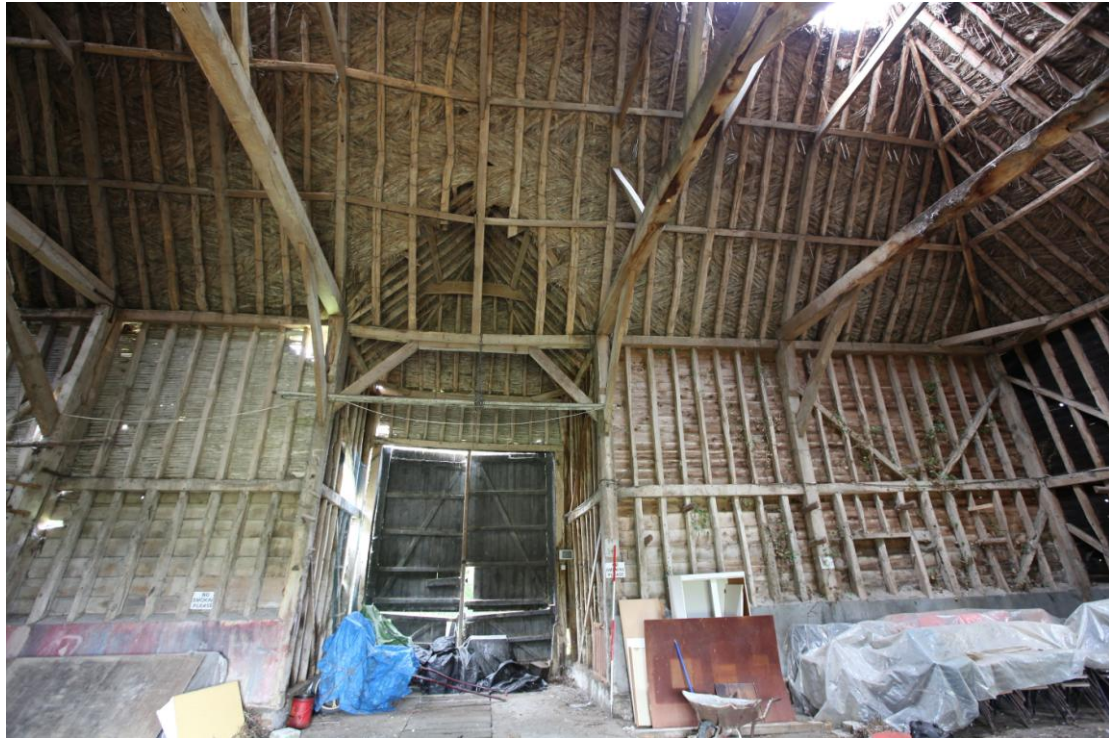
Illus. 11 The eastern end of the northern interior showing the entrance to the eastern porch (1a) with the original framed doorway in bay A to the right. The roof-plate above the porch contains empty mortises for studwork above an original lintel at the same level as the secondary corner braces, and the reed fleaking beneath the thatch is laid in a herringbone pattern.

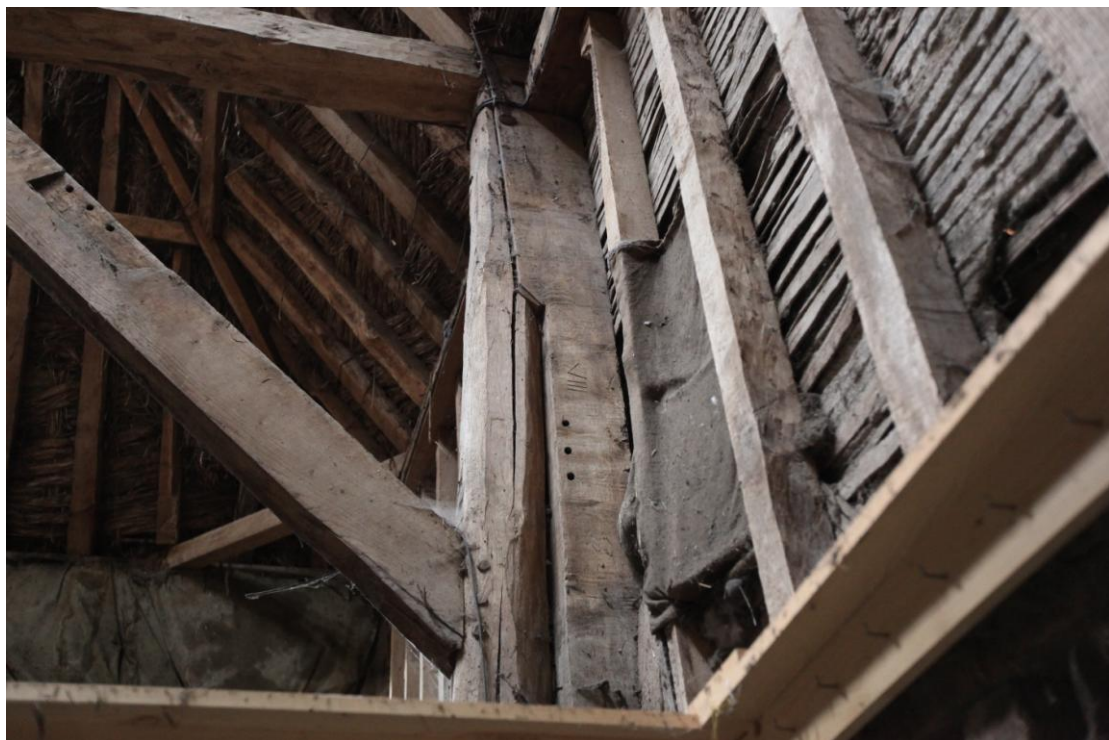
Illus. 12 A detail from the east of the northern storey post between bays J & I showing an inserted support post obstructing the jowl and mortise of the original arch-brace. The latter is numbered VIII.
