**Barn at  
Willow House,  
Fressingfield, Suffolk  
FSF 068**

**Heritage Asset Assessment**

# **Barn at Willow House, Harleston Hill, Fressingfield, Suffolk**

## **Heritage Asset Assessment**

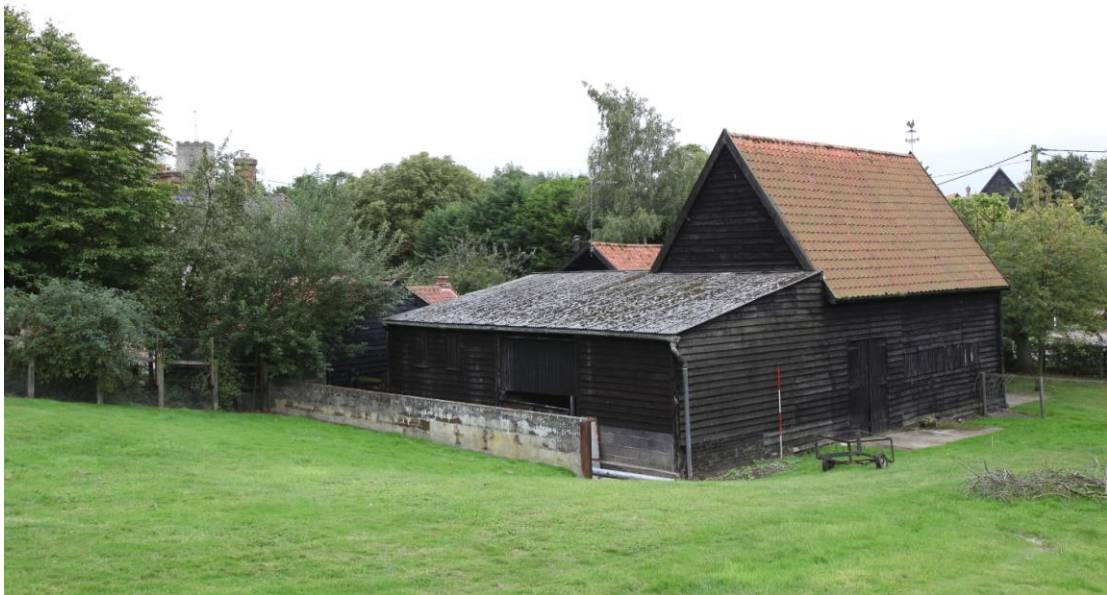
**Illus. 1** General view of the site from the north-east showing the church tower to the left and the gable of Church Farm Stables in the rear to the right. The steeply pitched pantiled roof of the barn was originally thatched and extended further to the left but was truncated in the 20<sup>th</sup> century to form the present ‘lean-to’.

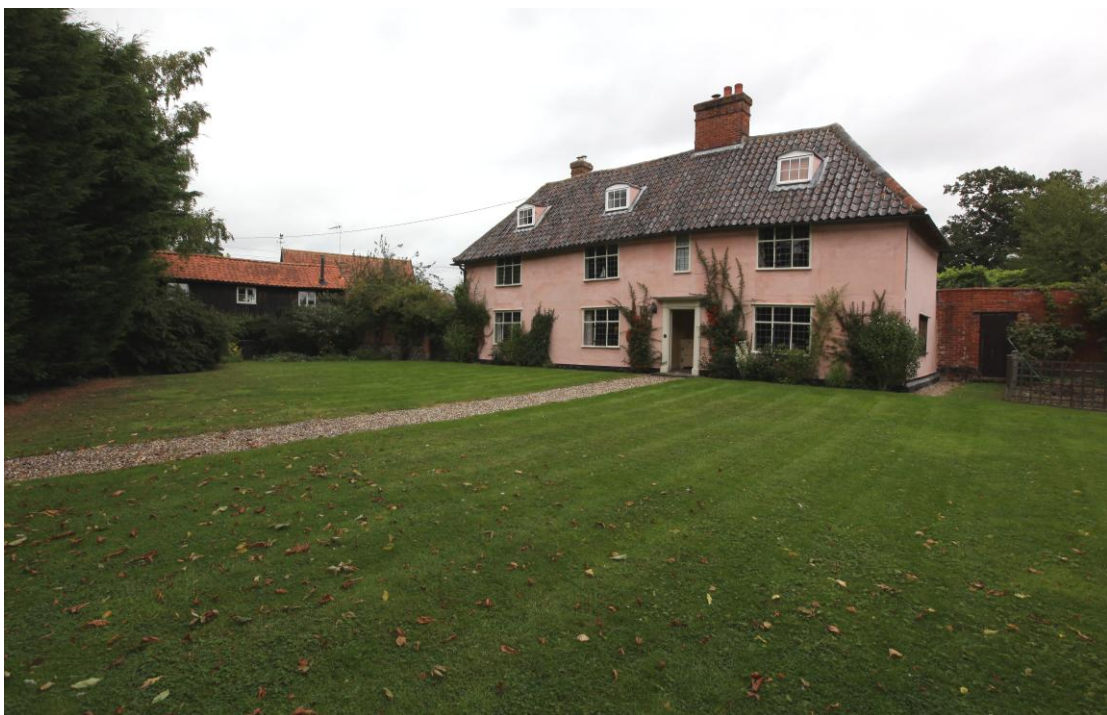
**Illus. 2** General view of the site from the south-west showing the high roof of the barn to the left of Willow House (a grade II-listed timber-framed and rendered structure of *circa* 1640 with a central hall flanked by a parlour to the right and a service bay to the left).

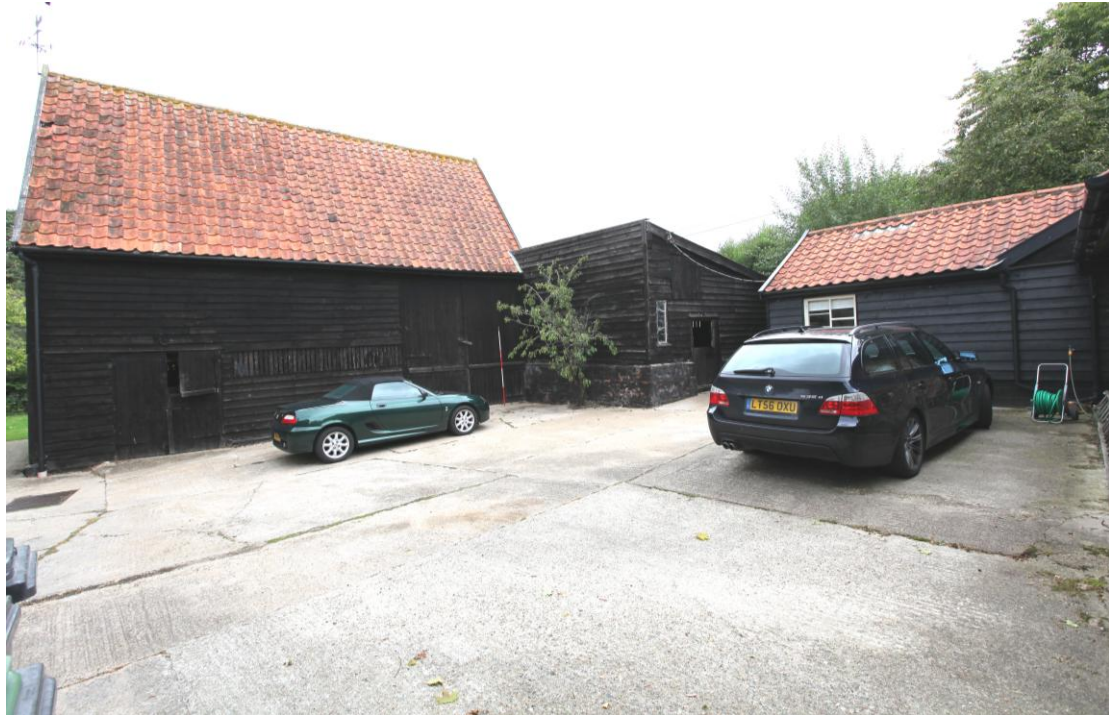
**Illus. 3** General view of the site from the concrete yard to the south-west showing the doors to the floored bays (A & B) to the left and the barn doors to the right. The roof of the southern shed (F) in the centre was originally of the same pitch and height as that of the barn but has been truncated.

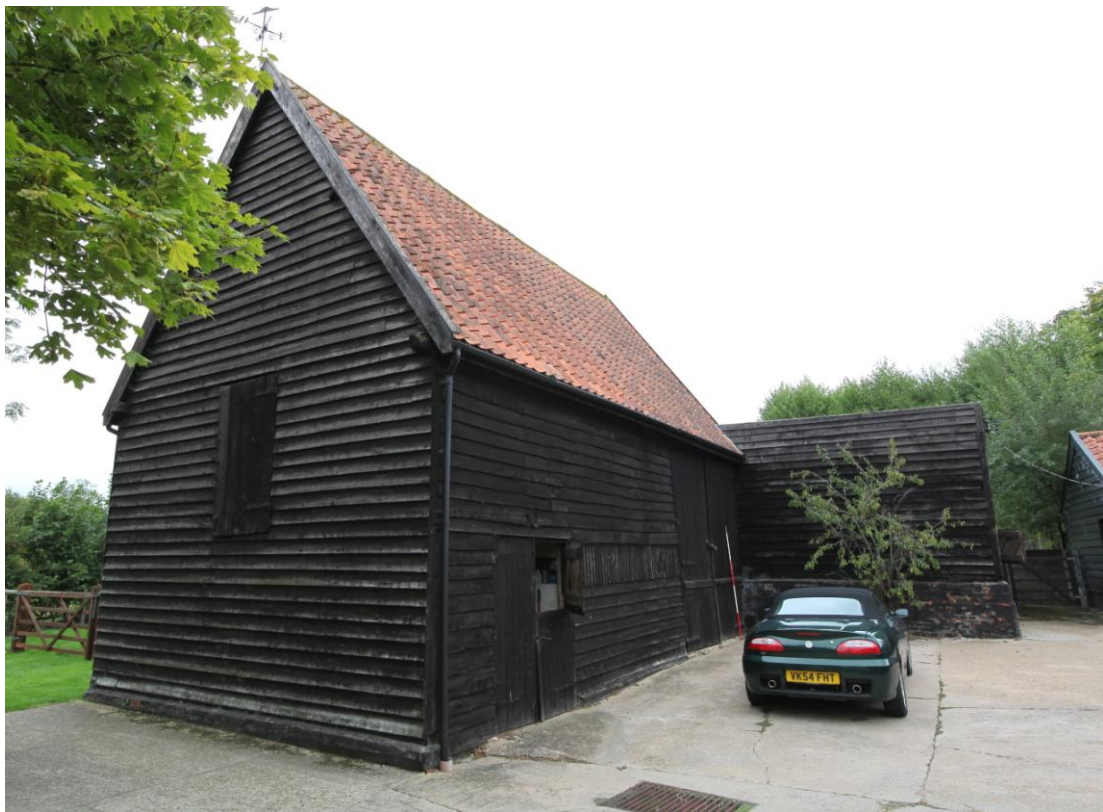
**Illus. 4** The exterior from the south-west showing the loading door to the loft in the barn's western gable.

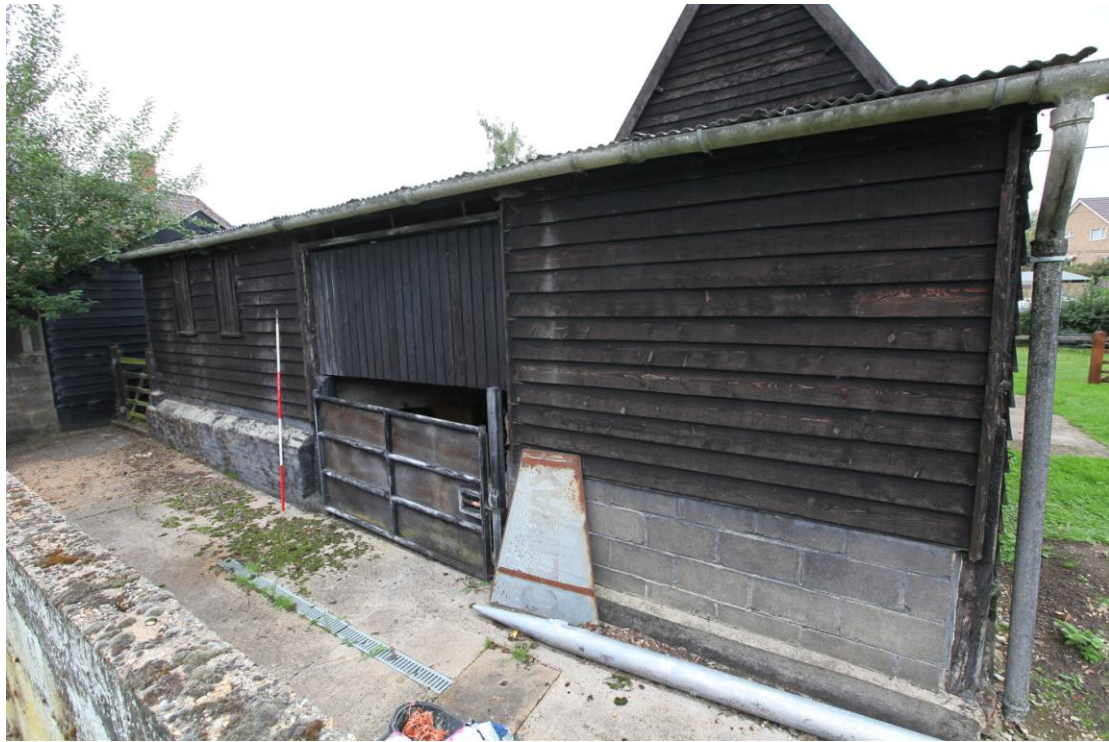
**Illus. 5** The eastern exterior which was almost entirely rebuilt in the late-20th century to incorporate what appears to be an entrance gate for cattle with glazed windows to the southern shed (F) to the left.

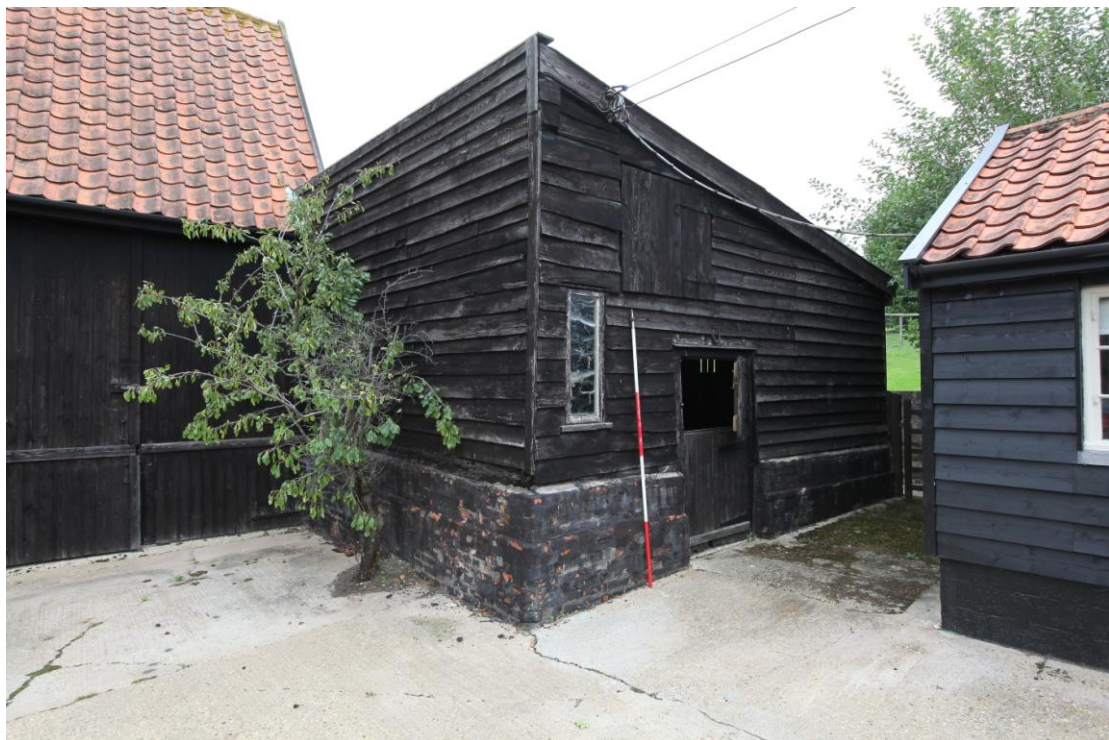
**Illus. 6** The exterior of southern shed (F) from the south-west showing its truncated roof and the loading hatch to the loft. This gable was originally of identical proportions to the western gable of the barn and the apexes of the two roof structures would have met at right-angles.

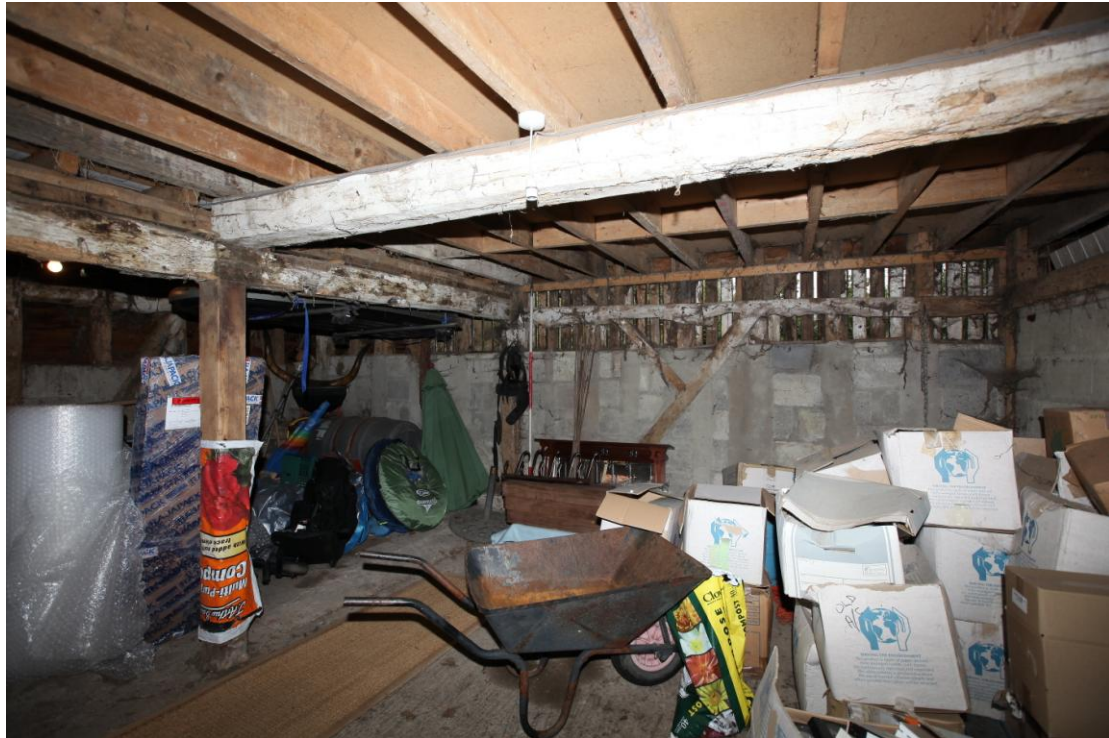
**Illus. 7** The northern interior of bay B showing the original axial and binding joists of the loft with recently renewed softwood common joists & cement block-work between the original studs of the external wall.

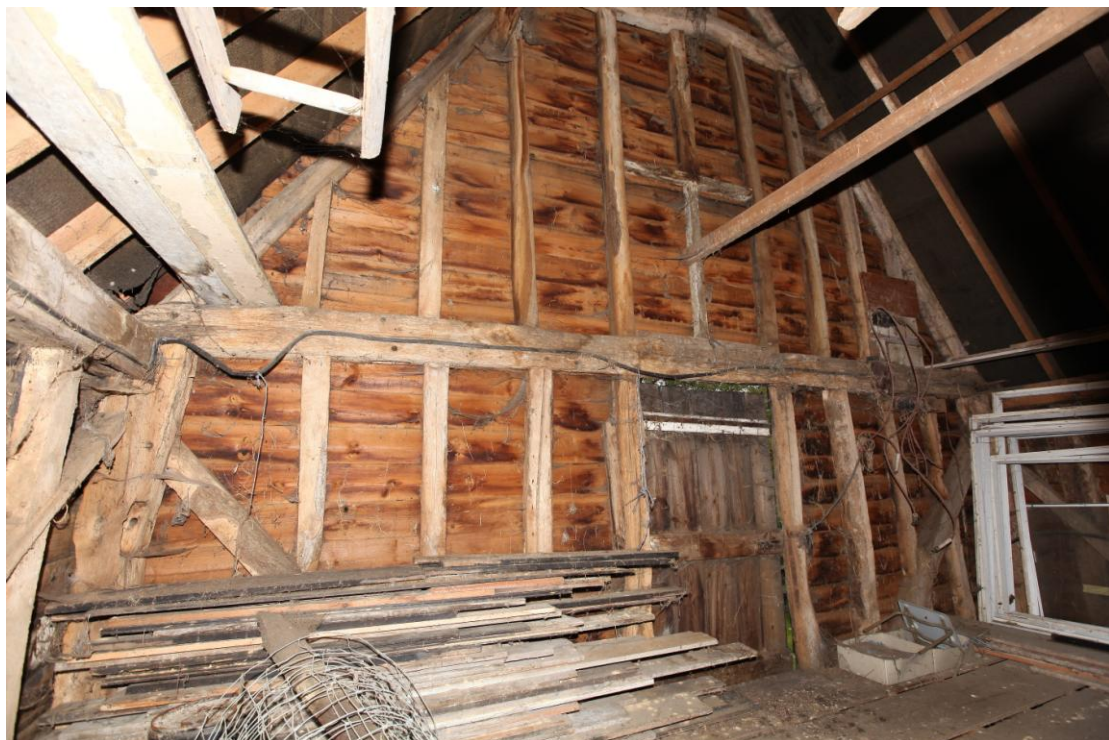
**Illus. 8** The largely intact interior of the western roof gable (seen from the loft in bay A) showing the original rafters and pegged primary wall braces with copious re-used timber. The horizontal timber above the tie-beam appears to have been the lintel of a blocked window.

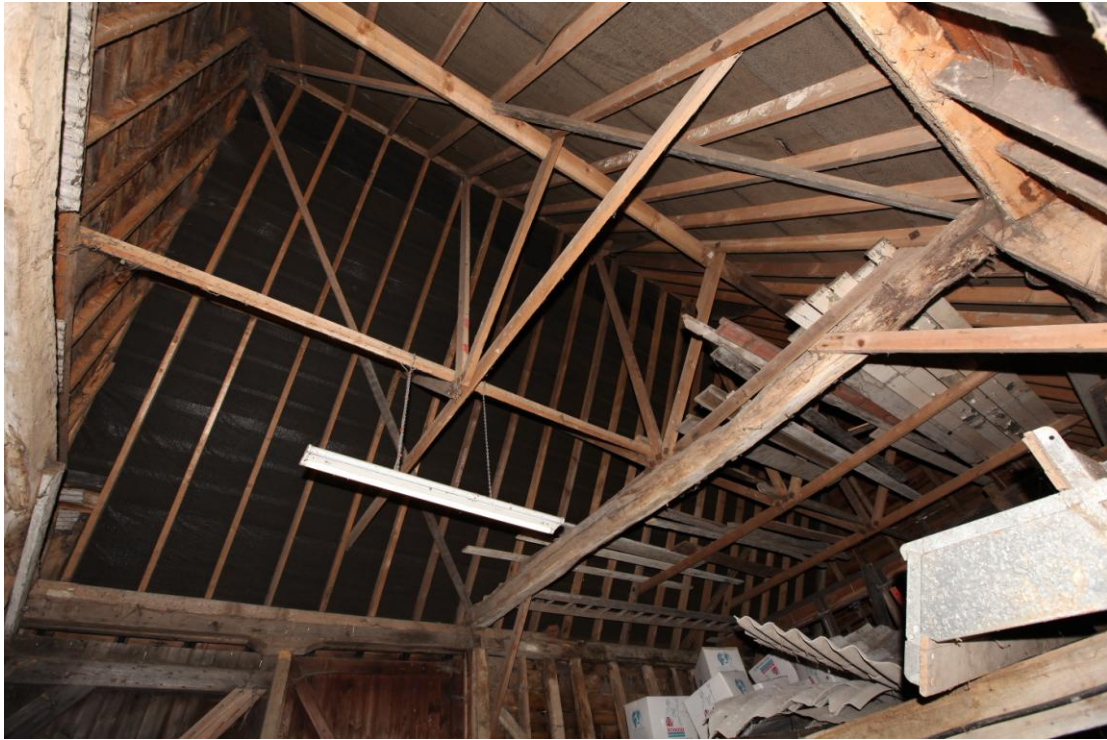
**Illus. 9** The interior of the open barn from the north showing the recently rebuilt softwood roof structure with the two-bay loft to the right & the central entrance doors in bay C to the left.

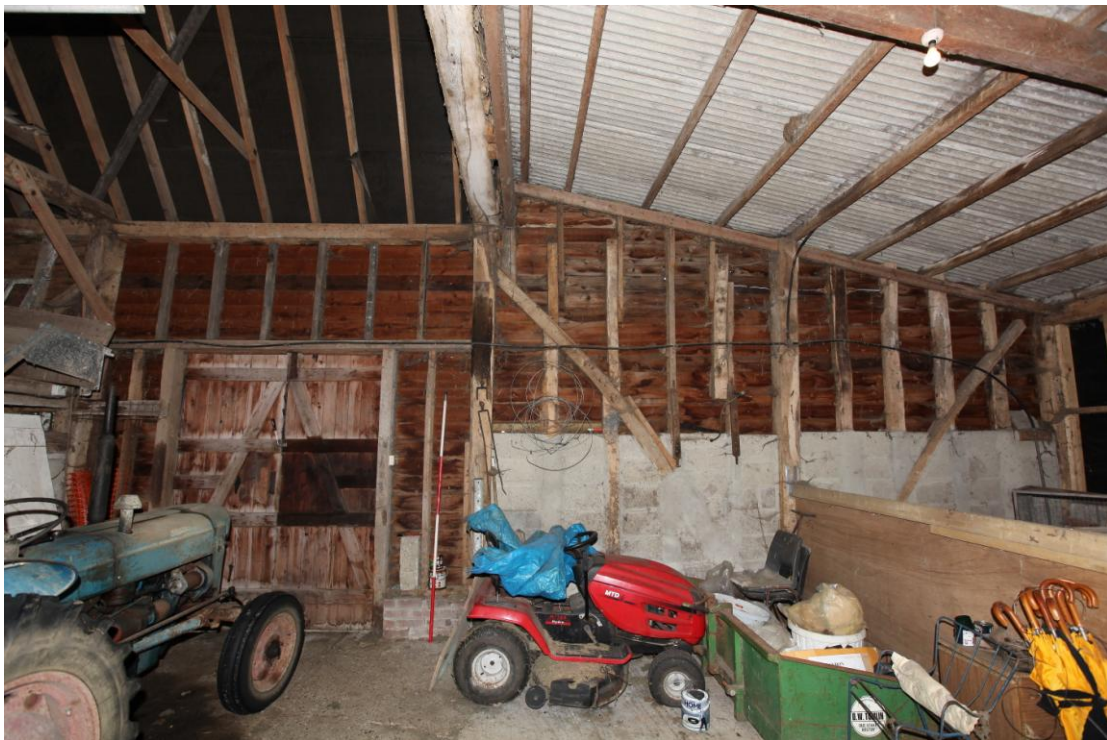
**Illus. 10** The eastern end of the barn's northern interior showing the 20<sup>th</sup> century doors in bay C to the left and the largely original framing of bays D and E to the right beneath the truncated roof. There is no evidence of tie-beam braces or loft joists in the jowled storey posts.

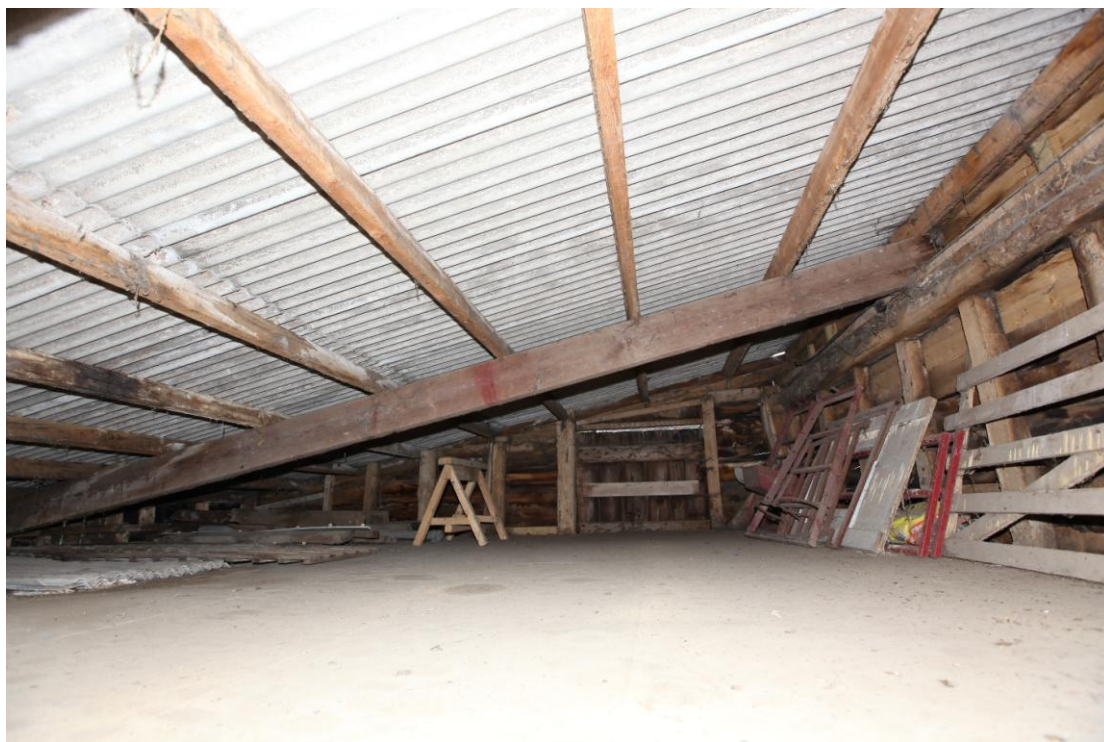
**Illus. 11** The truncated loft of the southern shed (F) seen from the open barn to the north showing the original studwork and jowled storey posts of the intact western elevation to the right.

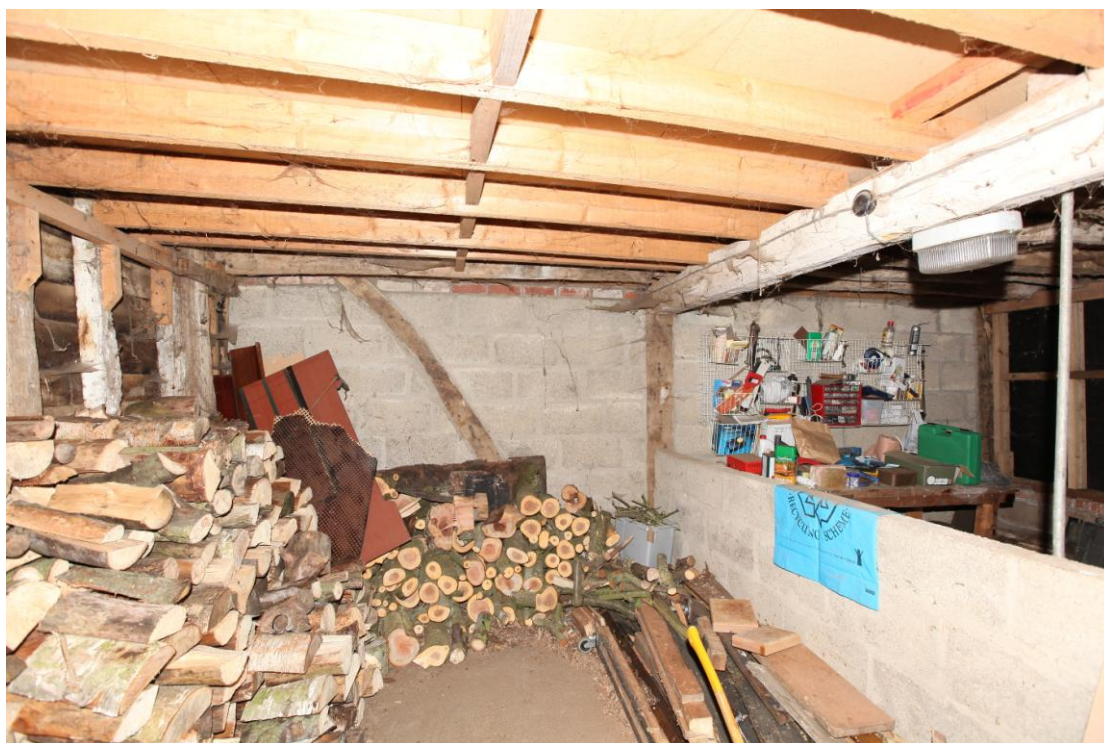
**Illus. 12** The interior of the southern shed (F) from the south showing the cement-block partition to the main barn with a single original primary brace. The whitewashed axial joist to the right is also original but the common joists of the loft have been renewed in softwood.
