**Barn at
Lake Farm,
Rougham, Suffolk
RGH 061**

Heritage Asset Assessment

**Barn at
Lake Farm,
Rougham Green,
Rougham,
Suffolk**

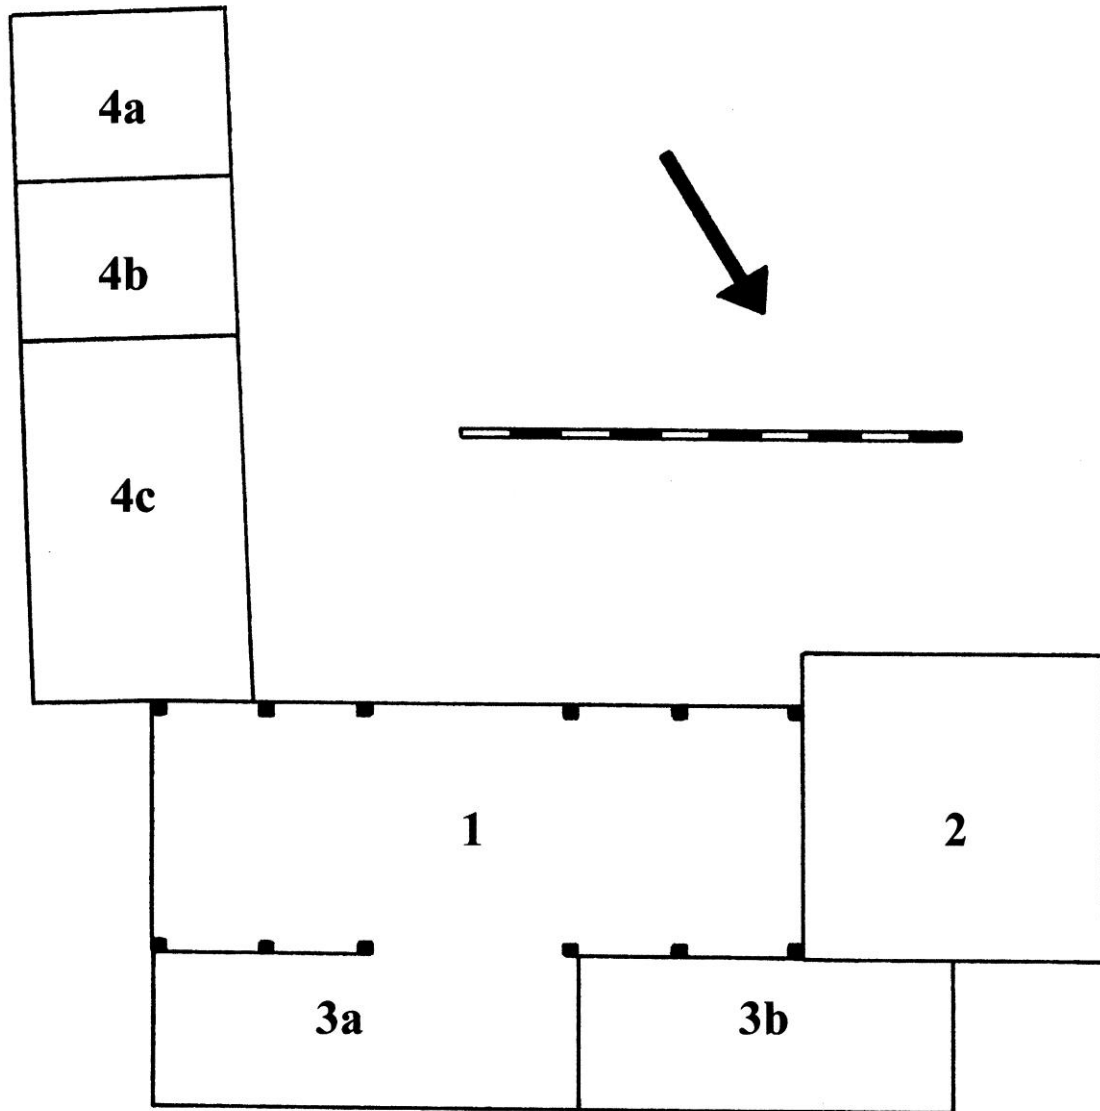
Figure 5

Schematic ground plan of the barn and attached sheds, identifying the bays and principal compartments for ease of reference in the text and photographs. Scale in metres.

1. Early-19th century (*circa* 1820) timber-framed and weatherboarded threshing barn of five bays with intermediate trusses dividing the outer bays (i.e. with tie-beams and posts without jowls but lacking arch-braces). Arch-braced tie-beams flanking central bay (northern arch-braces removed). Original door jambs survive to southern entrance. Tall red-brick plinth incorporating re-used ashlar (dressed stone) of possible medieval origin. Concrete floors but with beaten earth to threshing bay (presumably where the brick threshing floor has been removed). 20th century shallow-pitched softwood roof structure covered with corrugated iron. Pegged primary wall-braces and much re-used timber. External weatherboarding and doors largely renewed in 20th century. No evidence of studs to rear of threshing bay suggesting it always adjoined a rear lean-to. The wall framing substantially intact but with 20th century vehicle doors in

the eastern gable and a door to the loft over the adjoining modern garage interrupting the central post of the western gable.

2. Late-20th century garage of cement block-work disguised externally with weatherboarding to match the adjoining barn. Incorporating a modern false jetty (first-floor overhang) to its western gable. Built by the present owner on the site of a demolished 19th century granary (probably a stable or vehicle shed with hay loft or granary above). Of no historic value and not discussed further below.

3 Timber-framed and weatherboarded lean-to shed divided into two compartments but formerly with an additional compartment behind the threshing floor. Probably contemporary with the barn but now with vehicle doors in both gables. Glazed pantile roof.

4. Mid-19th century red-brick former shelter-shed, probably for cattle and originally with an open arcade to the yard on the west but now enclosed by mid-20th century boarded studwork and divided into three loose boxes by two late-20th century partitions of cement block-work. The original softwood clasped-purlin roof structure probably designed for pantiles but now covered with corrugated iron. Of limited historic value and not discussed further below.

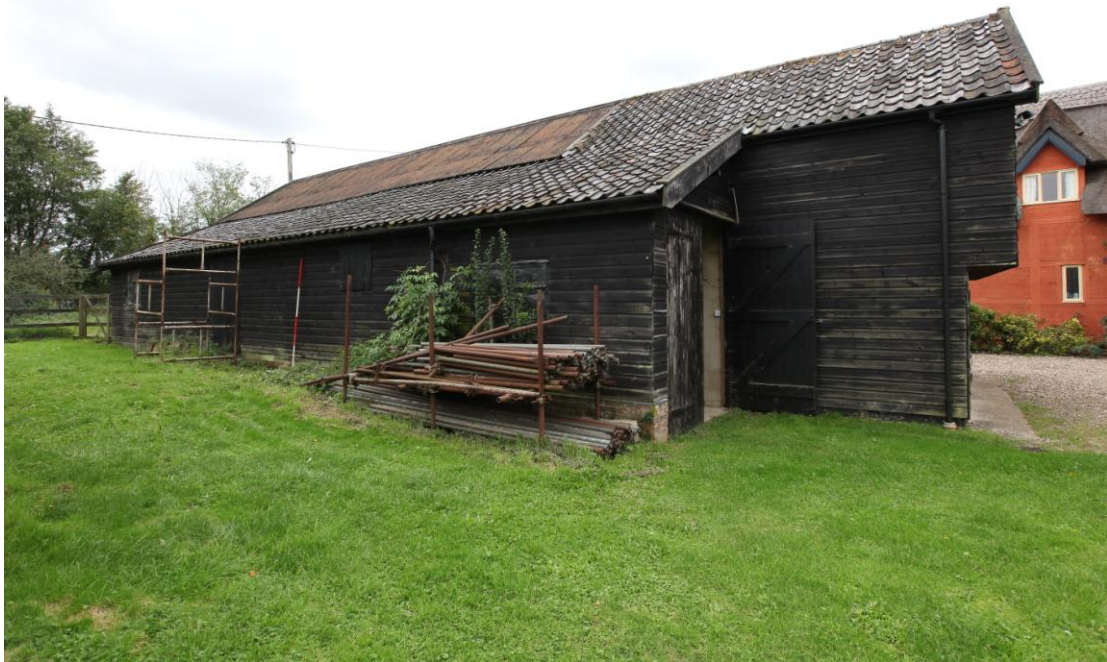
Illus. 1 The exterior of the barn from the north showing the glazed pantiles of the modern (1980s) garage with overhanging upper storey to the right and the lean-to shed (3) to the left. The corrugated iron roof of the main barn (1) is visible to the rear.

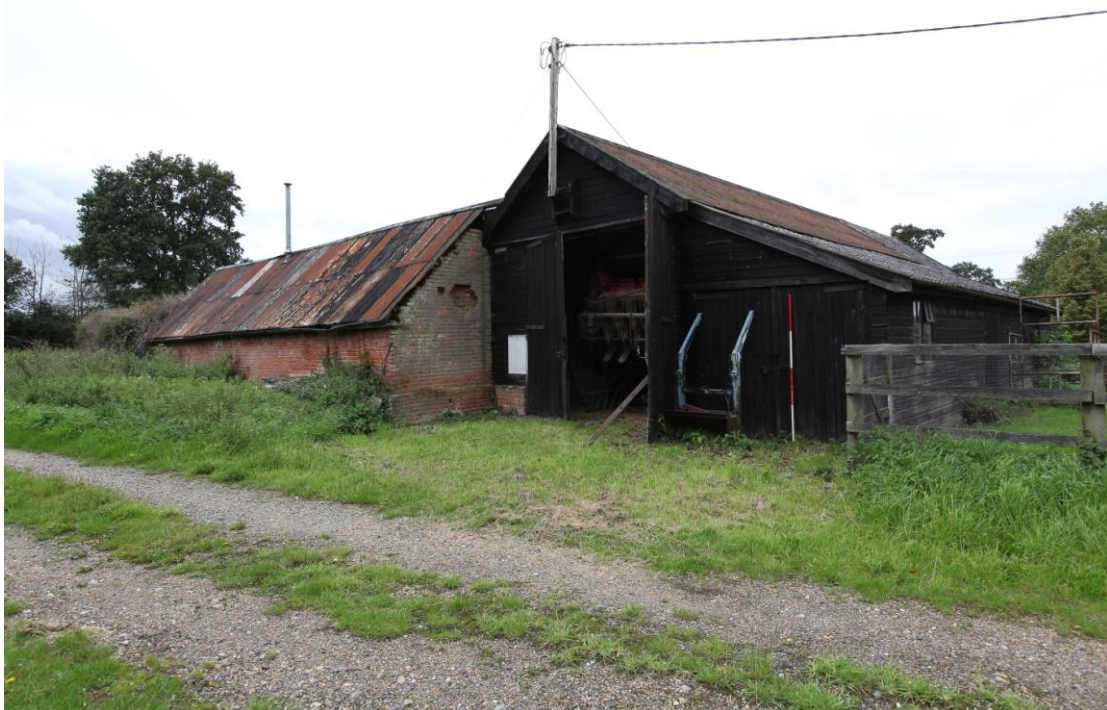
Illus. 2 The exterior from the east showing the inserted vehicle doors in the gables of the barn (1, centre) and the lean-to shed (3a, right) with the brick shelter-shed (4) to the left.

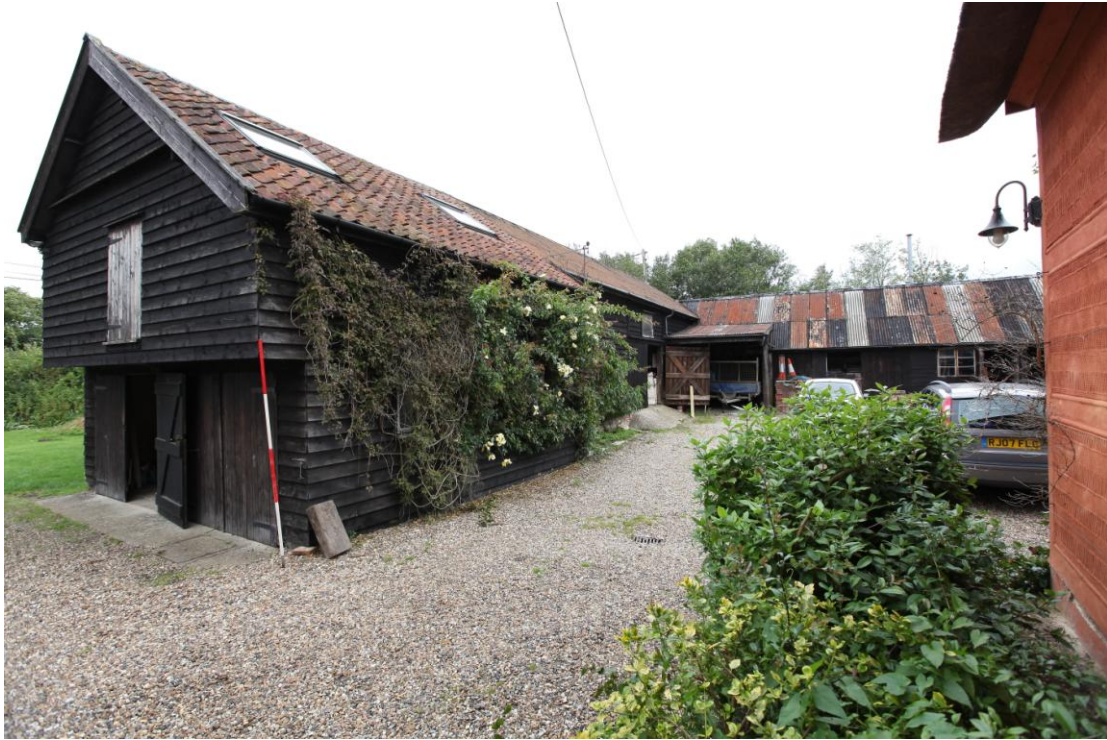
Illus. 3 The exterior from the west showing the unlisted but reputed 17th century farmhouse to the right with the brick shelter-shed (4) in the centre and the barn (1) and 1980s garage (2) to the left.

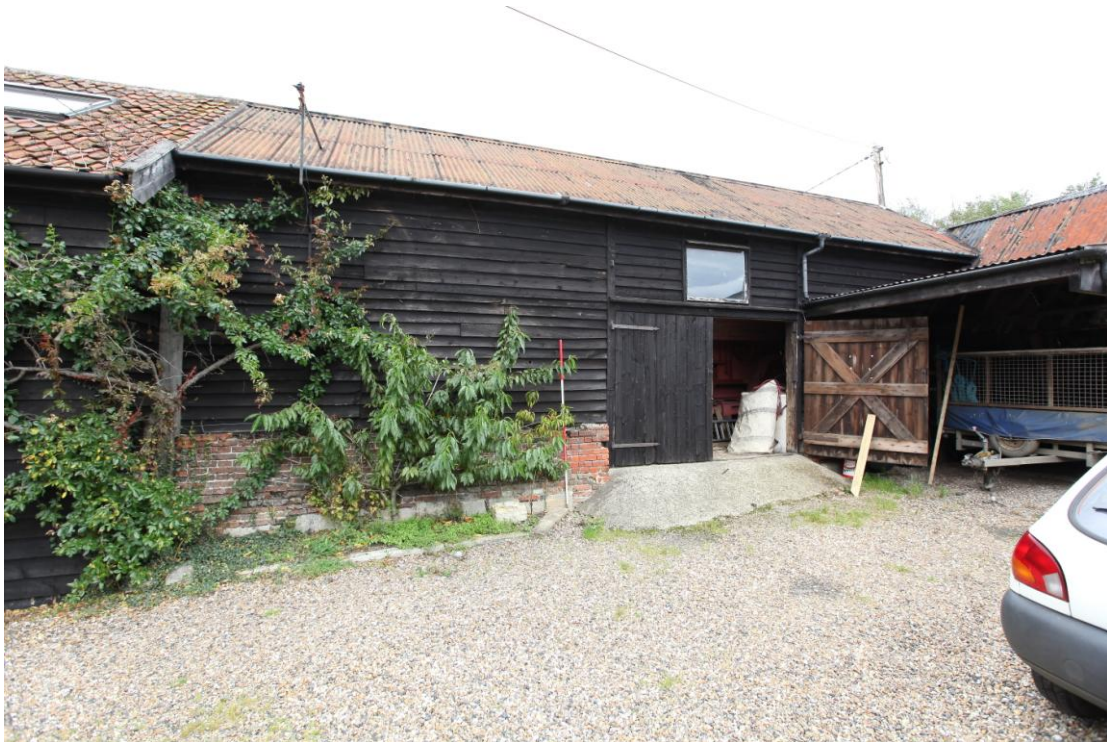
Illus. 4 The southern exterior of the barn (1) showing its 20th century weatherboarding and central doors with the original brick plinth contained re-used ashlar (dressed stone) to the left.

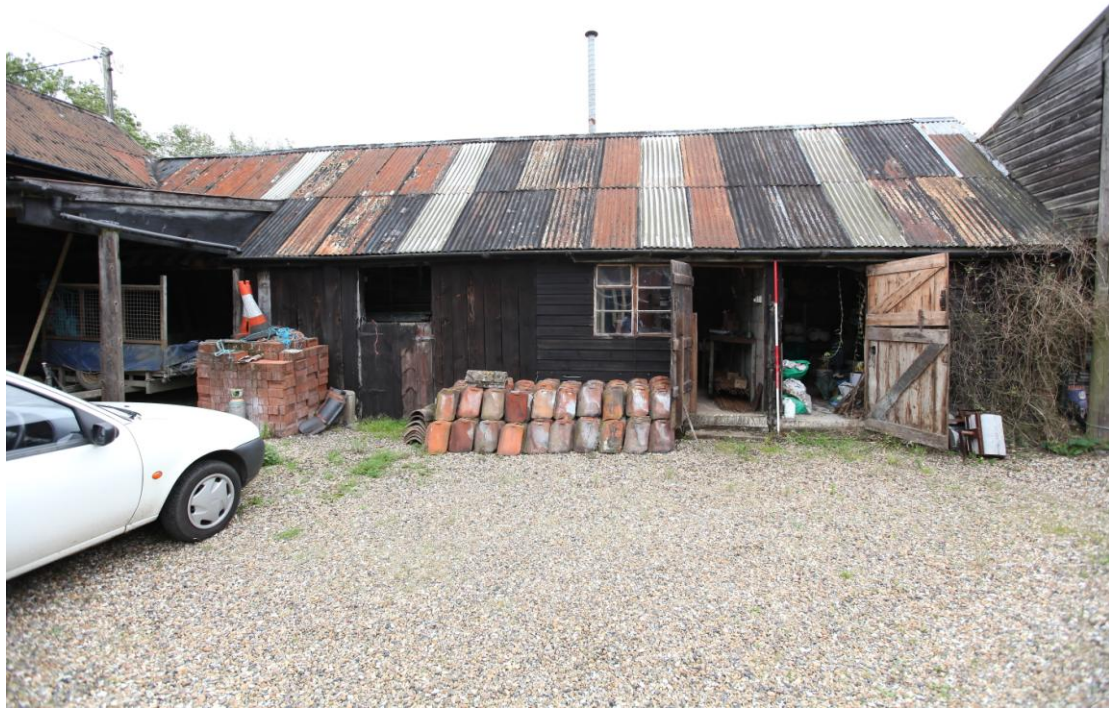
Illus. 5 The originally open western exterior of the brick shelter-shed (4) showing its 20th century boarded infill and corrugated iron roof.

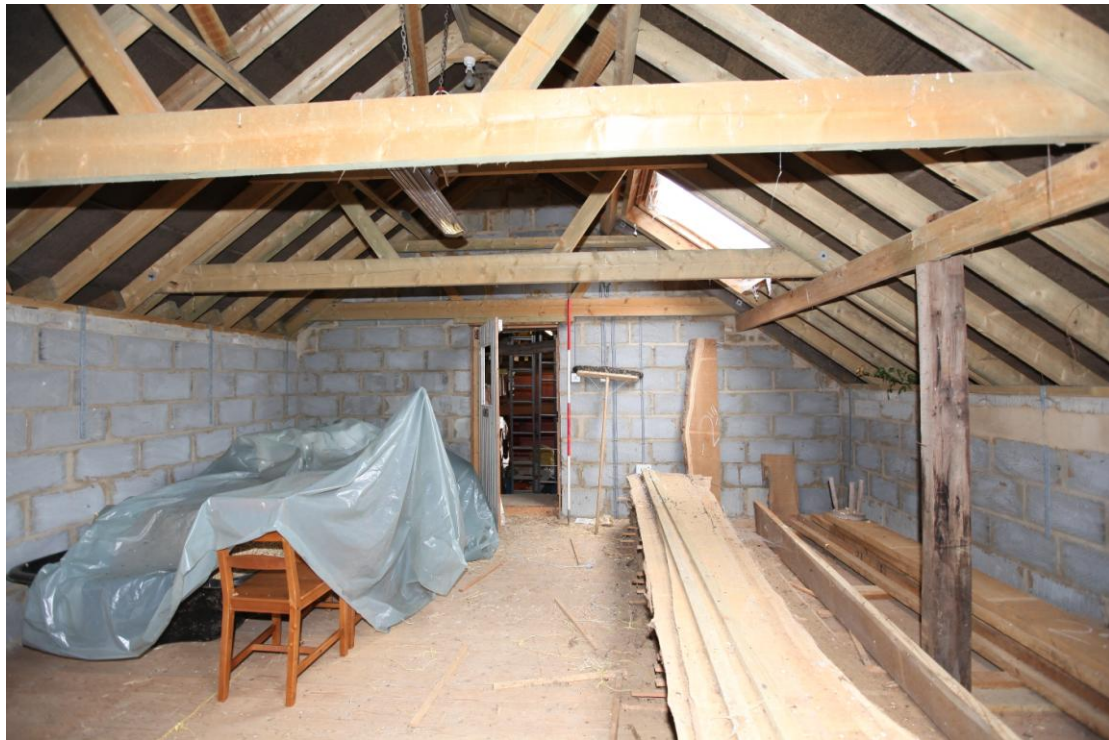
Illus. 6 The interior of the loft above the 20th century garage (2) from the west showing its cement-block fabric (hidden by weatherboarding to the exterior) and the door to the barn (1).

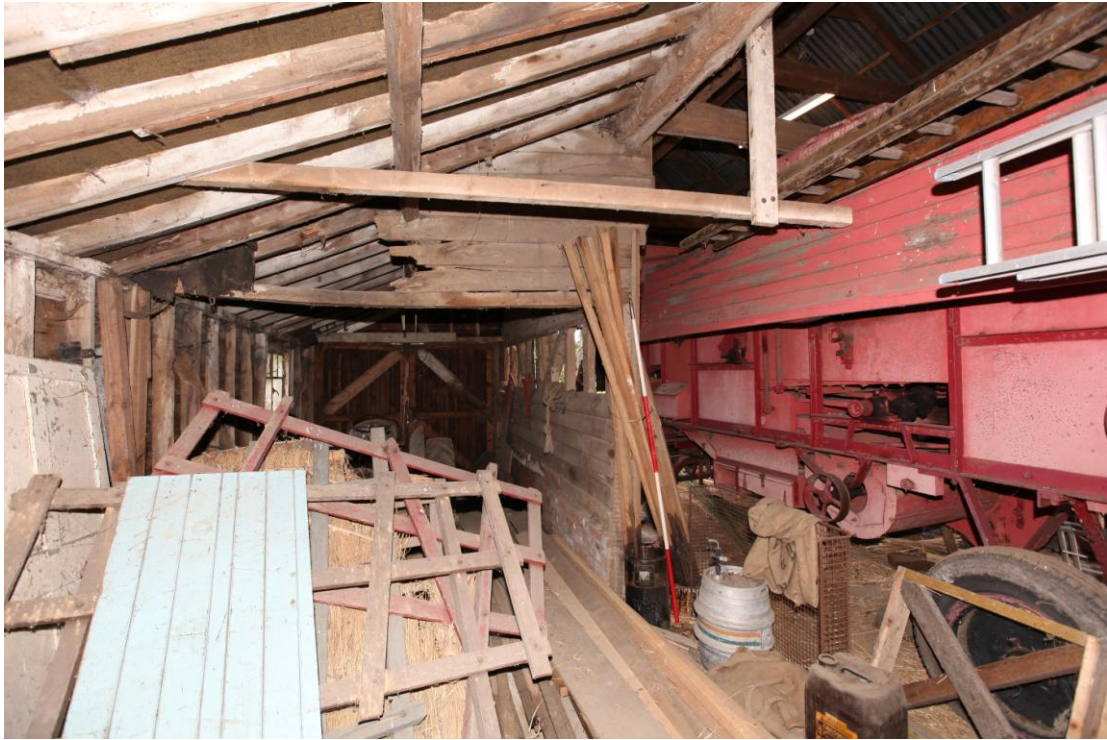
Illus. 7 The interior of the lean-to shed (3a) from the west showing the entrance to the central bay of the barn (1) to the right and the fragmentary remains of the boarded partition which originally divided the area adjoining the threshing floor from the eastern shed beyond.

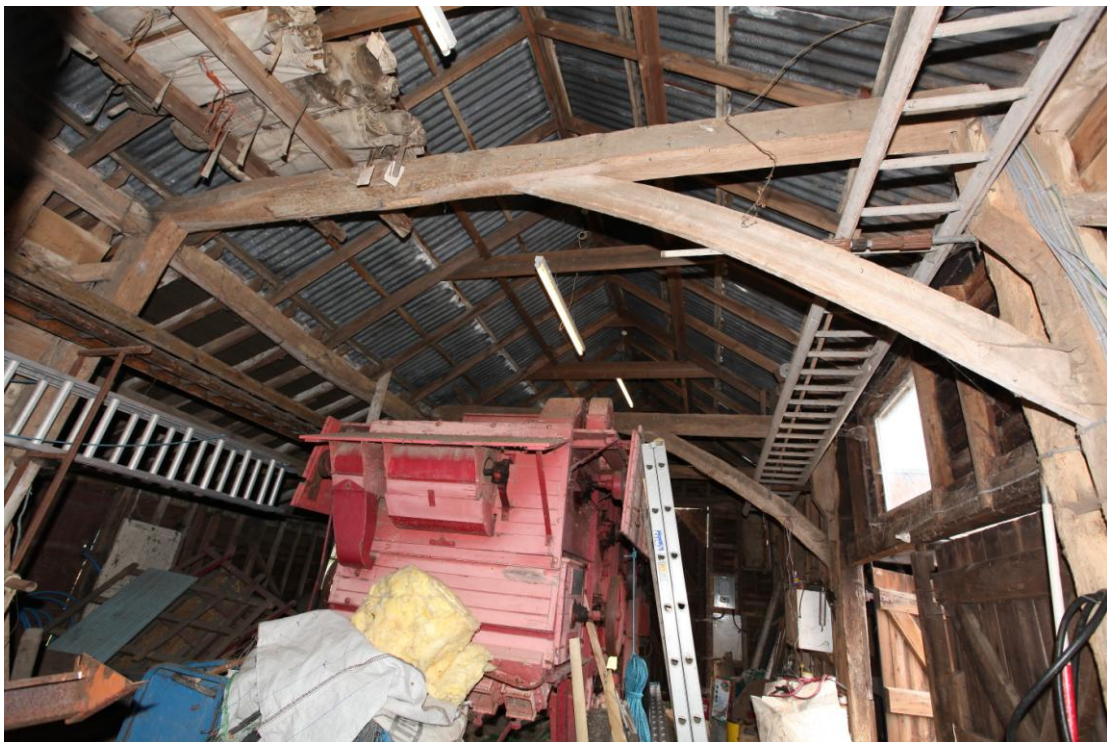
Illus. 8 The late-20th century softwood roof structure of the barn (1) from the west, showing the two original arch-braces tie-beams flanking the central bay to the right and the positions of the removed northern arch-braces to the left.

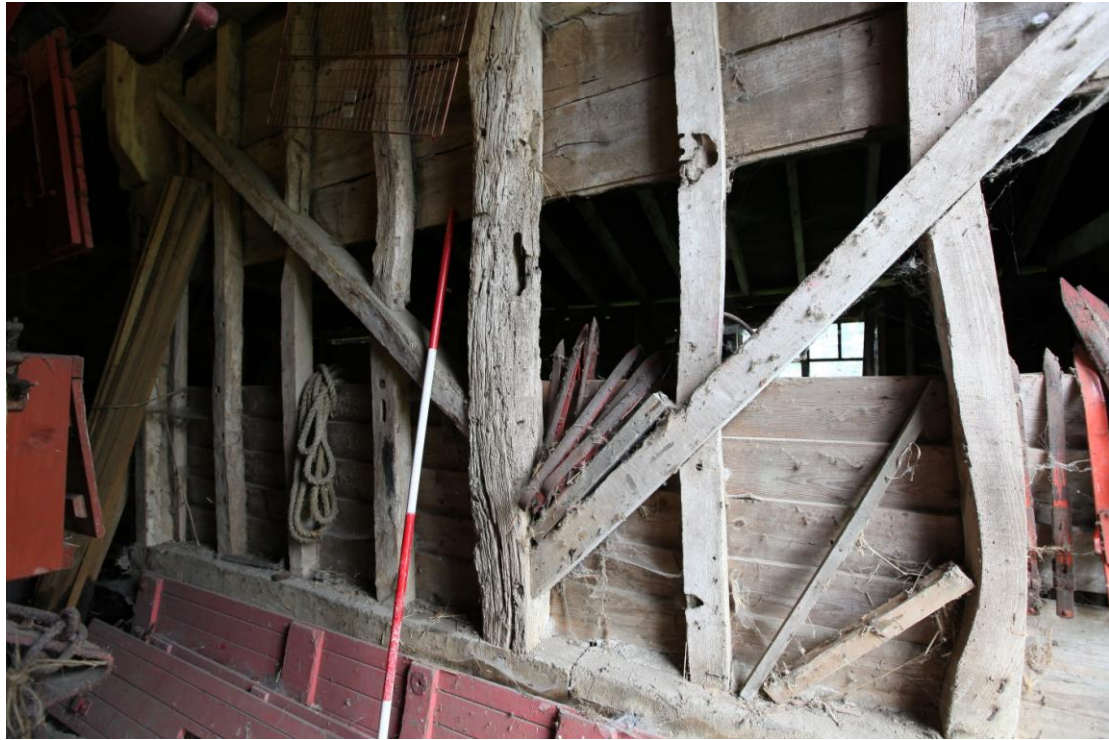
Illus. 9 The northern interior of the eastern bays of the barn (1) showing a typical section of wall fabric: The diagonal primary braces which interrupt the vertical studs are tenoned and pegged to the intermediate post in the centre. Many timbers, including the weathered post, contain empty mortises and have been re-used from earlier buildings.

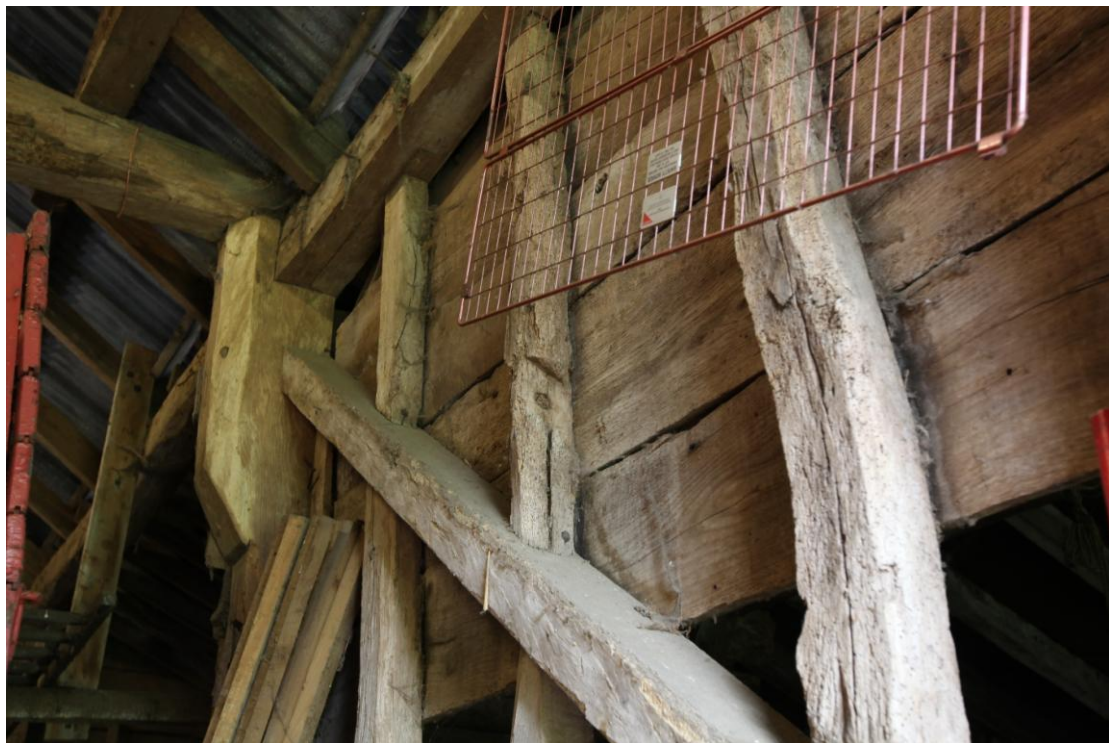
Illus. 10 A detail from the east of the northern jowled storey post to the east of the central bay showing a face-halved and bladed scarf joint in the roof-plate and copious evidence of re-used timber. The butted external boards shown here suggest the rear lean-to is an original feature.
