**Barn at Charity Farm,
Hemingstone,
Suffolk
HMG 028**

Historic Building Record

Barn at Charity Farm, Main Road, Hemingstone, Suffolk

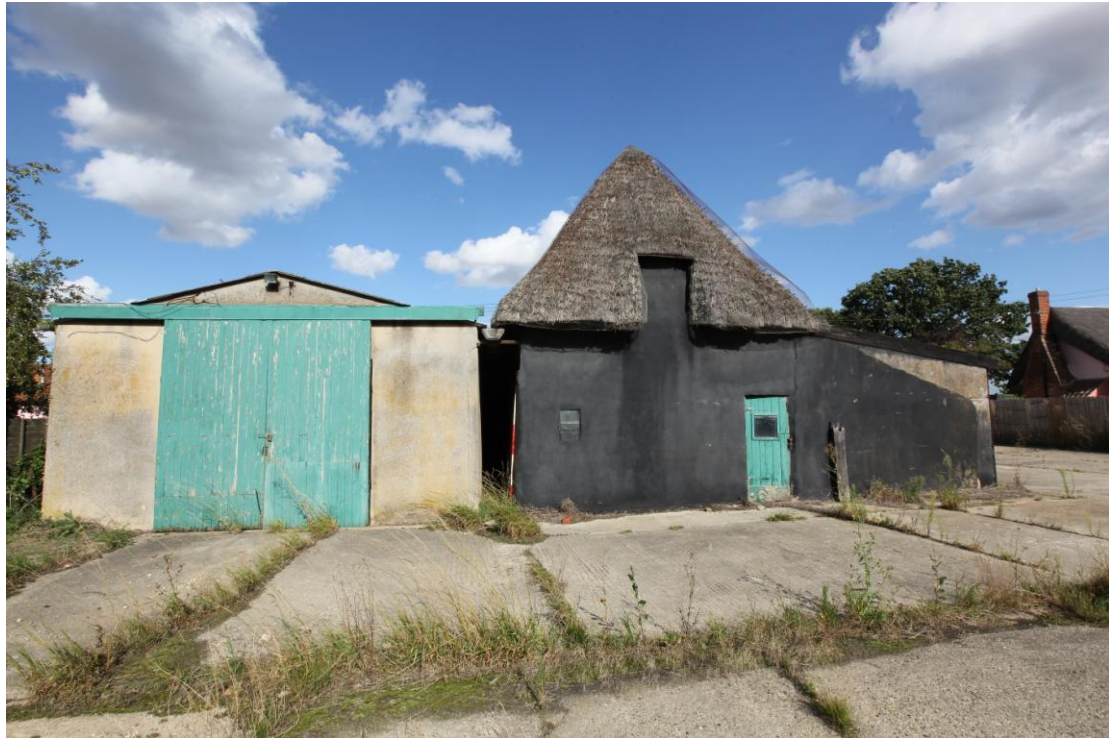
Illus. 3. The external western gable showing the sliding doors of the garage shed (3) to the left and evidence of a blocked window or loading hatch in the thatch of the hipped gable above the former stable (1c). Note the tarred external render and the profile of an earlier southern lean-to shed to the right.

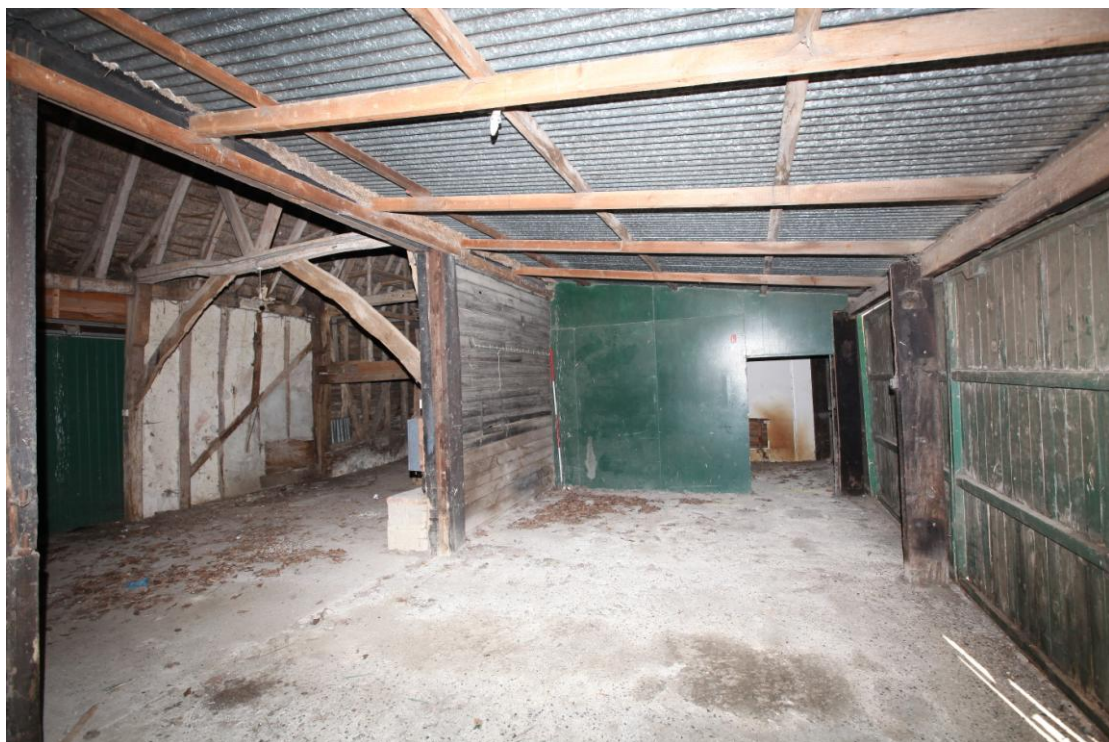
Illus. 4. The interior from the west of the 20th century lean-to shed (2) showing one of its two internal partitions and the tarred and weatherboarded southern exterior of the barn (1) to the left. The storey posts of the entrance in the central bay (1a) bear iron pintles for missing half-hung barn doors.

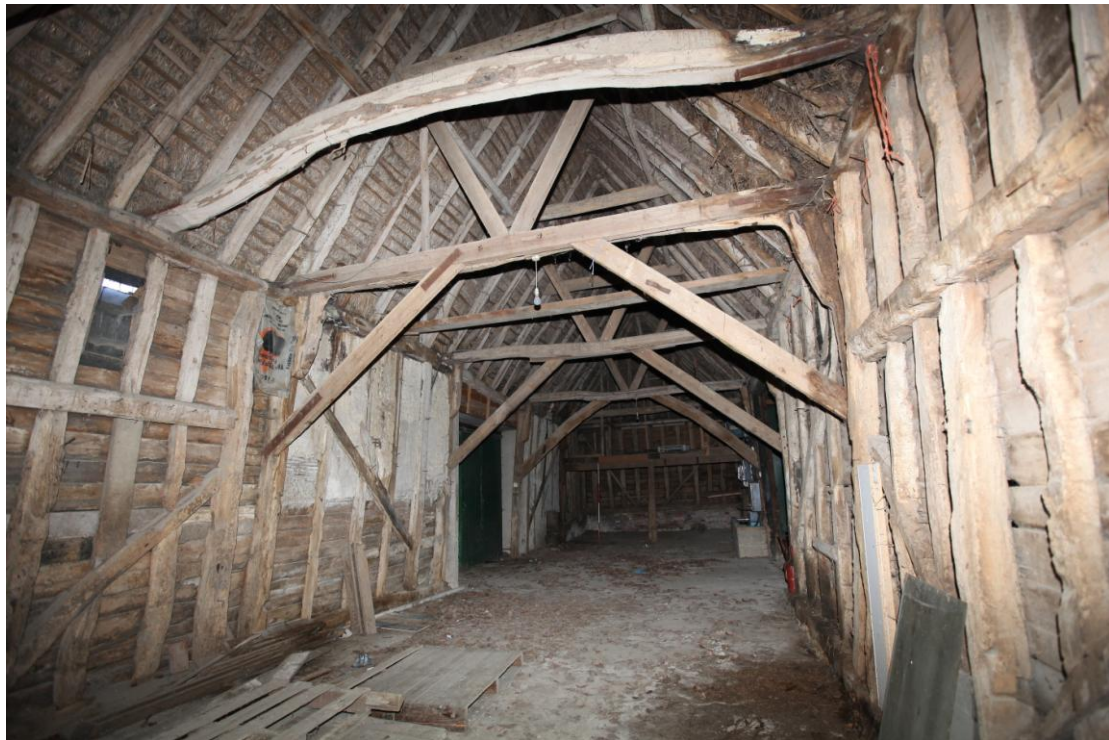
Illus. 6. General view of the barn interior from the west showing two secondary pairs of arch-braces to the tie-beams in the foreground and an original pair in the rear. The interior was originally divided into three compartments by lateral partitions that have since been removed, viz. a three-bay stable and hay loft in the foreground (1c), a slightly earlier three-bay threshing barn in the centre (1a) and a narrow floored bay that may have served an additional stable in the rear (1b).

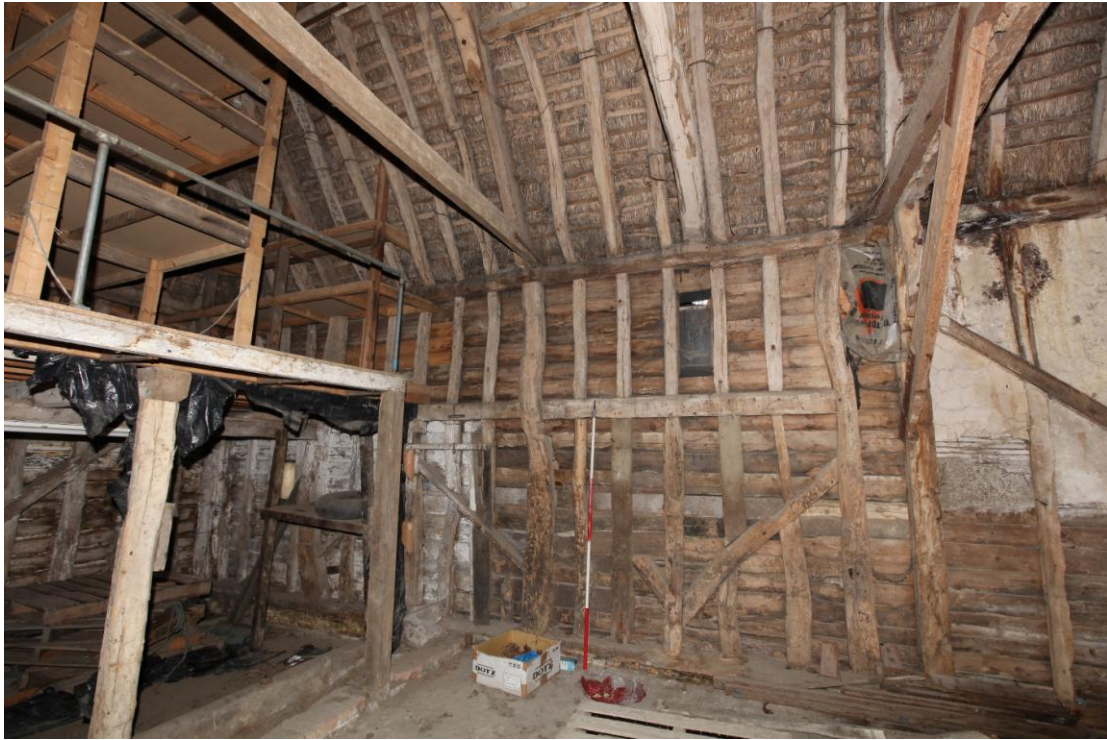
Illus. 7. The northern interior of the three-bay stable (1c) showing evidence of re-used timber with nailed diagonal primary braces and unusually distorted storey posts linked by mid-rails. The original tie-beam of the removed western gable of the three-bay barn is visible to the right (with some extant lath-and-plaster to its western bay). The remaining fragment of the original loft to the left has been largely rebuilt in modern softwood and supports a series of modern storage shelves.

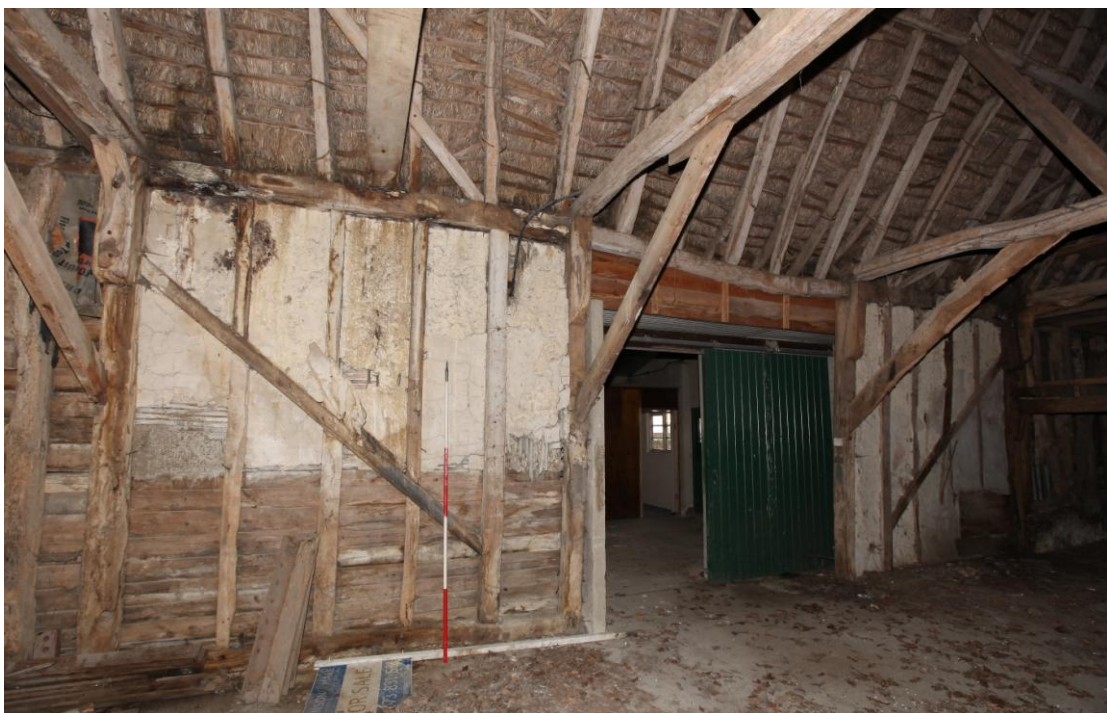
Illus. 8. The northern interior of the original three-bay threshing barn of *circa* 1800 barn showing its largely intact framing with pegged primary braces and the position of the northern entrance in its central bay. This entrance appears to have opened onto a rear porch (possibly with a lean-to roof structure rather than a vertical gable).

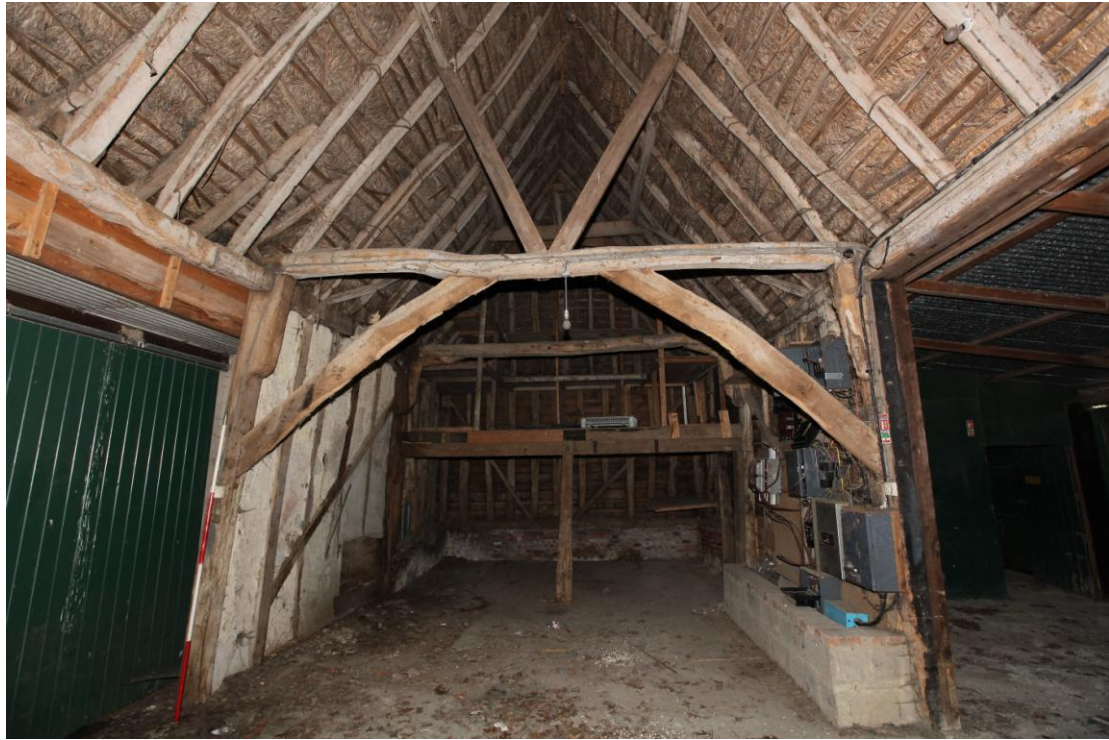
Illus. 9. The interior of the concreted central threshing floor of the three-bay barn (1a) seen from the west, showing the intact open-truss of the steeply-pitched clasped-purlin roof structure with later (V-shaped) queen-struts above its tie-beam.

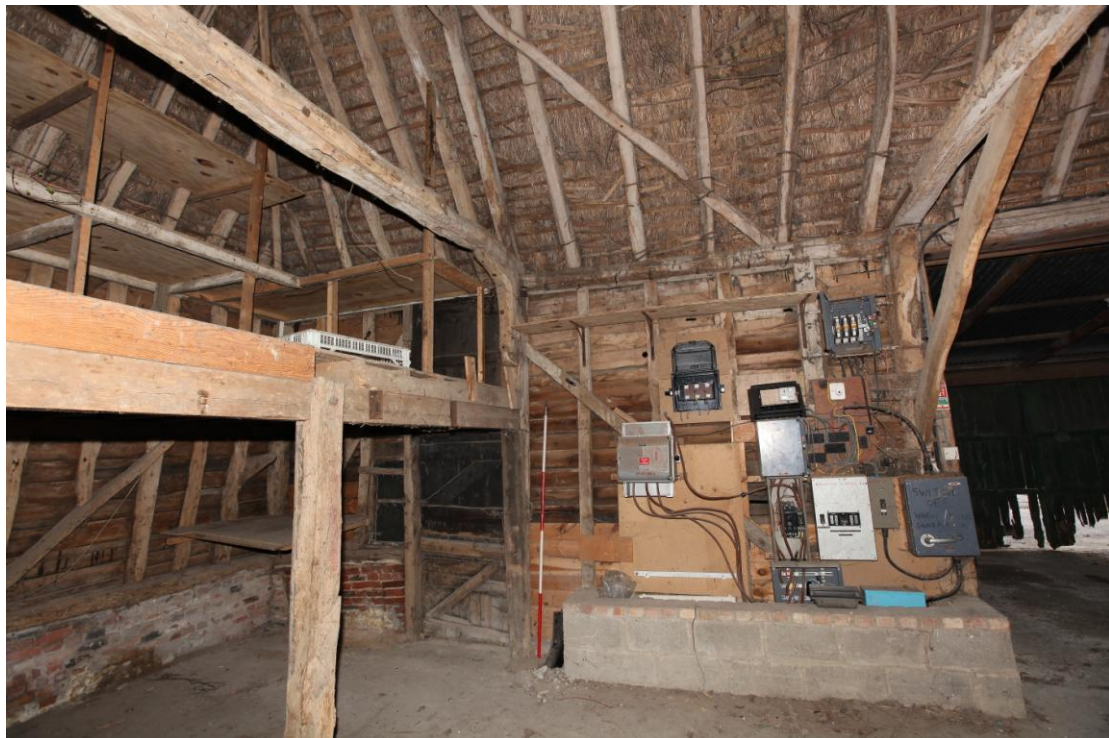
Illus. 10. The southern interior of the slightly later eastern bay of the barn (1b) showing its rebuilt loft with black-painted loading hatch and half-hung entrance door in the centre. The adjoining tie-beam of the threshing barn contains empty mortises for the studs of its missing eastern gable.

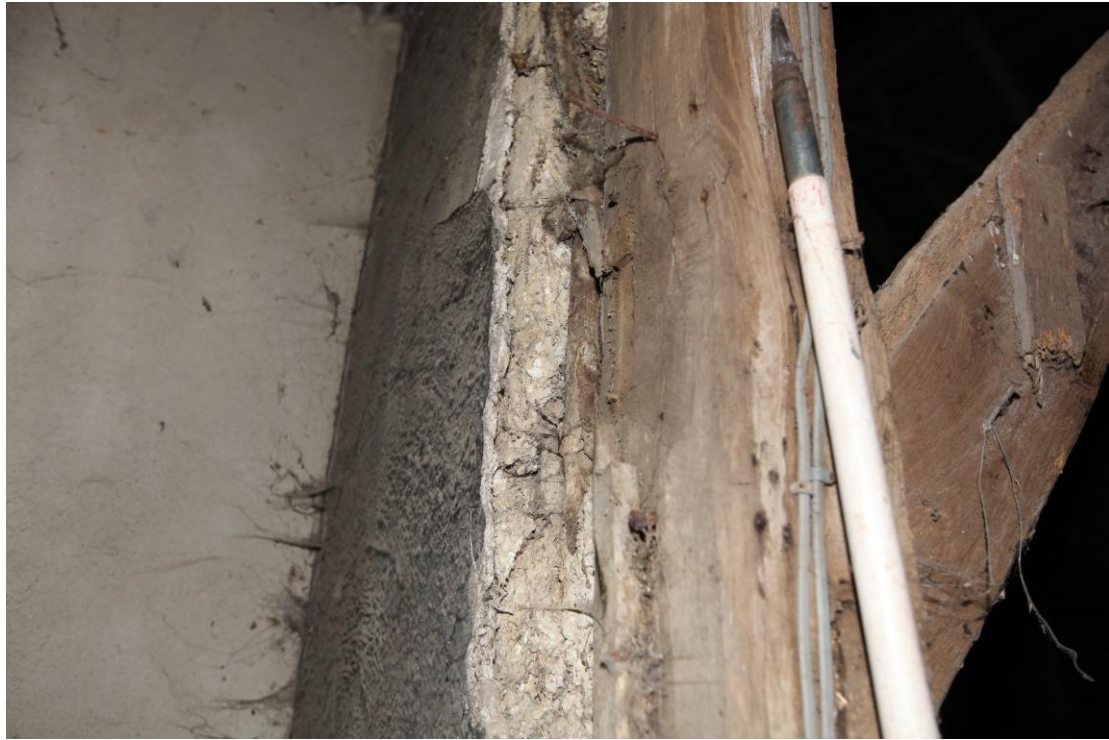
Illus. 11. The eastern truss of the central bay of the barn (1a) seen from the west, showing the narrow exposed section of original external roughcast clay daub with a skim of tarred lime plaster. The mortise of the demolished rear 'porch' which this daub abutted is also visible.

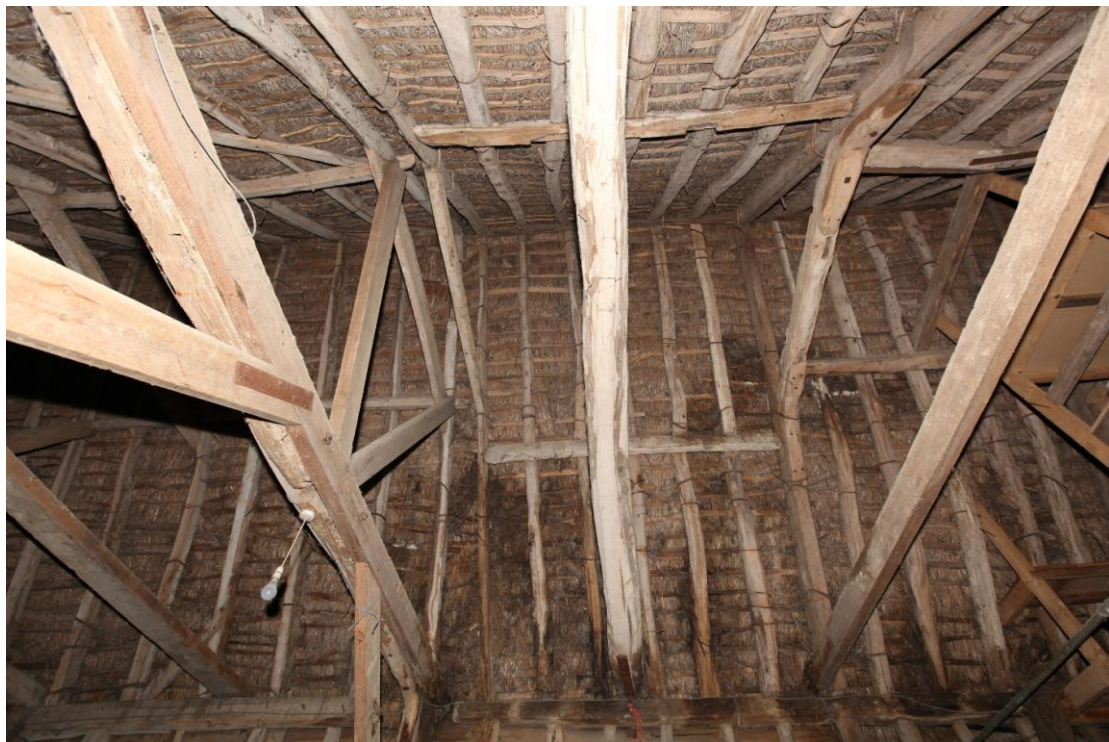
Illus. 12. The southern roof structure of the three-bay stable (1c) showing its triangular butt-purlins and the junction with the clasped-purlin roof of the barn (1a) to the left.
