**Barn at Ufford Hall Farm,
Fressingfield,
Suffolk
FSF 069**

Historic Building Record

OASIS ID: Suffolkc1-110270

September 2011

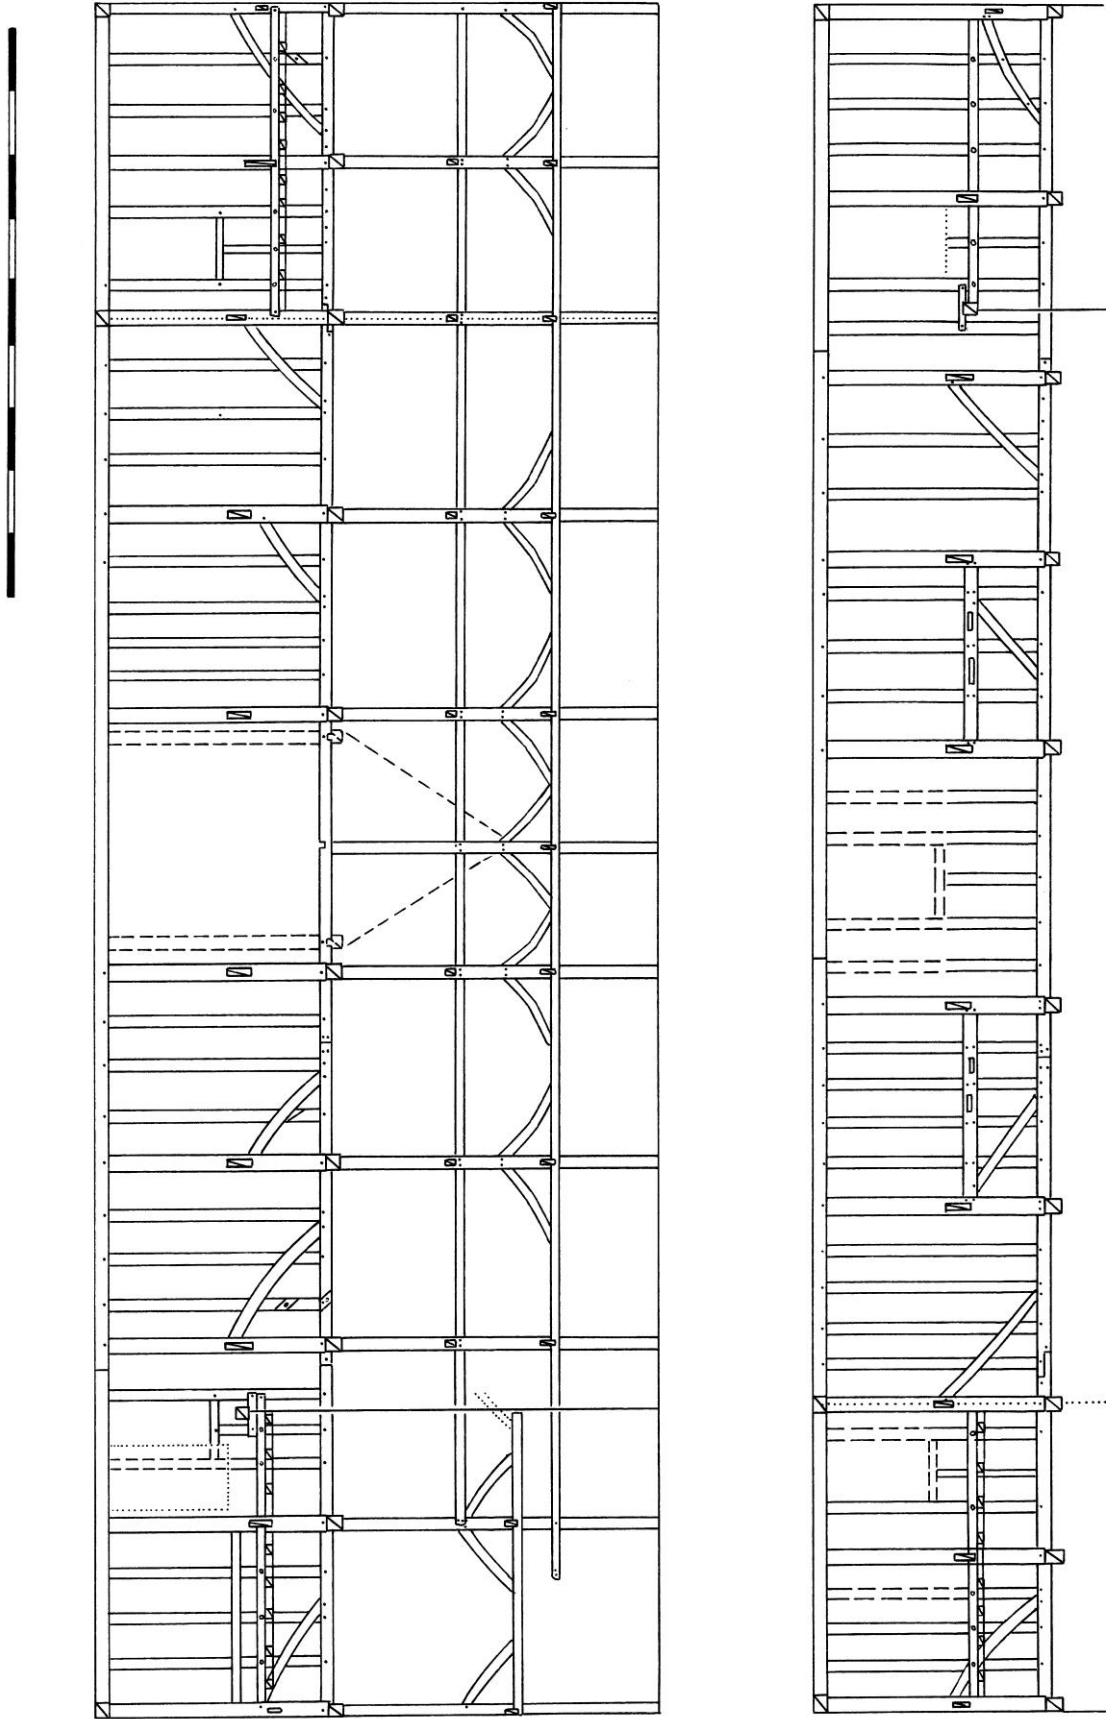
Figure 6 (page 11)

Internal elevations: Front (east) with roof structure below and rear above.

The rear roof structure is identical.

Note the original framed door lintels to both stables in the eastern elevation and the evidence of an earlier gabled porch which may also be an original feature. Although the roof of the northern stable (bays A & B) is fully integral to that of the threshing barn and there is no evidence of former hips there were (unusually) no wind-braces to the four corners of the barn or the adjoining corners of the stable. The roof of the southern stable (I & H) is an entirely different structure which once either extended further to the north or abutted an earlier barn – as indicated by the lap-joint in the purlin for a wind-brace for which there is no corresponding mortise in the original principal rafter of the barn. Most individual timbers of the barn and northern stable (bays A-G) show signs of re-use – including an apparent passing-brace trench in the eastern roof-plate of bay G - but there is no similar evidence in the southern stable. The ostensibly random mid-rails flanking the threshing bay in the western elevation are original features that were presumably intended to facilitate the re-use of short lengths of timber.

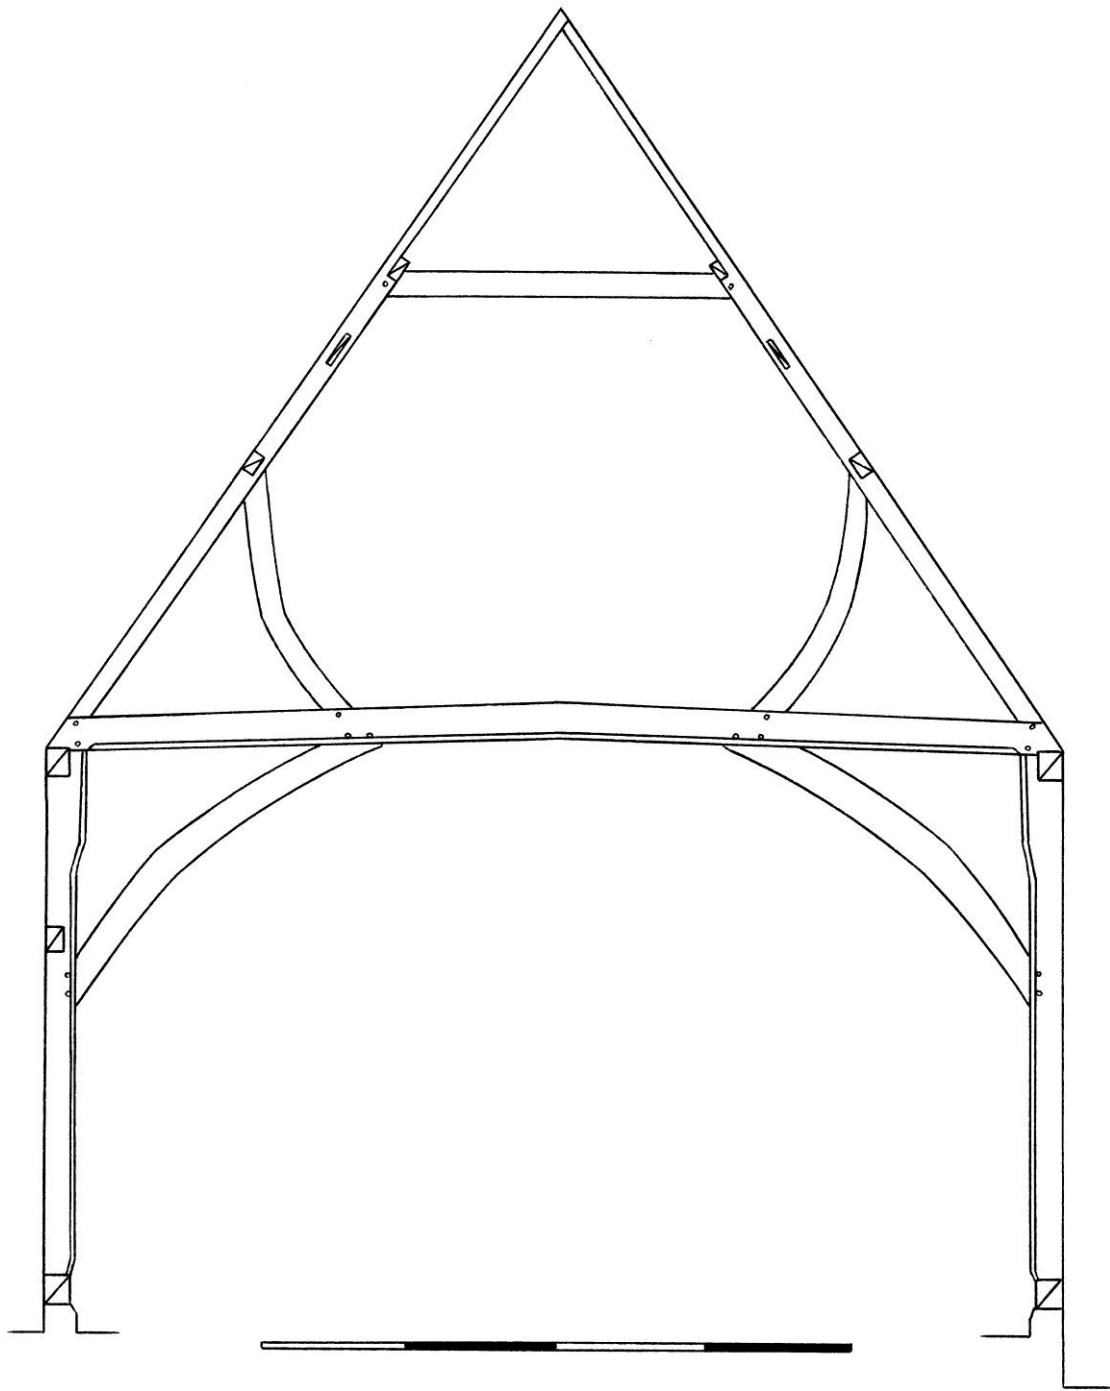
Figure 7 (page 12)

Typical open truss of threshing barn (specifically that between bays F and E viewed from the south). The unusual raking queen struts with sharp cranks (angles) may be early insertions as they are nailed rather than tenoned and pegged to the principal rafters, but this anomaly may have been a means to avoid weakening the junction by cutting a third mortise near those of the butt-purlins.

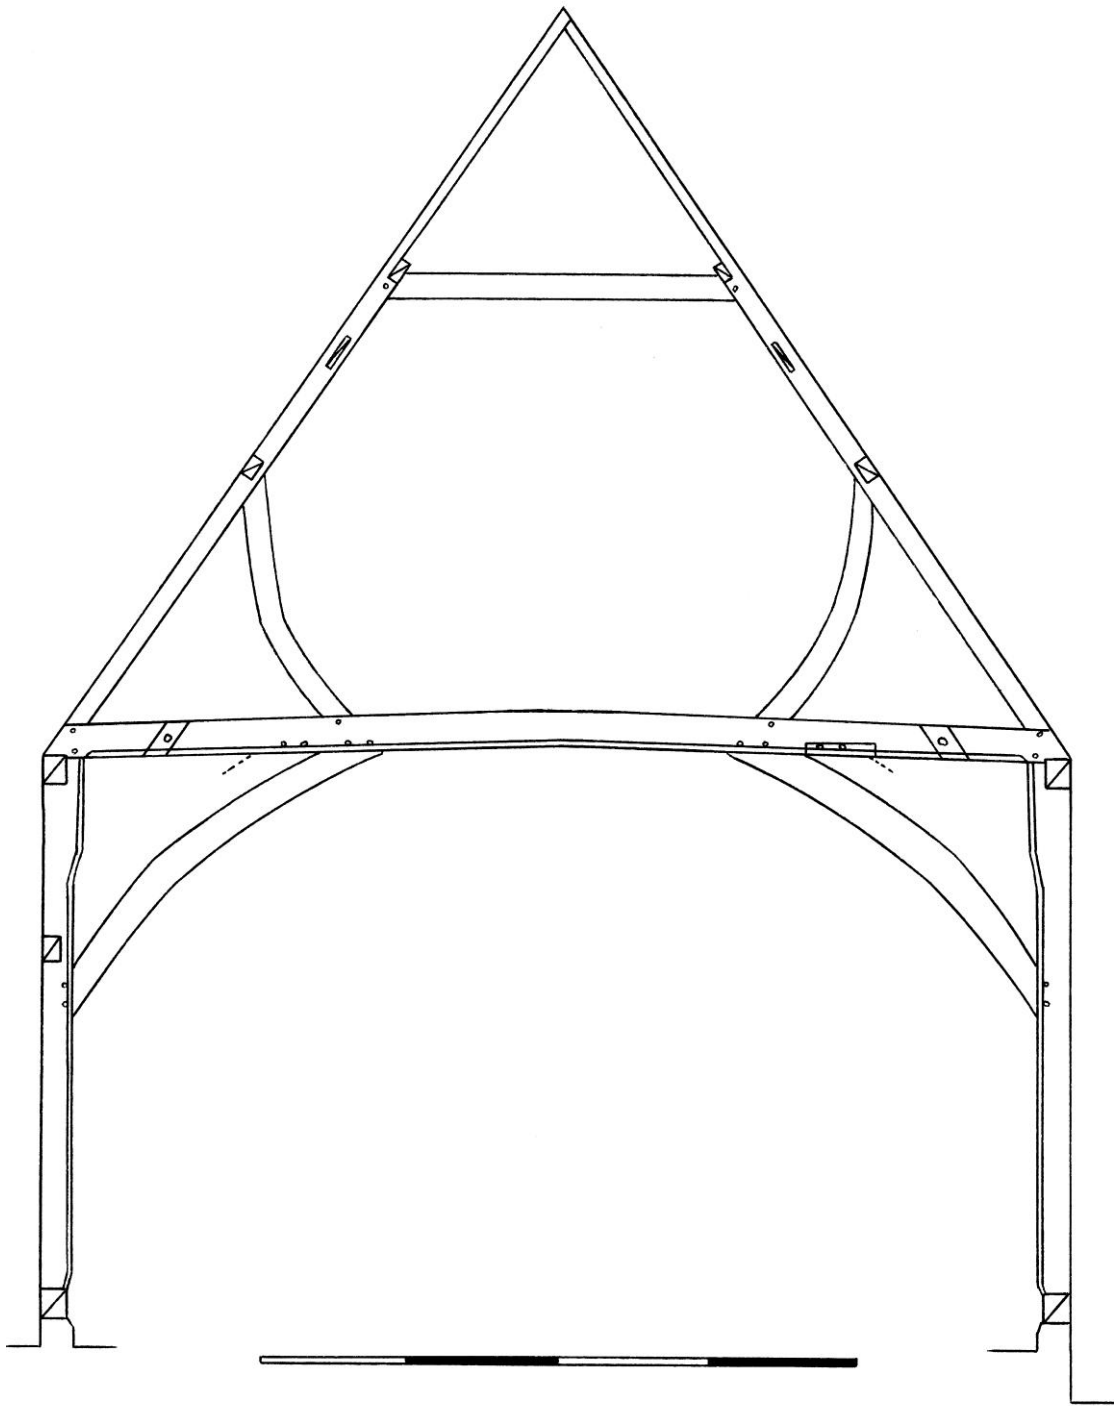
Figure 8 (page 13)

Open truss of threshing barn with re-used tie-beam (specifically that between bays G and F viewed from the south). Three tie-beams were re-used from an older frame and contain trenches for passing braces and mortises for shorter arch-braces in a manner associated with aisled barns of the late-13th and 14th centuries. Trenches can be seen in the southern side of the open truss in the stable (between bays A and B) and the northern side of the tie between bays C and D. The tie-beam between bays G and H contains stud mortises and is also re-used, but the ties of the remaining open trusses appear to be primary.

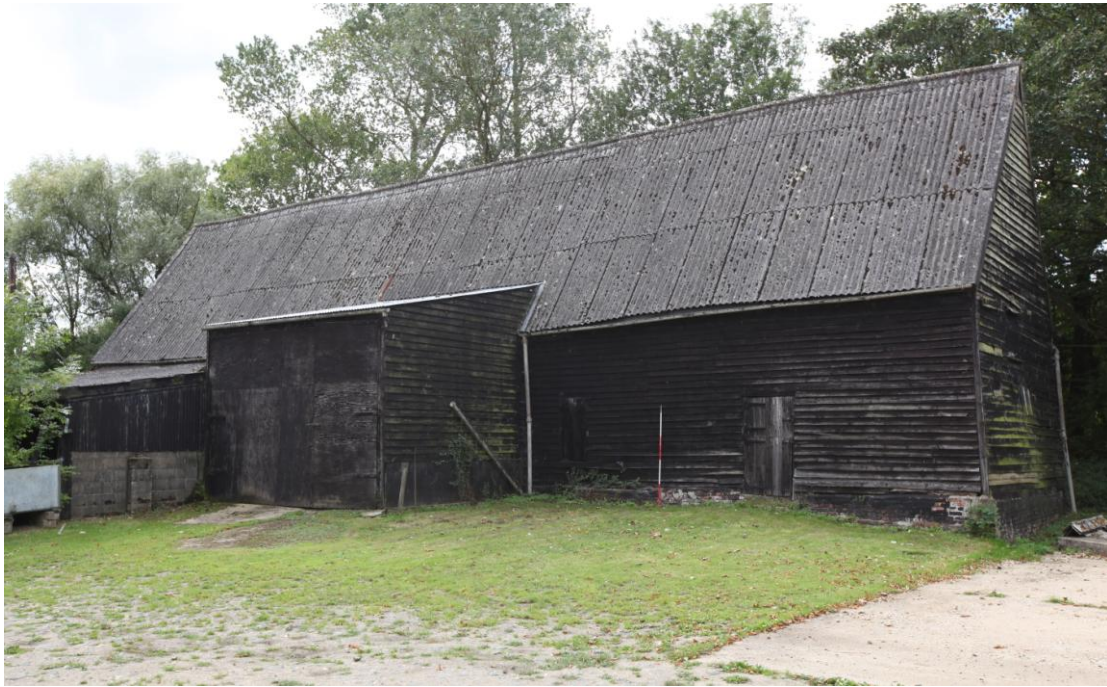
Illus. 1. The eastern exterior showing the corrugated asbestos roof (steeply pitched for its original thatch) with a late-20th century lean-to porch adjoining bay E to the left (on the site of an earlier, narrower gabled porch) and the half-hung entrance door to the northern stable in bays A and B to the right.

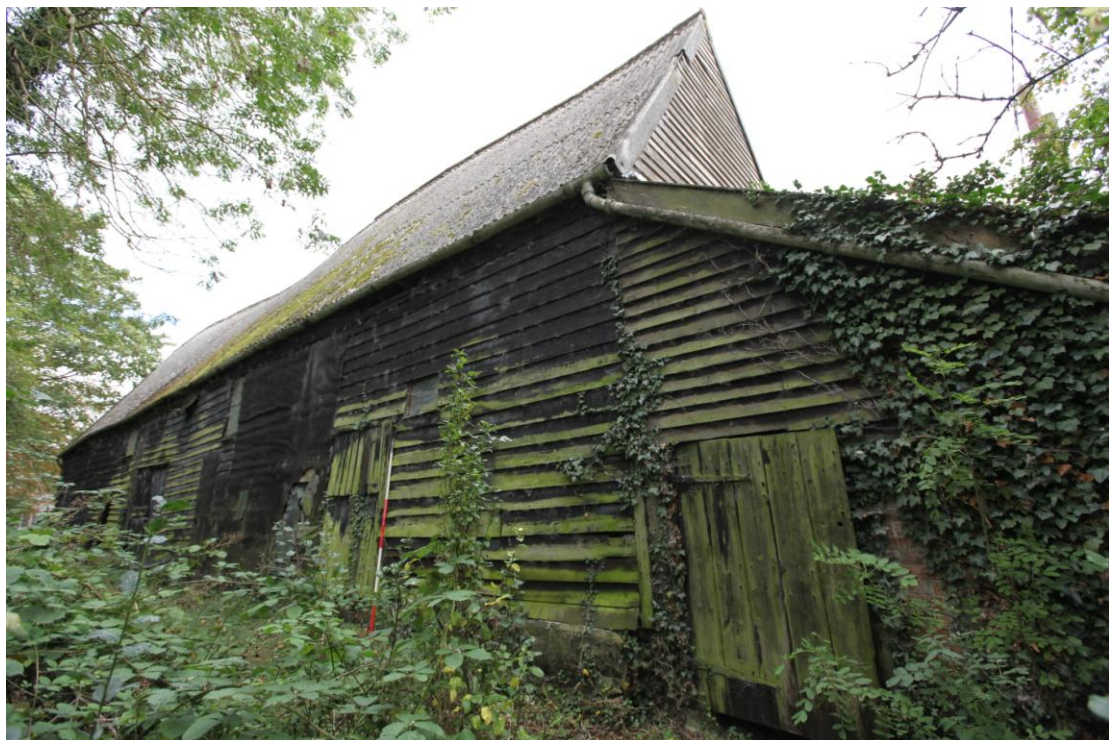
Illus. 2. The western exterior from the south-west showing the half-hung door to the southern stable (bays H and I) with the entrance to the 20th century lean-to against the southern gable to the right.

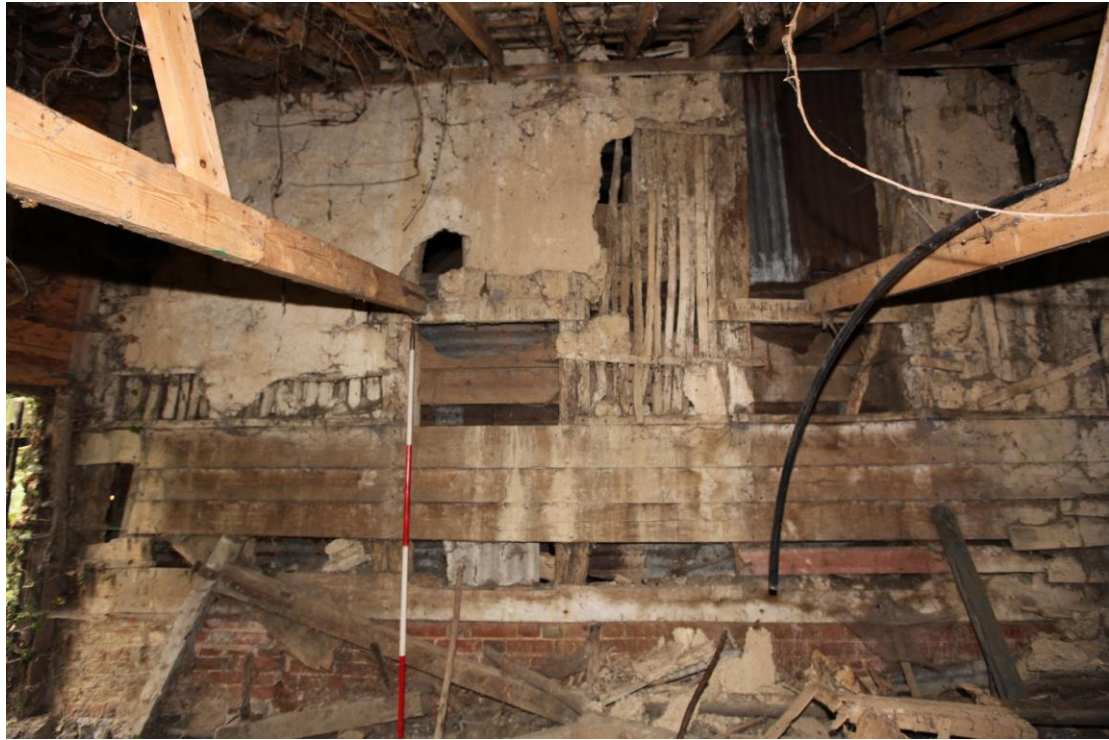
Illus. 3. The exterior of the southern gable preserved in the lean-to shed, showing the 18th or early-19th century ‘two-tier’ cladding of wattle and daub above weatherboarding. The entire barn is likely to have been clad in this manner before the addition of the present tarred weatherboarding.

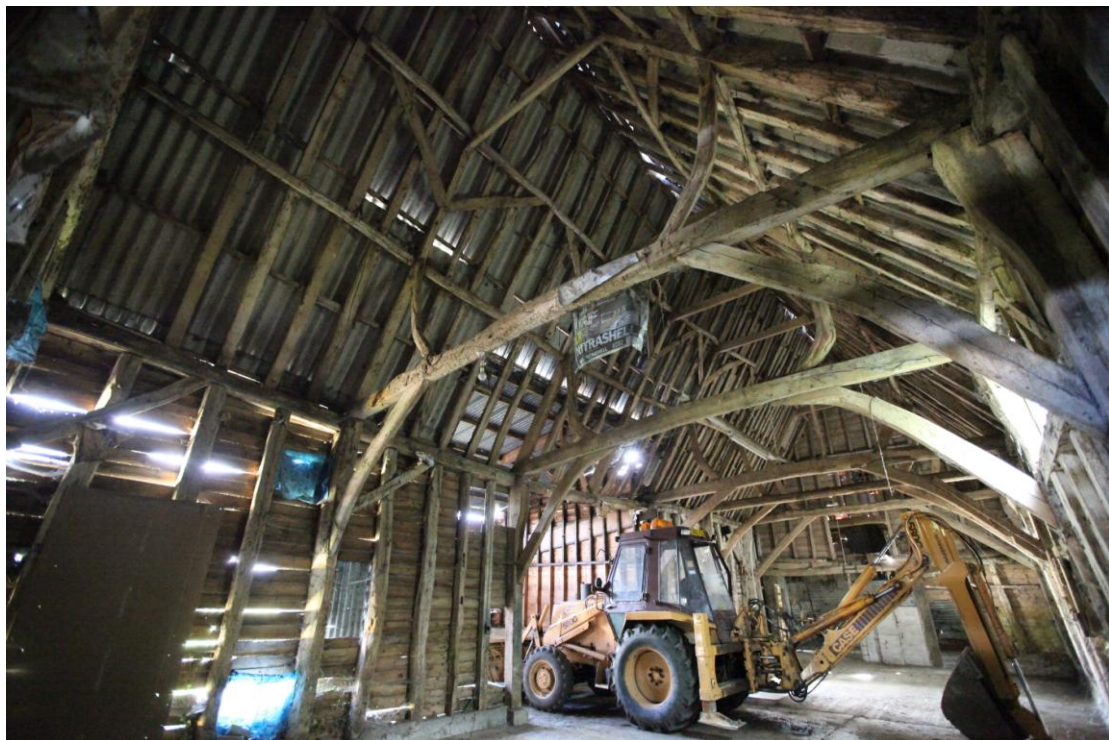
Illus. 4. A general view from the north-west of the main threshing barn (bays C-G) between the two stables, showing a tractor parked in the central threshing bay (E). The tie-beam between bays C and D in the foreground has trenches for passing-braces at both ends and has been re-used from an early-14th century or earlier building.

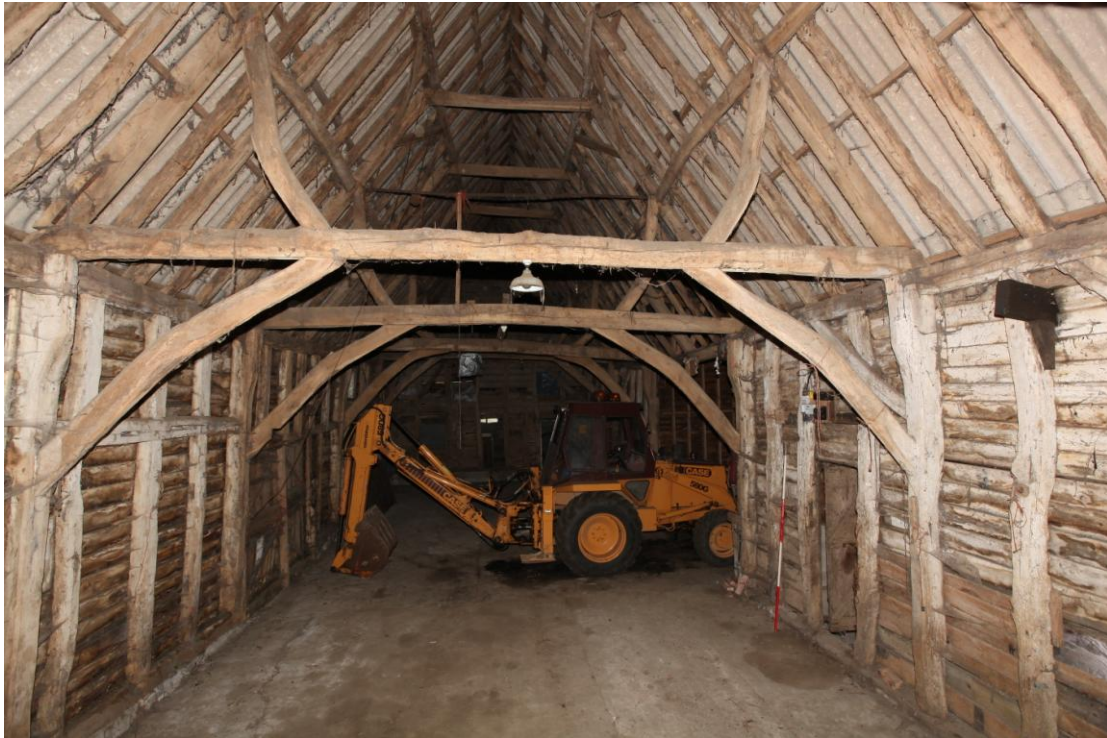
Illus. 5. A general view of the main barn (C-G) from the south, showing the distinctive profile of its roof trusses. The original mid-rail in bay F is visible to the left – apparently a device to allow the re-use of short lengths of timber.

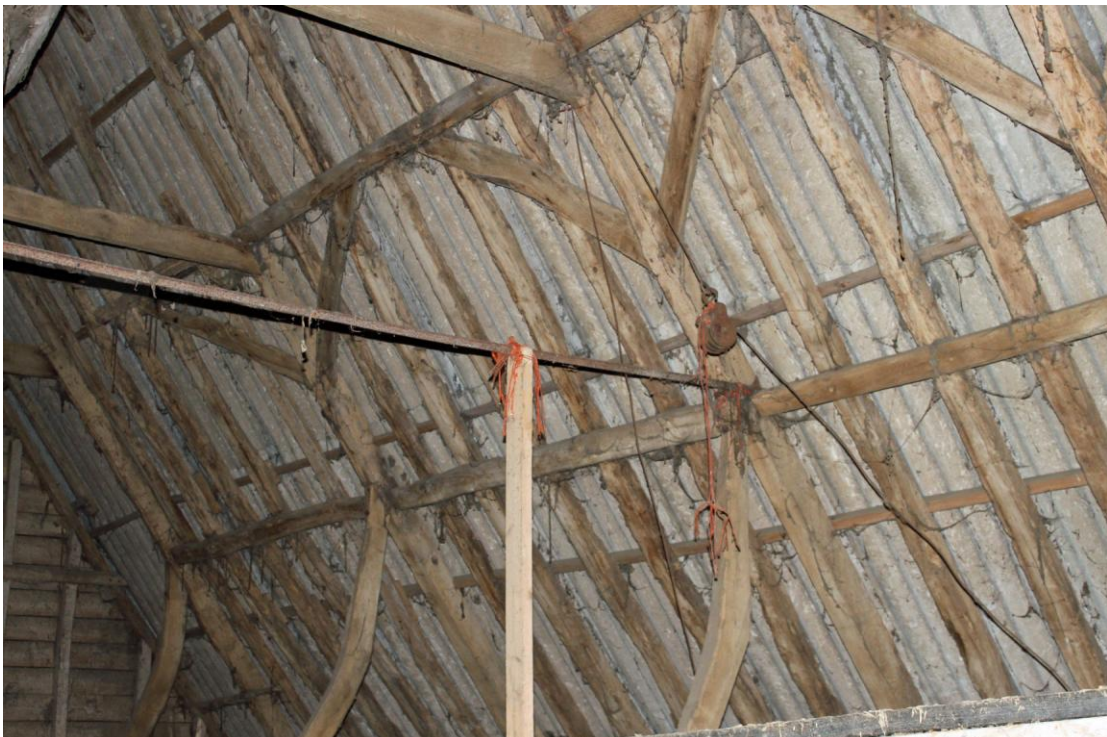
Illus. 6. The roof structure seen from the north-east, showing the exceptionally intact array of curved wind-braces to the upper tier of clasped-purlins and the lower tier of butt-purlins.

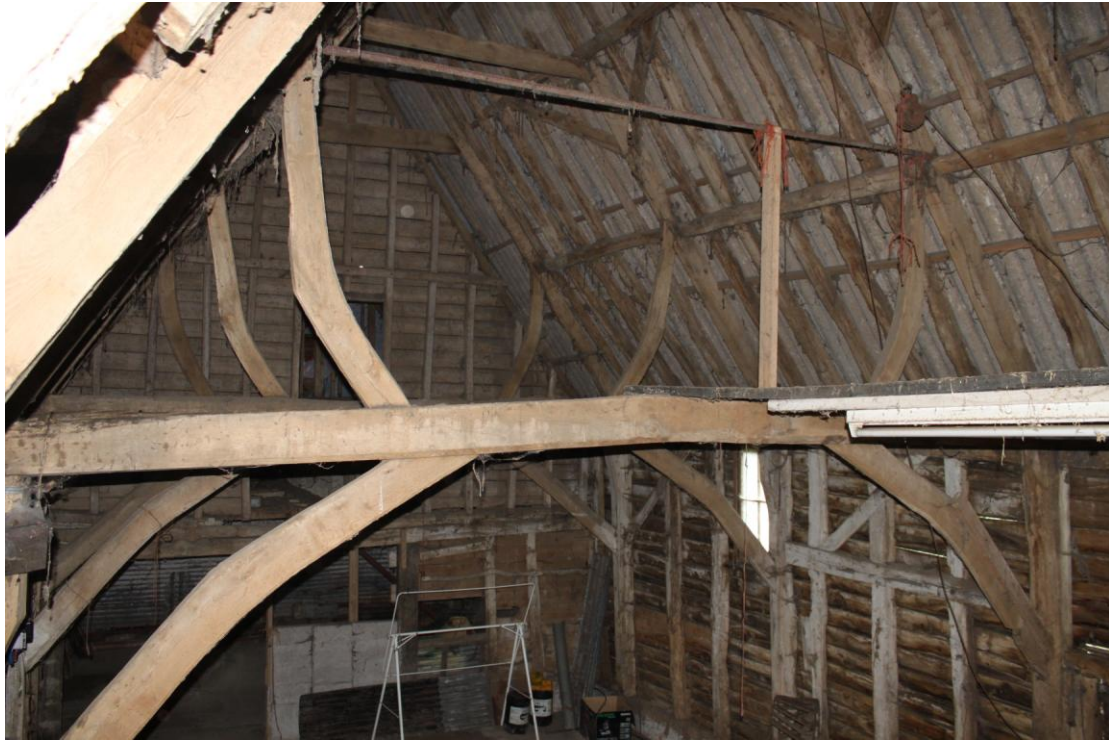
Illus. 7. The highly unusual cranked queen-struts between the tie-beams and principal rafters, seen from the north-east. These are tenoned and pegged to the tie-beams but nailed to the rafters and may possibly be secondary insertions.

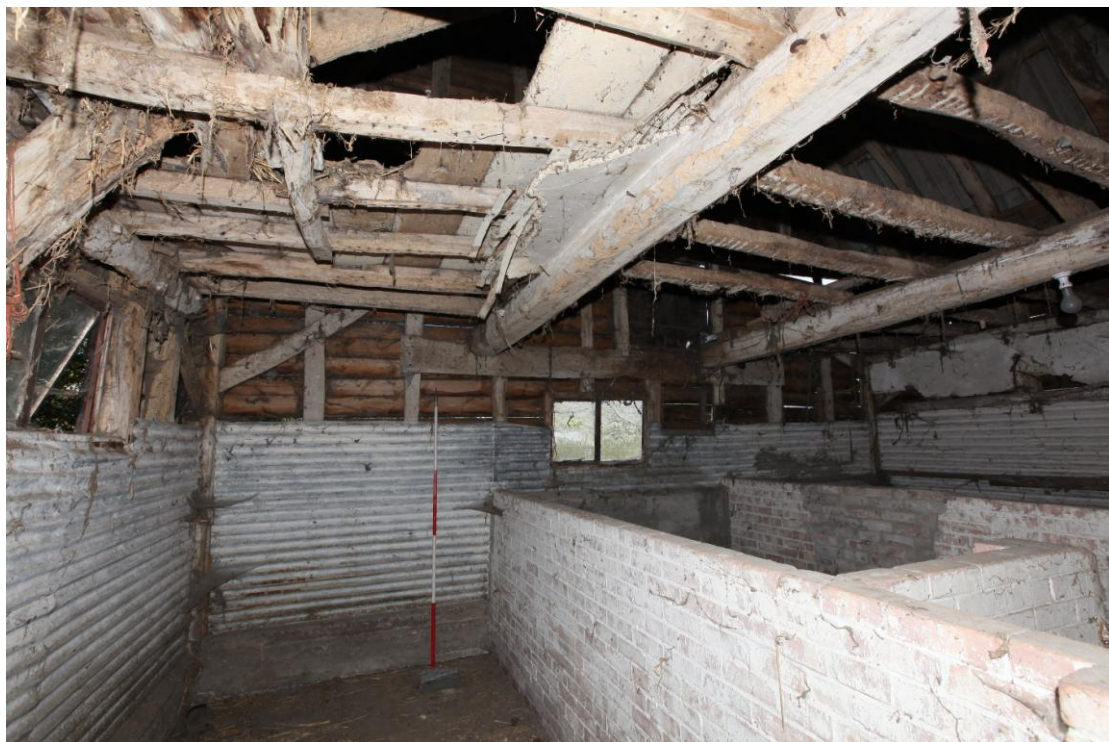
Illus. 8. The internal gable of the northern stable (bays A and B) showing the twin axial joists of the hay loft with remnants of lath-and-plaster. The mid-20th century brick partitions and wainscot of corrugated asbestos were probably designed to form loose boxes for calves.

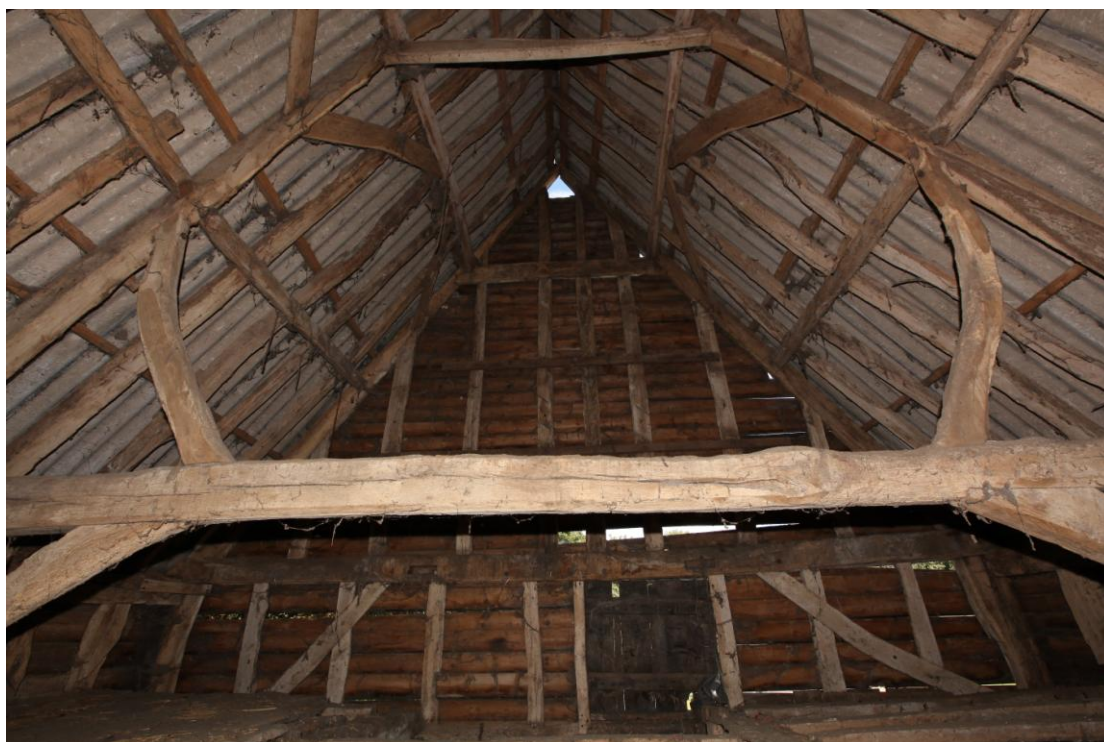
Illus. 9. The interior of the northern hay loft (bays A and B) from the south, showing the raking queen struts to the re-used tie-beam (with passing-brace trenches to left and right) and a loading hatch in the gable. The wind-braces extend to the gable in contrast to those of the main threshing barn.

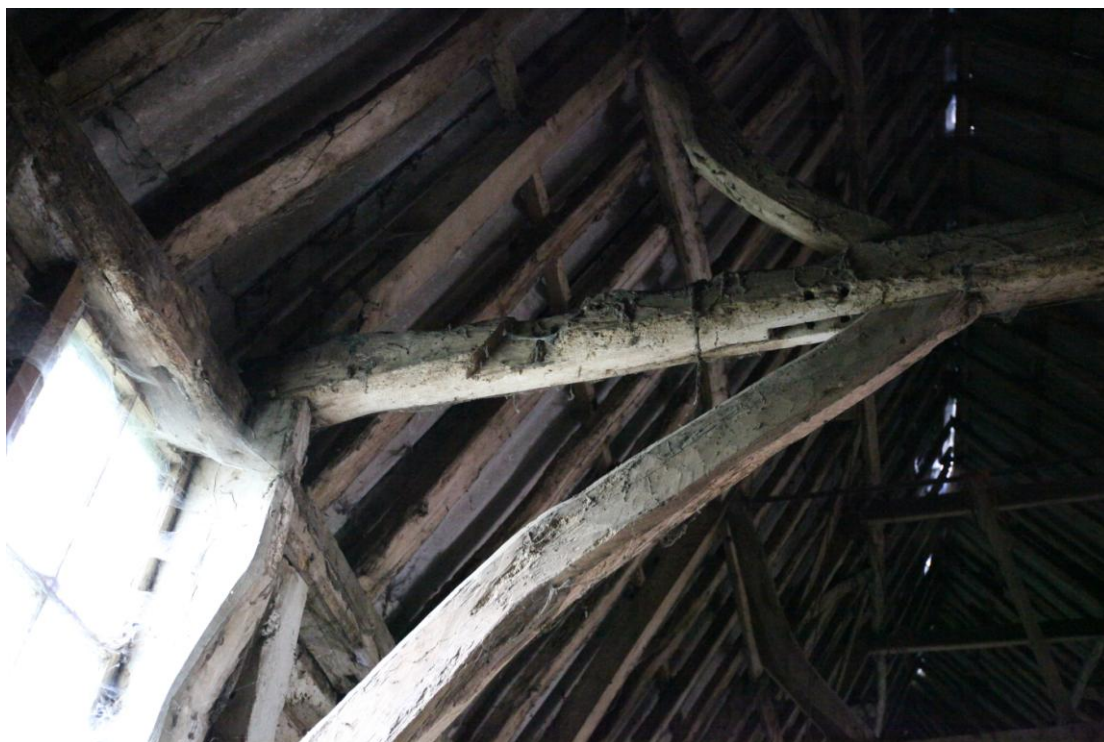
Illus. 10. The western end of the re-used tie-beam between bays G and F seen from the south, showing a trench for a passing brace of a type normally associated with barns of the early-14th century or before. An identical trench occurs at the opposite end of the same timber (as would be expected), but while many studs and roof-plates show similar indications the majority of the remaining tie-beams appear to be primary.

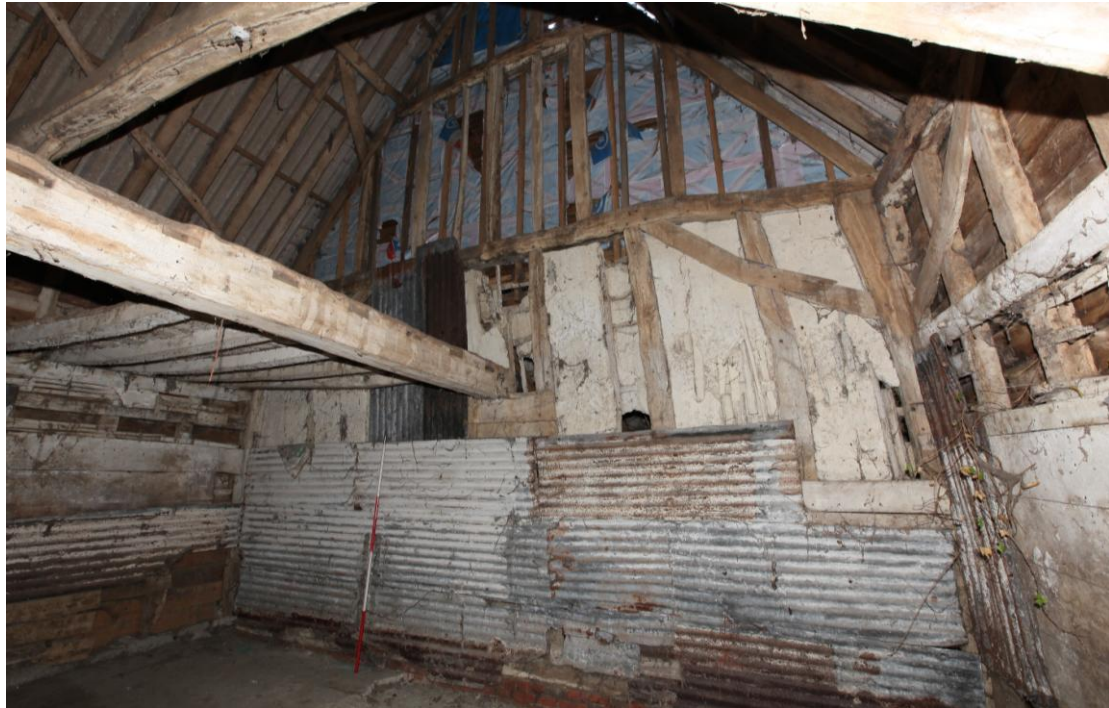
Illus. 11. The southern internal gable showing early wattle-and-daub and the remaining section of hay loft to the left. A hay rack and manger would have been attached to this gable, as indicated by a hay drop (narrow gap) in the ceiling of the loft immediately above.

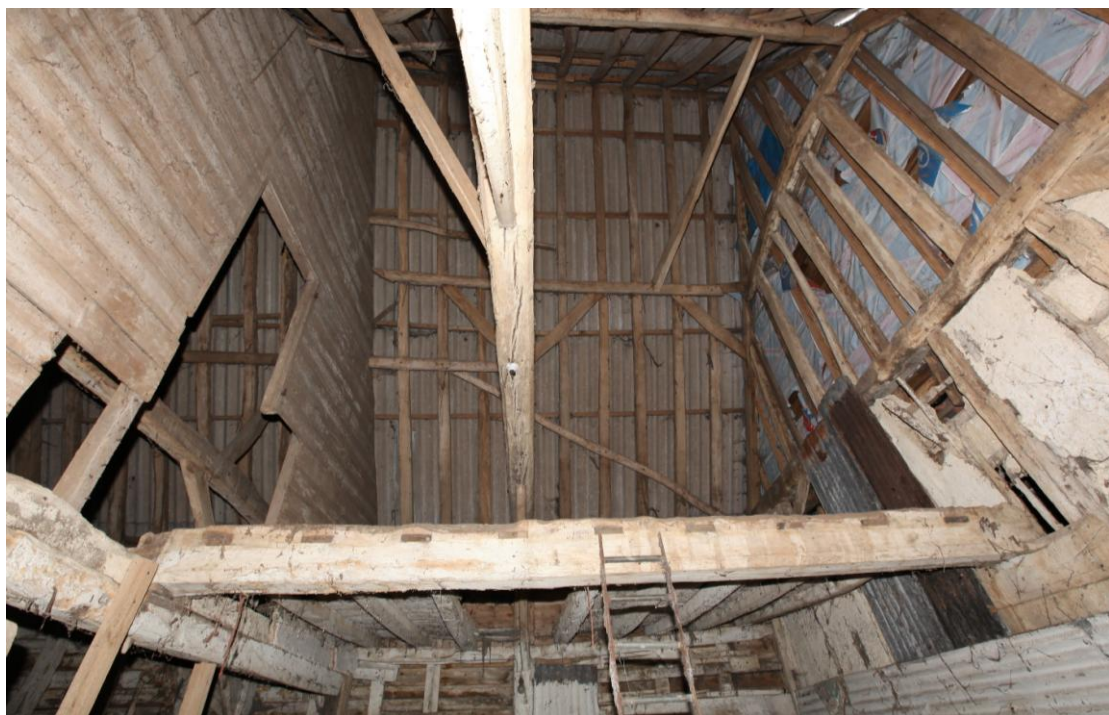
Illus. 12. The southern stable (bays H and I) from the west, showing the empty soffitenon mortises in the axial joist for the missing western half of the hay loft. Note the junction with the different roof of the main barn: The clasped and butt purlins of the latter project through the boarded loft partition to the left and are nailed to the rafters. This roof consists only of clasped-purlins and lacks queen-struts. This end of the building also differs in the absence of re-used timber and appears to pre-date the rest of the barn.
