**Granary at Cordell Hall
(belonging to Windolph's Farm),
Stansfield, Suffolk
STF 016**

Historic Building Record

Granary at Cordell Hall (belonging to Windolph's Farm), Stansfield, Suffolk

Historic Building Record (Supplementary)

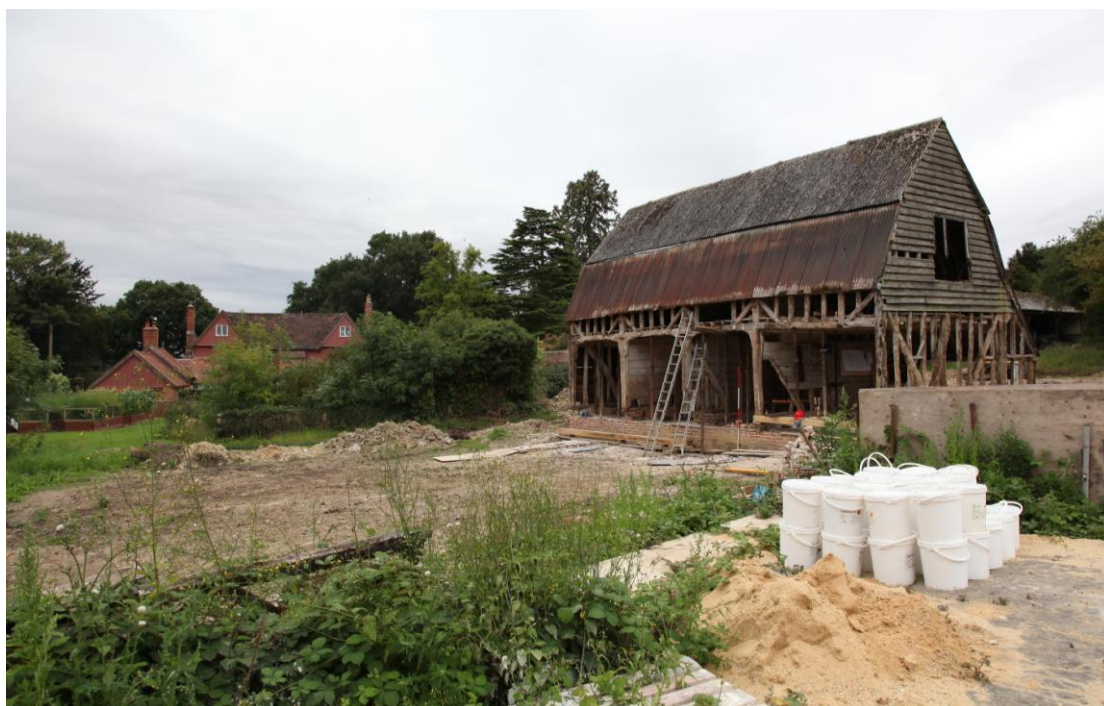
Illus. 1. General view of the site from the position of the former enclosed animal yards to the north-east showing the proximity of the granary (right) to the rear elevation of Cordell Hall (in rear to the left).

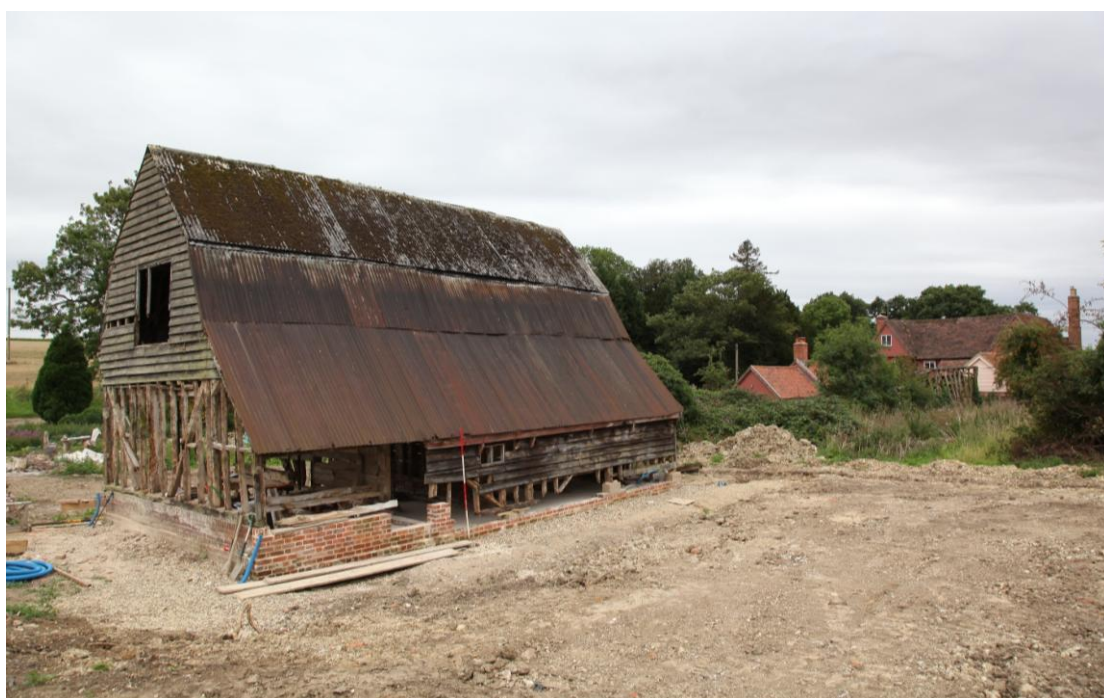
Illus. 2. General view of the site from the north-west showing Cordell Hall and a timber-framed outbuilding in the rear to right. The distance of the granary from the farmhouse suggests it may have been isolated on the edge of a track in the usual manner of cart lodges until the construction of new complex of yards and buildings to the east in the mid-19th century (of which nothing now remains).

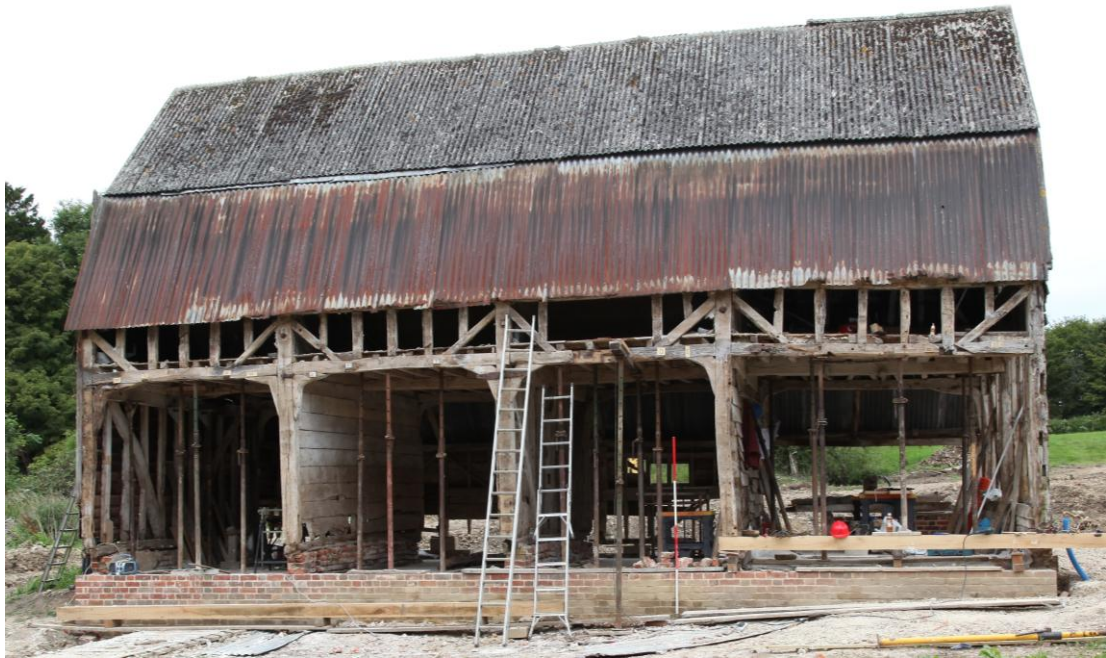
Illus. 3. The eastern exterior stripped of its cladding and showing the original knee-braces to the three formerly open southern bays to the left and the originally enclosed northern bay without knee-braces to the right.

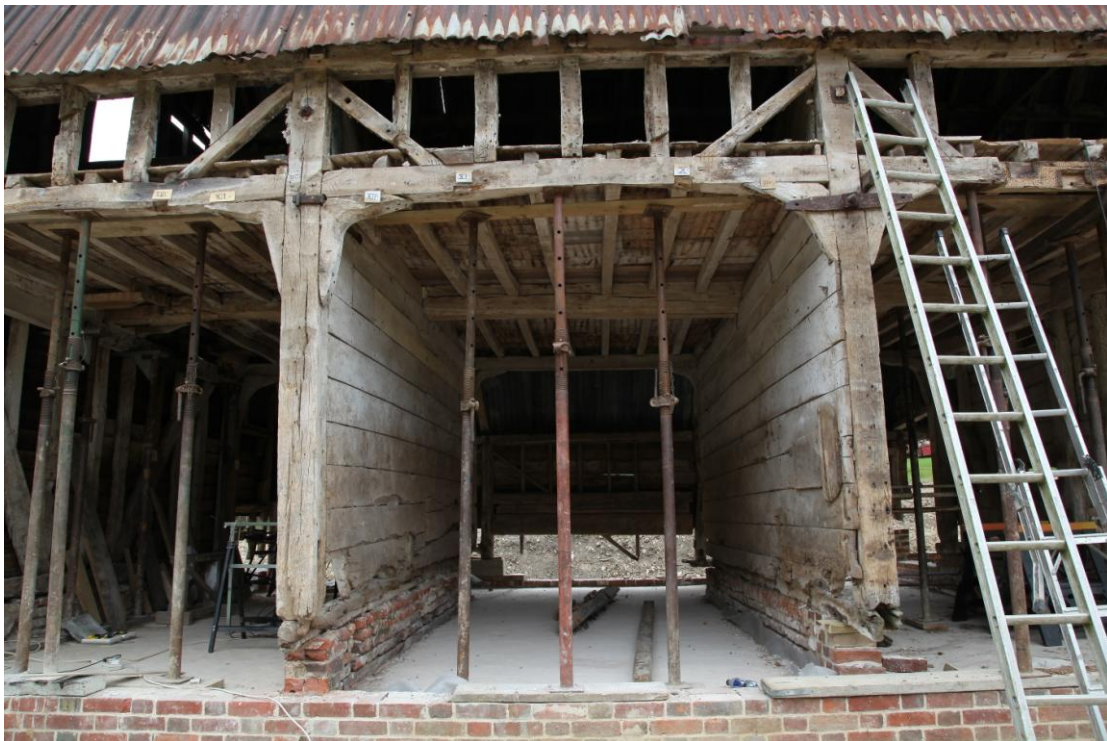
Illus. 4. Detail of the eastern exterior showing the central open bays with original nailed knee-braces to both front and rear. There are no mortises for original studs or wall braces beneath the mid-rails to match those which survive to the granary floor above, and the studs of the 'stable' conversion recorded in 2008 were notched and nailed in the standard manner of secondary insertions

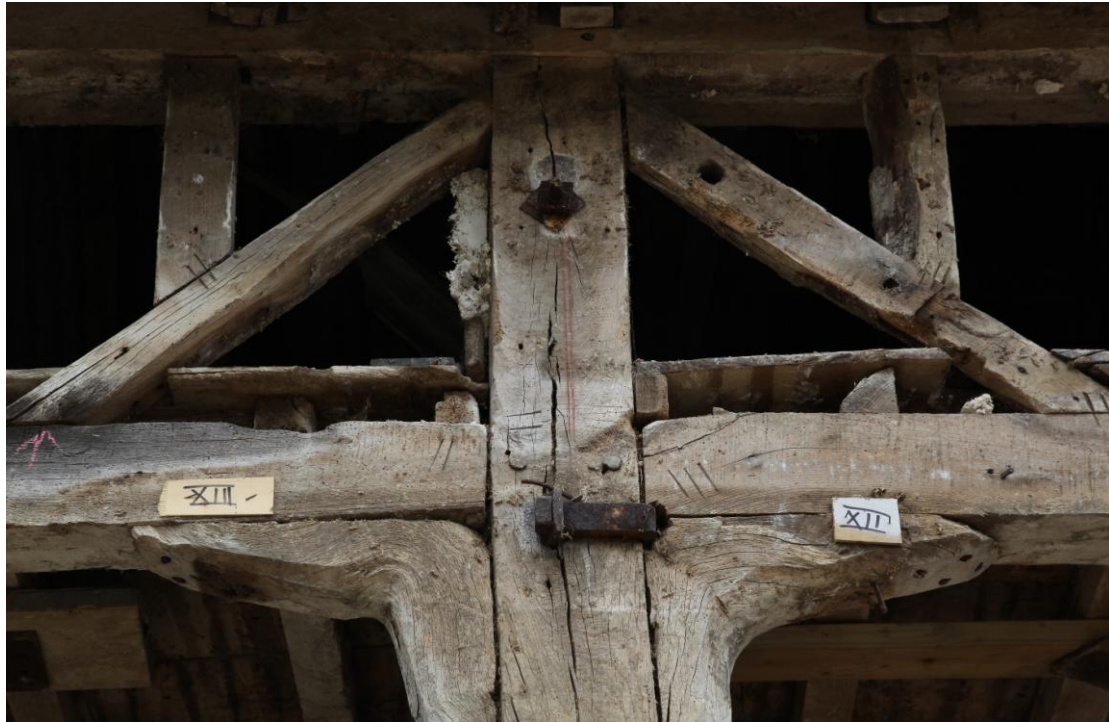
Illus. 5. Detail of the carpenter's numerals to the eastern exterior (section 3 of 10 from south to north (left to right) as photographed in Appendix 1). The mid-rail of the southern bay to the left is numbered II, as is the corresponding joist in the storey post, but the numbers II and III overlap the joints between the diagonal wall braces and the studs and mid-rails to left and right respectively.

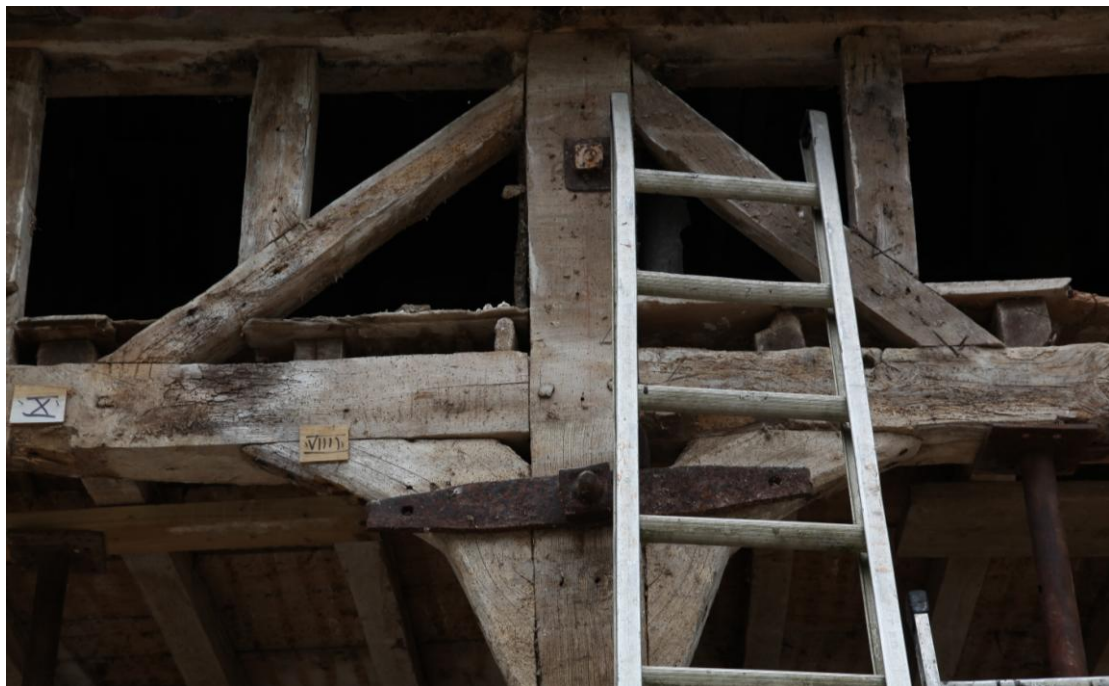
Illus. 6. Detail of the carpenter's numerals to the eastern exterior from (section 5 of 10 from south to north (left to right) as photographed in Appendix 1). In this case the numbers VIII and V overlap the joints between the diagonal wall braces and the studs and mid-rails to left and right. This 'block' system of marking, and the overlapping of the joints (which would have rendered the numbers very difficult to read in isolation) is unusual.

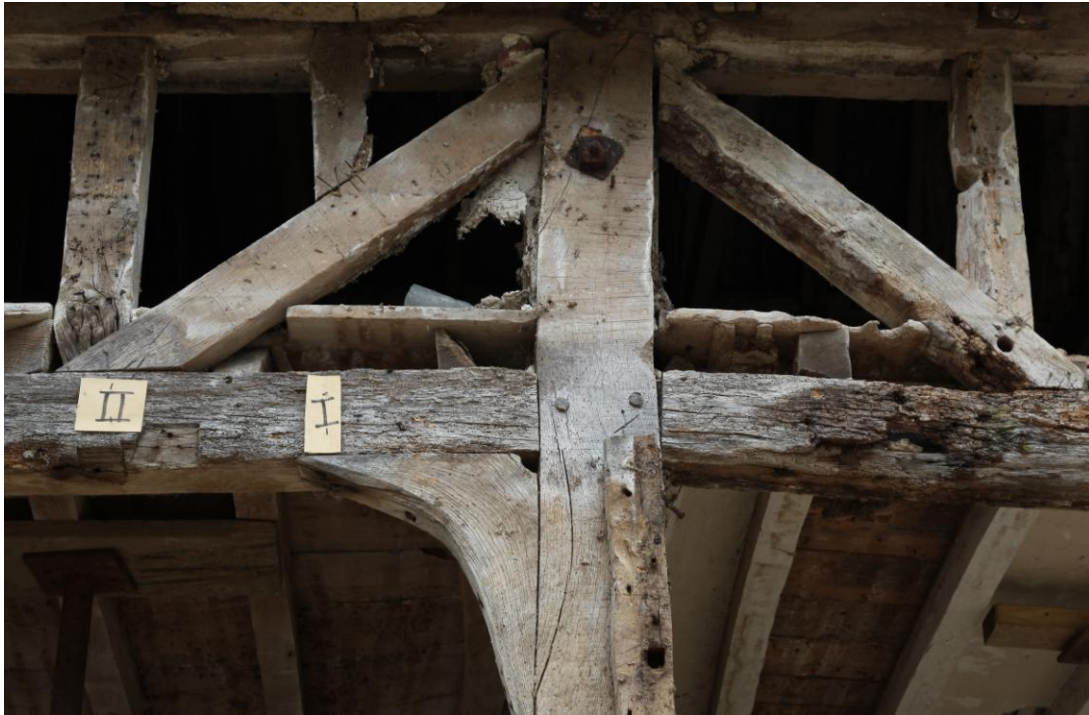
Illus. 7. Detail of the carpenter's numerals to the eastern exterior (section 7 of 10 from south to north (left to right) as photographed in Appendix 1). The numbers VII and VIII overlap the joints of the diagonal braces. Note the crude notch in the mid-rail to the left for a secondary stud of the 'stable' conversion.

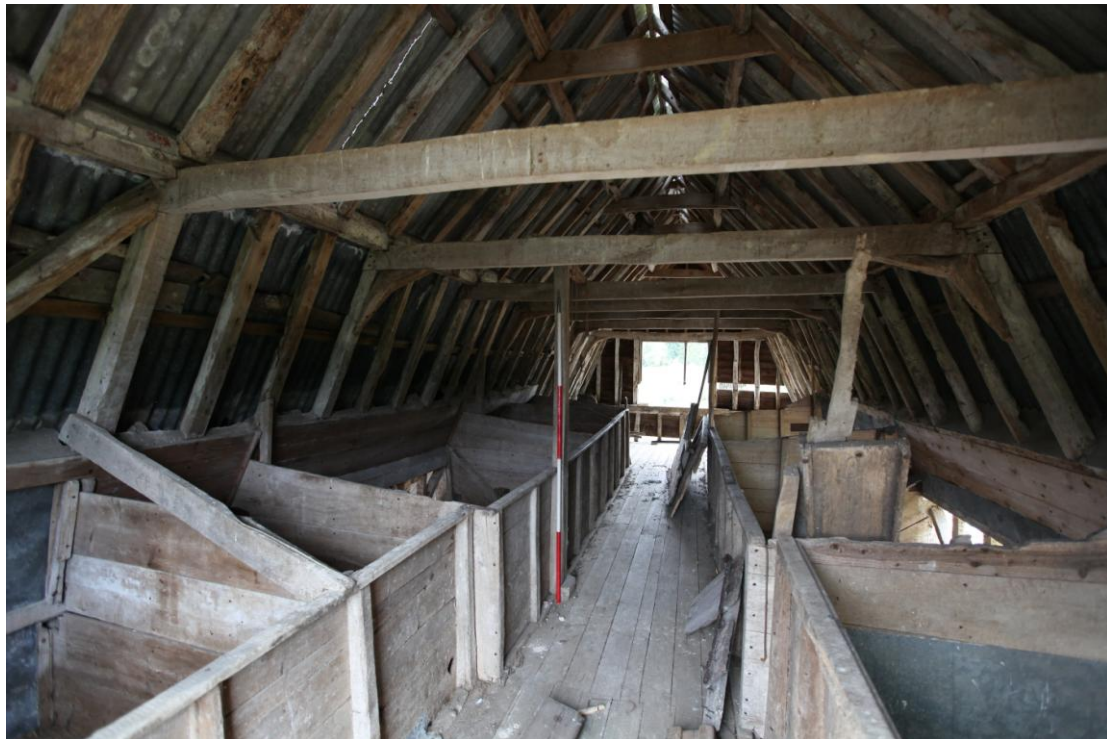
Illus. 8. The interior of the first-floor granary from the south showing the impressive array of 19th century boarded grain bins with an axial passage leading from the external entrance to a window in the northern gable.

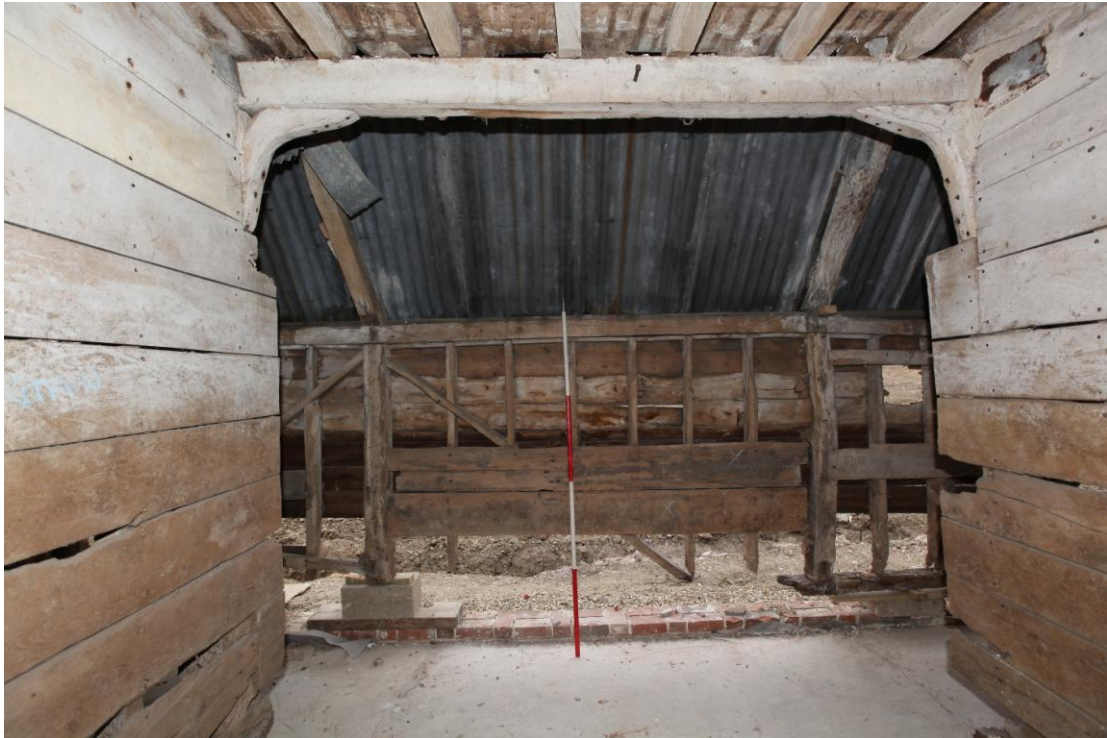
The framing of the rear lean-to differs significantly from the rest of the building and appears to be a later addition. Its studs and diagonal braces are smaller in scantling and are crudely notched over a continuous fillet of timber nailed to the soffit of the roof-plate. They also lack carpenter's numerals. The southern, narrow bays of the original building were clearly open to the front and rear in the normal manner while the northern shed was fully enclosed. The latter's rear wall was removed and replaced by knee-braces when the lean-to was added.

Illus. 9. The interior from the east of the penultimate southern bay showing the original nailed knee-braces to its rear mid-rail. The narrow studs of the rear lean-to, each crudely notched over a continuous fillet of timber nailed to the underside of the roof-plate, contrast dramatically with the quality of the main structure and suggest the lean-to is a later addition relating to the 'stable' conversion.

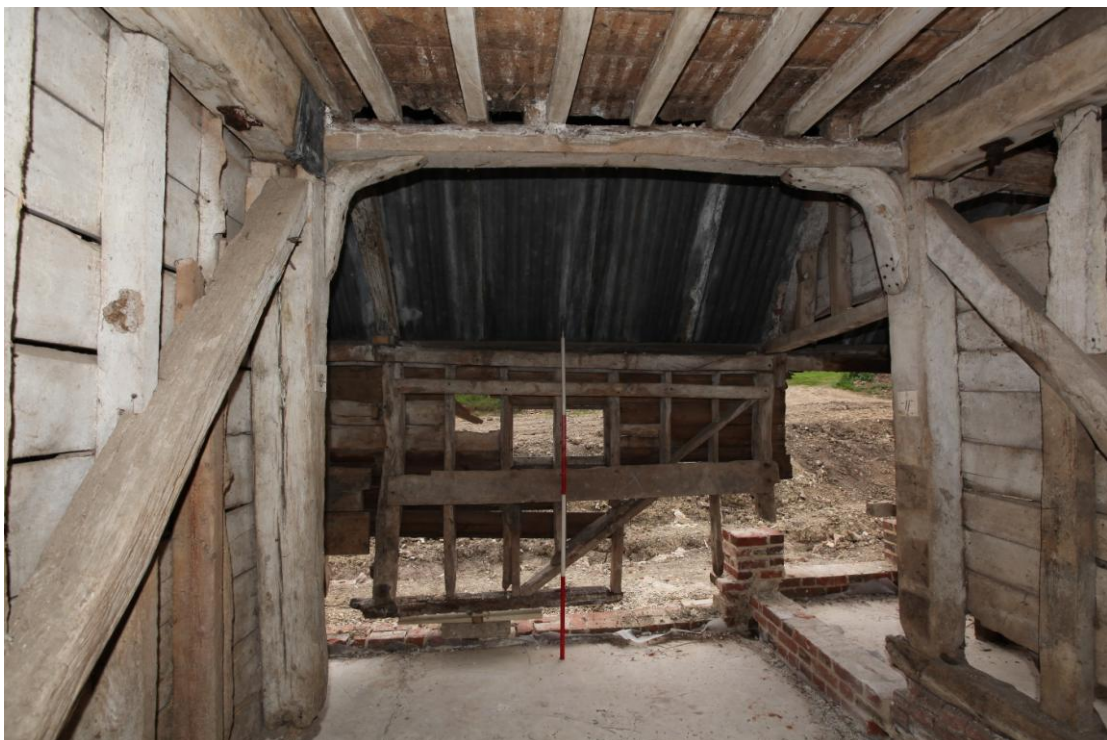
Illus. 10. The interior from the east of the penultimate northern bay showing the nailed knee-braces to its rear mid-rail and the narrow studs of the lean-to.

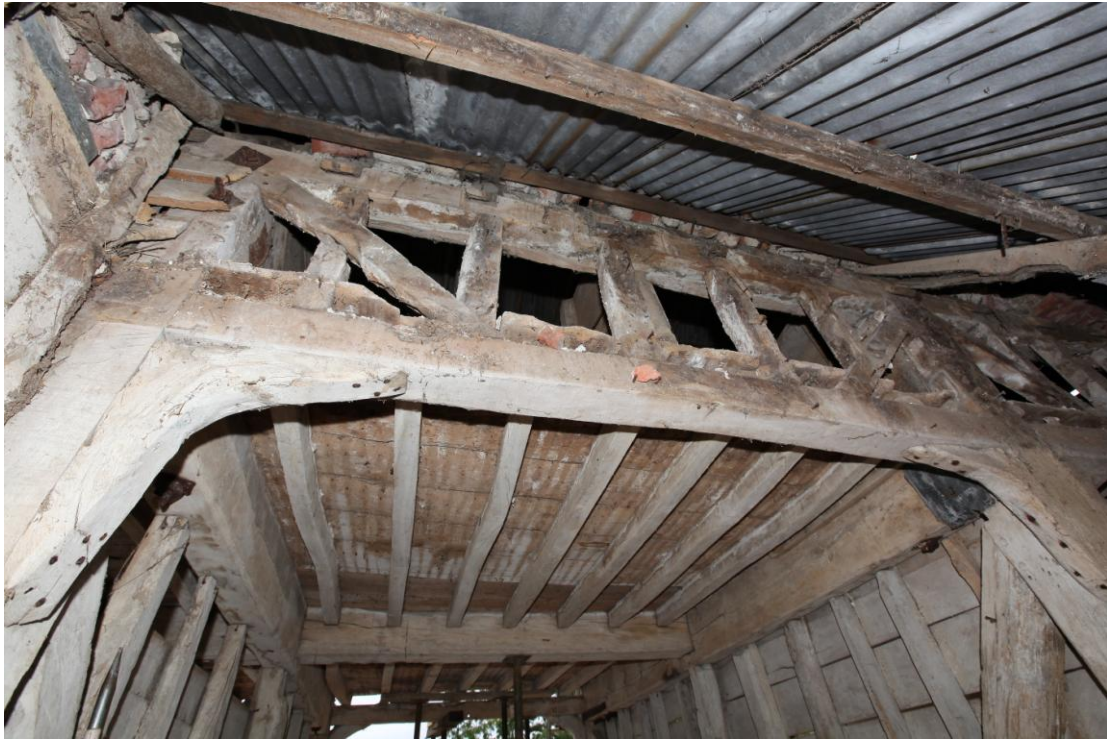
Illus. 11. Detail of the penultimate northern bay seen from the western lean-to, showing tenoned studwork and carpenter's numerals to the mid-rail and storey post. Both the mid-rail and storey post to the left are numbered III.

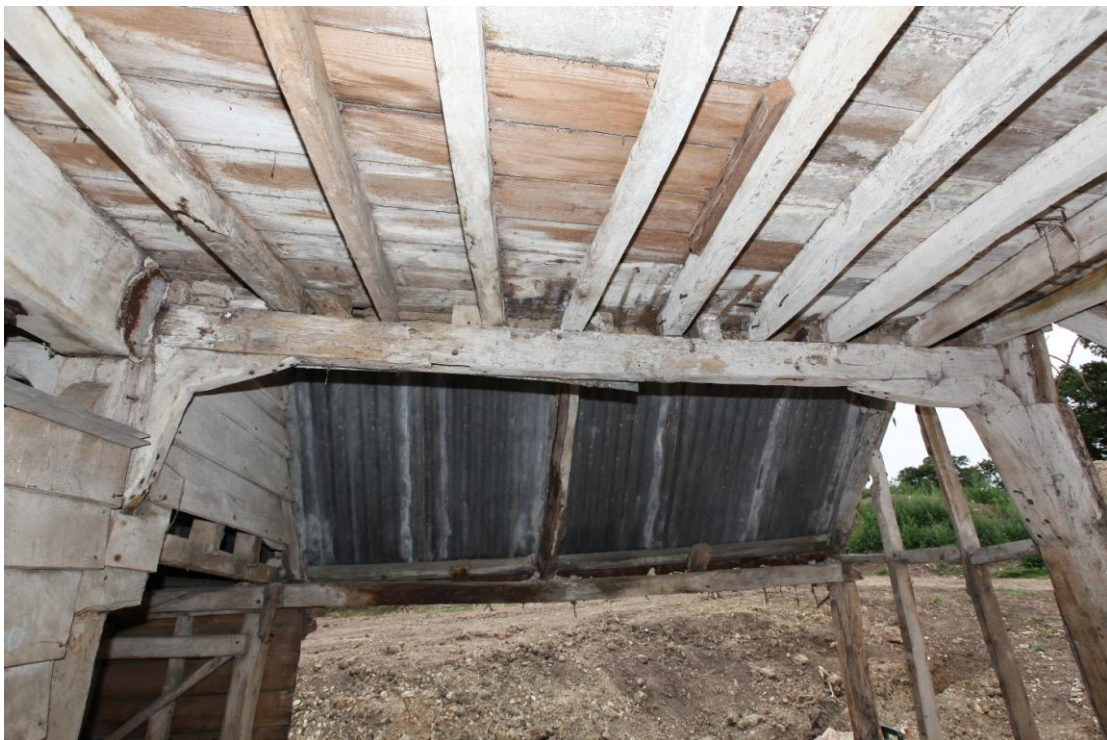
The exposure of the timber-frame, which was stripped of its weatherboarding at the time of the most recent inspection, revealed the loose boxes to be secondary features. When first built at the beginning of the 19th century the three narrow bays formed open-sided cart or implement shelters while the wider northern bay was an enclosed vehicle or storage shed. This layout is entirely typical of the period, as stated in the report of 2008. The front and rear mid-rails of all three open bays are supported by neatly chamfered knee-braces which are original to the frame. The studs of the granary storey above are tenoned and in some cases pegged to the horizontal principals but there are no mortises in the undersides of the mid-rails. The studs of the loose boxes were crudely notched and nailed in place, evidently secondary insertions, and had been removed by the time of inspection. Both the front and rear mid-rails of the wider northern bay, in contrast, contain two pegged mortises for missing original studs that reflect the extant framing of the granary storey. The front (eastern) rail lacks knee-braces and those to the rear are unequal in size and secondary to the structure.

Illus. 12. The interior from the east of the wider northern bay showing two empty pegged stud mortises in the underside of the mid-rail with later knee-braces of unequal size. The front (eastern) mid-rail of this bay contains identical mortises and lacks knee-braces, suggesting the bay originally formed an enclosed vehicle or storage shed alongside the three open bays of the cart lodge.
