**Sancroft Barn,
Laxfield, Suffolk
LXD 065**

Heritage Asset Assessment

September 2011

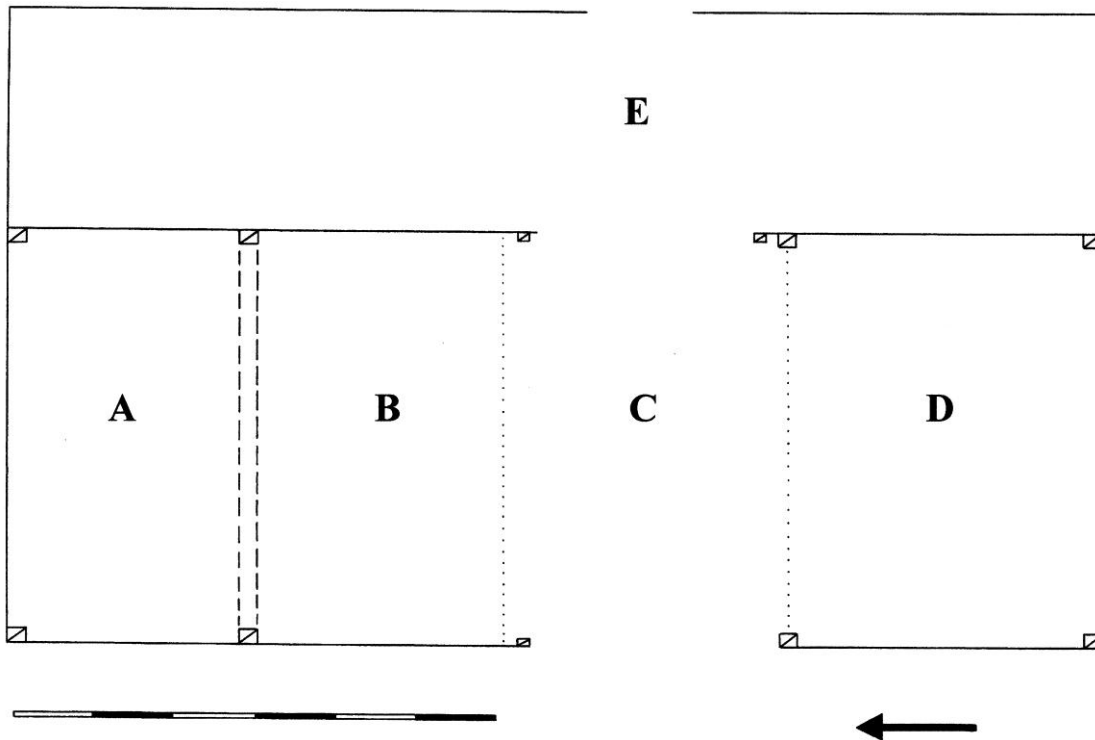
Figure 5

Ground plan of the barn, identifying the bays and principal compartments with letters for ease of reference in the text and photographs. With the exception of bay C the floors are of 20th century concrete throughout. Scale in metres.

A-B. Two intact bays of a late-16th or early-17th century timber-framed structure that originally possessed a loft and continued further to the south but has been truncated by the entrance bay of the later threshing barn (C). The tie-beams and roof structure are later replacements. The walls with internally trenced reverse-cranked braces but without any evidence of windows or doors. The loft was divided by a partition between the bays.

C. Entrance bay of the threshing barn with double-hung doors to the west and access to the rear lean-to and smaller rear doors to the east. Both roof-plates cut in the 20th century and replaced with softwood to increase headroom. This bay preserves a good 19th century threshing floor of gault brick.

D A single bay of the 18th or early-19th century consisting entirely of re-used timber from a 16th or early-17th century structure that contained a diamond-mullion window beneath its gable tie-beam. Diagonal primary braces interrupting the studs (pegged and tenoned to the storey posts but possibly re-using old mortises). The substantial eastern arch-brace of the open truss adjoining bay C to the north remains *in situ* but its counterpart to the west has been removed.

E. A 20th century lean-to of weatherboarded studwork with a corrugated iron roof and a northern gable of cement block-work. Vehicle doors to the southern gable. The iron pulley wheels of a belt drive are attached to the tie-beam south of the adjoining entrance bay (C). This structure is not of historic significance in itself but preserves an important section of original external roughcast render to bay D of the main barn

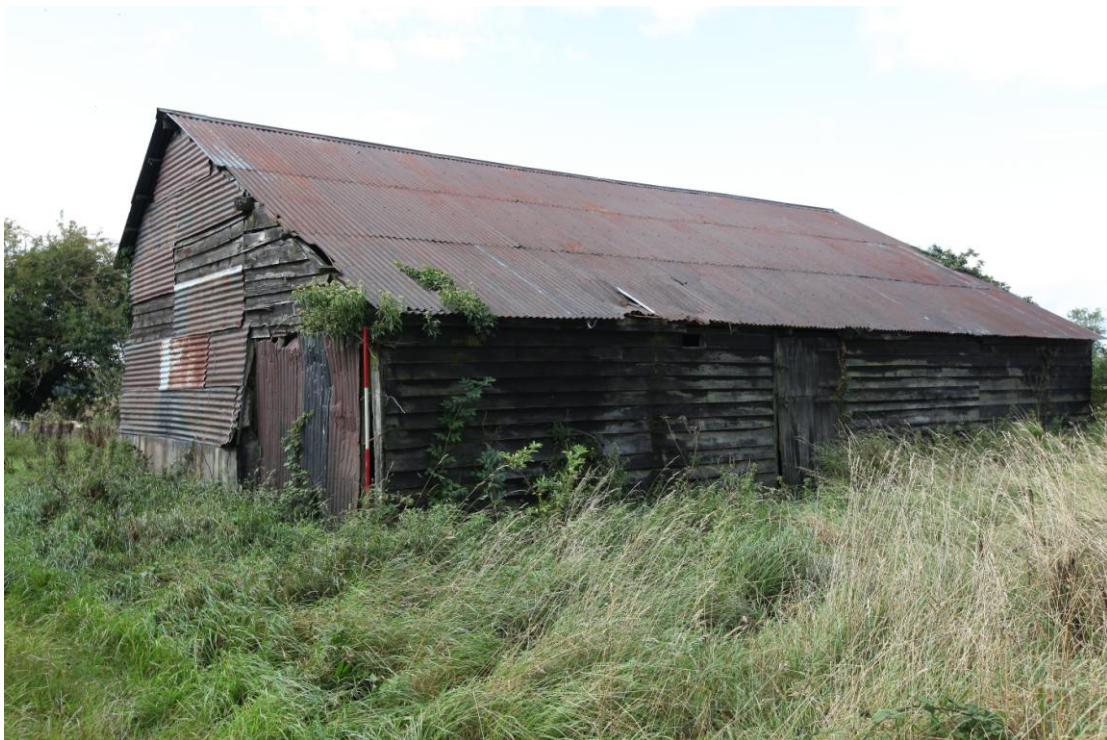
Illus. 2 The exterior from the south-east showing the shallow-pitched 20th century corrugated iron roof and cladding with the rear doors of the threshing bay (C) in the weatherboarded 20th century lean-to (E) to the right.

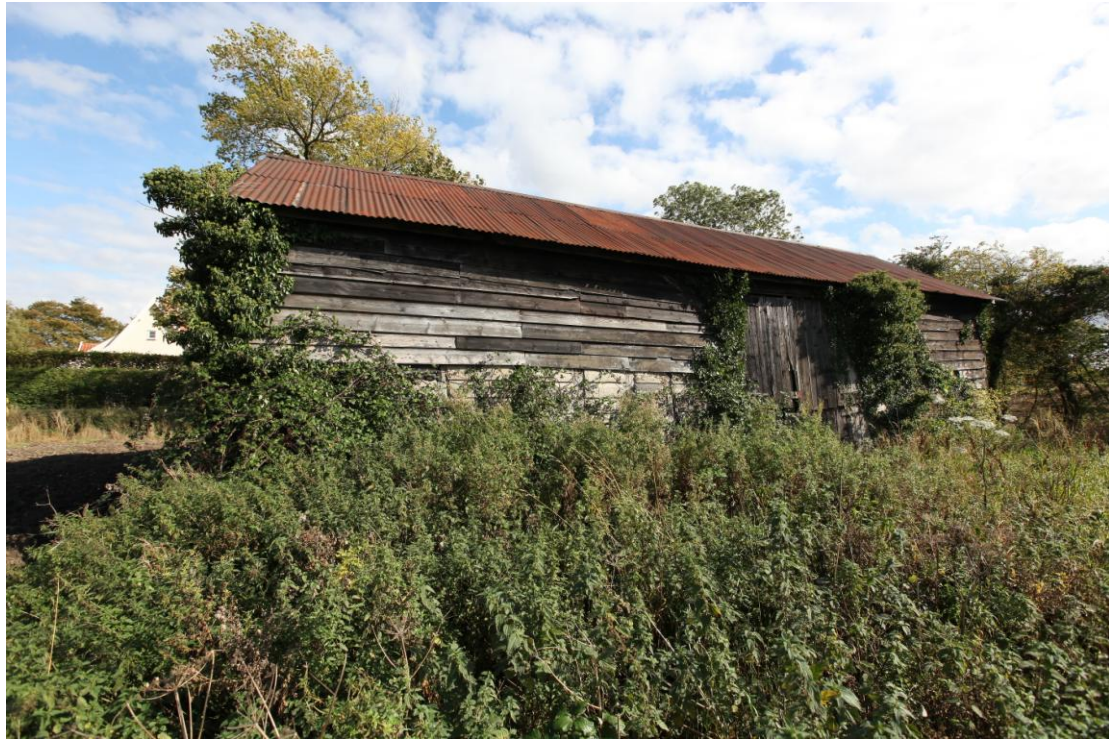
Illus. 3 The exterior from the west showing the principal half-hung entrance doors of the threshing bay (C) to the right and the barn's proximity to the grade II-listed early-17th century Sancroft Cottage on the opposite side of Stirrup Street (in the rear to the left).

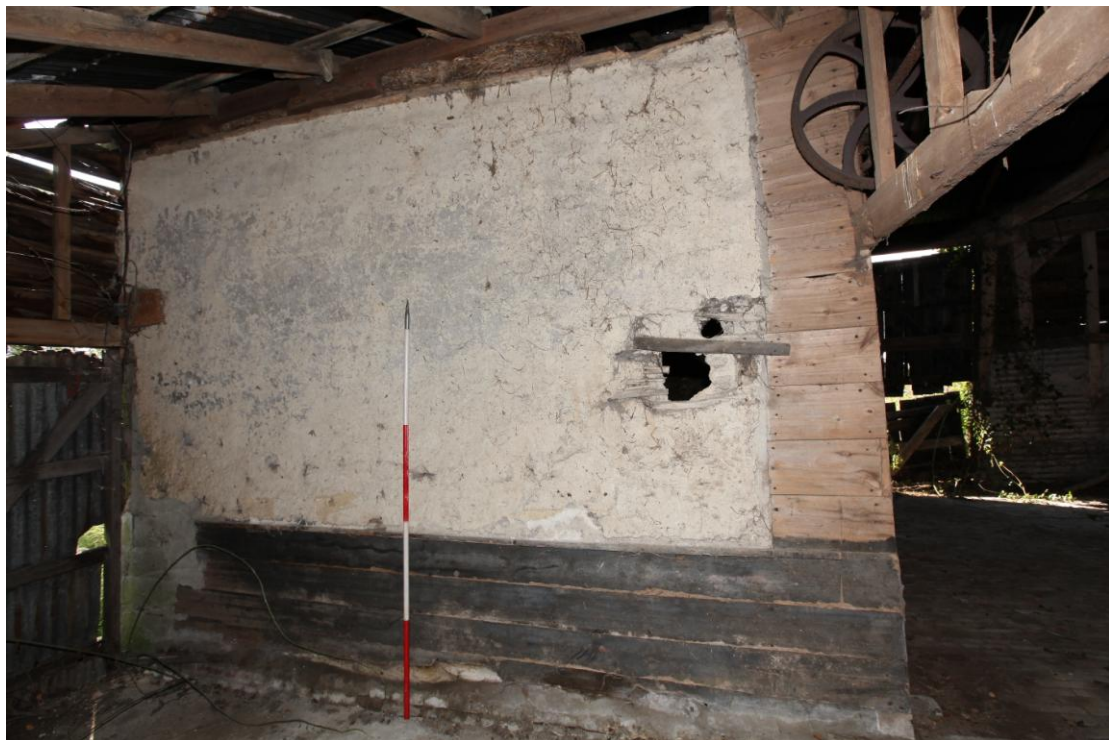
Illus. 4 The original eastern external whitewashed roughcast clay render to the 18th or early-19th century southern bay (D) with later tarred boarding to its base (seen from the 20th century lean-to (E) and showing the pulley wheel attached to its tie-beam to the right)

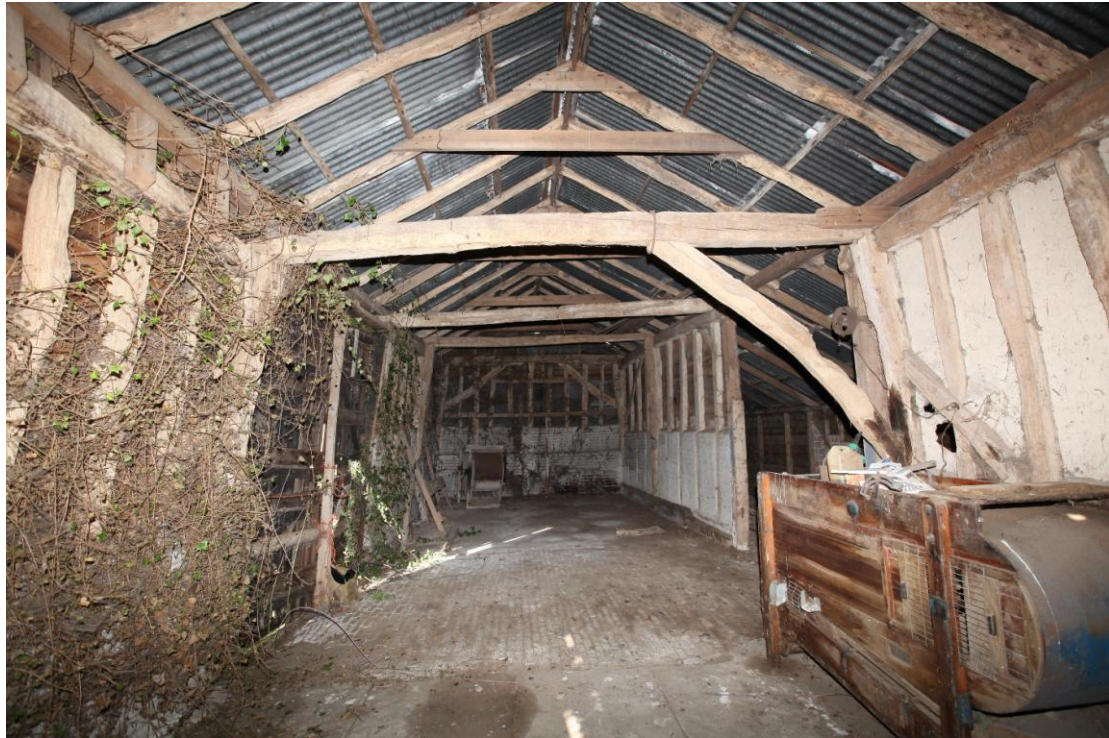
Illus. 5 A general view of the interior from the south showing the intact arch-brace to the tie-beam between bays C and D to the right, with the early-20th century grain sifter to the extreme right.

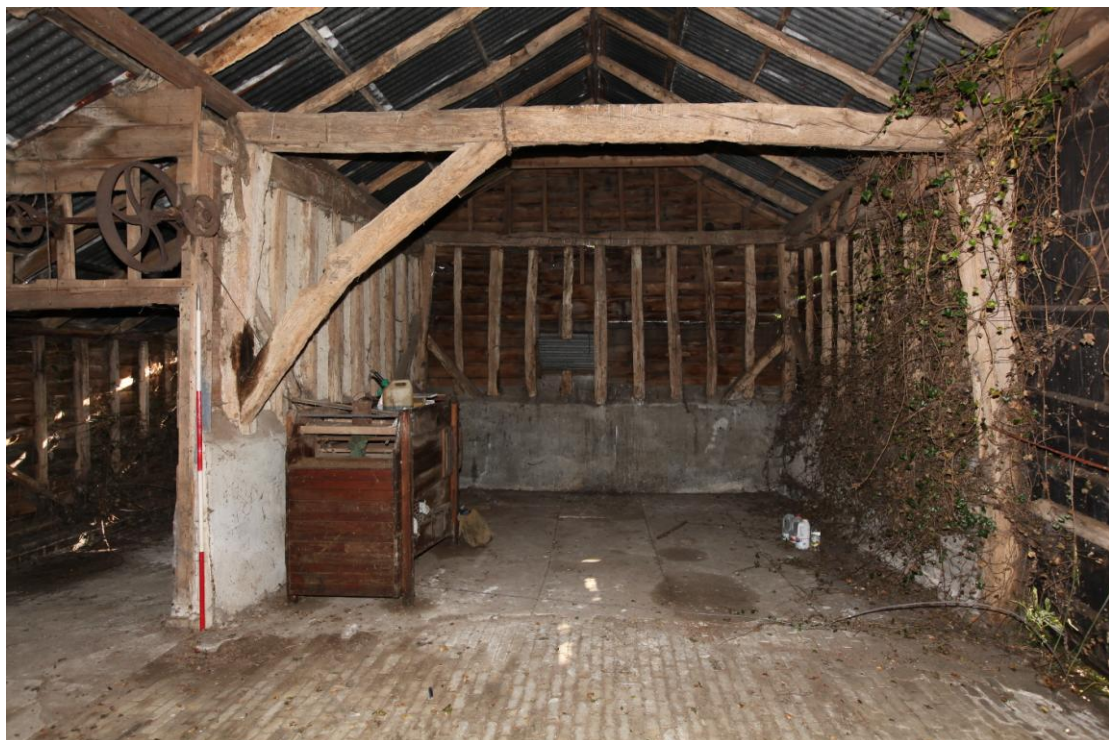
Illus. 6 The open truss to the south of the threshing bay (C) showing the well preserved gault brick threshing floor in the foreground and the 20th century rear lean-to (E) to the right. This truss is integral to the 18th or early-19th century southern bay and consists of re-used timber. The primary diagonal braces of the southern gable, which also consists of re-used timber, are visible in the rear.

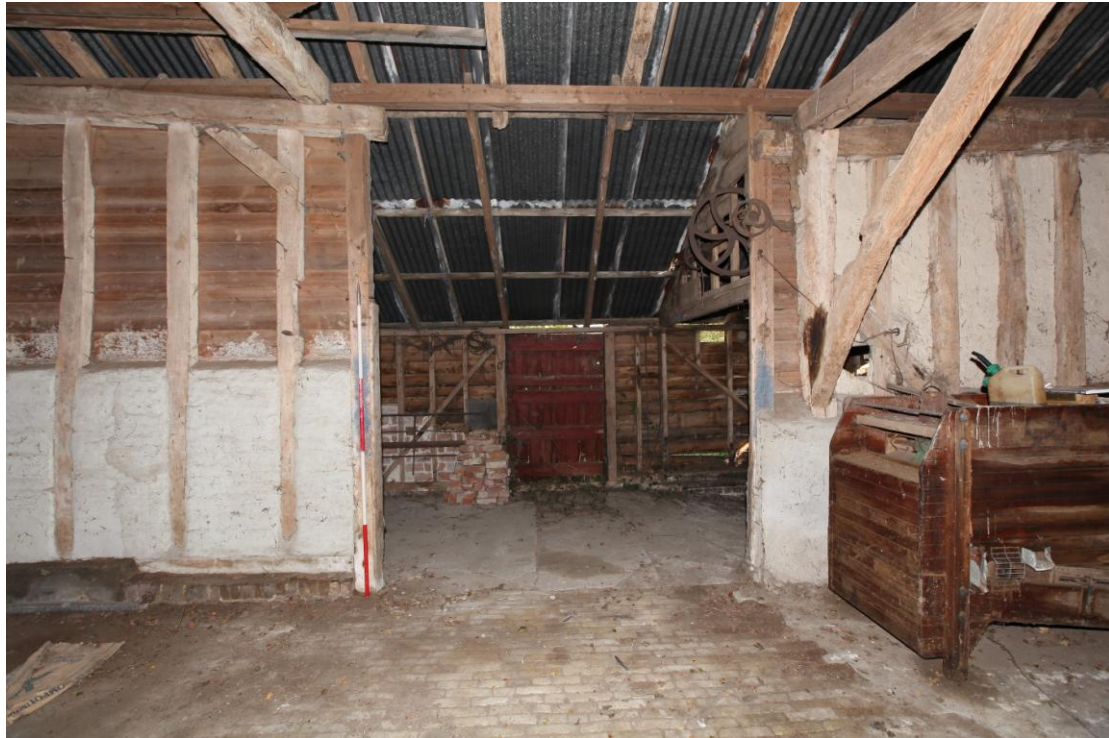
Illus. 7 The eastern interior of the threshing bay (C) showing the access to the rear lean-to (E) and the lack of storey post to the truncated late-16th or early-17th century framing of bays A and B to the left.

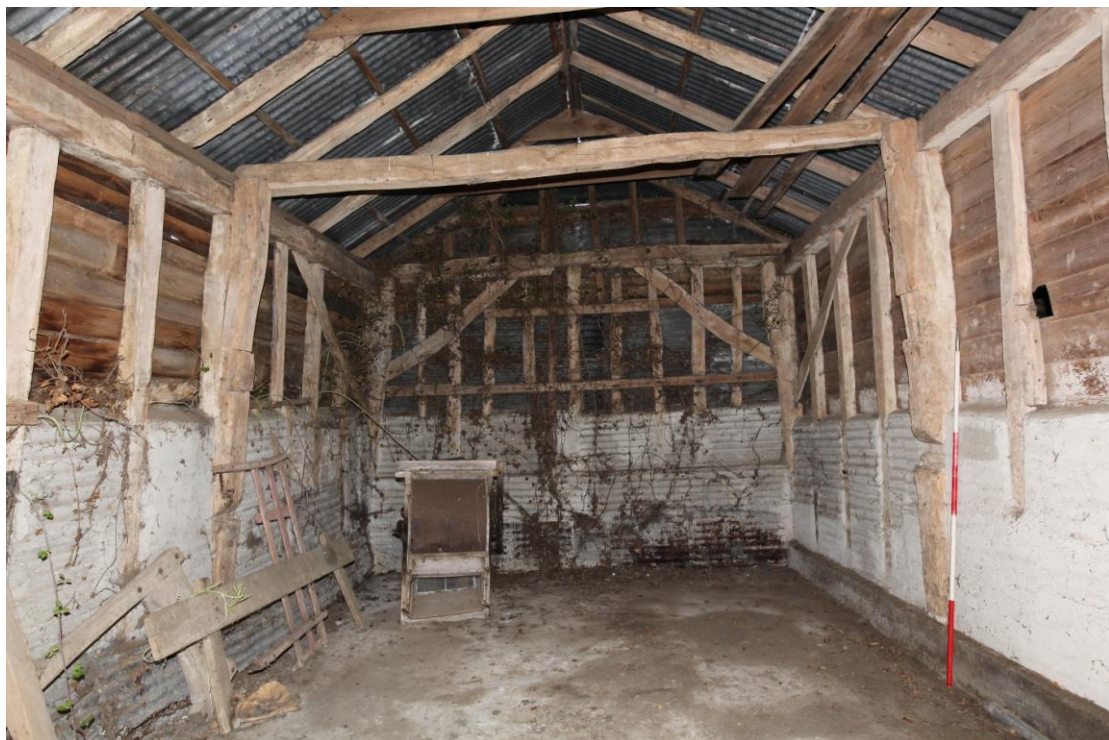
Illus. 8 The open truss of the early-17th century bays A and B from the south, which originally contained a loft supported by a binding joist spanning the width of the storey posts. The tie-beam is a later replacement but the posts also contain mortises for the down-braces of a partition above the binding joist (presumably with a central door).

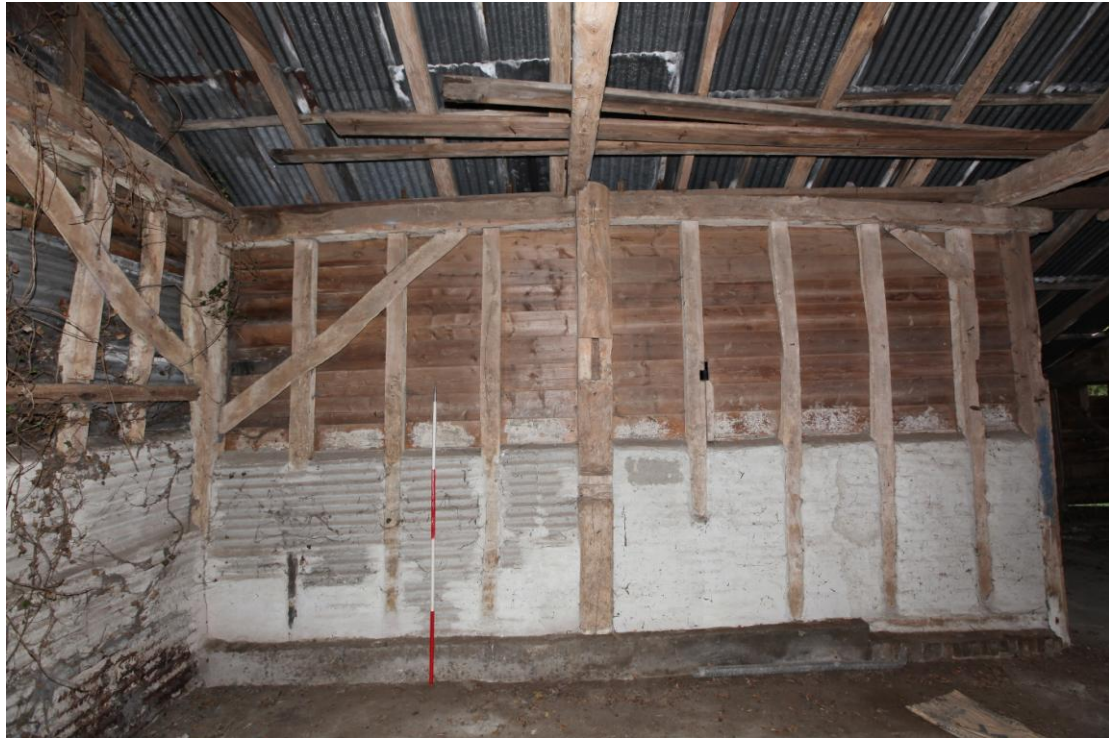
Illus. 9 The eastern interior of the intact northern bays (A and B) showing their internally trussed wall braces (truncated by the later entrance to the threshing floor to the right) with mortises for a first-floor partition and binding joist in the central storey post with the apparent notches of a hay rack beneath.

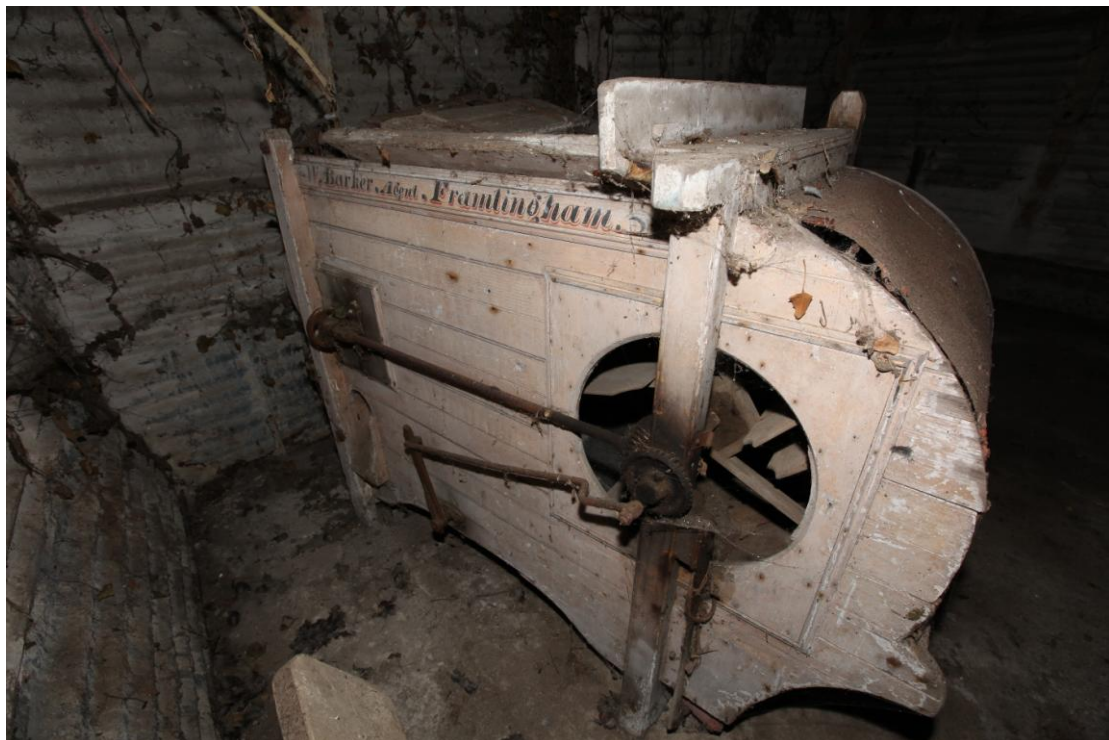
Illus. 10 The painted 19th century grain sifter in the barn's north-western corner, seen from south-west and showing the painted name 'W Barker, Agent, Framlingham'.
