**Barn at Shelland Hall,
Rattlesden, Suffolk
RAT 038**

Historic Building Record

OASIS ID: Suffolkc1-113357

October 2011

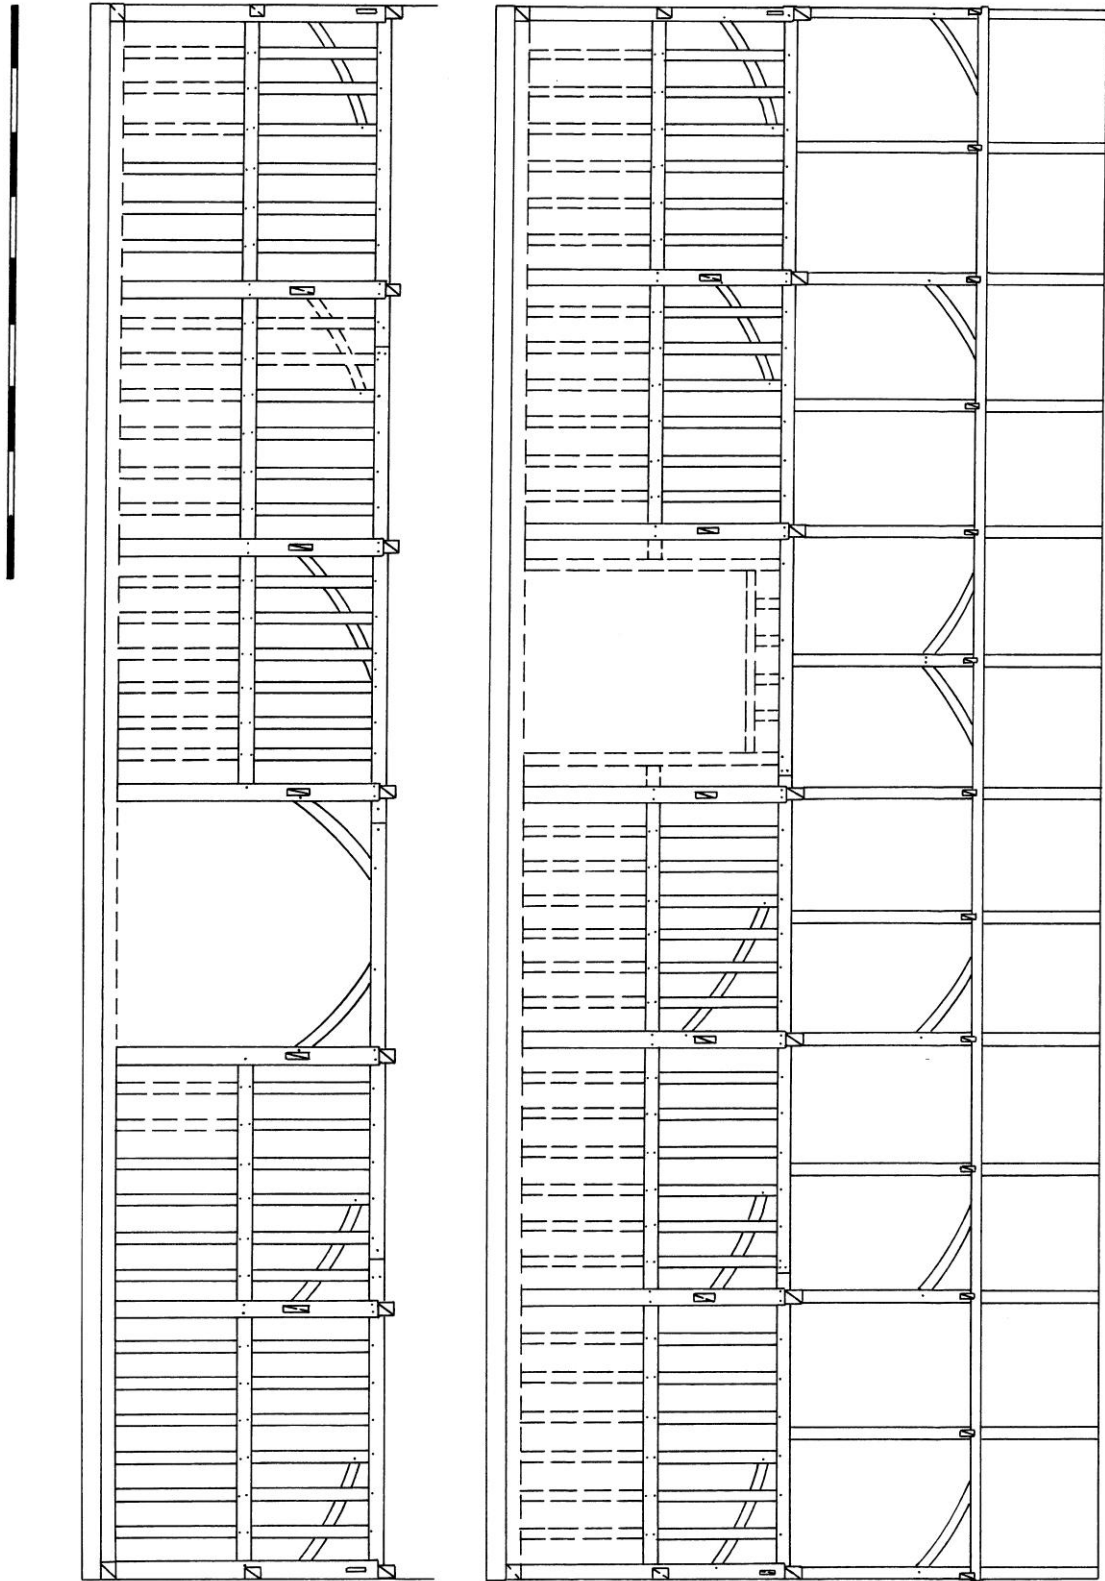
Figure 6

Internal elevations: Southern elevation showing access to porch in bay C with northern elevation and roof structure above (omitting common rafters). The southern roof structure is identical.

The wall studs between the ground sills and mid-rails are indicated by broken lines where they are either hidden by boarding and render or replaced by shuttered concrete. The arrangement of the original studs in the northern elevation of bay C (i.e. the present entrance) is conjectural as only their pegged mortises survive in the roof-plate.

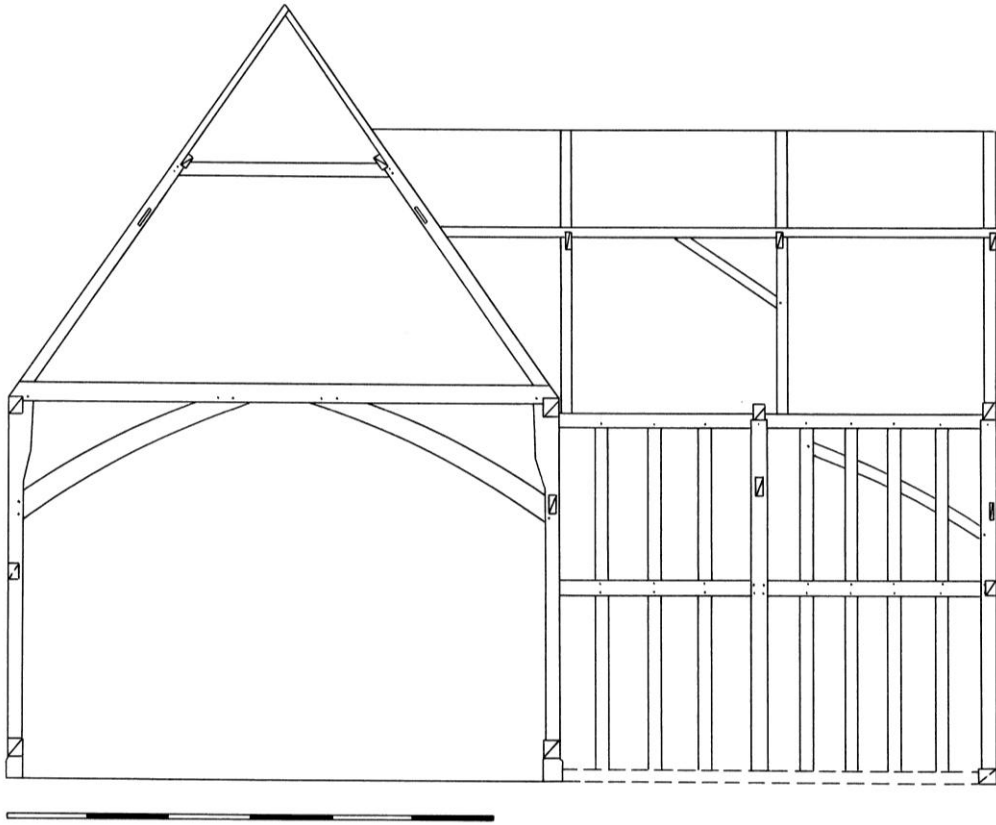
Figure 7

Typical open truss with internal side elevation of porch (1a). (Specifically the truss between bays C and D viewed from the west.)

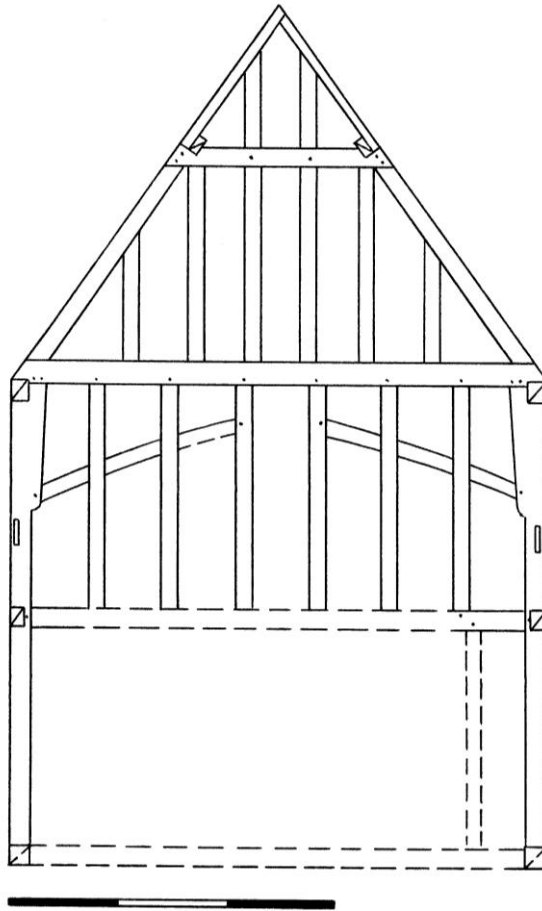
Figure 8

Internal elevation of southern gable of porch (1a).

It is unusual to find a 17th century gabled porch without full-height entrance doors. The studwork above the mid-rail is original, but the central section of the mid-rail itself is hidden and the width of the original door beneath is therefore unclear. A 19th century chamfered brick pier extends by 0.6 m (24 ins) from the right-hand corner post, suggesting the contemporary access was 3.3 m wide (11 ft) and approximately 2.1 m high (7 ft).

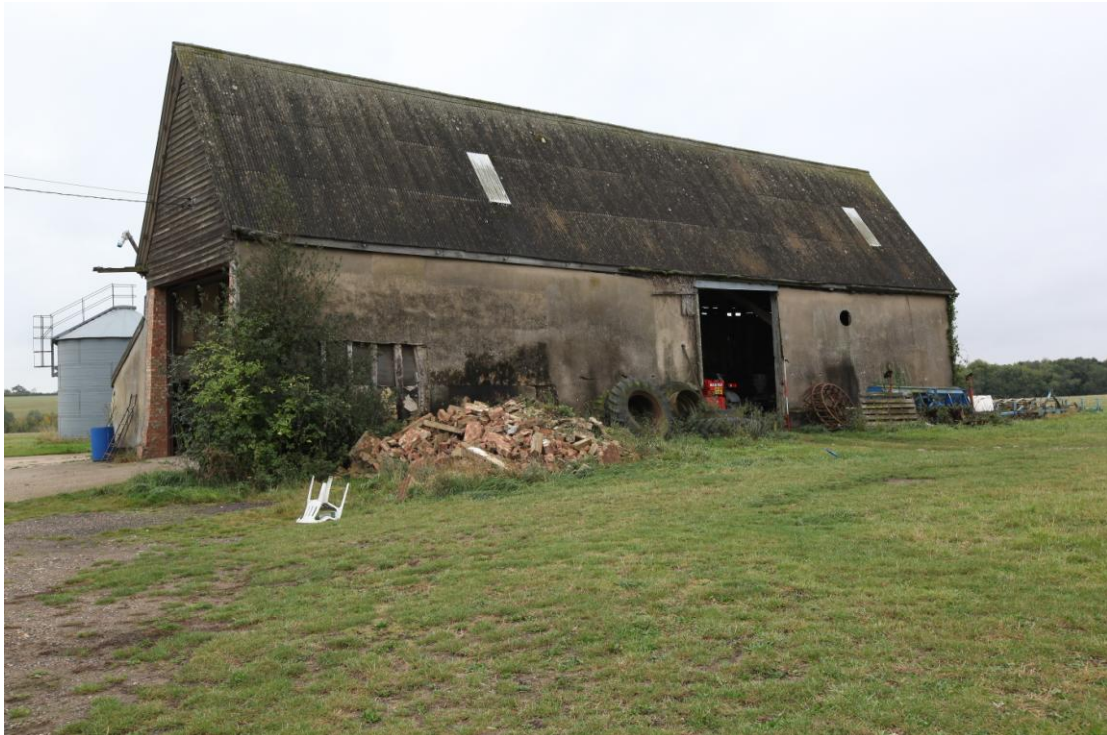
Illus. 2. Exterior from north-east showing corrugated asbestos roof (replacing thatch) and cement render to walls, with 20th century vehicle entrance in eastern gable to left and original entrance in bay C to right.

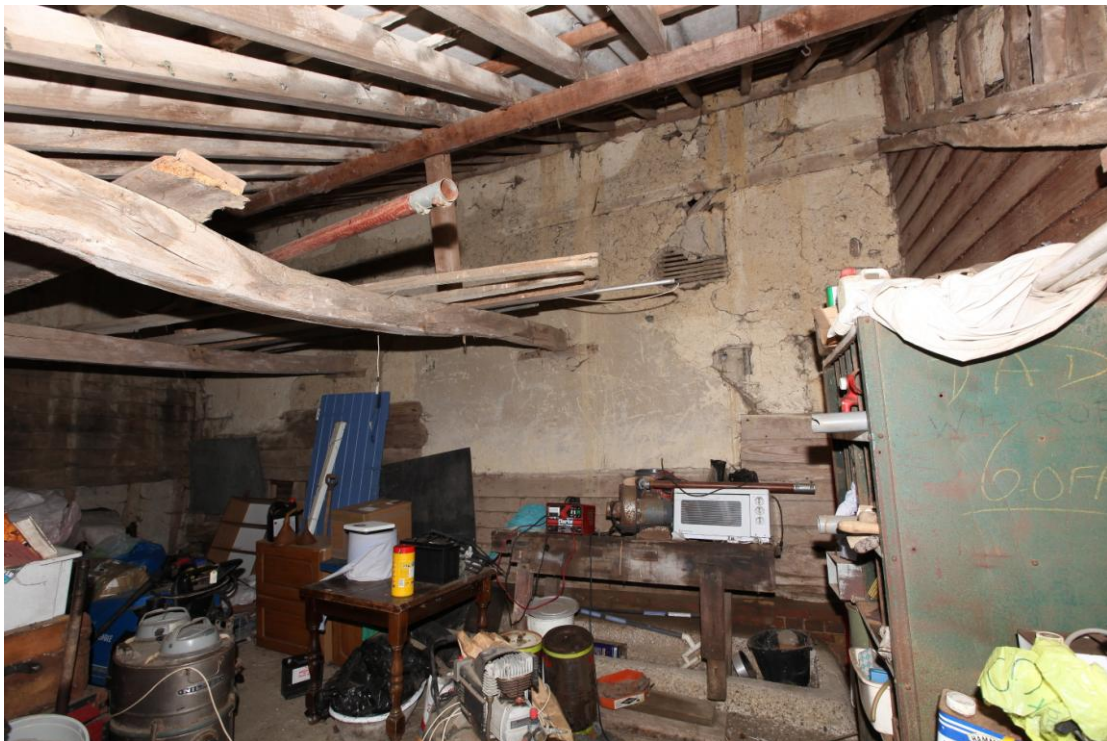
The present external cladding is of 20th century cement, but a substantial area of what appears to be original clay daub survives within the later lean-to sheds of the southern elevation. This roughcast, unpainted daub is secured by horizontal laths nailed to the outer surfaces of the frame and tied with hemp or bast (strips of bark) to narrow coppice poles set between the studs (some whole and some split). The lower section of wall in the central lean-to (3) has been reinforced with 19th century boarding. The quality of the individual studs, with irregular scantlings and waney edges, is too poor for them to have been exposed externally.

Illus. 4. Interior of lean-to shed (3) from south showing the original external render to the southern elevation of the barn (consisting of vertical coppice poles tied to nailed horizontal laths).

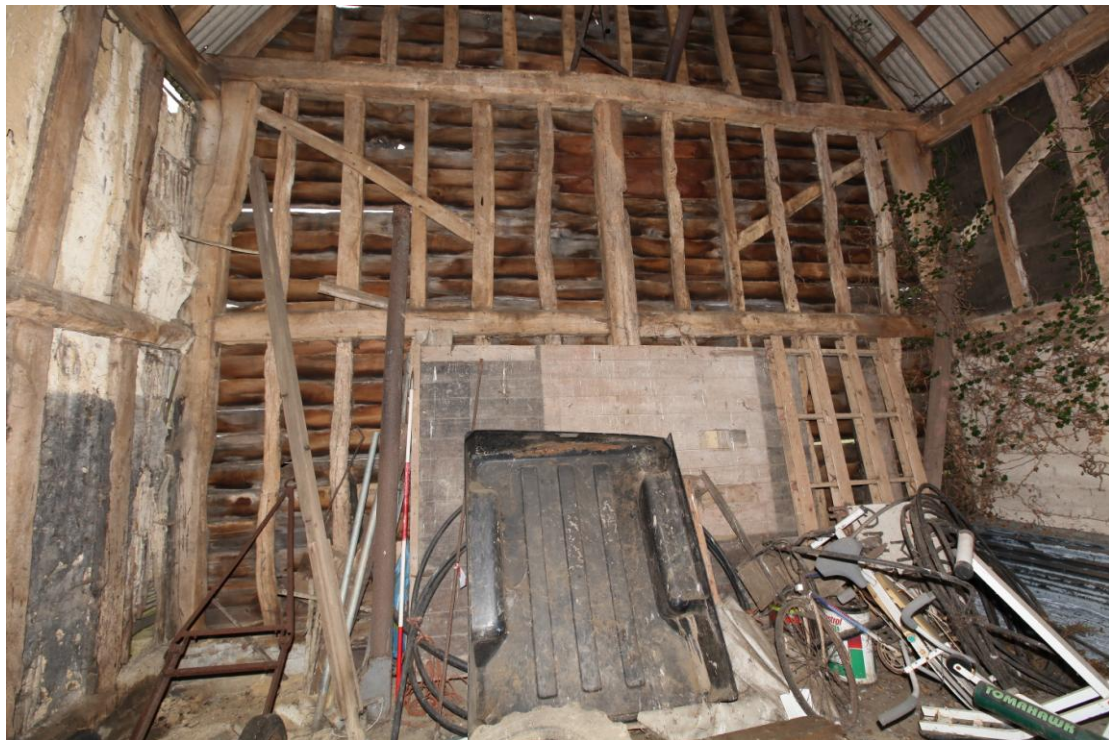
Illus. 6. Internal western gable showing the highly unusual original combination of an internally trenched wall brace to the left and external trenching to the right.

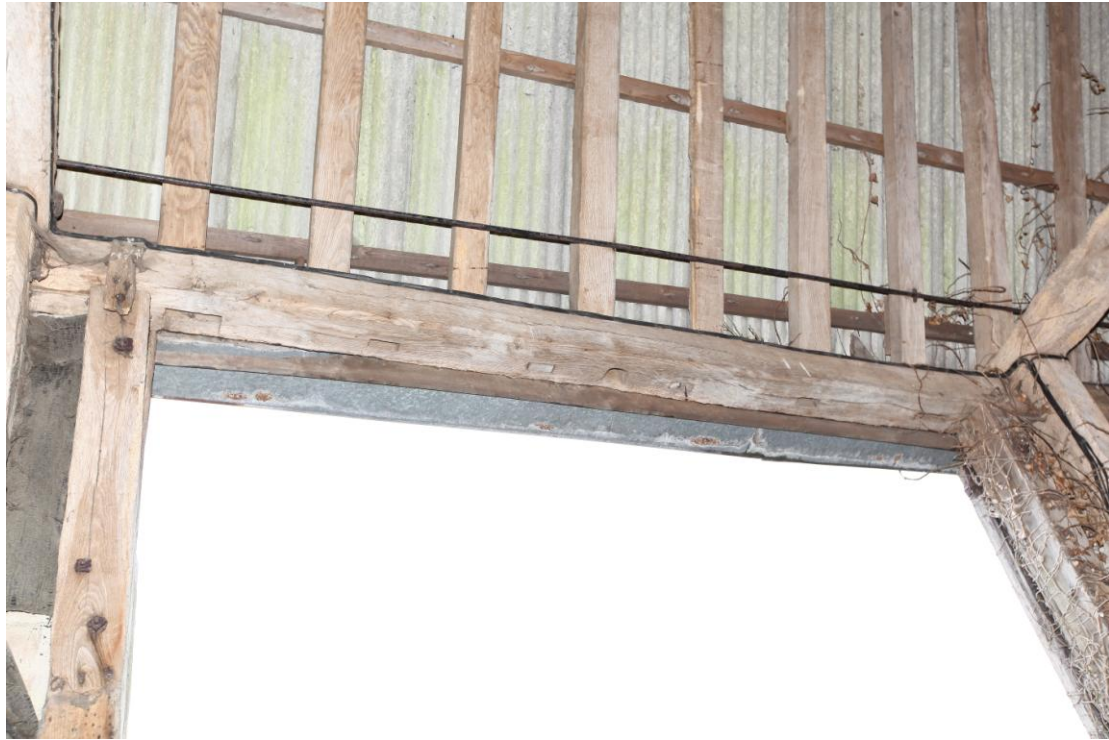
While it is common to encounter rear ‘porches’ in the 18th and 19th centuries, whether gabled or built as lean-to structures, intended to increase the length of the threshing floor, the porch here is an exceptionally early example of its kind. The proportions of the original door would be indicated by the pattern of stud mortises in the mid-rail, but this was hidden behind boarding at the time of inspection. The present brick jambs of the wide but low doorway beneath the same mid-rail are additions of the 19th or early-20th century. The present full-height entrance to the north is also an alteration, however, as pegged stud mortises are exposed in the relevant section of roof-plate. These suggest the original doorway was significantly lower than the eaves, with a separate lintel as shown in the reconstruction drawing (figure 6): the large outer mortises are close to the storey posts and undoubtedly held door jambs (the present timbers are nailed replacements), but it is unclear why the two central mortises which flank the later door-bar housing are pegged while the two intermediate mortises are not.

Illus. 7. Detail of the northern roof-plate above the current entrance in bay C showing the unusual arrangement of alternately pegged and unpegged stud mortises with a central housing for a door bar. The large outer mortises inside the present nailed jambs appear to have secured the original door posts.

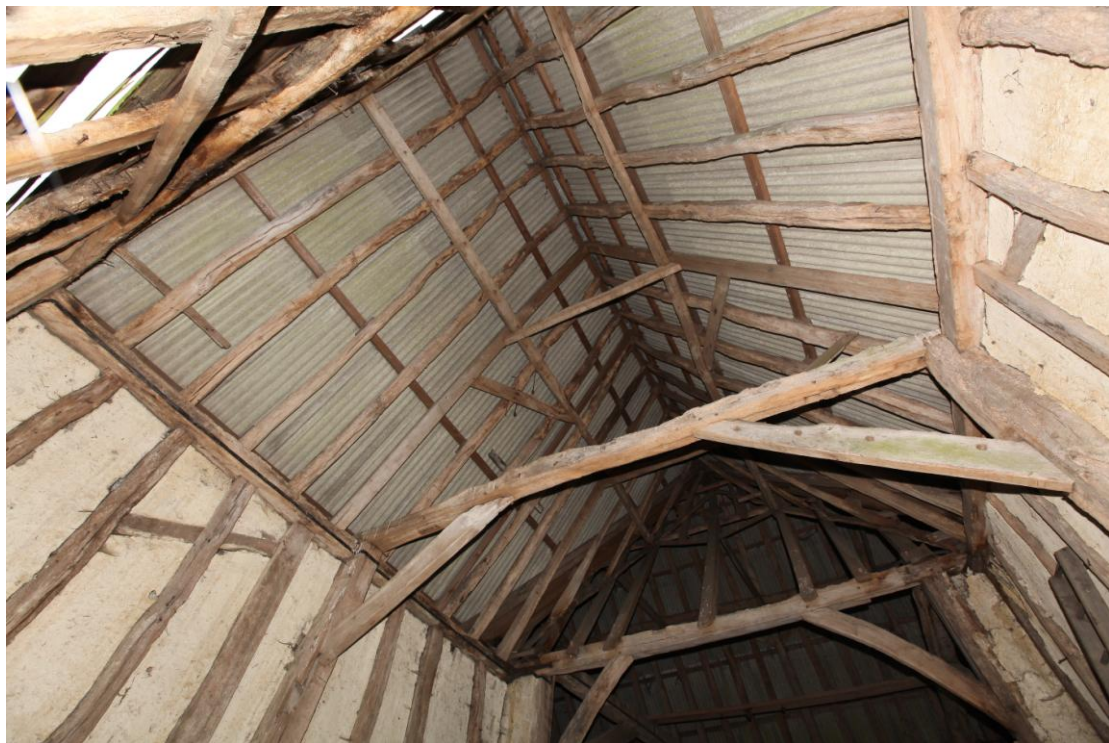
Illus. 8. Roof of porch (1a) from the south, showing its intact wind braces and arch-braced open truss with empty mortises in the underside of its re-used tie-beam. The braces of the southern roof-plate in bay C (visible in the rear) are also original.

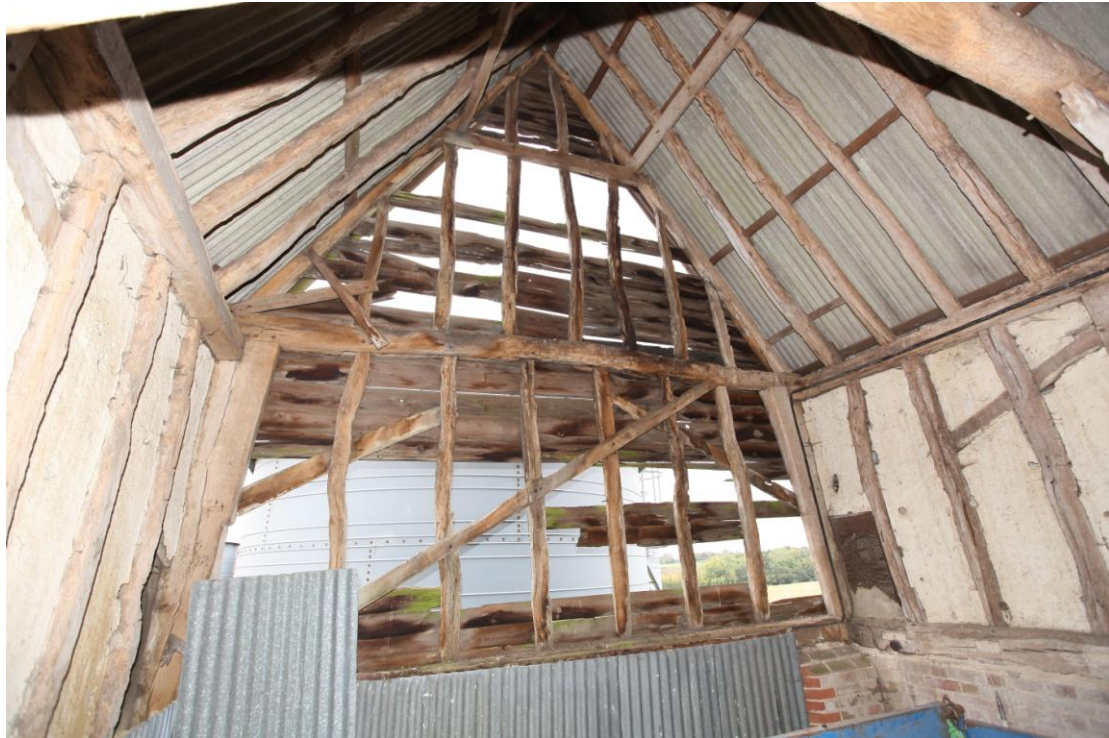
Illus. 9. The interior of the porch gable (1a) showing its original external wall braces to left and right with a later nailed internal diagonal brace in the centre. The mid-rail is an original feature but any evidence of the original doorway is obscured; the chamfered brick jamb to the right is an addition of the 19th century.

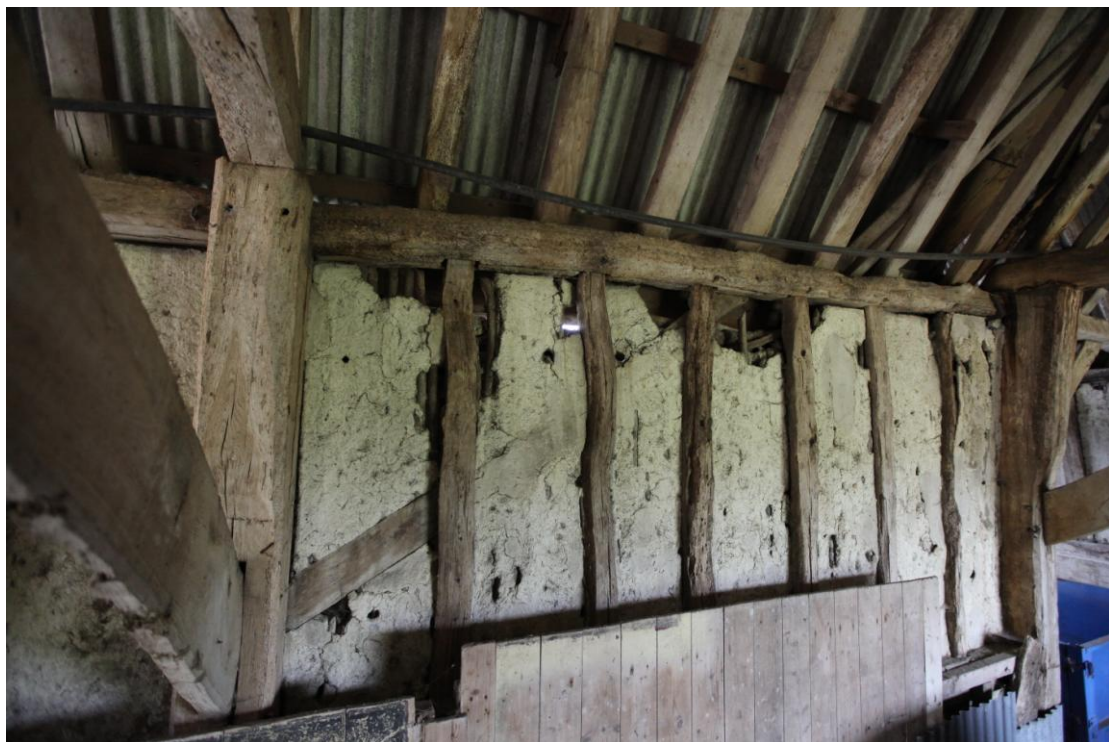
Illus. 10. The southern interior of bay D showing its intact external wall brace and wattle-and-daub, with entrance the entrance to the porch (1a) in bay C visible to the right.

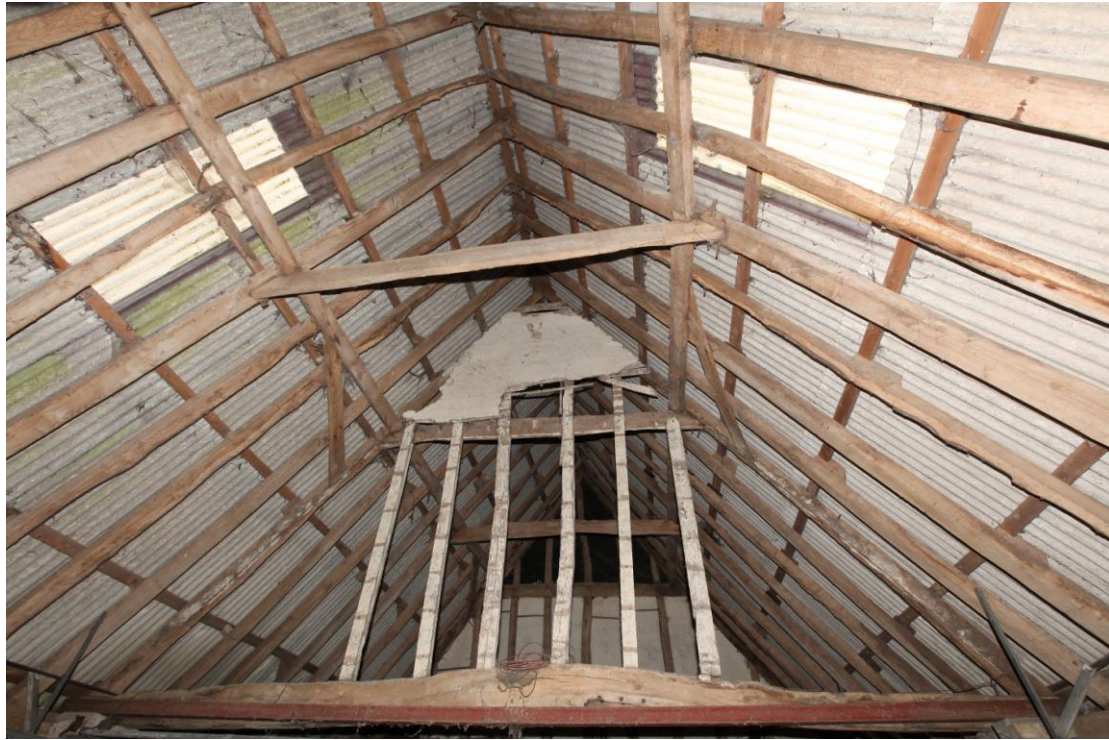
The eastern bay of the barn was divided from the rest during the 18th or early-19th centuries, as indicated by the remains of a daubed partition of nailed studs above the tie-beam between bays E and F. This alteration probably relates to the conversion of the end-bay into a stable and hay loft with a lean-to tack room (2) against its southern elevation. The latter retains bentwood harness hooks and a good brick floor, but the loft and other evidence of the conversion has been removed along with the entire eastern gable. The central lean-to of the southern elevation (3) was rebuilt in the 20th century but probably formed an open-sided shelter shed for the adjoining horse or cattle yard; it was added between 1839 and 1882 as it appears in figure 2 but not figure 3. The western lean-to (4) is a 20th century corrugated iron vehicle shed of no historic value.

Illus. 11. The roof structure of the eastern bays seen from the west, showing the remains of a later partition which divided the eastern bay (F) from the rest of the interior (probably to form a stable). The pegged mortises of the original arch-braces are visible in the tie-beam.

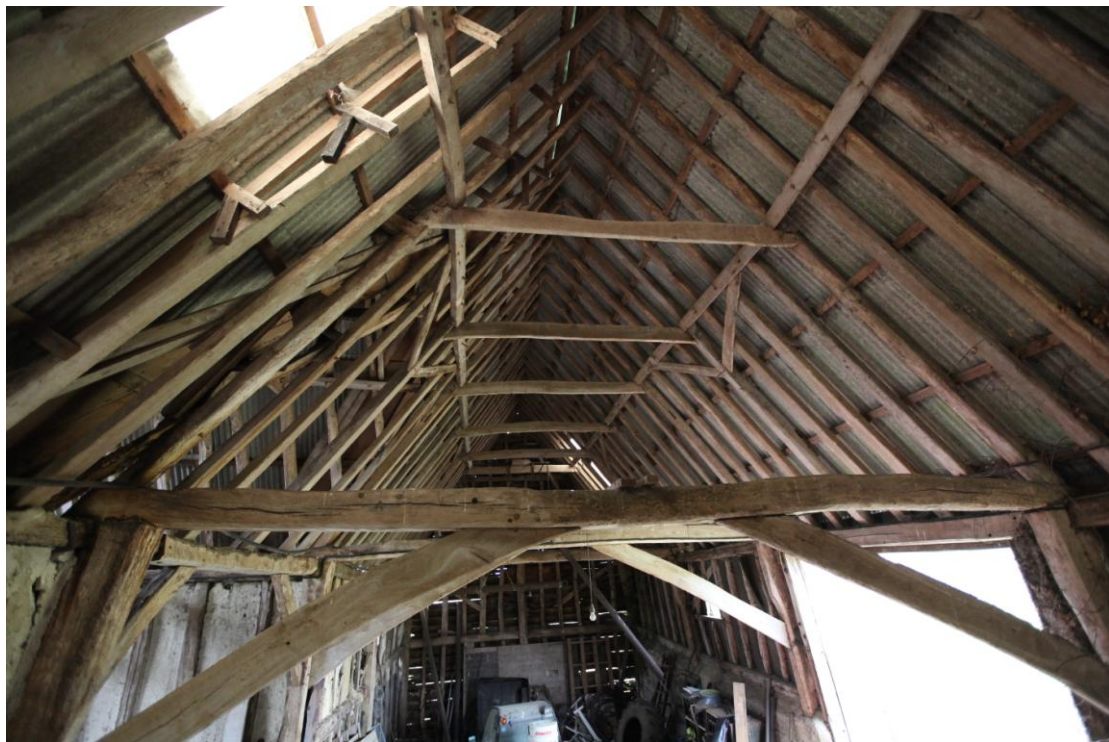
Illus. 12. The clasped-purlin roof structure of the western bays seen from the east, showing its fully intact wind braces and the open truss adjoining the entrance bay (C) in the foreground.
