**Farm Buildings at  
Stanny House Farm,  
Iken, Suffolk  
IKN 108**

**Historic Building Record**

# **Farm Buildings at Stanny House Farm, High Street, Iken, Suffolk**

## **Historic Building Record**

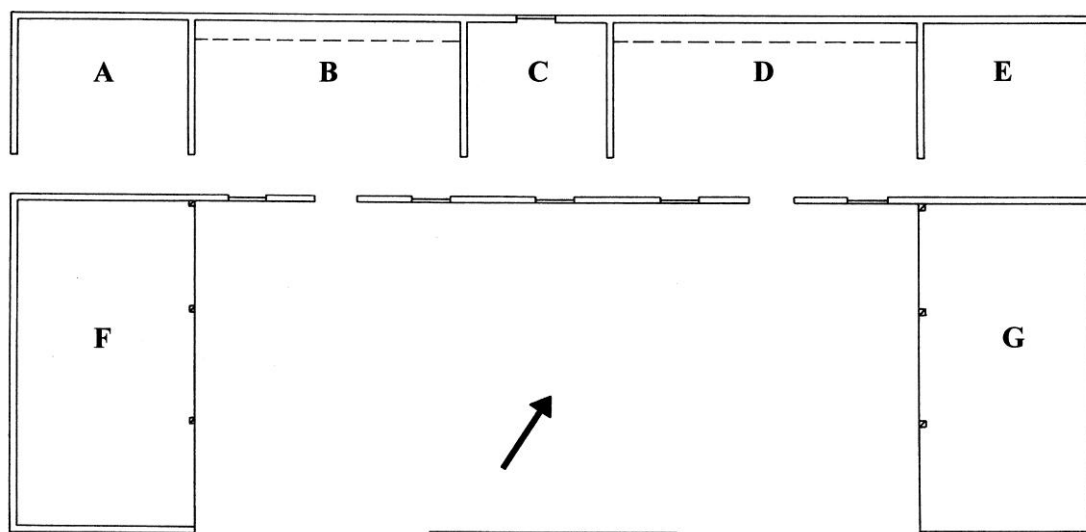
Figure 6

Ground plan of the single-phase brick stable block identifying each area with a letter for ease of reference in the text and photographs. Scale in metres.

- A. Single-storied shed with external doorway to west. Originally adjacent to a horse engine and probably used as a feed preparation and storage area.

- B. Stable retaining its original boarded hay rack and manger with a hay drop to the loft above. Remains of ostensibly later boarded stalls and original ladder stair to loft in south-western corner. 8.5 m in length (28 ft). Loft above.

- C. Central tack room with original wooden harness hooks to western, northern and eastern walls. Loft above.
- D. Stable from which the manger and hay rack have been removed but retaining a hay drop in the ceiling. Original ladder stair to loft in south-eastern corner. 9.75 m in length (32 ft). Loft above.

- E. Single-storied shed with external doorway to east.
- F. Open-sided shelter-shed with original chamfered arcade posts and lintels.
- G. Open-sided shelter-shed with original chamfered arcade posts and lintels. Remains of 20<sup>th</sup> century hay rack to eastern interior.

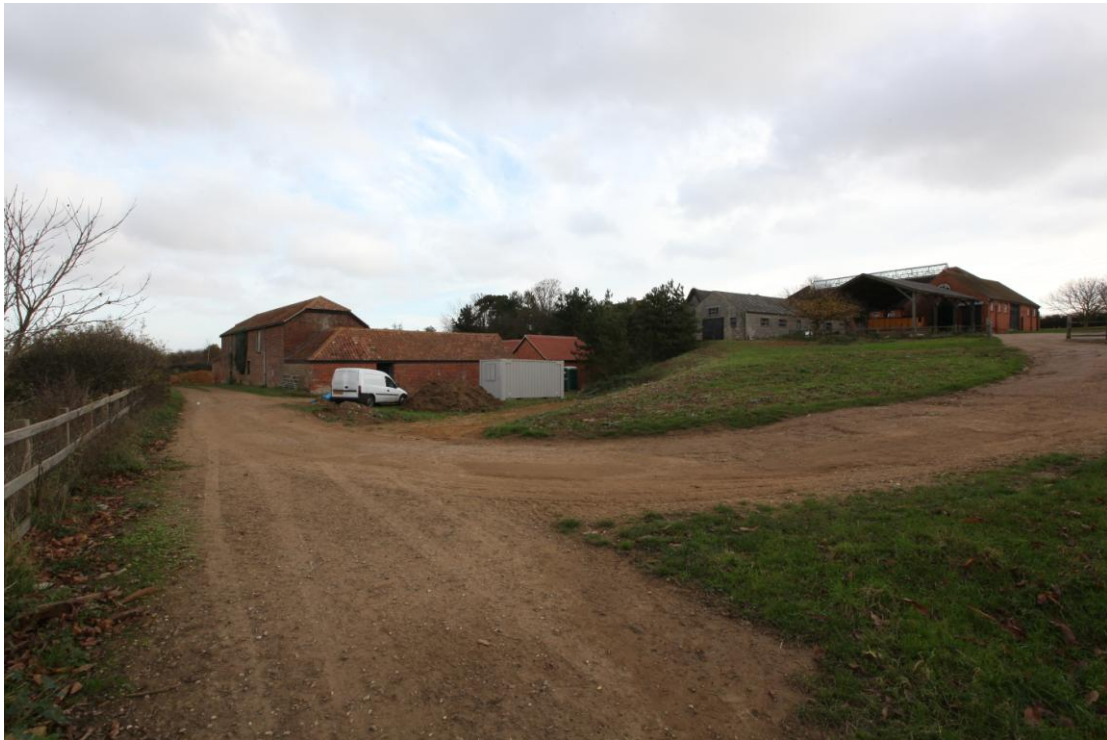
**Illus. 1. General view of the site from the west showing the stable block adjoining the track to the left and the 1920s brick dairy range on higher ground to the right.**

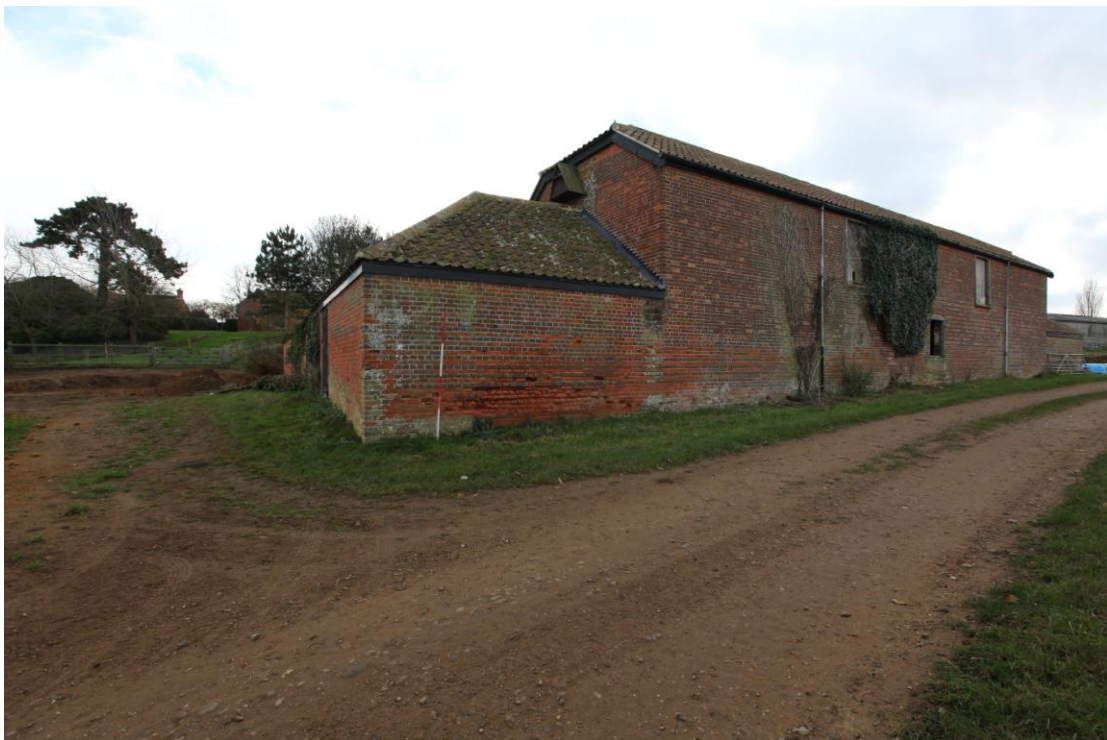
**Illus. 2. The stable range from the north showing the chimney of the farmhouse in the rear to the left. The single storied sheds flanking the main stable range are integral features, and the central window to the tack room and both first-floor loft doors visible here are original.**

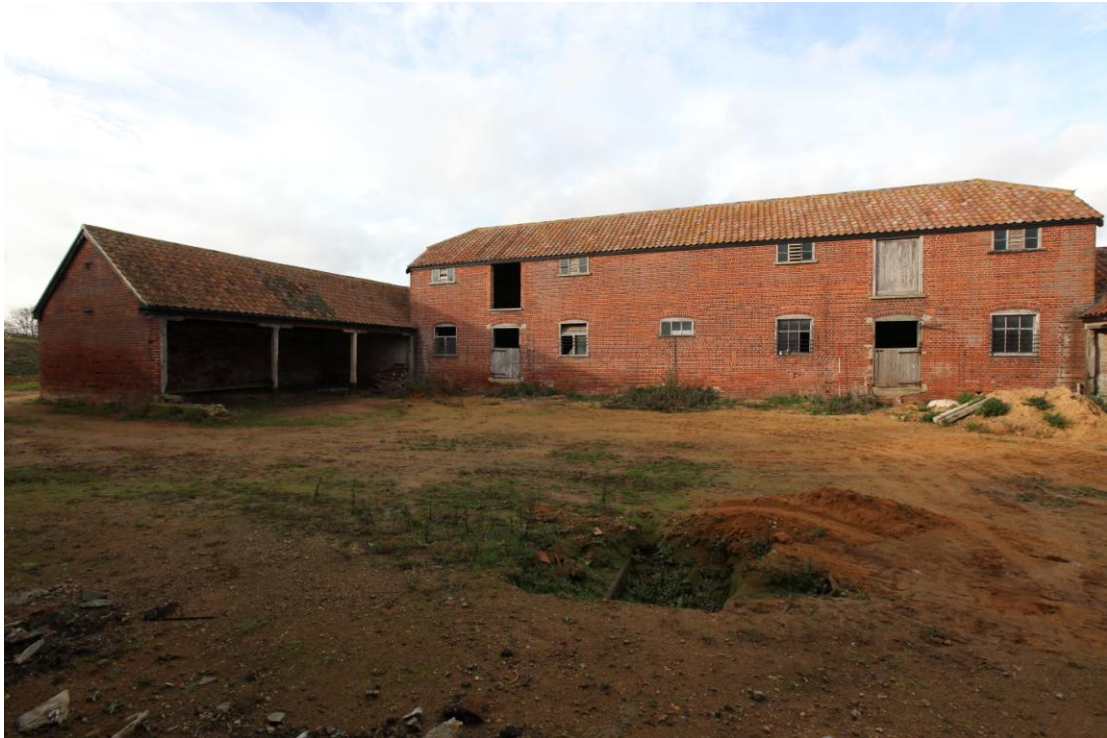
**Illus. 3. The stable yard seen from the east, with the western shelter-shed (F) to the left and two-storied stable range and hay loft to the right.**

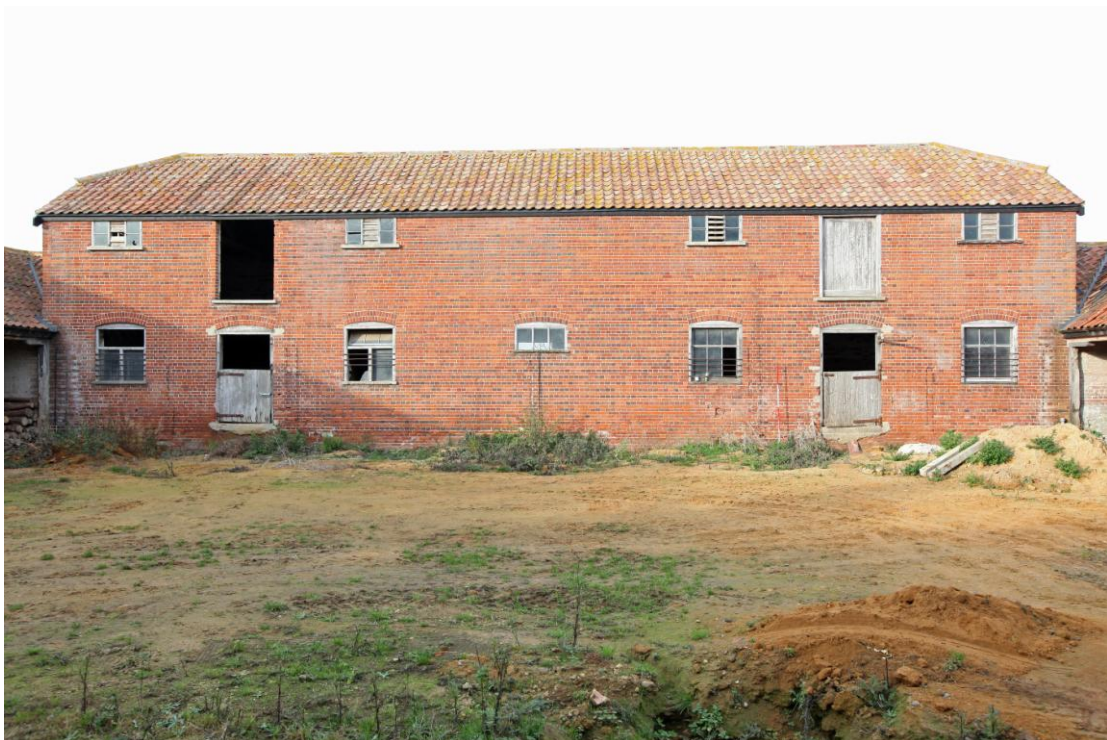
**Illus. 4. The southern facade of the stable range from the yard. This elevation is largely original apart from the first-floor loading doors to the hay loft which are secondary insertions interrupting the pattern of brickwork.**

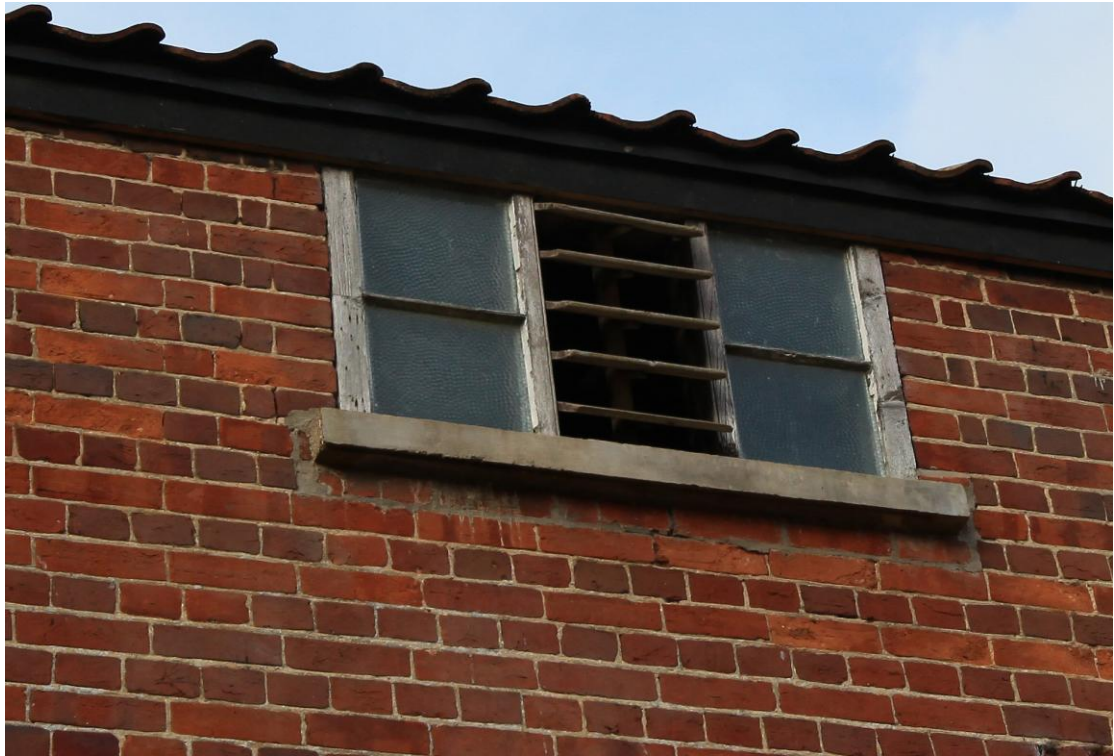
**Illus. 5. Detail of one of the unusual loft windows in the southern exterior showing its original central louver operated by a vertical spindle. The sill is a replacement.**

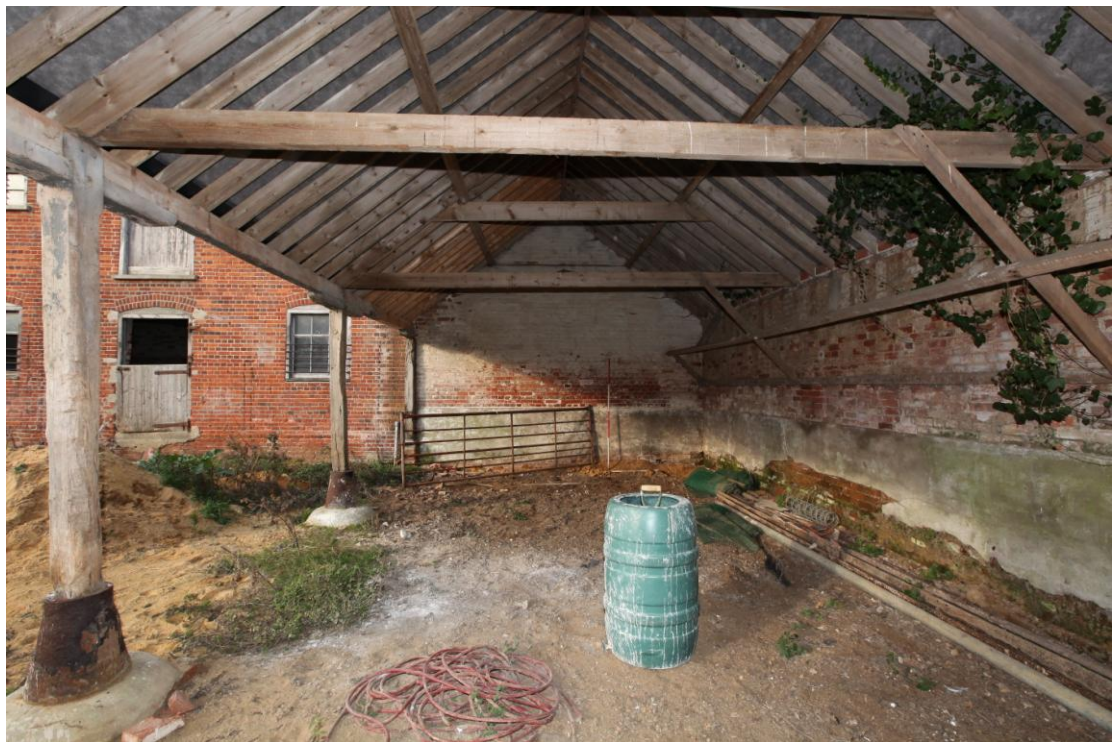
**Illus. 6. The interior of the eastern shelter-shed (G) from the south, showing its softwood clapped-purlin roof structure and the remains of a 20th century hay rack to the right. The chamfered arcade posts and lintels to the left retain their original iron conical bases.**

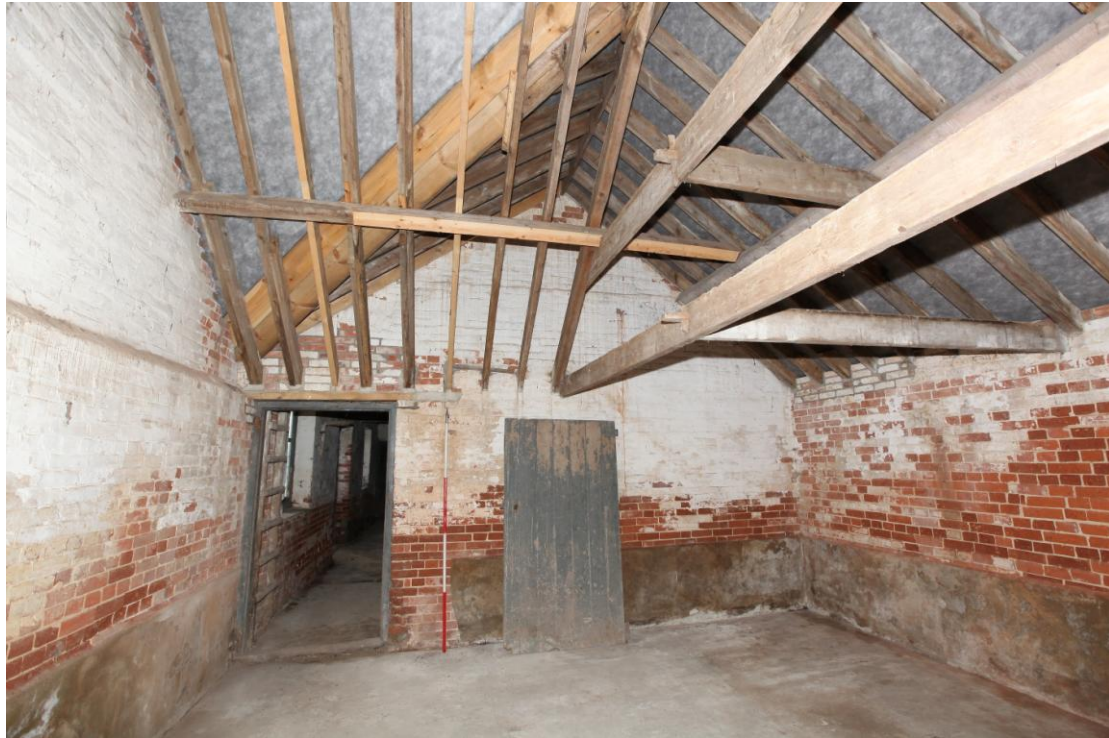
**Illus. 7.** The interior from the north-east of the single-storied eastern shed (E) showing its original softwood roof structure (with some recent repair) and the connecting door to the eastern stable (D).

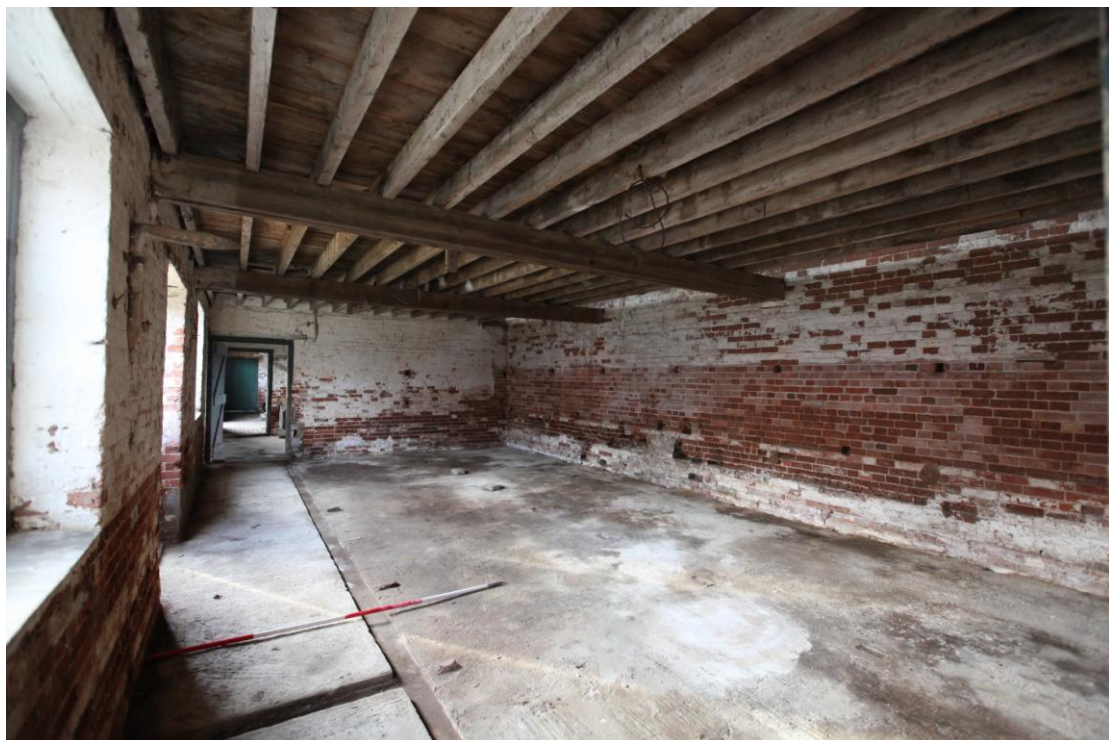
**Illus. 8.** The interior of the eastern stable (D) from the north-east showing the position of the removed hay rack & manger beneath the hay drop against the rear wall to the right and the axial passage to the left. The concrete floor is a 20<sup>th</sup> century replacement.

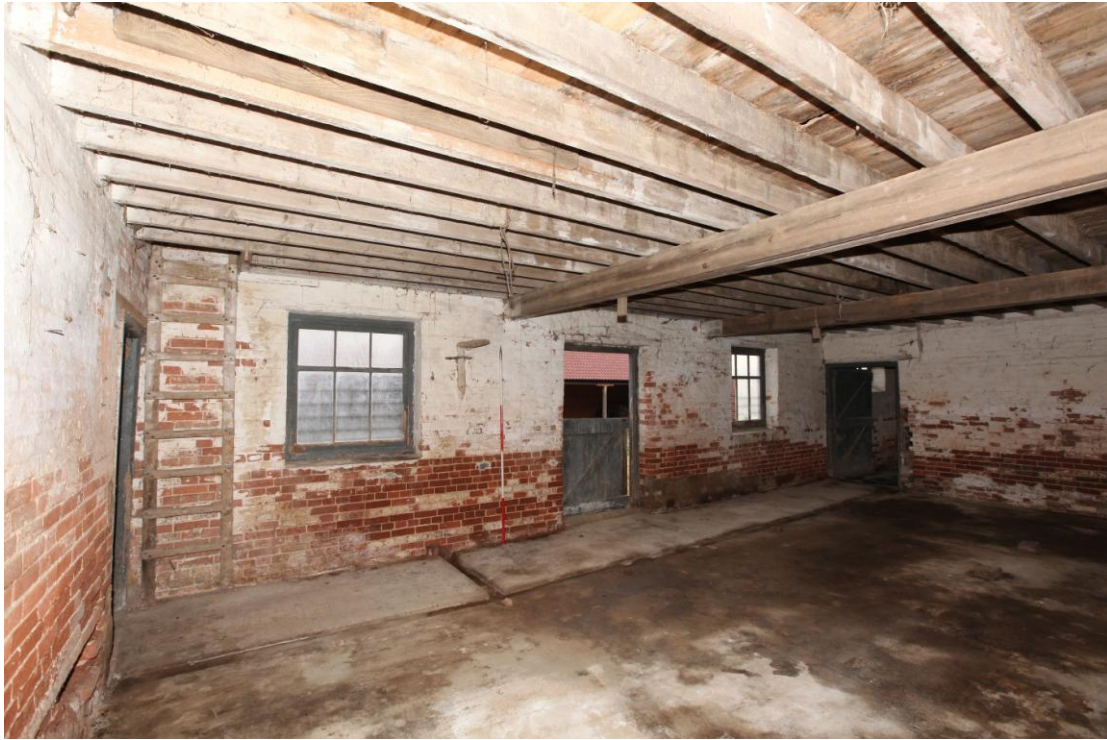
**Illus. 9. The southern interior of the eastern stable (D) showing its central yard door flanked by windows with an original vertical loft ladder to the left.**

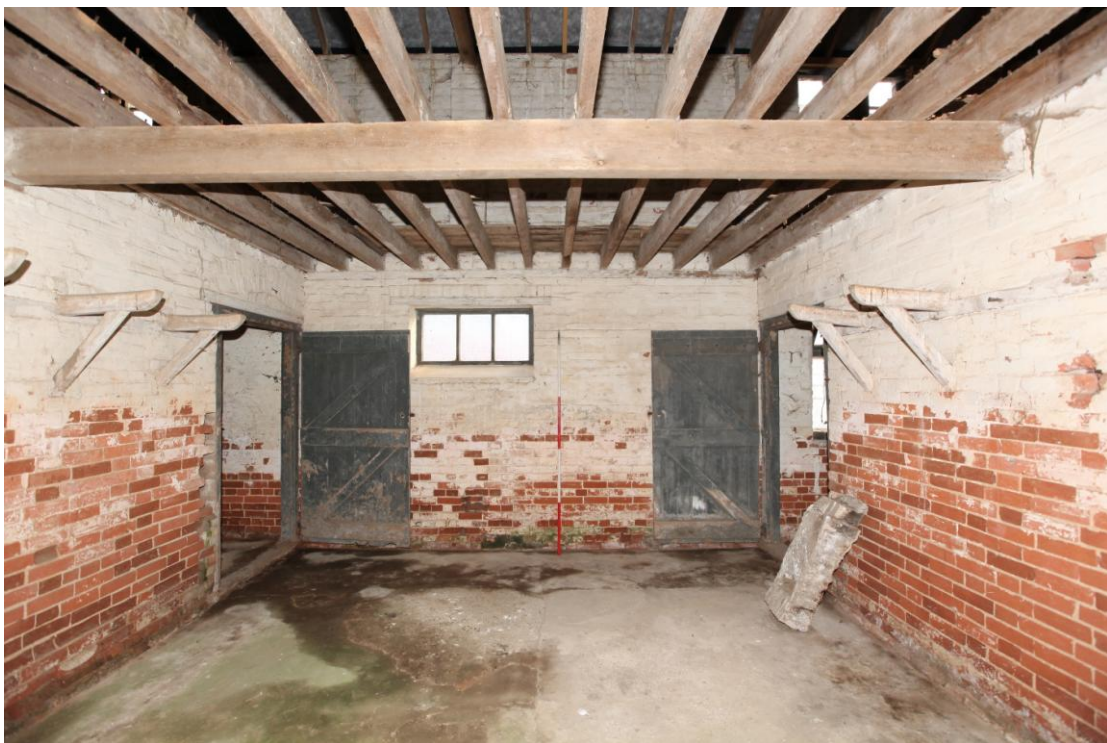
**Illus. 10. The southern interior of the central tack room (C) showing the original wooden harness hooks and the doors to the eastern and western stables (D and B) to the left & right respectively.**

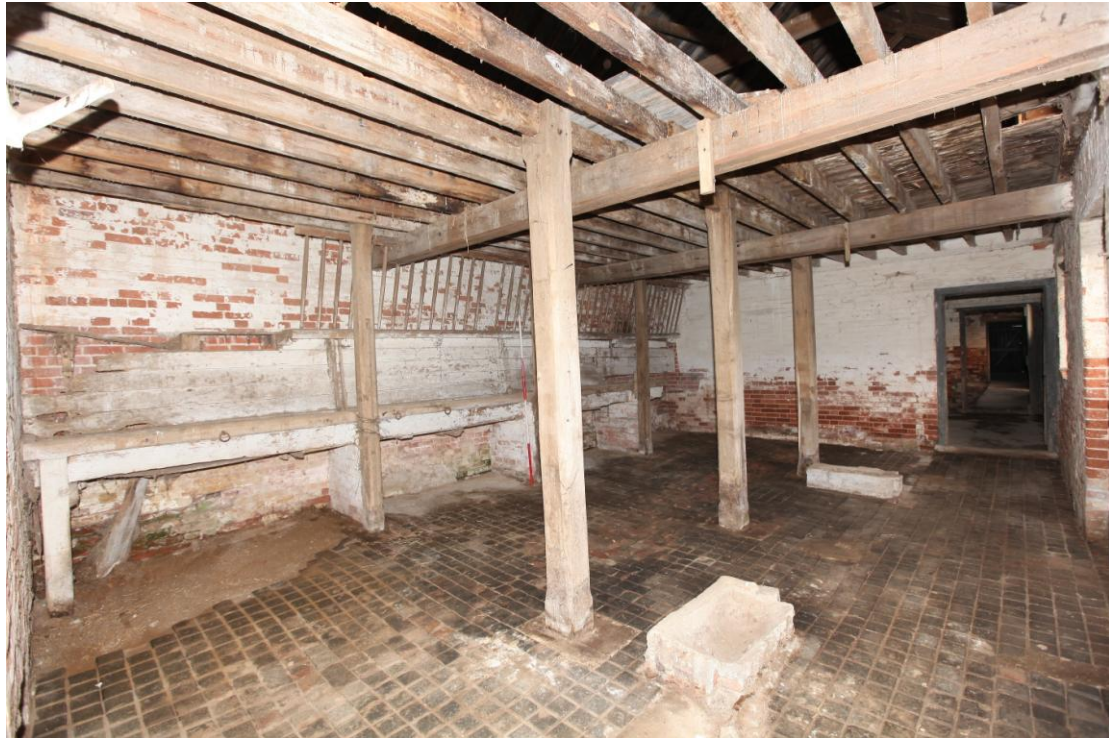
**Illus. 11.** The interior of the well preserved western stable (B) from the south-west showing the original hay rack and manger to the left with the nailed posts of ostensibly secondary stall divisions (from which the boarded partitions have been removed). The tiled floor appears to be original.

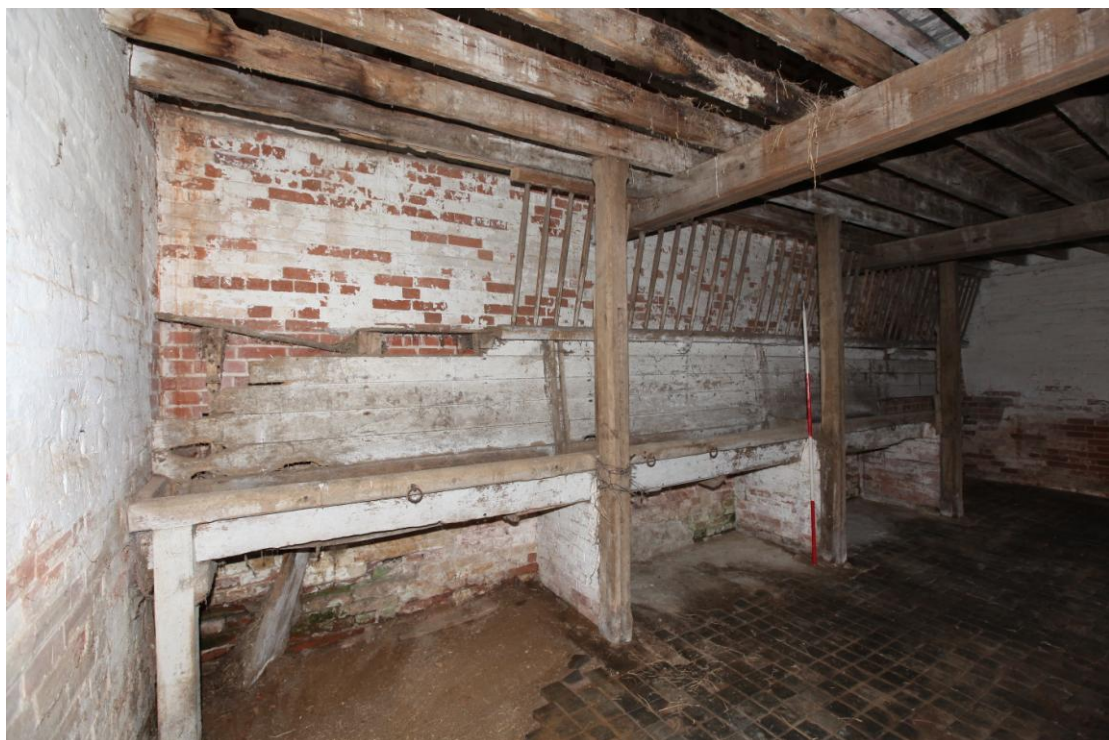
**Illus. 12.** The manger & hay rack to the rear of the western stable (B) showing three bolted vertical posts with vertical grooves for missing stall partitions.

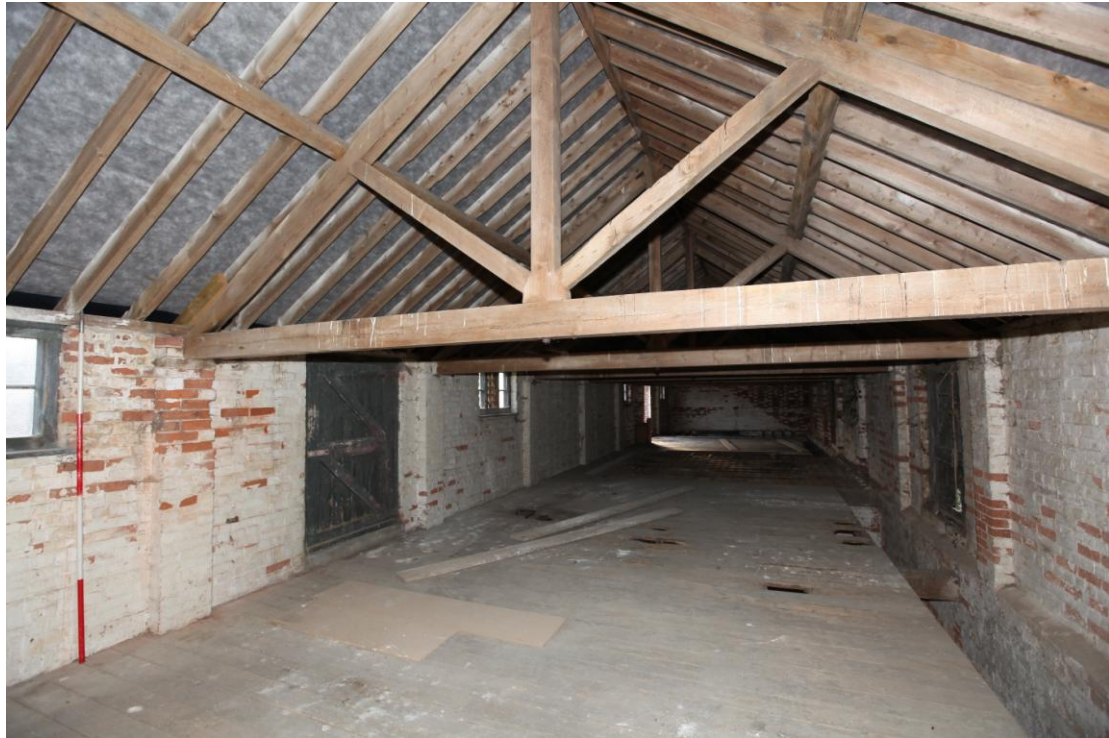
**Illus. 13. The interior of the hay loft on the undivided upper storey seen from the north-east and showing the original prefabricated king-post softwood roof trusses with a hay drop in the floor to the right.**

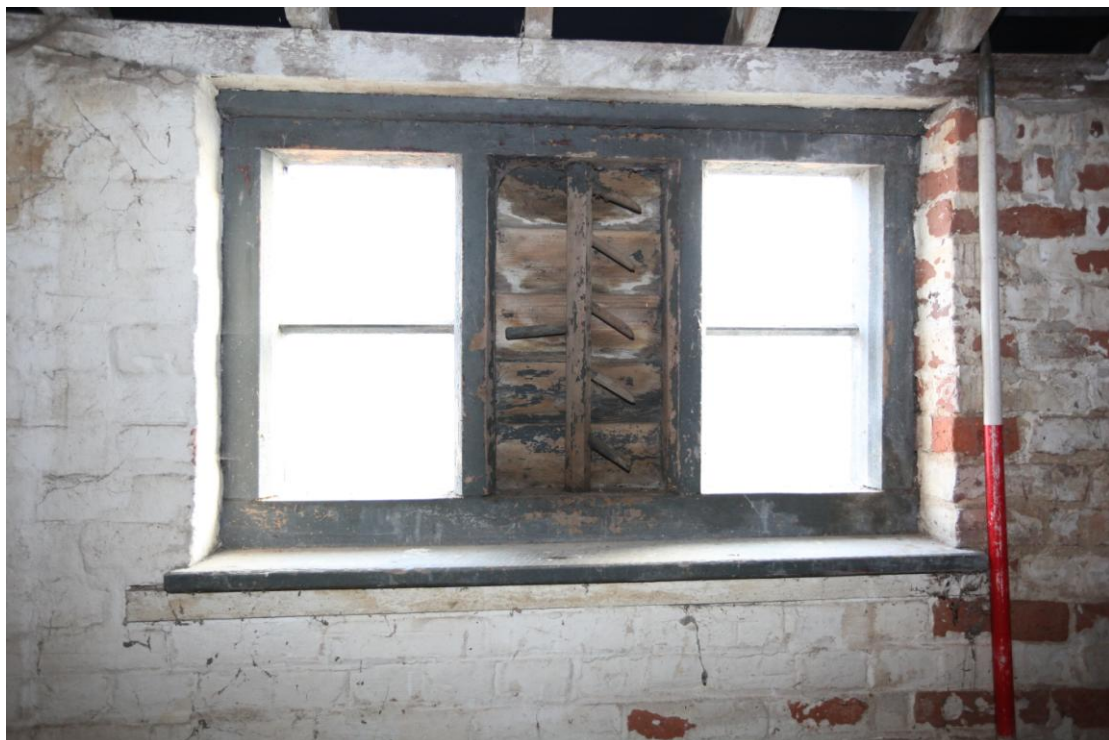
**Illus. 14. Internal detail of an original hay loft window in the southern elevation showing the central louver in the closed position. Wooden pegs raise each slat when the vertical spindle is turned.**
