**Agricultural Buildings at
Street Farm,
Redgrave, Suffolk
RGV 049**

Heritage Asset Assessment

December 2011

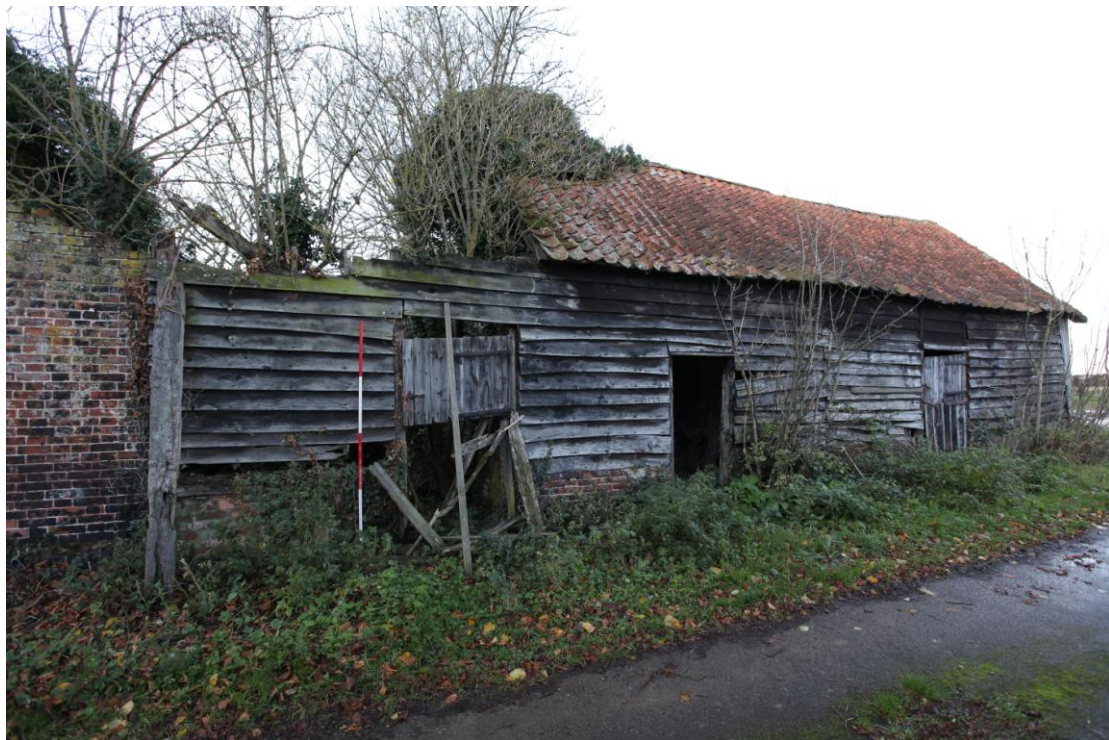
Illus. 4. The eastern exterior of the stable range (1) showing the three entrance doors to the partly collapsed loose-box (1c) to the left, the tack room (1b) in the centre and the stable (1a) to right.

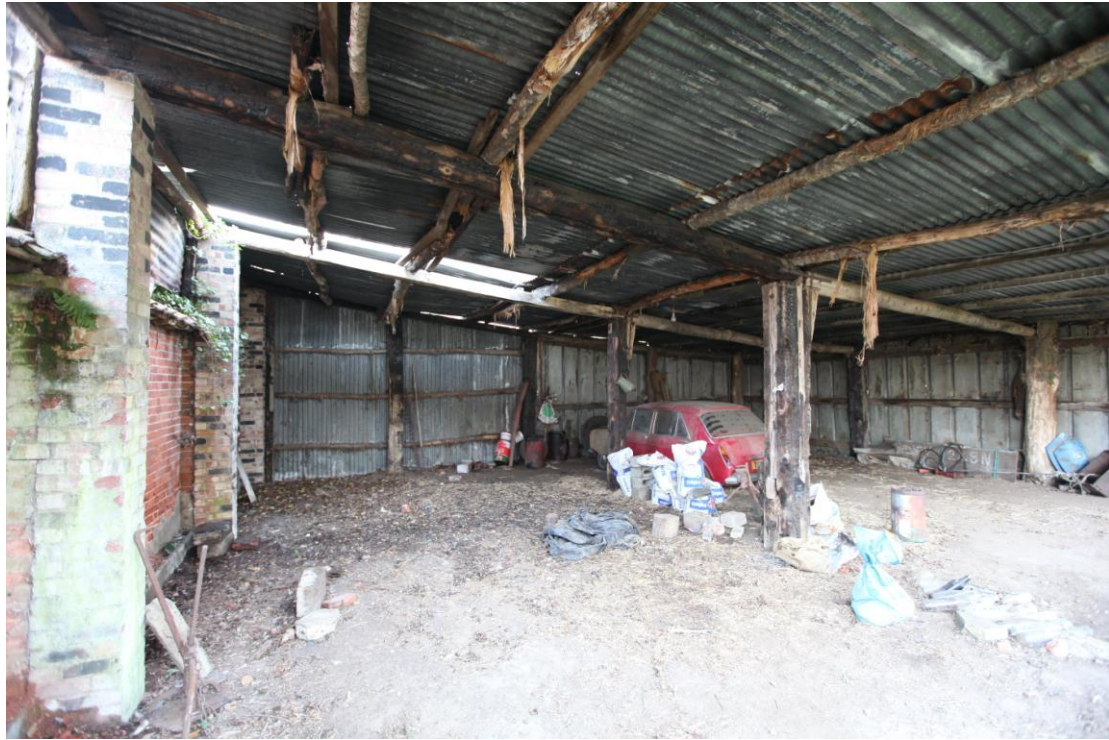
Illus. 5. The interior of the 20th century corrugated iron vehicle shelter (3) from the north showing the western exterior of the 19th century brick shelter-shed (2) to the left.

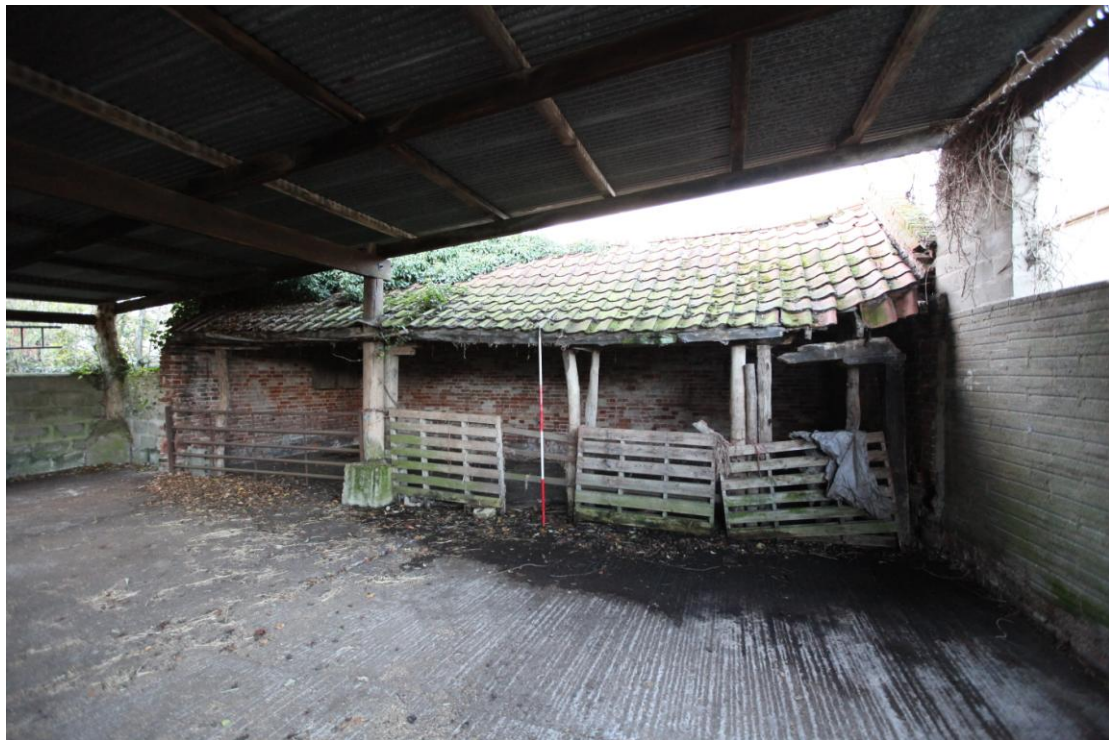
2. A red-brick and pantiled open-sided shelter-shed serving the yard adjoining the stable. *Circa* 1870 but on the site of an earlier building shown on the tithe map of 1846. Softwood clasped-purlin roof structure with nailed collars. The timber arcade posts to the eastern elevation are 20th century replacements.

Illus. 6. The open-sided eastern exterior of the 19th century brick shelter-shed (2) from the 20th century covered yard showing its pantiled roof and renewed arcade posts.

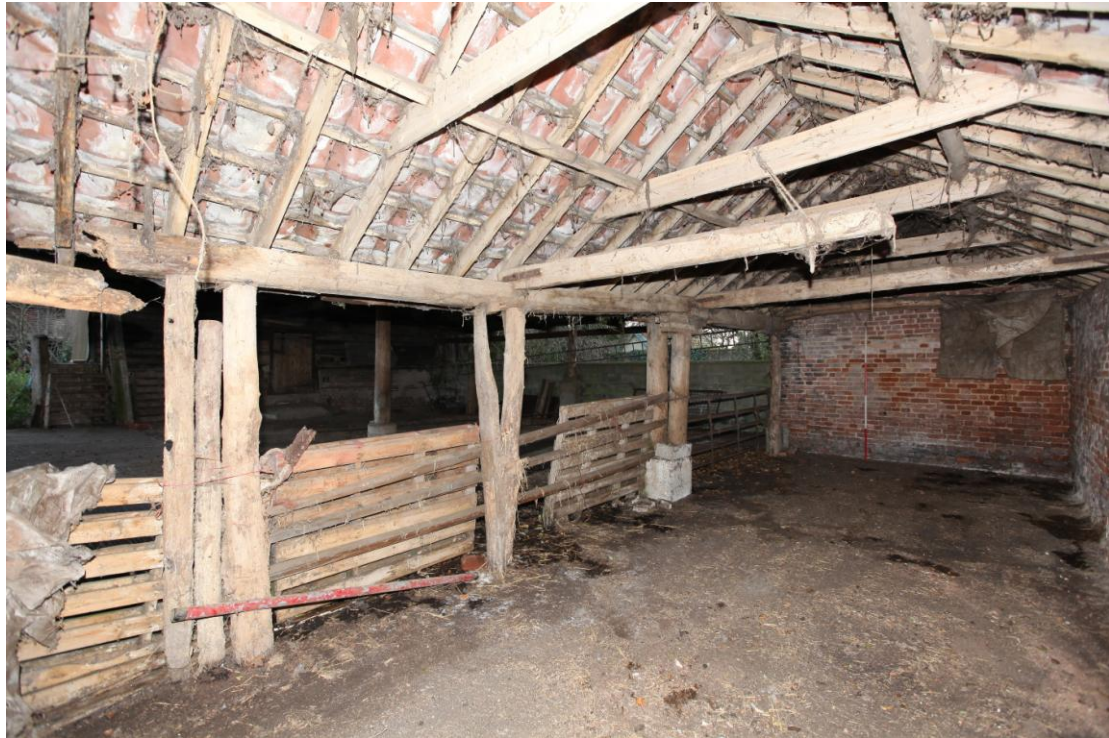
Illus. 7. The interior of the 19th century brick shelter-shed (2) from the north showing its renewed cylindrical arcade posts to the left and the original softwood roof structure of clasped-purlins with nailed collars (typical of the latter part of the 19th century).

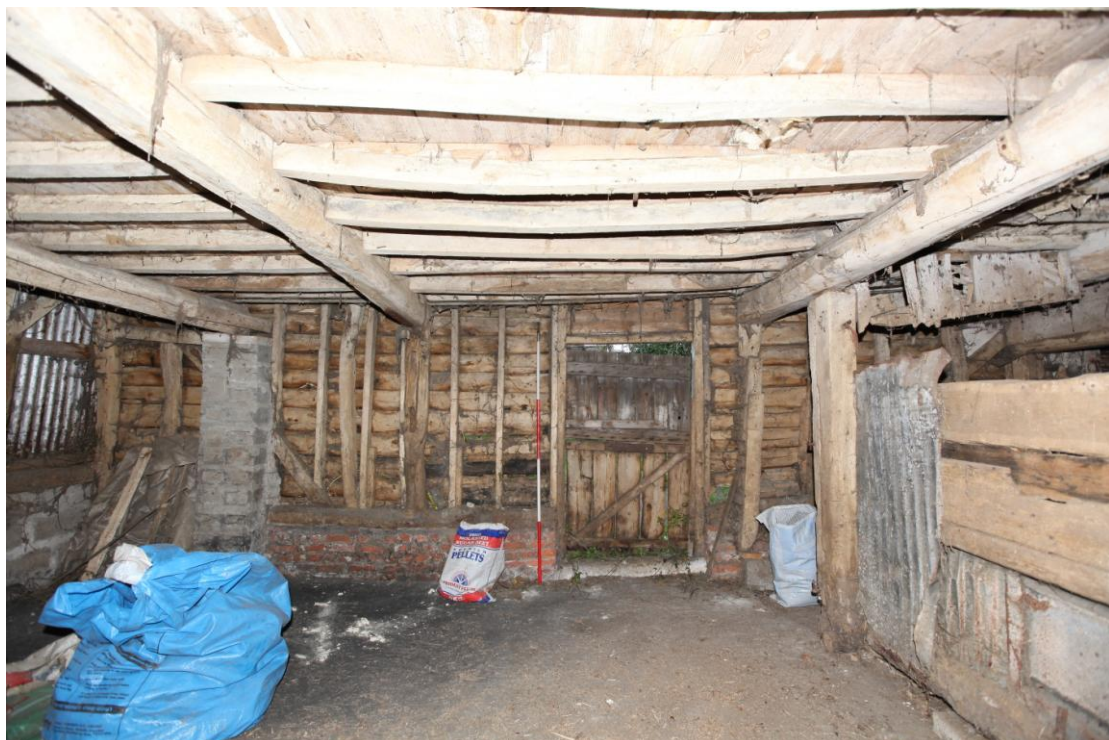
Illus. 8. The eastern interior of the stable (1a) showing the half-hung door to the farm entrance track with hay drops in the ceiling to both left and right (the mangers and racks removed). The boarded stall to the right is a later insertion and the floor is of 20th century concrete.

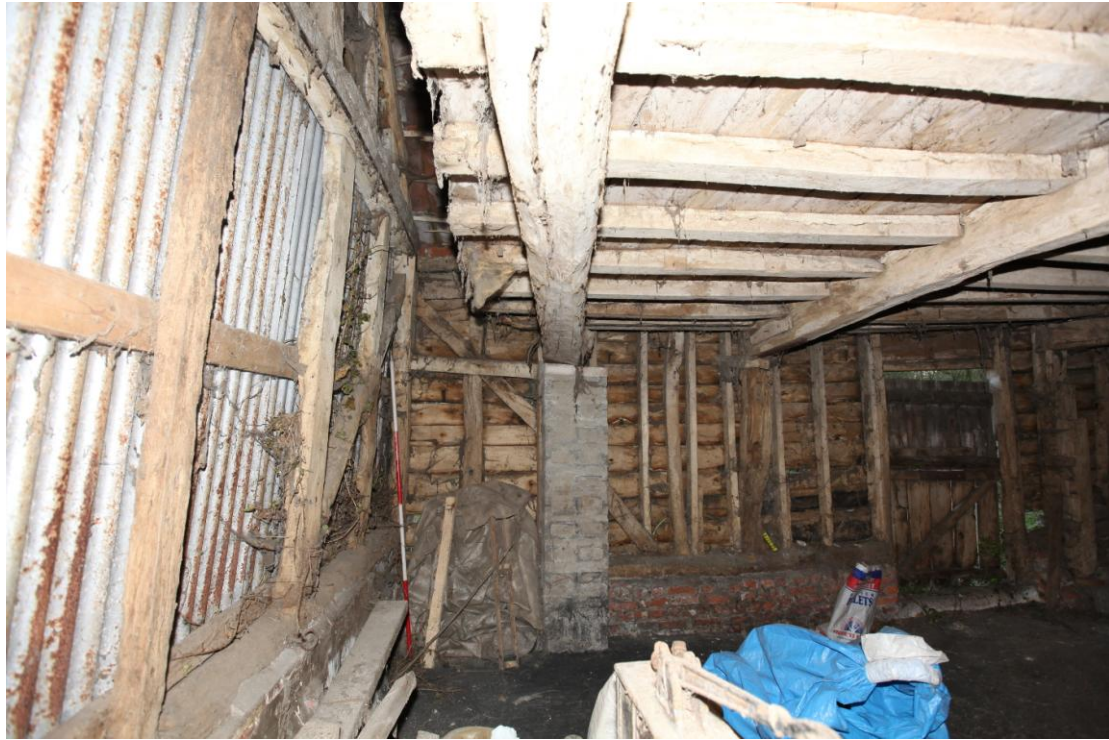
Illus. 9. The interior of the stable (1a) from the west showing the hay drop in the ceiling against the northern gable (clad in corrugated iron) to the left and the door to the farm track to the right.

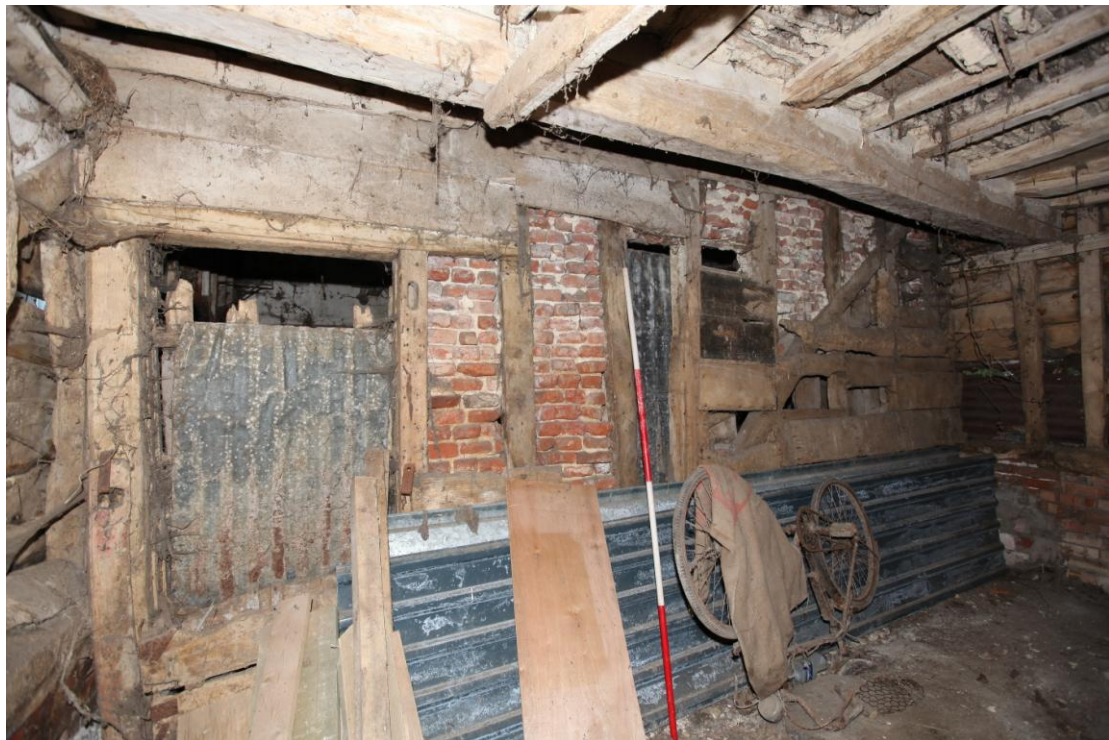
Illus. 10. The brick-nogged southern interior of the stable (1a) showing the door to the tack room (1b) to left and the position of the missing trough and rack beneath the hay drop to the right.

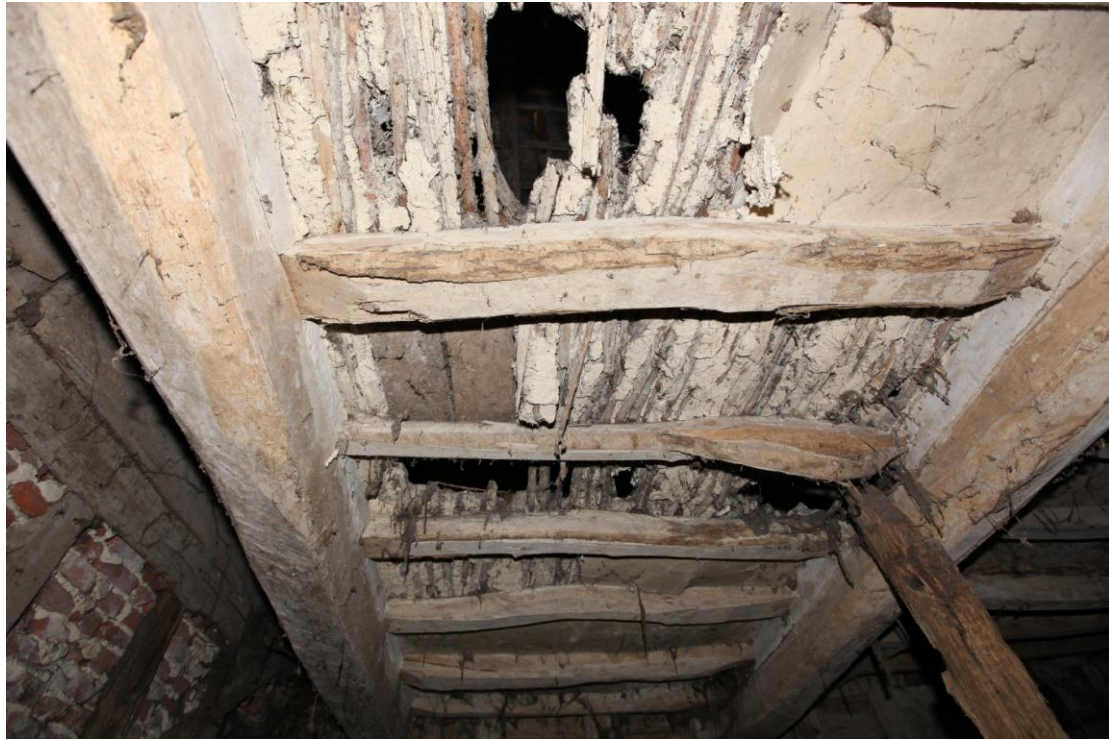
A later boarded stall has been inserted to the south of the central cross-entry and this has protected an area of original wattle-and-daub (i.e. coppice poles and clay) laid above the common joists but beneath the loft boards. This would have ensured that no dust fell through the boards into the stable beneath and is a fragile and unusual survival which has been removed from the rest of the ceiling where the soffits of the boards are now exposed. The remains of a loft ladder remain to the south of the western entrance. The floors are of 20th century concrete in much of the stable (laid when the space was converted for cattle in the 1960s as indicated by an automatic drinker adjoining the western entrance), but what appear to be original cobbles remain in the southern stall with original bricks in the passage linking the eastern entrance to the tack room – and original bricks also survive in the tack room itself.

Illus. 11. A detail from the east of the ceiling in the southern stall of the stable (1a), showing the wattle-and-daub laid over the joists (under the loft boards) with the hay drop to the left.

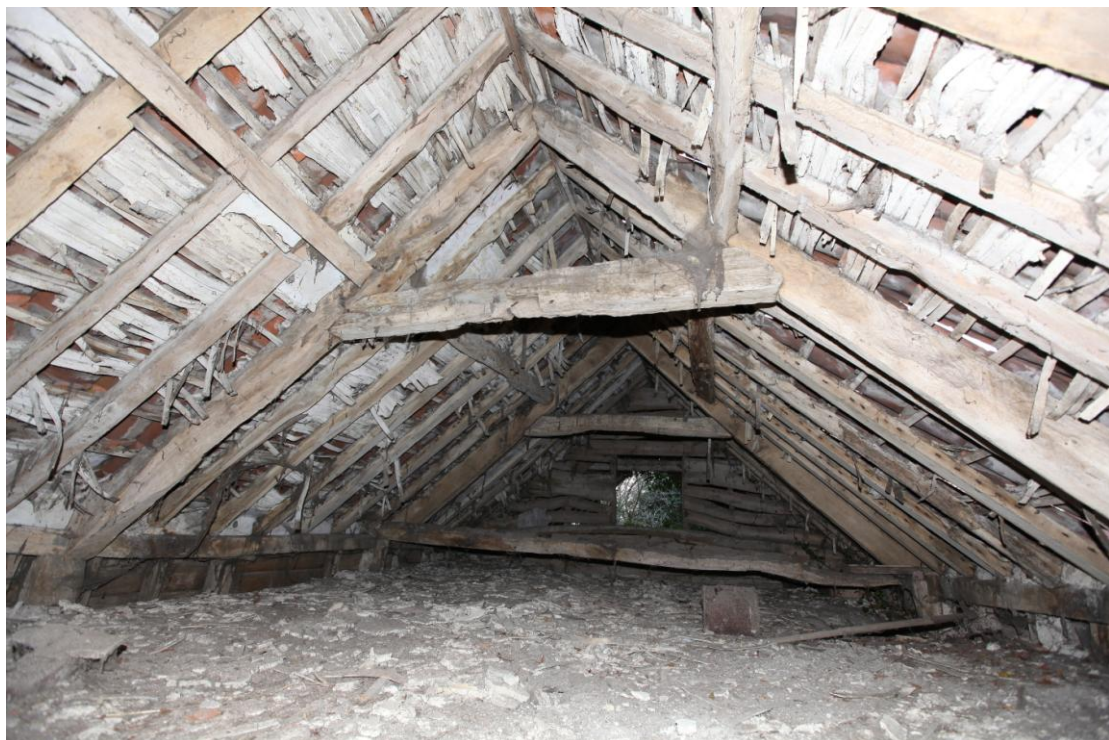
Illus. 12. The butt-purlin roof structure of the hay loft over the stable (1a) seen from the northern gable. The lath-and-plaster beneath the pantiles appears to be original but many timbers show evidence of re-use from older buildings. The hatch in the rear is an internal feature which opens onto the loft of the tack room (1b).

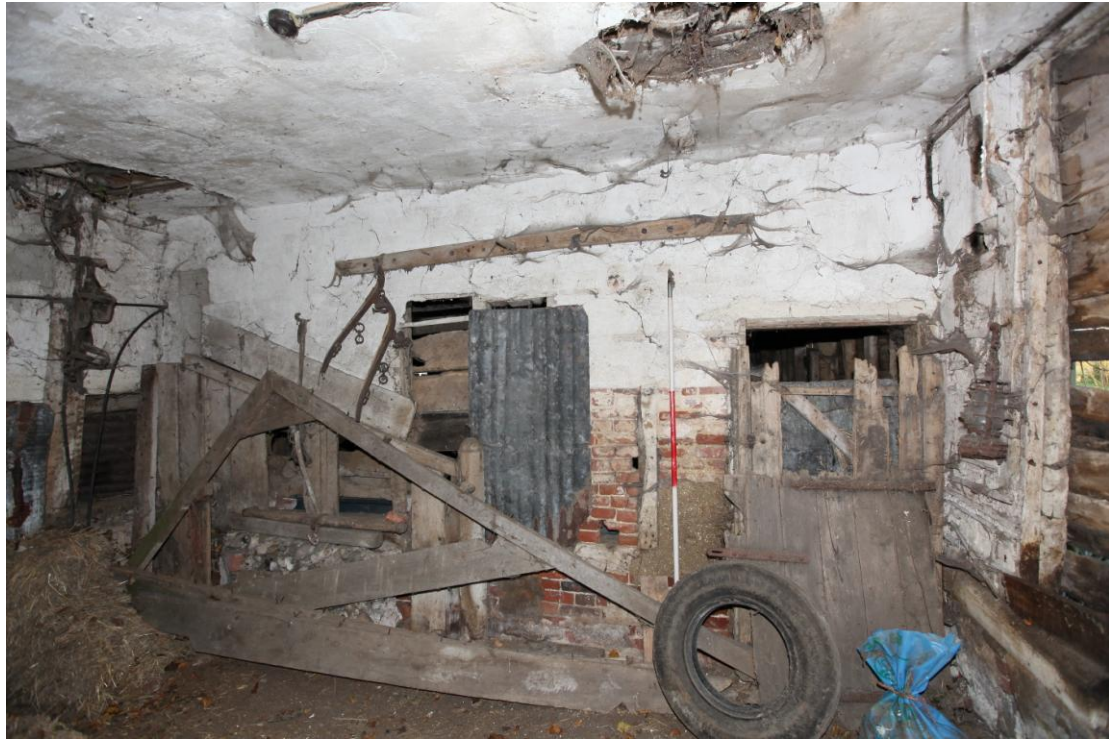
The central tack room differs from the northern stable in that its ceiling is of tall-sectioned softwood joists at the same height as the roof-plates and was evidently designed for its present thick layer of lath-and-plaster, despite the presence of wattle-and-daub above. The internal walls are similarly rendered and whitewashed, with a wooden rail of harness hooks from which leather tack still hung at the time of inspection. The presence of a good oak stall partition at the western end of the northern interior indicates the room was designed not as a tack room but as a high quality stable (the chamfered finial is chamfered and carved) for riding or trap horses. This partition appears to be in situ, with an original flat surface against the wall.

Illus. 13. The northern interior of the tack room (1b) showing the door to the stable (1a) to the right with the original 19th century ceiling of tall-sectioned joists sandwiched between wattle-and-daub above and thick lime plaster beneath. Note the wooden rail of harness hooks (with harness still attached) and the slope of a stall partition with a carved oak finial to the left.

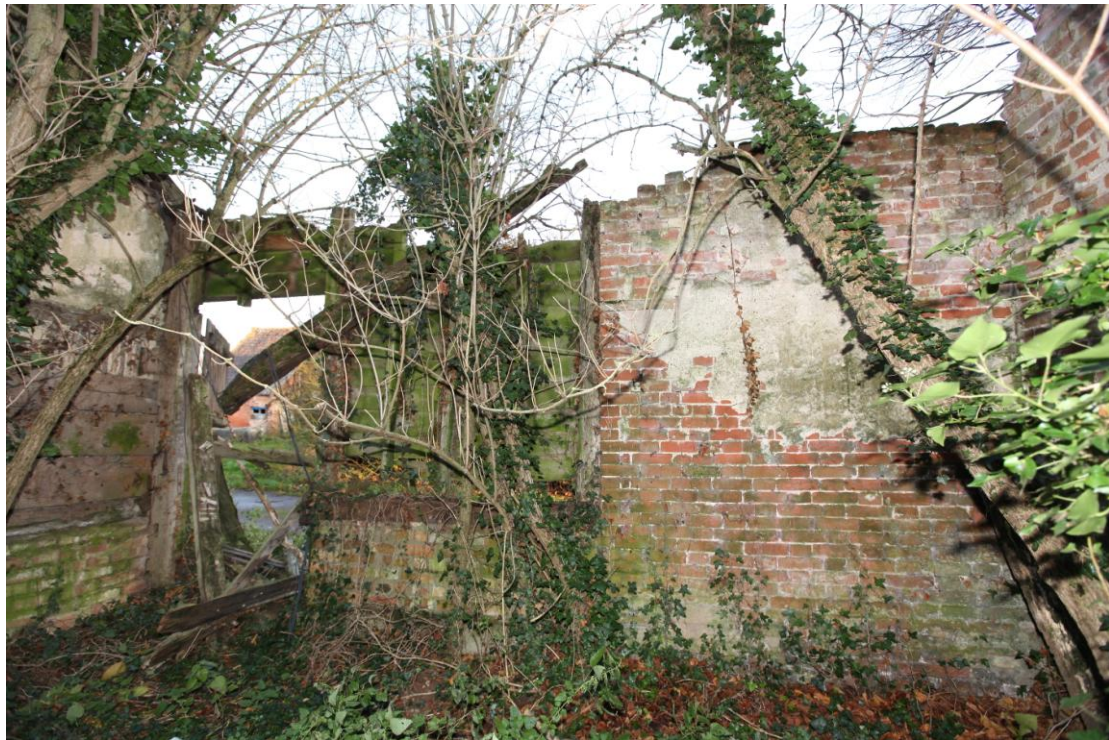
The loose-box to the south of the building had largely collapsed at the time of inspection and lacked its roof. This area was used to accommodate mares and foals in the 1950s. The northern half of the eastern elevation consists of studwork while the rest is of brick, and in its present form the box probably represents a mid-19th century extension of 2.75 m (9 ft) to the southern gable of the original stable. Precise analysis of this point is hampered by its fragmentary condition but such an interpretation is consistent with the 19th century maps which show an increase in length between 1846 and 1886.

Illus. 14. The eastern interior of the partly collapsed loose-box (1c) showing what appears to be a 19th century brick extension to the earlier timber-framed stable range to the left.
