**The Old Maltings
Barton Mills,
Suffolk
BTM 049**

Supplementary Historic Building Record

The Old Maltings, The Street, Barton Mills, Suffolk

Supplementary Historic Building Record To be read in conjunction with the Heritage Asset Assessment of January 2011

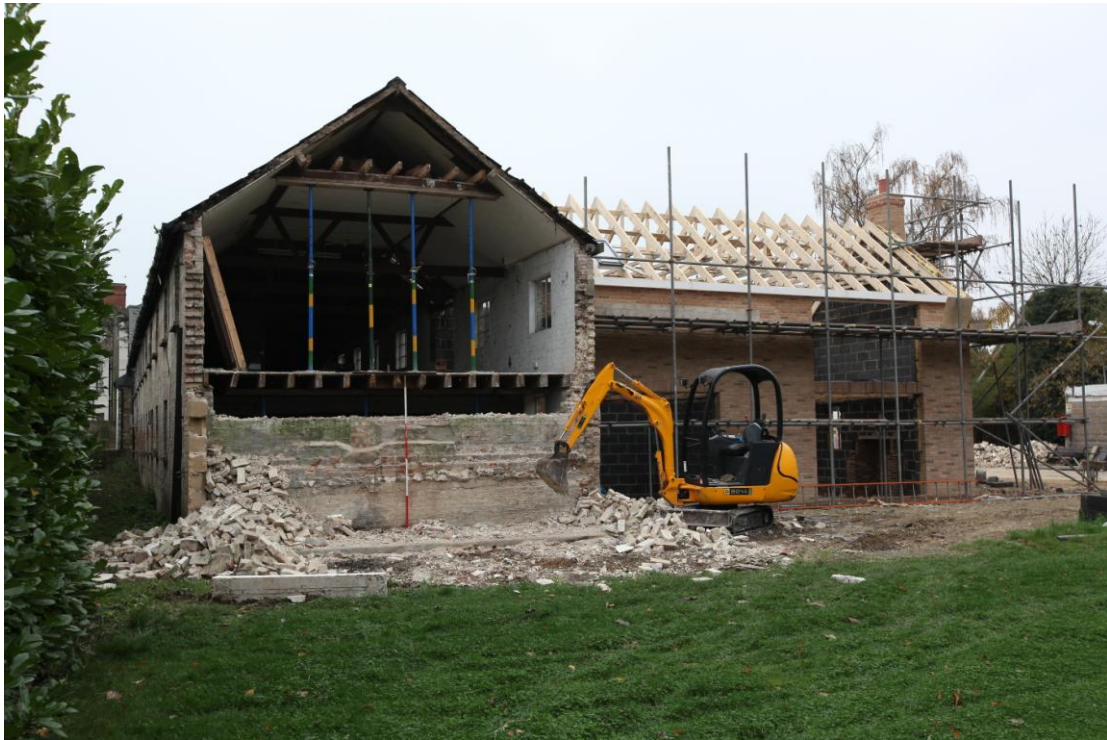
Illus. 1. The exterior of the partly demolished northern gable showing evidence of a raised floor in the previously demolished structure which occupied the foreground.

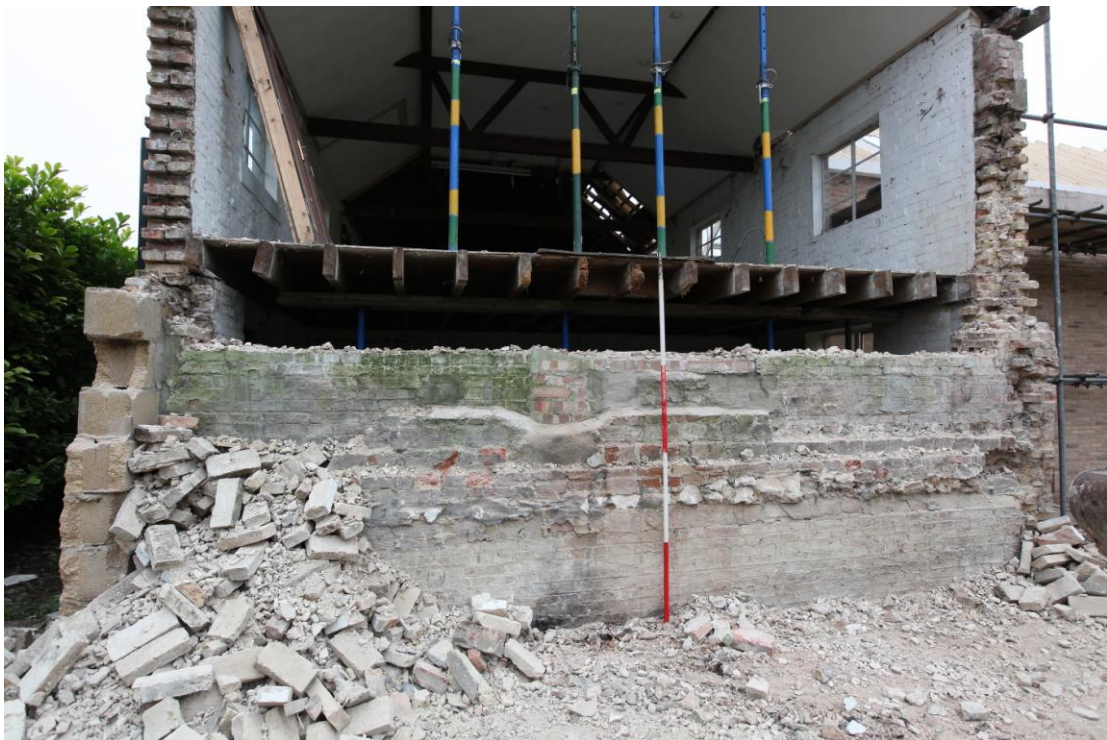
Illus. 2. The northern external gable showing a projecting course of masonry 1.25 m above the internal floor. This appears to relate to a raised floor in the previously demolished structure in the foreground.

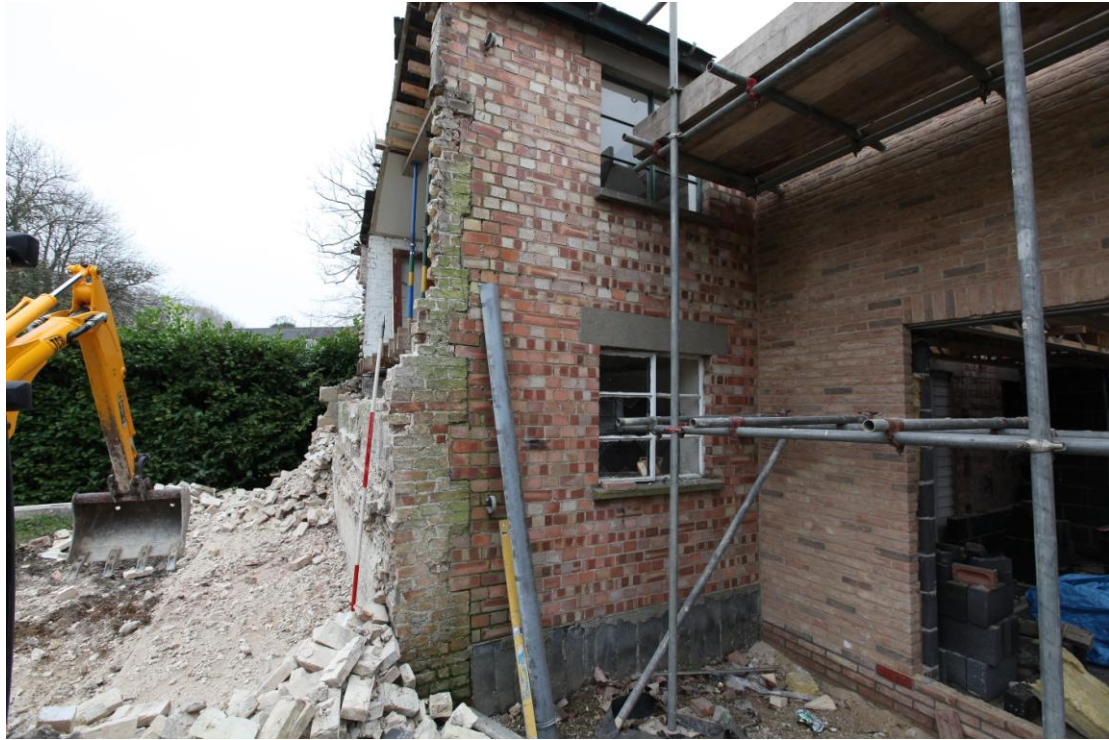
Illus. 3. The north-western corner of the building showing the recent extension to the right. The 20th century Fletton brickwork in the centre has been intruded into the corner of a previously demolished structure which extended further to the north (left) and contained a raised floor as indicated by the projecting course of clunch in its partly demolished gable.

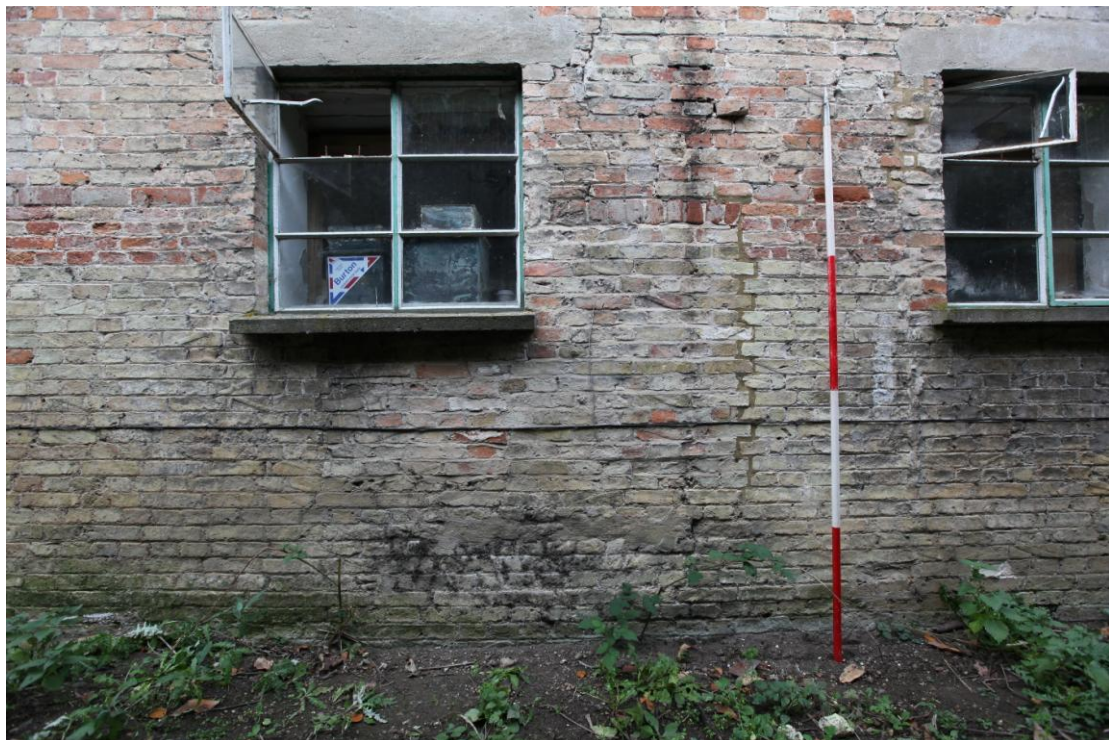
Illus. 4. The eastern exterior showing the lintel and closers (quarter-bricks) defining right-hand edge of a blocked low original window to the right (visible to the left of the scale). The courses of red brick at the same height as the lintel formed a decorative band dividing the original upper and lower storeys.

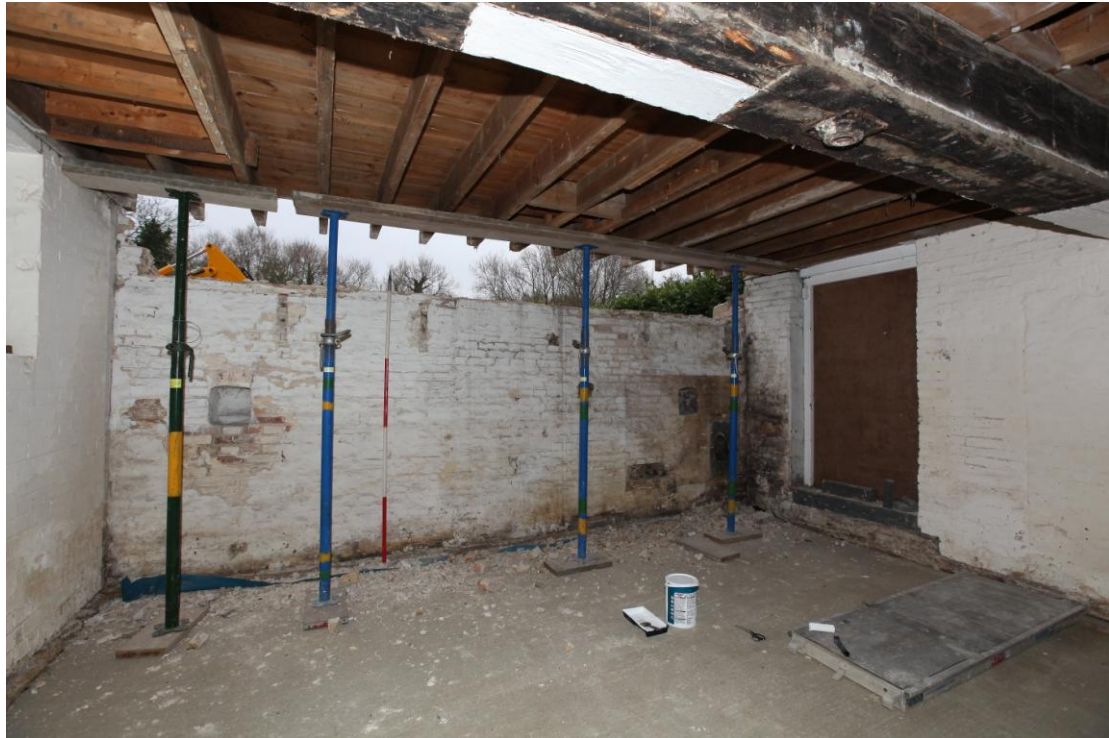
Illus. 5. The interior of the northern gable showing original square niches to left and right together with the 20th century softwood common joists of the ceiling.

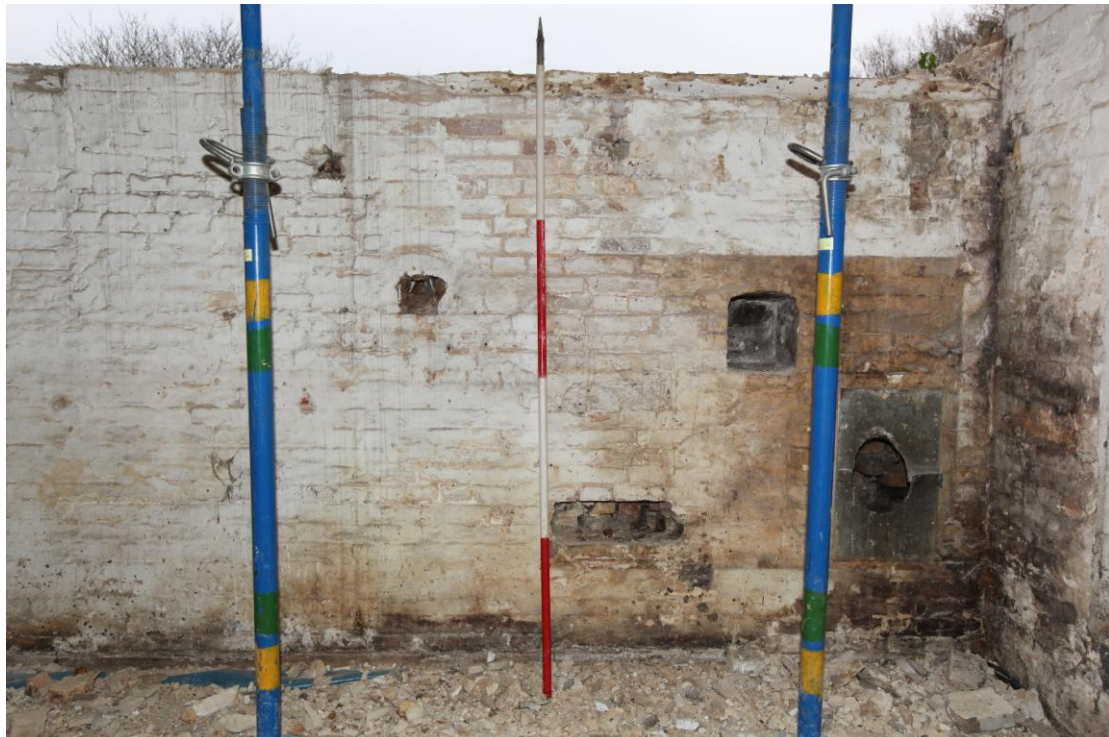
The northern gable was of particular interest, with two original lamp niches to right and left and other secondary apertures of uncertain purpose. One of the latter, located slightly to the east of the gable's centre, contained a metal-lined chute descending from the exterior to the interior. This may have been designed to load grain from a demolished adjoining granary into a steeping pit or directly onto a growing floor. This interpretation is supported by the configuration of the gable which was integral with a previously demolished western wall that continued northwards towards and formed a chamber with a suspended floor indicated by a projecting course of clunch 1.25 m above the present internal floor. Suspended floors of this kind are more consistent with granaries than kilns, and the location of the original kiln remains uncertain: if grain entered the malting process from the river it may have adjoined the road at the opposite end of the range. The demolished building appears to have extended further to the east, where the remains of a wall projecting at right-angles from the surviving eastern elevation was visible in January 2011 (but had been demolished along with the upper section of the northern gable prior to the most recent inspection). The western end of the present gable did not extend further to the south, but formed a corner respected by closers (returning to the east and north) and now adjoins 20th century Fletton brickwork. The northern end of the present western elevation was presumably formed by another structure or may have opened into a studwork lean-to of some kind; any firm evidence of its arrangement was destroyed by the existing Fletton wall in the mid-20th century.

Illus. 6. The eastern half of the northern internal gable showing an original square niche to the right with a secondary metal-lined chute to the left and two additional secondary apertures.

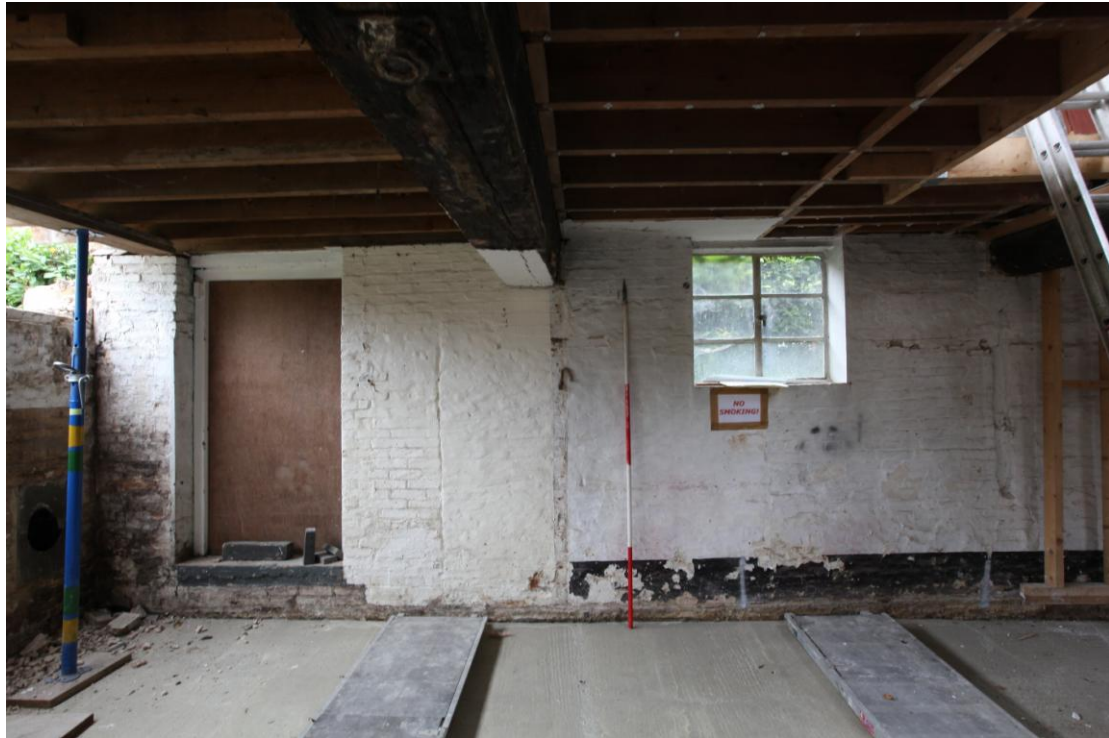
The walls were whitewashed with a skirt of black paint immediately above the floor, and contained clear evidence that the original binding joists of the ceiling had been raised by approximately 35 cm (14 ins): five courses of 20th century brickwork lay beneath each timber. A layer of beaten clunch in the excavated floor at the southern end of the range appeared to represent the original floor level, indicating that the lower storey was a low, undivided space with headroom of only 1.75 m (5 ft 8 ins) to the soffits of the binding joists. This is consistent with the evidence of two blocked windows and a blocked doorway at the northern end of the eastern elevation, all of which rose to the same height (i.e. approximately 0.3 m or 12 ins above the sills of the present Crittall windows). This level coincides with four courses of red brick in the gault brick eastern external elevation which formed a decorative band dividing the upper and lower storeys. The existing common joists are of tall-sectioned softwood and suggest, in conjunction with the Crittall windows and the Fletton brickwork of the upper walls, that the building was raised in height and extensively refurbished in the middle decades of the 20th century (i.e. 1930s-1950s). The internal walls also preserved the scars of earlier lateral partitions, but none of these were either integral to the brickwork or interrupted all layers of whitewash – suggesting the original building was entirely undivided. There was no evidence of additional external doors and windows and the ground floor was probably very poorly lit, with (presumably) roof dormers serving the malting floor above. Such an arrangement is consistent with early maltings elsewhere.

Illus. 7. The northern end of the eastern interior showing the partly demolished northern gable to the left. The scar of a blocked original door is visible to the right of the existing door (with later infill between the two) and patches of secondary brickwork beneath both original binding joists show the extent to which they have been raised. A vertical groove beneath the right-hand joist terminates at the original ceiling height.

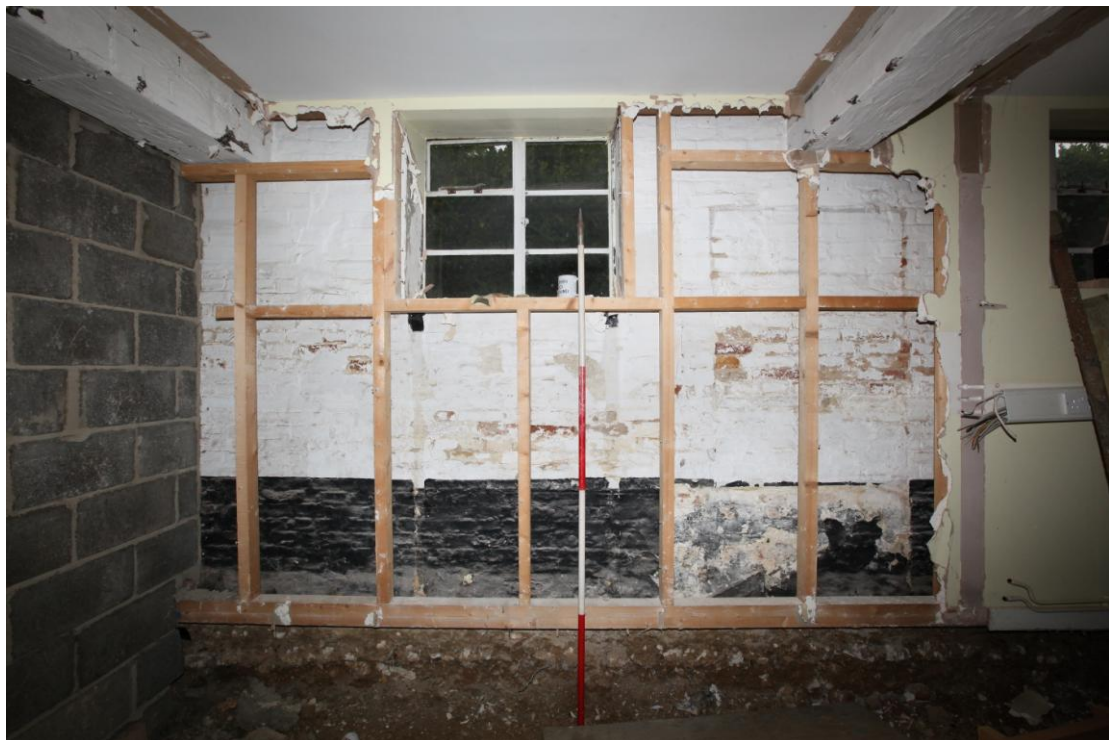
Illus. 8. The eastern interior of the southernmost of the three sections into which the maltings has been divided by block-work partitions, showing the whitewash and painted black skirt beneath the 20th century cladding which still survives to the right (with the vertical scar of the former office partition, 1d).

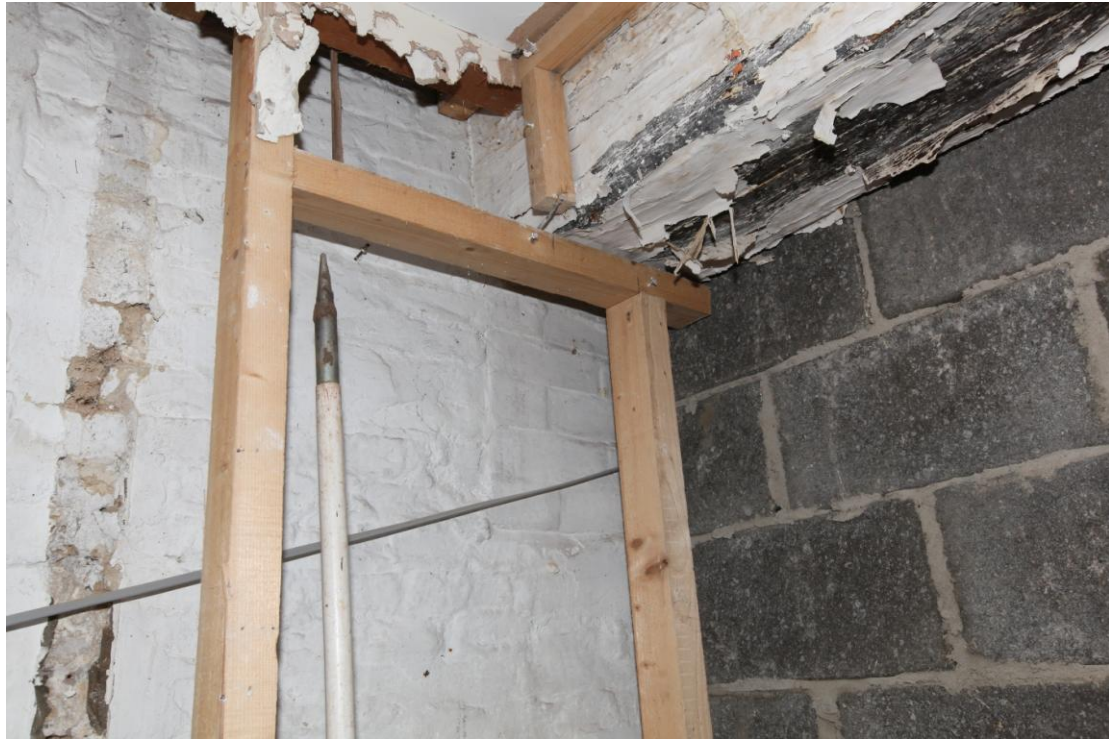
Illus. 9. A detail of the later brick infill beneath the raised binding joist in the western interior of the southern section. The vertical scar to the left relates to a secondary partition which pre-dates the most recent dry-lining.

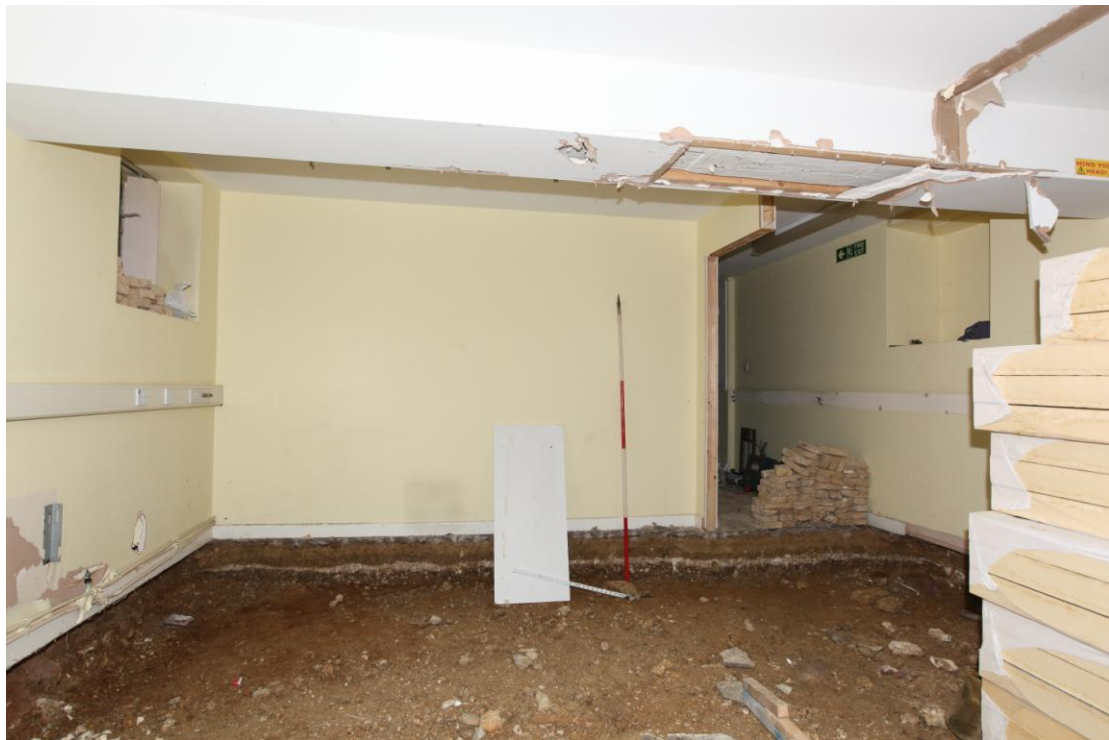
Illus. 10. The southern section of the maltings from the north showing the partition of the surviving 20th century office compartment (1c) and a horizontal layer of beaten clunch in the section of excavated floor beneath. This layer appears to represent the original floor and suggests headroom of no more than 1.75 m to the binding joists before they were raised in the 20th century.
