**Barn at
Potash Farm,
Benhall, Suffolk
BNL 029**

Heritage Asset Assessment

February 2012

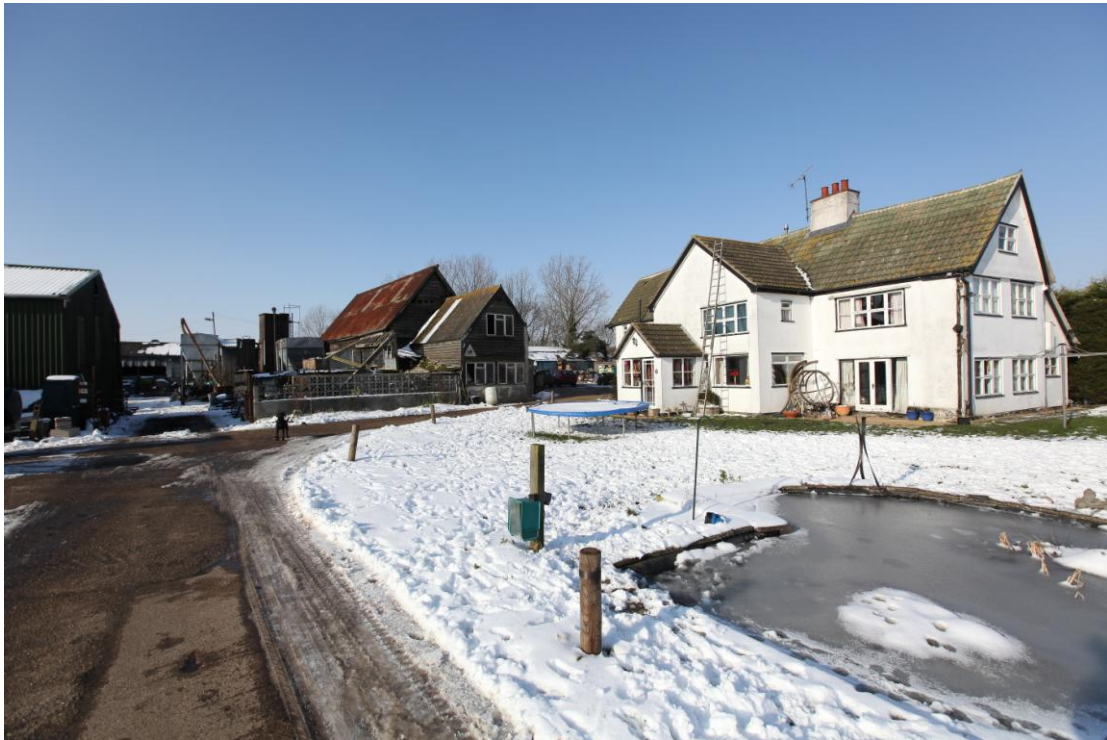
Illus. 1. General view of the site from the entrance track to the east showing the unlisted (but possibly 17th century) farmhouse (7) to the right and the 19th century barn complex in the centre.

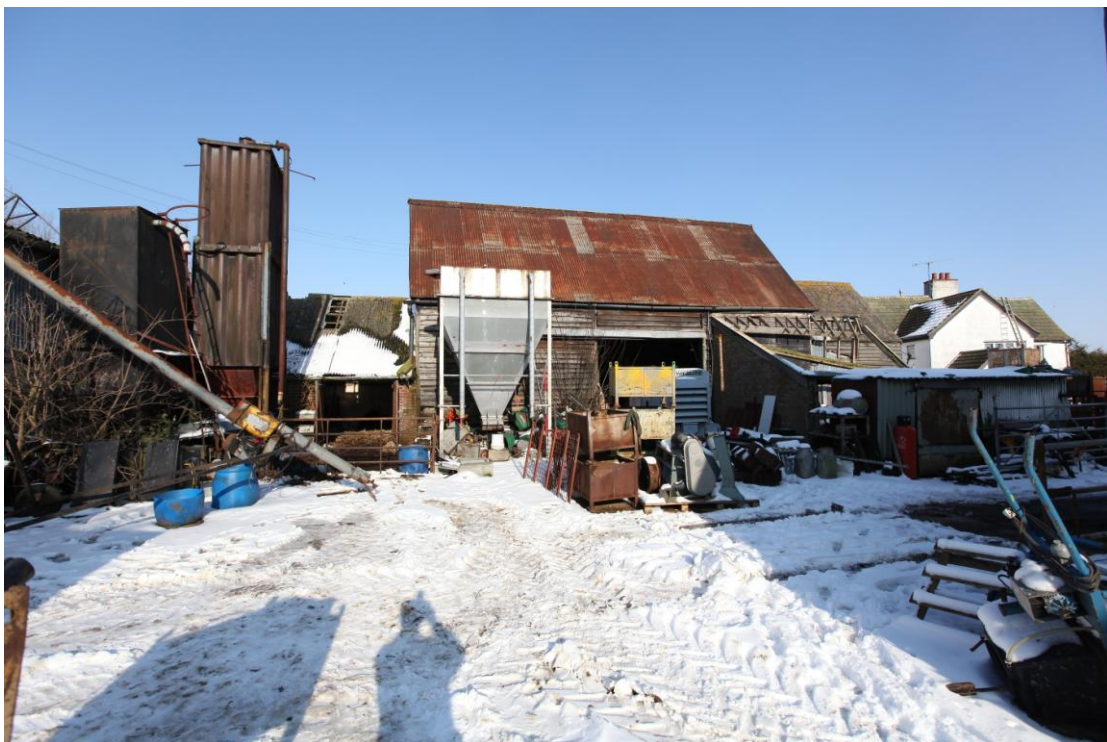
Illus. 2. General view from the south showing the tall corrugated-iron roof of the main barn (1) in the centre with the brick loose box (3) to the left and the milking parlour (2) to right. The farmhouse (7) is visible in the rear to the right.

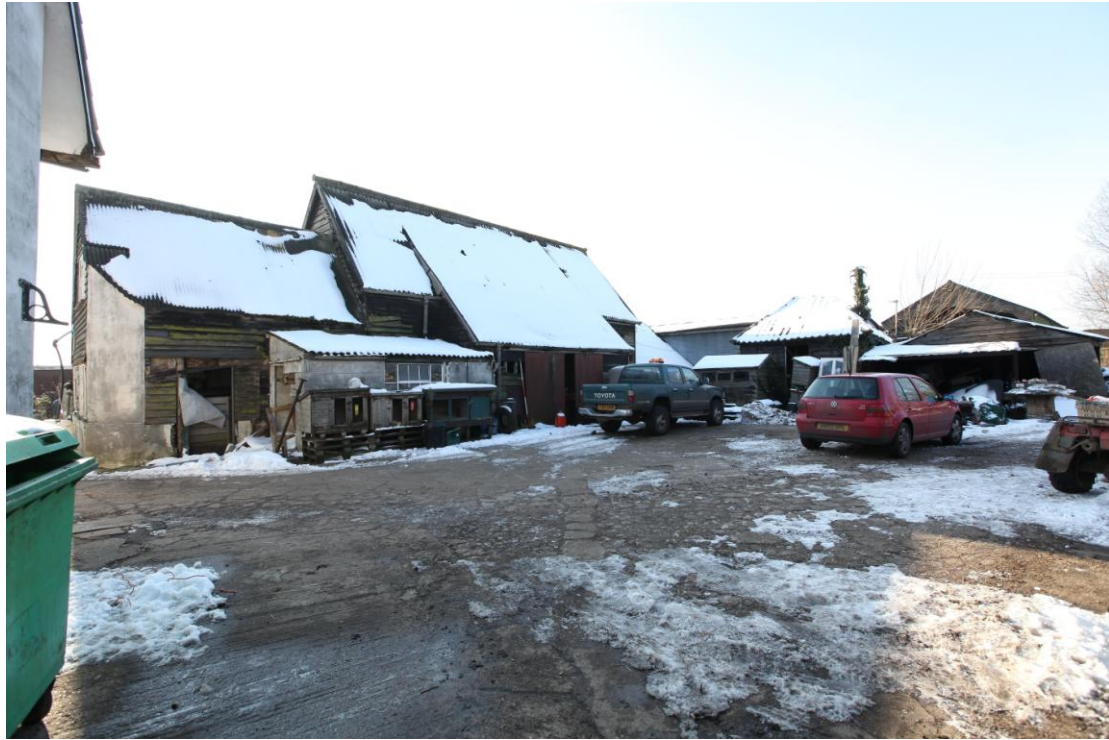
Illus. 3. General view from the north-east showing the detached granary with hipped pantiled roof (4) to the right (surrounded by 20th century sheds), with the barn (1) and milking parlour (2) to left. The barn's lean-to porch (1a) is an original feature shown on the 1883 Ordnance Survey.

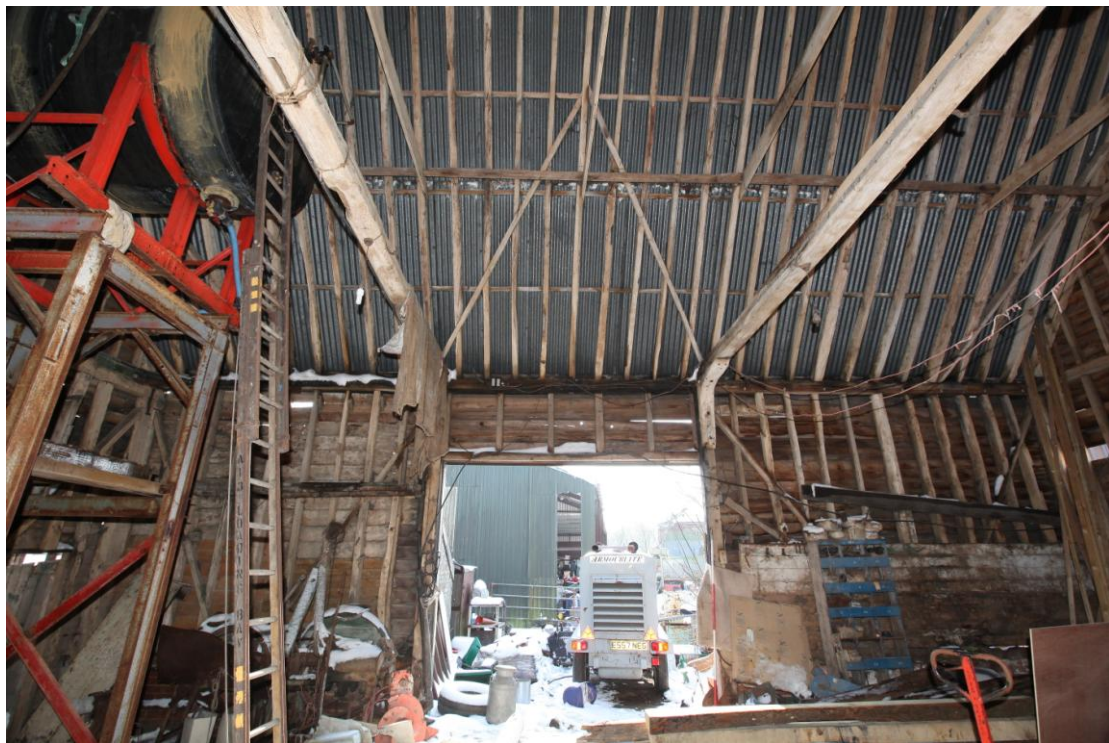
Illus. 4. The southern interior of the barn (1) showing the original entrance in its central bay (now reduced in height and lacking doors). The bolted knee-braces to the tie-beams are original features, and the diagonal primary wall and rafter braces are typical of the mid-19th century.

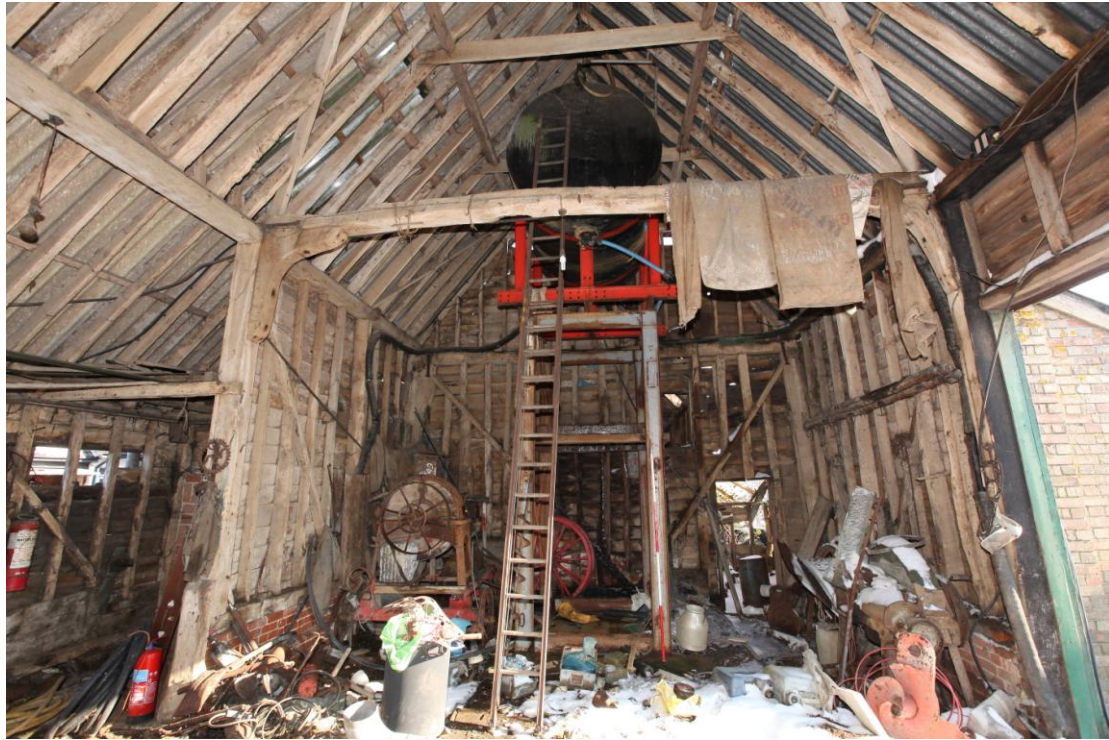
Illus. 5. The eastern interior of the barn (1) showing the original entrance in the central bay to the right and the contemporary lean-to porch (1a) to the left. The collars of the clasped-purlin roof are nailed rather than pegged to the principal rafters.

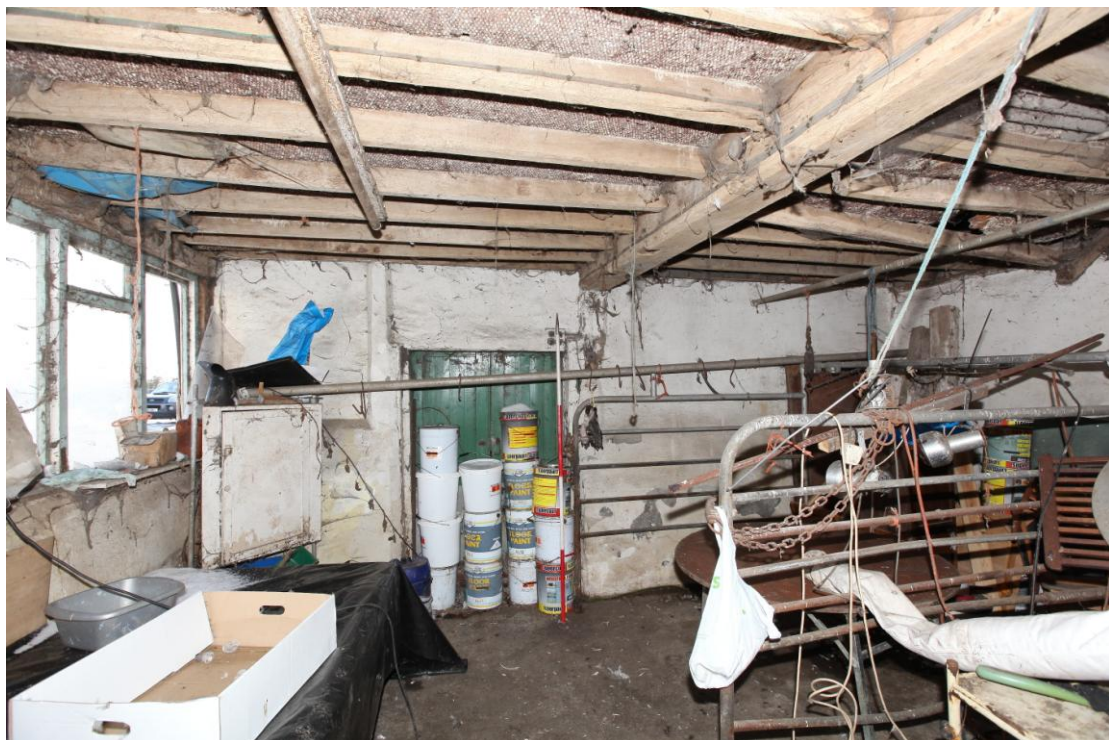
Illus. 6. The rendered and whitewashed southern internal wall of the milking parlour (2) showing its two external doors with the 20th century windows of the eastern gable to the left. Although used most recently as a milking parlour this shed may have been designed as a stable.

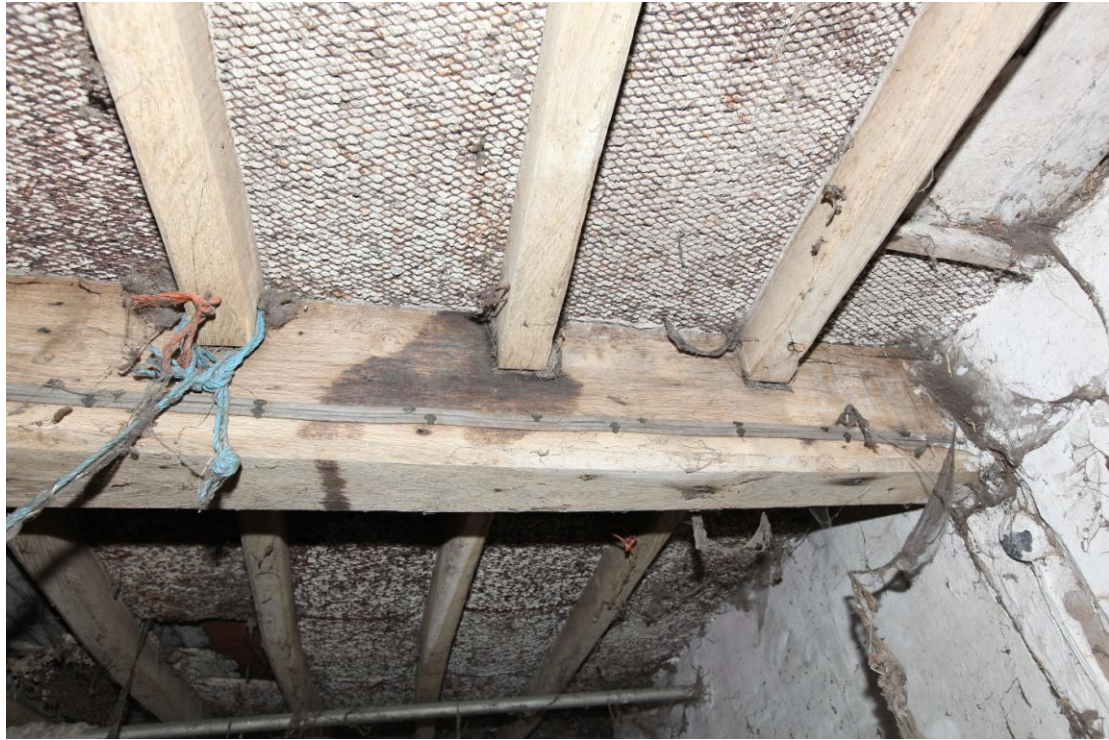
Illus. 7. A detail from the east of the original ceiling in the milking parlour (2) showing its neatly chamfered and stopped tall-sectioned oak common joists. There is no evidence of a hay drop but the original loft boards have been replaced with wire mesh.

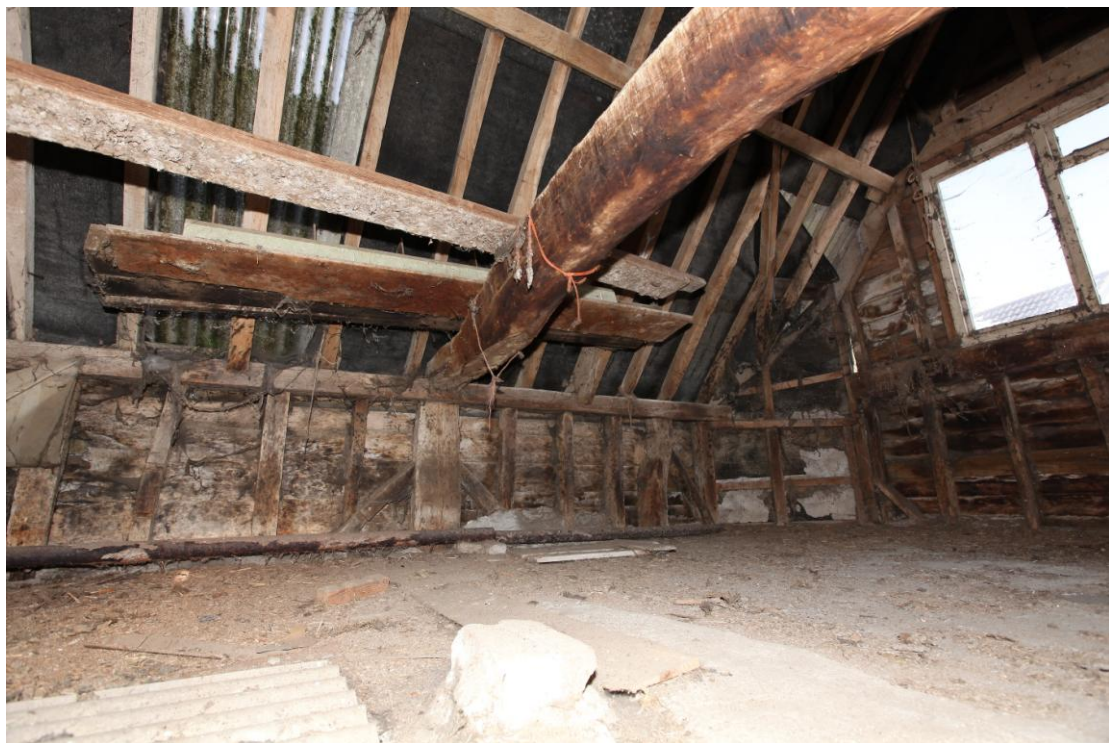
Illus. 8. The northern interior of the loft above the milking parlour (2) showing its timber-framed walls with nailed primary braces and an original tie-beam. The rafters of the butt-purlin roof structure are also interrupted by diagonal braces as in the roof of the barn (1) and both buildings appear to be contemporary.

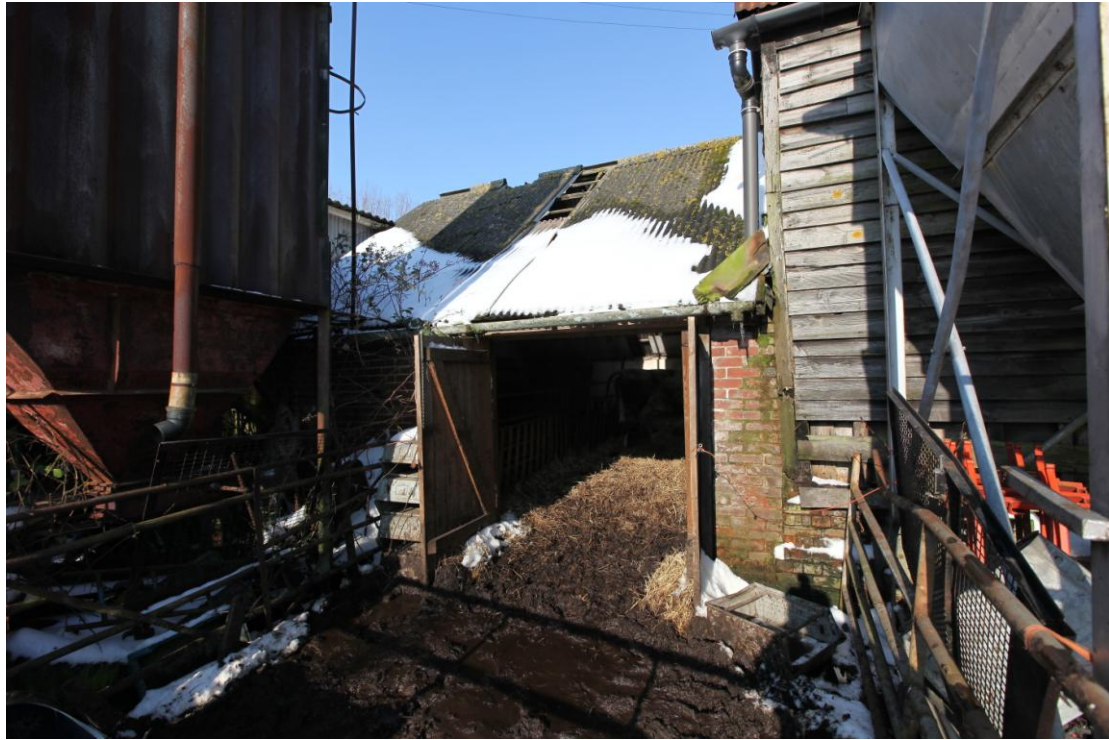
Illus. 9. The southern exterior of the brick loose box (3) showing the modern cattle pen in the foreground and the corner of the barn (1) to the right.

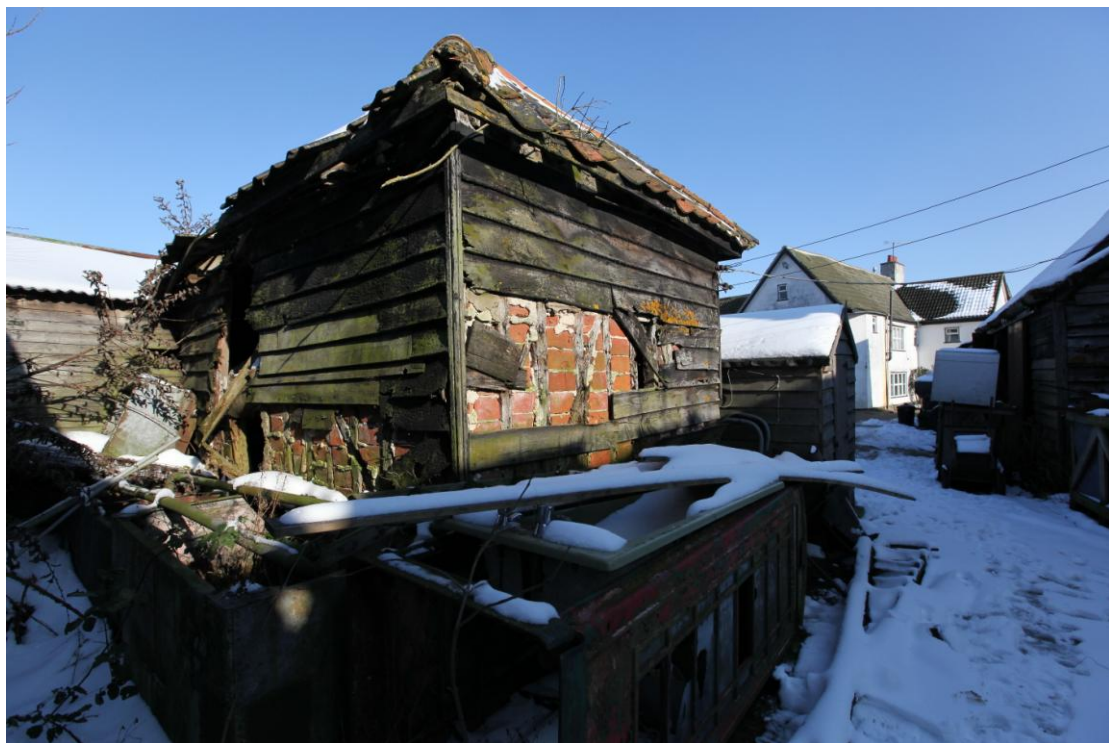
Illus. 10. The detached granary (4) from the south-west showing its hipped pantiled roof and the remains of heavily tarred original weatherboarding. The farmhouse (7) and barn (1) are visible to the right.

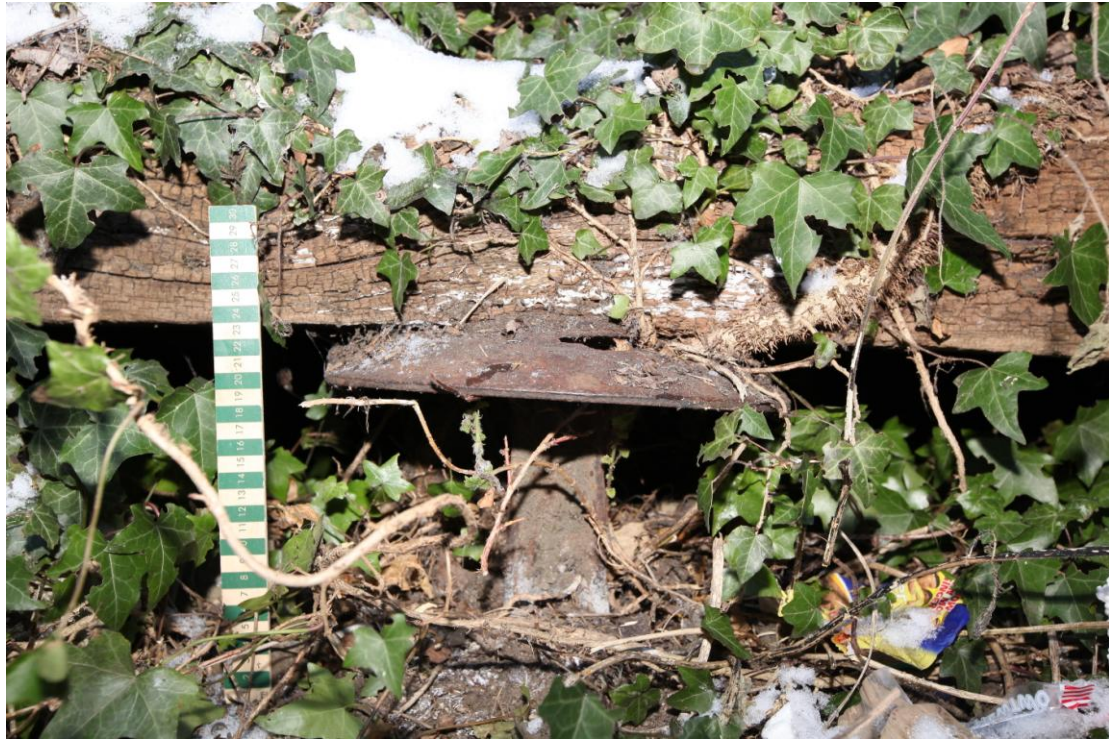
Illus. 11. A detail of the cast-iron mushroom with cross-sectioned base supporting the eastern ground sill immediately beneath the entrance to the detached granary (4).

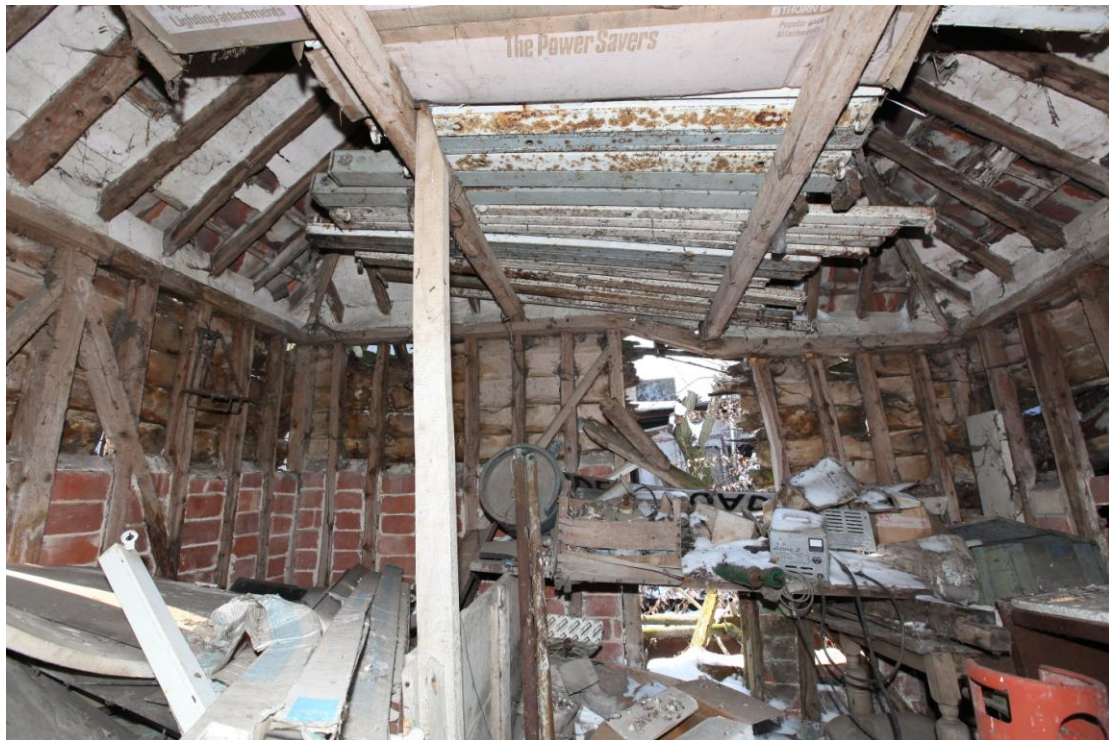
Illus. 12. The interior of the detached granary (3) from its central eastern entrance showing the narrow ostensibly secondary door in its western wall and the plaster beneath the pantiles. The brick infill probably indicates the height of the missing grain bins.
