**The Barn,  
Redgate Farm,  
Wherstead, Suffolk  
WHR 071**

**Historic Building Record**

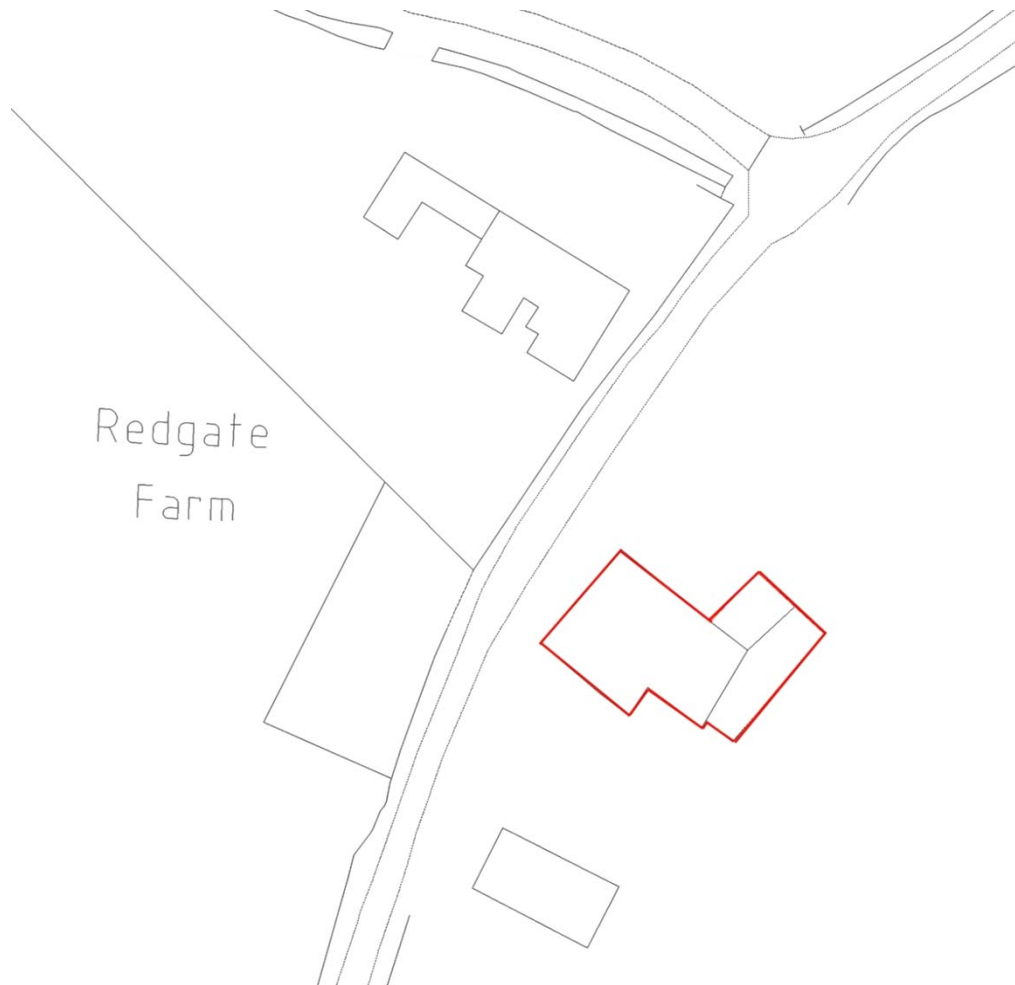
© Crown Copyright. All rights reserved. Suffolk County Council Licence No. 100023395 2010

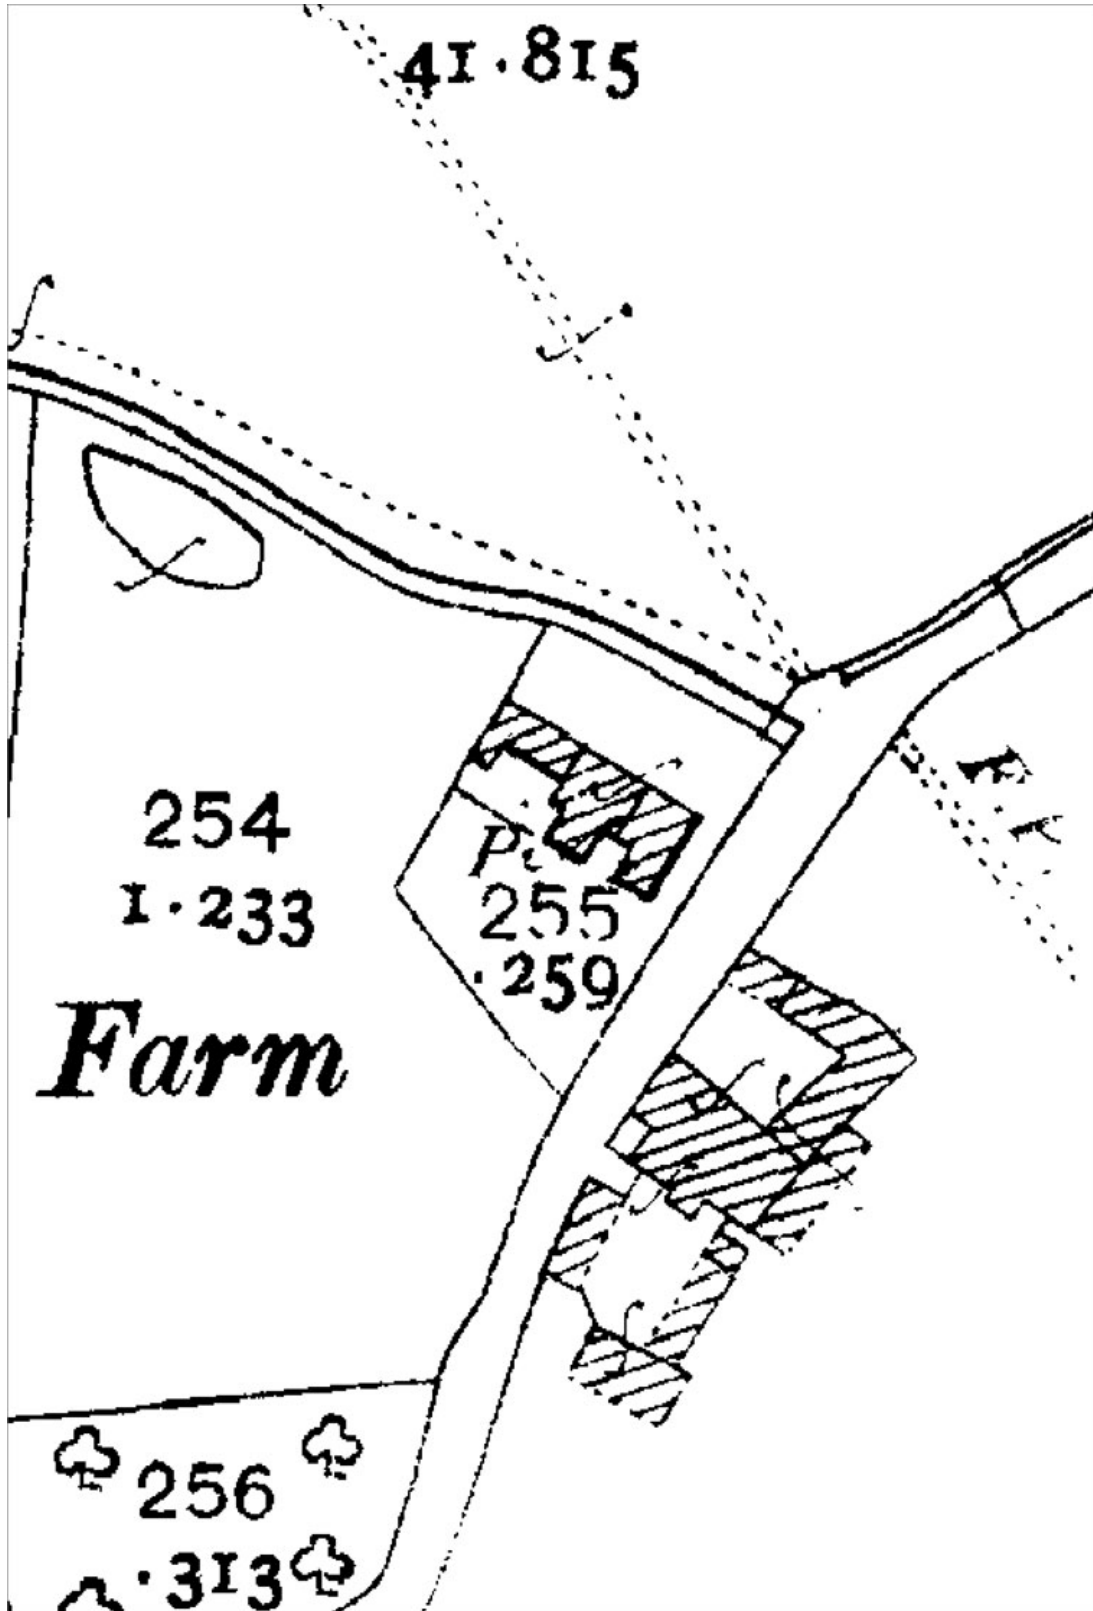
**The first edition 25 inch Ordnance Survey of 1882, showing the addition of various sheds and yards to the barn. These changes were necessary to accommodate the cattle into most local farmers diversified after the arrival of the railways.**

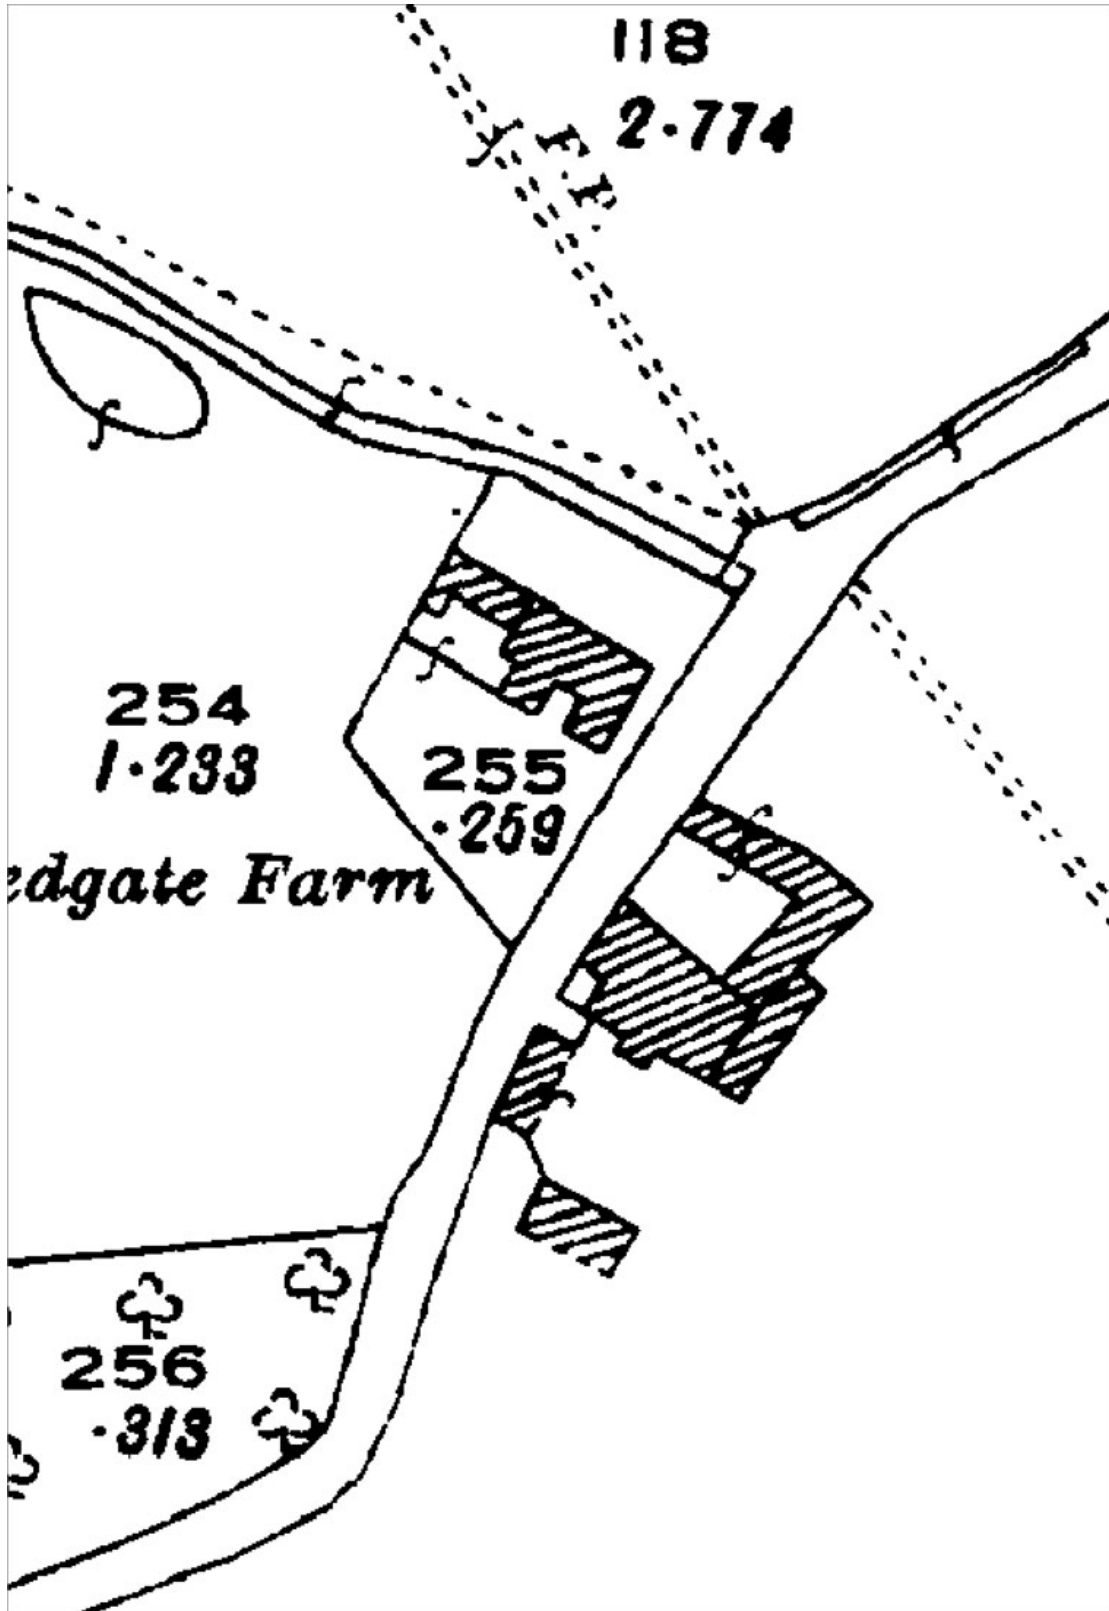
Figure 5  
The third edition Ordnance Survey of 1927 showing the partial demolition of the southern yard of 1904.

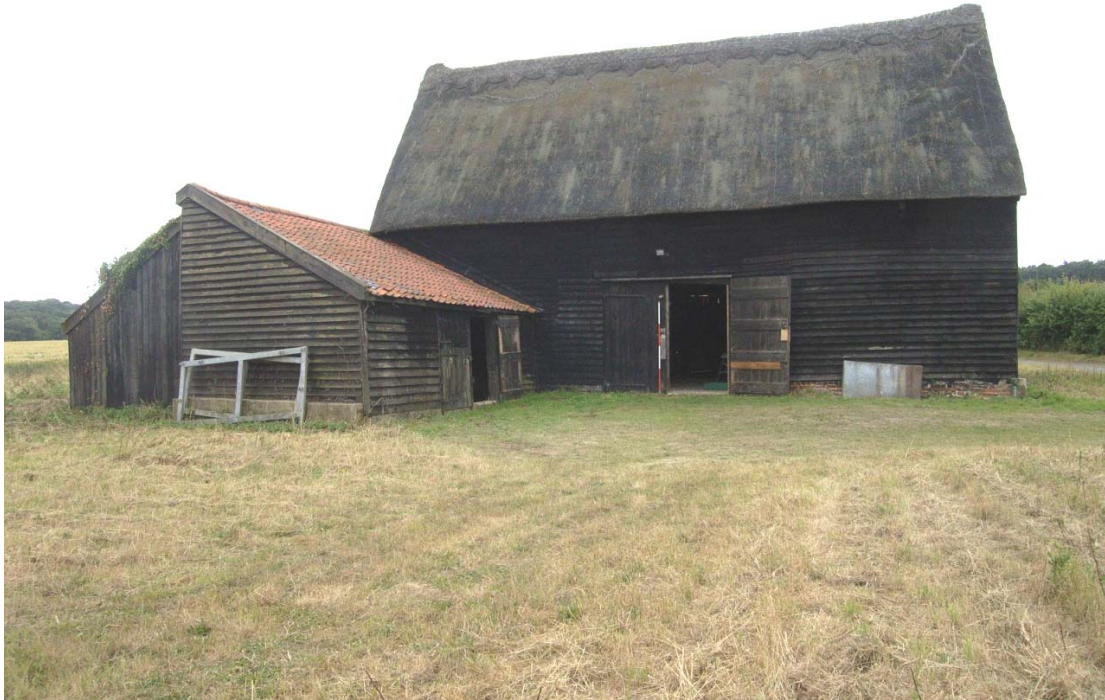
**Illus. 3. Exterior of barn from north-east showing the central entrance doors with the pantiled loose boxes (3) and open shed (4) to left.**

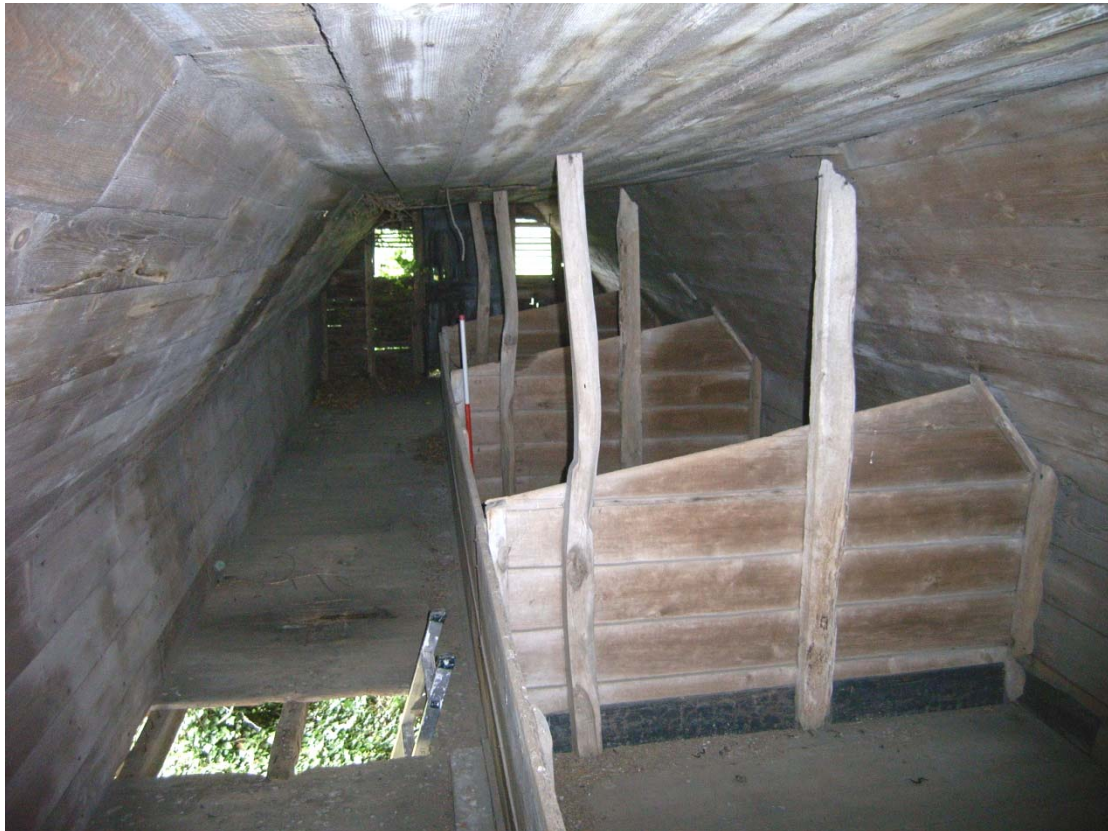
**Illus. 4. Interior of granary (6) from east showing good boarded grain bins.**

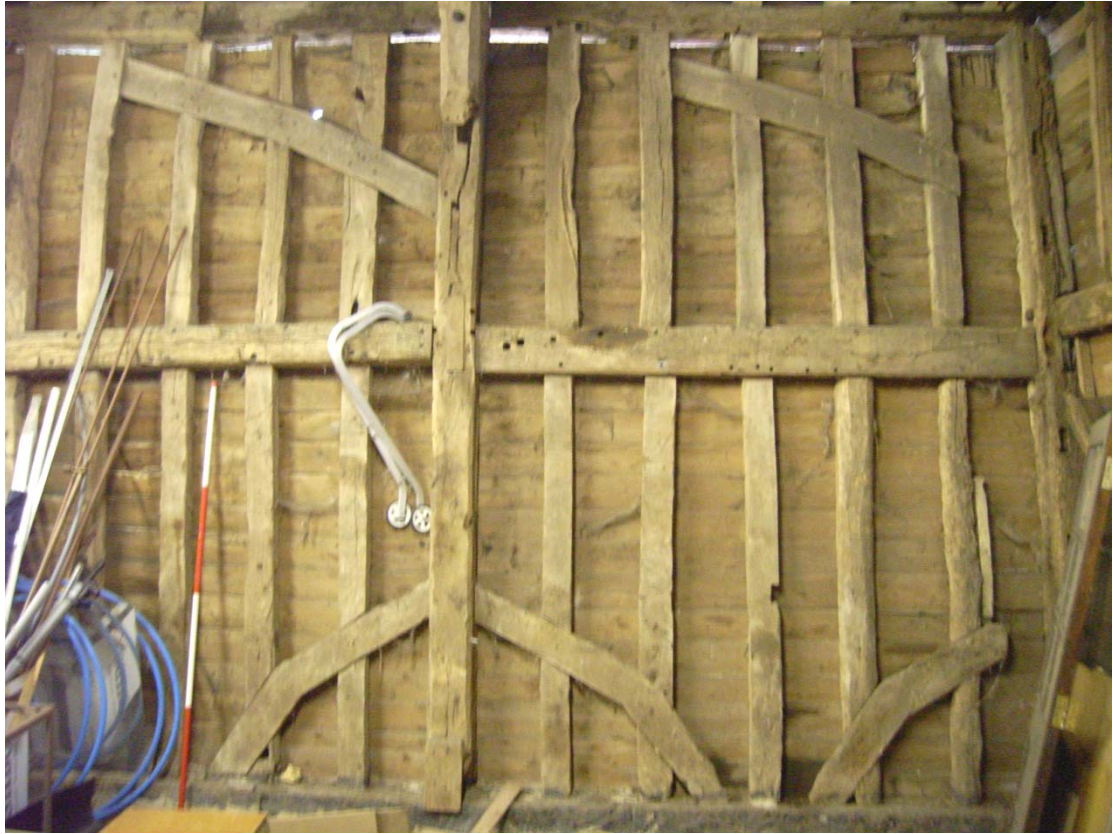
**Illus. 9.** Detail of the eastern half of the northern interior showing the distinctive bracing pattern with tension braces above the mid-rails and cranked foot braces to the storey posts. The north-eastern corner post to the right is a replacement and a face-halved and bladed scarf joint of 17<sup>th</sup> century form is visible in the roof-plate at top-left.

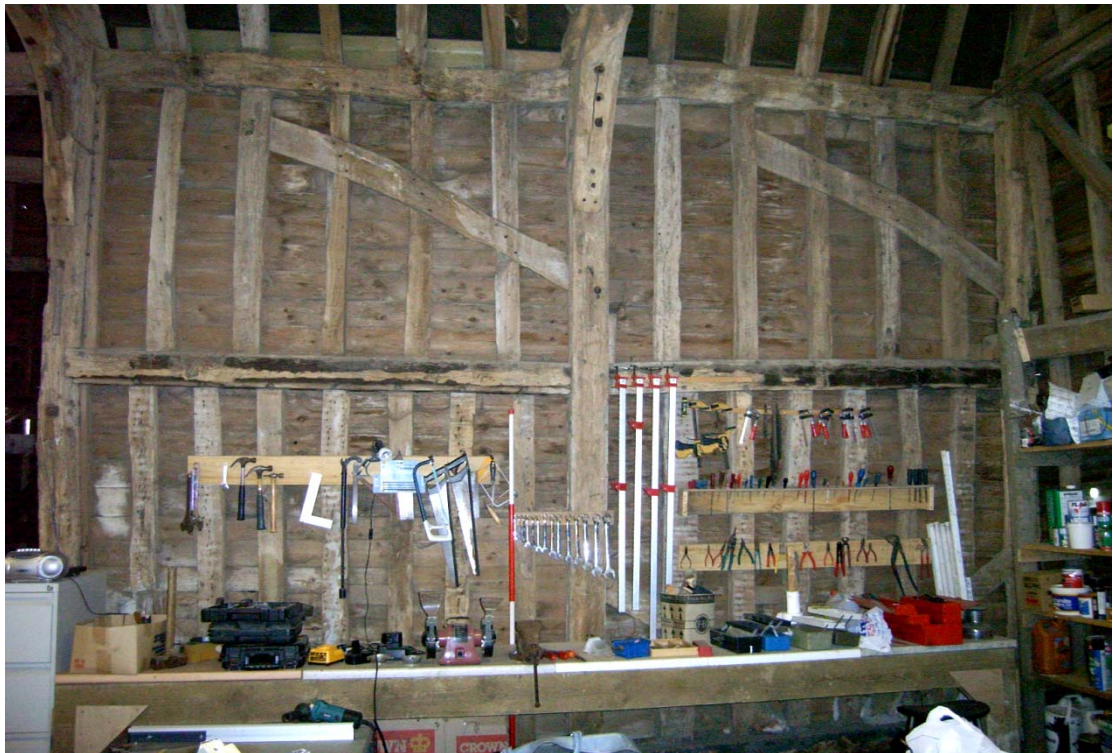
**Illus. 10.** Western half of southern interior showing tension and foot braces with charred re-used mid-rails.
