**The Old Dairy,
Valley View Cottage,
Middleton, Suffolk
MDD 018**

Historic Building Record

The Old Dairy, Valley View Cottage (Valley Farm) Leiston Road, Middleton, Suffolk

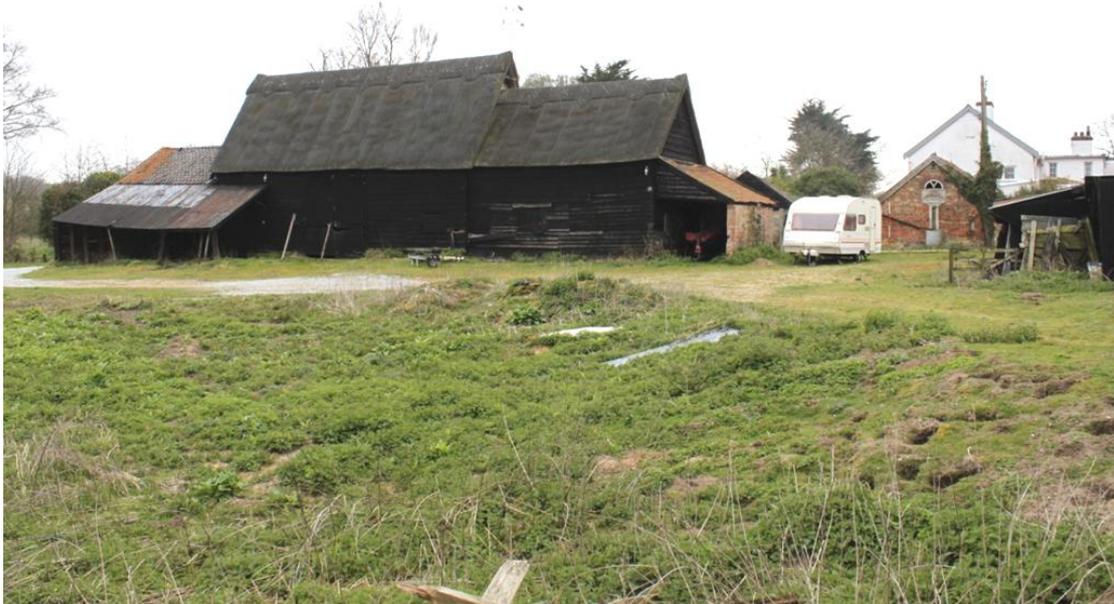
Illus. 1. General view of site from north-east showing thatched barn (2) to left and dairy (1) to right with farmhouse (3) in rear.

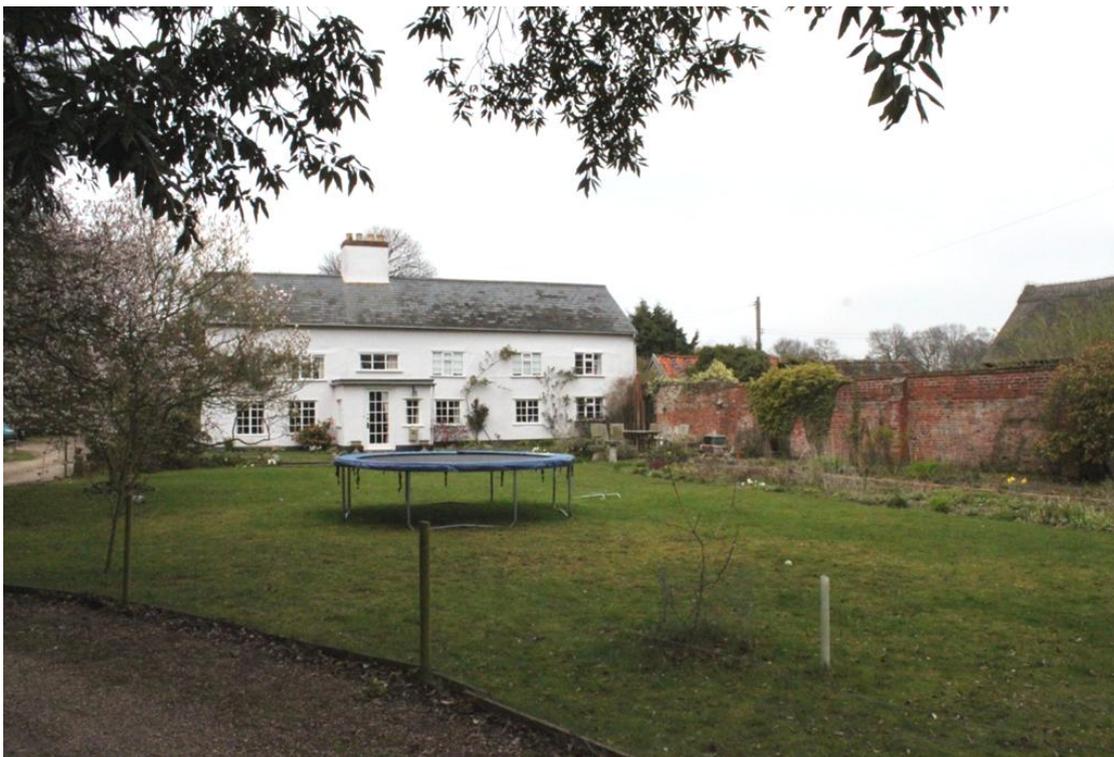
Illus. 2. General view of site from south-east showing facade of farmhouse (3) to left with roofs of dairy (1) and barn (2) to right.

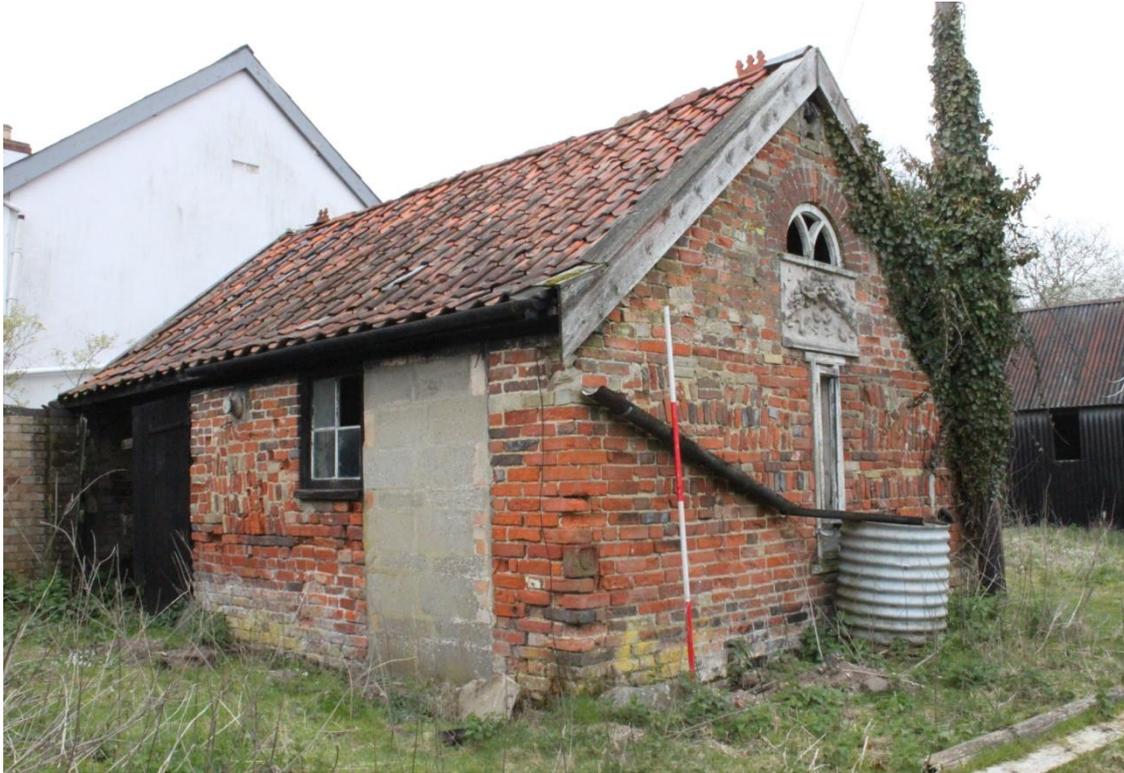
Illus. 3. Exterior from east showing blocked original door to northern shed (1a) with double doors to southern shed (1b) and farmhouse (3) to left.

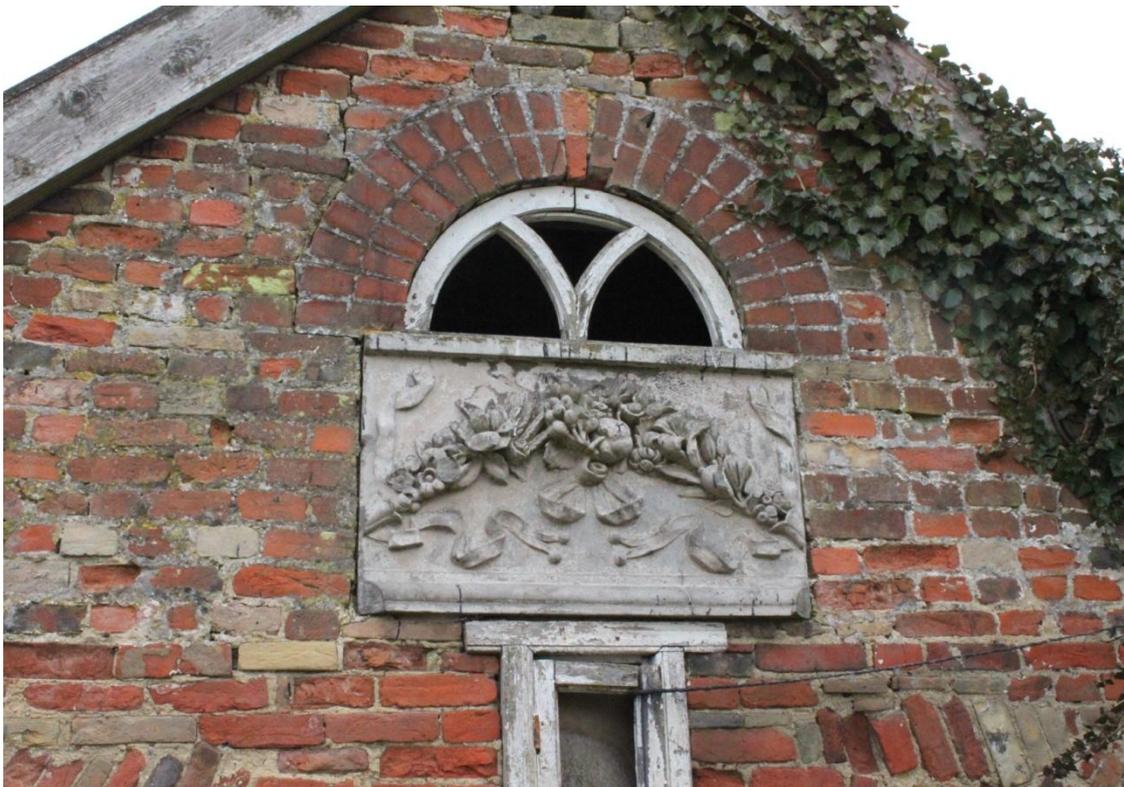
Illus. 4. Detail of re-used stone panel in northern external gable with narrow secondary window below.

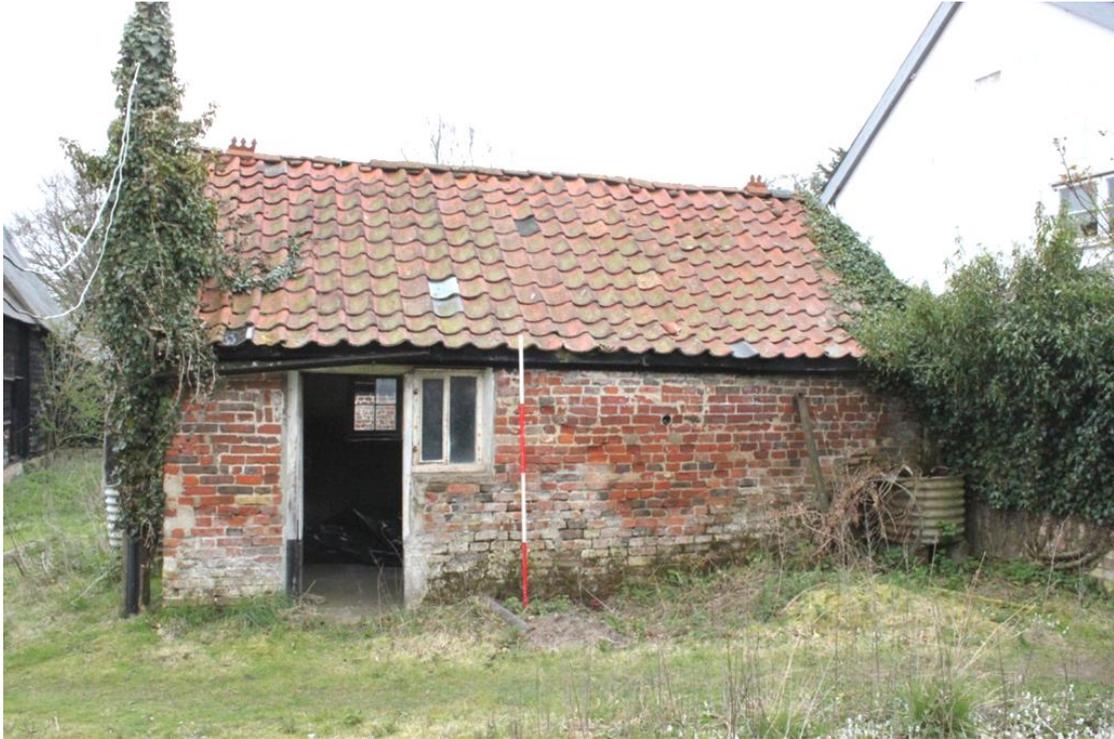
Illus. 5. Exterior from north-west showing secondary door to northern shed (1a) to left and close proximity to farmhouse (3) to right. The listed thatched barn and stable are visible to the left.

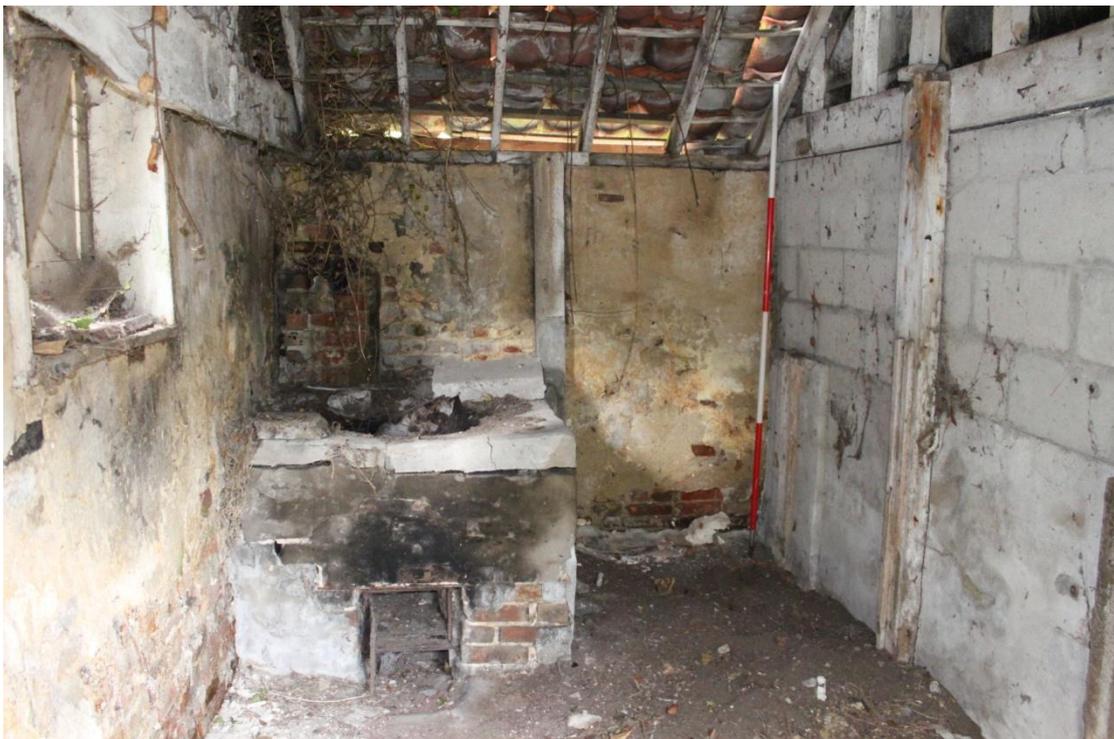
The internal lime render of the southern gable retains a number of incised apotropaic (evil-averting) symbols that are often found on both domestic and agricultural buildings from the late Middle Ages onwards. These take the form of the Marian letter 'M' (i.e. for the Virgin Mary). Designed to protect crops and stock against 'evil spirits' their appearance in a relatively late context such as this demonstrates the longevity of the superstition in Suffolk.

Illus. 6. Interior of southern shed (1b) from east showing copper to left and vertical groove of grain bin in post to right. The internal partition to the right is a 20th century block-work insertion, and the apotropaic 'M' symbols are incised into the plaster of the southern gable to the left.

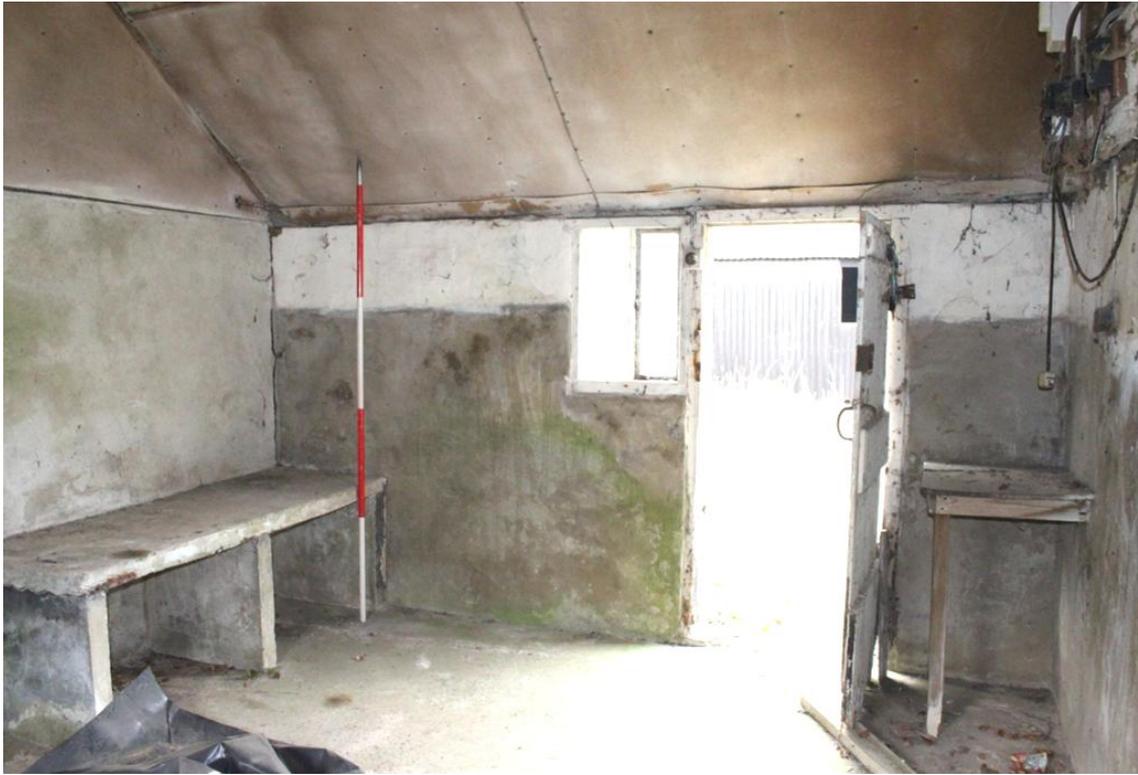
Illus. 7. Interior of northern shed (1a) showing secondary door and window with stone shelf to left.

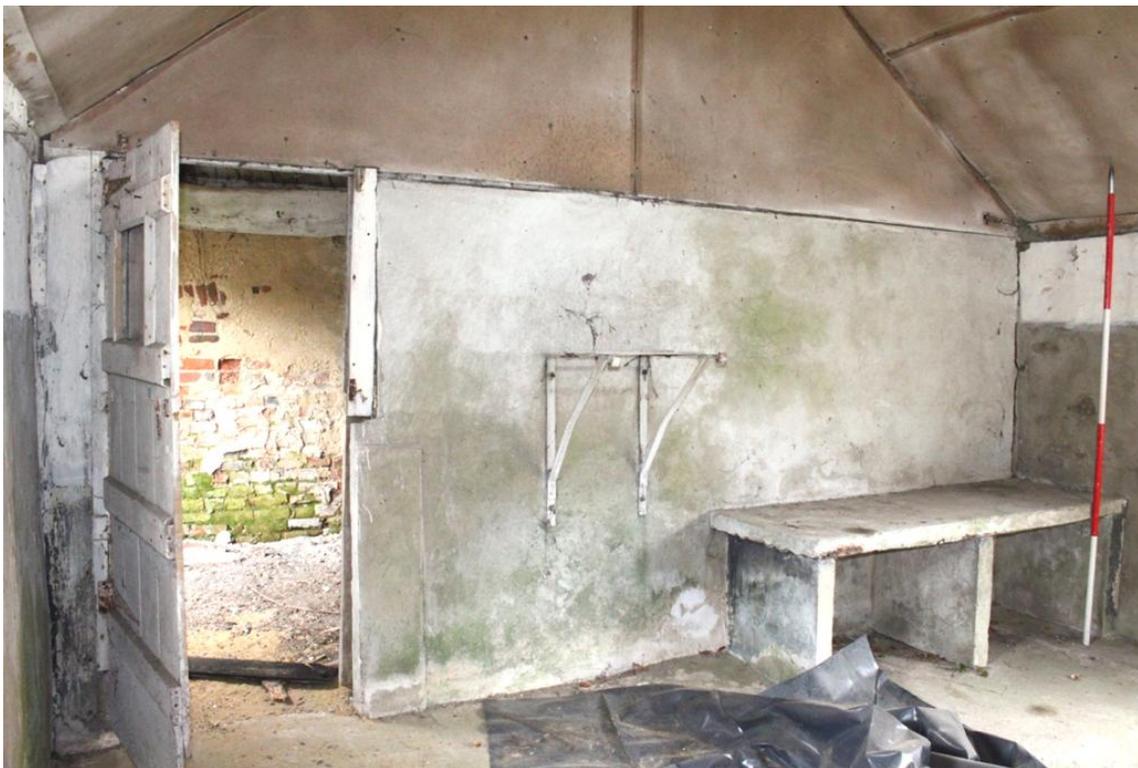
Illus. 8. Interior of northern shed (1a) from north-east showing stone shelf to right and door to southern shed (1b) to left.
