**Bribery Cottage,  
Walsham le Willows,  
Suffolk  
WLW 102**

**Heritage Asset Assessment**

**March 2012**

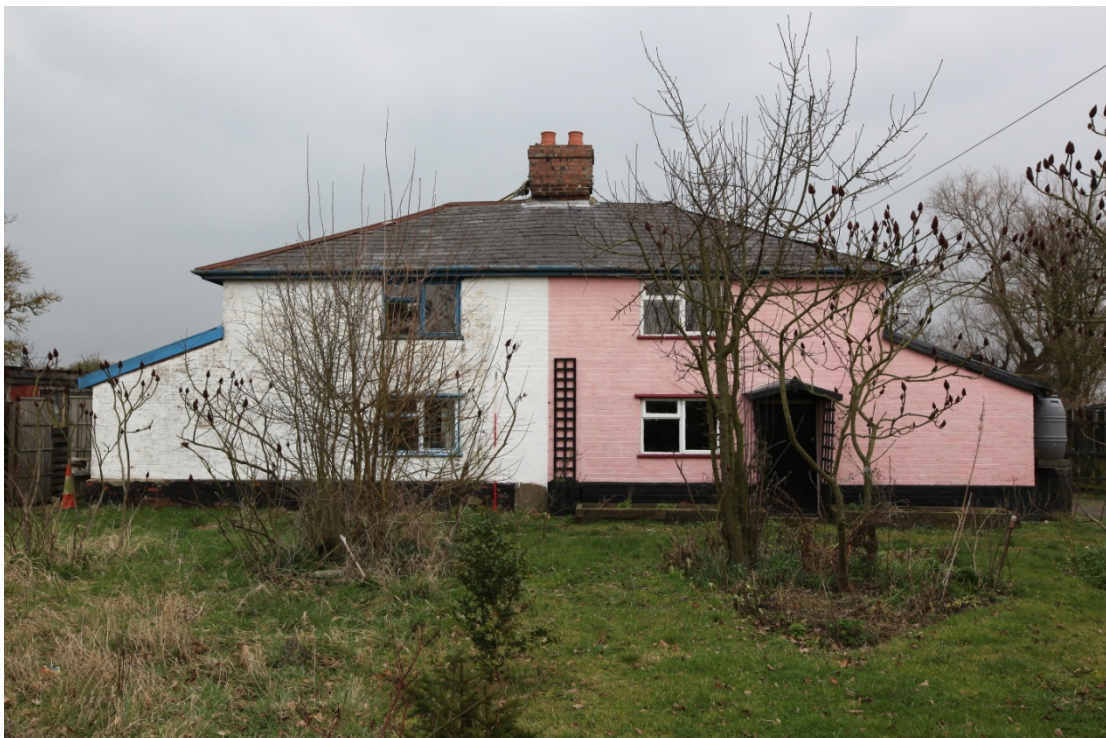
**Illus. 2.** The symmetrical western facade with contemporary lean-tos adjoining both gables. The present brick facade and slate roof date from a late-19<sup>th</sup> century refurbishment and the original building was probably thatched. The original left-hand entrance was blocked when the two cottages were combined and the present windows inserted during the 1960s.

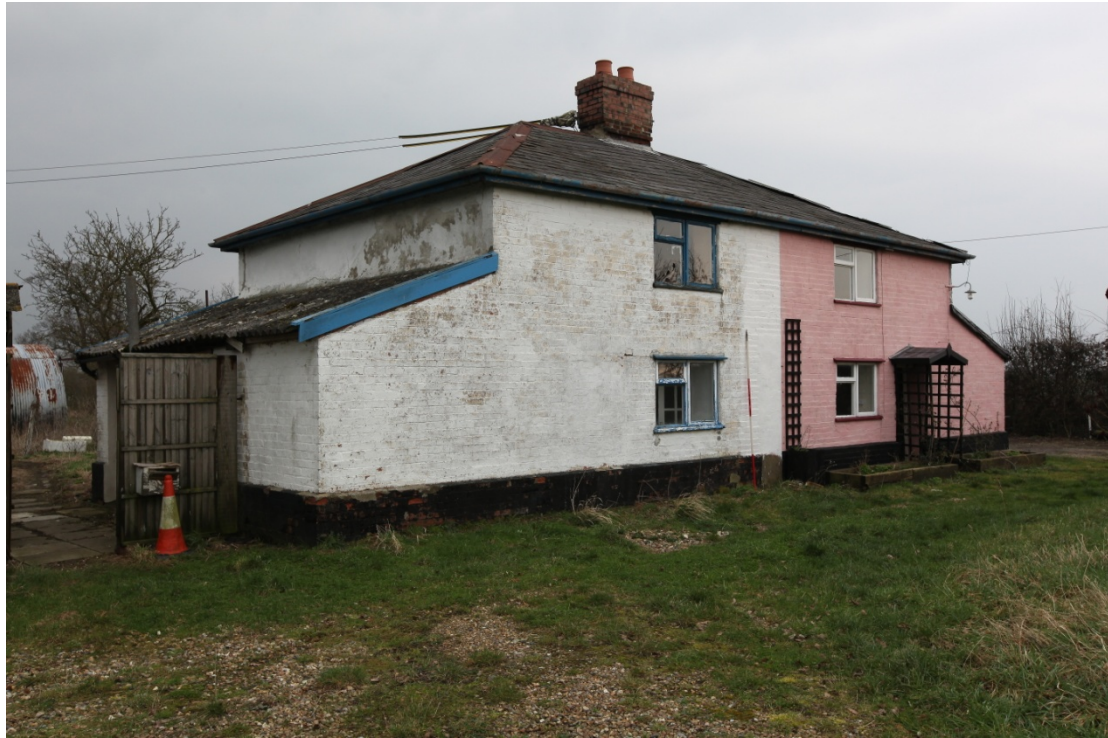
The external wall fabric of both the two-storied range and the lean-tos is 0.5 m thick (19 ins) and consists of a thin red-brick outer facing (now painted) laid in stretcher bond of 11 cm (4 ins) and a 0.3 m (11 ins) thick inner core of clay. This is revealed in the northern gable where the rendered clay fabric remains exposed and the narrow width of the brickwork to the front and rear is clearly visible. The precise nature of the clay fabric is unclear as only a small area is exposed internally (to the north of the entrance to Bathroom 1 as shown in figure 5 and illus. 9) but this appears to consist of shuttered clay and straw rather than individual clay blocks (i.e. clay lump). The present occupant, Mr Scase, whose family has owned the property since 1964, has made various alterations to the walls (including the insertion of an arched doorway between the Kitchen and Living Room in cottage 1) and reports a similar situation elsewhere: he has discovered no evidence of clay lump. Mr Scase also reports that the outer surfaces of the external walls are painted black beneath the brickwork, and that the brick facade is a later addition. The presence of black 'paint' is consistent with the use of tar to preserve clay and weatherboarded buildings from the weather, as was standard practice in 19<sup>th</sup> century Suffolk. The present roof consists of machine-sawn softwood rafters nailed to a ridge-board in the manner of the late-19<sup>th</sup> century and cannot be contemporary with the clay walls as it respects the increased width of the building after the addition of its brick facade. The original cottages of rendered and tarred clay probably possessed a more steeply pitched roof of thatch or tile as might be expected of a cheaply built structure of the early 19<sup>th</sup> century (when slate was a new, fashionable and relatively expensive material).

**Illus. 3. The exterior from the north-west showing the one remaining area of exposed original fabric of rendered clay above the lean-to of the northern gable. The same area of the southern gable is weatherboarded. The upper part of the chimney consists of 20<sup>th</sup> century Fletton brick and was probably rebuilt in the 1960s.**

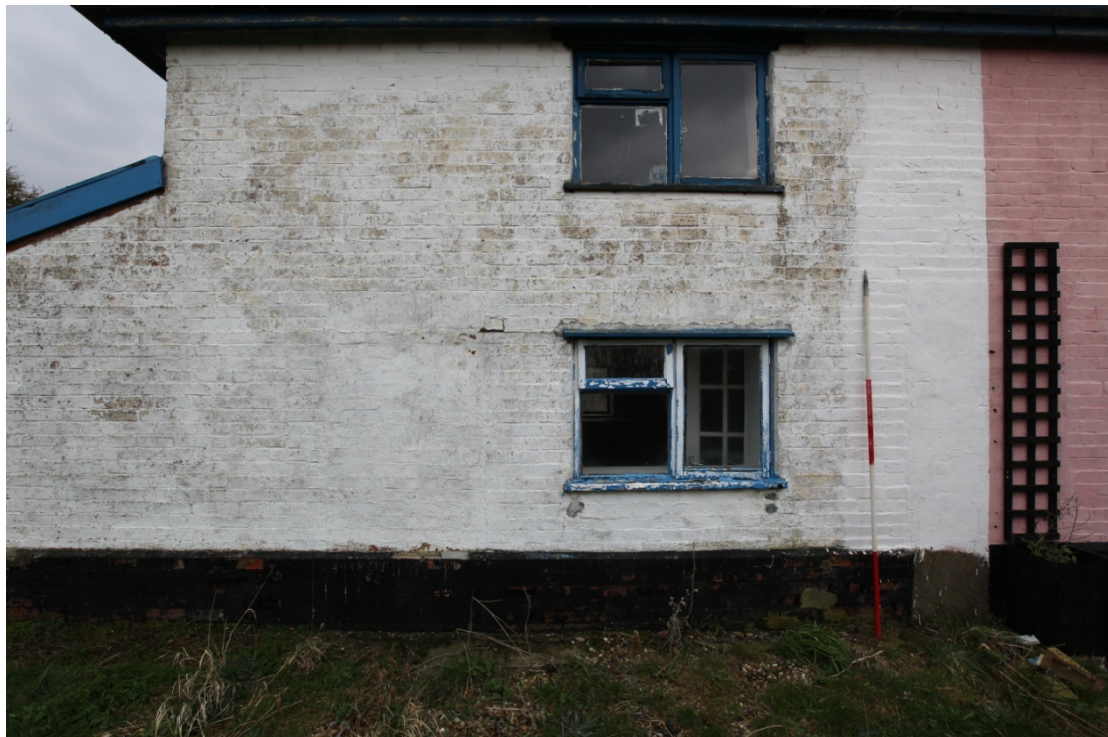
**Illus. 4. The western facade of the northern cottage (2) showing the flat brick arches of the 19<sup>th</sup> century entrance door to the left and the narrower window above the present 1960s window to the right. The central door of the 1960s conversion (since blocked) is visible to the right but lacks an arch and interrupts the brickwork.**

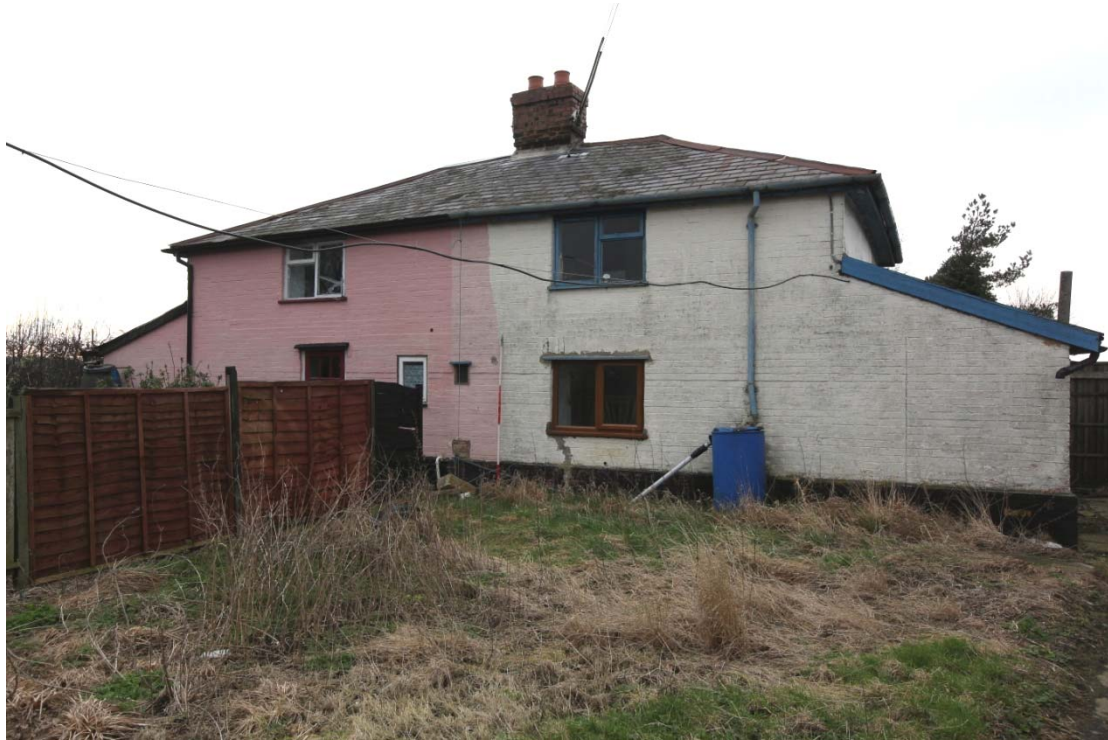
**Illus. 5. The rear (eastern) exterior with evidence in the brickwork of two earlier, narrow ground-floor windows but no doors. The position of the southernmost window to the left is now occupied by a secondary door.**

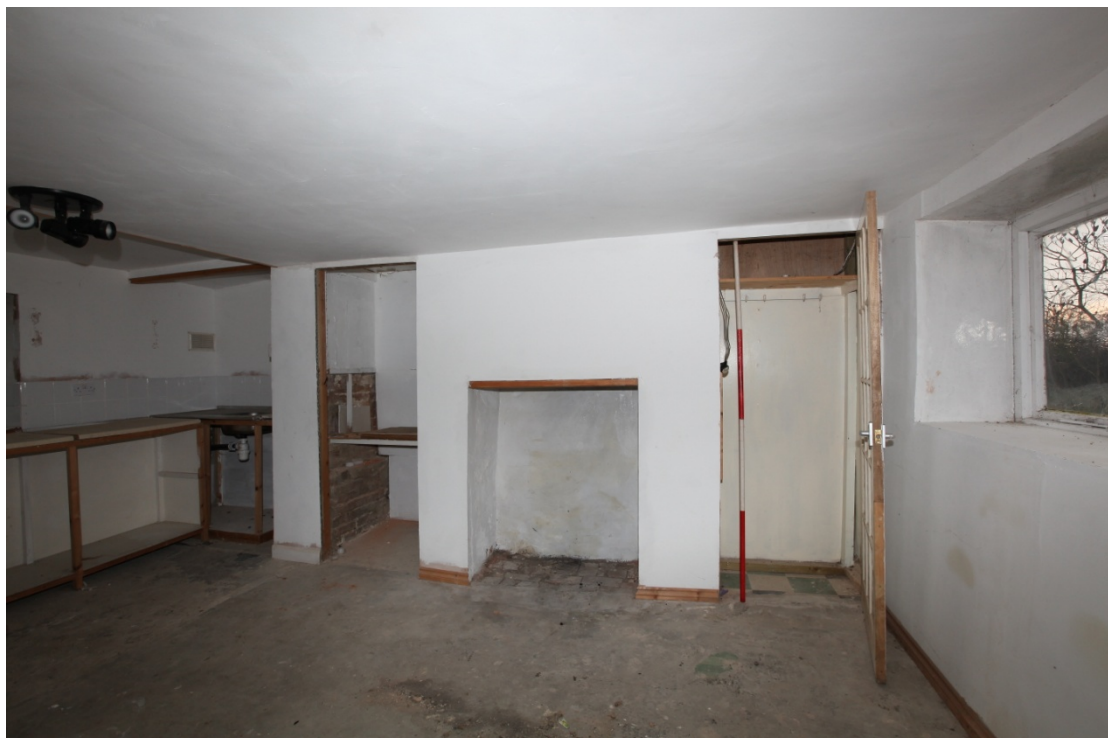
The fireplace of the northern cottage is rendered, but the exposed brickwork of an alcove to the east contains a shelf which almost certainly indicates the position of a demolished bread oven. The brickwork of the southern fireplace preserves a blocked door in its western pier that undoubtedly opened onto a missing oven, suggesting that the two ovens were on opposite sides of the chimney precisely as shown in figure 6. The present stair of the northern cottage is a modern insertion, and the southern cottage possessed only a temporary ladder at the time of inspection, but the original stairs must have risen to the rear of each chimney where the broad 19<sup>th</sup> century floorboards have been renewed with narrow deal.

**Illus. 6. The Living Room of the northern cottage (2) seen from the north, showing the 0.5 m thick front (western) wall to the right and the rendered fireplace with an exposed area of 19<sup>th</sup> century brickwork to the left. A fragmentary shelf and a small original aperture in this brickwork probably indicate the position of a bread oven to the rear of the main fireplace.**

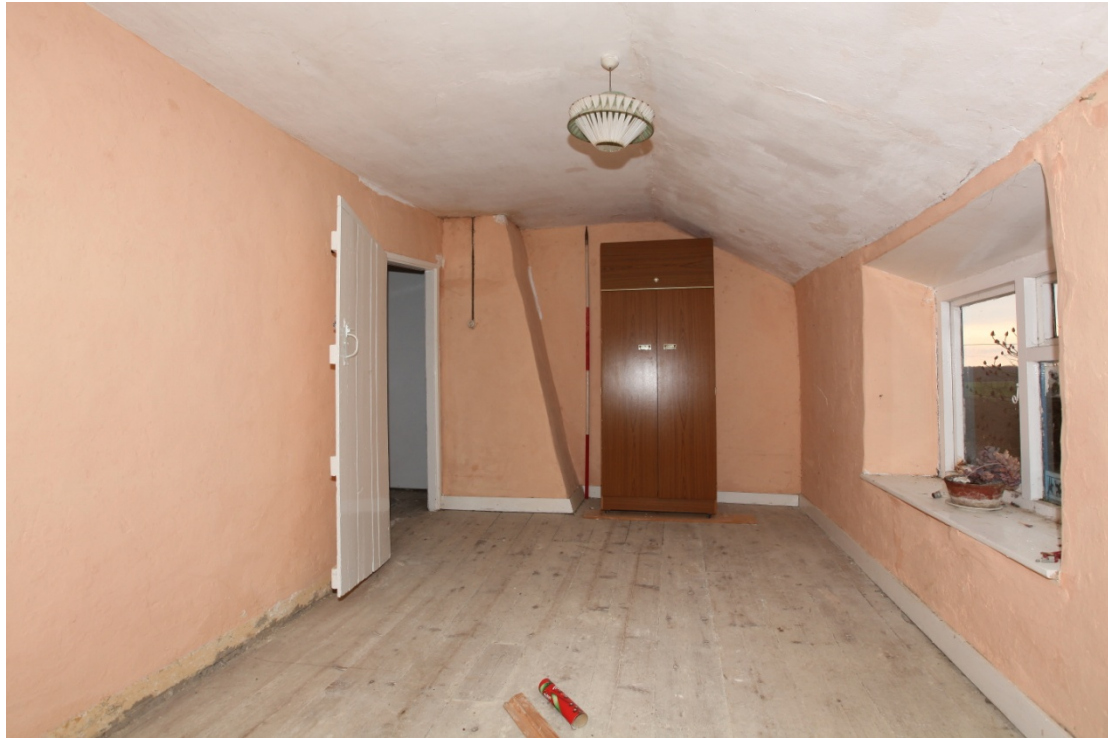
**Illus. 7. The Front Bedroom (2B) of the northern cottage from the north, showing the slope of the central chimney and the 0.5 m thickness of the western facade to the right. A 19<sup>th</sup> century plank-and-batten door opens onto the rear bedroom (2A) to the left.**

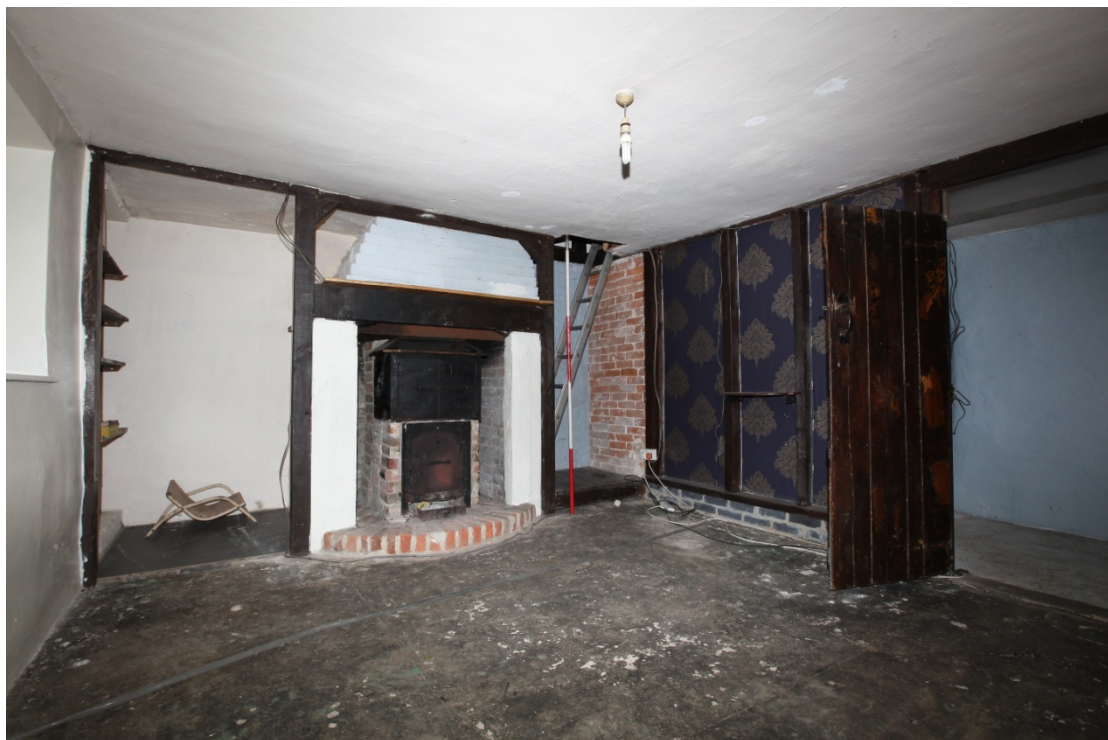
**Illus. 8. The southern Living Room (1) from the south showing the 19th century brick fireplace with a recent studwork partition adjoining the Hall (1) to the right. The recess to the rear of the fireplace may have contained a copper as there is evidence of a bread oven to the front (illus 12). The studs framing the chimney are modern.**

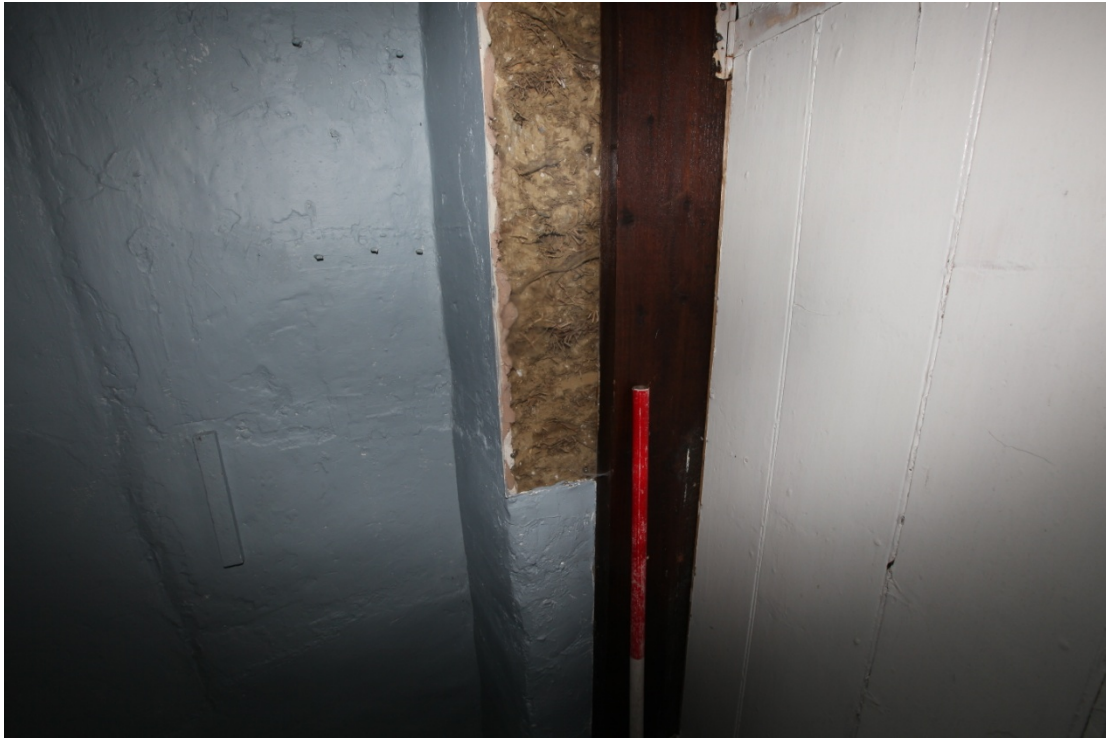
**Illus. 9. A detail of the eastern pier of the door to the Bathroom (1) of the southern cottage showing an exposed area clay and straw fabric with no obvious sign of individual blocks.**

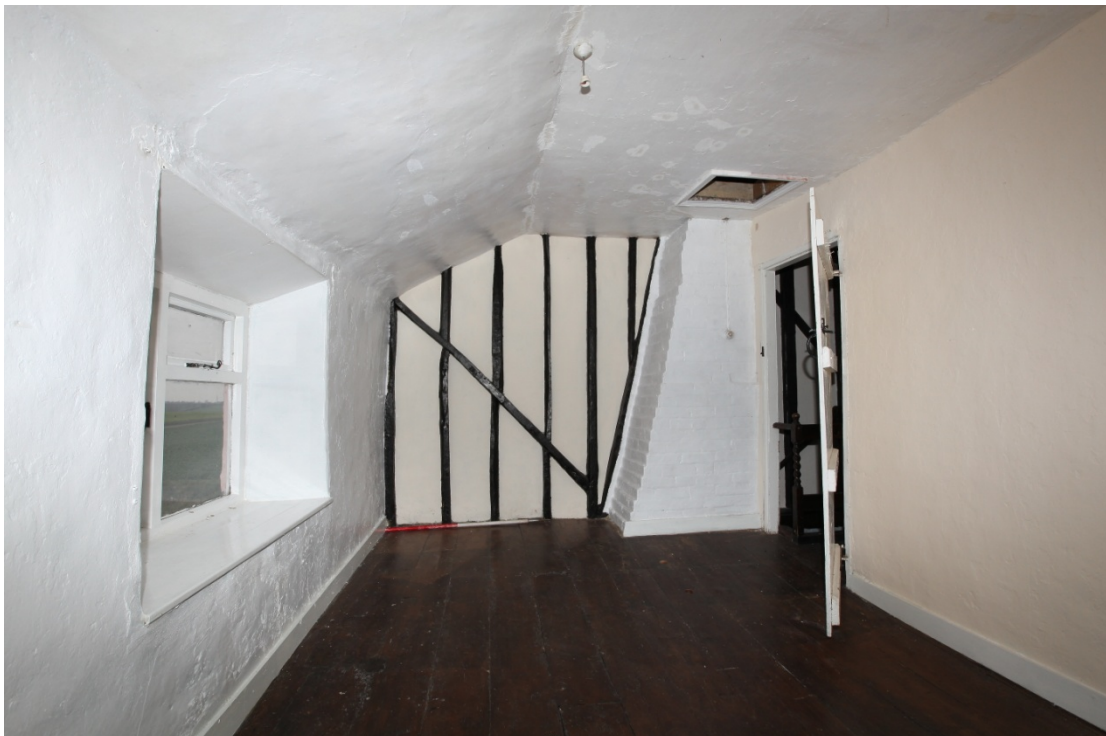
**Illus. 10. The front Bedroom (1B) of the southern cottage from the south, showing the 19th century studwork partition to the west of the central chimney and the 0.5 m thickness of the external wall. The 19<sup>th</sup> century plank-and-batten door opens onto the Landing (1).**

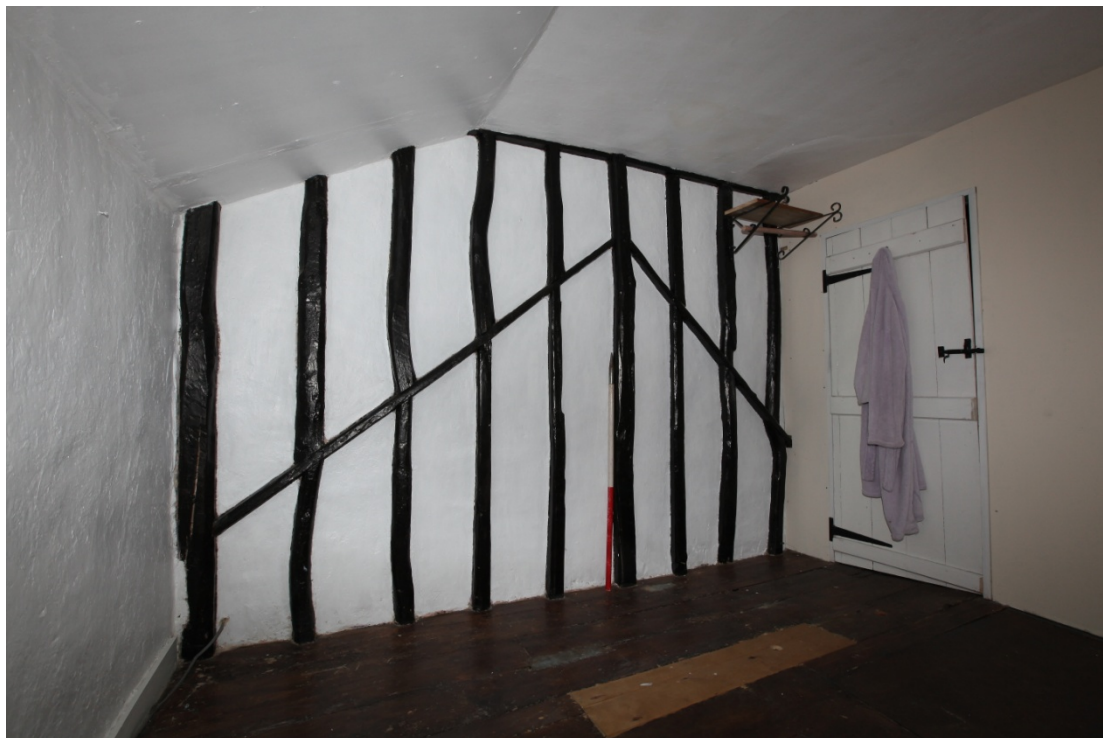
The upper storey of each cottage is divided into a pair of bedrooms by axial partitions of studwork with lath-and-plaster to one side. The framing is typical of the early-19<sup>th</sup> century, with narrow, irregular studs interrupted by diagonal primary braces (illus. 11). Each partition retains what appears to be an original plank-and-batten door with a Suffolk latch. The historic layout of the lower storey is less certain as the interior has been extensively modernised in recent decades and no original stairs survive. Each cottage contained a main living area of 4.6 m in length internally (15 ft) by 5.2 m in width (17 ft), with a central brick fireplace and a narrow store-room of 1.8 m in length (5.5 ft) housed within the gable lean-tos (which are also of clay fabric and appear integral to the main range). The present partition between the southern Living Room (1) and the rear 'Hall' (1) is a modern addition and it is unclear whether the two living spaces were sub-divided in the 19<sup>th</sup> century. Each cottage was entered by a door in its outer front corner, as indicated by flat arches in the brickwork (i.e. a row of headers), but the northernmost is now blocked. The single front and rear windows are insertions of the 1960s but occupy the positions of narrower predecessors as shown by similar flat arches above their lintels, and these were presumably reflected on the upper storey to create a symmetrical appearance. There is no evidence of doors in the 19<sup>th</sup> century brickwork of the rear elevation and each cottage appears to have been provided with a back door in the gable of its lean-to: there is evidence of a blocked door in the position of the present Bathroom (2) of the northern cottage and the side-door of its southern counterpart is probably in its original location. As the door between the southern Living Room (1) and Kitchen (1) is a recent insertion the original internal doors evidently lay to the rear, much as in figure 6 below.

**Illus. 11.** The rear Bedroom (1A) of the southern cottage seen from the east, showing the hipped southern gable to left and the 19th century studwork partition to the front Bedroom (1B). The plank and batten door to the right opens onto the stair Landing (1).

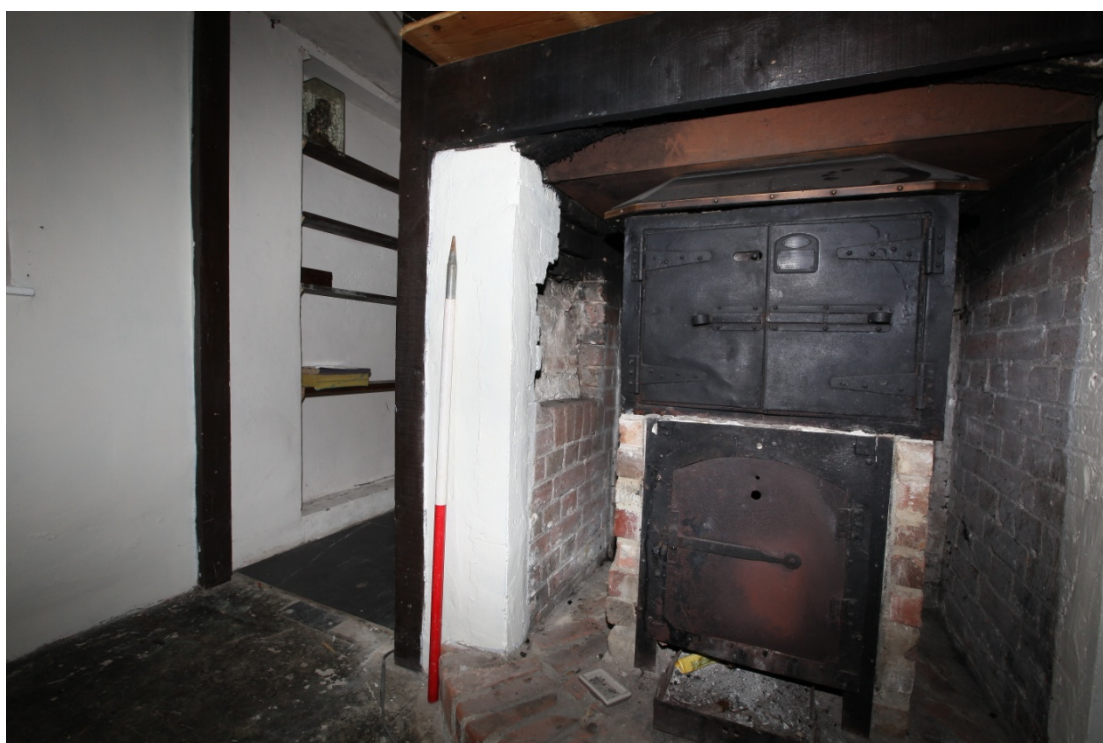
**Illus. 12.** A detail of the 19th century fireplace in the southern Living Room (1) showing the aperture of a probable bread oven door in its left-hand pier.
