**The Barn,
Ashtree Farm,
Wilby, Suffolk
WBY 026**

Heritage Asset Assessment

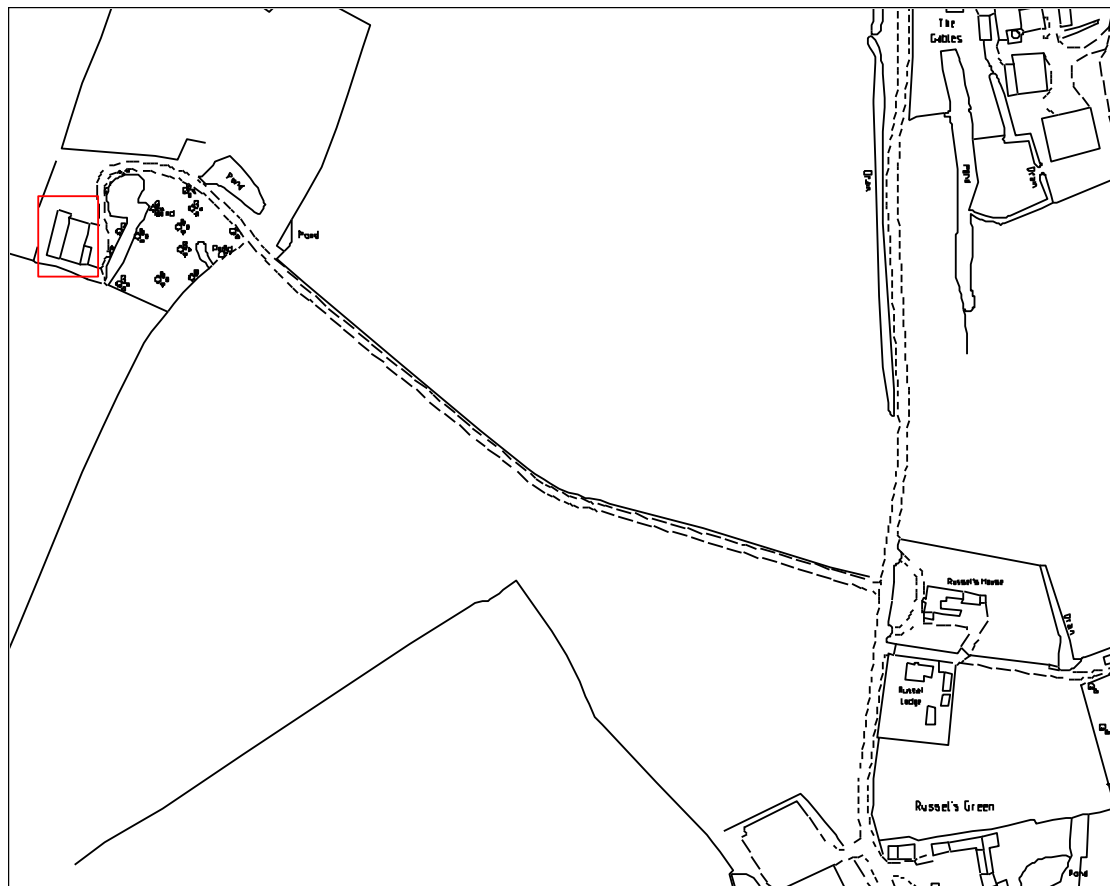
© Crown Copyright. All rights reserved. Suffolk County Council Licence No. 100023395 2008

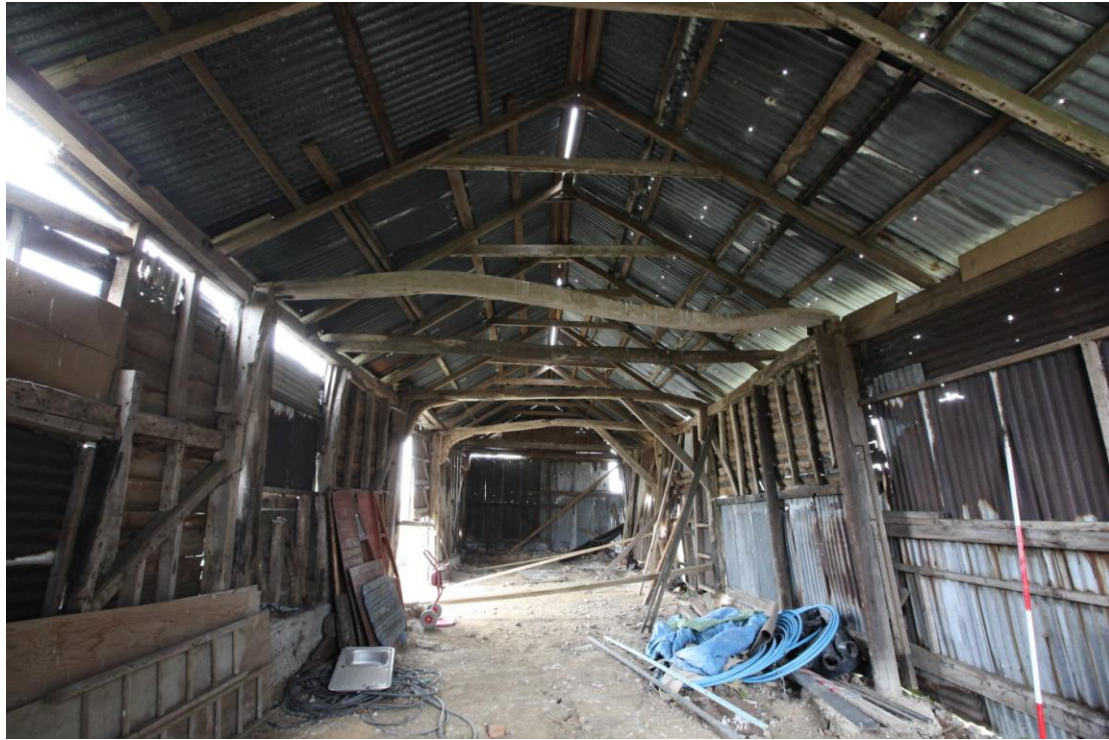
Illus. 5. A general view of the interior from the north showing the late-18th or early-19th century timber frame with substantial areas of 20th reconstruction and a replaced through-purlin roof of softwood with nailed collars and some re-used timber.

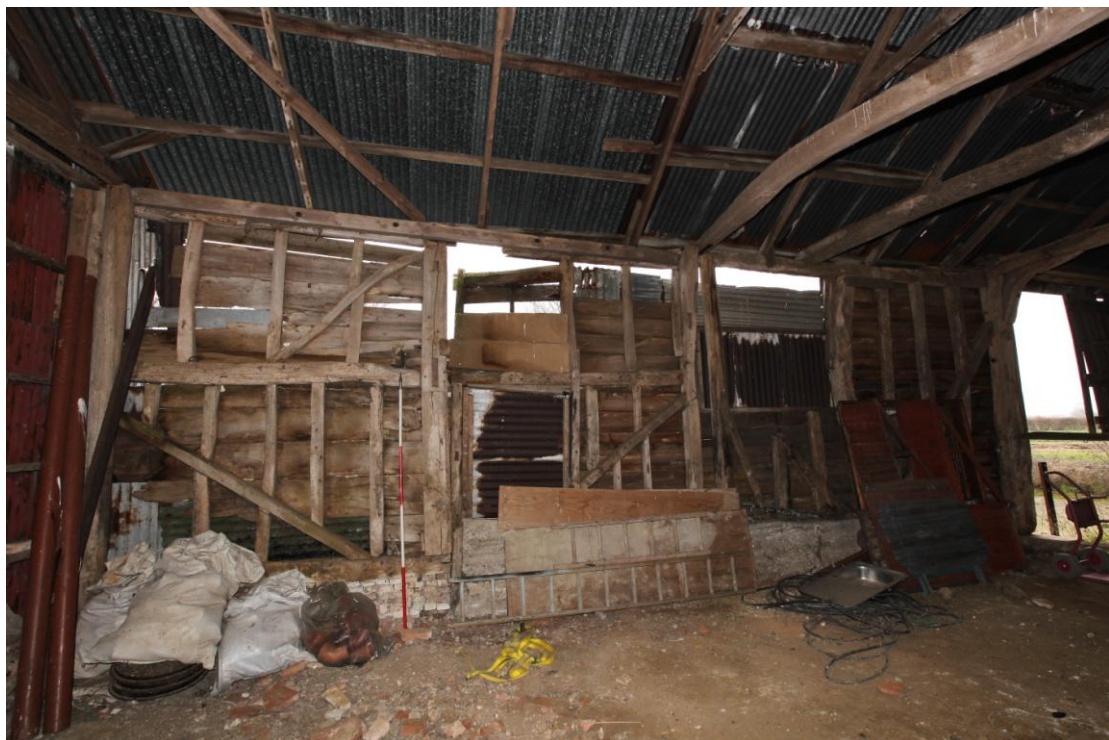
Illus. 6. The largely intact framing of the eastern interior of the two stable bays (E and D) showing their pegged primary braces and the mortise in the central storey post which held the binding joist of the missing hay loft. The tie-beam to the right is a replacement, but marks the position of a removed partition between the stable and the three-bay threshing barn. The northern gable to the left was completely rebuilt in the 20th century.

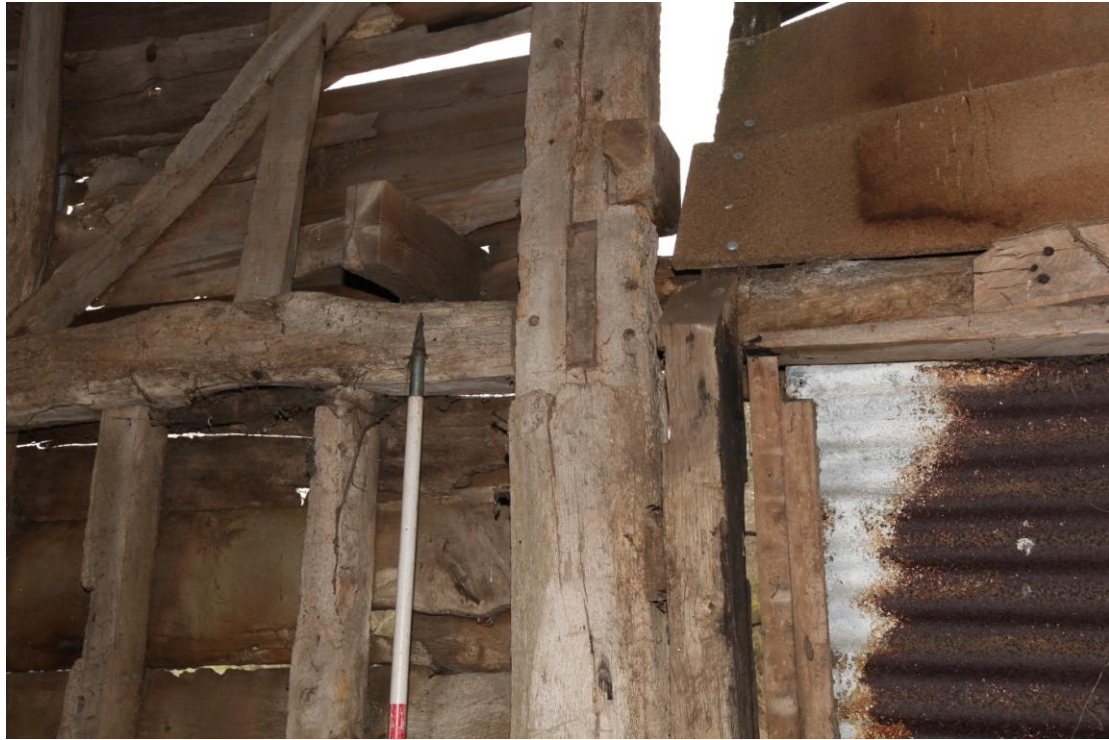
Illus. 7. A detail from the west of the mortise and integral corbel in the central storey post of the two stable bays (E and D) for the binding joist of a missing hay loft. The blocked door in bay D to the right is a secondary insertion and the original stable entrance presumably lay in the rebuilt northern gable or western wall.

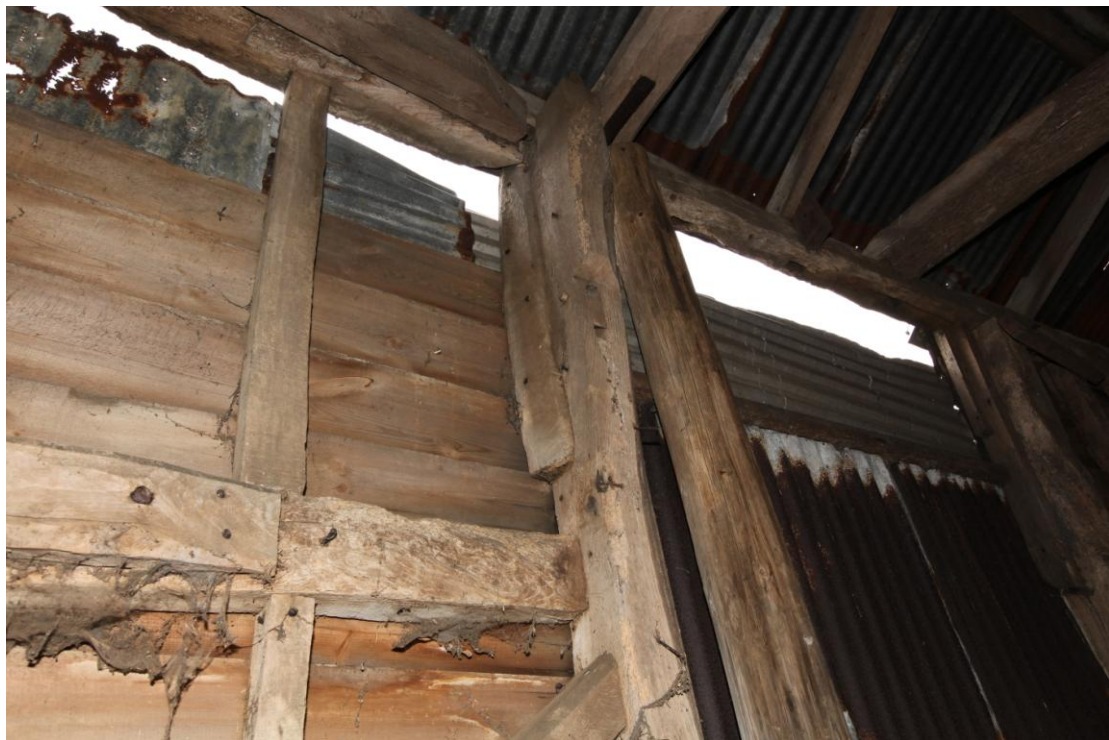
Illus. 8. The junction of bay D (left) and the jowled north-eastern corner post of the three-bay barn (bay C). The mid-rail of bay D is nailed rather than tenoned to the post, and the two roof-plates are linked by a crude butt joint – suggesting the two structures were not built in a single phase of construction. The post contains a pegged mortise for the diagonal brace of a missing lateral partition (i.e. the gable of the three-bay barn).

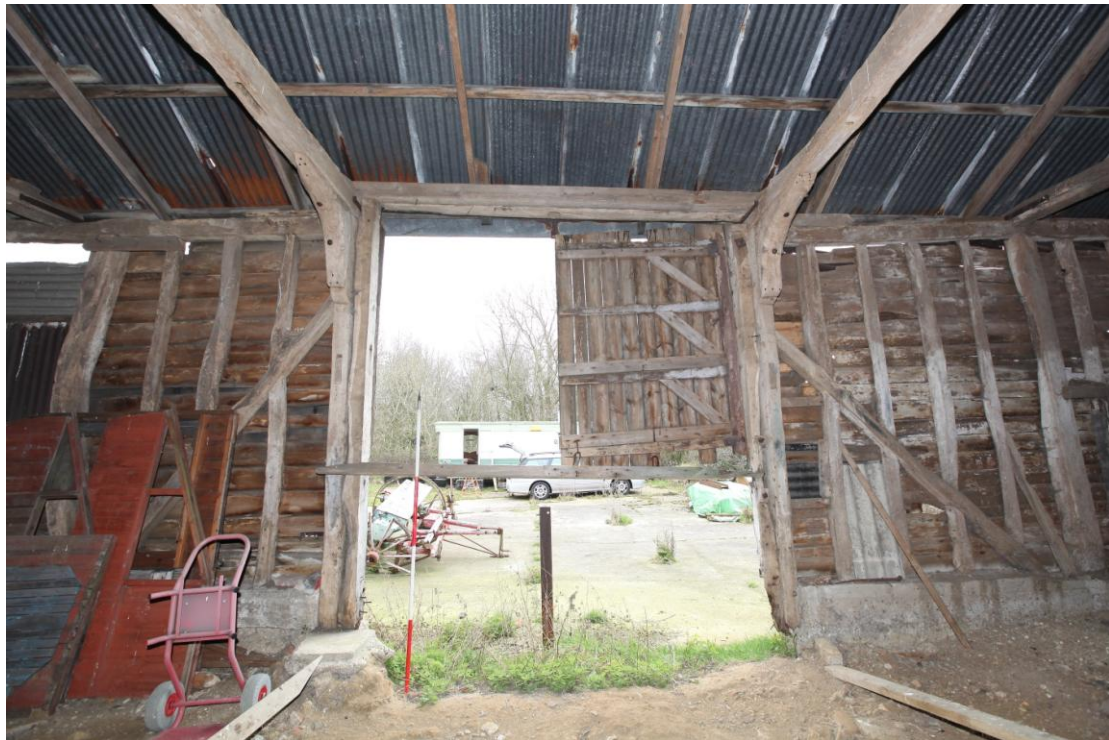
Illus. 9. The eastern interior of the original entrance bay B showing its raised secondary roof-plate and the bolted knee-braces which replaced the original arch-braces to the tie-beams.

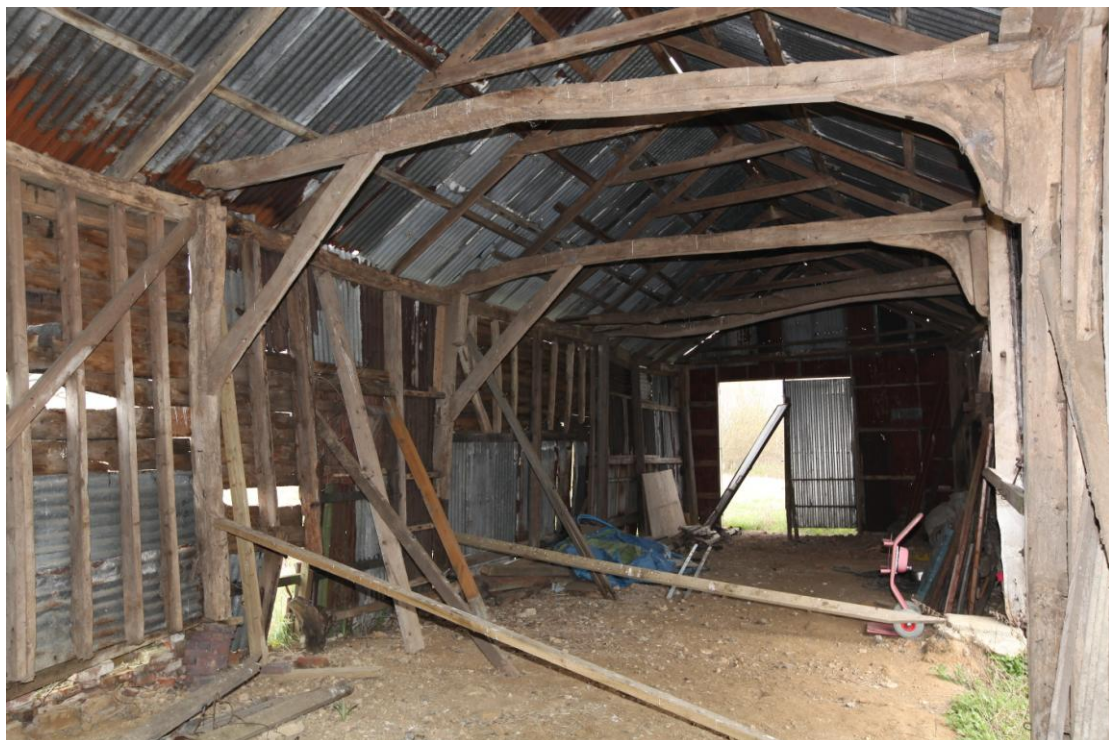
Illus. 10. The two original arch-braces to the tie-beams flanking the western interior of the entrance bay B, as seen from the south-east. The matching braces to the right were replaced by bolted knees in the 19th century. Note the 20th century vehicle doors in the northern gable and the loose earth floor throughout the barn.

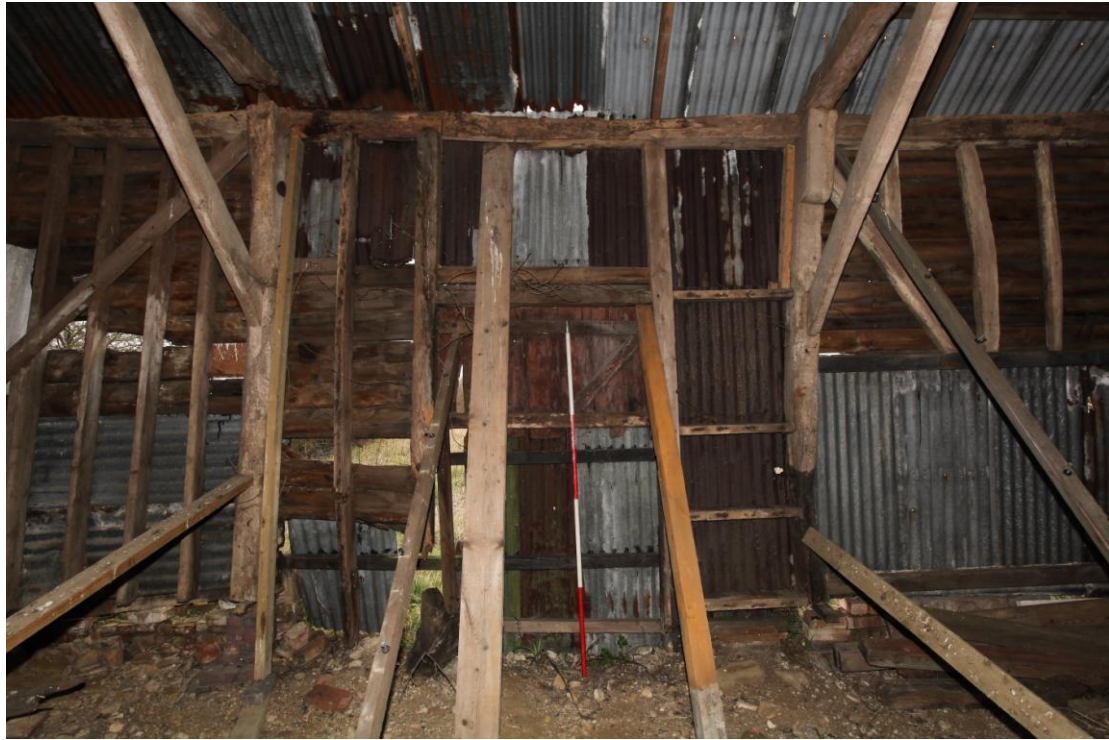
Illus. 11. The western interior of the entrance bay B showing the 20th century narrow door in the centre. The jowled storey posts on each side contain mortises for the lintel of the original low rear door of the threshing floor as seen in illus. 12 below. The roof-plate contains a series of empty mortises for the missing studwork above this lintel, proving the barn always faced east towards the farmhouse.

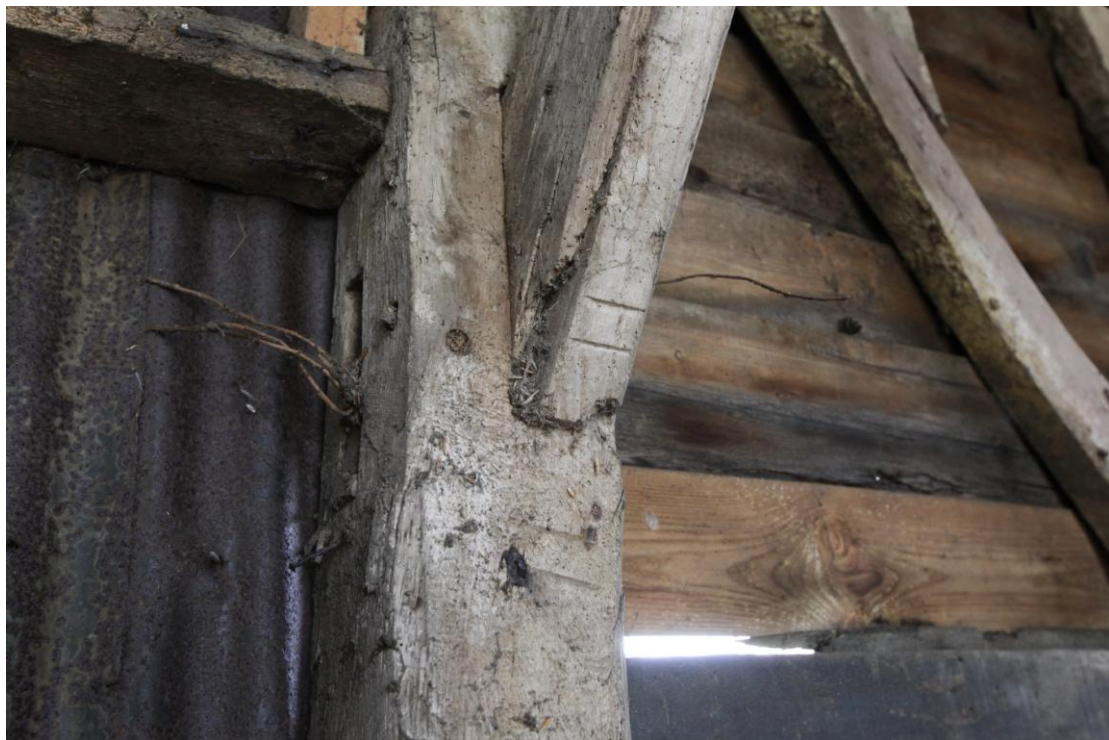
Illus. 12. A detail of the western storey post to the north of the entrance bay B showing the neatly chiselled carpenter's numeral II (on both the post and arch-brace) and the pegged mortise for the lintel of the original low rear door to the left.
