**Barn to Rear of
2-6 Little Lane,
Wickham Market, Suffolk
WKM 034**

Historic Building Record

Barn to Rear of 2-6 Little Lane, Wickham Market, Suffolk

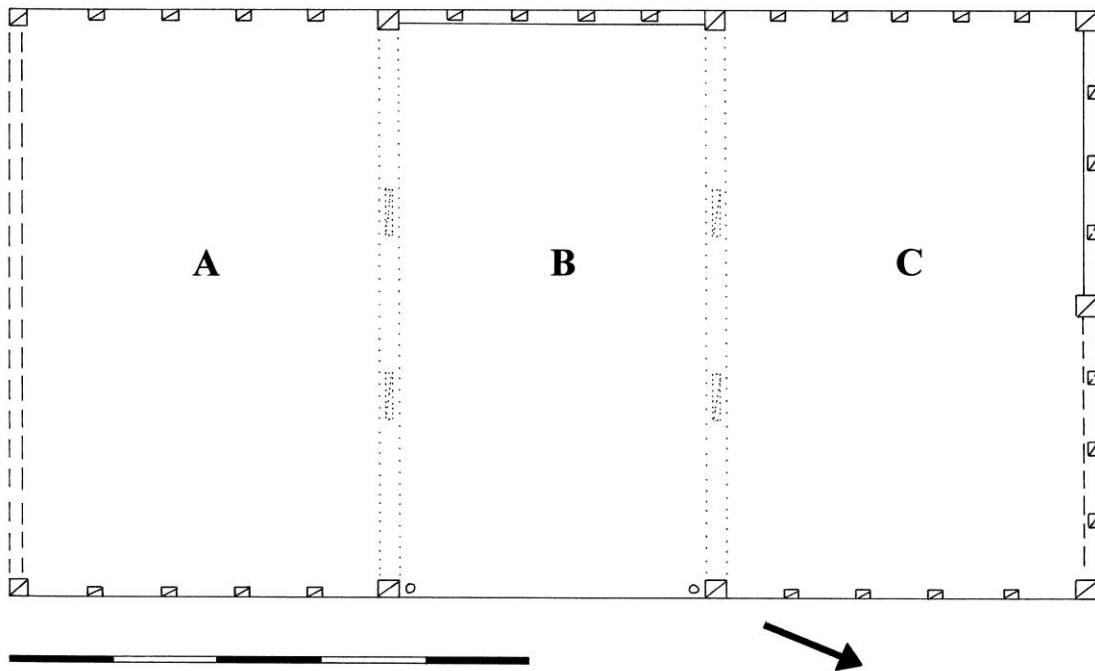
Figure 5

Ground plan of the barn identifying each of its three bays with a letter for ease of reference in the text and photographic record. The studs are shown *above* the mid-rails. The southern bay (A) was divided from the rest in the 19th century and converted into a shed with a first-floor granary.

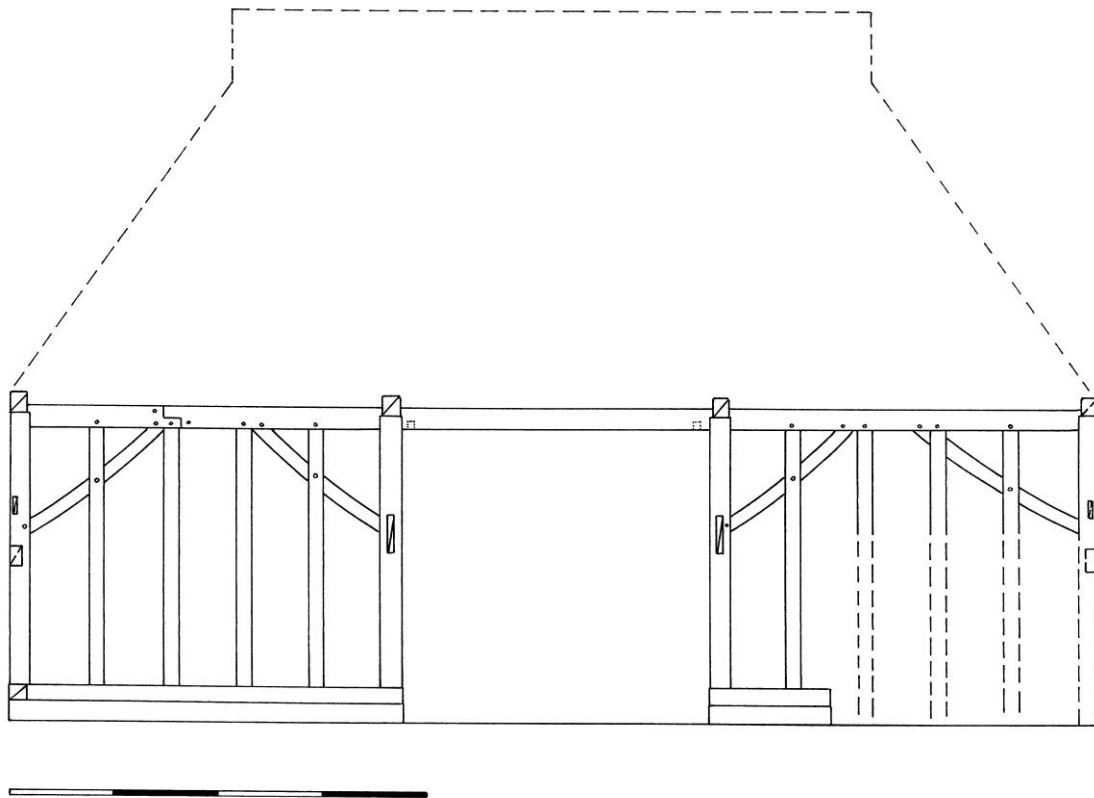
Figure 6
Front (eastern) internal elevation showing the remaining original frame but omitting later insertions. Scale in metres.

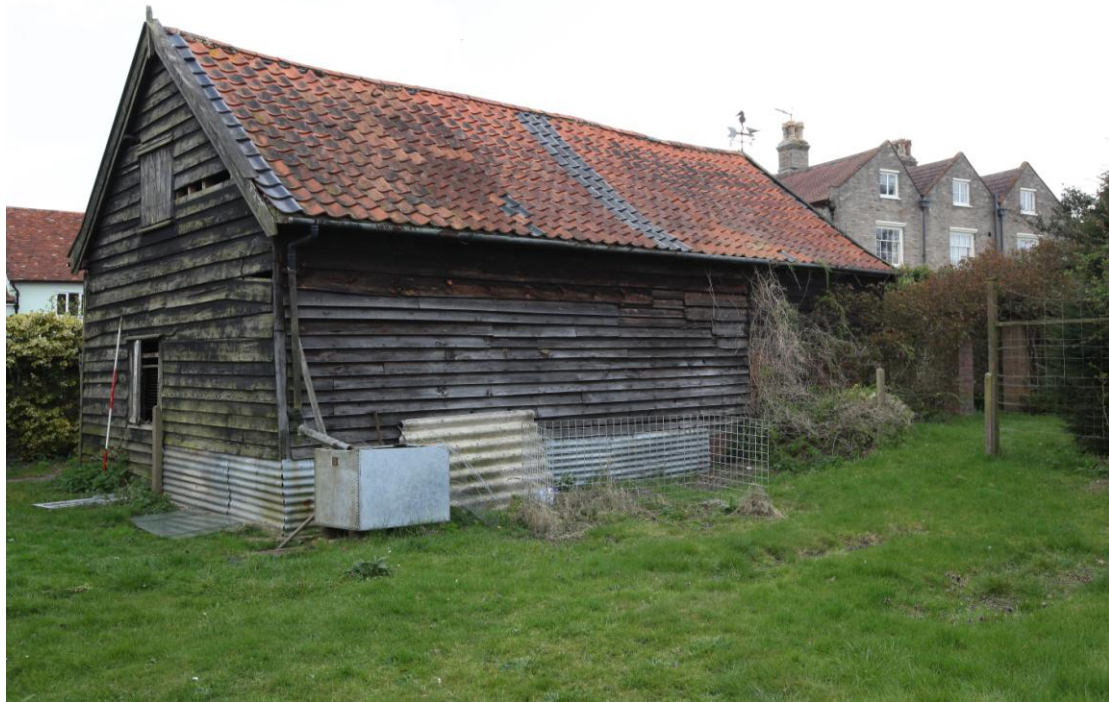
Illus. 3. The barn from the north-west showing its proximity to the rear gables of Hill House to the right. The glazed window and hatch of the northern gable to the left date are 19th century insertions and much of the weatherboarding was renewed in the 20th century. The small central doorway to the threshing bay (B) has been blocked.

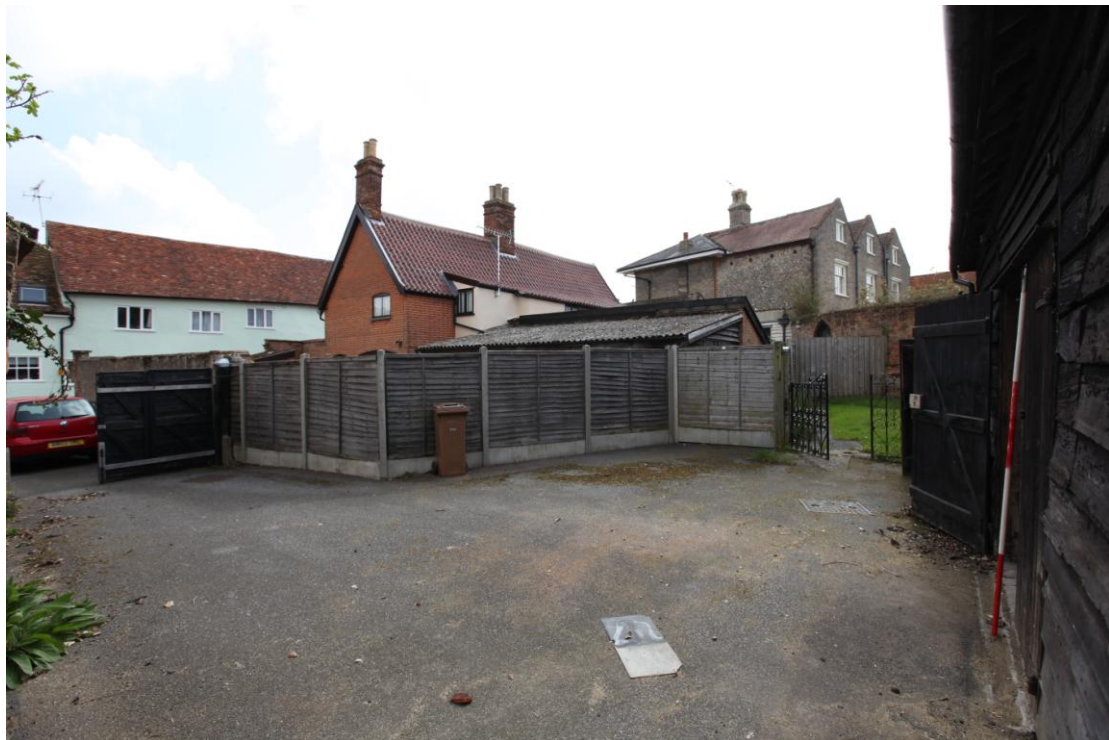
Illus. 4. The metalled yard in front of the barn seen from the north, showing the eastern facade of the barn to the right with the fenced yard of Sycamore Cottage in the centre and the gables of Hill House in the rear. It is unclear to which of the adjoining properties the barn originally belonged: Sycamore cottage is not listed but its proportions suggest it may be a contemporary structure of *circa* 1600.

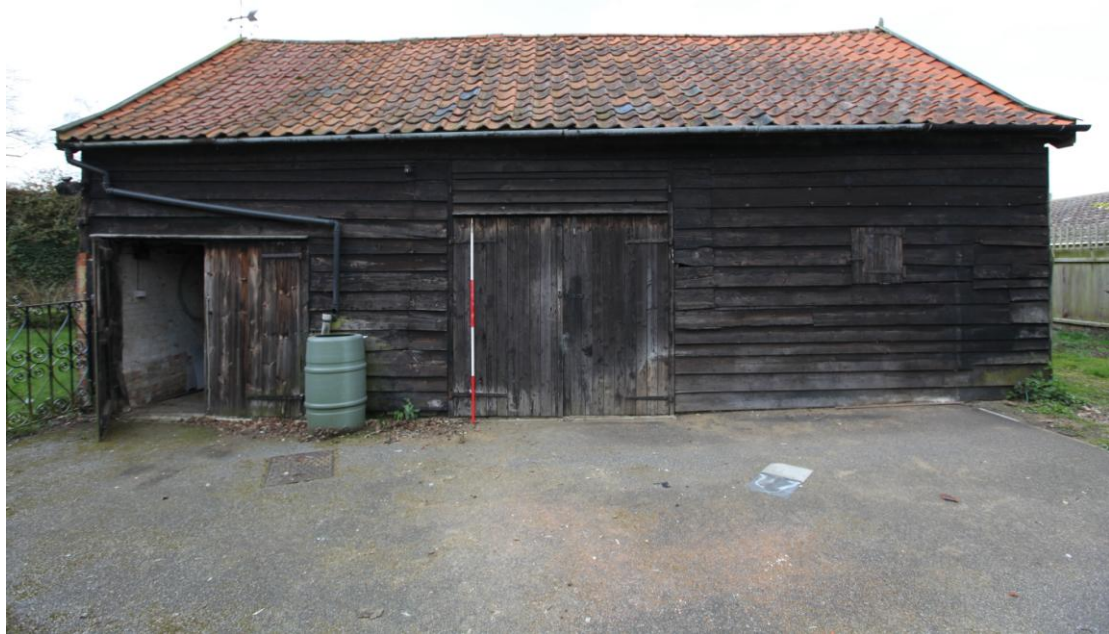
Illus. 5. The eastern facade of the barn showing the 20th century doors in the position of the original central entrance (bay B) with evidence of taller 19th century doors in the same position. The southern bay (A) to the left was converted into a separate shed with a first-floor granary in the 19th century but its present doors also date only from the 20th century. The pantiles are an alteration of the 19th century and probably replaced a steeply-pitched thatched roof. Sections of heavily tarred weatherboarding survive from the 19th century but most has been renewed.

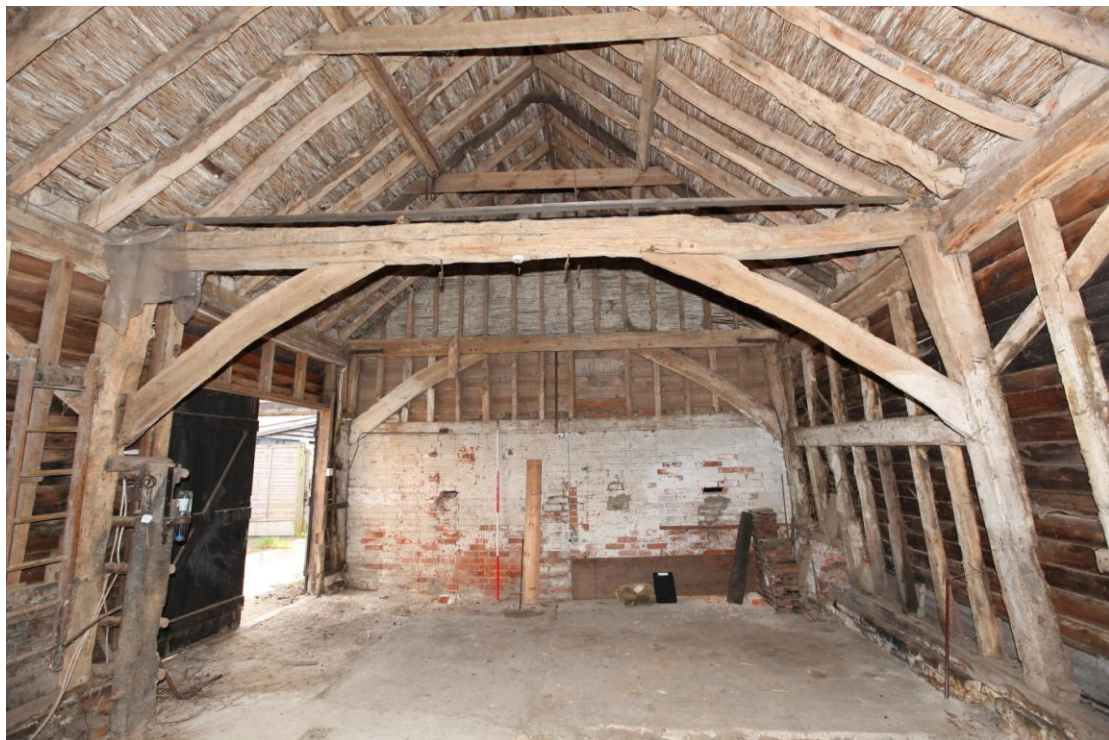
Illus. 6. The two intact arch-braced open trusses seen from the northern gable, with the 19th century brick and studwork partition of the southern bay (A) in the rear. The 19th century roof retains its original reed fleaking beneath the tiles.

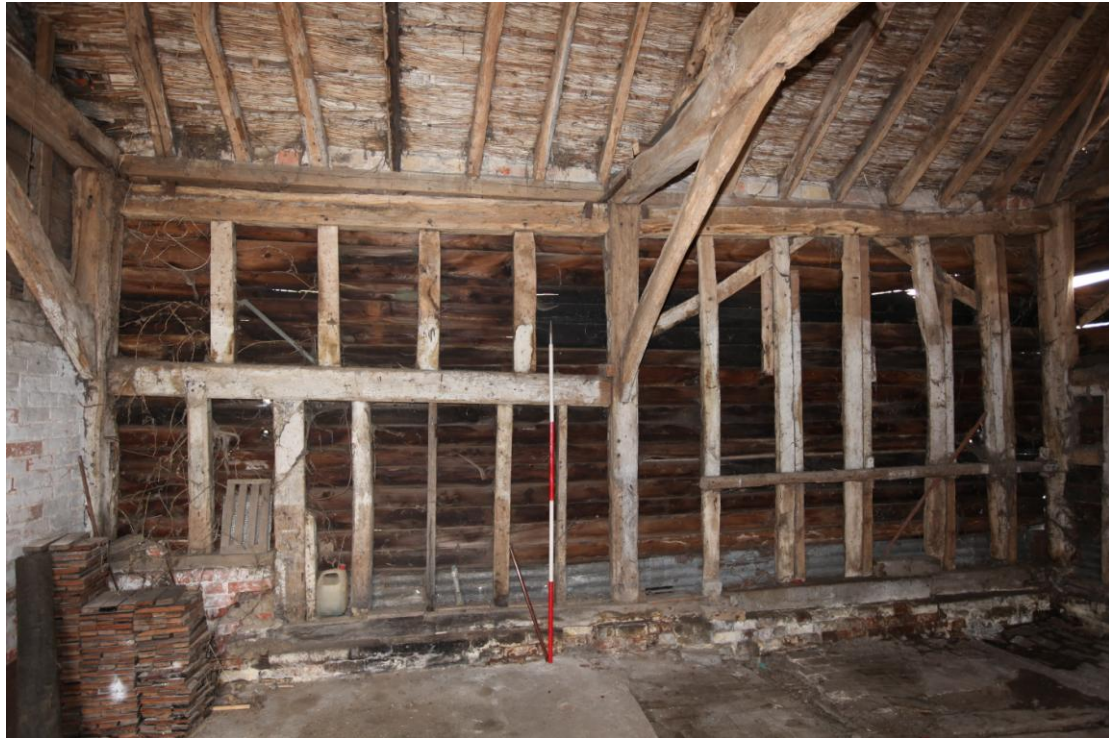
Illus. 7. The rear (western) interior of the two northern bays (B & C), showing the largely original timber framing with externally trenched wall braces. The horizontal mid-rail of the central bay (B) to the left is secondary, but the storey posts contain mortises for a lower predecessor that would have formed the lintel of a small rear door. The low height of these mortises (1.2 m or 4 ft above the present concrete floor) indicates the ground level has risen by as much as 0.6 m – or the walls have been reduced to the same extent.

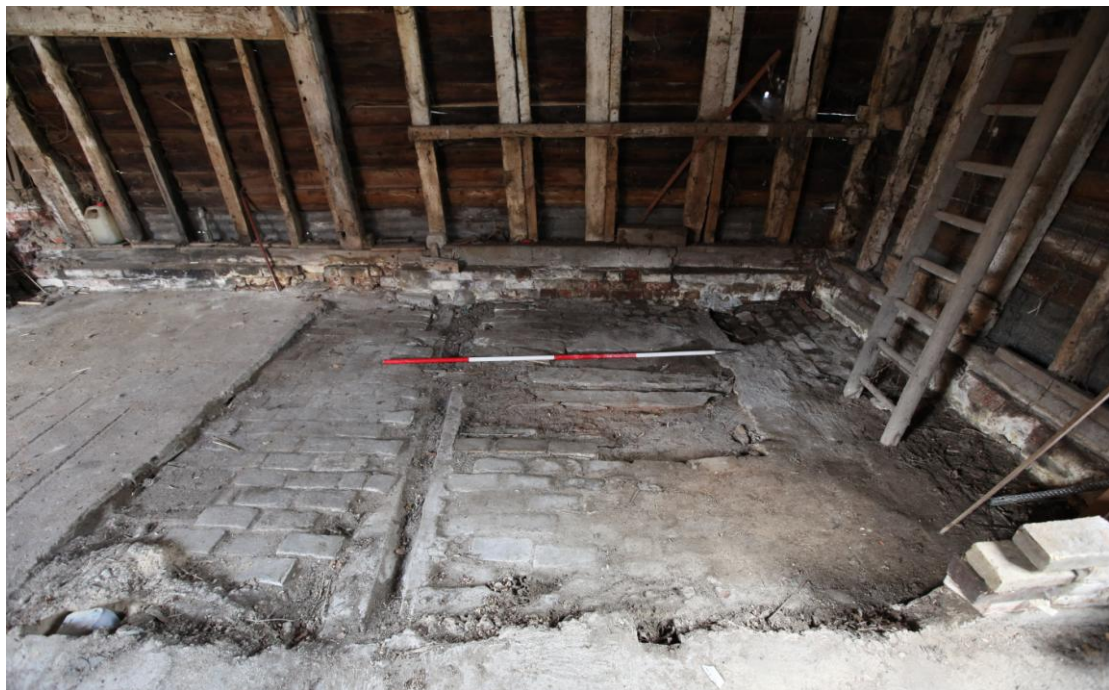
Illus. 8. A section of 19th century brick flooring with a lateral drain exposed beneath the 20th century concrete floor in the north-western corner of the barn (i.e. in bay C, viewed from the east). This end of the barn have been used as a stable at some point.

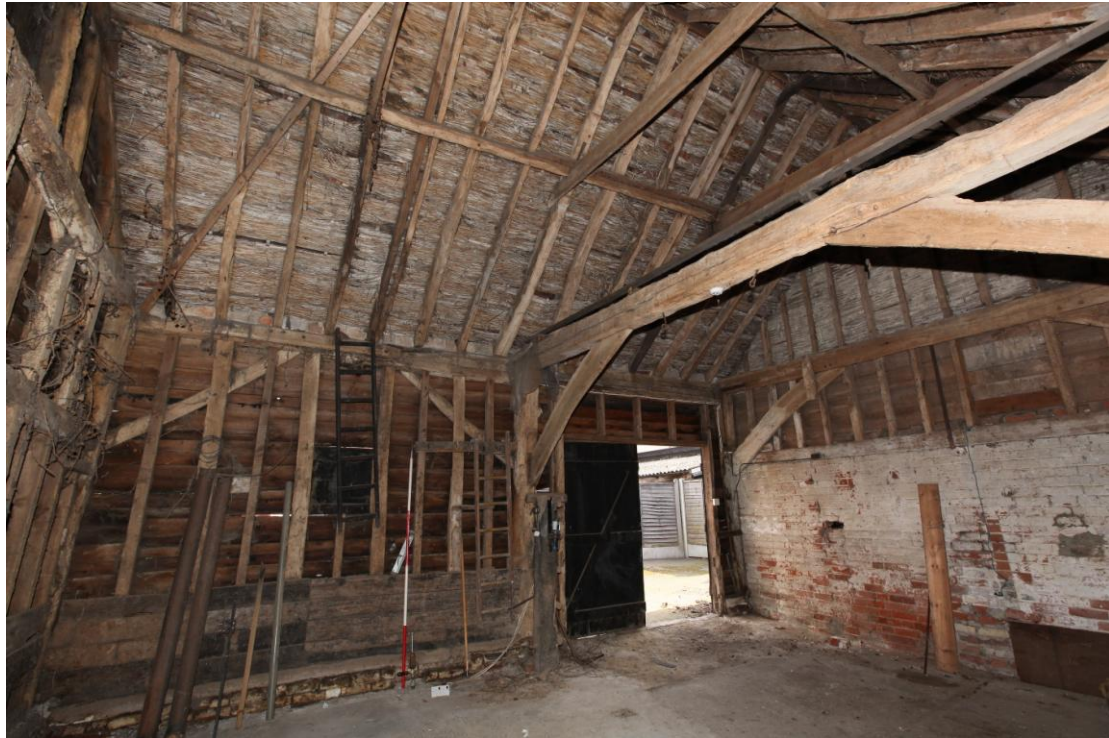
Illus. 9. The eastern interior of the two northern bays (C & B) showing the position of the original entrance to the right and the intact studwork of bay C to the left (with narrow secondary studs nailed in between).

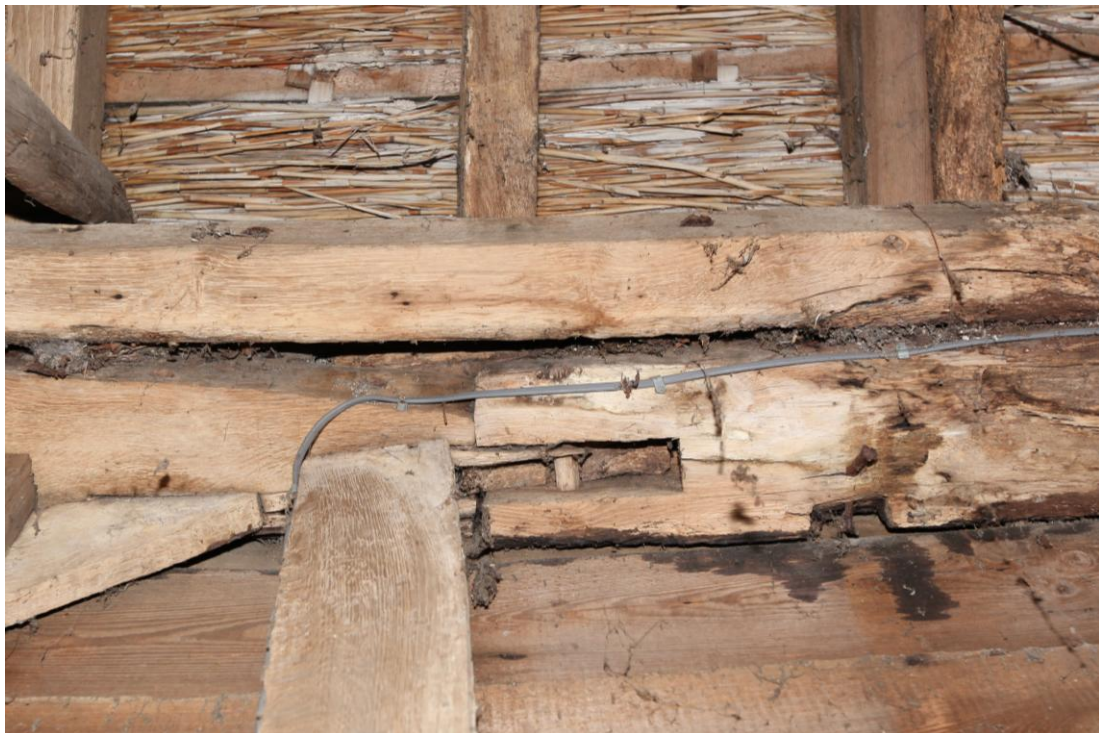
Illus. 10. A detail of the soffit (underside) of the eastern roof-plate in the northern bay (C) showing the tenon of a 16th century type edge-halved and bridled scarf joint. The halving is short at approximately 13 cm (5 ins) in length and the joint was secured by a bolted internal plate in the 19th century.

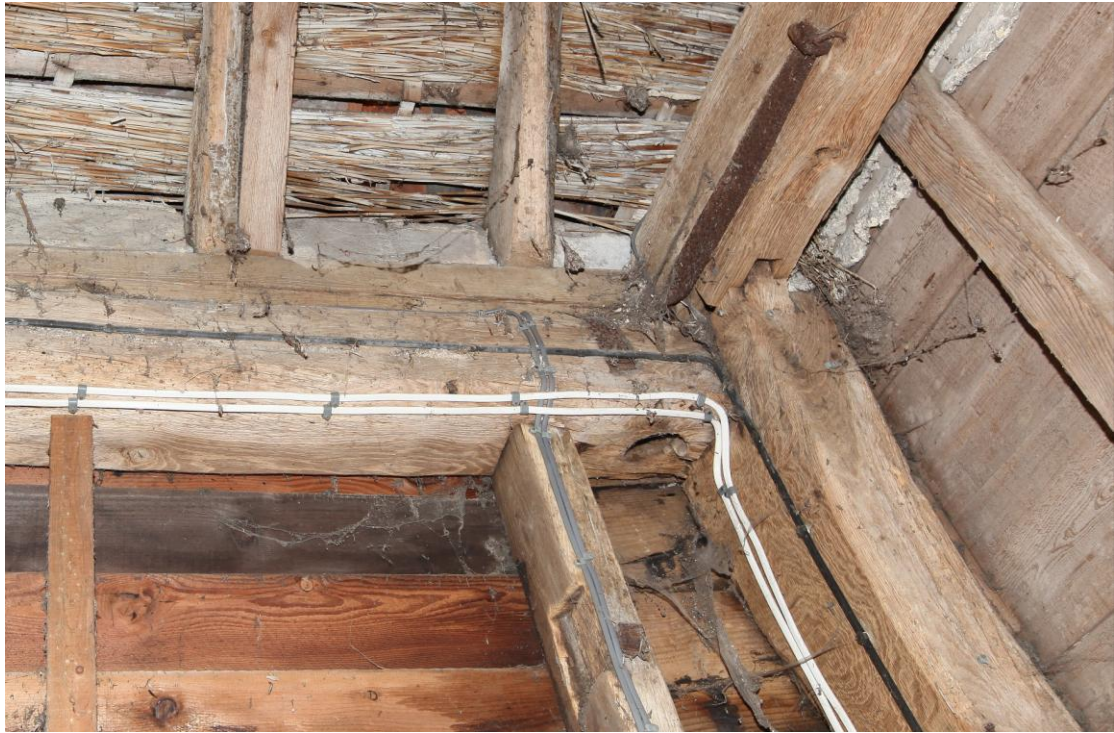
Illus. 11. A detail of the eastern roof-plate in the central bay (B) showing the cylindrical housing for the pin hinge of the original barn doors to the right. An identical feature lies to the left of the bay. The studwork beneath is modern.

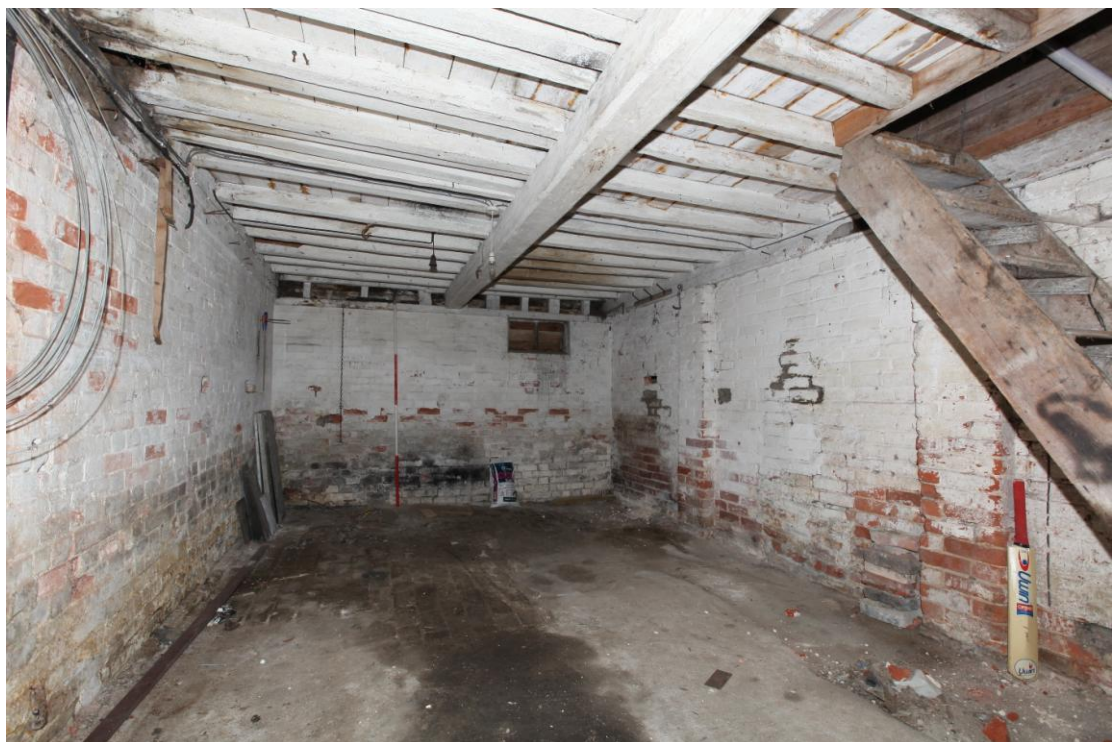
Illus. 12. The interior from the east of the southern bay (A) showing its 19th century brick walls and ceiling with a 20th century loft stair to the right. The feet of the original studs are visible above the brickwork in the rear (western) wall. This area was initially open to the rest of the barn but has a 19th century brick floor and was probably converted into a vehicle or storage shed with a granary above.

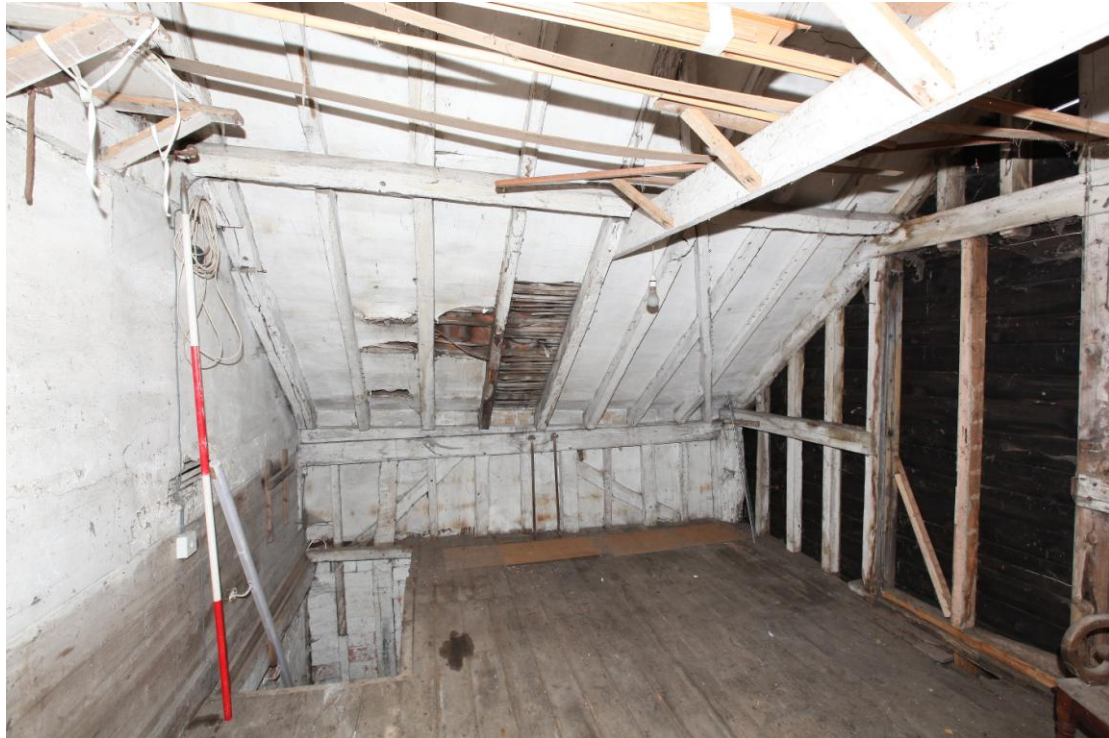
Illus. 13. The eastern interior of the loft above the southern bay (A) showing the 19th century whitewashed roof and rebuilt southern gable with a blocked original (19th century) external door in the southern gable to the right. This door would have been reached by an external stair and suggests the loft operated as a granary. The apotropaic (i.e. evil-averting) symbols in illus. 14 below are on the internal plaster wall to the left.

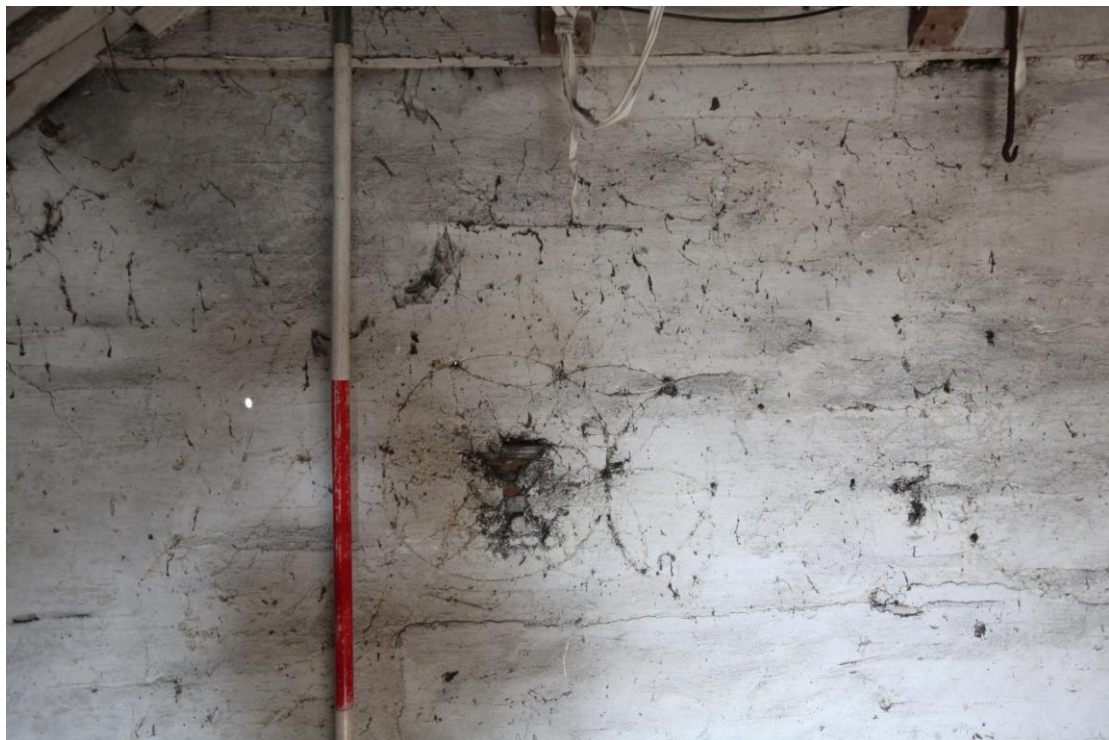
Illus. 14. A detail of the large, boldly incised apotropaic interlocking circles and 'daisy-wheels' to the northern internal partition of the loft in bay A. Such features are often found in granaries and are believed to have been intended to protect the vital grain from harm.
