Alpheton Hall, Alpheton (ALP 019), Record of Archaeological Monitoring

Planning Application No.	B/05/00714	Oasis No.	Suffolkc1-12818
Map Ref.	TL 8733 5049	SMR No.	ALP 019
SCCAS Rpt. No.	2006/009	Finds	Post-medieval

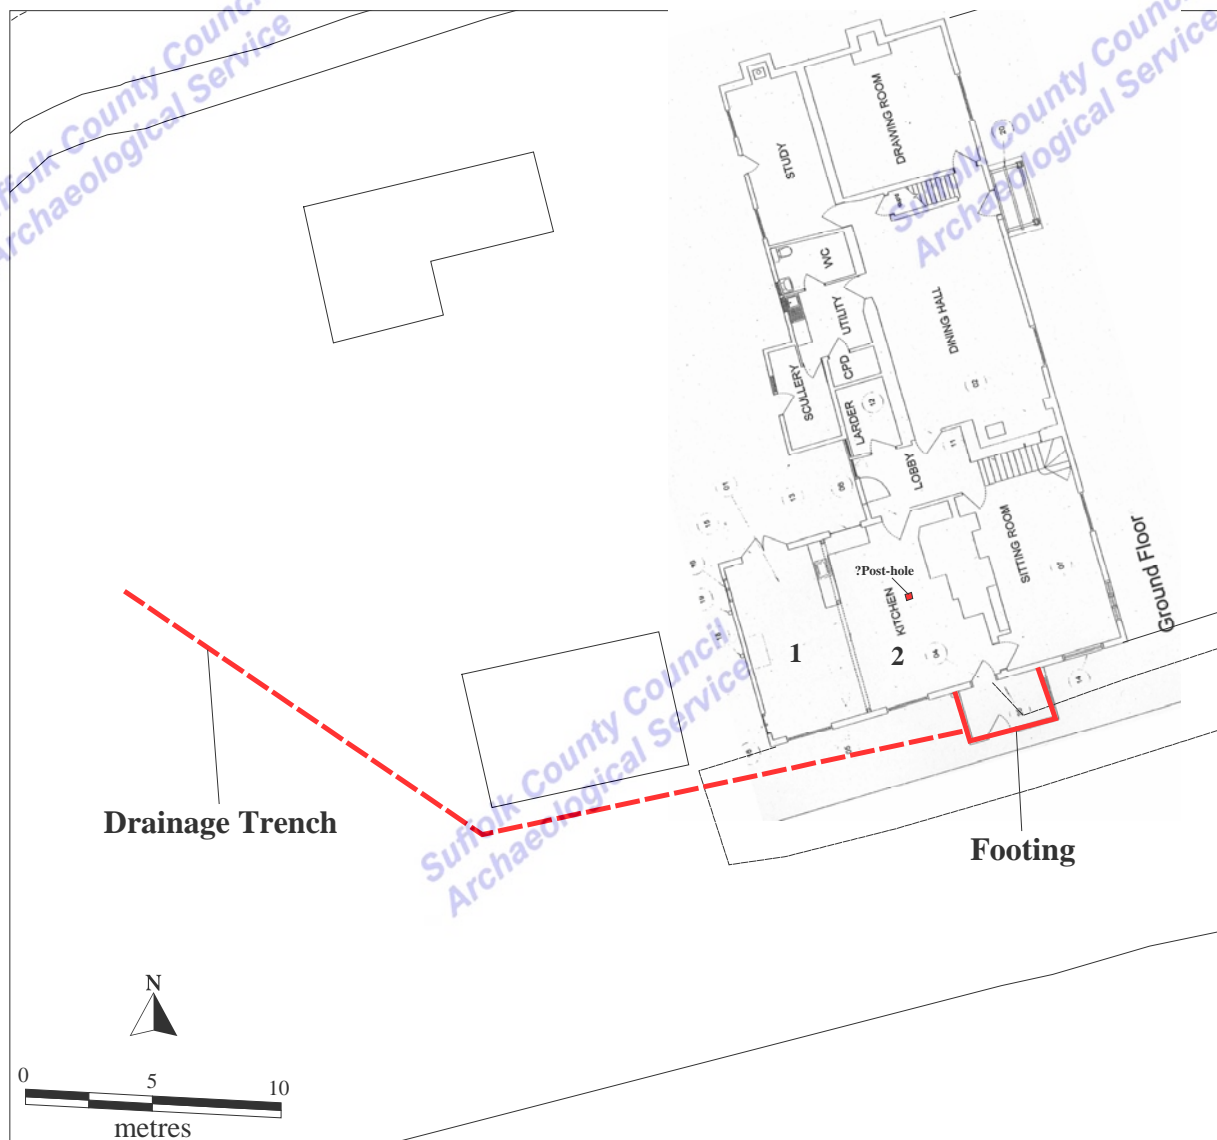
Fig. 2 1:350 scale plan

Footings: a footing trench for a new porch on the southern side of the building had been excavated to a depth of *c.*0.3 metres (Fig. 2). Located in what was effectively the entrance/driveway providing access to the rear of the building, the character of the overburden reflected this use. Approximately 0.2 metres of stratified deposits, all representing metalling material for the driveway were recorded overlying a stiff grey/brown clay, possibly representing naturally occurring subsoil in the base of the trench. No archaeological features were visible and no finds were recovered.

Drainage Trench: a trench excavated to contain a pipe taking rainwater to a soakaway extended in a west-south-westerly direction away from the footing for a distance of *c.*20 metres before turning to the north-west for a further *c.*16 metres and terminating at an existing soakaway (Fig. 2). No archaeological features were

Floor lowering: Part of the alteration works involved lowering the floor levels in two rooms of the existing building, marked **1** and **2** in Figure 2. This entire operation had been undertaken prior to the monitoring visit. As a result, the composition and stratigraphy of the removed material was not observed by an archaeologist.

Only one feature of interest was recorded, a possible post-pad/hole in the kitchen (Fig. 2). The feature was *c.*0.3 metres square comprising orange clay with a suggestion of a rectangular post-setting (*c.*0.15 metres square) at its centre.
