**The Barn,
Hawkins Farm,
Mendlesham, Suffolk
MDS 162**

Heritage Asset Assessment

July 2012

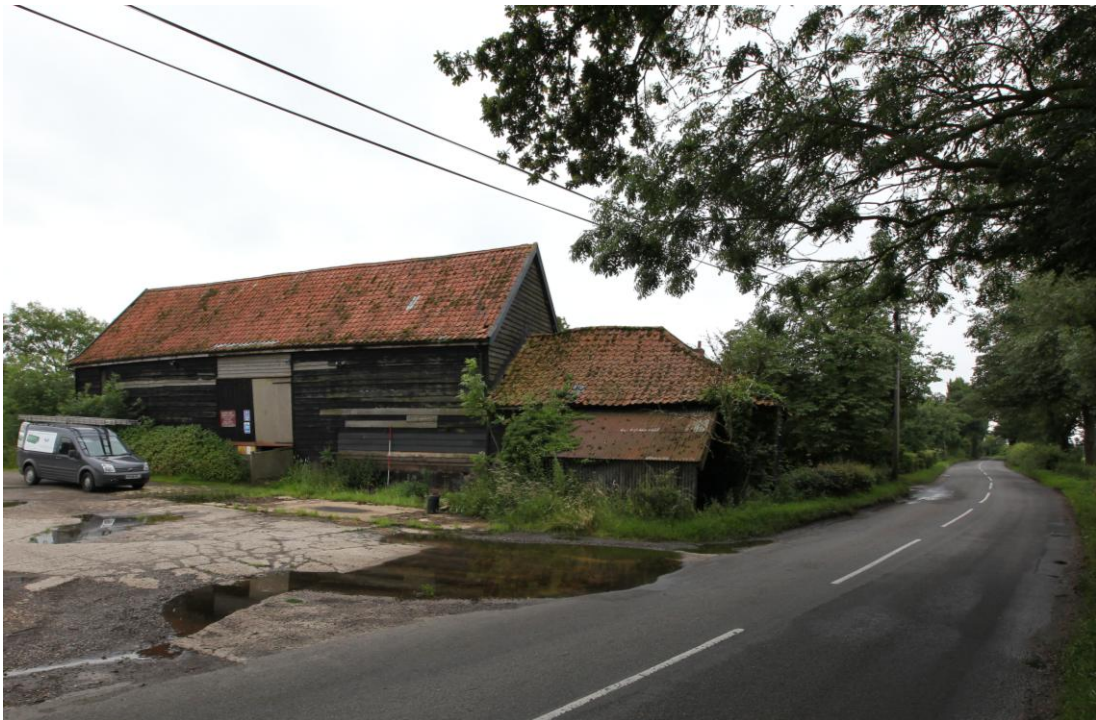
Illus. 1. A general view of the site from the north showing the rear elevations of the weatherboarded and pantiled barn (1) and cart lodge (2) at right-angles to the road between Mendlesham and Stowmarket.

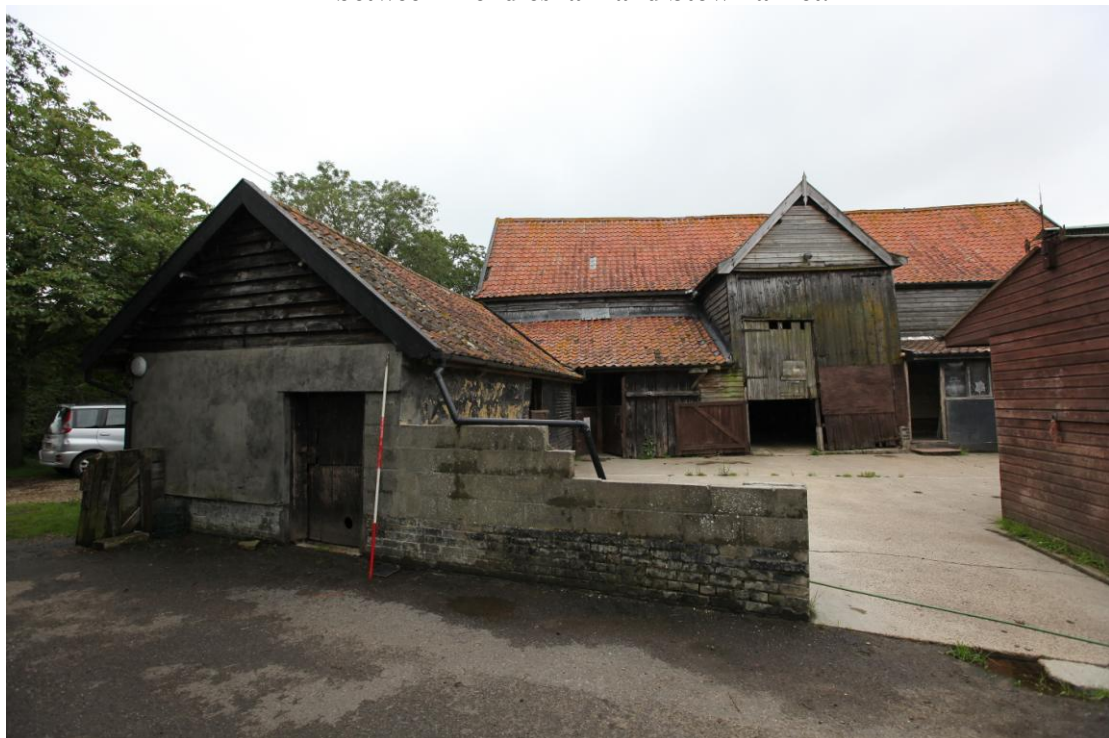
Illus. 2. A general view of the barn (1) and enclosed yard from the south-west showing from left to right the brick and clay-lump cattle shed (3), the lean-to loose boxes containing re-used charred timber (4), the barn's original entrance porch and the modern cement-block office (5). The timber-clad structure to the extreme right is a modern stable range.

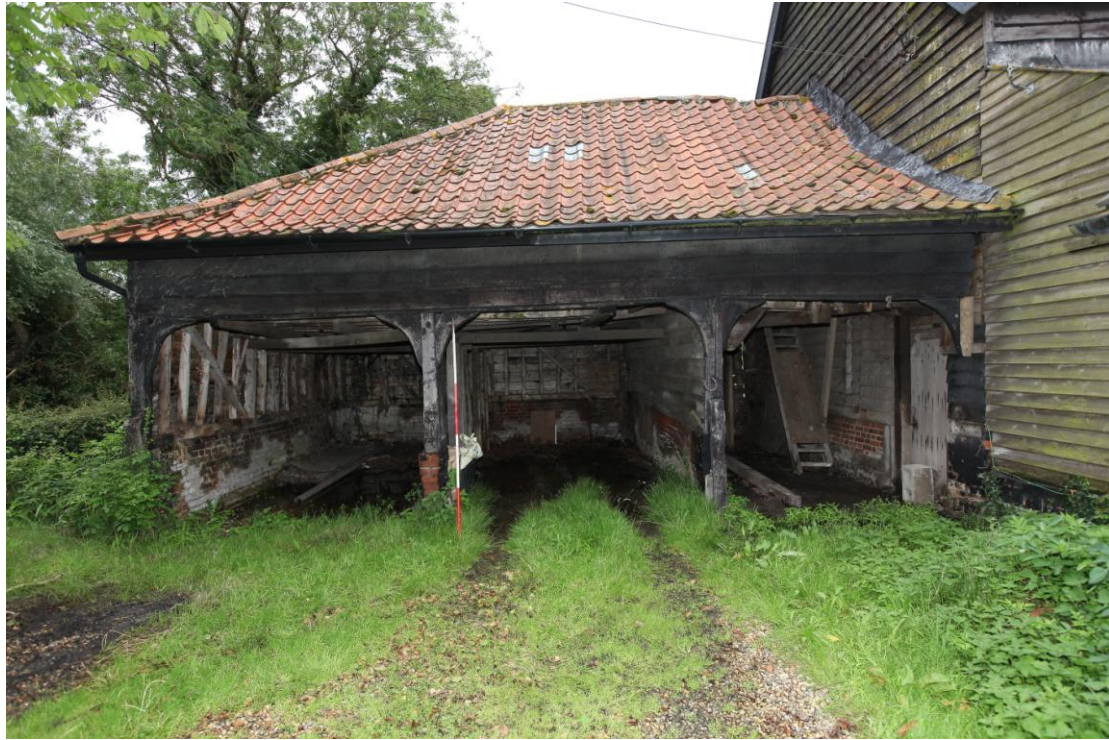
The elm weatherboarding is heavily tarred and appears to be largely original, and apart from its missing grain bins the entire structure is exceptionally well preserved.

Illus. 3. The open arcade of the well preserved cart lodge (2) from the south showing the heavily tarred weatherboarding of its first-floor granary with the divided eastern bay (2a) containing the stair to the right.

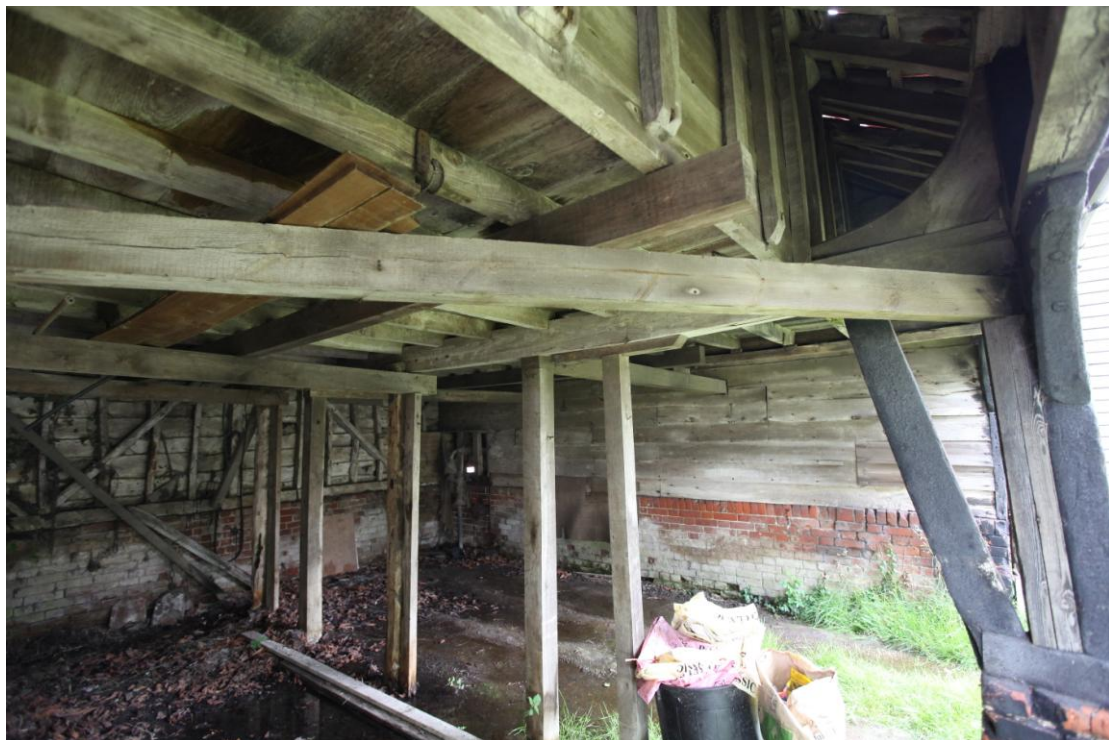
Illus. 4. The interior of the cart lodge (2b) from the west showing the lodged joists and boarded walls of the granary with a reversed knee-brace to the binding joist and various secondary reinforcing timbers.

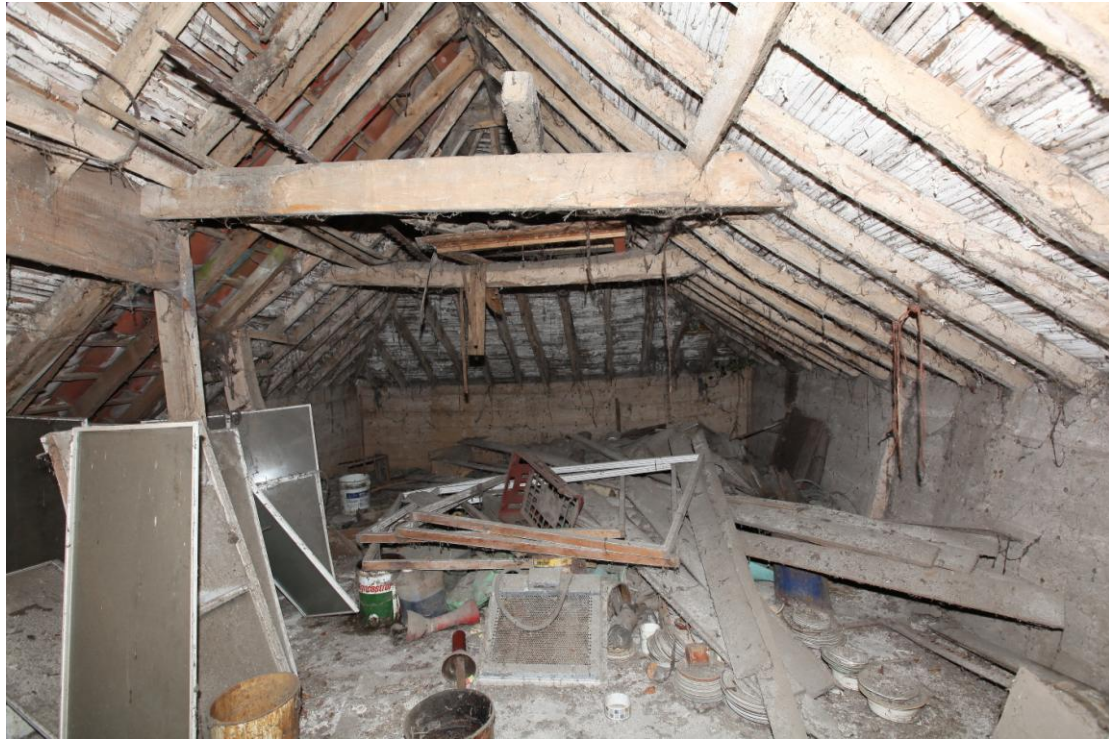
Illus. 5. The interior of the granary above the cart lodge (2) from the east, showing its clasped-purlin roof structure with nailed collars and the boarded internal walls which preserve evidence of removed grain bins.

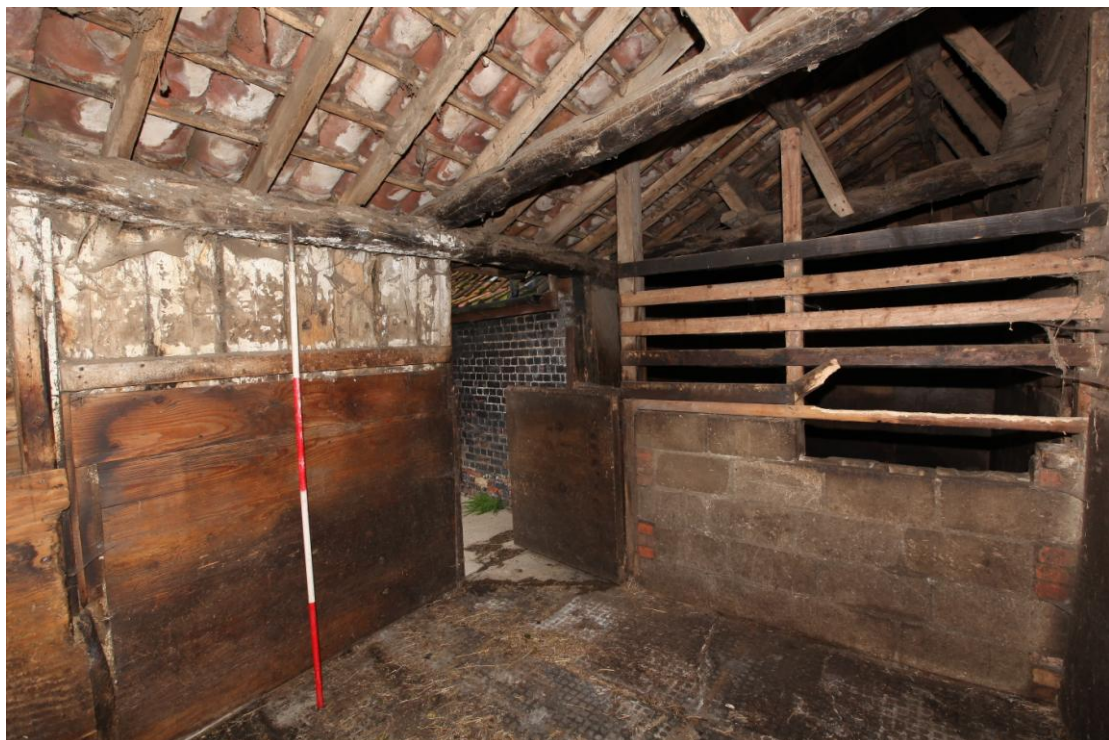
The two weatherboarded lean-to loose boxes (4) adjoining the western bays of the barn were converted into stables during the 1990s and have been much altered. The Ordnance Survey of 1904 (figure 4) shows the yard elevation with a broken line, indicating it was designed as an open-sided shelter-shed. The structure's chief interest lies in the heavily charred timbers of its roof-plate and tie-beam. These appear to have been re-used rather than burnt *in situ* (as there is no damage to the adjoining fabric of the barn), and may survive from the premises that were destroyed by fire on June 8 1822.

Illus. 6. The interior of the lean-to loose box (4a) adjoining the barn's southern elevation seen from the east (with the weatherboarded wall of the barn to the right). The partitions appear to be secondary but the original roof-plate and tie-beams are charred and may have been re-used after the fire of June 8th 1822.

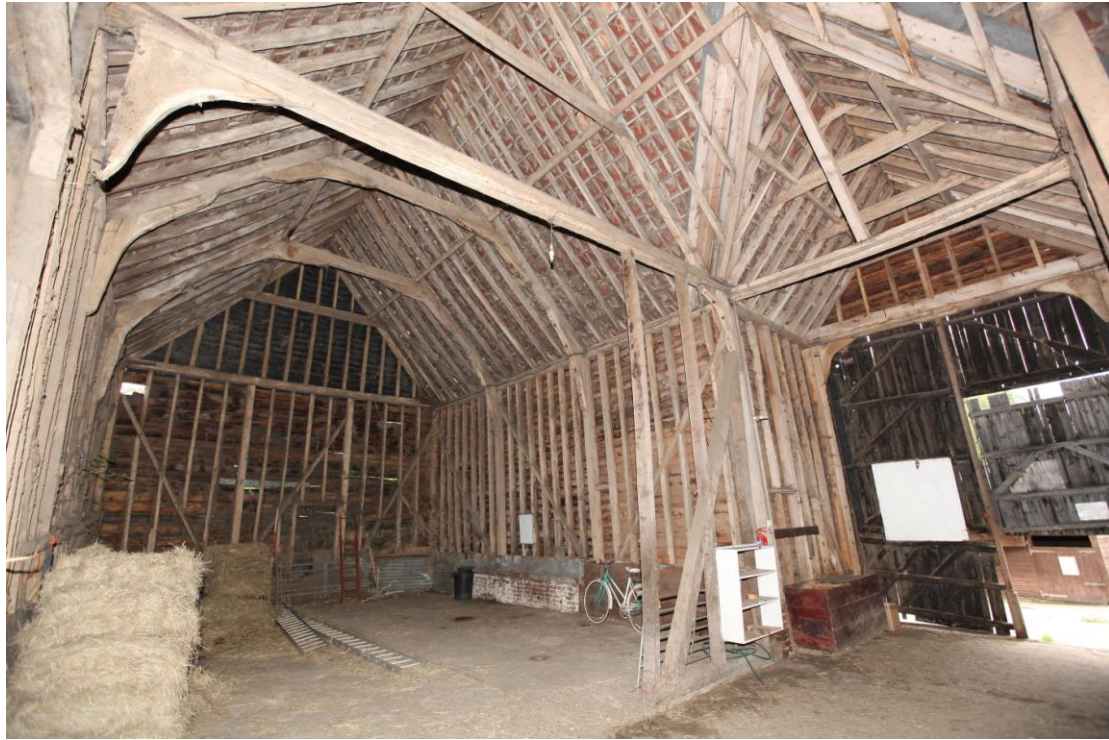
Illus. 7. A general view of the interior of the barn (1) looking south-east from its central threshing floor showing the eastern gable to the left and the integral porch to the right. There is evidence of original full-height doors to both the north and south of the threshing floor.

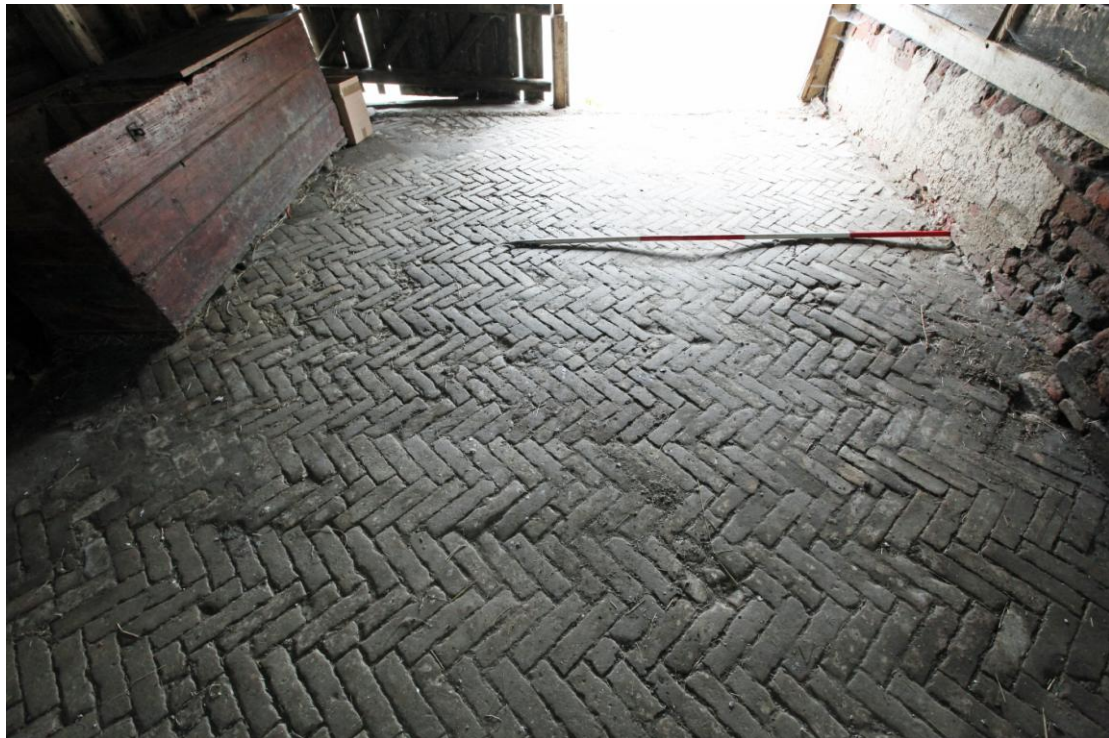
Illus. 8. A detail from the north of the exceptionally fine and complete original herringbone-pattern threshing floor of gault brick showing the painted deal 19th century grain bin to the left. Several small apotropaic circles survive on the internal weatherboarding to the right.

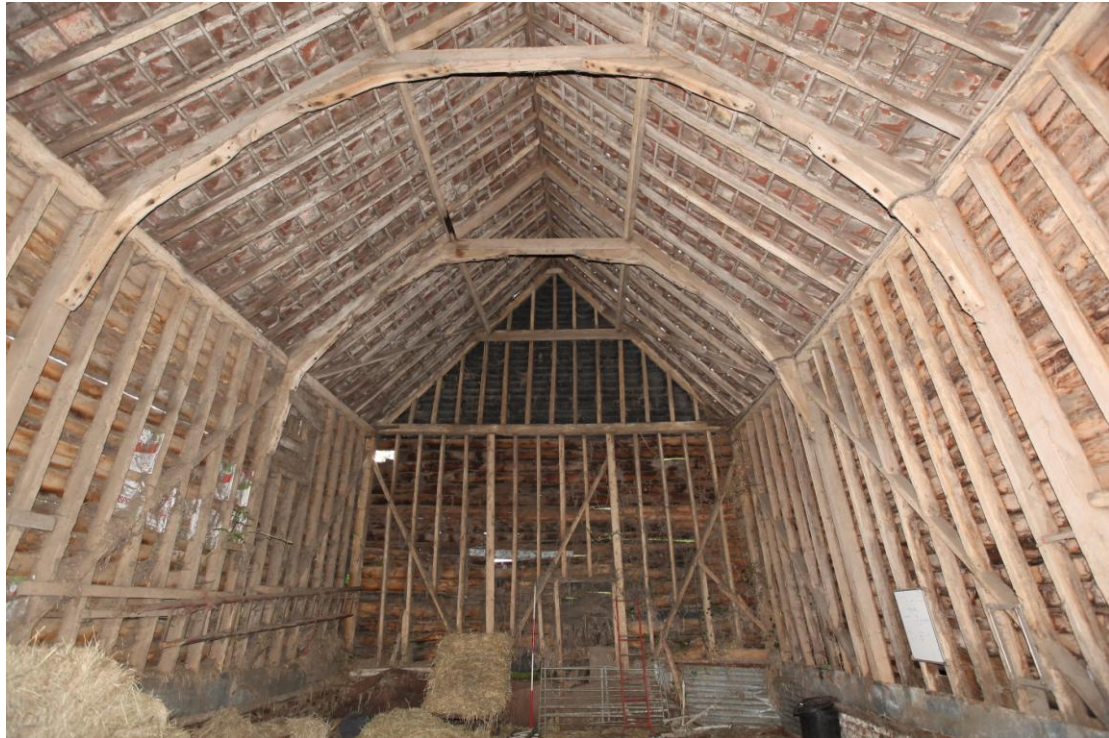
Illus. 9. The eastern bays of the barn (1) showing the remarkably complete original framing with bolted knee-braces linking the principal rafters to both the pegged roof collars and the wall posts (removing the need for horizontal tie-beams and so increasing headroom). The loading hatch in the easternmost bay to the left is an original feature.

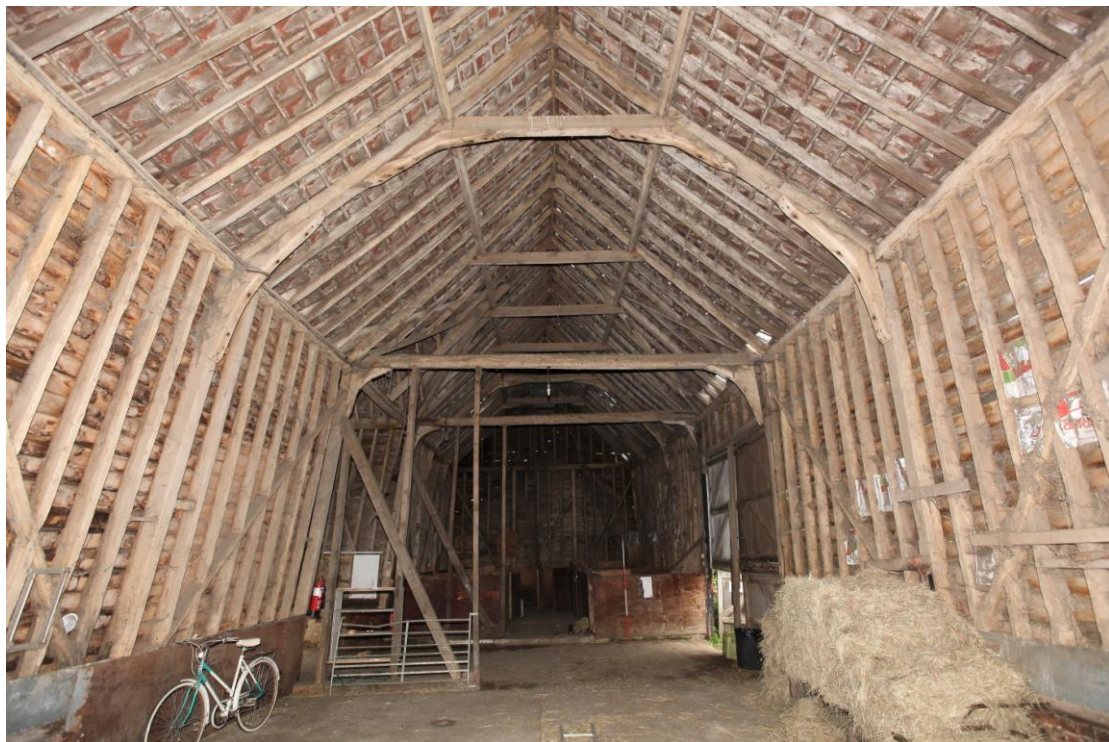
Illus. 10. The interior of the barn (1) looking west showing the knee-braced horizontal tie-beams flanking the entrance bay with later studwork beneath each. A series of boarded horse boxes was inserted into the western bays during the 1990s when the barn was converted into a riding stable.

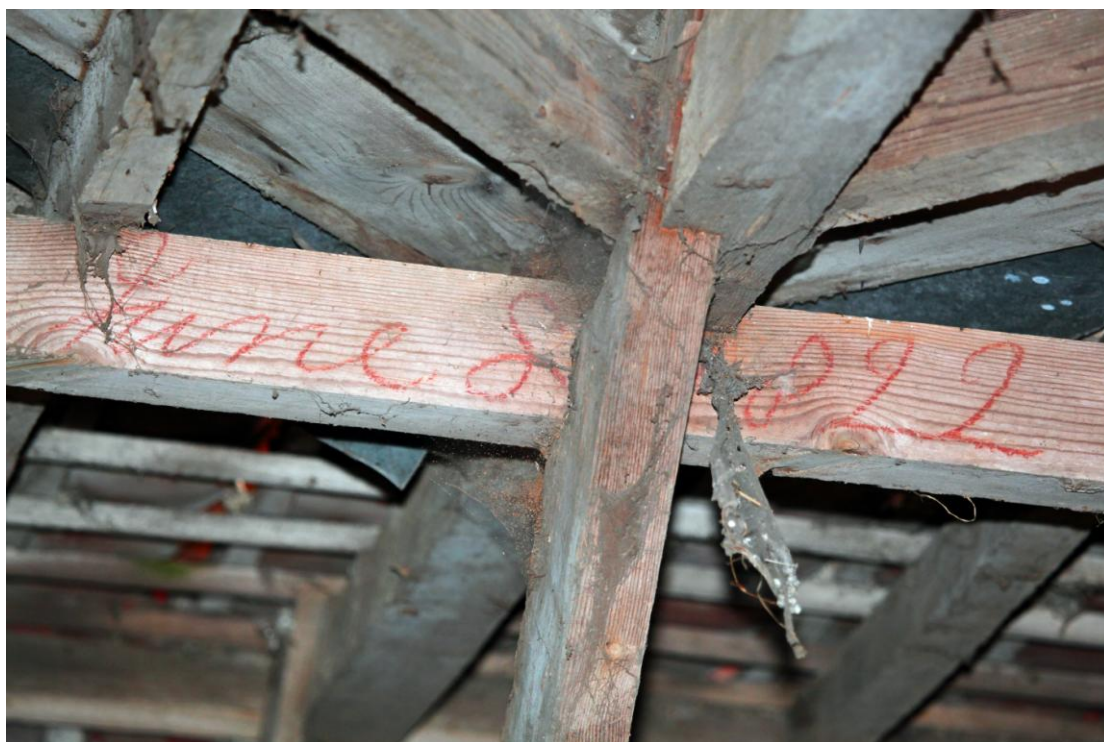
Illus. 11. A detail of the red-ochre inscription on the underside of the barn's southern purlin (reading from west to east). No. 16 of 20 photographs: 'June 8 1822' (the date of the 'Fire in these Premises'). (Slightly enhanced in Photoshop.)

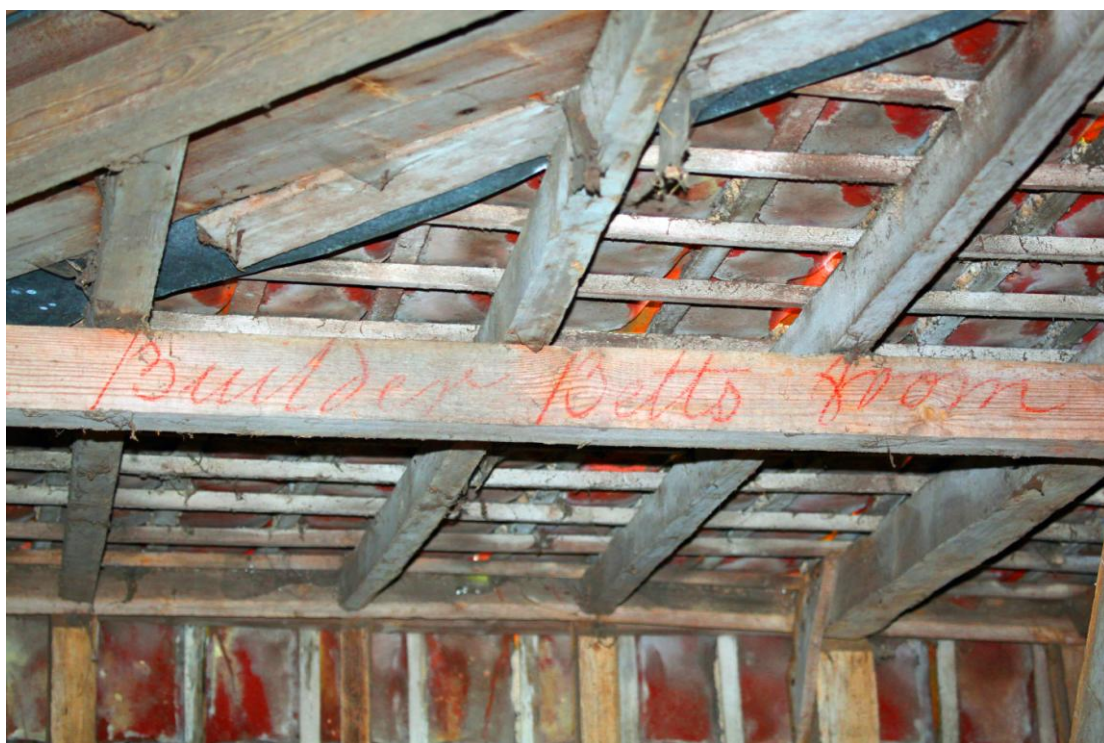
Illus. 12. A further detail of the red-ochre inscription on the underside of the barn's southern purlin. No. 17 of 20 photographs: 'Builder Betts from' (Stowmarket). (Slightly enhanced in Photoshop.)
