**Outbuilding at
Lane Farmhouse,
Wilby, Suffolk**

Enhanced Historic Building Record

April 2012

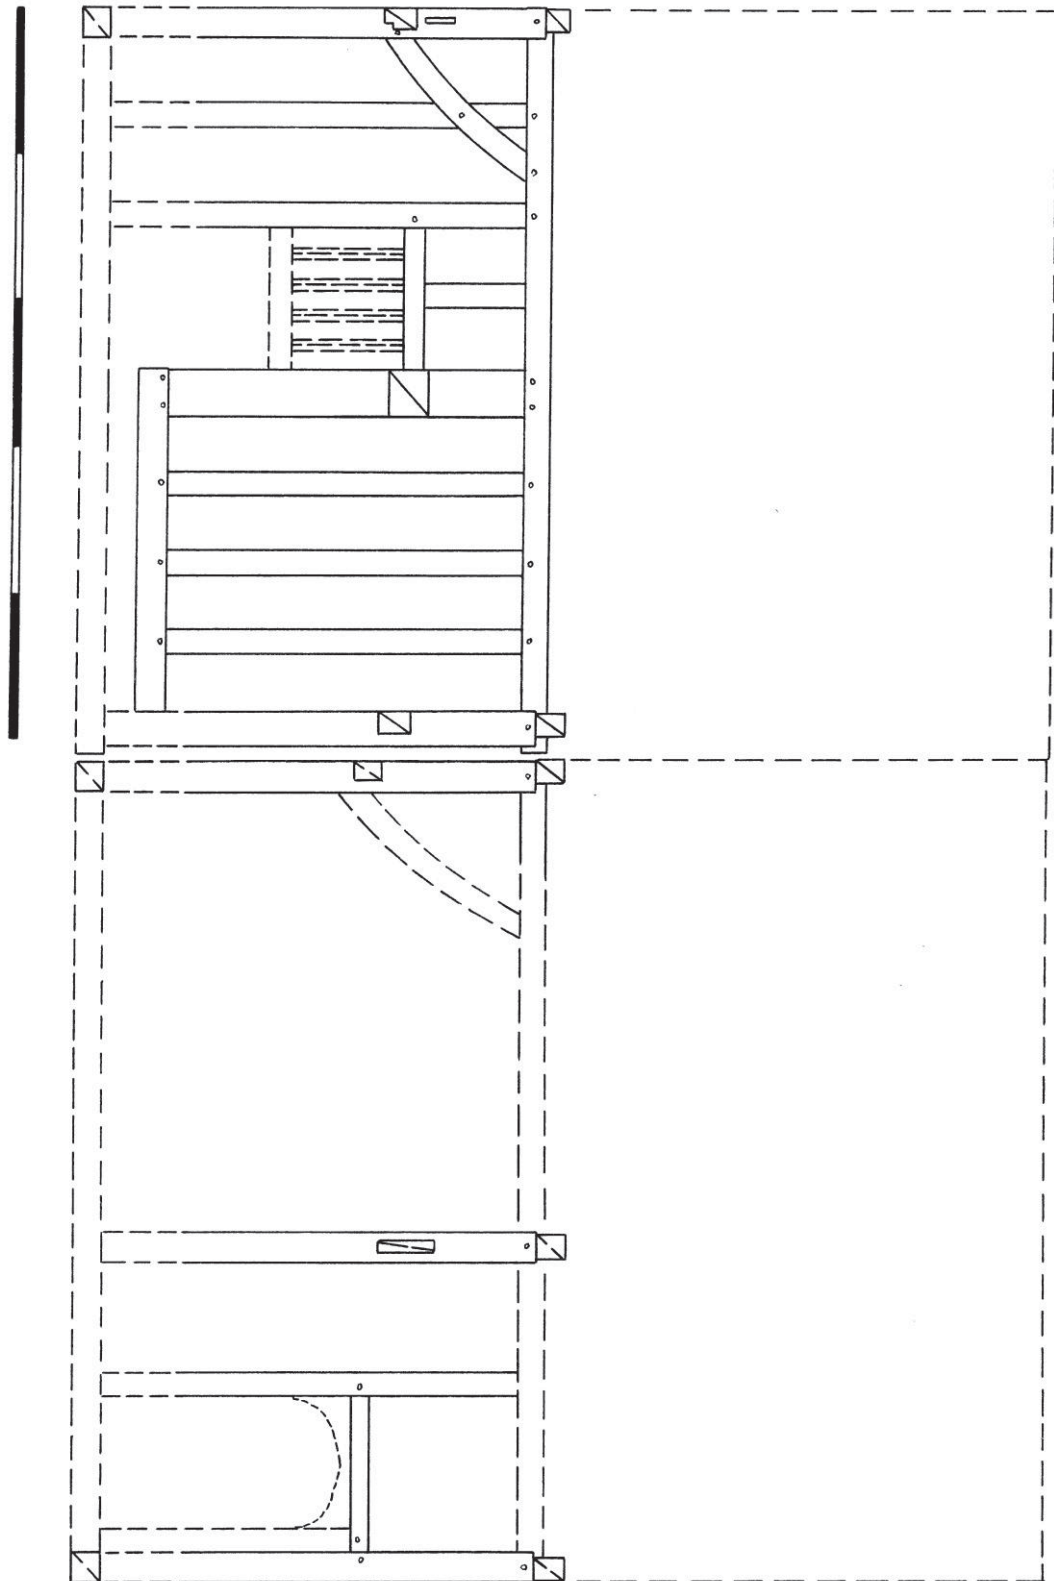
Figure 7

Northern internal elevation. The roof-plate of the former open hall to the right was replaced in the 19th century and there is no evidence of its western bay. The door arch is conjectural but the lintel and part of its western jamb are *in situ*.

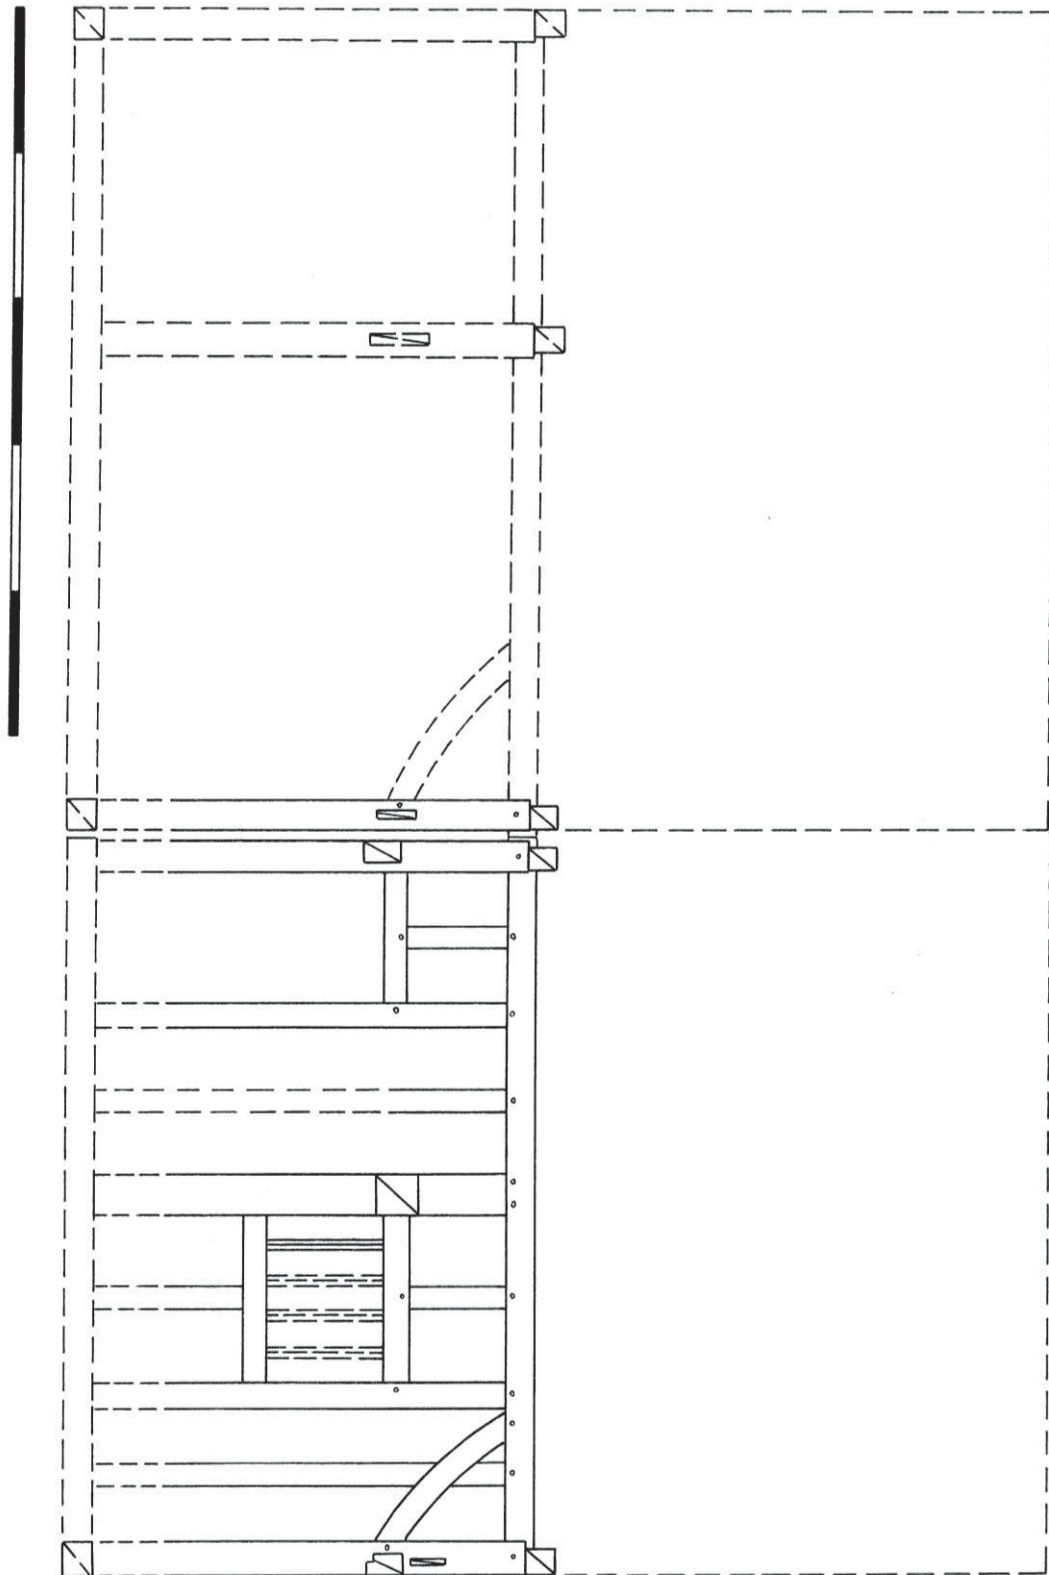
Figure 8

Southern internal elevation. The framing of the former open hall to the left was entirely replaced in the 19th century and there is no evidence of its appearance: the storey posts shown here by broken lines reflect those of the northern elevation. The gap in the 16th century frame to the right appears to be an original doorway. Note the single original diamond mullion.

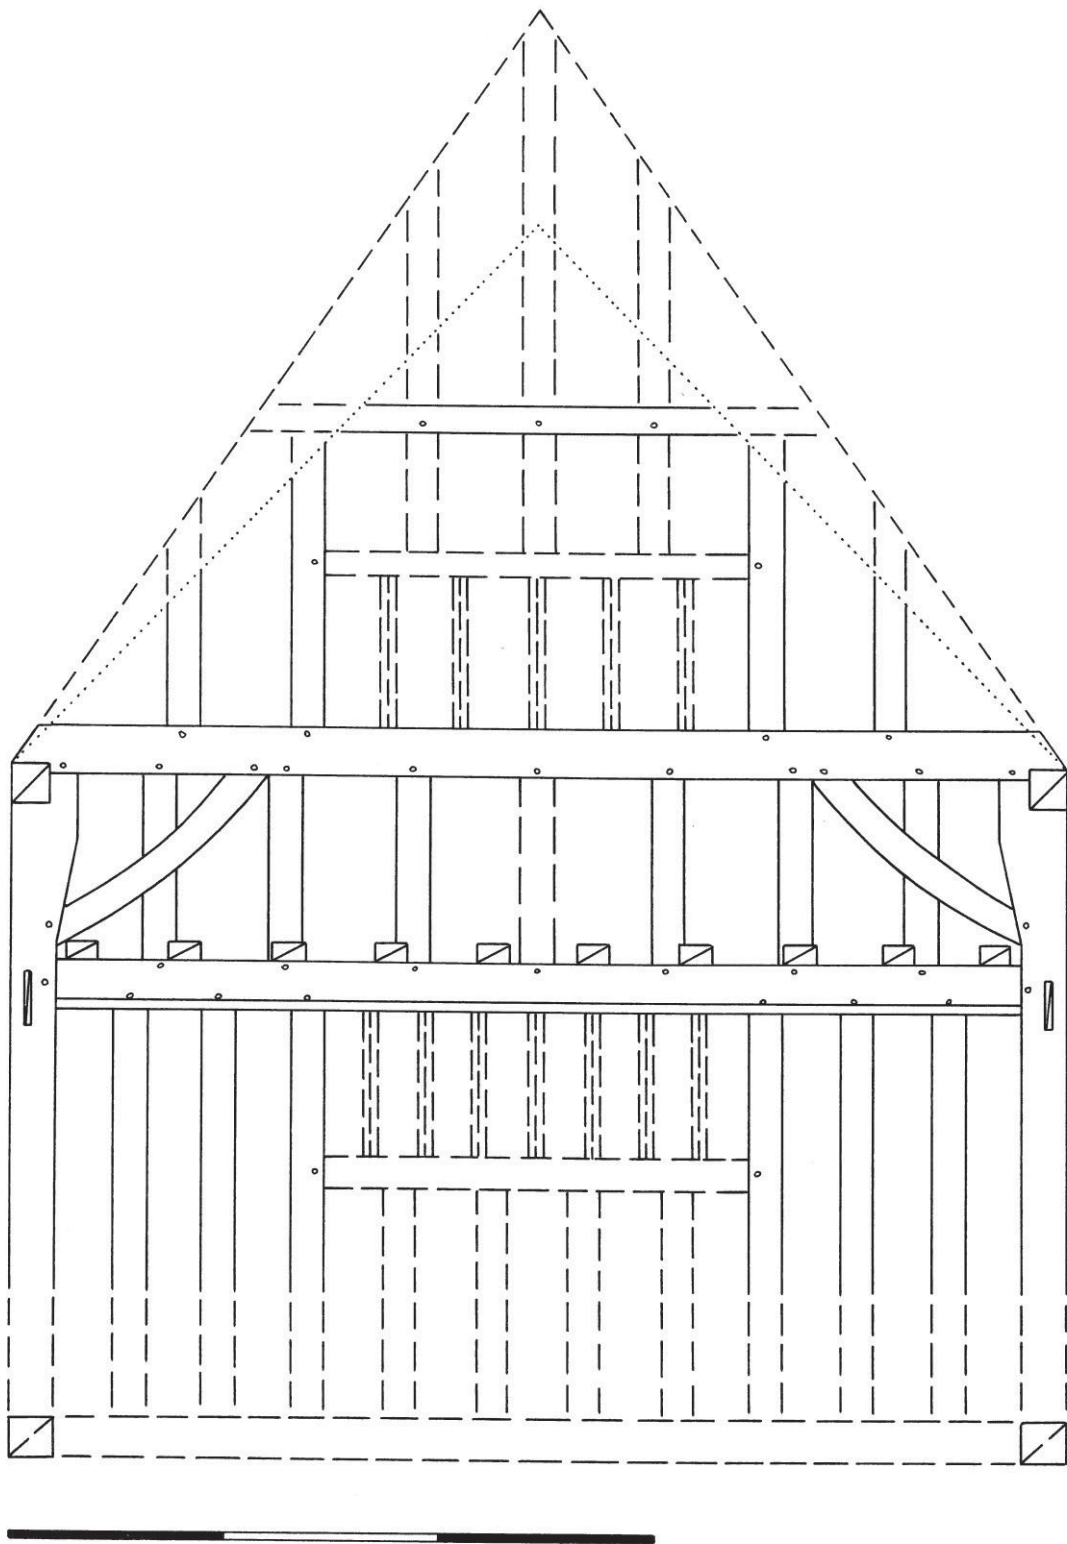
Figure 9
Interior of western gable. The pitch of the existing 20th century roof is indicated by dotted lines, and the original pitch is conjectural. A narrow shutter groove spans the length of the mid-rail.

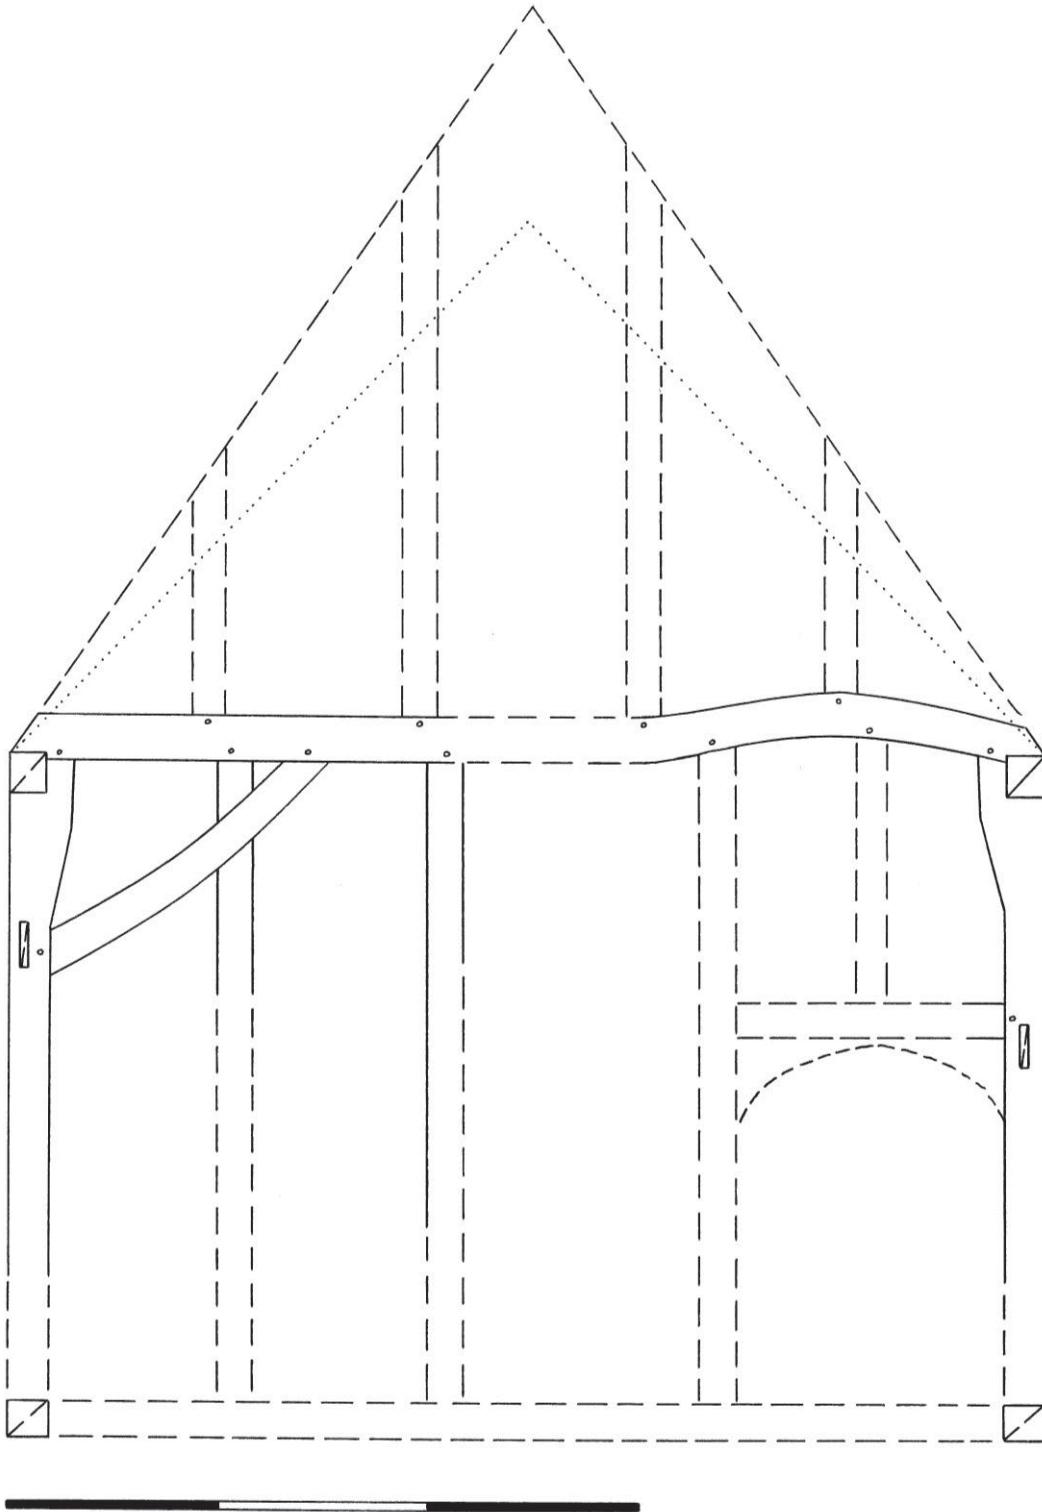
Figure 10

High-end partition of open hall (i.e. central partition viewed from east). The surviving studs and tie-beam timbers are heavily sooted. The arch door head is conjectural, and a separate jamb may have adjoined the post to the right –as in the external door to the north. The unusual curve in the tie-beam appears to have reflected the door beneath.

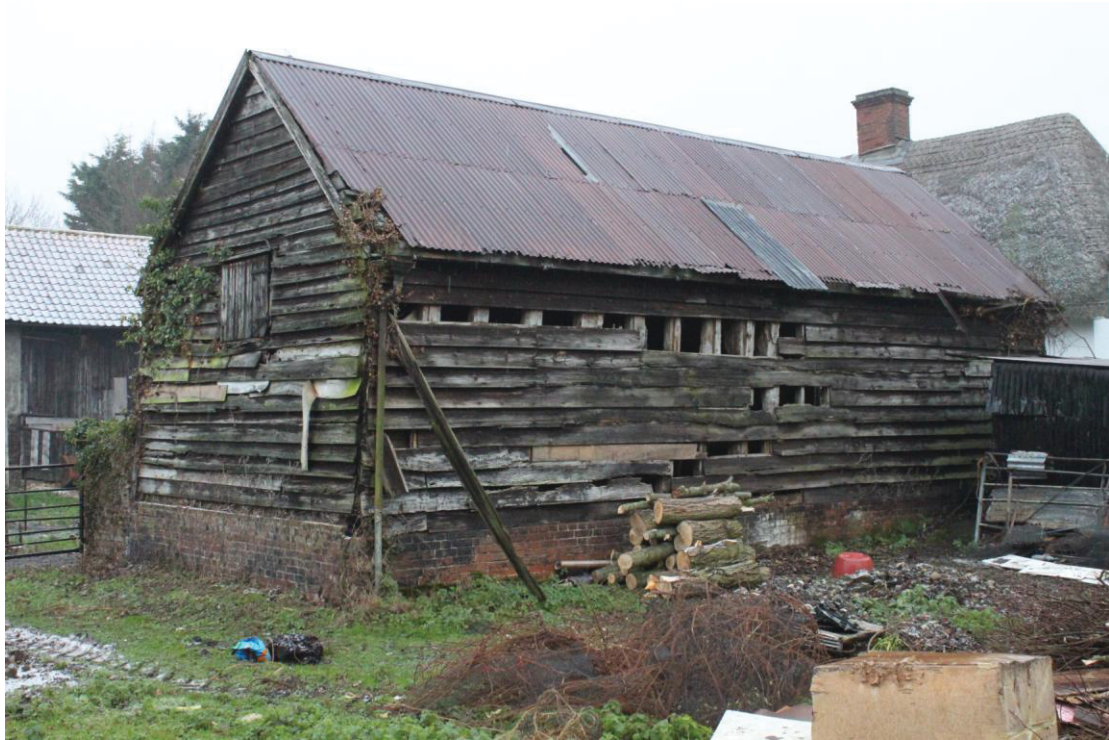
Illus. 3. Exterior of the outbuilding (1) from south-west showing loft loading hatch in western gable to left and farmhouse to right. The cladding and brick plinth are additions of the mid-19th century, at which time the building may have been moved several metres to the east (right) of its original position.

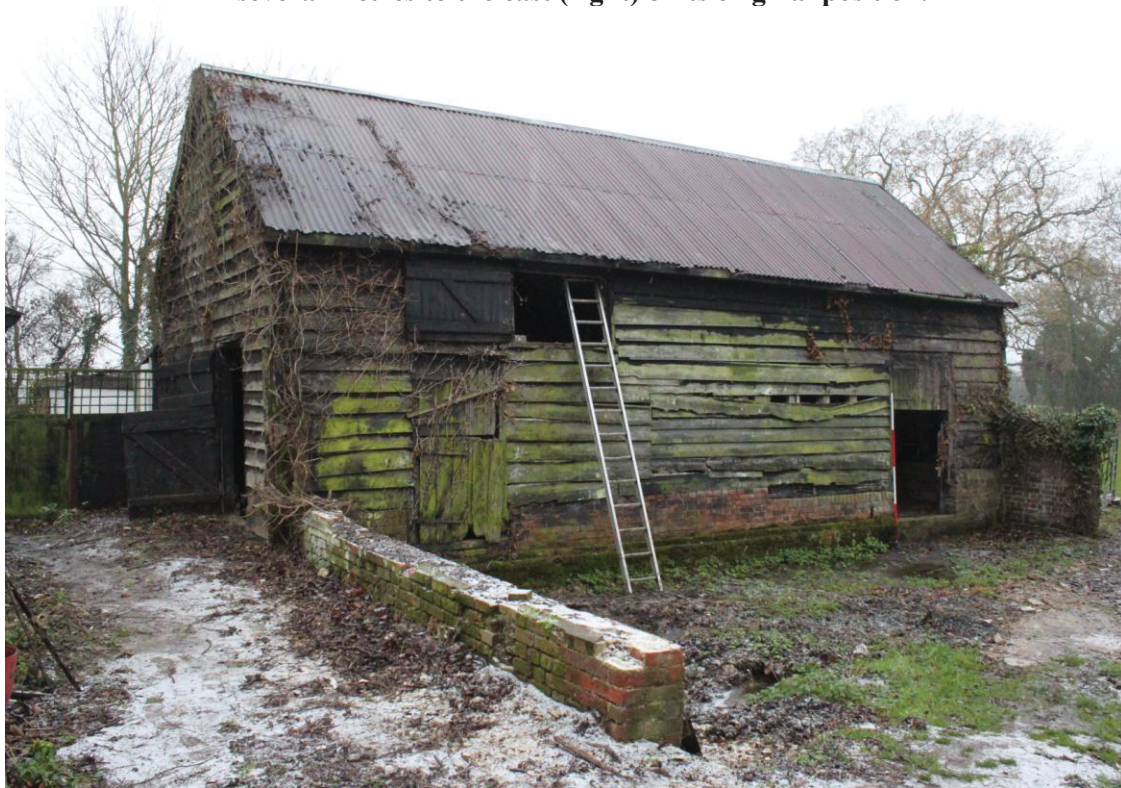
Illus. 4. Exterior of outbuilding (1) from north-east showing half-hung entrance doors to the cow house (1a) left and stable (1b) right with the loading hatch to the eastern loft and the later door in the eastern gable to the left.

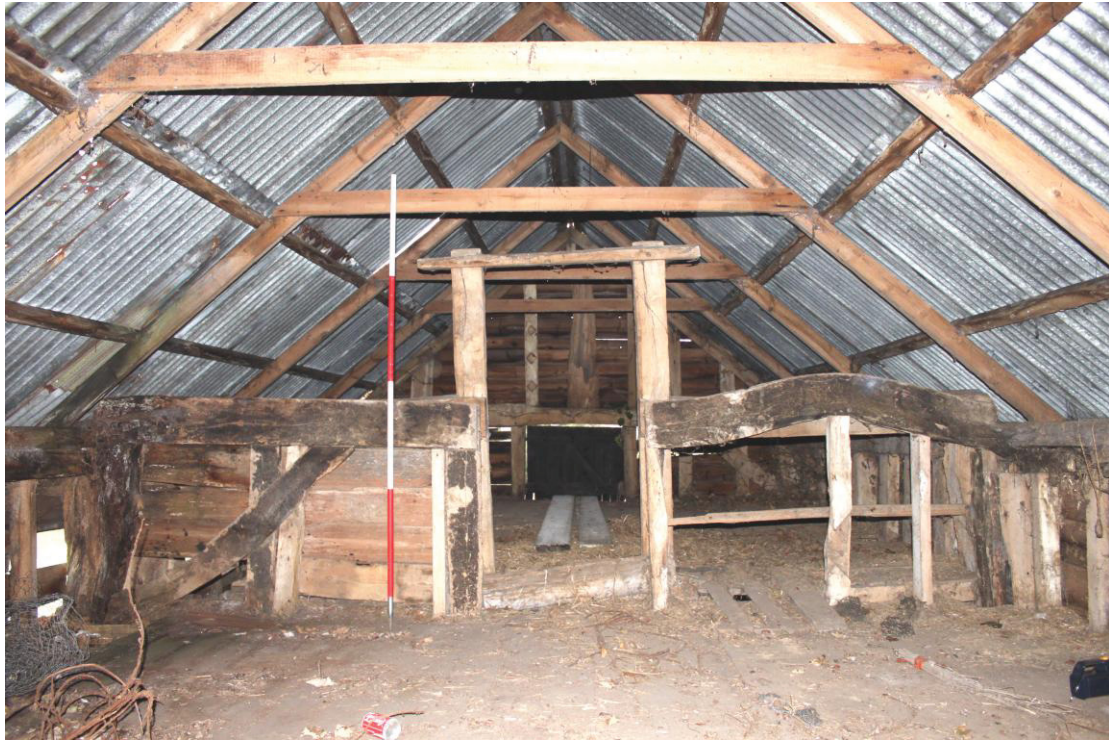
Illus. 5. Interior of eastern loft from east showing the upper part of the sooted medieval 'high-end' partition which divides the building into two halves. Note the original wall brace to the left and the bow in the tie-beam to right. This bow would have reflected an original doorway beneath, which explains the absence of a right-hand wall brace. The central door is an insertion of the 17th century and the roof is modern.

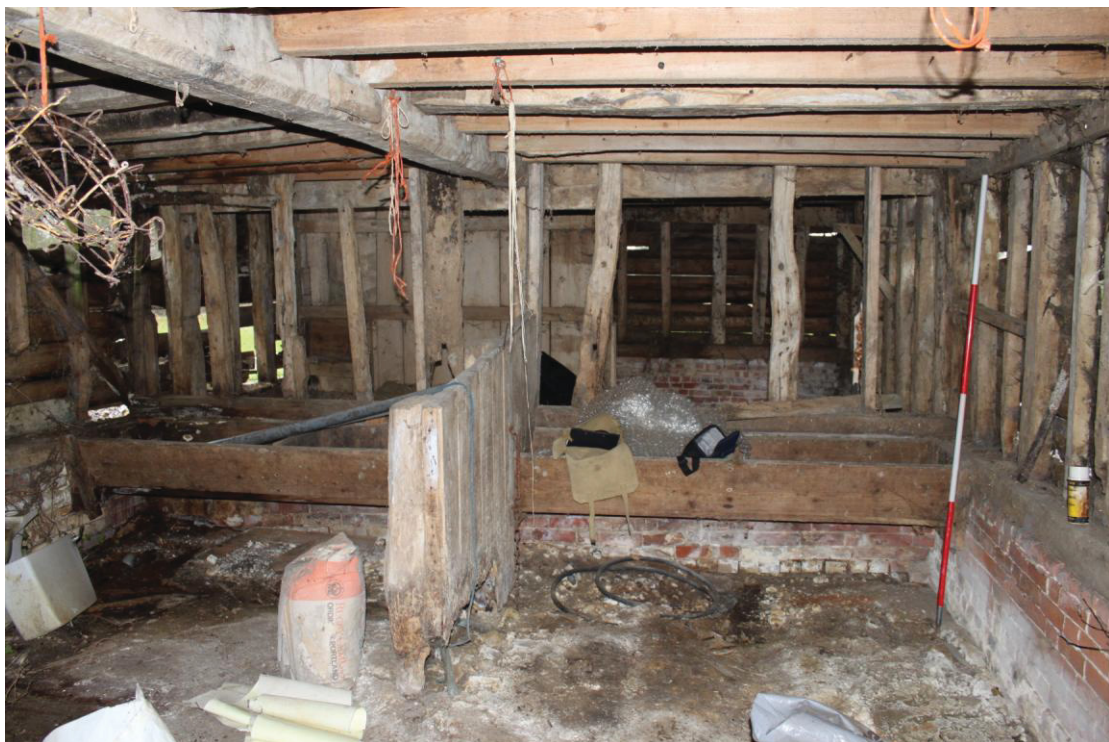
Illus. 6. Internal 'high-end' partition from east showing the low cattle manger and axial stall divider on the ground floor. A sooted original stud is visible to the left of the divider.

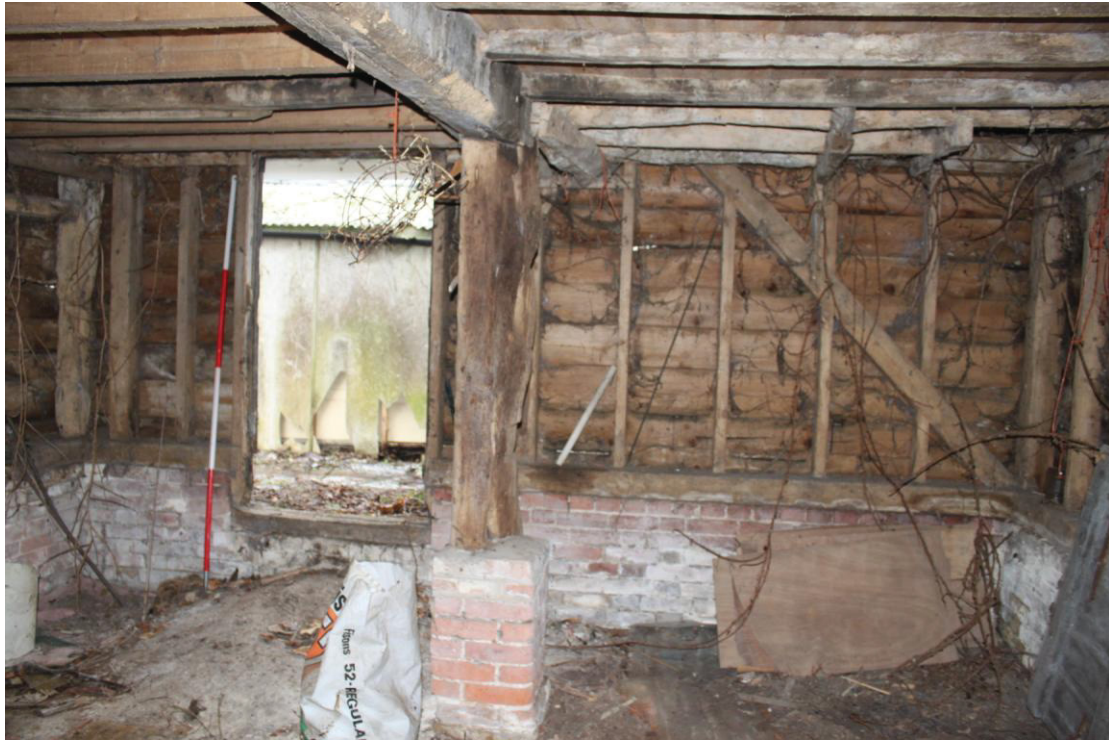
Illus. 7. Eastern internal gable showing 20th century framing with a door opening towards the farmhouse. The central post is an insertion of the 19th century which supports the end of the 17th century axial ceiling joist where it would formerly have abutted a chimney.

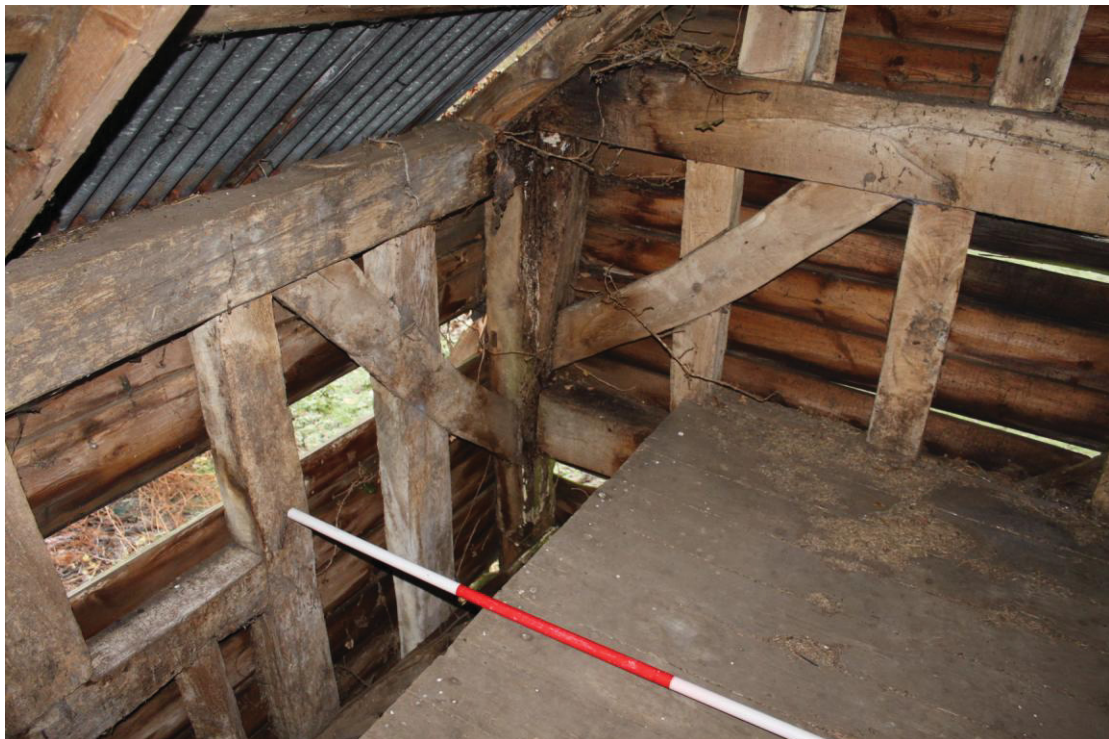
Illus. 8. Internal south-western corner of western loft showing corner braces & original diamond-mullion window to left. The left-hand mullion (not visible here) is the only original mullion to survive *in situ*. The western half of the building dates from the late-16th century in contrast to the 15th century eastern half.

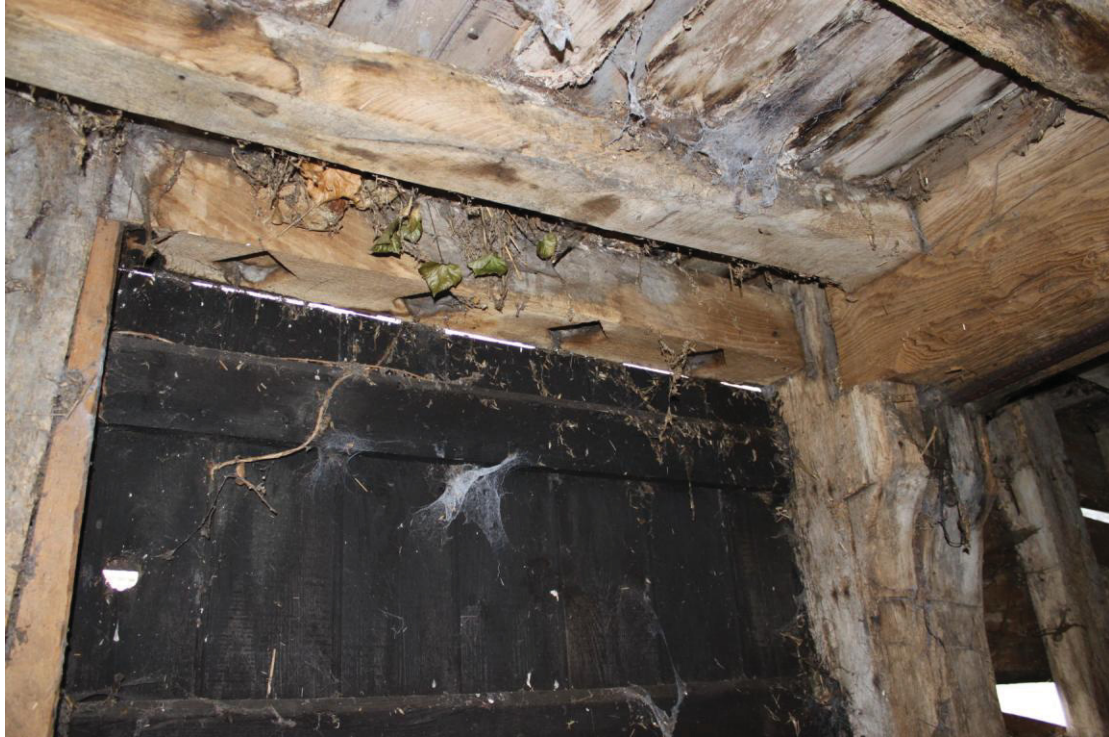
Illus. 9. Detail of the original diamond mullion mortises in the lintel of the northern door of the western stable. The step-stop chamfered binding joist with a neatly-cut corbel block is visible to the right.

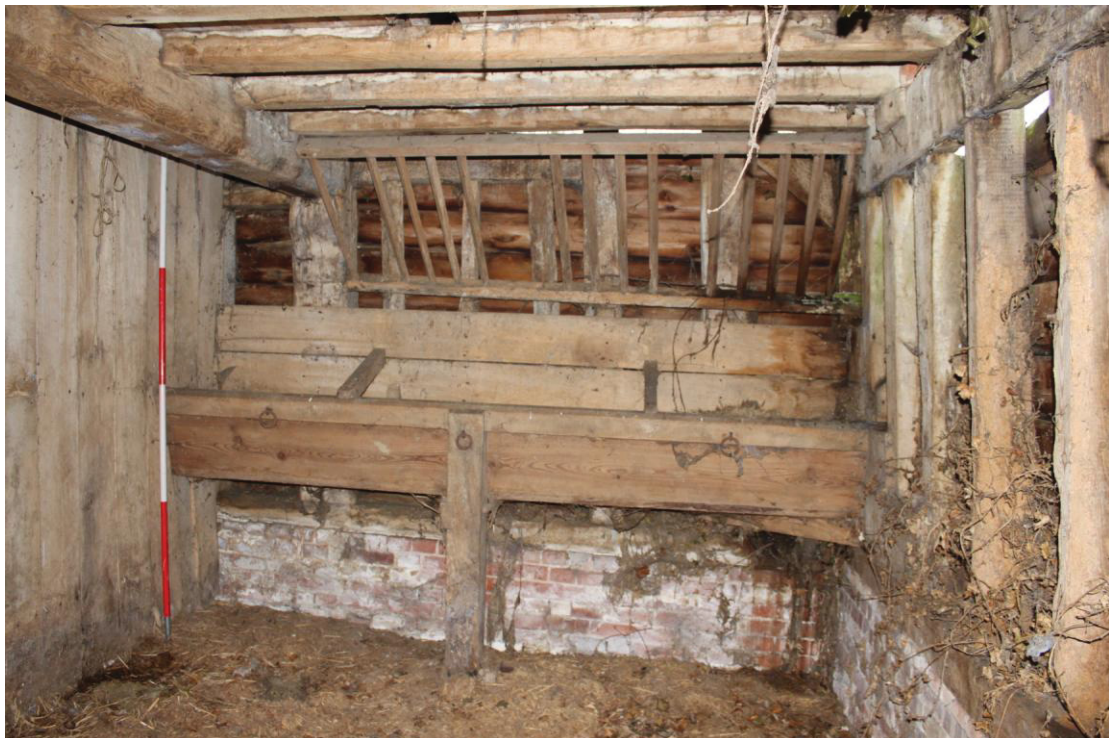
Illus. 10. The feeding trough and hay rack at the western end of the southern internal elevation (at horse height), showing the western gable to the right. Note the original diamond mullion window behind the rack (with original mullion to left), and evidence for additional mullions in the gable. A narrow shutter groove spans the entire width of this gable. The boarding to the left is a stall divider.
