**The Barn,  
Heath Farm,  
Coney Weston, Suffolk  
CNW 019**

**Heritage Asset Assessment**

# **Barn at Heath Farm, Coney Weston, Suffolk**

## **Heritage Asset Assessment**

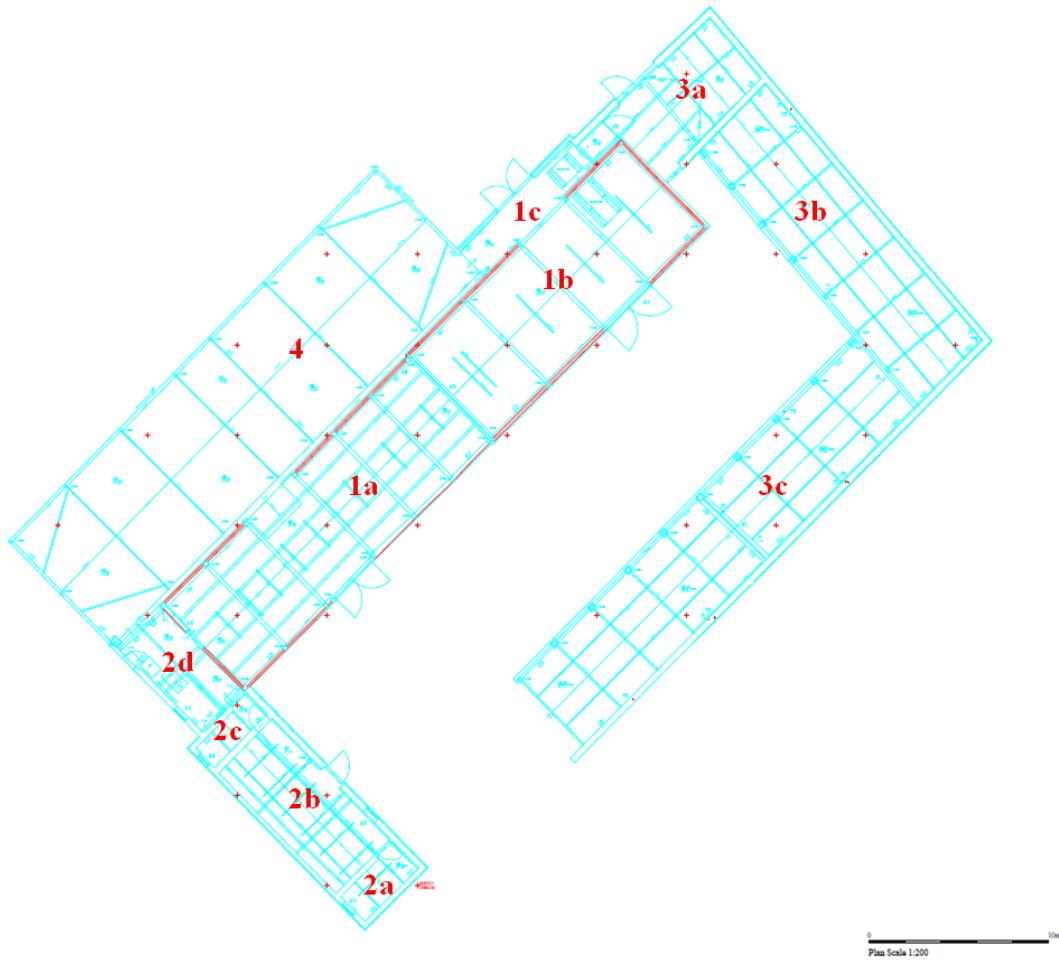
Figure 7

Ground plan of the barn complex identifying each area with a number for ease of reference in the text and photographic record. The main timber-framed and weatherboarded barn is outlined in red.

1. A large timber-framed and weatherboarded double threshing barn with a corrugated iron roof (probably replacing thatch) extending to a total of 36.1 m in length by 6.5 m in width (118.5 ft by 21.5 ft) on a north-east/south-west axis. The walls rising to 4 m (13.25 ft) at their roof-plates including flint-rubble plinths with red-brick dressing of approximately 0.6 m in height internally. Divided into two phases of construction: A six-bay 16<sup>th</sup> or early-17<sup>th</sup> century barn to the south-west (1a) and a four-bay late-18<sup>th</sup> or early-19<sup>th</sup> century barn to the north-east (1b), (referred to as the 16<sup>th</sup> and 18<sup>th</sup> century barns for simplicity in this report). The later of the two structures is *in situ*, with significant remnants of its original external boarding painted with red ochre, but the Tudor frame was moved from another site and reassembled against the 18<sup>th</sup> century barn's south-western gable at some later date (but before 1843). Both barns were originally entered from the south-east, facing the farmhouse. The remains of a contemporary rear porch project from the 18<sup>th</sup> century structure (1c) and a gault brick threshing floor survives in the 16<sup>th</sup> century barn.

2. A mid-19<sup>th</sup> century single-storied clay-lump stable with a flint-rubble north-eastern facade dressed in red brick. Corrugated asbestos roof (probably replacing pantiles) and narrow tack rooms (2a and 2c) with original wooden hooks at each end of the main stable (2b) which retains its original hay rack but has lost its manger. Linked internally to a probably contemporary but narrower clay-lump lean-to shed adjoining the south-western gable of the barn. An unusually well preserved example of a clay-lump stable.

3. An L-shaped range of open-sided shelter-sheds defining a narrow horse yard to the south-east of the barn and incorporating an enclosed shed (3a) adjoining its north-eastern gable. The latter contains an unusual storage cupboard in the angle of the barn and the rear porch (1c). The flint-rubble walls with red brick dressing may survive in part from 19<sup>th</sup> century shelter-sheds and yard walls on the site but in its present form the range did not exist in 1902 (figure 6 above) and probably dates from *circa* 1910. The king-post roof trusses, rafters and plates consist largely of deal, and an original internal partition to the south-eastern range (3c) corresponds with a yard wall shown on the historic Ordnance Surveys. The range provides good historic context for the barn and stable but is not of special interest in its own right and is not discussed further below.

4. A mid- to late-20<sup>th</sup> century steel-framed grain storage shed clad in corrugated asbestos. Of no historic significance and not discussed further below but serving to protect the original external weatherboarding of the adjoining barn and probably replacing an earlier lean-to which performed the same task.

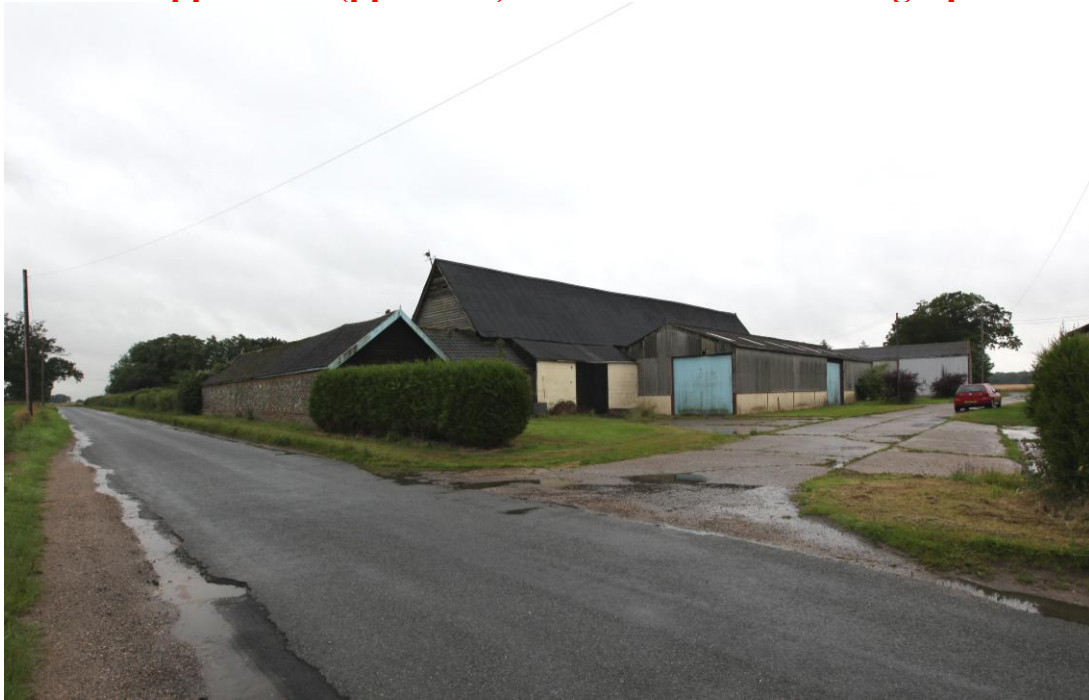
**Illus. 1. A general view of the site from the public road to the north showing the farm entrance to the right. The flint-rubble shelter-shed (3) adjoins the road to the left with the partly original lean-to porch (1c) and the 20<sup>th</sup> century store (4) adjoining the main barn (1) to the right.**

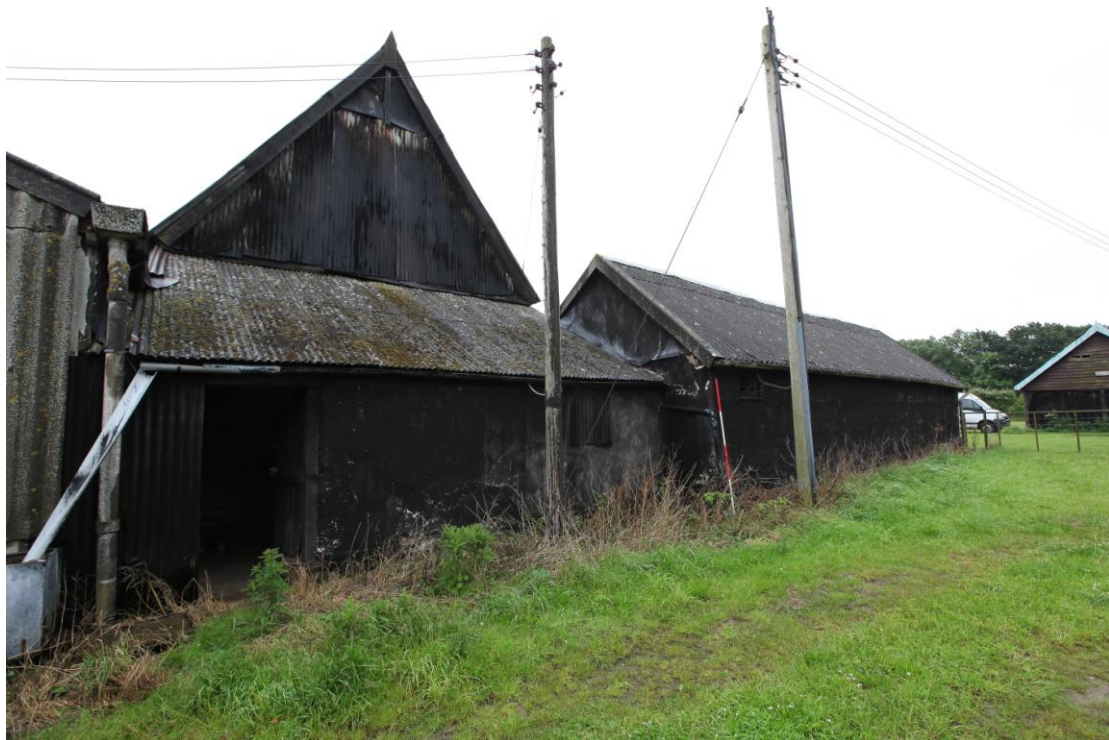
**Illus. 2. The south-western gable of the barn showing the adjoining 19<sup>th</sup> century clay-lump lean-to shed (2d) with the clay-lump stable (2a-2c) to the right and the 20<sup>th</sup> century store (4) to the left. The building in the rear to the right is an open-sided cart lodge behind the house known as 'Greystones'.**

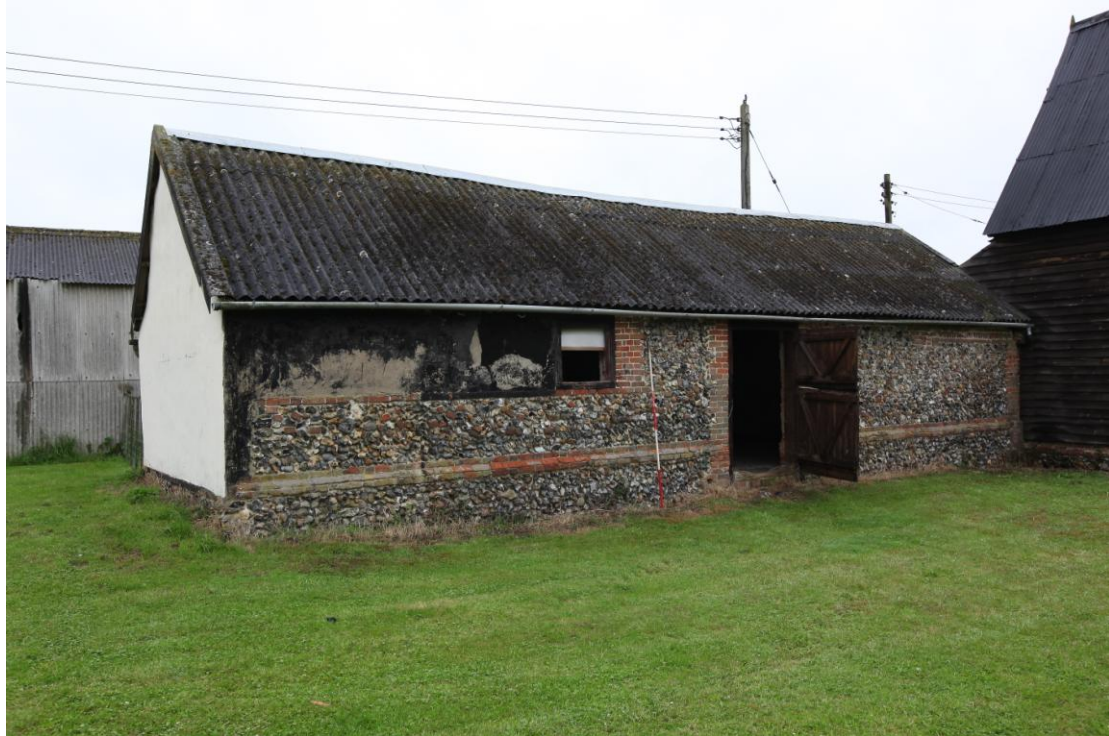
**Illus. 3. The flint-rubble north-eastern facade of the clay-lump stable (2a-2c) from the east showing its original entrance with the scar of a demolished adjoining shed to the left. The upper part of the wall to the left of the window appears always to have consisted of clay-lump. The junction with the barn (1a) is visible to the right.**

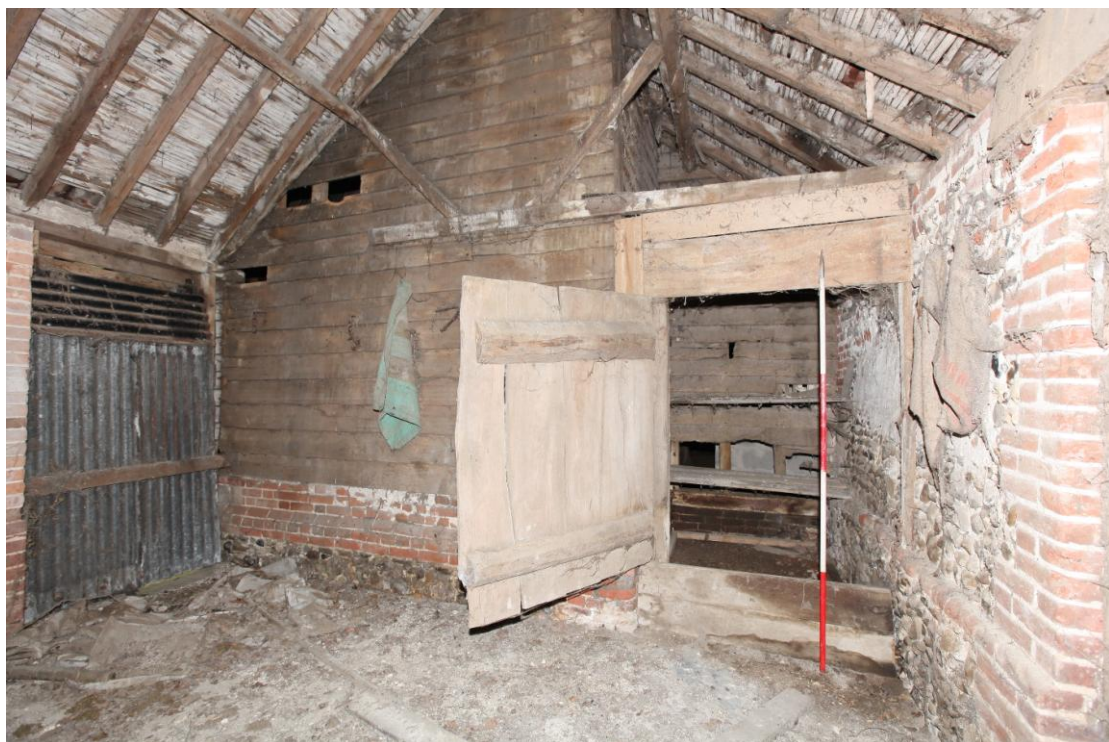
**Illus. 4. The weatherboarded north-western corner of the barn (1b) within the 19<sup>th</sup> century enclosed shed (3a). An unusual lean-to storage cupboard lies in the angle of the flint-rubble shed and the earlier porch (1c) to the right. The door to the left opens onto the horse yard.**

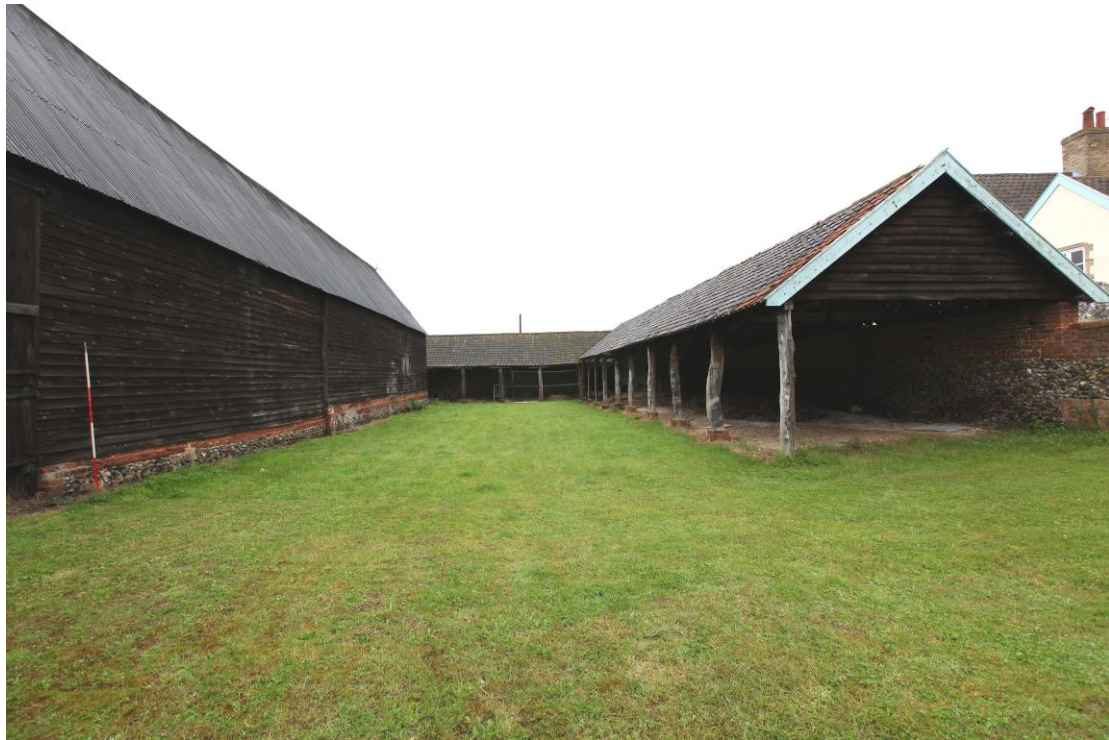
**Illus. 5. The horse yard from the south-west showing the two-phase barn (1) to the left with the open-sided shelter-sheds 3c & 3b to the right and in the rear respectively. The adjacent house known as ‘Greystones’ is visible to the right.**

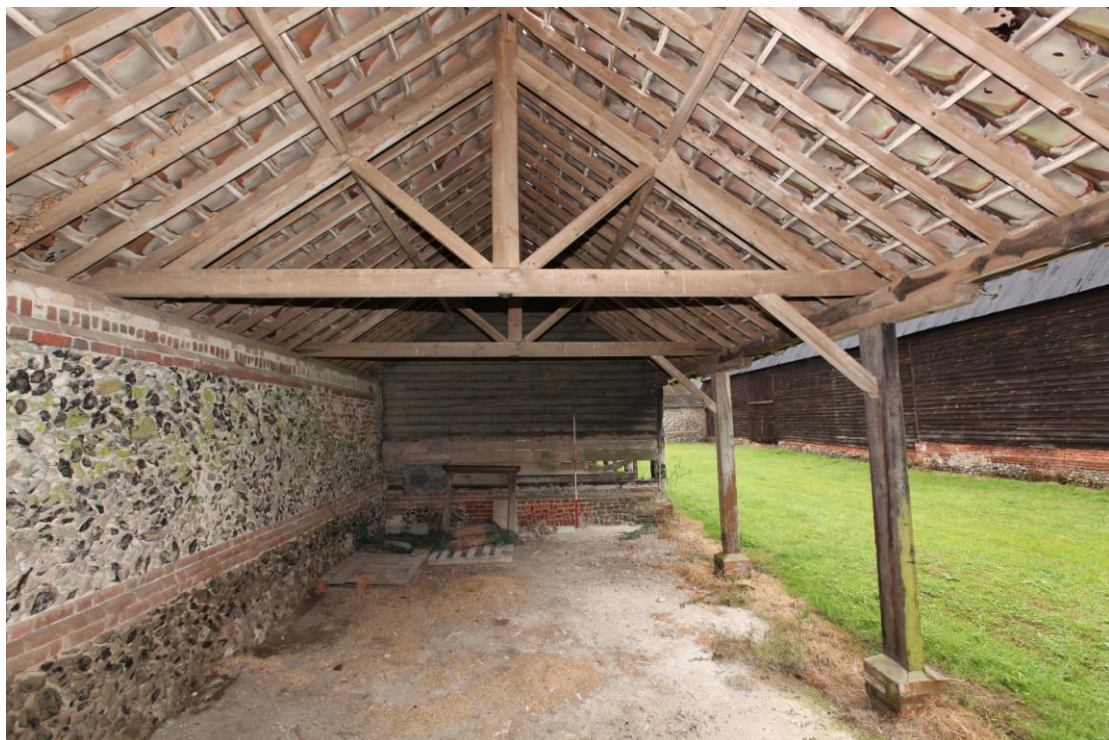
**Illus. 6. The interior from the north-east of the shelter-shed (3c) showing its flint-rubble fabric and original king-post roof trusses of machine-sawn softwood. The barn (1) is shown to the right.**

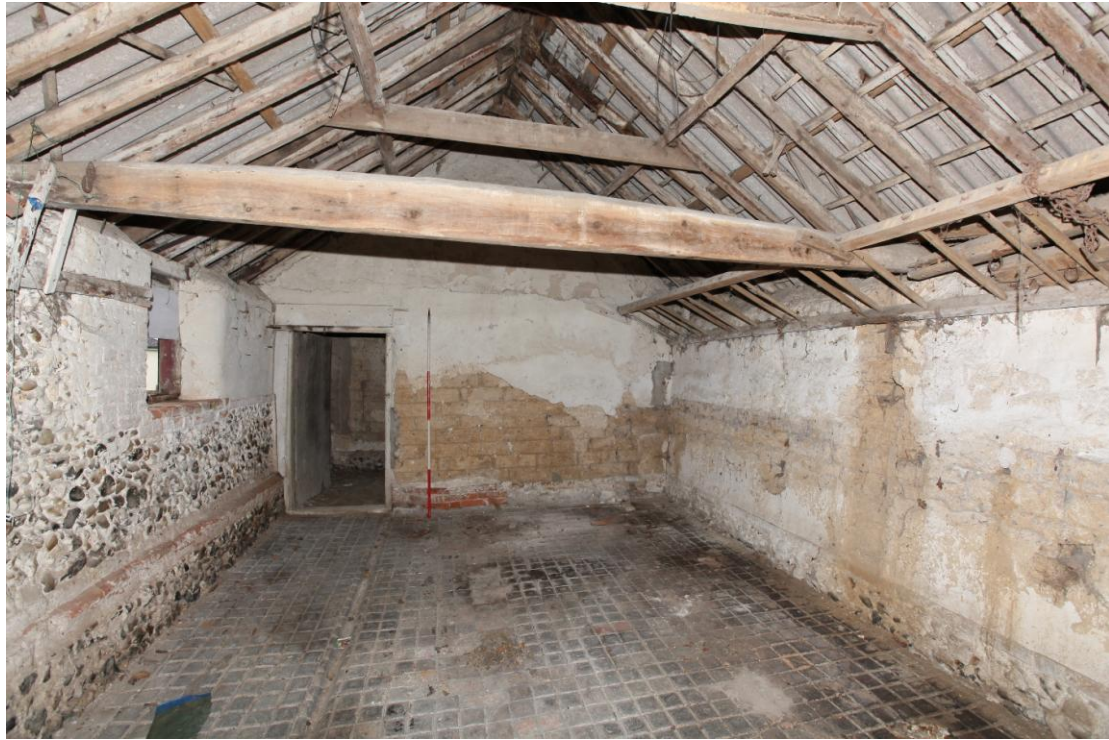
**Illus. 7.** The interior from the north-west of the single-storied clay-lump stable (2b) showing the largely intact 19<sup>th</sup> century hay rack to the right and the entrance to the southernmost of the two tack rooms (2a) to the left. The scar of the missing manger is visible beneath the rack.

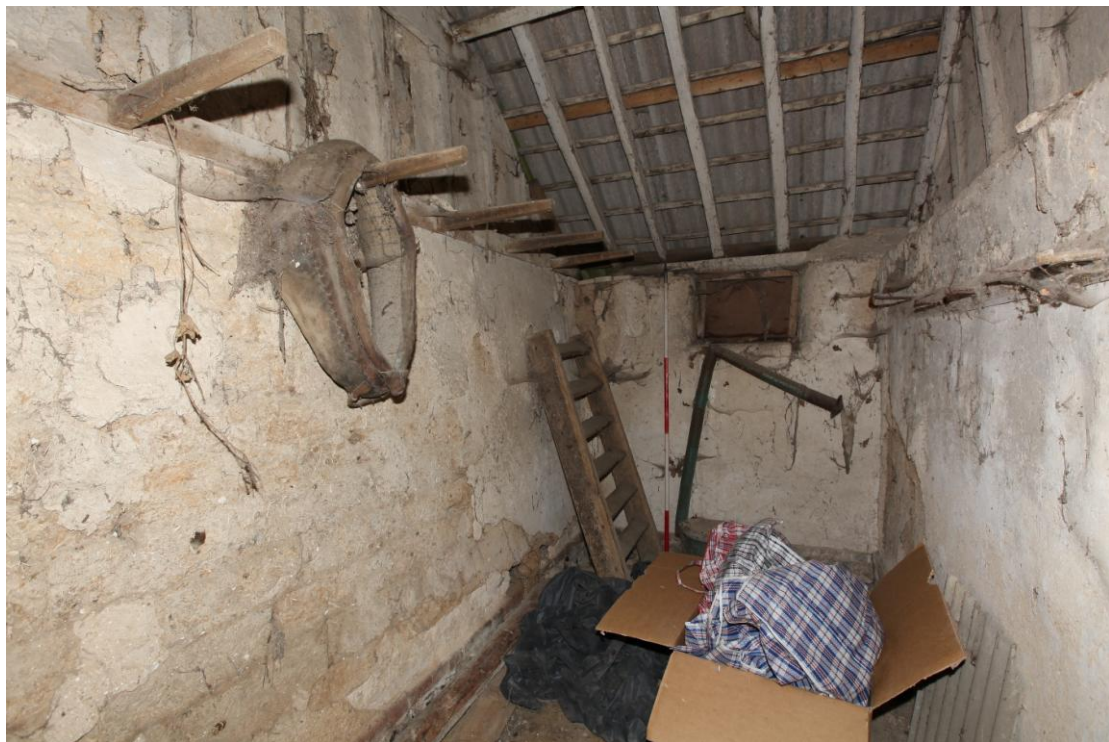
**Illus. 8.** The southern tack room (2a) from the north-east showing its clay-lump fabric with a leather horse collar hanging on a series of original wooden harness hooks to the left.

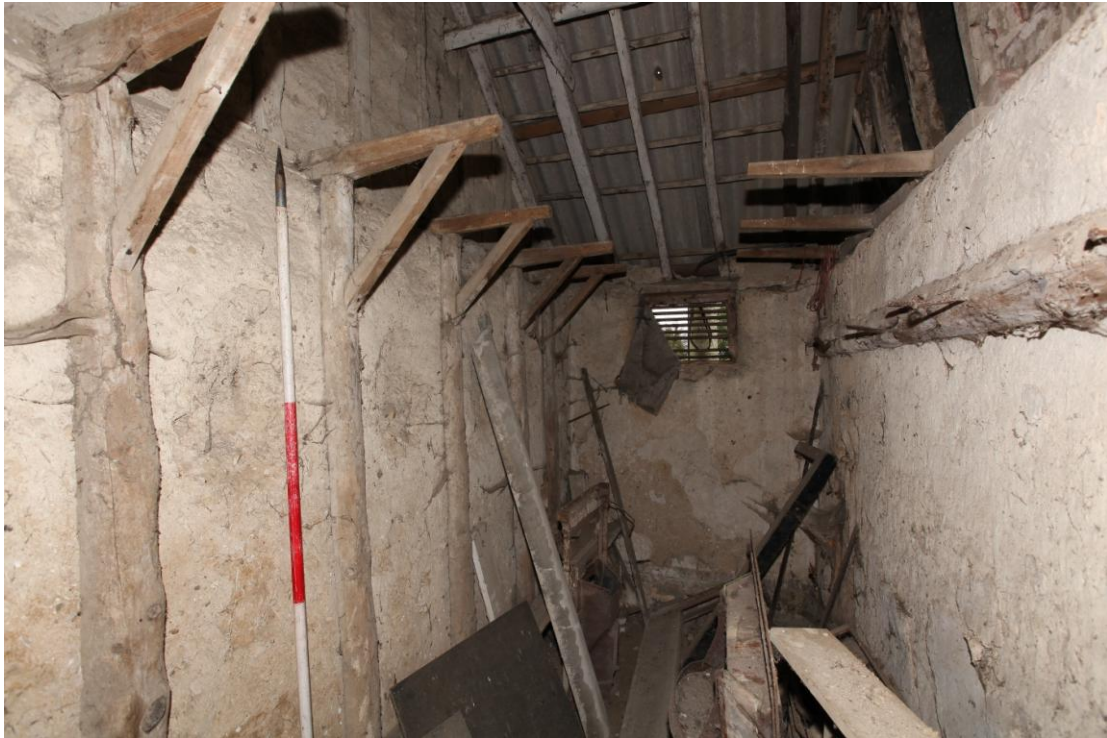
**Illus. 9. The northern tack room (2c) from the north-east showing its original wooden harness hooks to both left and right.**

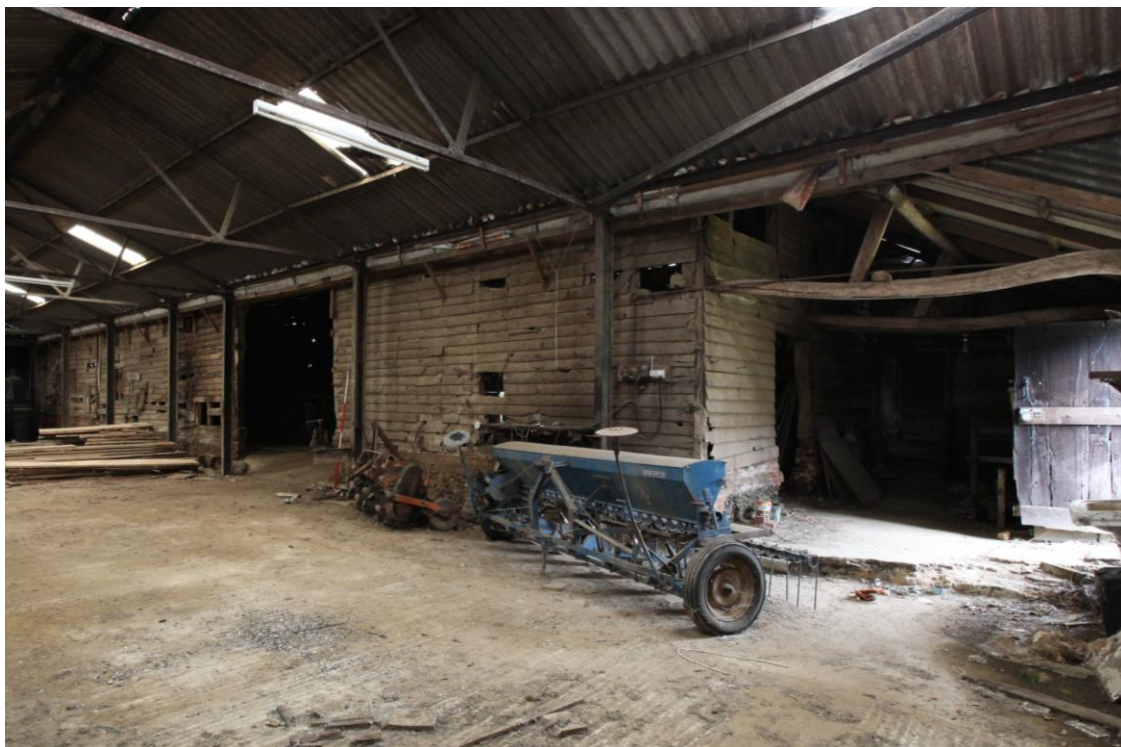
**Illus. 10. The unpainted external weatherboarding of the barn (1) from the 20<sup>th</sup> century store (4) to the west, showing the remains of the clay-lump lean-to shed (2d) adjoining the south-western gable to the right.**

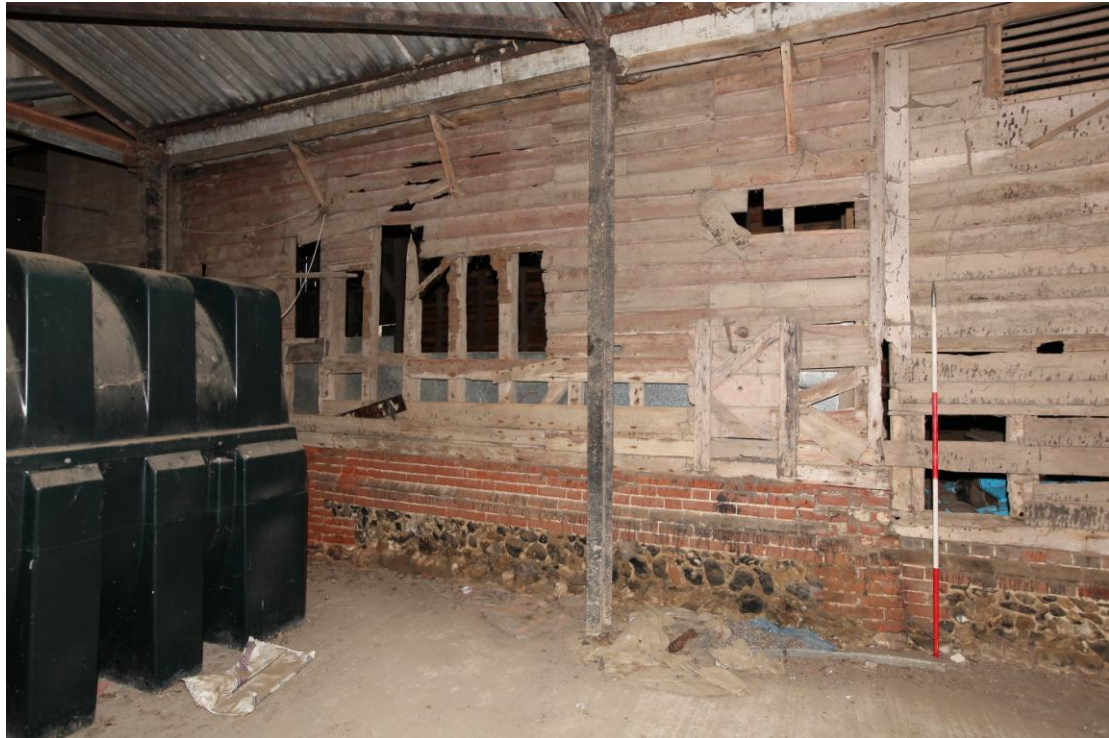
The most historically interesting aspect of this structure is the survival of extensive red-ochre pigment to the north-western external weatherboarding where it is protected within the 20<sup>th</sup> century store (4). (See illustration A2.11 below.) It was presumably preserved from the elements by a lean-to shed or similar secondary feature prior to the store's construction. Many 18<sup>th</sup> century barns were treated in this manner, long before 'Suffolk Pink' appeared on houses in the middle of the following century, and explain the 'Red Barn' at Polstead where Maria Marten was famously murdered in the 1820s. Most evidence was obliterated in the late-19<sup>th</sup> century when tar became available as a cheap by-product of the town gas industry. If not coloured red, white or 'blue' (a blue/grey colour created by adding lamp-black to whitewash), weatherboarding was traditionally left unpainted, and the contrast between the extensive red of the side elevation, which would have been visible from the road, and the rear (south-western) gable is of particular interest. The gable's cladding was largely unpainted, but red ochre was used to define the loading hatches (at least one of which is secondary as it interrupts studs in the tie-beam) and the overhanging rafters as detailed above.

**Illus. 11.** The weatherboarded north-western exterior of the barn from the 20<sup>th</sup> century store (4) showing the junction between its two phases. The boarding of the 18<sup>th</sup> century structure (1b) to the left of the scale rod retains traces of original red-ochre pigment, but there is no evidence of colourwash to the 16<sup>th</sup> century bays (1a) on the right.

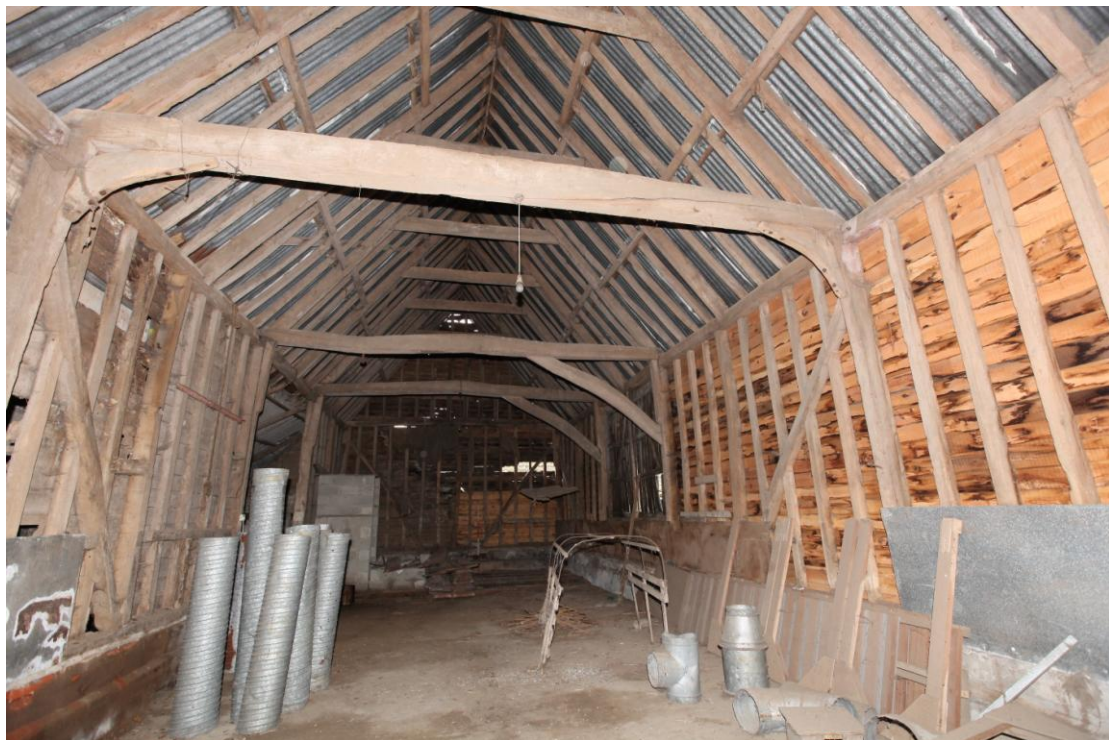
**Illus. 12.** The interior of the four-bay 18th century barn (1b) from the south-west. The timber frame remains largely intact, with two original arch-braces flanking the south-eastern entrance and bolted knee-braces to the outer tie-beam in the foreground.

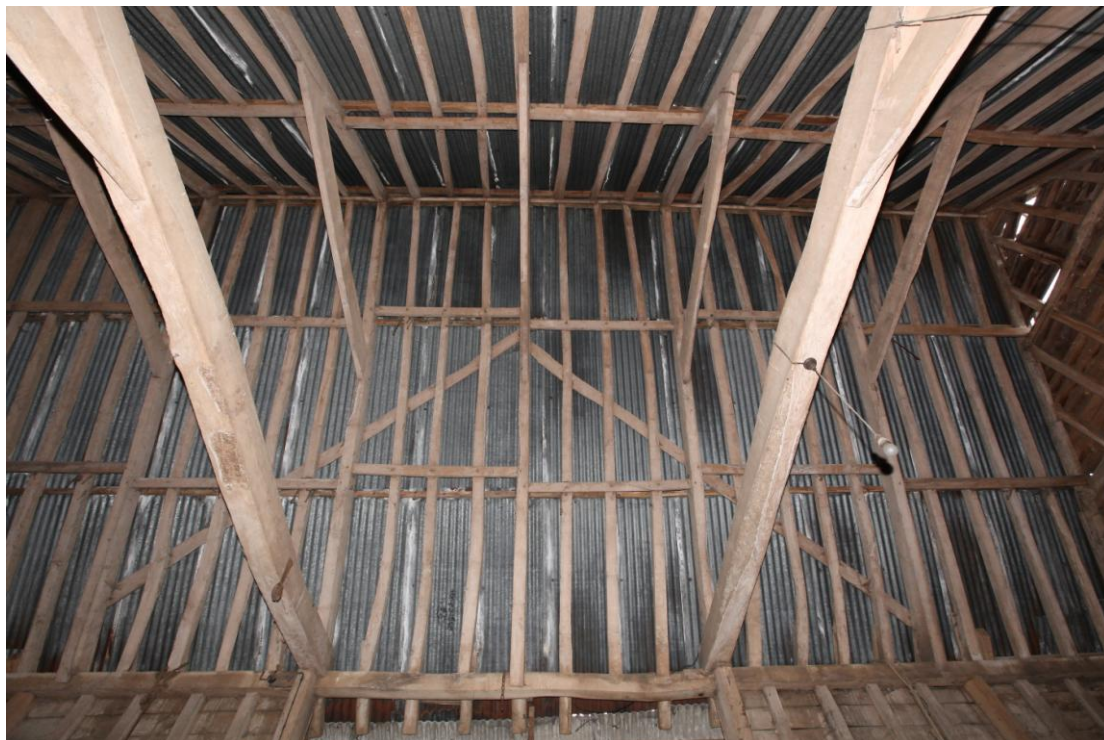
**Illus. 13.** The diagonal lap boards in the north-western roof of the 18th century barn (1b) reflecting the original gabled roof of the rear porch (1c). The staggered butt-purlin structure, with pegged collars and a ridge-board, is completely intact.

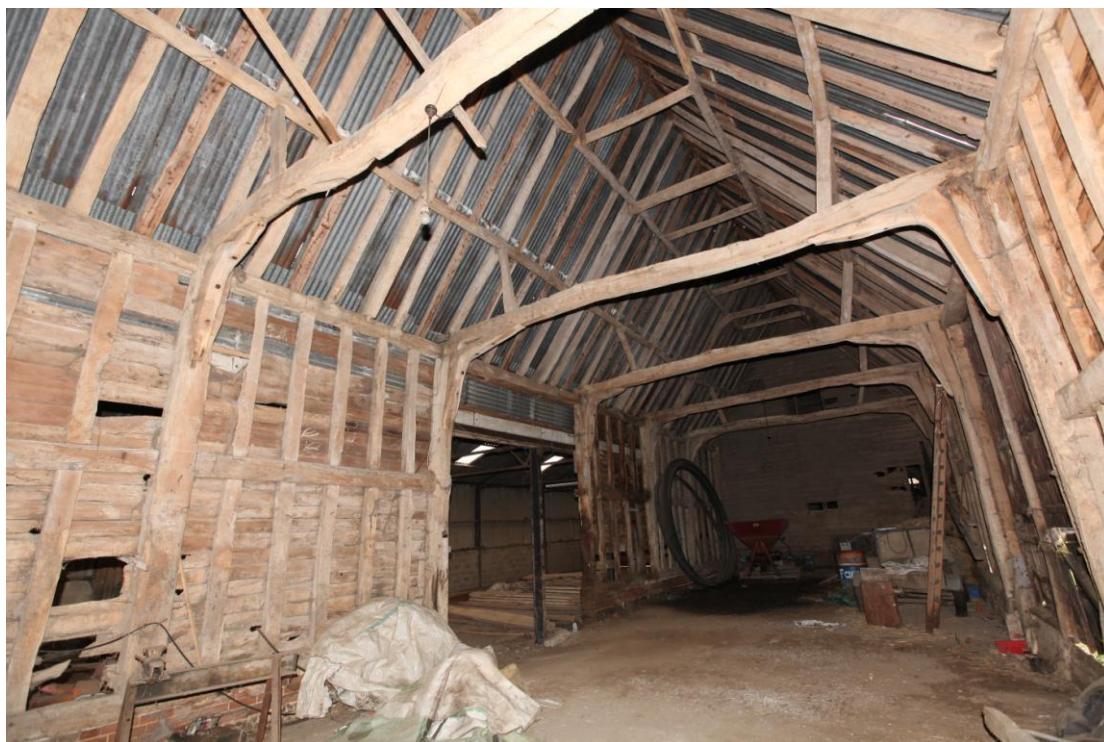
**Illus. 14.** The six-bay 16th century barn (1a) seen from the south-west. The original arch-braces to the tie-beams have been replaced by bolted knee-braces but the majority of its studs and mid-rails survive with evidence of internally trenched wall braces to all four corners.

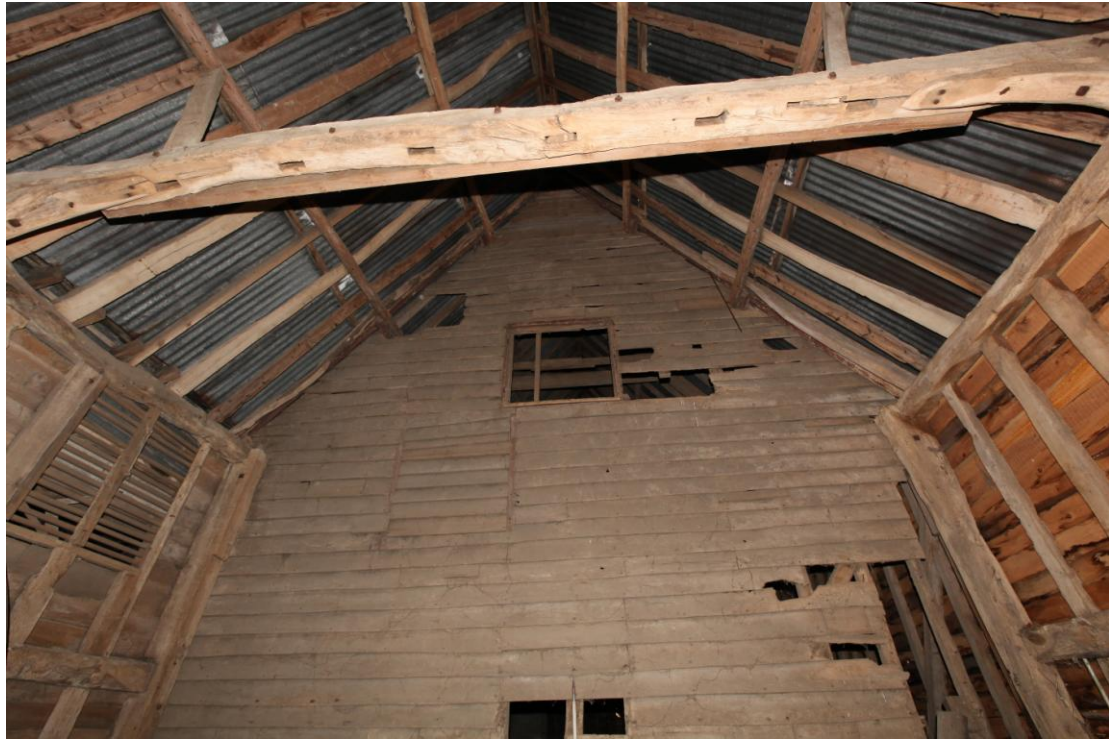
The most obvious physical proof that the entire structure has been re-used lies at the north-eastern end of the frame, where the timbers of the original gable are missing and the corner posts abut the intact, weatherboarded gable of the 18<sup>th</sup> century barn (1b). Had the latter been built as an extension to the 16<sup>th</sup> century barn (as the list description states), the situation would have been reversed, with the 18<sup>th</sup> century building borrowing the gable of its older neighbour. More dramatically still, the 18<sup>th</sup> century gable was clearly an external wall at some point, exposed to view before the Tudor frame was added: it contains two external loading hatches neatly defined with red-ochre pigment, and the final rafters of the roof (projecting in the manner of a barge board) are similarly painted along with the ends of the purlins to which they are nailed. The selective use of red ochre in this manner is a rare survival, protected by the 'Tudor' extension, which sheds important light on the appearance of local barns in the late-18<sup>th</sup> century. The 1777 enclosure map (figure 2) confirms the structural evidence, showing the site as an empty field in the middle of what had been rough heath land until the previous year. The ownership link with Hall Farm, as recounted above, offers a possible origin for the 16<sup>th</sup> century barn, which could have been made redundant by the new early-19<sup>th</sup> century 'Napoleonic' farm buildings that survive on this higher status site.

**Illus. 15. The north-eastern end of the 16<sup>th</sup> century structure (1a) showing the intact weatherboarding of the 18<sup>th</sup> century structure's external gable complete with red ochre pigment to its projecting rafters and hatch rails. The framing of the 16<sup>th</sup> century gable is lacking and the left-hand post is a replacement – suggesting that the earlier barn was moved to its present position only after the completion of the 18<sup>th</sup> century barn. The tie-beam above contains empty mortises for an internal stable partition.**

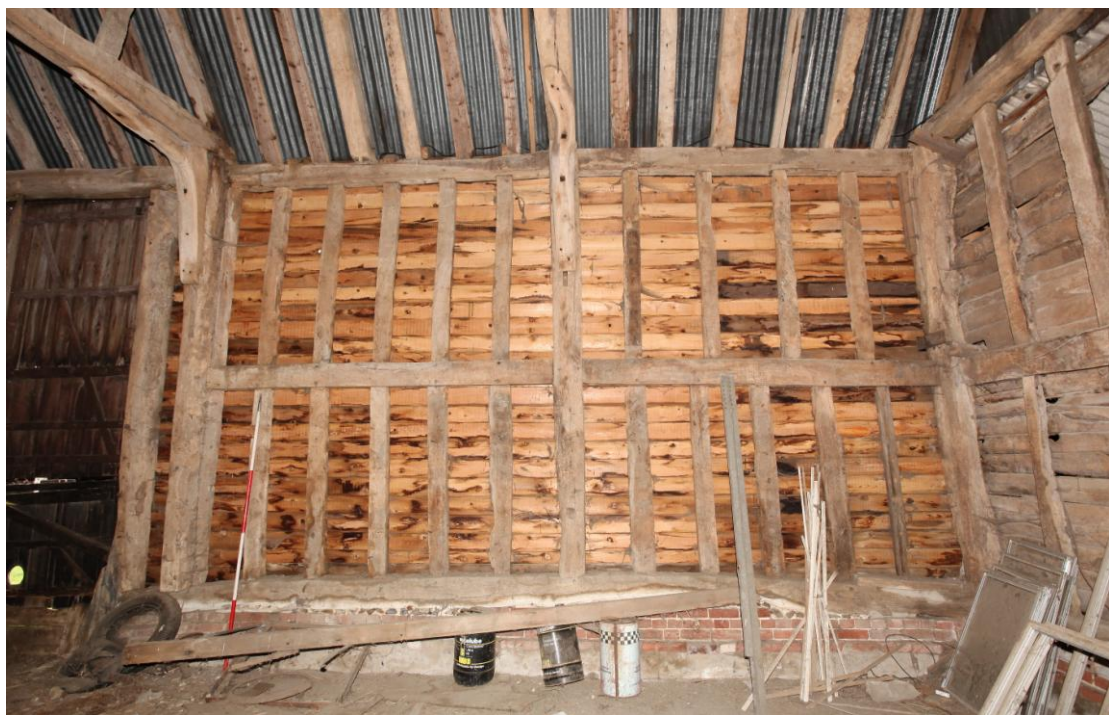
**Illus. 16. The south-eastern interior of the western bays of the 16<sup>th</sup> century barn (1a) showing the more widely spaced studs of the end-bay to the right. The studs contain mortises for the sill of a window or hatch above the mid-rail, but there is no evidence of mullions in the roof-plate.**

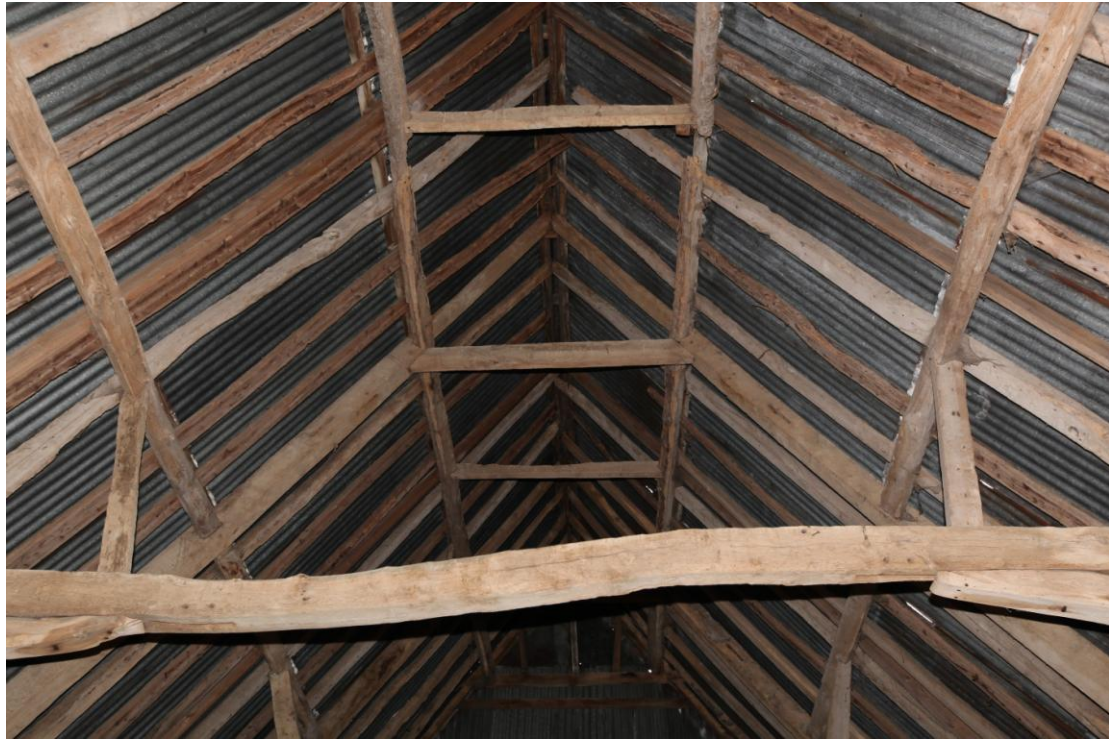
At first sight the framing appears largely intact and original, but a number of anomalies point towards a major reconstruction. While its principal rafters appear intact the roof has been largely rebuilt, with a high proportion of roughly hewn common rafters of pine and a ridge-board in the style of the 19<sup>th</sup> century. Both clasped-purlins have been similarly renewed, apart from short lengths at the south-western end of the barn, and the loss of every single wind-brace, wall brace and tie-beam brace would be surprising in a frame that had remained *in situ* from the beginning. The present bolted knee-braces and the queen struts beneath the lower purlins are typical 19<sup>th</sup> century alterations but in this instance probably date the barn's reconstruction on its existing site. More dramatic anomalies include the presence of pegged mortises for lower collars in four of the principal rafters, which are fully integral to the roof but are significantly larger than their counterparts and were probably re-used from an 18<sup>th</sup> century butt-purlin roof of similar type to that of the northern barn (1b). The wall fabric contains other conflicts, such as the wider spacing of the studs in the western bay of the south-eastern facade (figure 9) which appears to have possessed a window above its mid-rail as two studs contain pegged sill mortises; the roof-plate above, however, is devoid of any corresponding evidence (such as mullion mortises) and the stud which now separates the window jambs is fully tenoned but not pegged to the plate and mid-rail. The opposite wall contains evidence of an external door against the south-western corner post, but its position is also blocked by a tenoned stud which in this instance is also pegged to the ground sill. These timbers could not have been inserted without dismantling the frame, and neither the window nor the door would normally be found at the end of an end open barn. Both features are consistent with stable bays, however, and it seems likely that they were formerly associated with the internal partition described above – the various posts and tie-beams having been reassembled in the wrong places. The north-western corner post is clearly a replacement as it lacks mortises for the corner braces found elsewhere (including the adjoining roof-plate) but is nonetheless neatly jowled and pegged to the mid-rail.

**Illus. 17. The roof structure at the south-western end of the 16<sup>th</sup> century structure (1a) showing the lower tier of linear butt-purlins and the original clasped-purlins (which have been replaced elsewhere). The principal rafters contain pegged mortises for wind-braces and an anomalous lower collar which suggest a major reconstruction.**

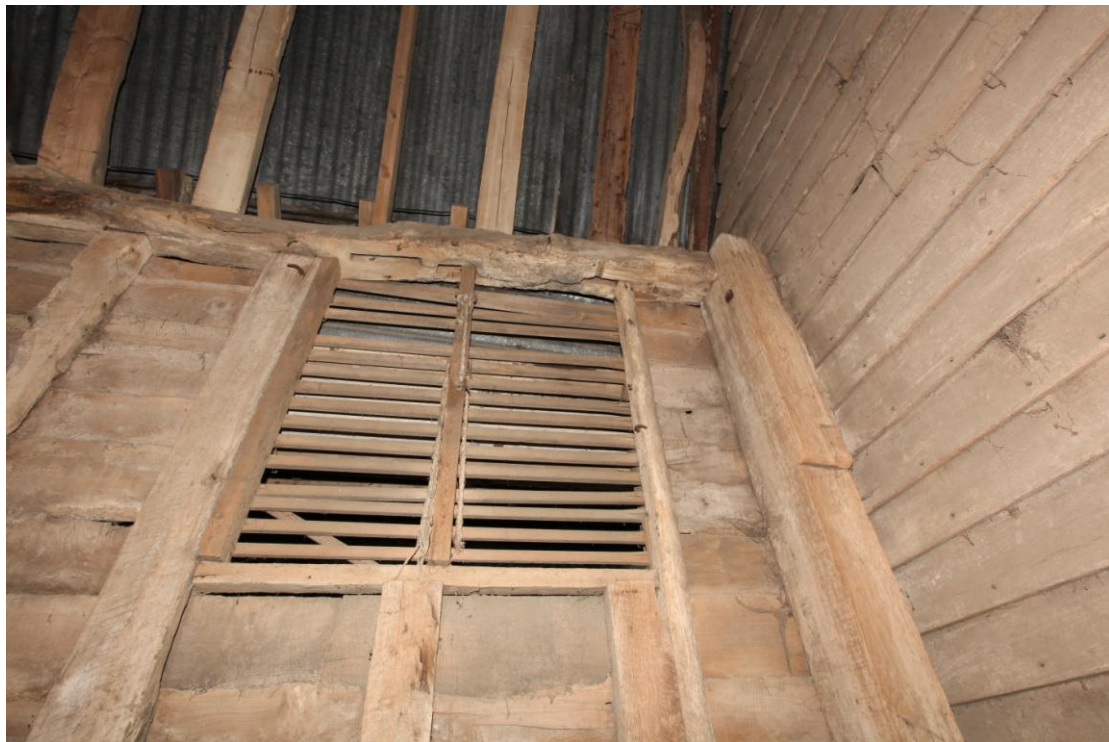
**Illus. 18. The 19<sup>th</sup> century louver at the north-eastern end of the 16<sup>th</sup> century barn's north-western elevation. The roof-plate above contains empty mortises for two original studs and an internally trenced wall brace, but there are no corresponding mortises in the right-hand corner-post which is a later replacement.**
