**Barn at
White House Farm,
Southolt, Suffolk
SLT 008**

Heritage Asset Assessment

OASIS ID: Suffolkc1-133994

September 2012

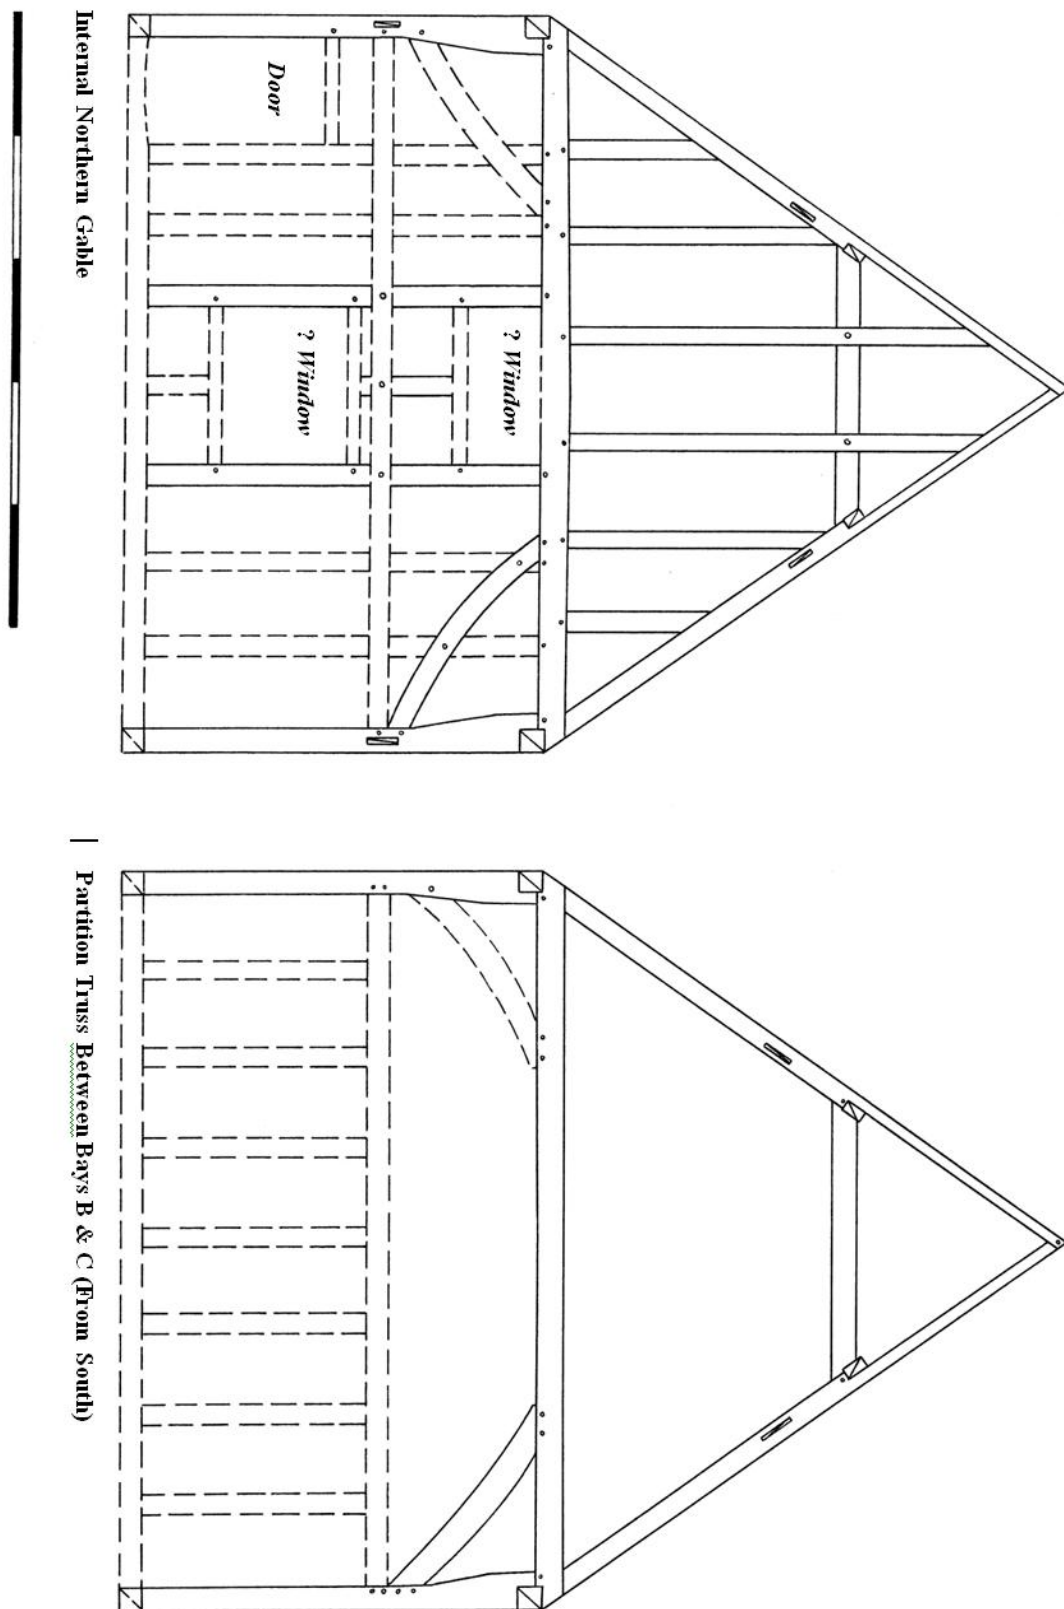
Figure 10. Internal elevation of northern gable and internal partition between two-bay open barn (A-B) to south and floored bays (C & B) to north – viewed from south. It is not clear whether the recently ‘restored’ diamond mullion windows of the gable are original as modern timber has distorted the evidence.

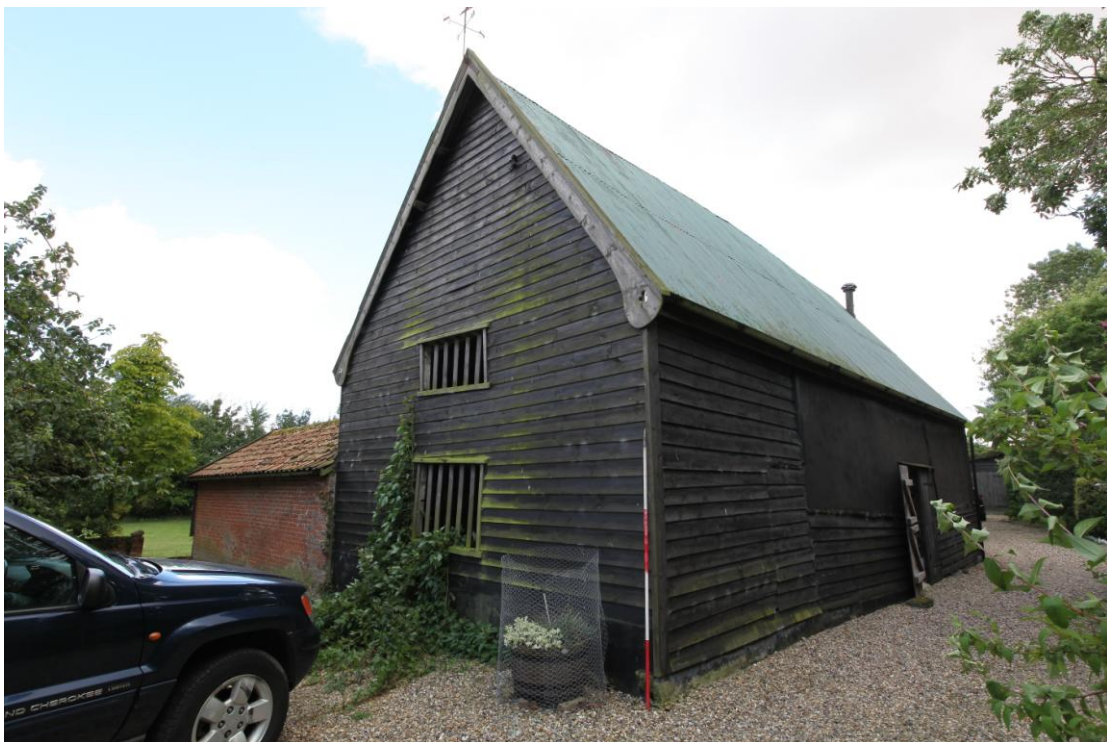
Illus. 4. The exterior of the barn (1) from the north-west showing the late-20th century diamond-mullion windows in its gable. There is internal evidence of an original gable door to the left of the scale rod.

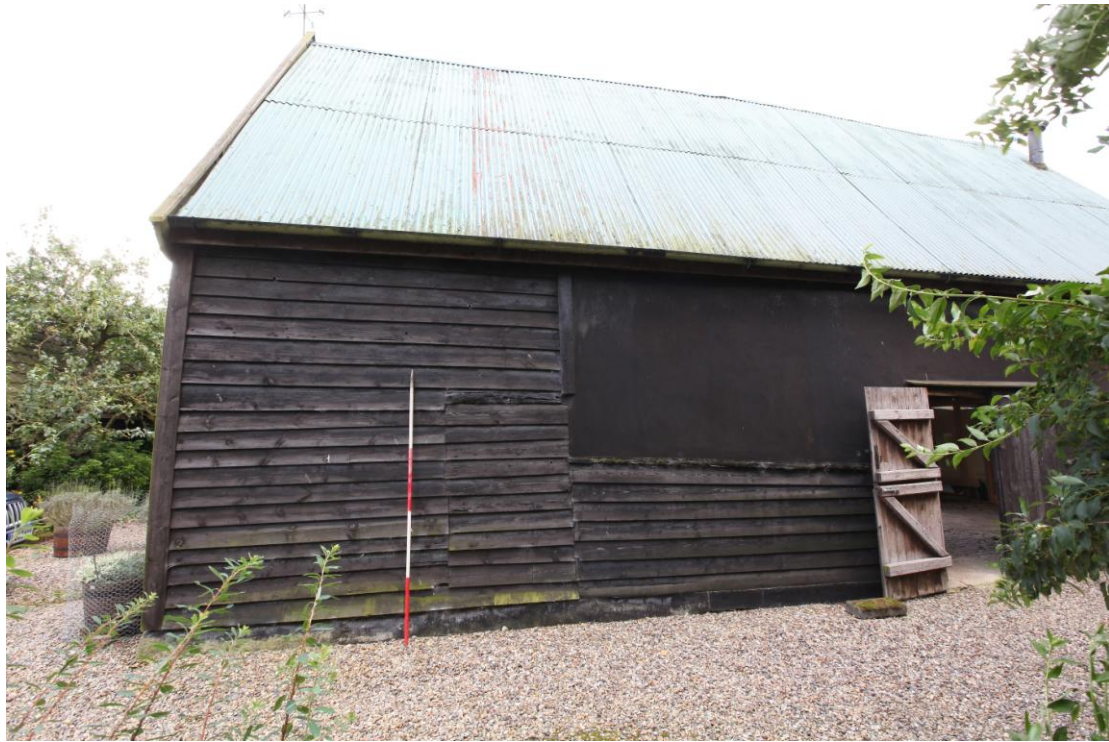
Illus. 5. The western exterior of the barn's northern showing the outline of a blocked secondary door in the position of the original ground-floor window in bay C (the window lintel forming the door lintel to the right of the scale rod). The two-tier cladding of cement-rendered clay daub above weatherboarding reflects the barn's appearance in the 18th and 19th centuries, although the daub probably extended to the ground initially.

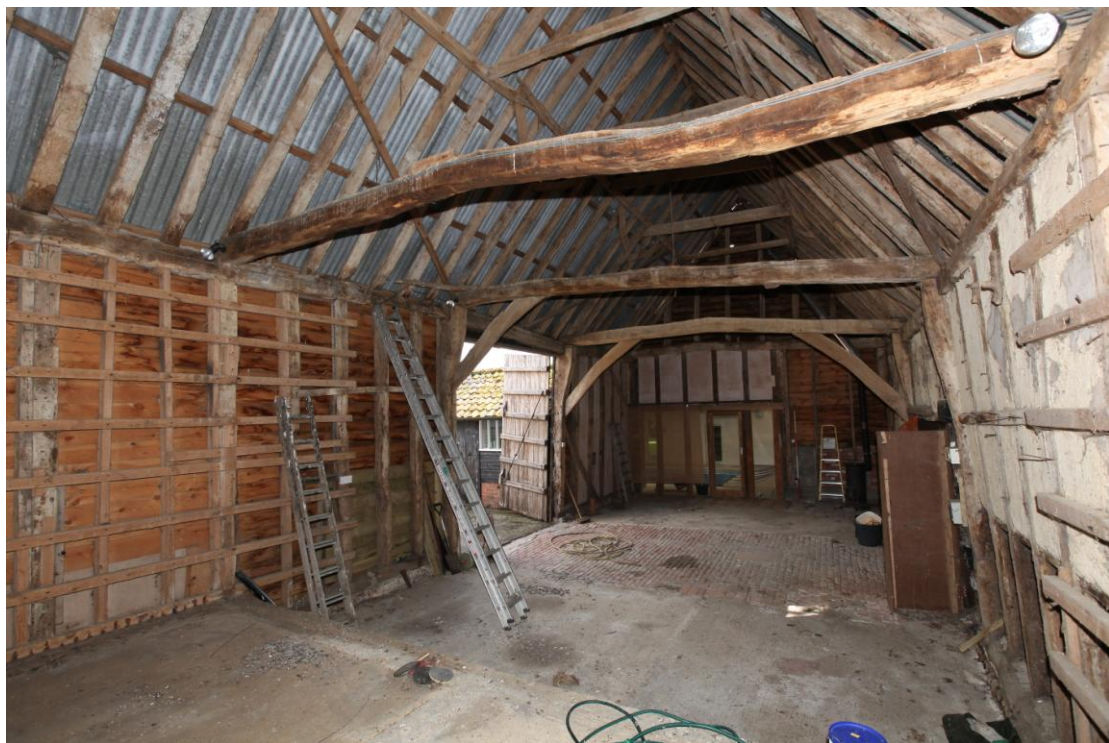
Illus. 6. The interior of the barn (1) from the north, showing the original tie-beam without braces between bays C and D in the foreground and three of the original four arch-braces flanking the threshing floor in bay B to the rear. The braces were omitted to maximise headroom on the (removed) loft in the two northern bays.

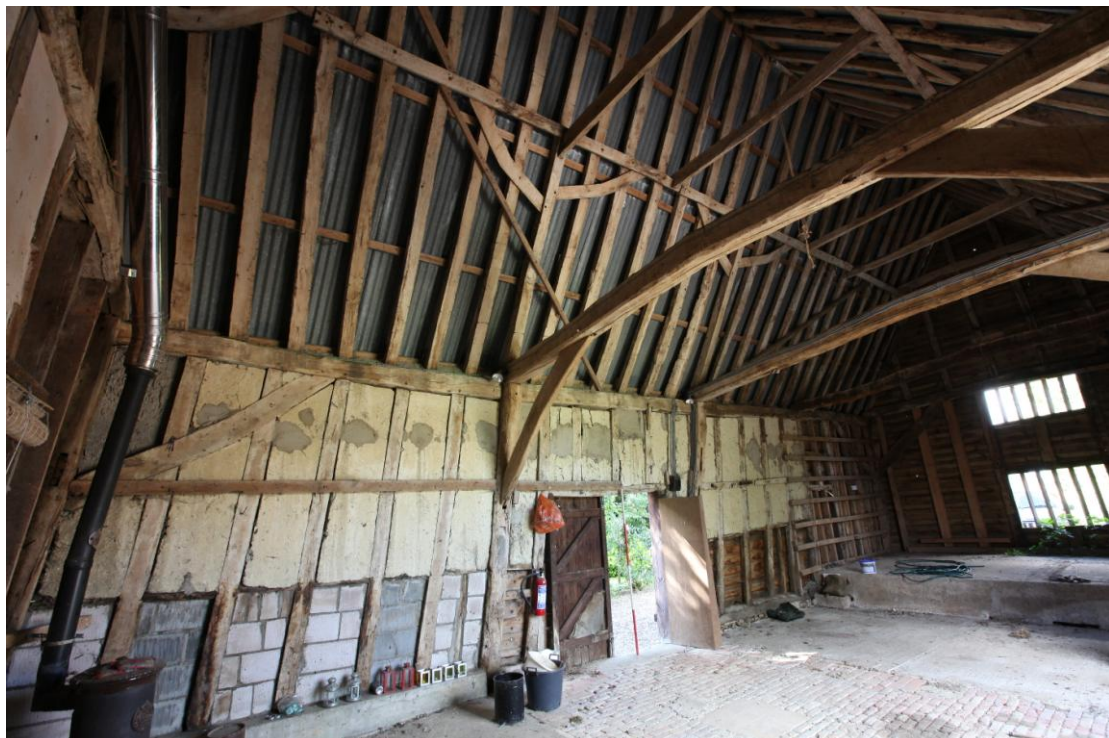
Illus. 8. The barn's internal western elevation showing the largely intact wall and roof framing with a 20th century concrete platform in the northern bay (D) to the right. The wattle-and-daub between the studs appears to be original (with recent patching in cement) but has been replaced by cement block-work where it adjoins the lower tier of external weatherboarding shown in illus.5 above.

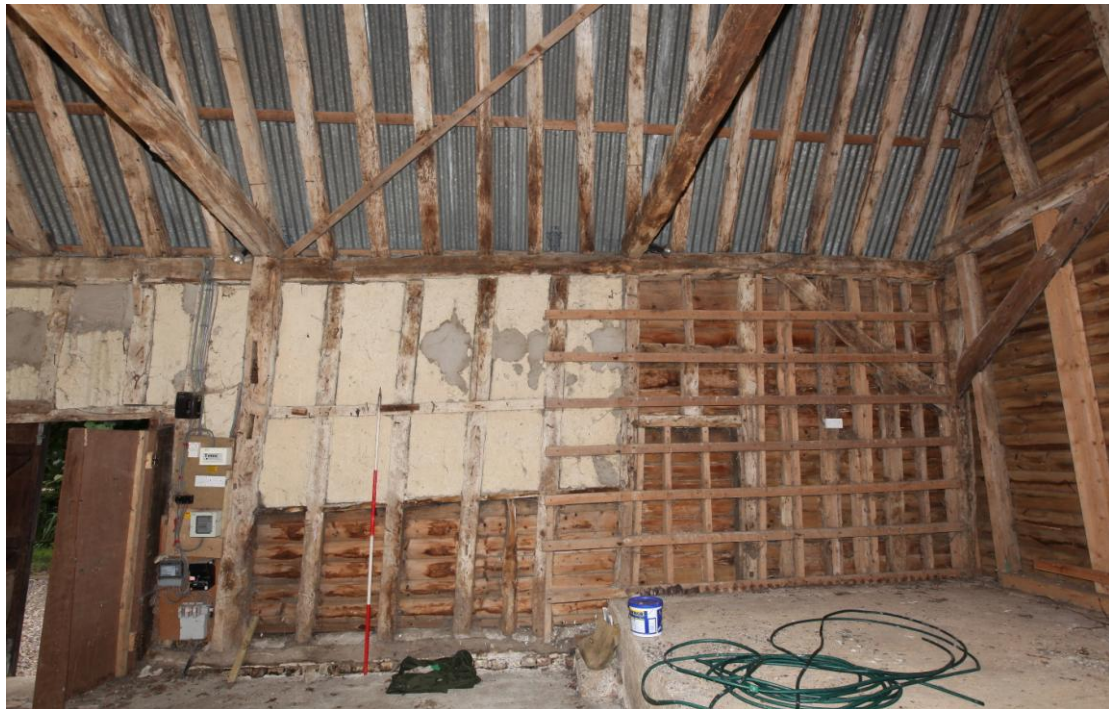
Illus. 9. The western interior of the two northern bays (C and D), divided by a tie-beam and principal roof truss but not a storey post. These bays were originally floored over at the height of the horizontal batten 2 m above the present ground level in bay C to the left, and there is evidence of original ground and first-floor windows to the right. The battens of bay D are modern and probably relate to the use of the raised concrete platform as a grain store.

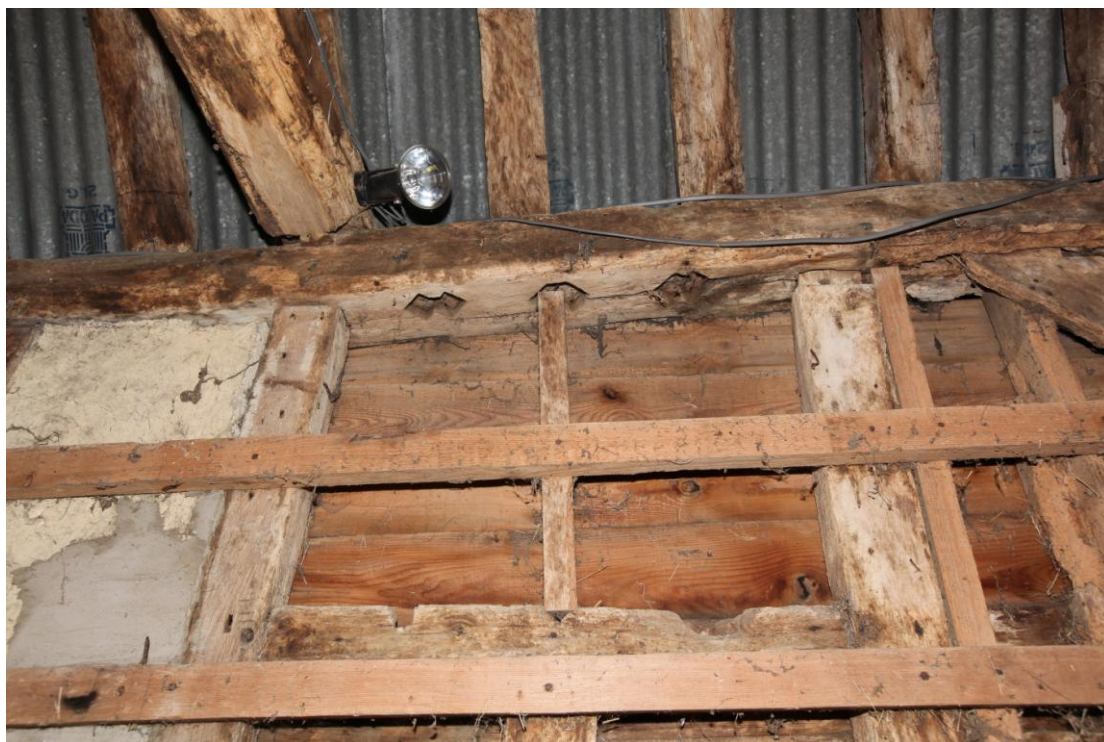
Illus. 11. A detail of the unusual ‘double’ diamond mullion mortises in the western roof-plate of bay D with the original window sill beneath. This window lit the missing loft, and its mortises relate to the correction of an error by the carpenter who seems to have intended four mullions before realising there was only room for three. The eastern window immediately opposite was 20 cm wider (8 ins) and was able to accommodate four mullions. The error was not repeated in the sill.

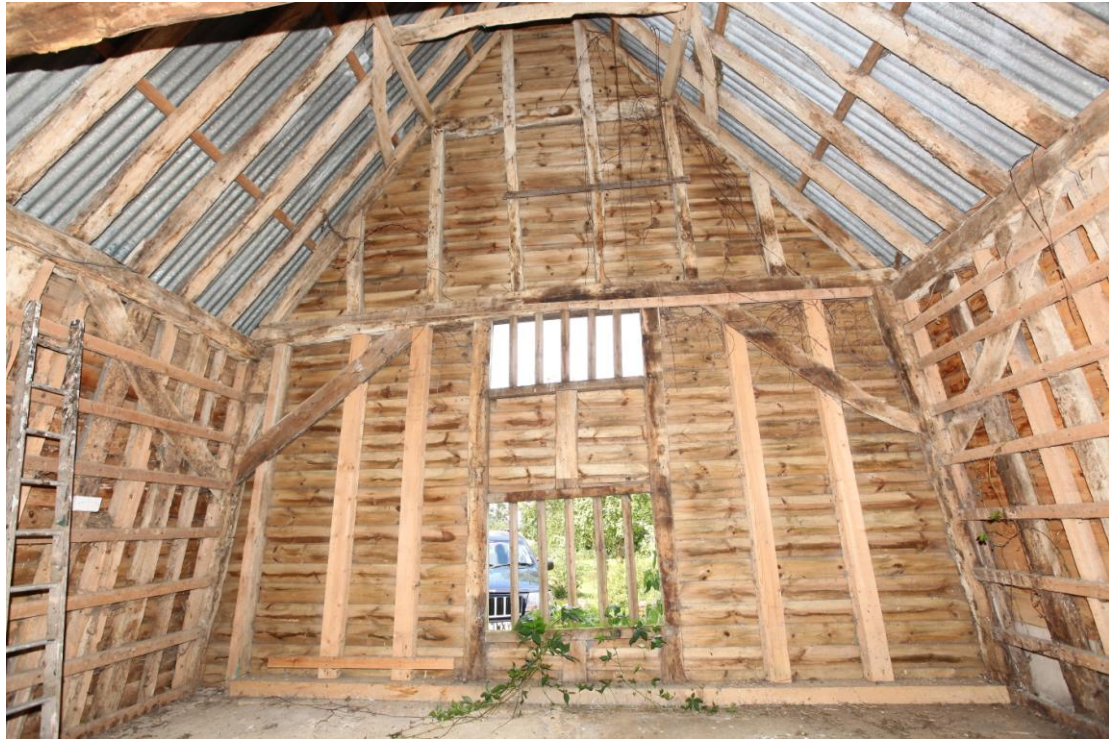
Illus. 13. The interior of the northern gable. The vertical studs were replaced as part of a late-20th century restoration, and the left-hand brace is also secondary, but the right-hand brace and window jambs are original with pegged trenches for a missing mid-rail. A pegged mortise in the left-hand corner post and a corresponding gap in the studwork reveal the position of an original external door. The diamond mullion windows are modern and it is unclear whether they recreate original features or are entirely secondary.

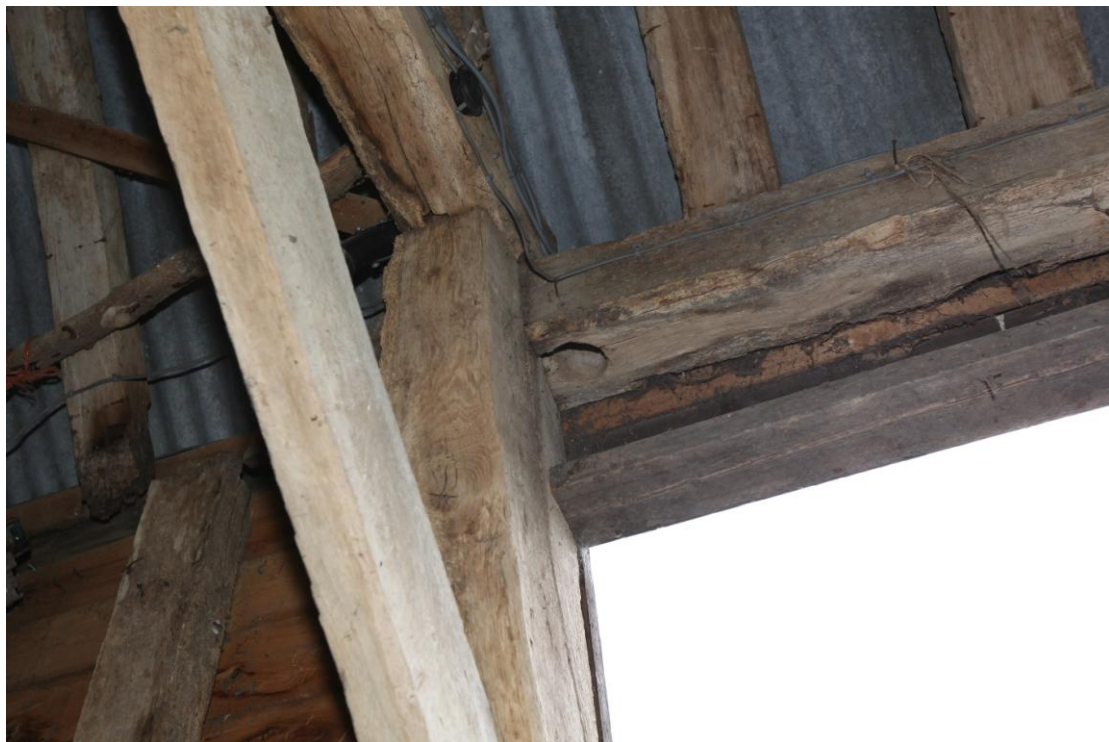
Illus. 14. A detail of the eastern roof-plate of bay B showing the circular pin-hinge housing of the original entrance door. The present doors are modern replacements.
