**Barn at
Elmer Farm,
Finningham, Suffolk
FNN 020**

Heritage Asset Assessment

Barn at Elmer Farm, Walsham Road, Finningham, Suffolk

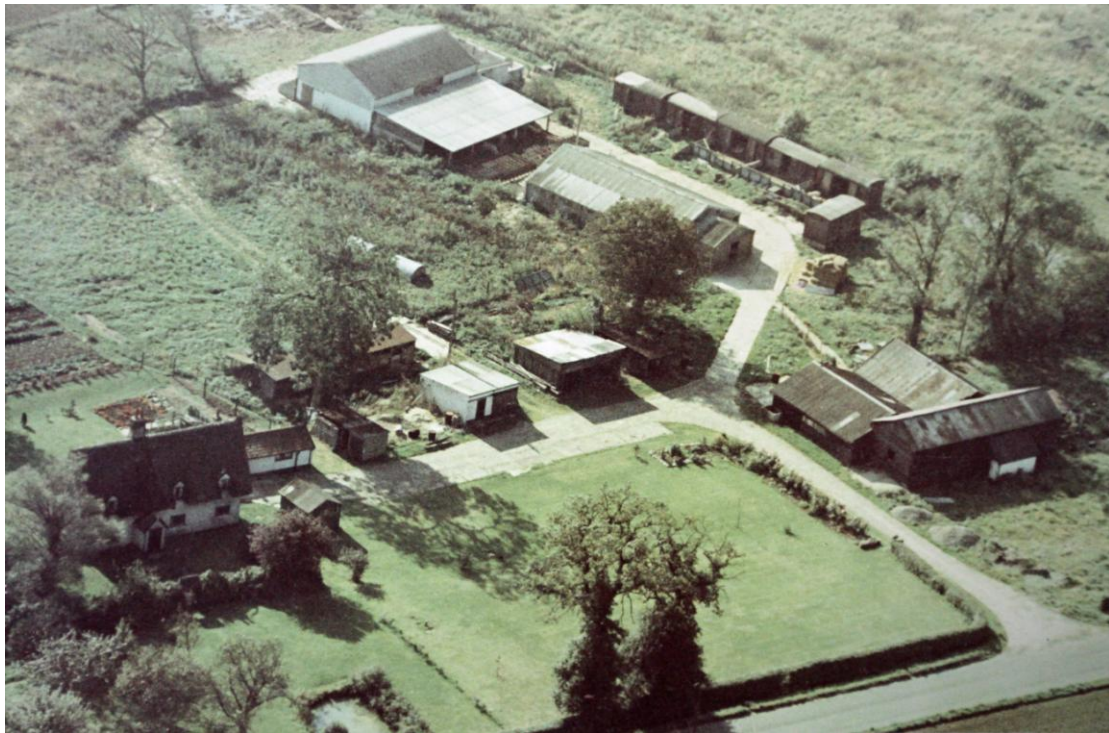
Illus. 1. A 1974 aerial view of the site from the north-east showing the barn to the right, the grade II-listed thatched 17th century former farmhouse to the left and the remains of the medieval Allwood Green in the foreground. The two single-storied 20th century sheds adjoining the barn's southern elevation have since been demolished.

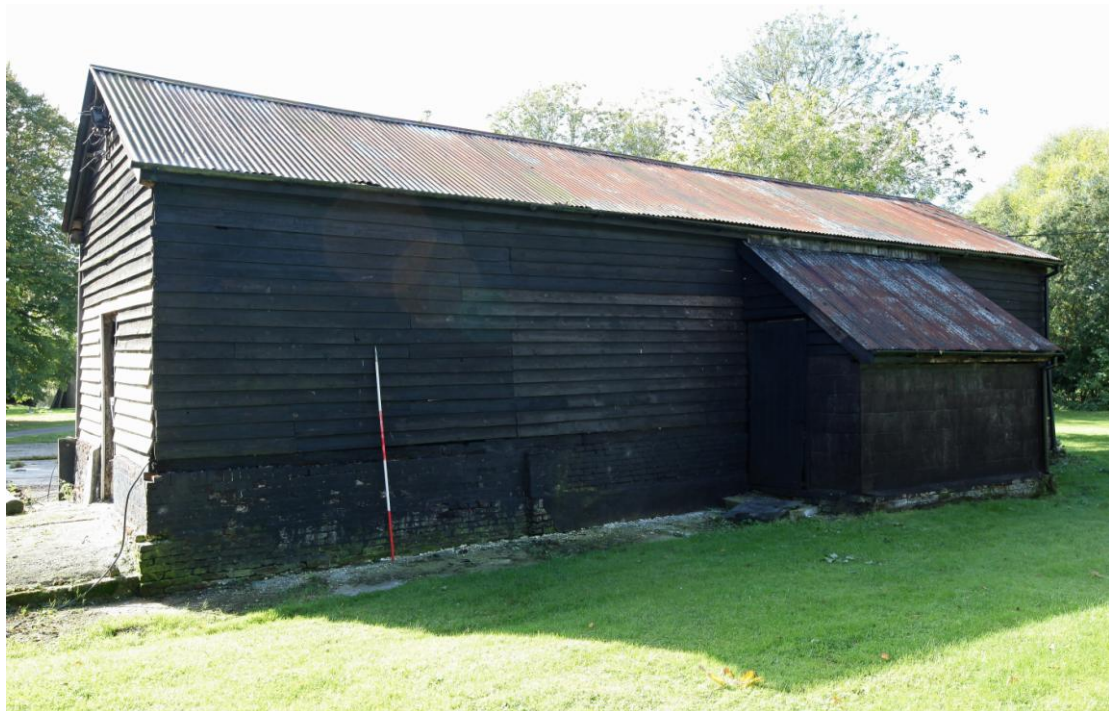
Illus. 2. The northern exterior of the barn from the remains of Allwood Green showing its corrugated iron roof, 20th century weatherboarding and cement-block lean-to porch (1c) with a modern door in its eastern side-elevation.

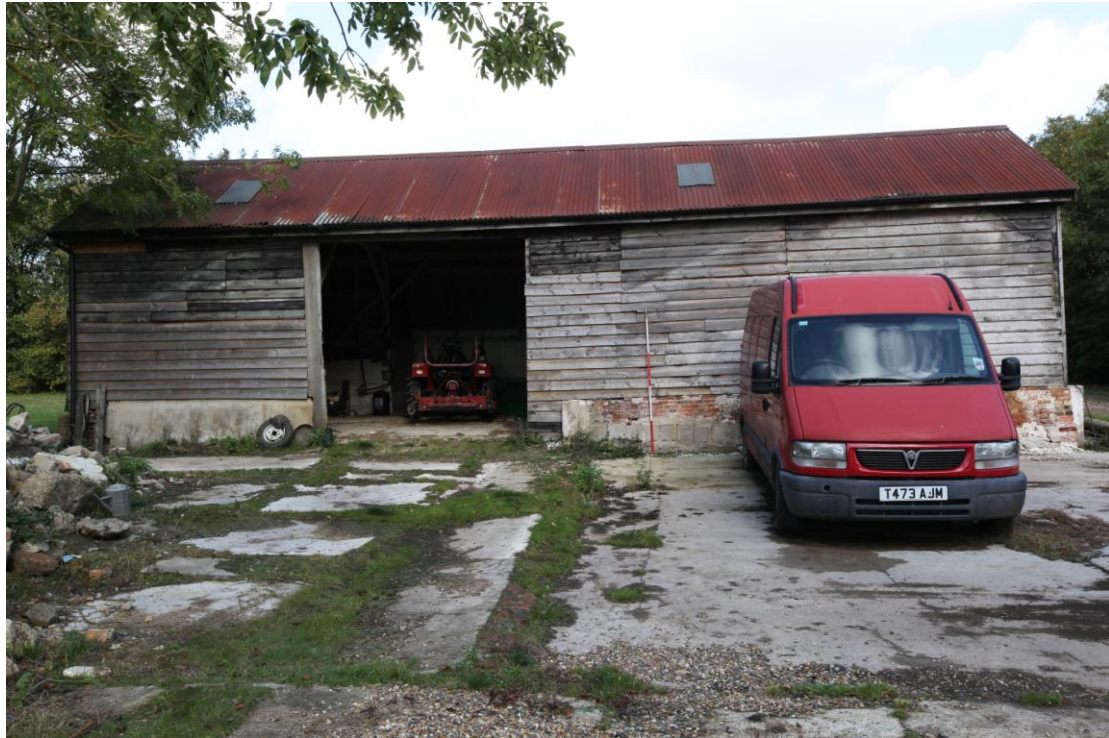
Illus. 3. The southern exterior bearing the roof scars of the two demolished 20th century sheds shown in illus. 1 above with the original entrance in the central bay of the threshing barn (1a) to the left (lacking its doors).

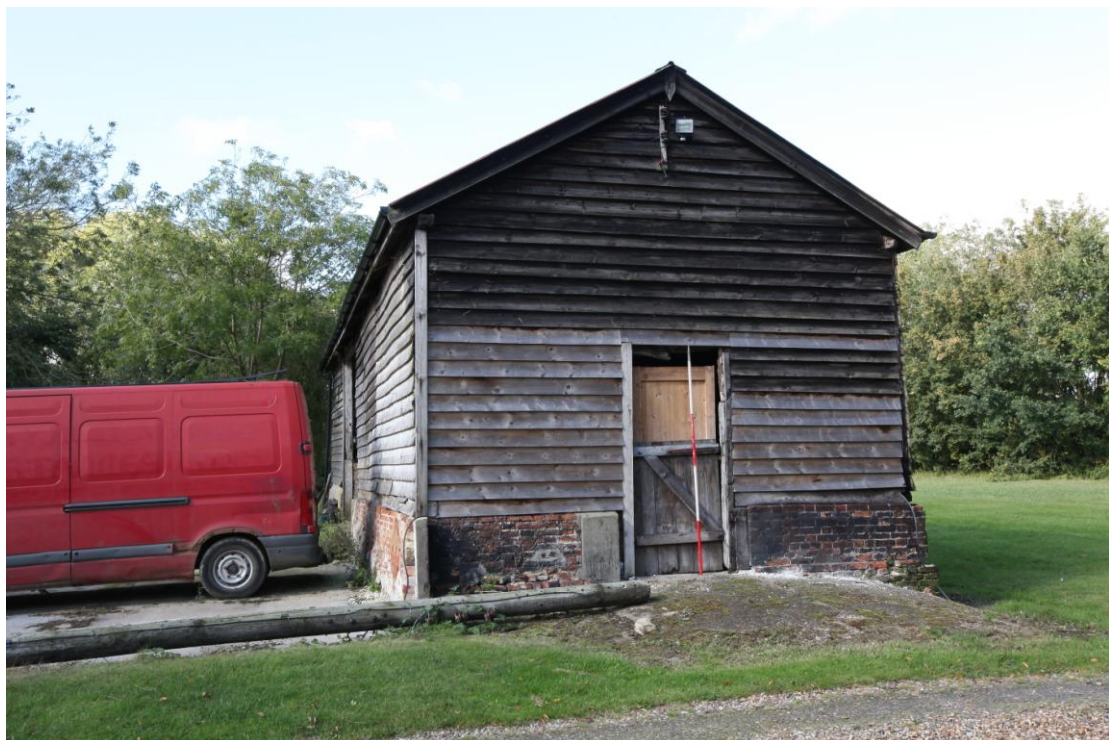
Illus. 4. The eastern external gable showing the original entrance to the stable (1b) which is respected by the rebuilt brick plinth to the right. The original plinth to the left is cement-rendered and consists largely of re-used 16th and 17th century bricks.

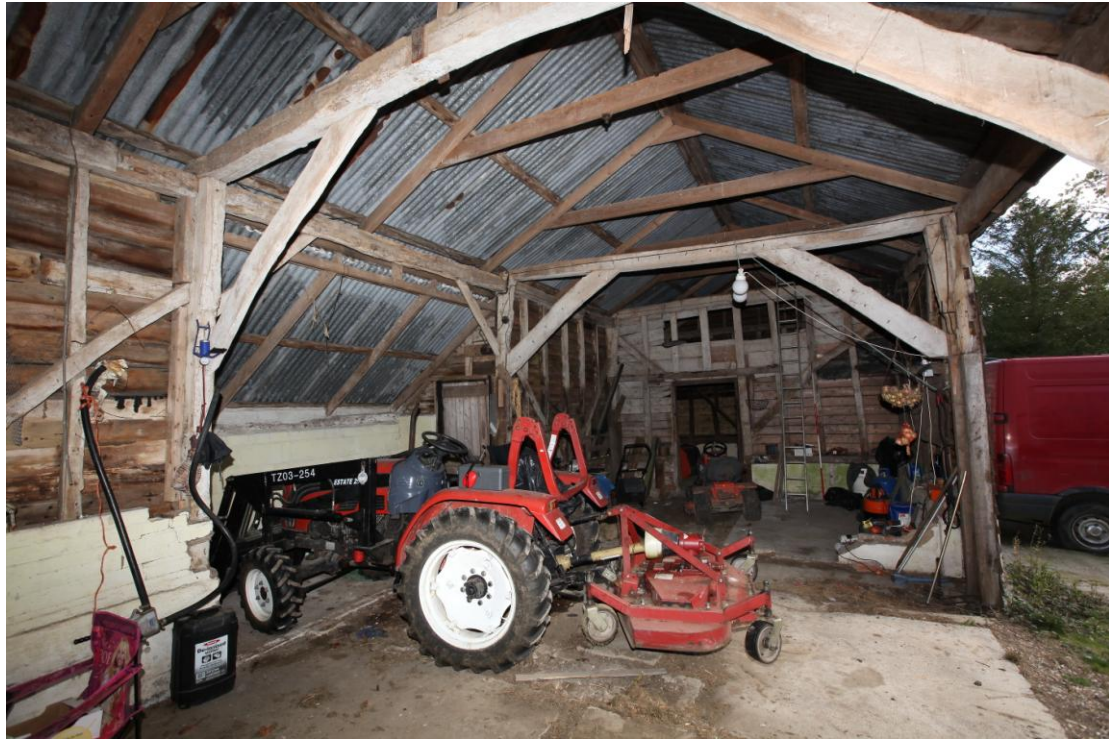
Illus. 5. A general view of the three-bay threshing barn (1a) from the west showing its intact tie-beam braces and mid-20th century softwood roof structure. The lean-to rear porch (1c) adjoins the central bay to the left but the threshing floor has been replaced or covered by concrete. The roof-plate above the original southern entrance to the right was replaced in the 20th century.

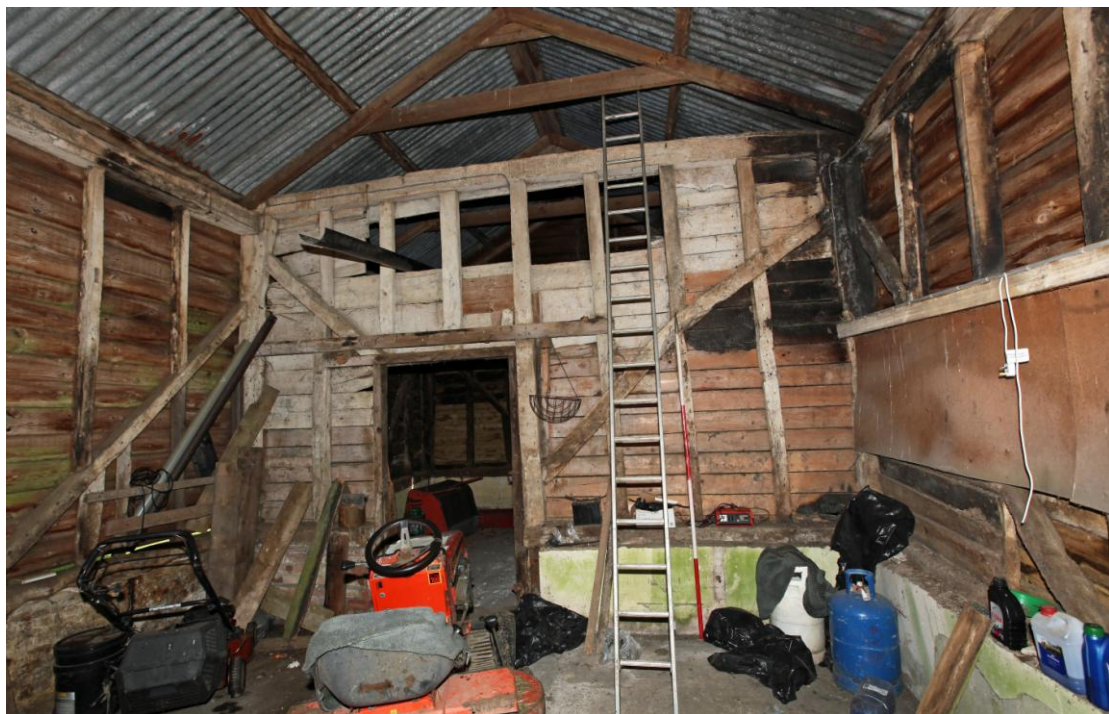
The internal partition against the threshing barn now terminates at the tie-beam, but initially continued into the missing roof as the tie-beam contains a series of un-pegged stud mortises in its upper surface. There is no evidence of an external loft loading-hatch, but one may have existed in the absent roof gable. The tie-beam of the same gable contains a series of horizontal dowel holes that penetrate the timber and may have attached an external pentice board or a canopy of some form above the stable's entrance. The holes respect the length of the timber and the width of the building and there is nothing to suggest the tie-beam has been re-used from elsewhere (such as a ladder or hay rack) – but this is an unusual feature. The external tarred weatherboarding consists of narrow softwood and appears to have been replaced in the 20th century. Its southern elevation bears the scars of the two wide sheds shown on the aerial photograph of 1974 (illus. 1 below), but in their final form these are unlikely to have pre-dated the mid-20th century. An area of charred timber in the south-eastern corner of the threshing barn bears witness to a localised fire that post-dated the new roof, but in general the framing is exceptionally complete.

Illus. 6. The internal eastern gable of the threshing barn (1a) showing the later door to the stable (1b) which interrupts a tenoned and pegged diagonal wall brace. The blackened timbers to the right are charred due to a recent localised fire which affected the 20th century roof. The tie-beam contains un-pegged mortises in its upper surface for a full-height partition between the barn and hay loft.

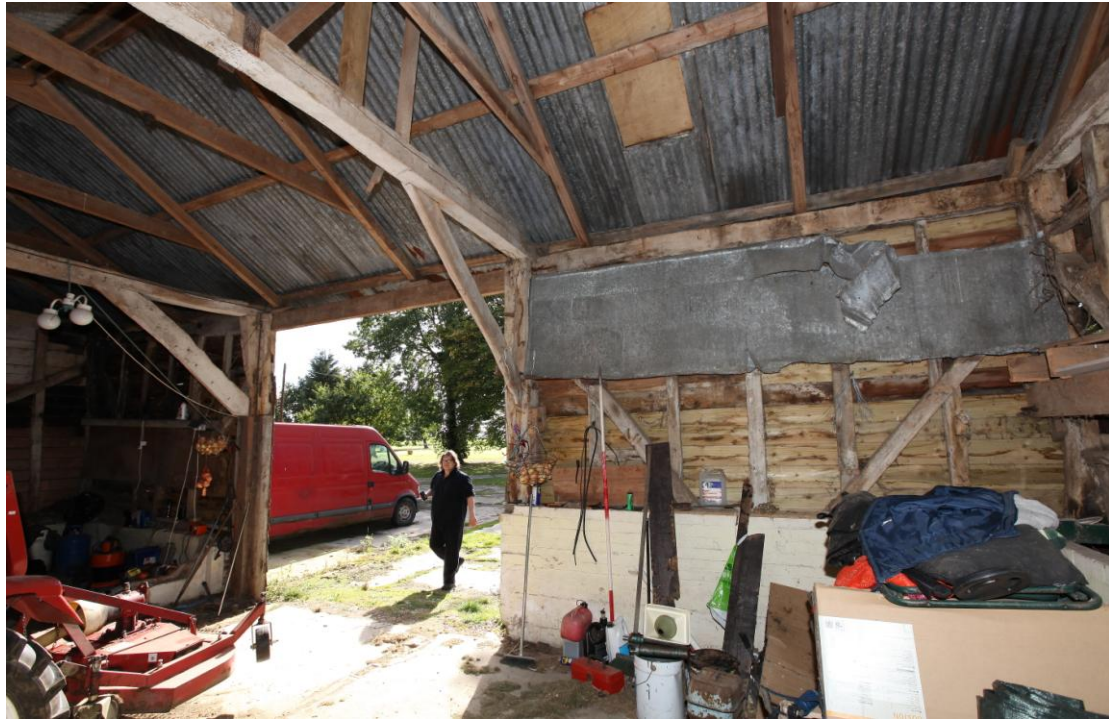
Illus. 7. The southern interior of the threshing barn (1a) showing the original entrance in the central bay (lacking its doors and roof-plate) with the brick internal walls of a 20th century grain bin in the western bay to the right. The wall framing survives largely intact with primary braces that are tenoned and pegged to the jowled storey posts and ground sills.

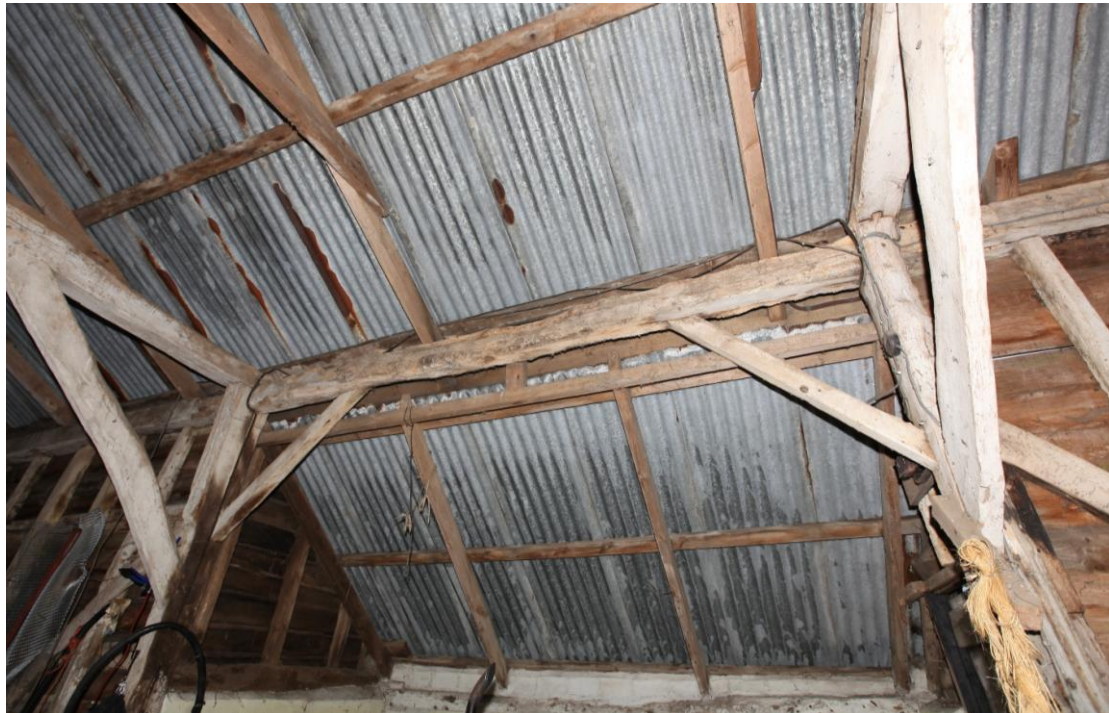
Illus. 8. A detail of the northern roof-plate of the threshing barn (1a) adjoining its central lean-to porch (1c), showing the original tenoned & pegged braces from the storey posts. These braces demonstrate that a porch must have existed here from the outset, although the present structure has been rebuilt in cement block-work and its roof-plate (which may be a re-used timber) contains no evidence of a central door.

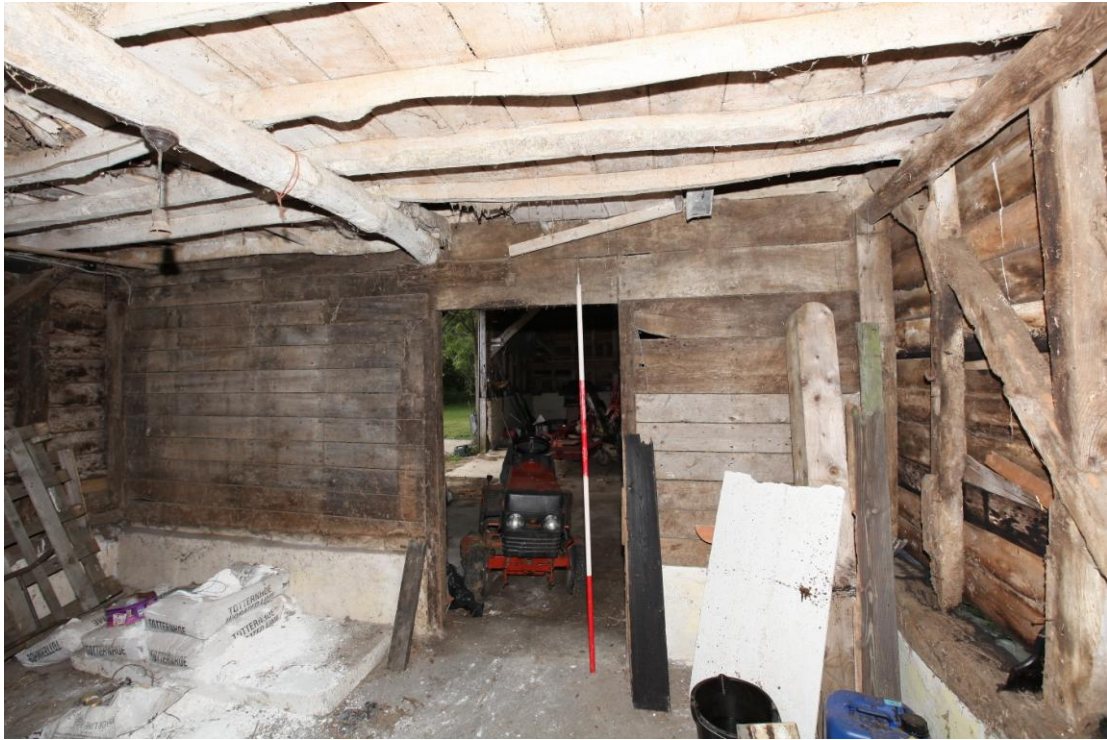
Illus. 9. The interior of the original stable bay (1b) from the east, showing the position of the missing manger and hay rack beneath the partial hay drop adjoining the internal partition against the threshing barn (1a) – now cut by a later connecting door.

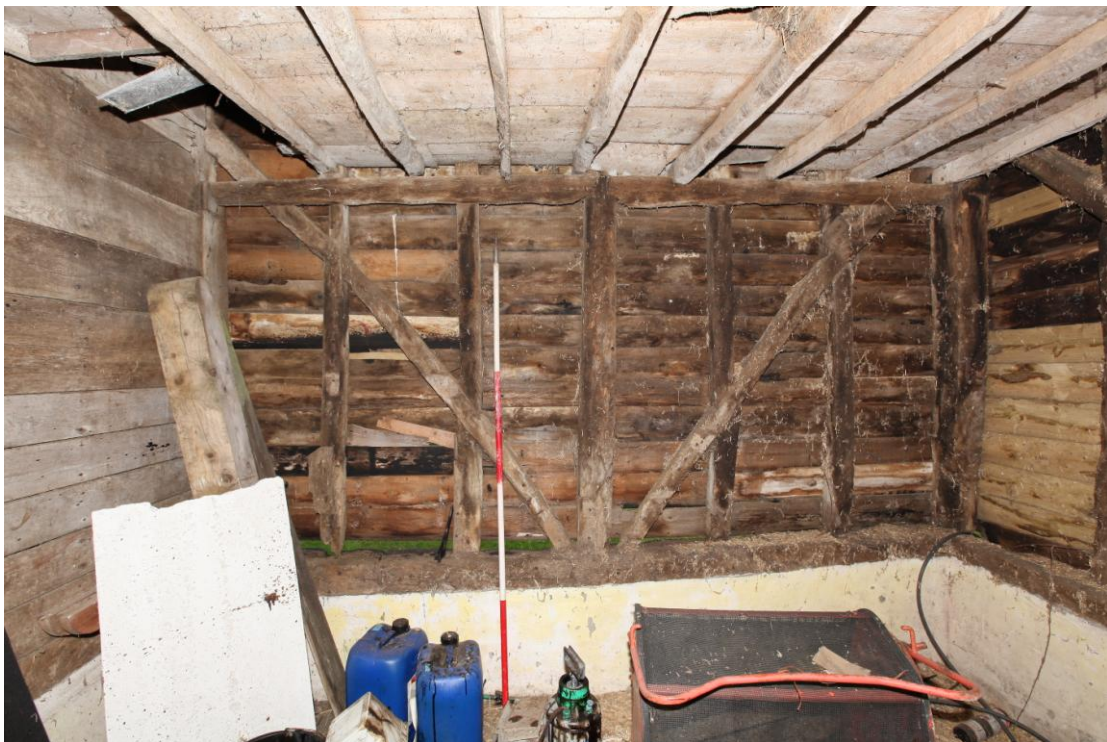
Illus. 10. The northern interior of the stable (1b) showing its original framing and the clamp (rail) which supports the ends of the original ceiling joists with the hay drop (aperture in ceiling) to the left.

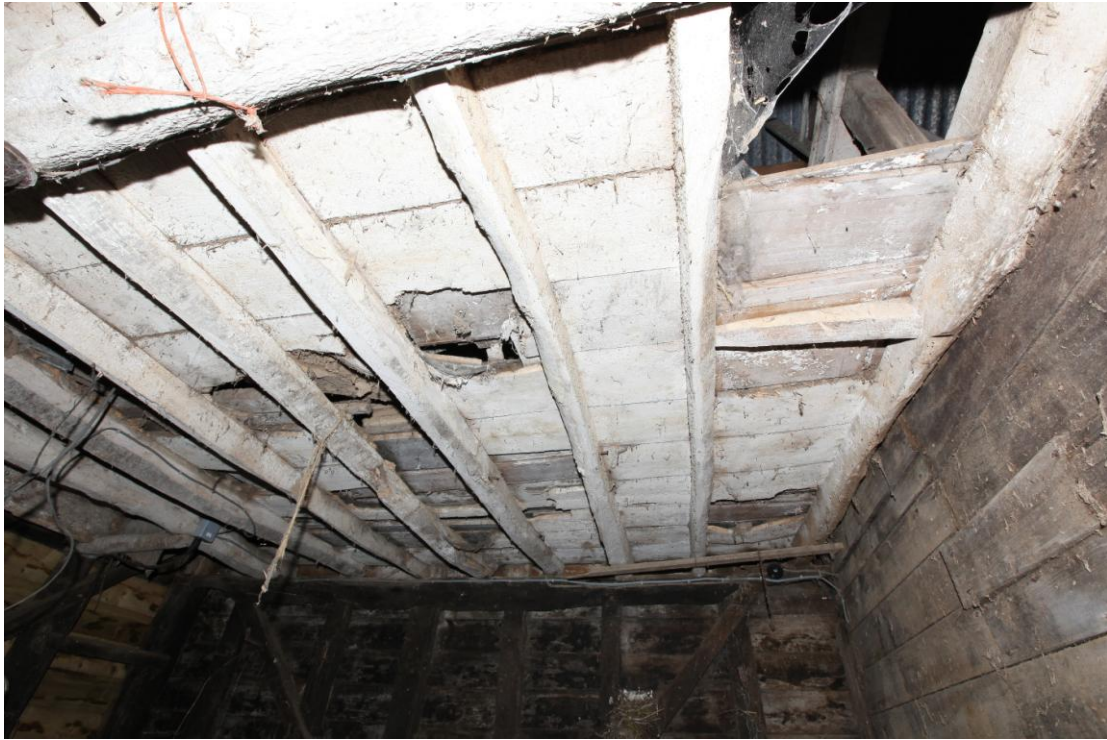
Illus. 11. The original ceiling joists of the stable (1b) from the north, showing the partly blocked hay drop above the missing hay rack against the internal partition to the right. The whitewashed floorboards adjoining the southern elevation appear to be original, and the hay drop did not span the entire width of the building. The original tapered strut to the right is one of two that survive.

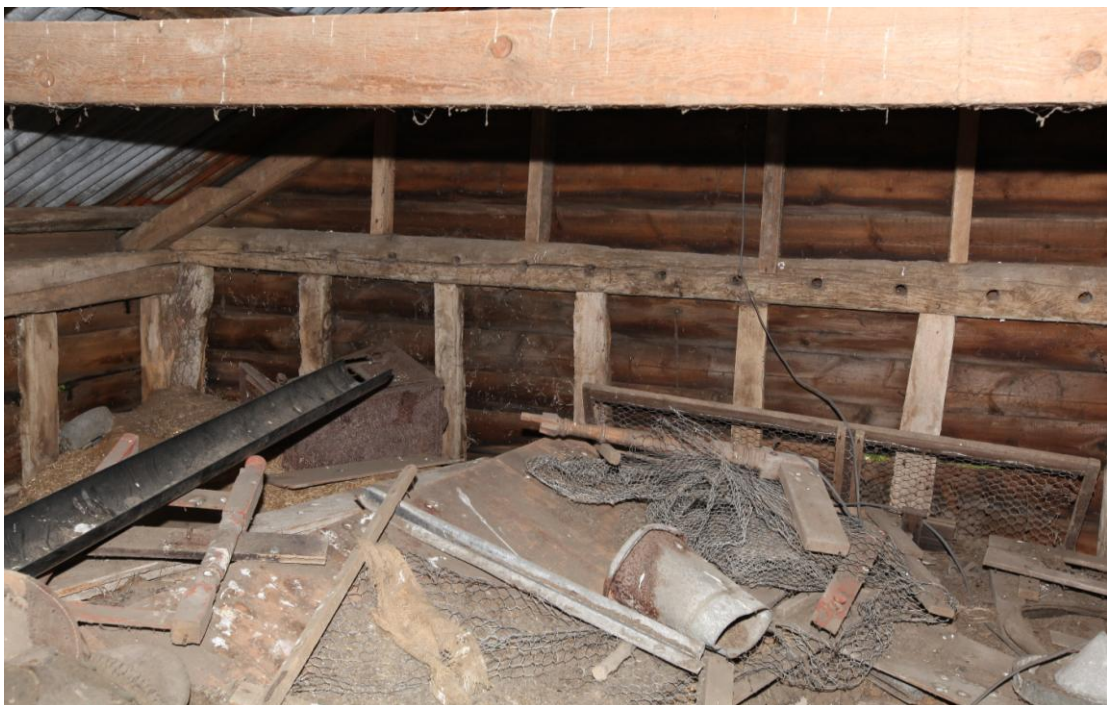
Illus. 12. The internal north-eastern corner of the hay loft above the stable (1b) showing the unusual series of dowel holes in the tie-beam of the eastern gable to the right. These penetrate the timber and may have been intended to secure an external pentice board or canopy above the stable's entrance. There is nothing to suggest the timber is re-used.
