**Barn at  
Potash Farm,  
Kenton, Suffolk  
KNN 019**

**Heritage Asset Assessment**

# **Barn at Potash Farm, Eye Road, Kenton, Suffolk**

## **Heritage Asset Assessment**

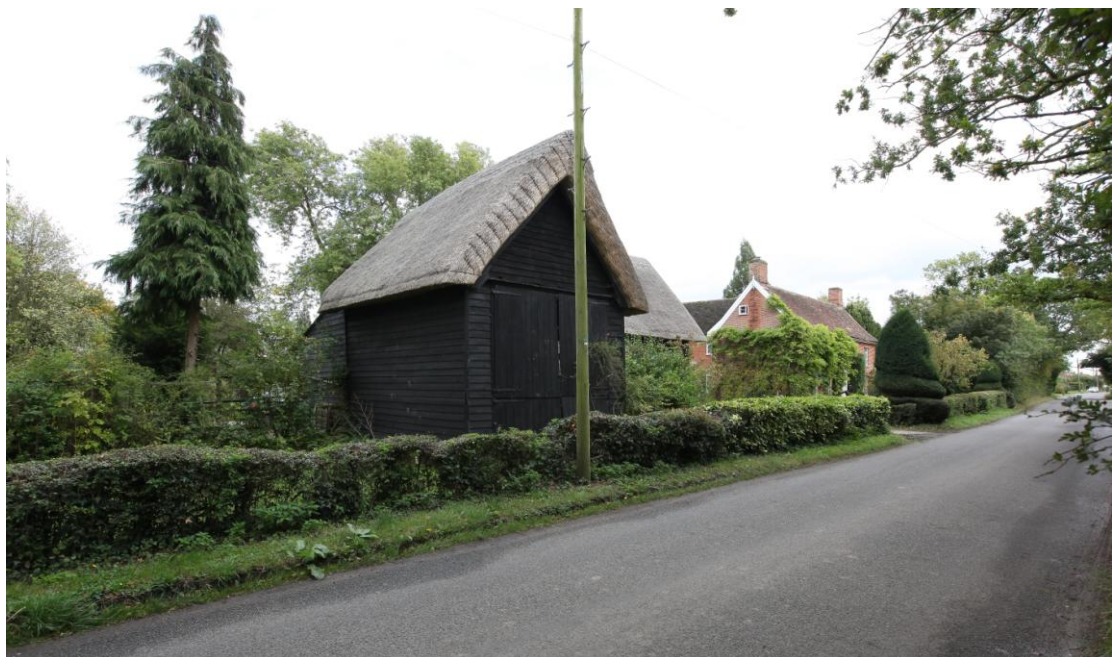
**Illus. 2. A general view from the Eye Road to the north, showing the barn's porch (1) to the left and the farmhouse in the rear. The majority of the barn which this porch once abutted has been demolished, resulting in a highly distinctive building which forms the entrance to the village when approaching from this direction and makes a very significant contribution to the local landscape.**

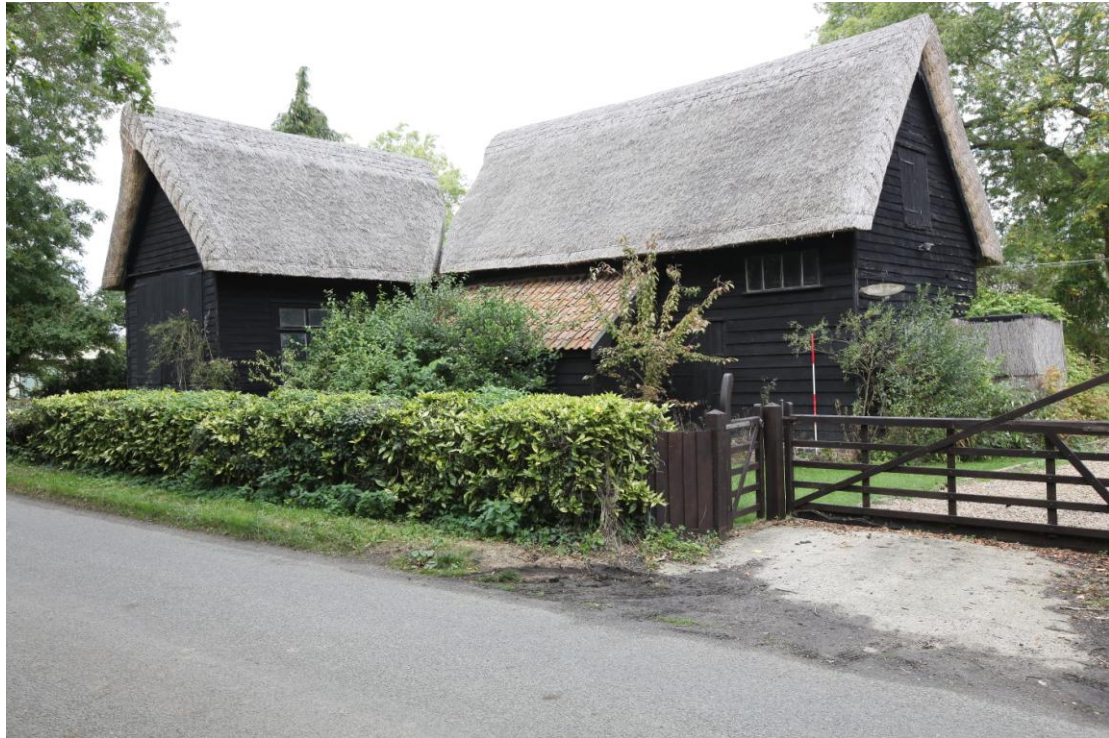
**Illus. 3. The barn from the south-west, showing its distinctive L-shaped profile with two substantial thatched roofs adjoining corner-to-corner at right-angles. The pantiled western lean-to shed (4) is visible in the centre. The thatch is recent and most of the weatherboarding in this elevation was renewed as part of a heavy mid- to late-20<sup>th</sup> century refurbishment. A number of modern windows which would otherwise detract from its traditional appearance are hidden by shrubs.**

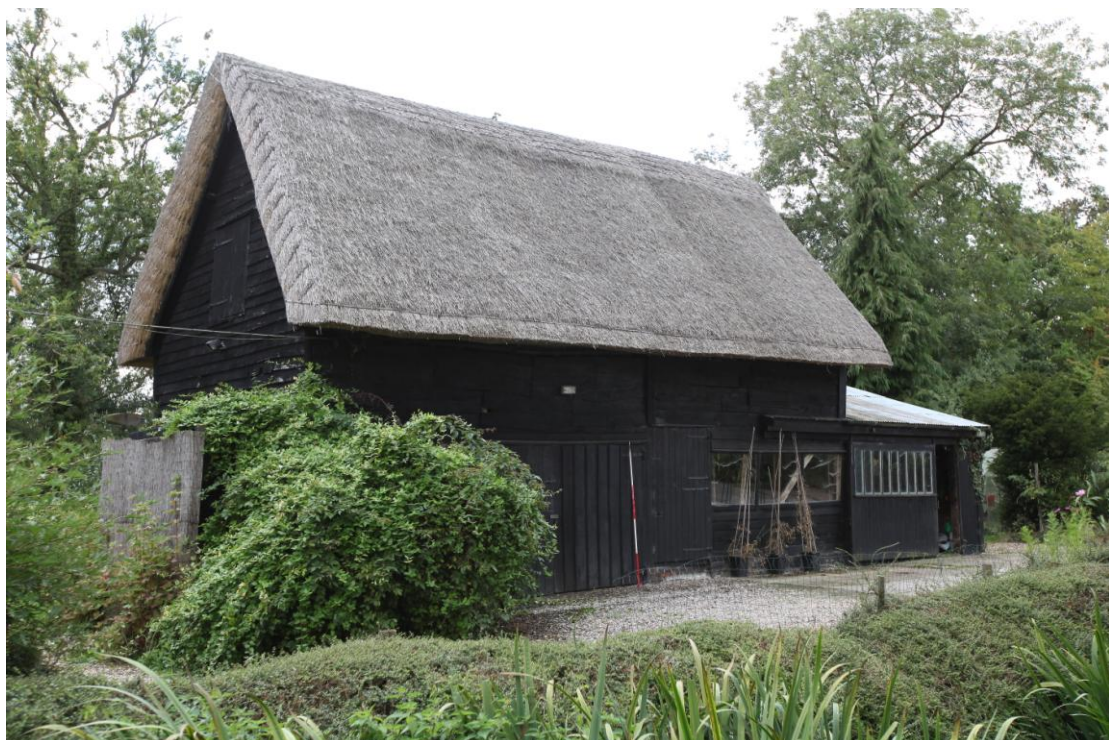
**Illus. 4. The barn southern range from the south-east, showing the left loading hatch and the 19<sup>th</sup> or early-20<sup>th</sup> century weatherboarding which survives in the southern gable.**

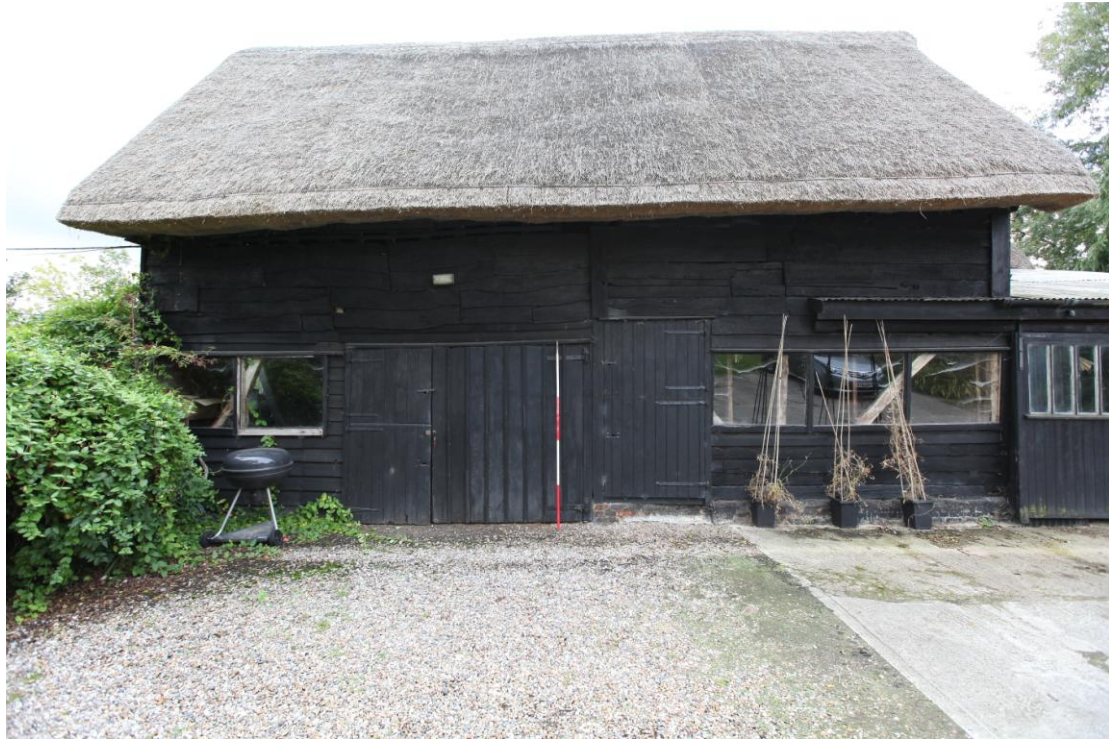
**Illus. 5.** The eastern exterior of the southern range, which consists of the southern bay of a late-18<sup>th</sup> or early-19<sup>th</sup> century threshing barn to the right of the scale rod (2) and an early-19<sup>th</sup> century former stable (3) to its left. The various ground-floor doors and windows were inserted during the 20<sup>th</sup> century but good, heavily tarred and waney-edged weatherboarding survives above.

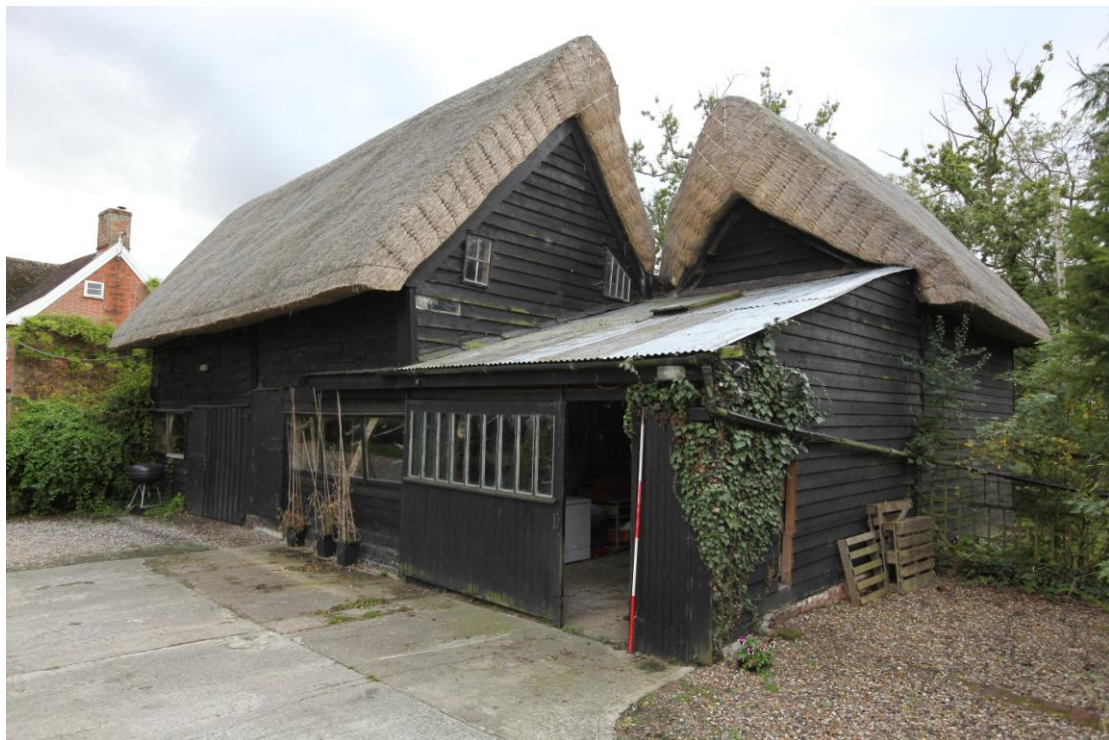
**Illus. 6.** The unusual appearance of the building from the north-east. A mid-20<sup>th</sup> century lean-to shed with a corrugated iron roof (5) occupies the site of the demolished threshing bay of the original barn, with the surviving early-19<sup>th</sup> century porch (1) to the right and the barn's southern end-bay (2) and the former stable (3) to the left.

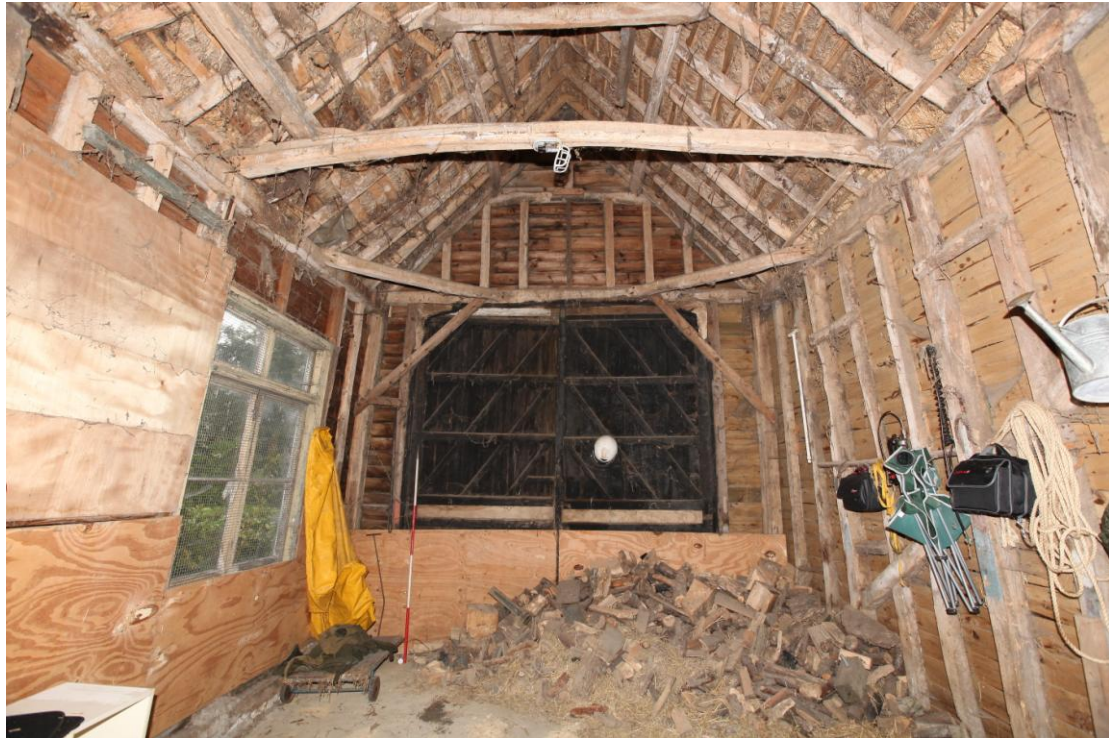
**Illus. 7. The interior from the east of the 19th century porch (1). The wall framing is largely original, although cut by modern windows to the left and partly hidden by boarding. The barn doors are good late-19<sup>th</sup> century half-hung examples with original bolted knee-braces framing the doorway.**

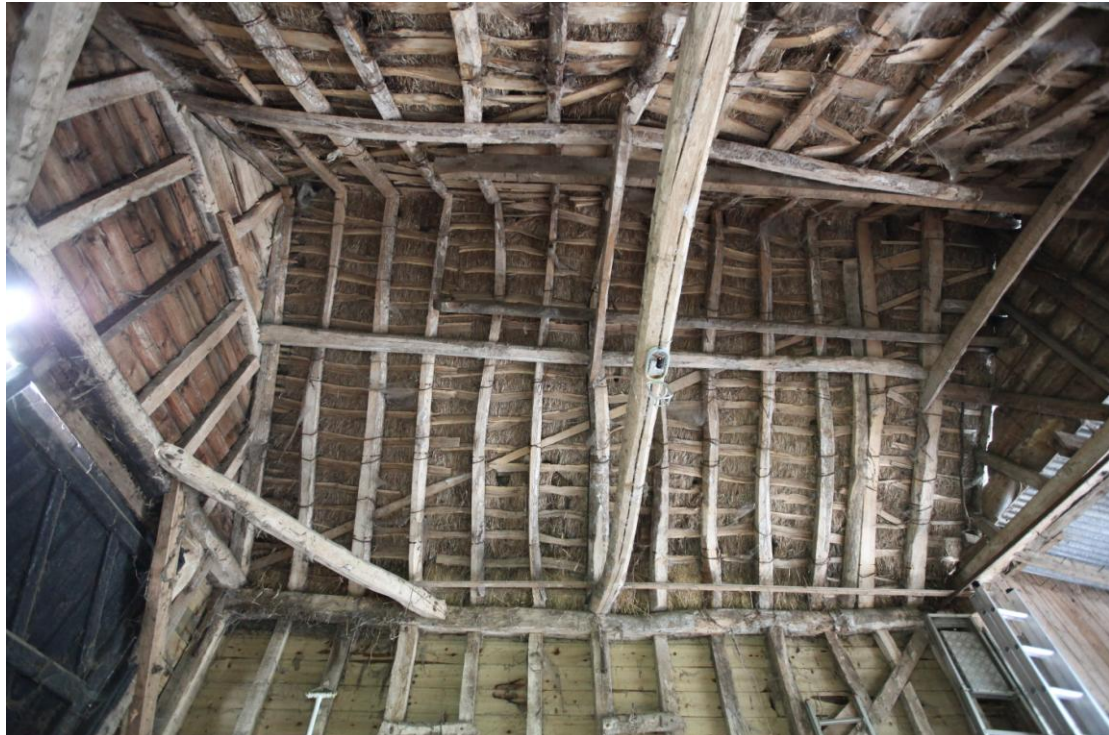
**Illus. 8. The intact original clasp-purlin roof structure of the porch (1) showing its nailed collars and a central tie-beam without braces. These features are typical of the early-19<sup>th</sup> century.**

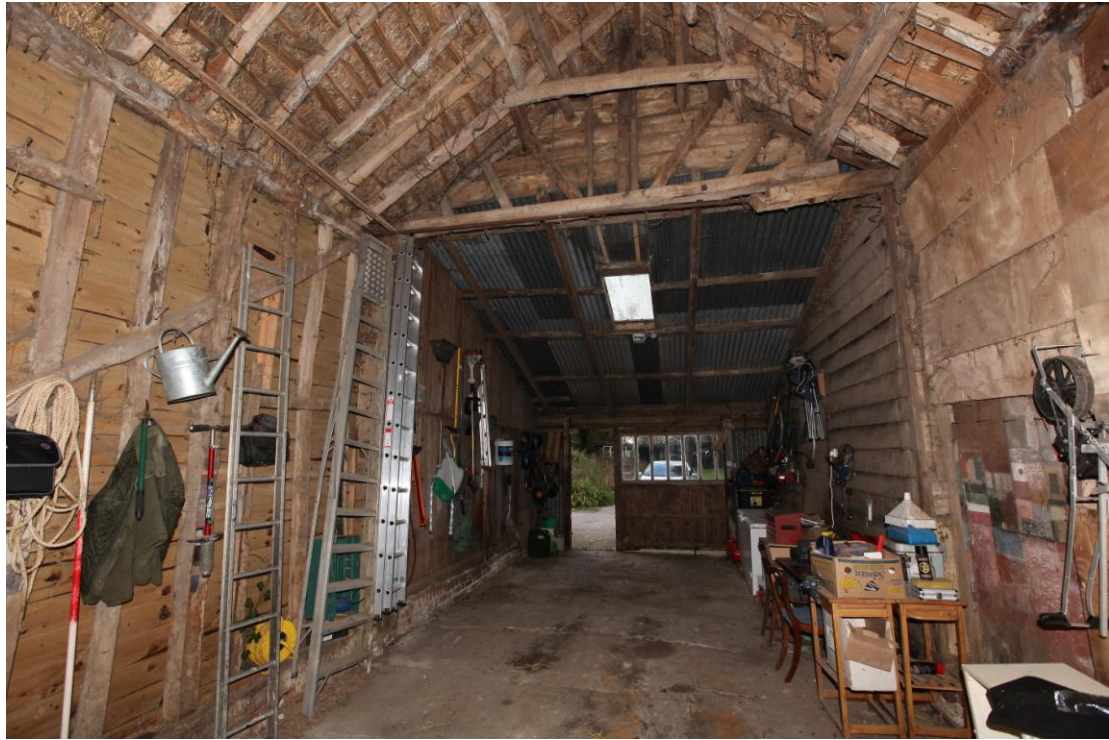
**Illus. 9. The porch (1) from the west showing its junction with the 20th century lean-to shed (5) which replaced the threshing barn into which the porch initially opened. A short surviving section of the demolished barn's roof-plate is visible at top right (it continues into the remaining southern bay from which the lean-to is divided by a later boarded partition).**

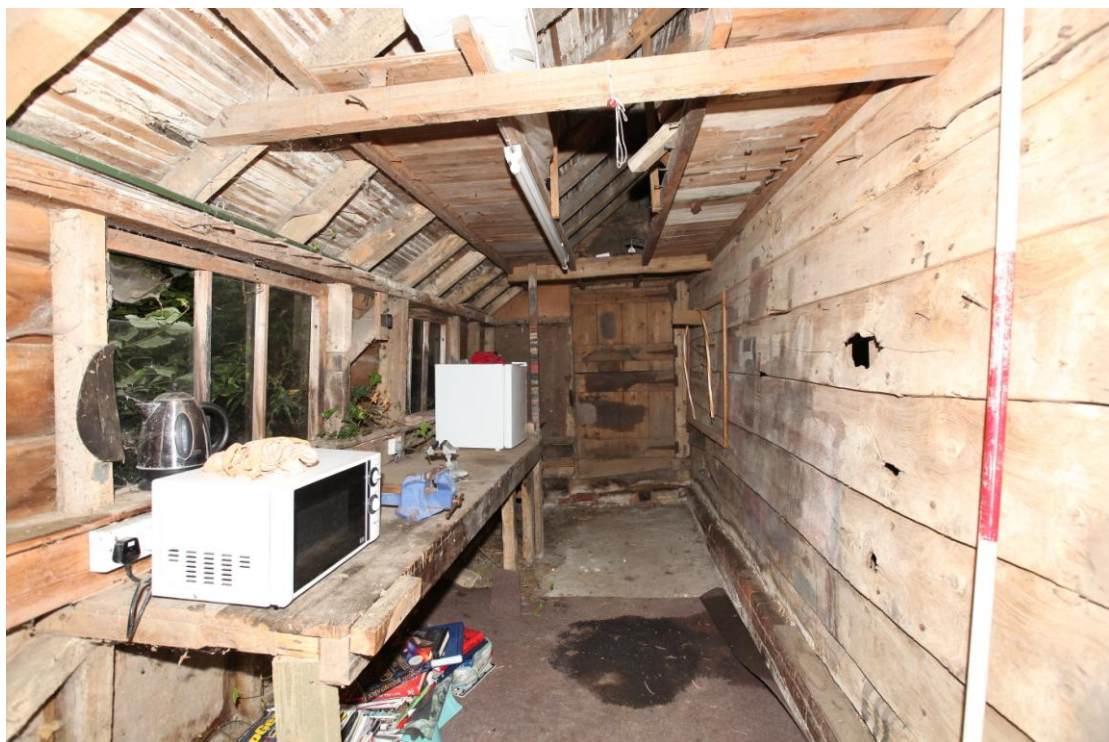
**Illus. 10. The interior from the south of the 19<sup>th</sup> century lean-to shed (4) in the angle of the porch (1) and the southern bay of the barn (2). The windows to the left are insertions of the 20<sup>th</sup> century but the impressively wide boards to the right appear to be original to the barn.**

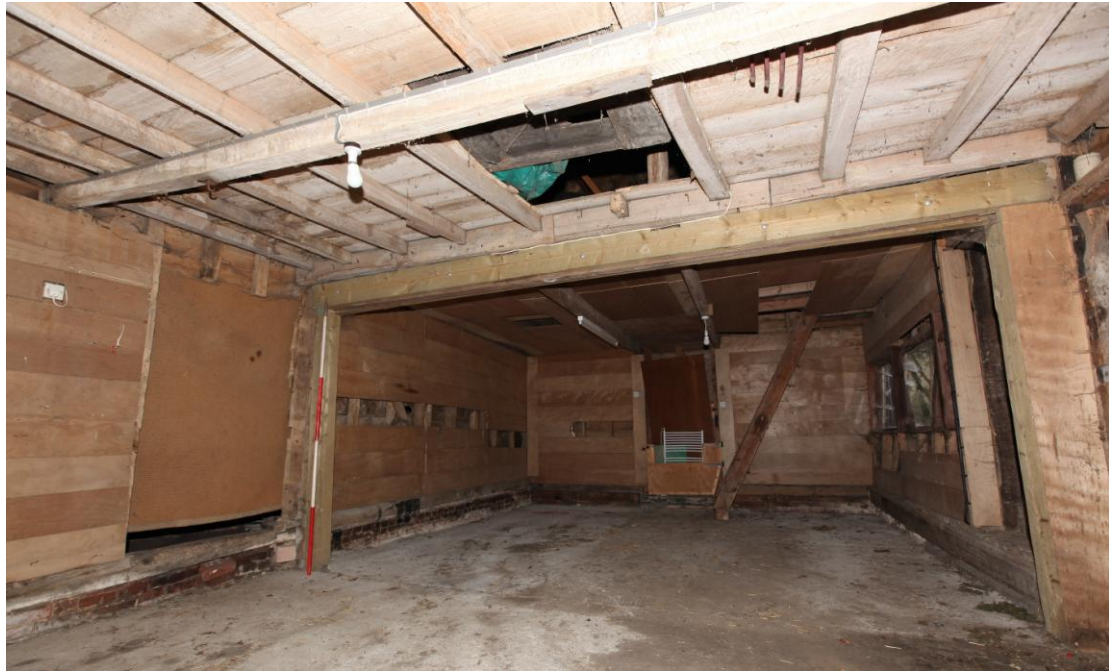
**Illus. 11.** The undivided ground-floor of the southern range from the south, showing the wall framing largely hidden by late-20<sup>th</sup> century boarding. The ceiling of the former stable (3) in the foreground was renewed in the 20<sup>th</sup> century, although one binding joist may be original. The door to the left opens onto the lean-to shed (4) which may have served as a tack room. The partition between the stable and the southern bay of the barn (2) has been removed and its position is indicated by the scale rod and corresponding new softwood in the ceiling.

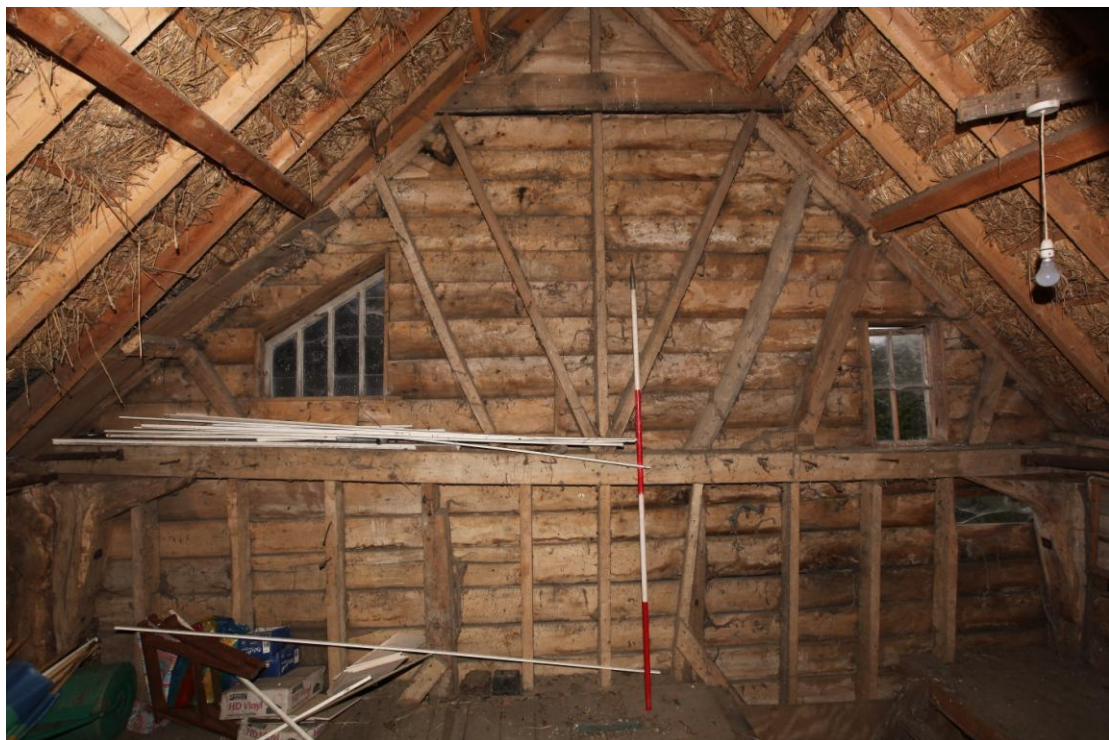
**Illus. 12.** The internal northern gable of the southern bay of the original barn (2) showing the later partition dividing it from the site of the demolished threshing floor. The tie-beam has been renewed but the bolted knee-braces of the formerly open truss (to right and left) appear to remain *in situ*. The floor is a 20<sup>th</sup> century insertion.

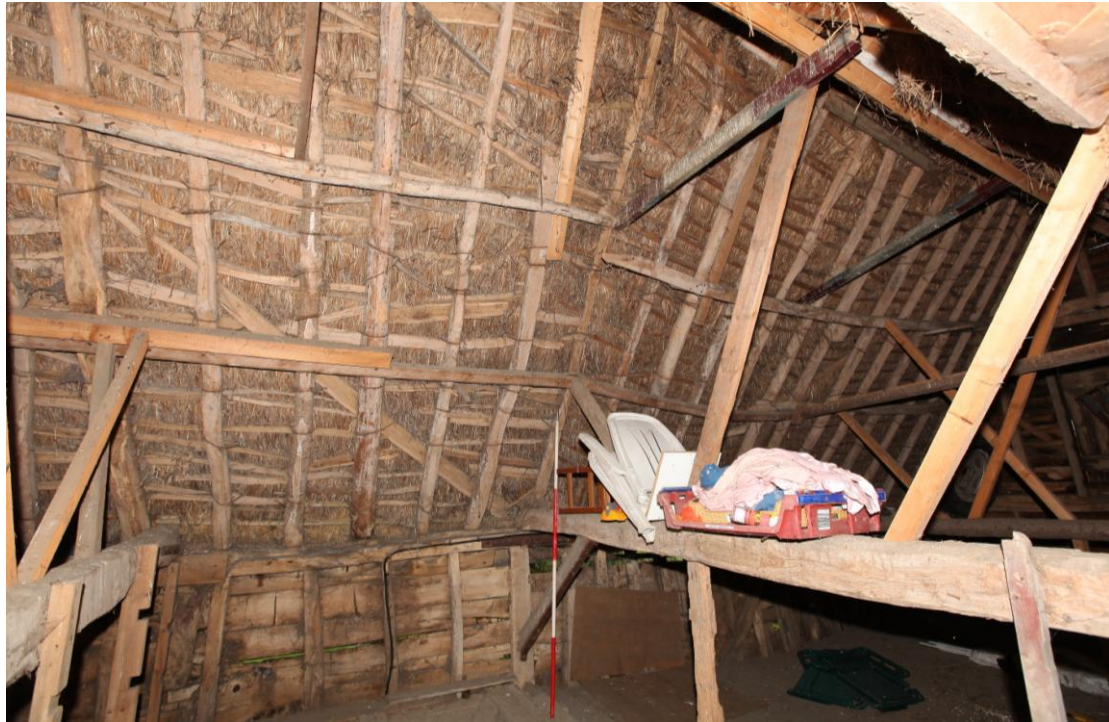
**Illus. 13.** The eastern roof structure of the southern bay of the original threshing barn (2) showing the tie-beam containing the empty pegged mortises of its original southern gable to the right – with the roof of the later stable (3) beyond. The studs of the barn are pegged to the roof plate while those of the stable are not. The clasped-purlin roof is partly original but its collars have been removed and the various struts are modern.

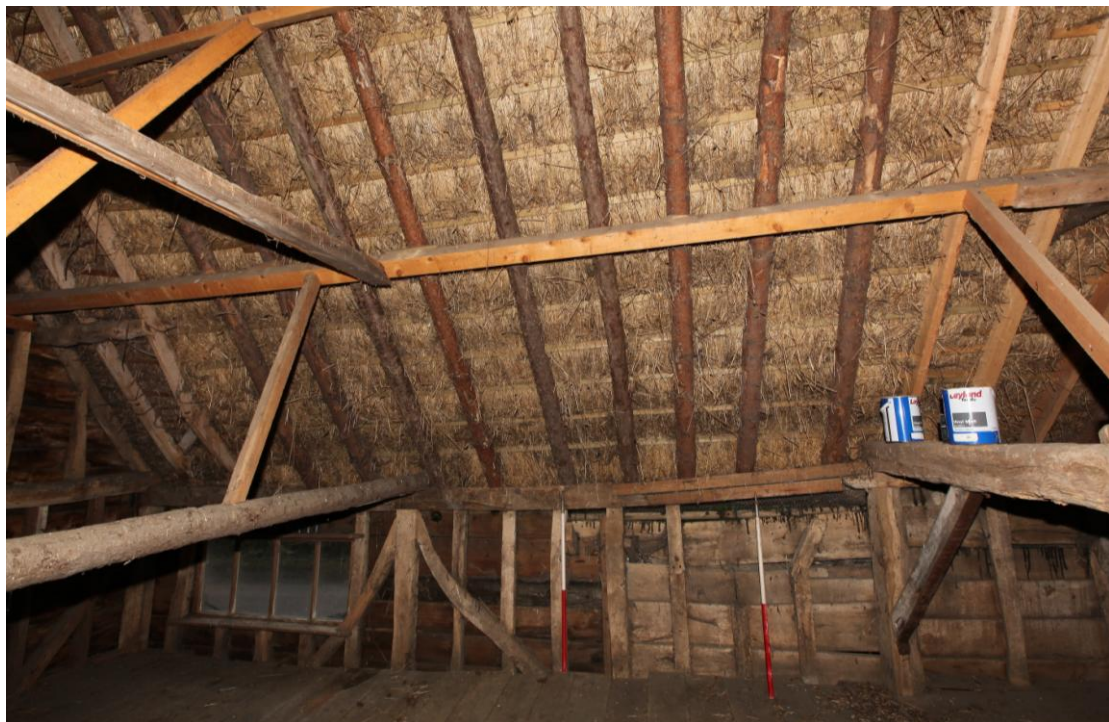
**Illus. 14.** The western interior of the former stable (3) showing the recently replaced rafters and purlins in the roof with the corner of the original barn (2) with a shaped terminal to its roof-plate on the right. The distinctively curved primary wall braces to the left are nailed to the post and the studs are tenoned but not pegged to the roof-plates unlike those of the earlier barn.
