**Upper Barn,
Lower Ufford Road,
Ufford, Suffolk
UFF 036**

Heritage Asset Assessment

October 2012

Historic Building Record

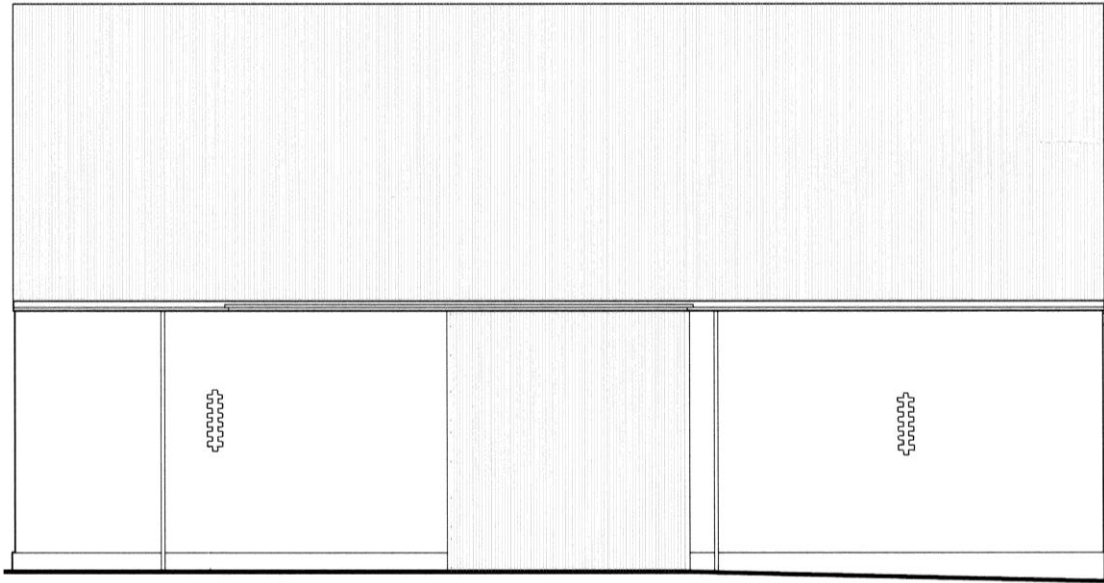
Figure 5
Eastern external elevation showing 20th century sliding doors
and original ventilation loops.
Adapted from a drawing provided by Clarke & Simpson. Scale in metres.

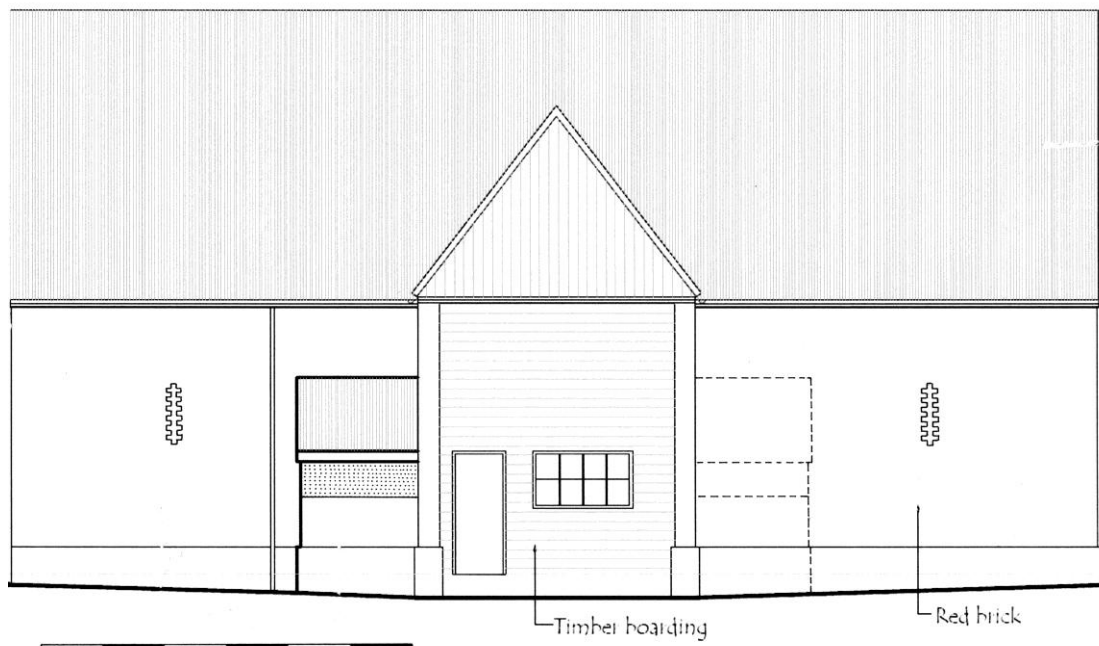
Figure 6
Western external elevation showing original ventilation loops and hipped porch (now
blocked by 20th century weatherboarded studwork). The northern lean-to shed to the
left is also original but its walls were later raised (shaded) and its southern counterpart
(indicated by broken lines) has been demolished.
Adapted from a drawing provided by Clarke & Simpson. Scale in metres.

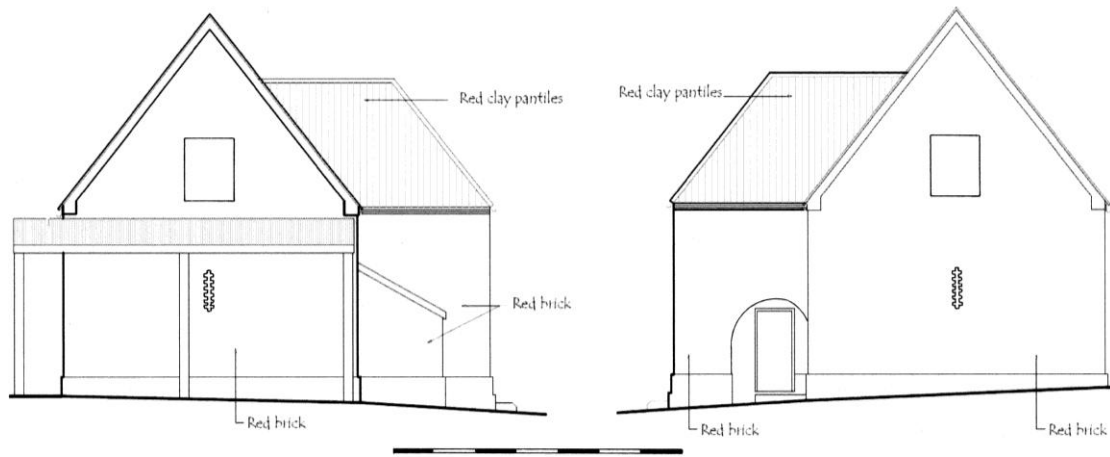
Figure 7

Northern (left) and southern external gables showing the ventilation loops and the outlines of the blocked pitching holes in both roofs. The southern elevation of the porch shows the original arched opening to the demolished lean-to shed. Adapted from a drawing provided by Clarke & Simpson. Scale in metres.

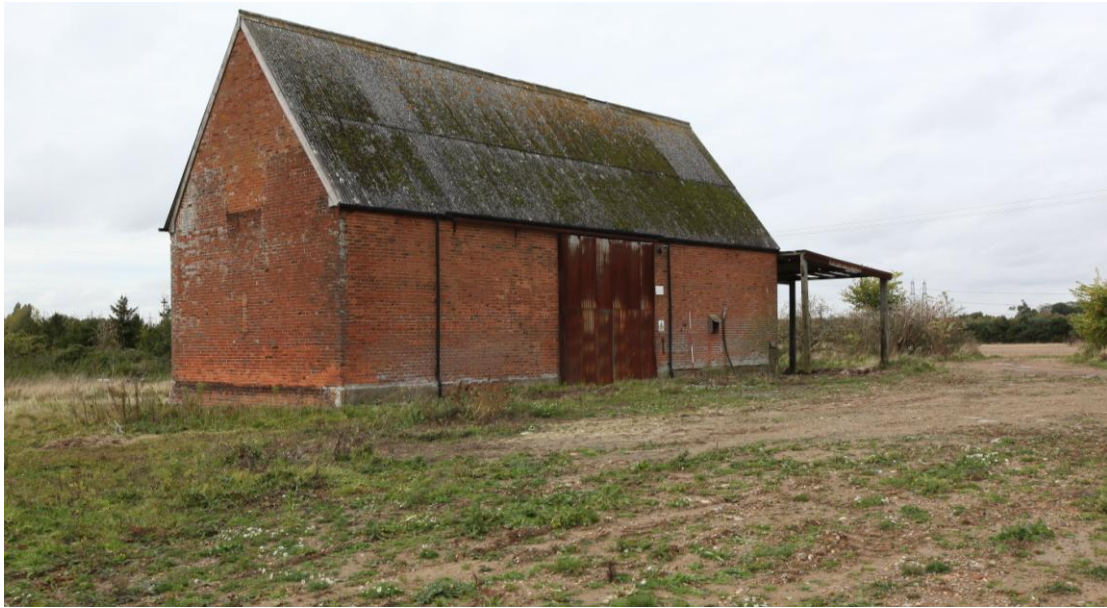
Illus. 1. The barn from the south-east showing its isolated location in open countryside. The steep pitch of the roof suggests the present corrugated asbestos replaced thatch. The apex of the southern gable was rebuilt in the 20th century but the outline of a large pitching hole is still visible in the roof gable with a blocked ventilation loop beneath. 20th century sliding doors of corrugated iron occupy the position of the original central entrance.

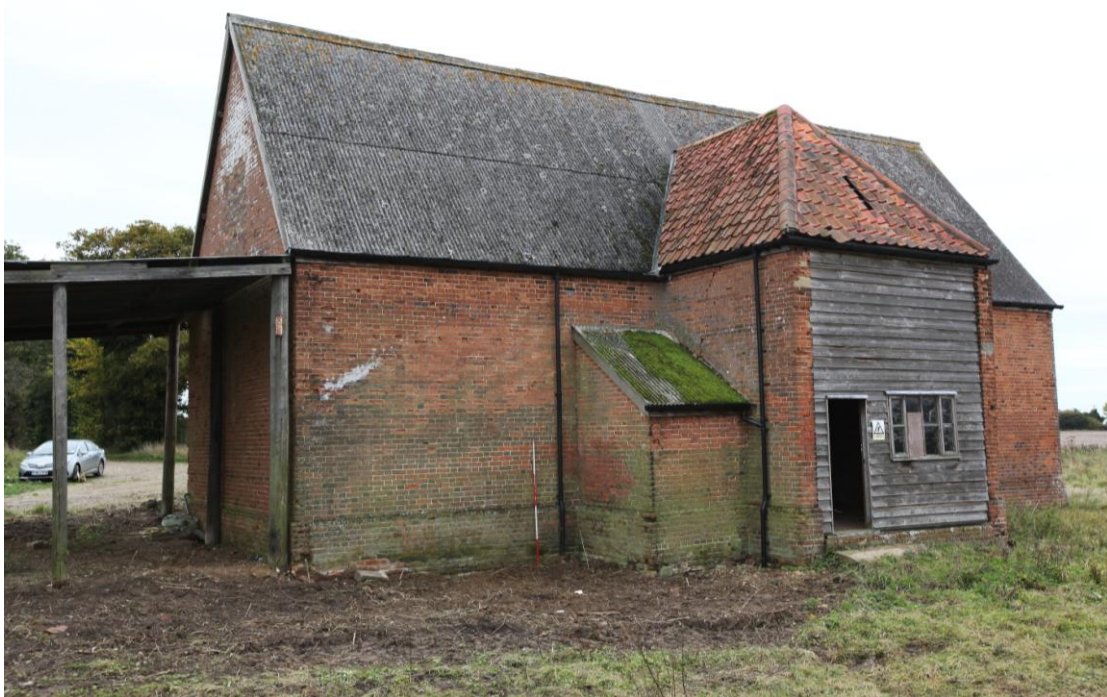
Illus. 2. The barn from the north-west showing the original hipped porch, now pantiled, with an integral lean-to shed in the return angle. The weatherboarded studwork is a late-20th century insertion which replaced original doors (the barn possessed opposing full height doors from the outset). A blocked pitching hole is visible in the northern roof gable, and the roof scar of a demolished single-storied shed shown on 19th century maps can be seen to the left.

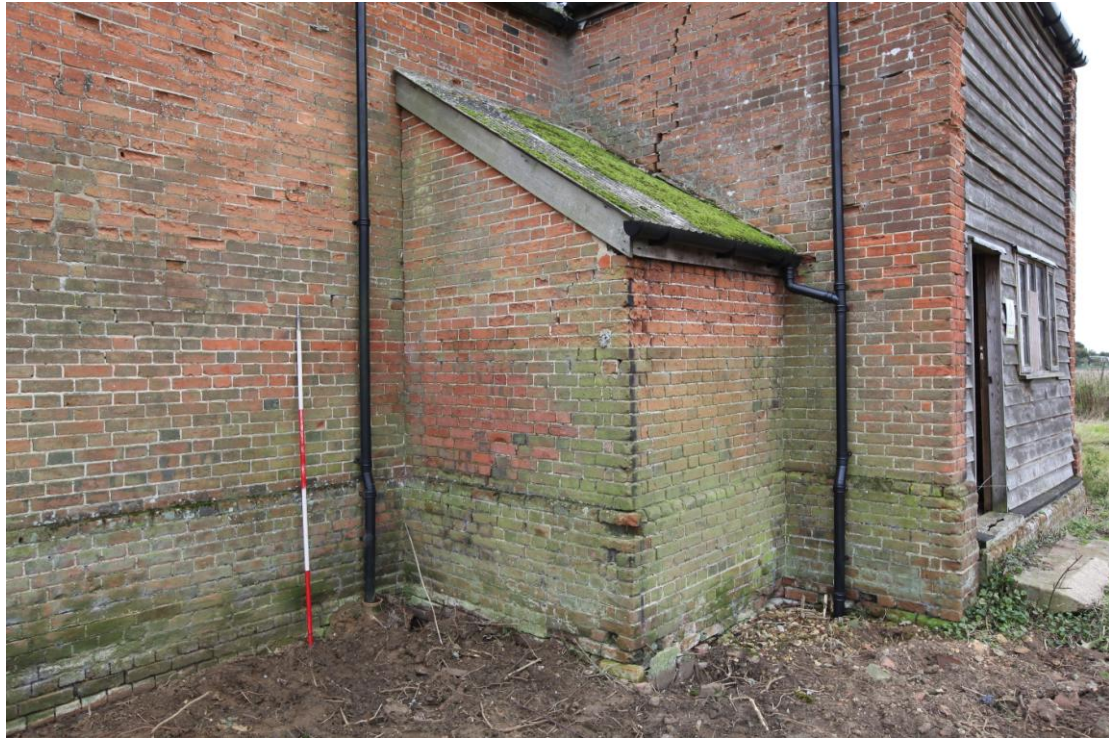
Illus. 3. The lean-to shed to the north of the porch showing its largely original brickwork (keyed to both the porch and barn) to a height of 1.8 m, with the lighter bricks of a seven-course lift beneath the eaves of the present 20th century roof structure. The later brickwork is not keyed to the barn.

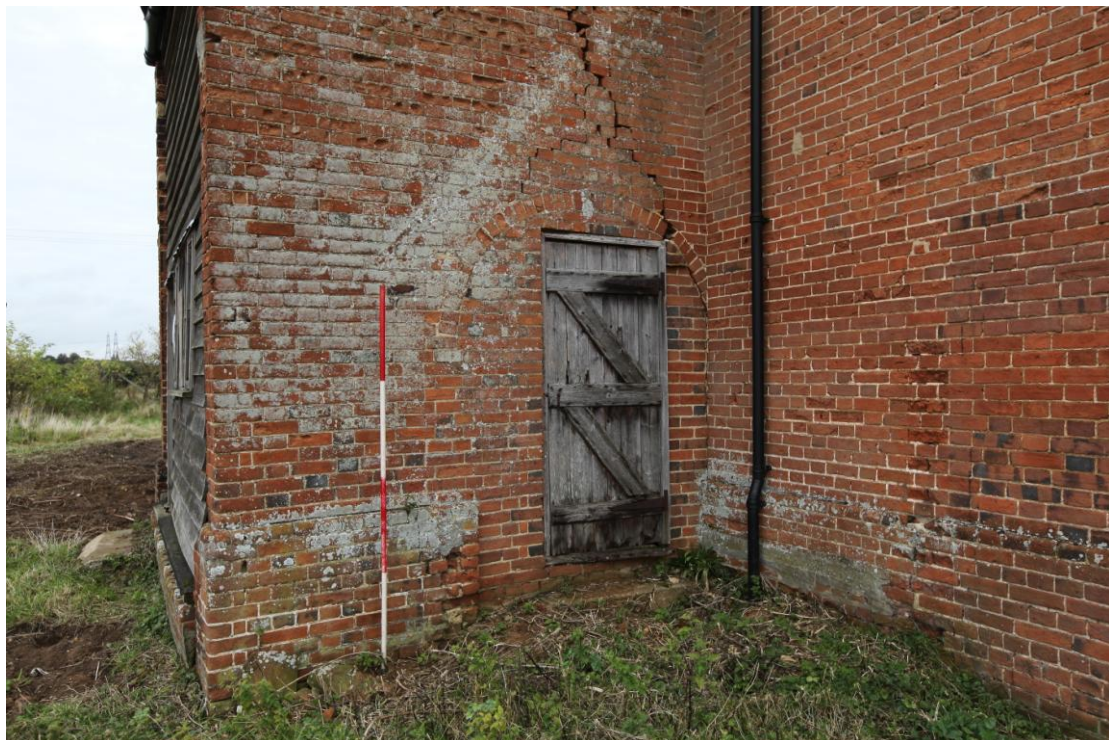
Illus. 4. The southern elevation of the porch showing the arched aperture and roof scar of a demolished lean-to shed which reflected its remaining counterpart to the north. The scar of its southern wall is visible in the brickwork of the barn to the right. The narrow doorway is a later insertion into the arch.

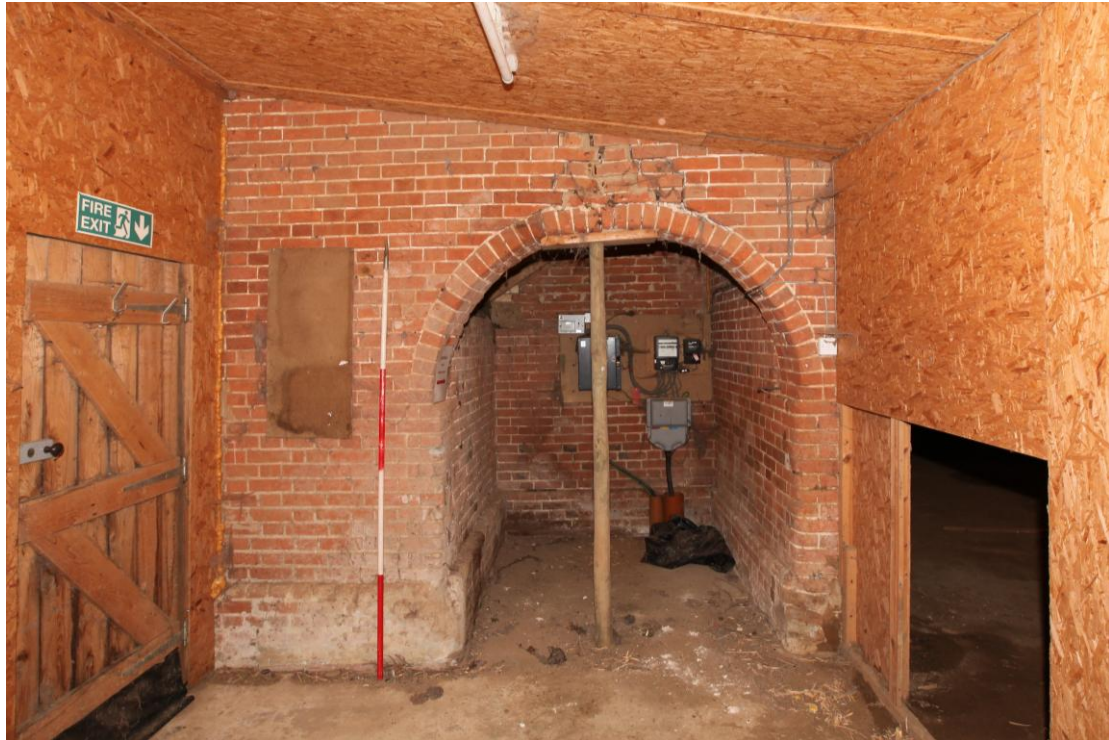
Illus. 5. The interior of the porch from the south, showing the original arched opening to the integral lean-to shed. Two wooden blocks are set into the brickwork of both piers, presumably to secure the jambs or rails of a boarded hatch or partition, and the shed is likely to have operated as a grain store adjoining the threshing floor. The fire-board ceiling and partition to the main barn on the right are late-20th century insertions.

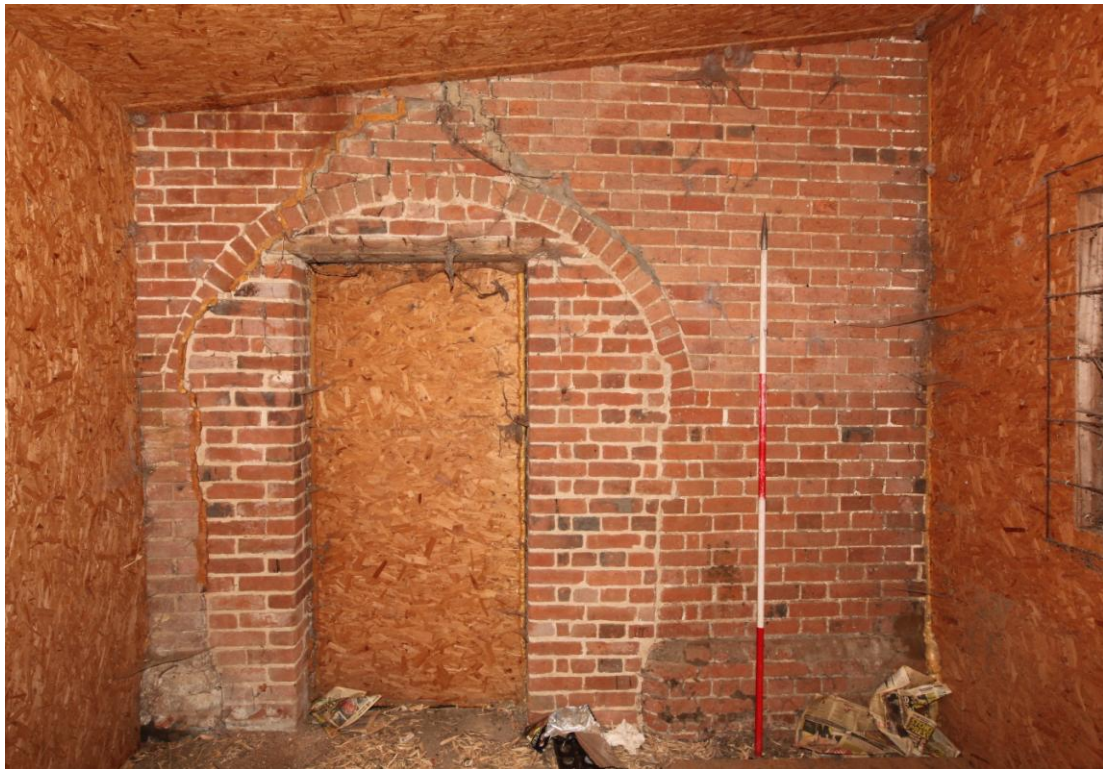
Illus. 6. The interior of the porch from the north, showing the identical arched aperture to the demolished southern lean-to shed and its subsequent reduction to form the narrow doorway in illus. 4 above.

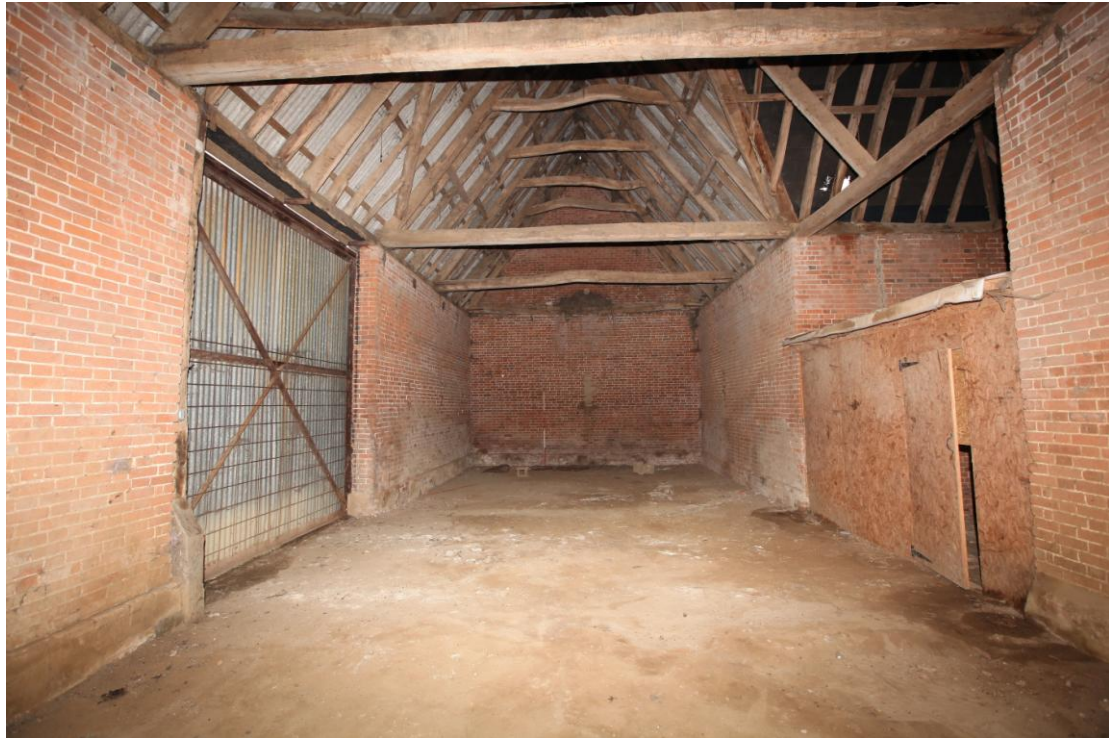
Illus. 7. The interior of the barn from the north with the original full-height entrance in the centre of the eastern elevation to the left, immediately opposite the western porch with its modern fibre-board partition on the right. The floor is of concrete throughout.

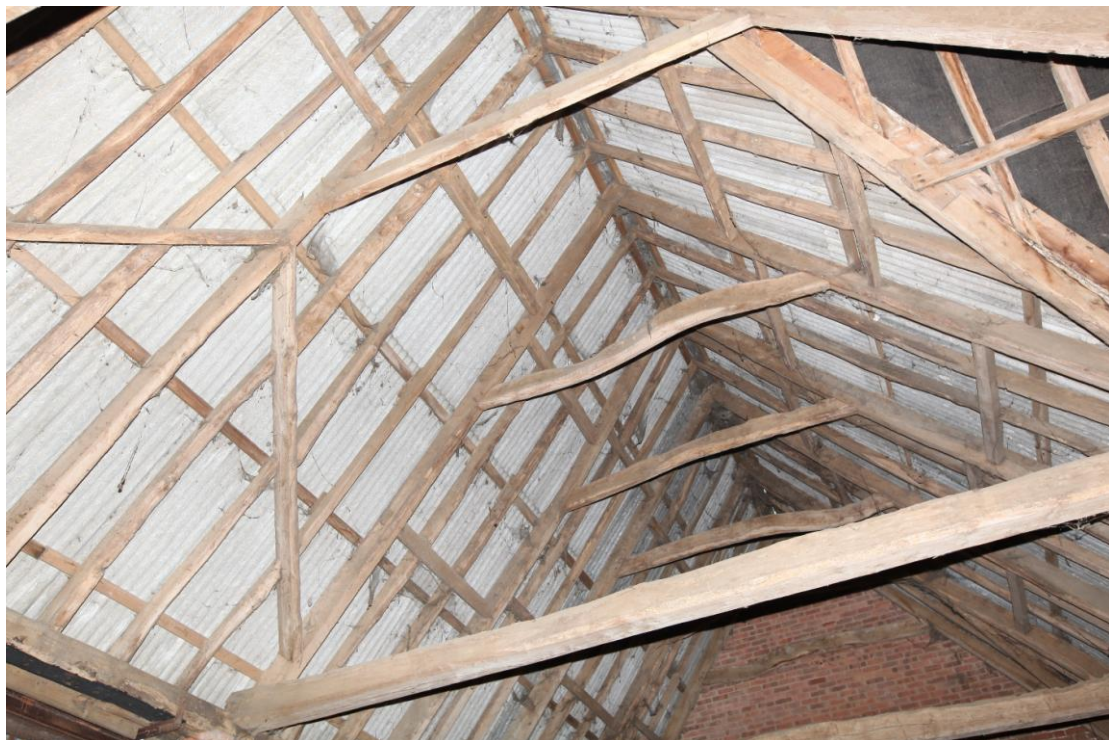
Illus. 8. The completely intact original roof structure containing two tiers of staggered butt-purlins with pegged through-tenons, pegged collars, and asymmetrical primary rafter braces (seen from the north). The rafter braces above the eastern entrance to the left reflect the lap boards of the western porch to the right but are lower in pitch and do not indicate the former presence of an eastern porch.

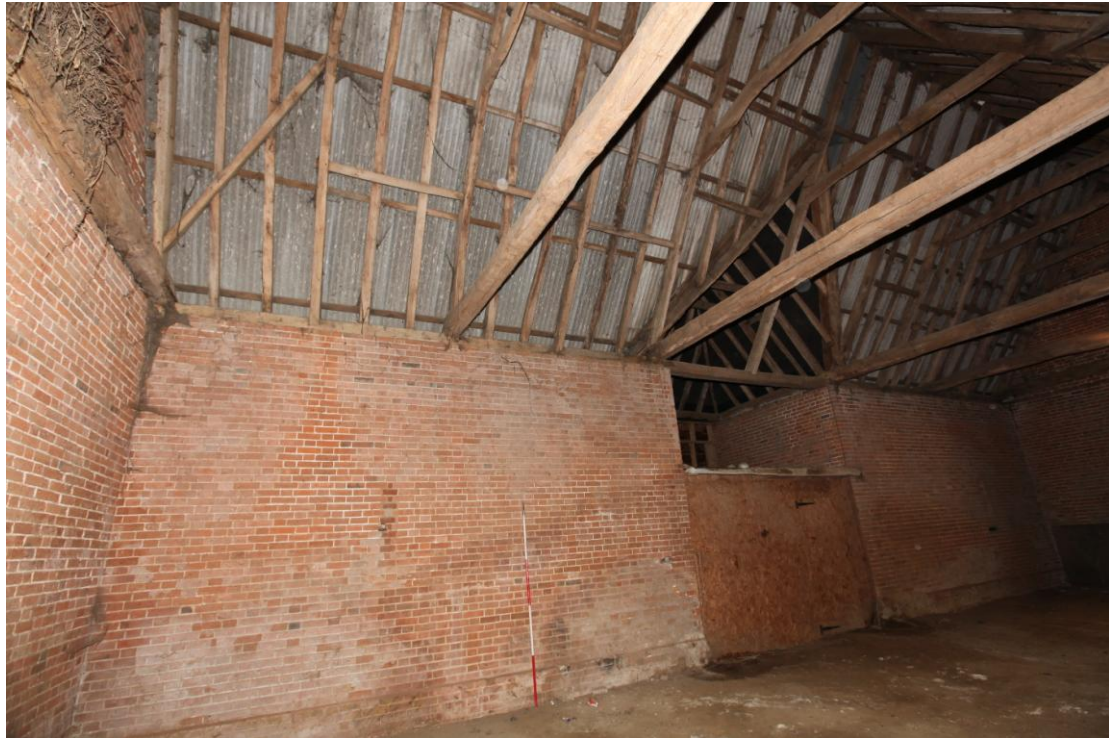
Illus. 9. The western internal elevation showing the central porch with a primary rafter brace to the southern gable to the left but not to the northern gable. The situation is reversed to the east. Two short ‘purlins’ were tenoned to the external face of each gable rafter to penetrate the brickwork and secure barge-boards. The blocked ventilation loops of the outer bays are not central (unlike those to the east) as they accommodated the lean-to sheds flanking the porch.

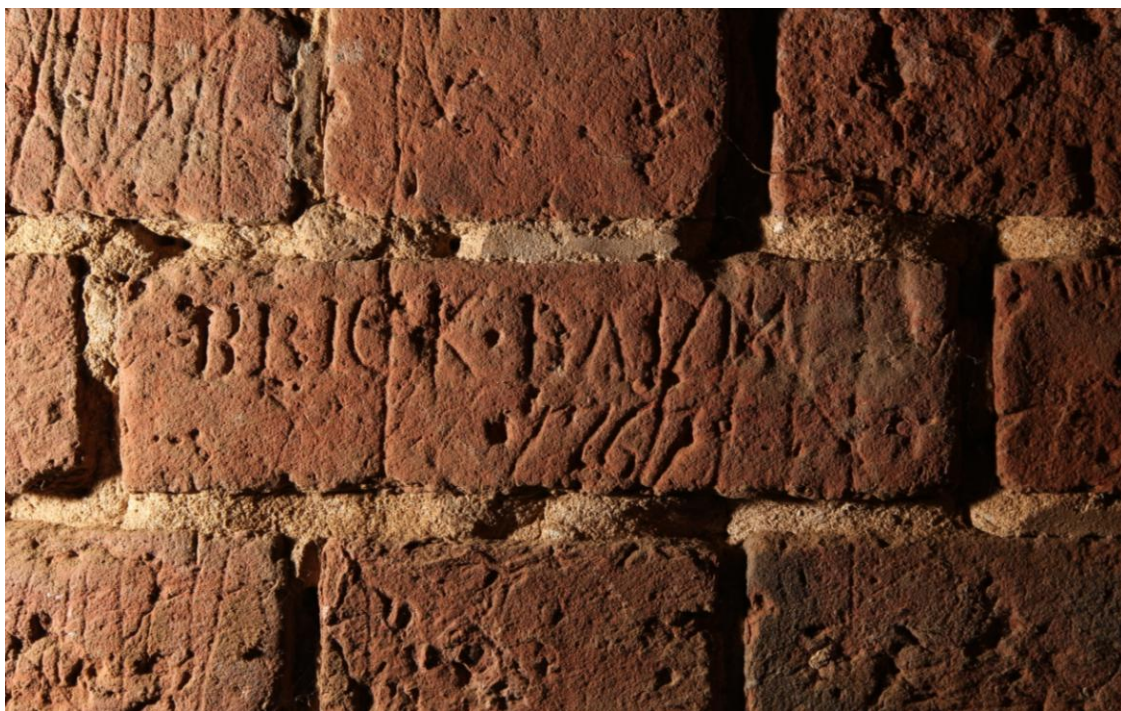
Illus. 10. A detail of the neatly incised tally marks along with a name and date to the western interior of the barn at a height of 1.5 m immediately north of the porch: 'BRICK BARN 1767'. This appears to be entirely genuine, and is consistent with the building’s architectural detail.

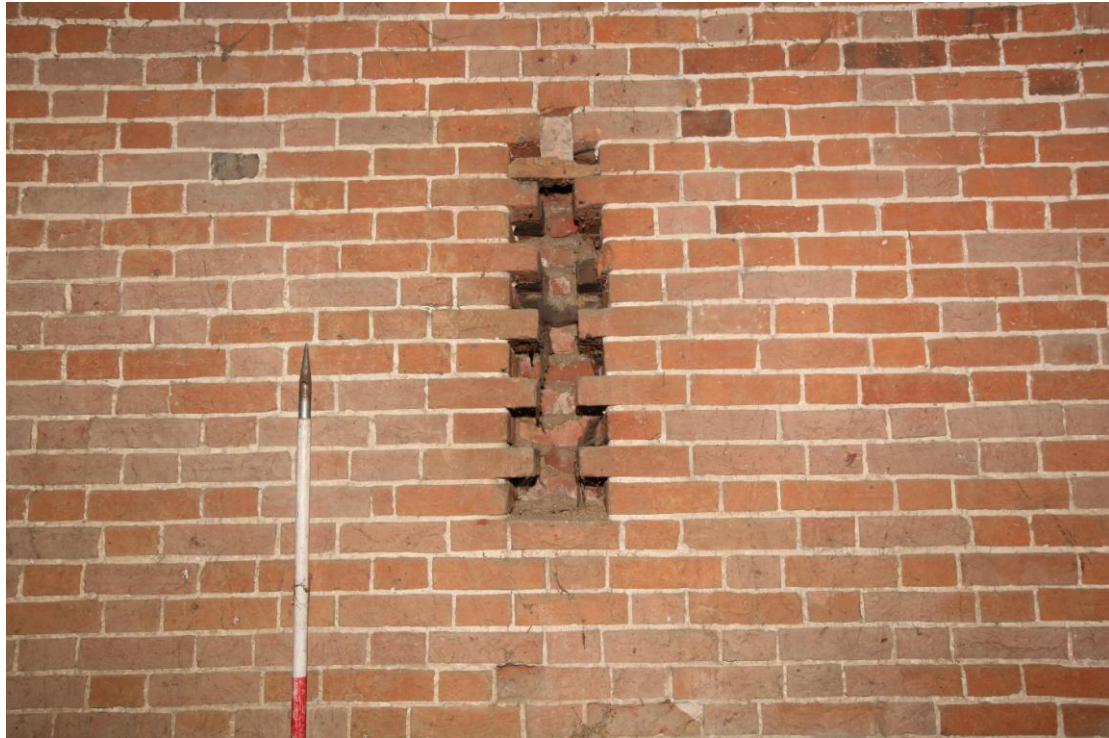
Illus. 11. The blocked ventilation loop to the internal northern gable showing its original indented brickwork. The barn contains six identical loops (in both gables and to both sides of the eastern entrance and western porch).

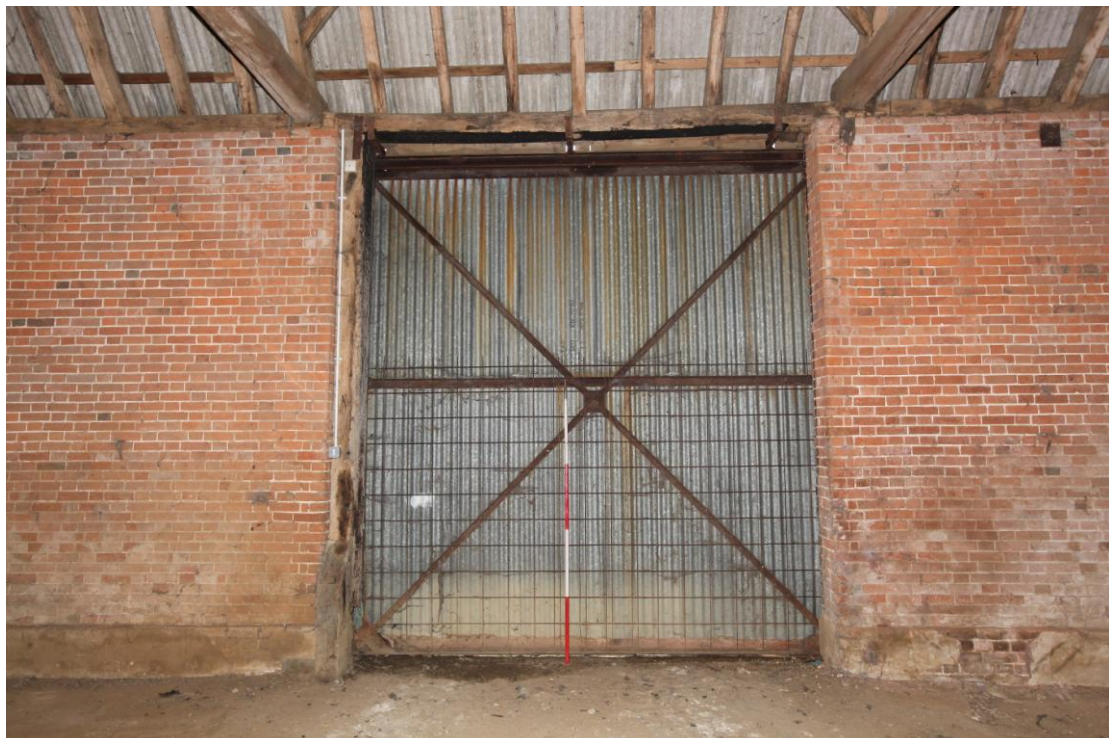
Illus. 12. The central entrance of the eastern elevation showing an ostensibly original door jamb to the left. The roof-plate contains a pegged mortise for a second jamb to the right with a central mortise to hold the door bar of the original full-height barn doors. The remaining jamb bears an incised date '1762' at a height of 1.75 m but this appears to be a relatively modern misreading of the original 1767 date on the opposite wall.

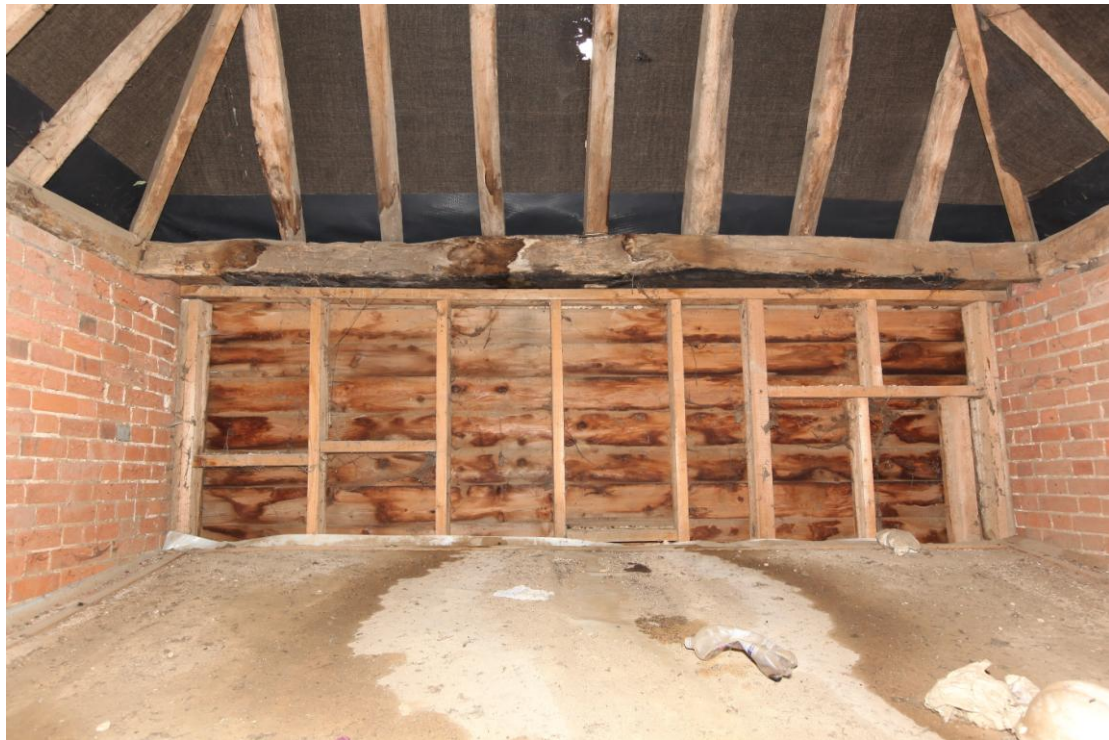
Illus. 13. The tie-beam of the hipped porch gable (above the modern fibre-board ceiling) showing a central mortise for a door bar with double-pegged mortises at both ends for the missing jambs of full-height original doors. The softwood studwork and weatherboarding are insertions of the late-20th century. The barn evidently contained full-height doors at both ends of its threshing floor: a rare feature in an 18th century barn.

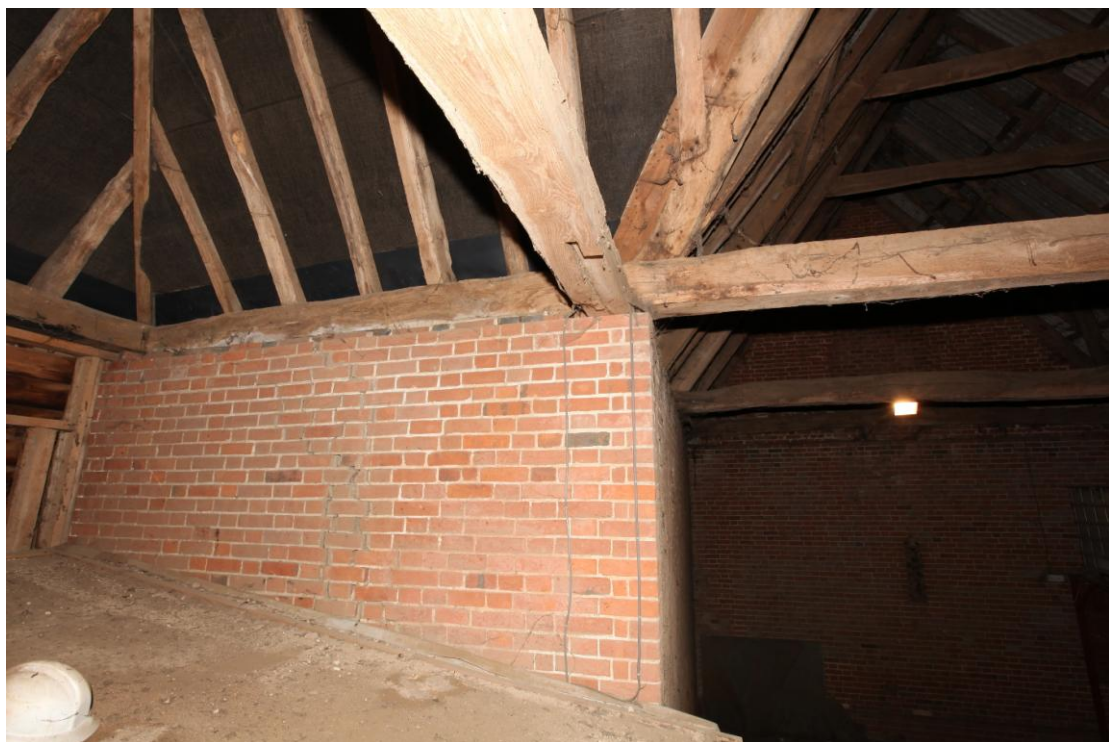
Illus. 14. The northern side-elevation of the porch showing the tie-beam of the main barn continuing to form its roof plate; this oak timber is an impressive 9.9 m (32.5 ft) in length, as is its counterpart to the south.
