Eye Castle masonry repairs EYE 116

Archaeological Monitoring Report

SCCAS Report No. 2012/184

Client: Mid Suffolk District Council

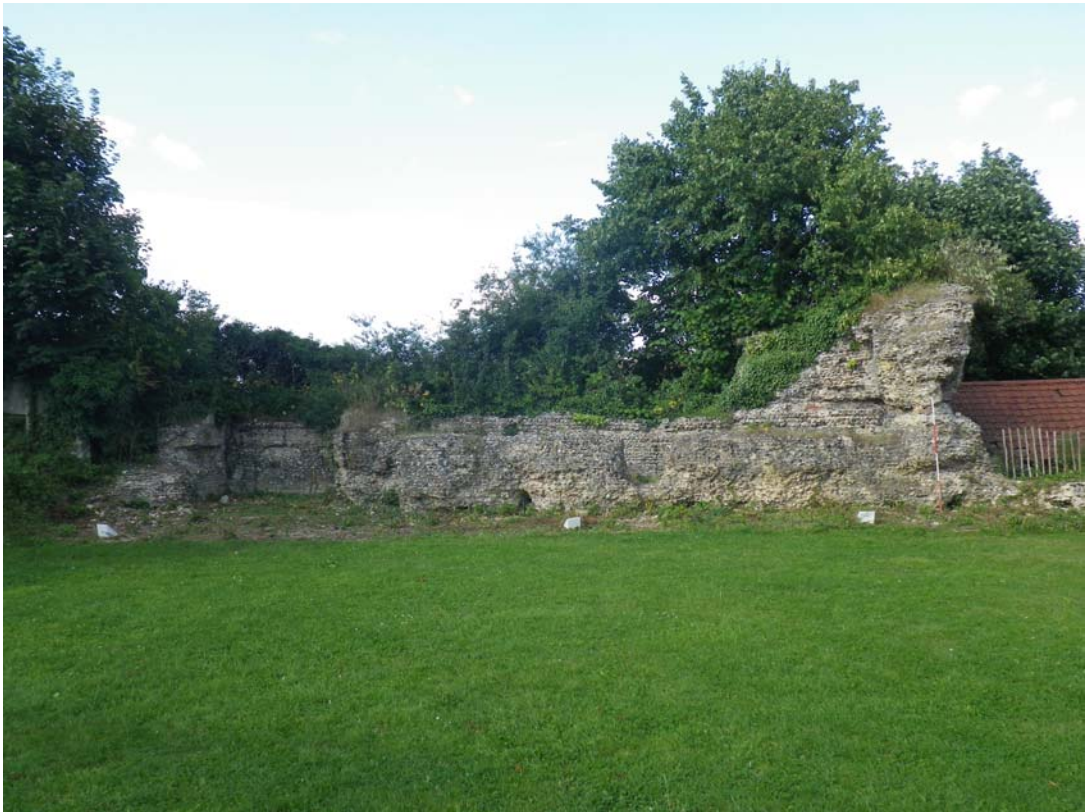
Plate 1. The bailey curtain wall from within the bailey looking south. The open structure on the left is the remains of the west tower, the south wall of which has been truncated at ground level. The tall section on the right is a partition wall between chambers 2 and 3. The entrances to the series of channels below floor level can be seen at the base of the south (nearest) wall.

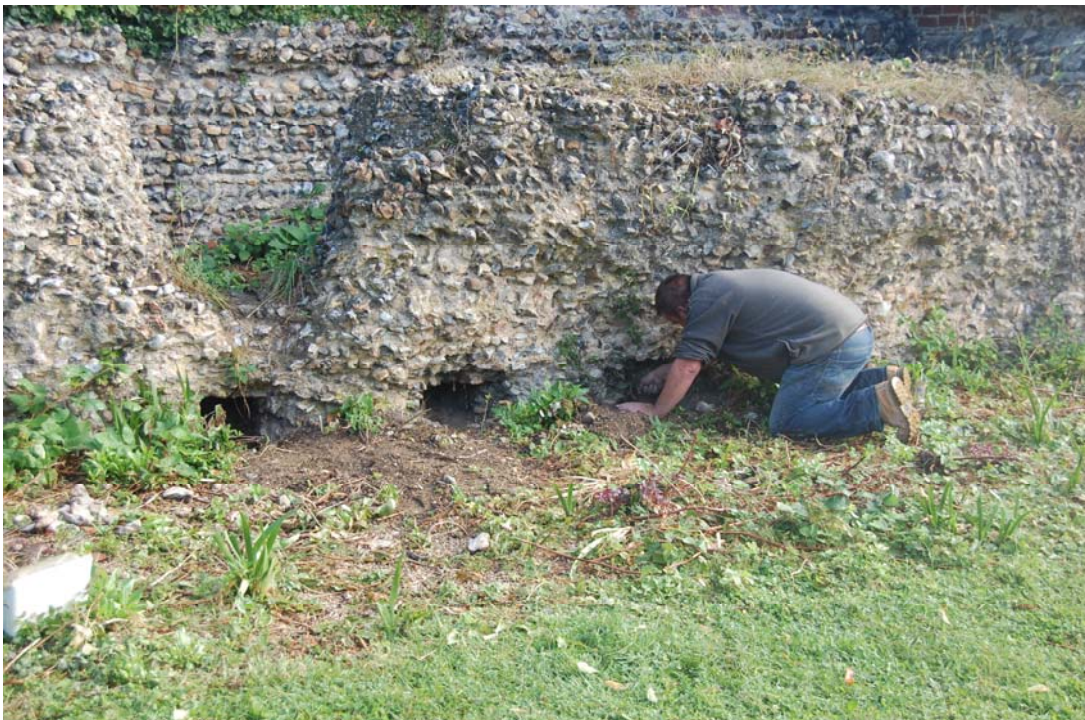
Plate 2. Excavating the channel entrances (Nos 7, 8 and 9) at the base south wall of chambers 1 and 2, showing the arrangement of channels in groups of three

The repairs concentrated on the consolidation of the eroded base of the wall and stabilising overhanging sections of masonry, together with the blocking of the entrances of a series of box channels that pierced the entire thickness of the wall (Pls. 2 and 3). The channels are described as 'drains below floor level' on the RCHM plan (Fig. 2). This interpretation is speculative and the evidence inconclusive (see discussion). The channels had become infilled with soil and allowed the ingress of roots to the monument fabric. Twelve of the channel entrances were recorded (all on the south wall face) and these are shown on the RCHM plan; it was confirmed that these were structural features requiring preservation. The holes were blocked using tile and brick fragments, materials not used in the original fabric, to enable the holes to be identified and read as recently blocked features, and the depth of fill was recessed from the original face to maintain their appearance.

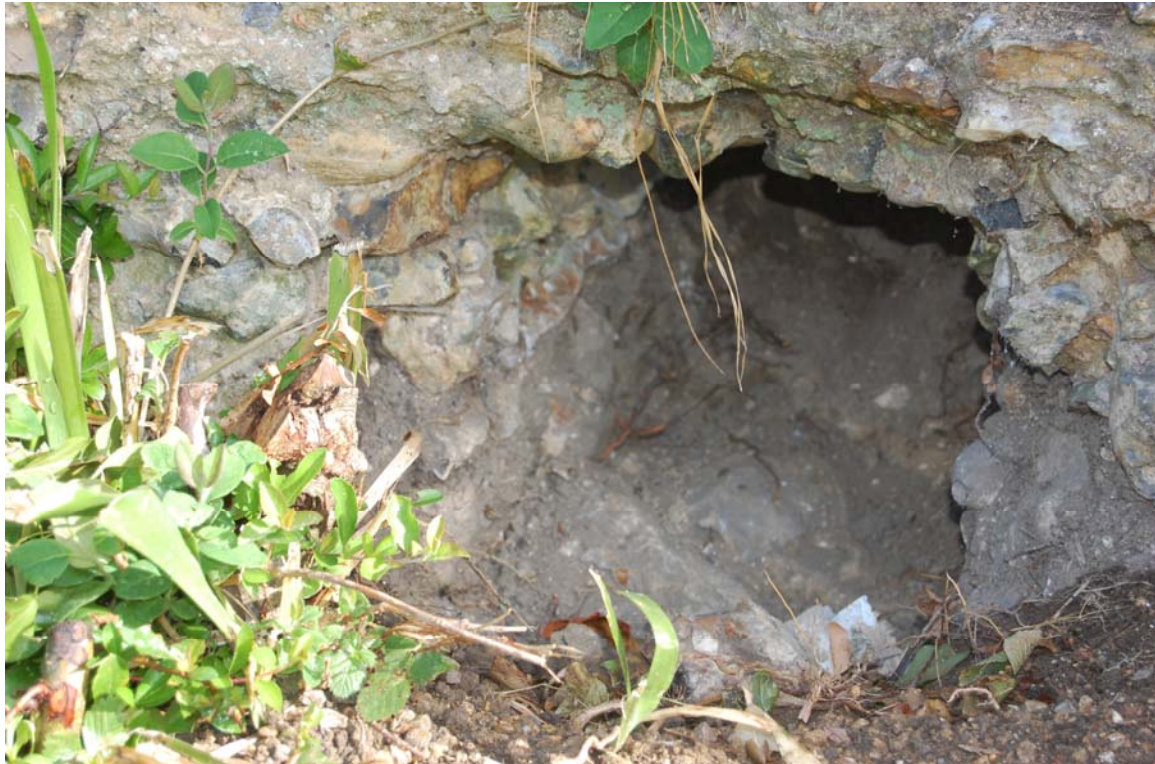
Plate 3. Entrance to one of the channels which are square-section and measured 300mm across. The internal faces were neatly finished suggesting that they had been constructed around timber beams. The floor of the channels was mortared flint and the voids had become blocked with soil which was partially excavated prior to blocking with 'masonry'.

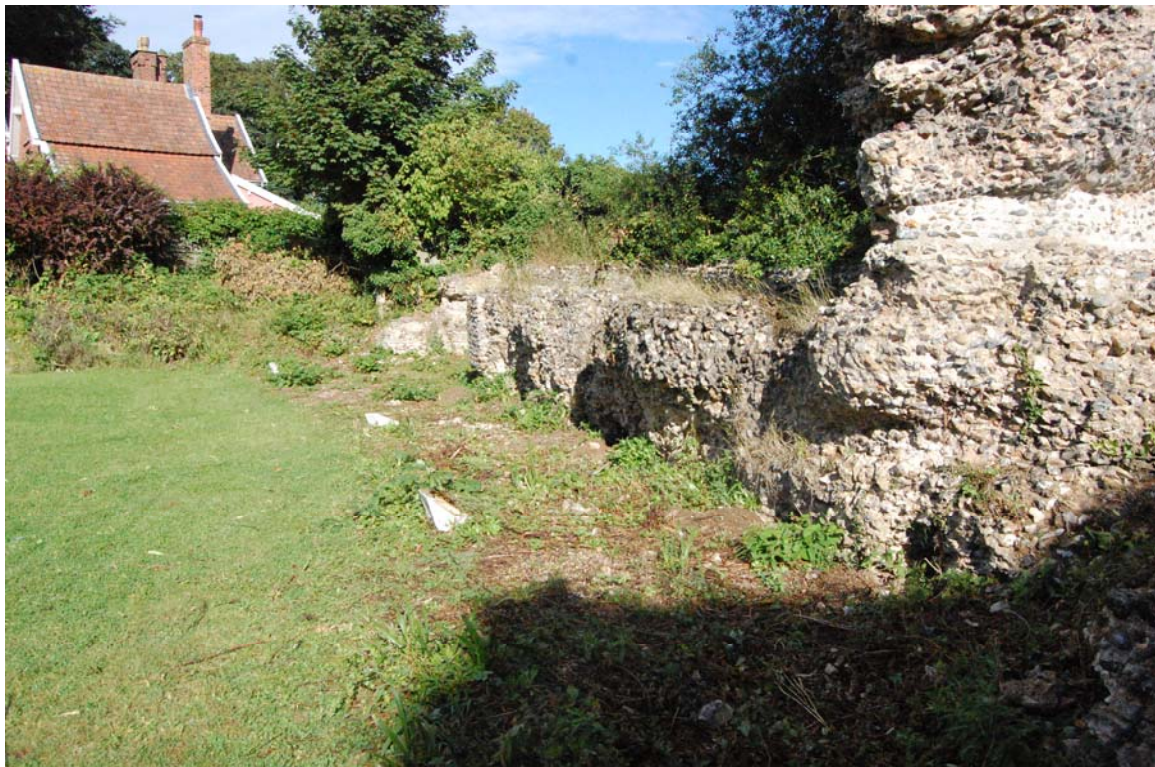
All of the original face work on the exterior of south wall has been lost exposing the core fabric over much of the monument (Pl. 4). Deep horizontal gouges can be seen cutting into the core work on the tallest section of wall (the partition between chambers 2 and 3). The gouges occur on both opposing faces creating a severely 'pinch waisted' profile at mid height (Pl. 6). This gives the impression that the upper section had, in the past, become a completely detached block. Better preservation of the wall's original thickness over the upper section had created an acute overhang; previous repairs had filled the gouges with brick but these were to be further consolidated with flint to preserve the wall's stability.

Plate 4. South exterior elevation bailey wall looking NW. None of the original Norman face-work survives and the core fabric is exposed. This is scarred with horizontal 'gouges' seen running E-W across the face and in profile in the elevated section in the foreground; similar gouges were observed running N-S across the face of the partition wall.

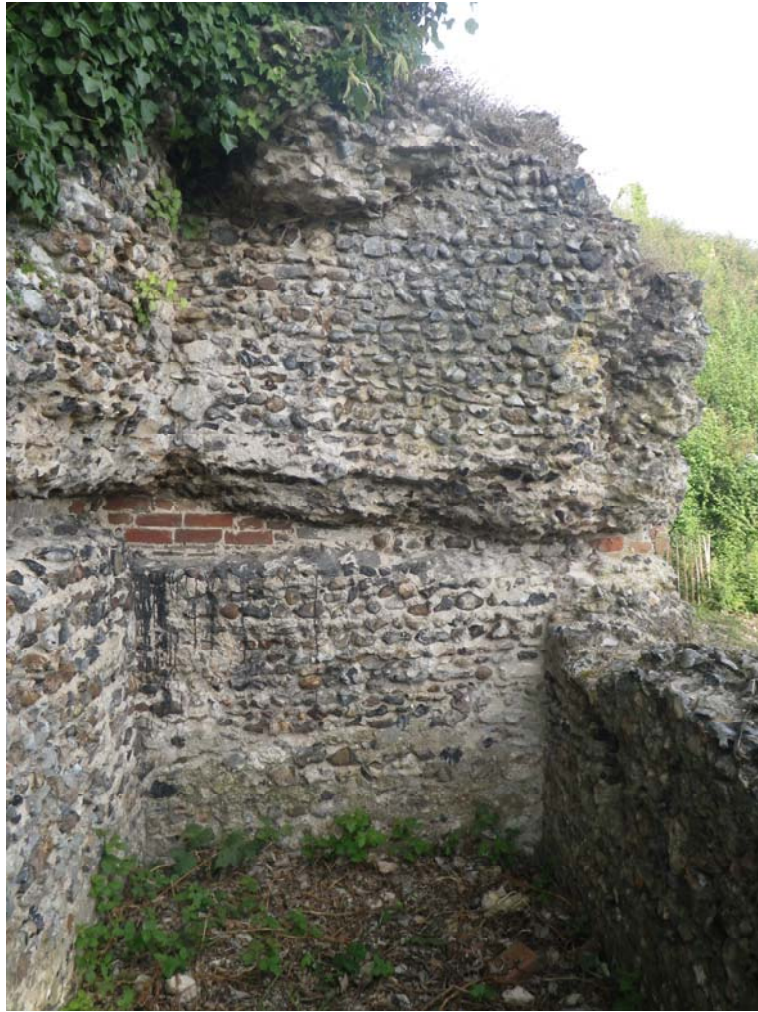
Plate 5. West face of the N-S partition wall between chambers 2 and 3. A horizontal channel, repaired previously with brick, divides the wall at mid-height and can be seen returning on the north wall at the left of the picture. Horizontal flint coursing characteristic of Norman masons can be seen on the lower wall and appears angled on the upper suggesting that the upper block has slumped and was once detached. The N-S channel is directly over channel No.10 below the ground floor level.

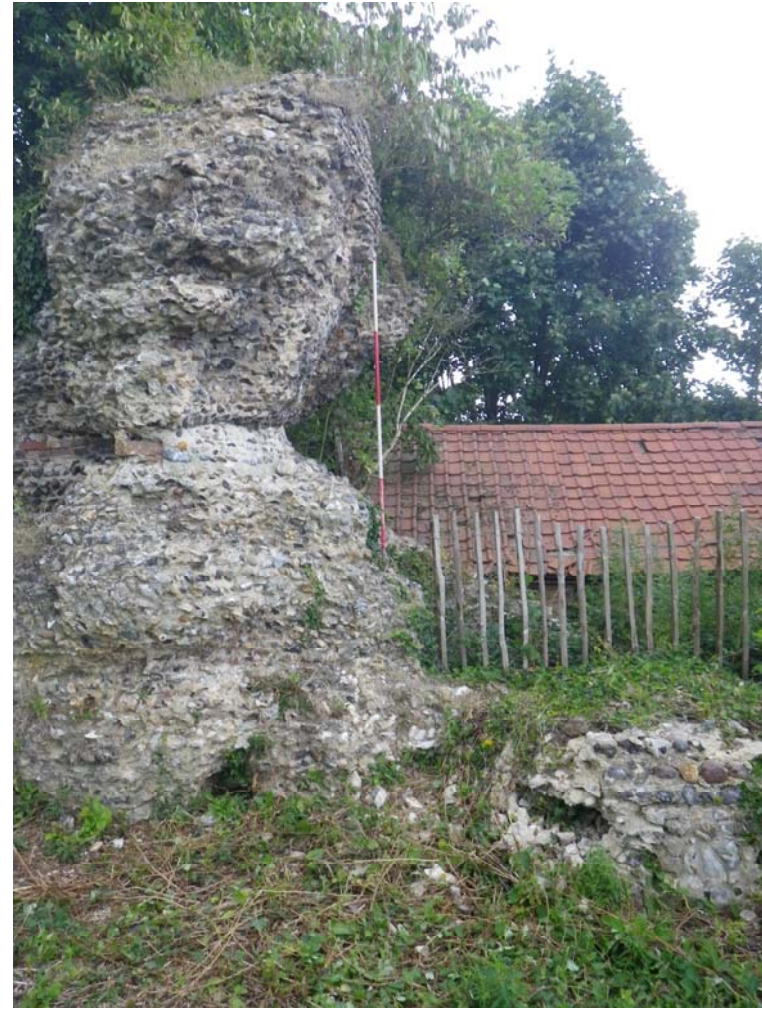
Plate 6. The partition wall between chambers 2 and 3 looking N. The ranging pole is on the line of the original wall face, as demonstrated by fragments of surviving Norman facework at the top and bottom of the wall, and illustrates the degree of fabric loss in the middle of the wall.

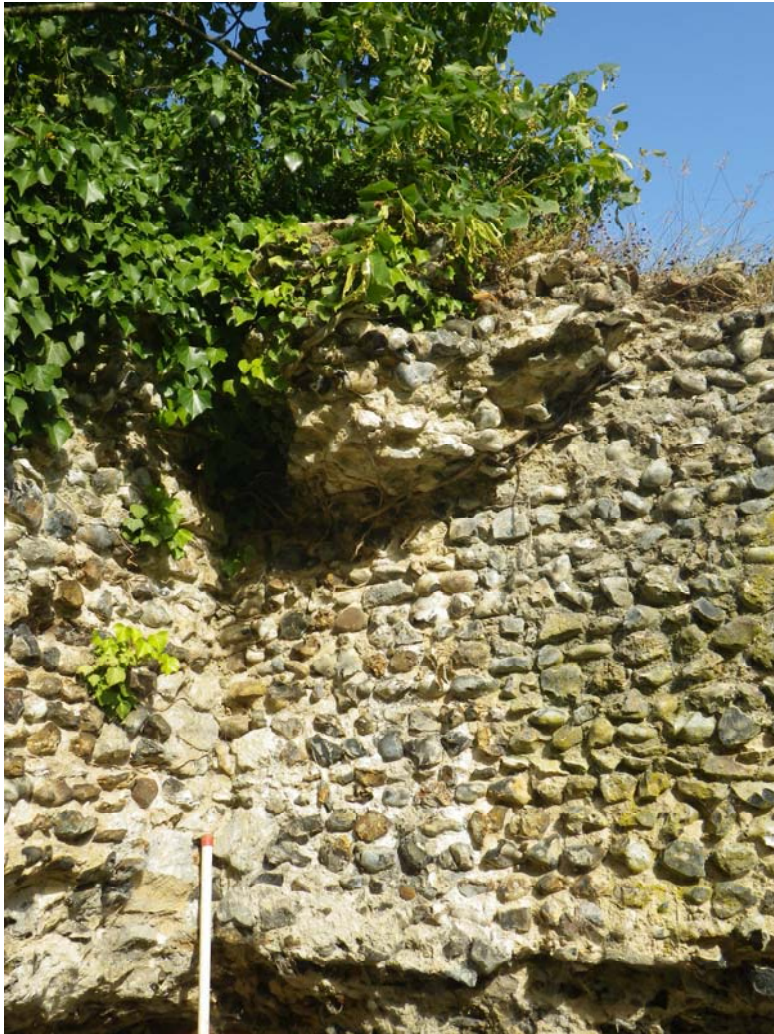
Plate 7. Block of overhanging masonry in the in the NE corner of chamber 2. It is possibly the start of a vault to support the floor above but there is no evidence of a taper to a springing point below the block to suggest where the vault might start. It only exists in the corner and did not extent across the face of the east or north wall. It is an original feature and likely to represent some form of corbelling or support for a ceiling or floor at this level.

In addition a projecting block of bonded flint which overhung chamber 2 was to be tied and supported (Pl. 7).

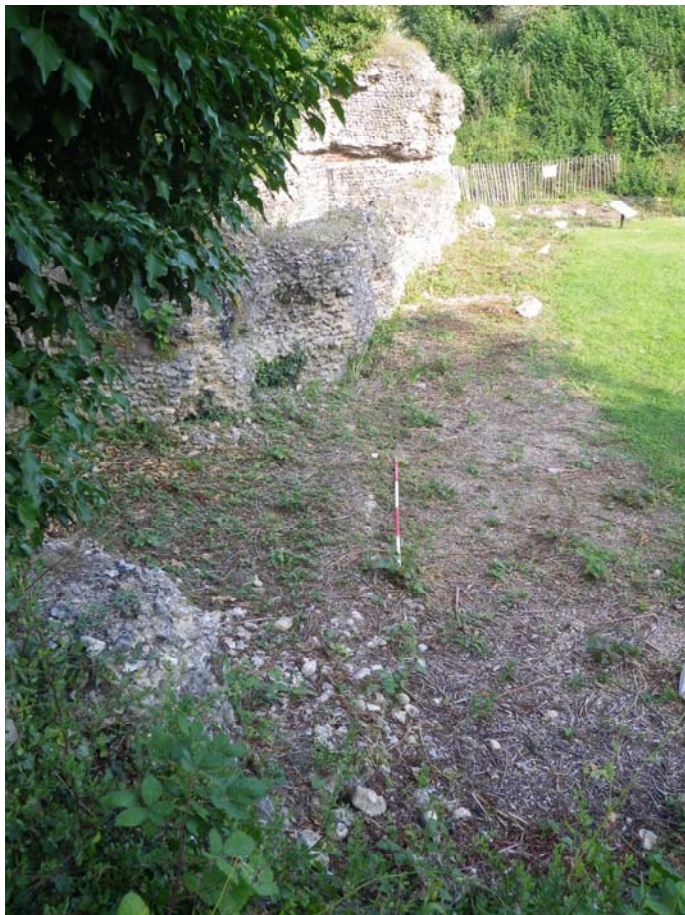
The repairs to the monument have been seen to have been done in a sympathetic way and in line with English Heritage advice. Areas around the east tower and the south wall of the west tower however are still vulnerable and in need of consolidation or protection.

Plate 14. The south wall of the west tower truncated close to ground level. The ranging pole lies along the line of the wall and is positioned against its exterior face.

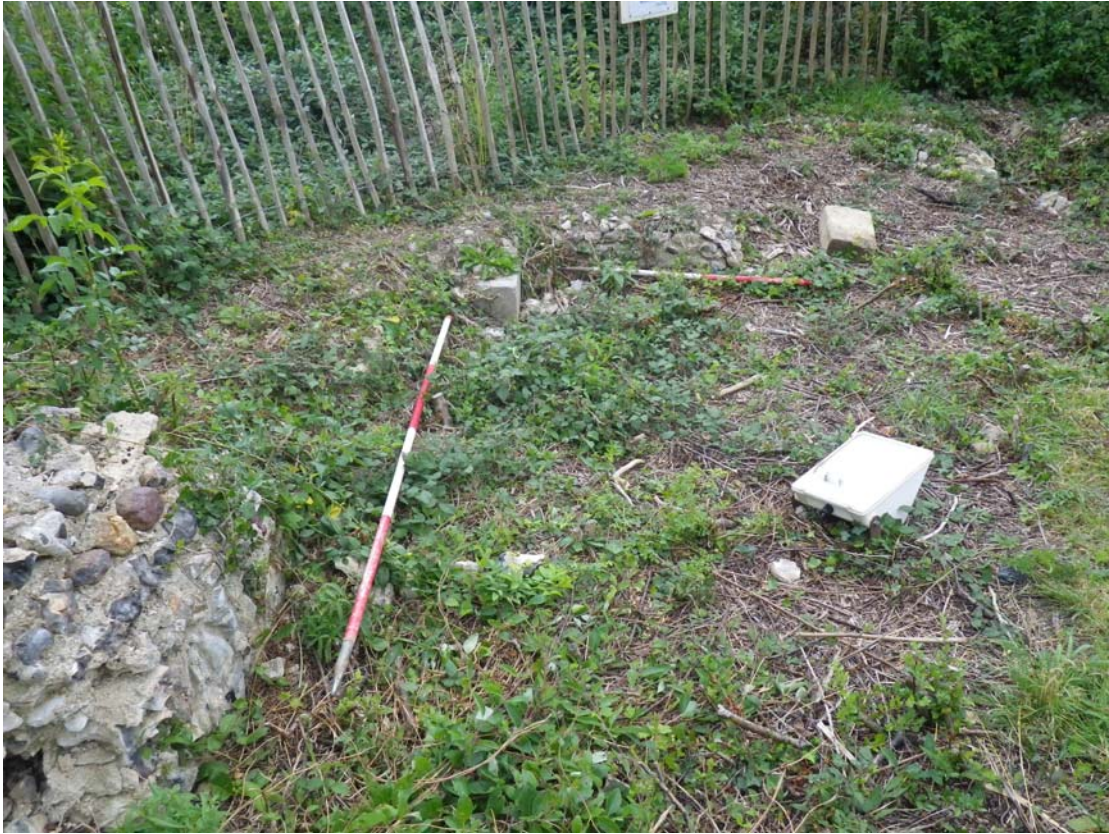
Plate 15. Truncated remains of the east tower. The ranging pole are aligned with the tower walls, the block of stone where the pole meet is an *in-situ* quoin.

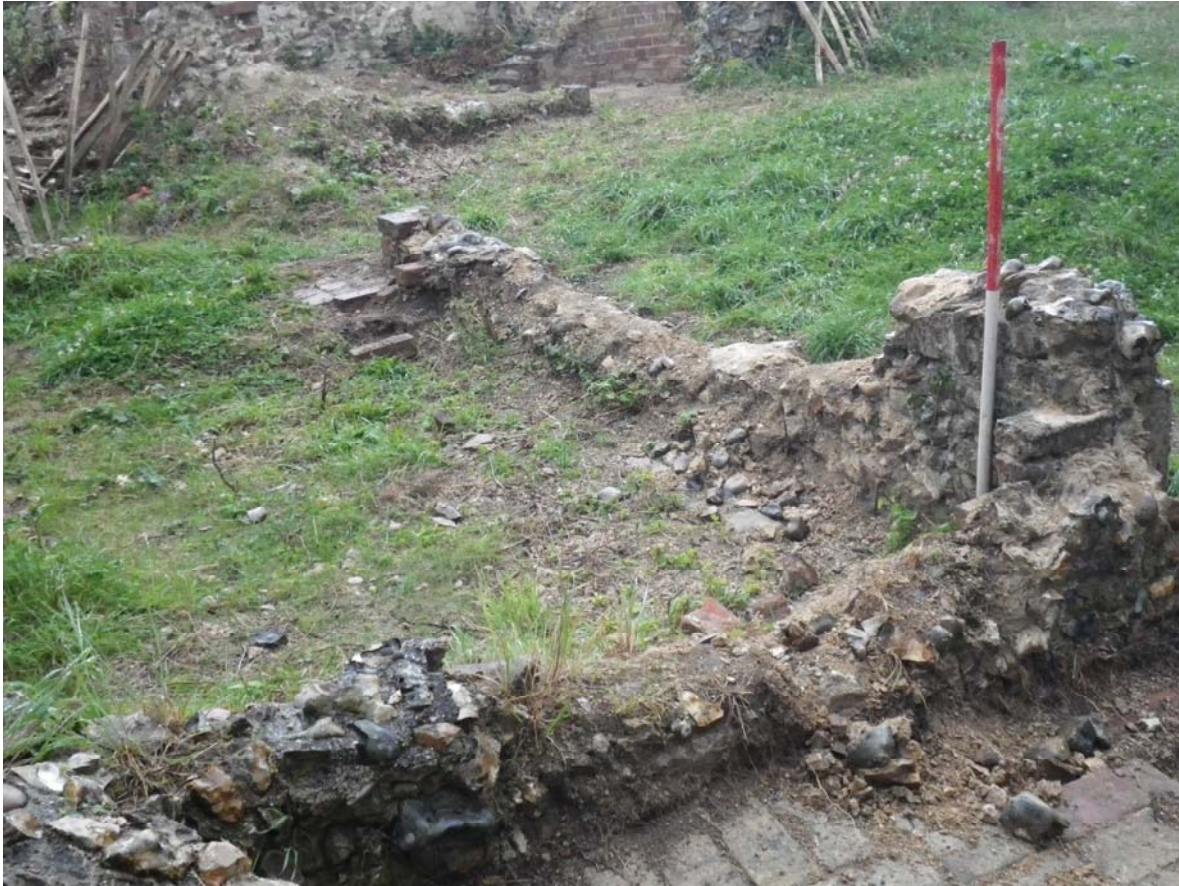
Plate 17. An example of the condition of the 19th century walls inside Kerrison's Folly prior to repairs

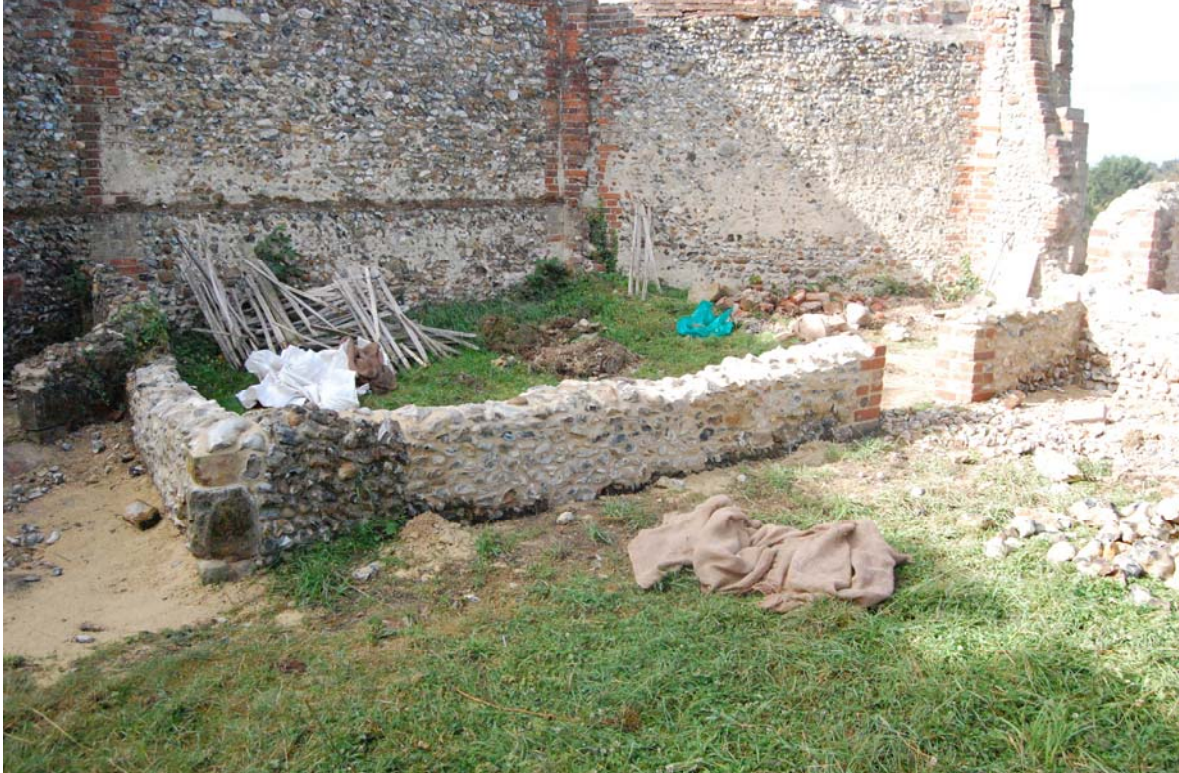
Plate 18. The same wall following the remedial work.

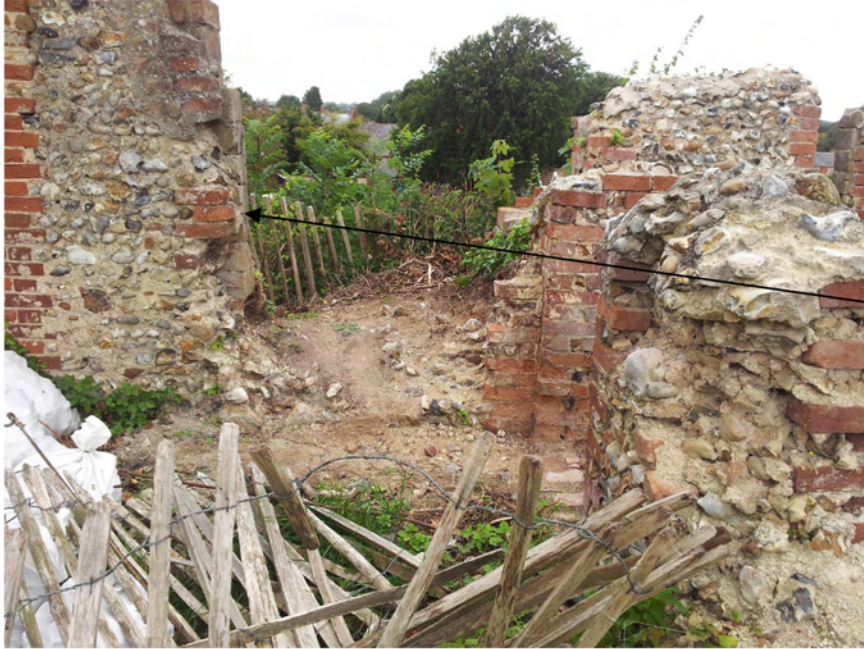
Photo 1

Area to be in-filled, stonework to left hand side indicates that a window opening was originally in this location.

If the opening detail is recreated in a similar manner to surviving window opening, the feature would have interpretation within the structure, plus the opening would be sufficiently narrow to eliminate the potential hazard.

The original width of the opening can hopefully be established through the on-site investigations in the local area by uncovering the dressed stone cill sections; these would also be re-used to re-create the opening. The inner face would be formed using the same canted brick detail (either recovered from the site, or with matching materials sourced by the building contractor), and flint/brickwork to match the existing construction.

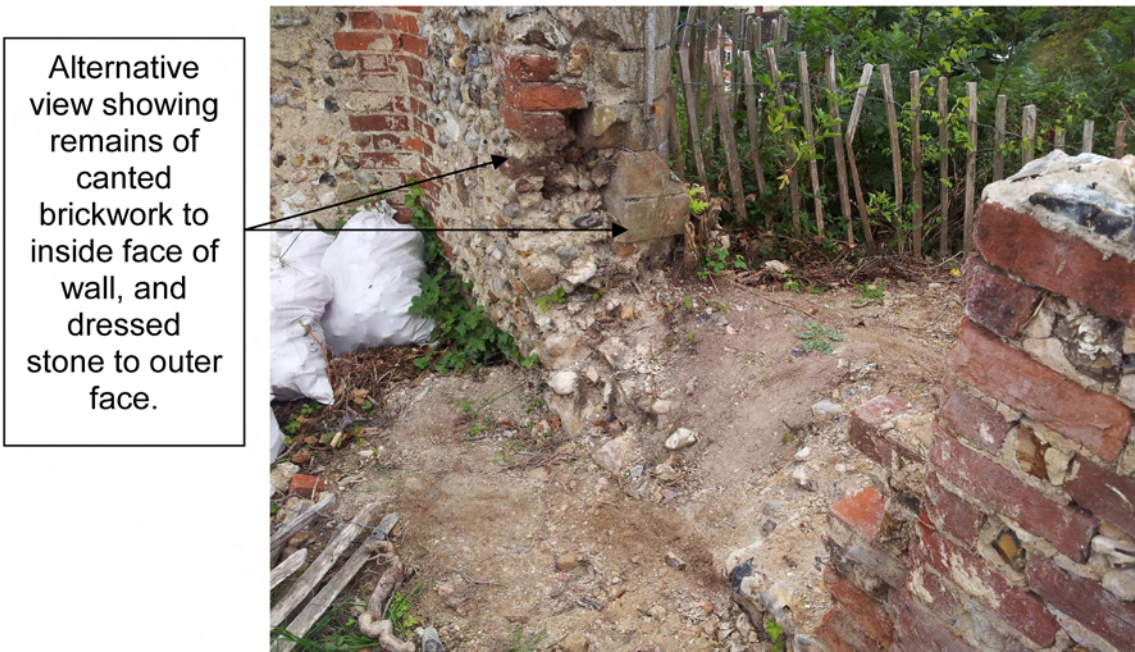
Photo 2

Alternative view showing remains of canted brickwork to inside face of wall, and dressed stone to outer face.

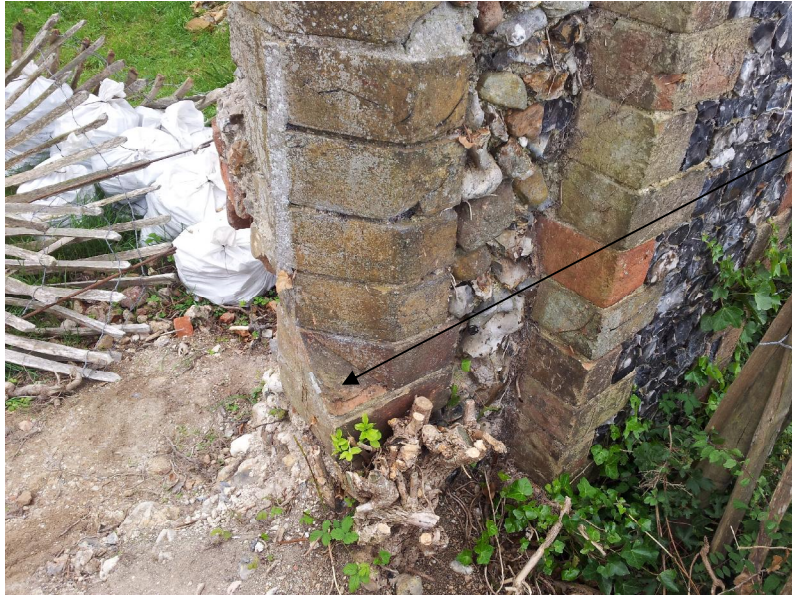
Photo 3

External view showing dressed stone detail, showing where cill line was located.

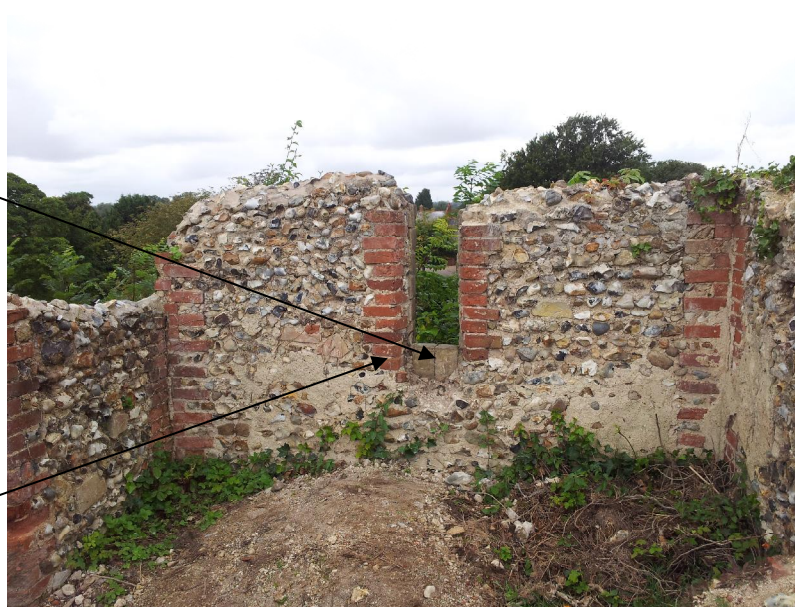
Photo 4

Remaining opening located near former spiral staircase. Opening is narrow (two stone cill sections wide).
Canted brickwork detail to inside face of wall.

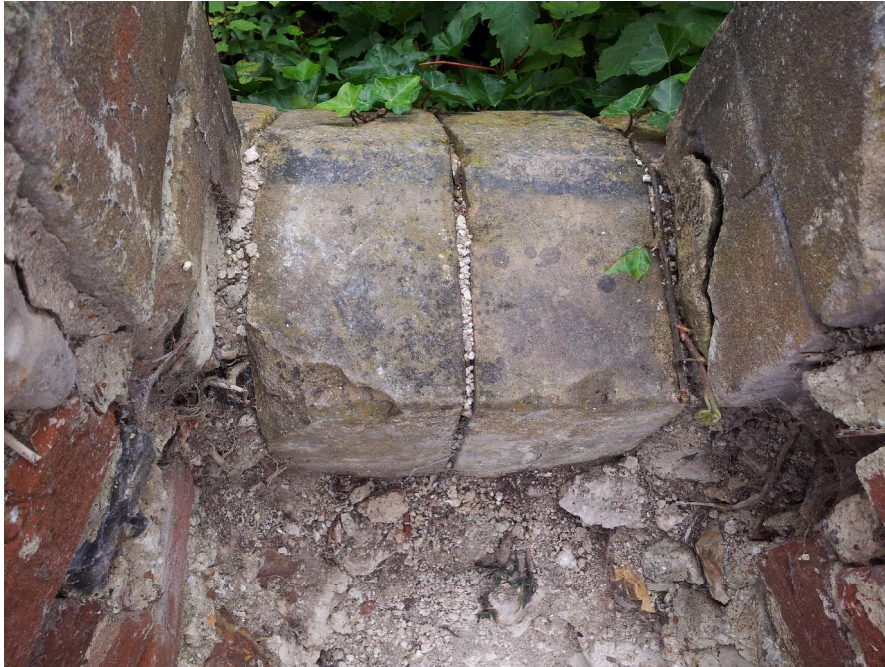
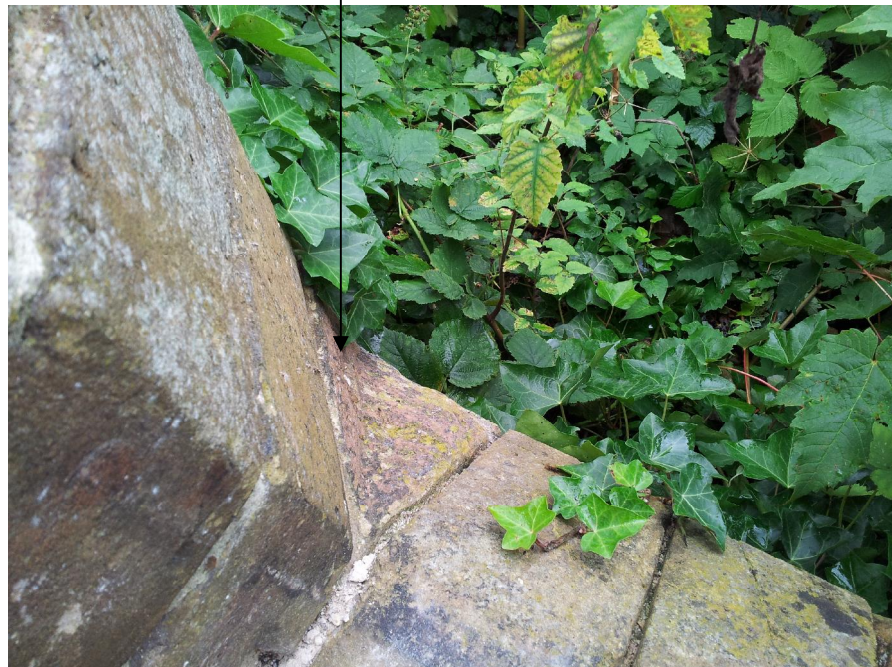
Close up views of stone cill sections to opening located near former spiral staircase. External dressed stone detail to vertical section is identical to the where in-fill is required.
