**Barn and Outbuildings at
Mulletts Farm,
Barking, Suffolk
BRK 128**

Historic Building Record

Barn and Outbuildings at Mulletts Farm, Willisham Road, Barking Tye, Suffolk

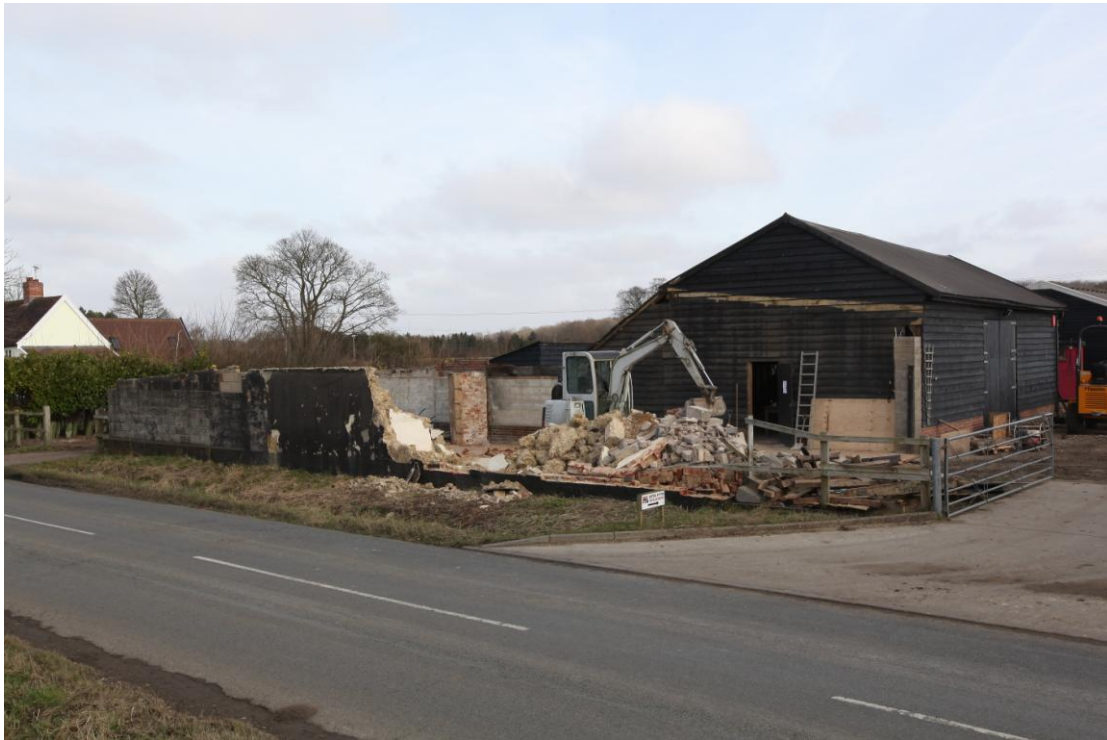
Illus. 1. The site from Willisham Road to the west, showing the barn (1) to the right, the grade II-listed farmhouse to the left and the remains of the mid-19th century shed of shuttered clay (2) in the foreground.

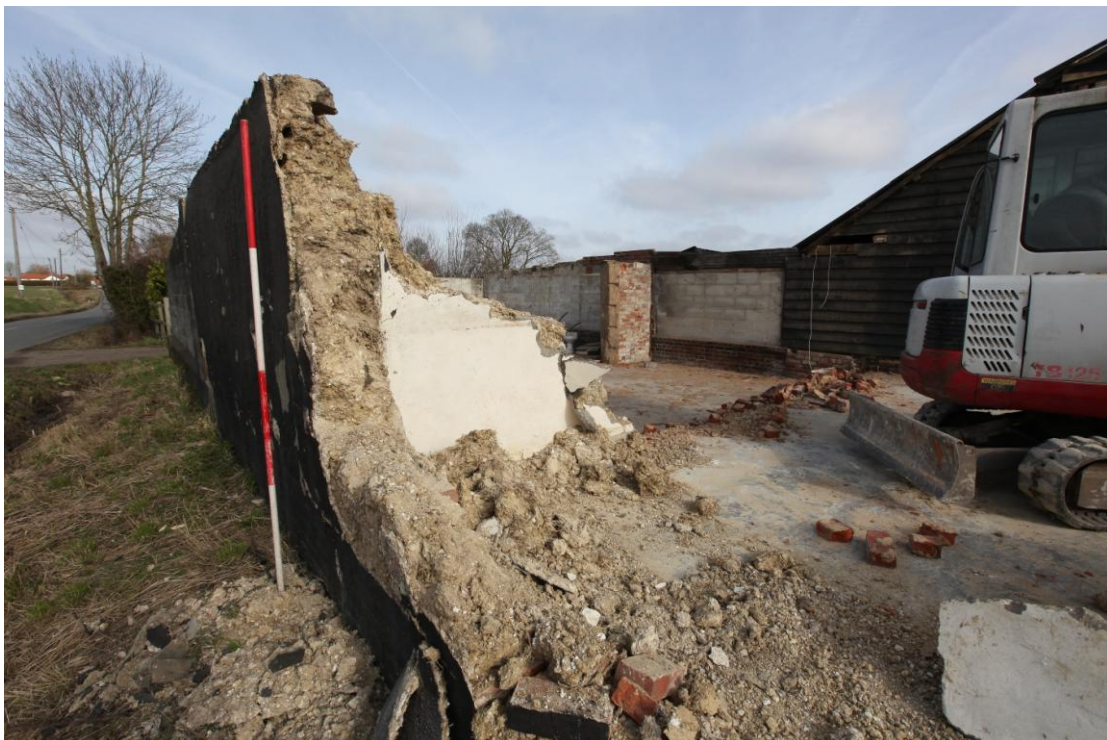
Illus. 2. A detail from the south of the partly demolished tarred western wall of the shuttered clay shed (2a) adjoining the barn's western gable. There is no trace of clay lump blocks within the fabric.

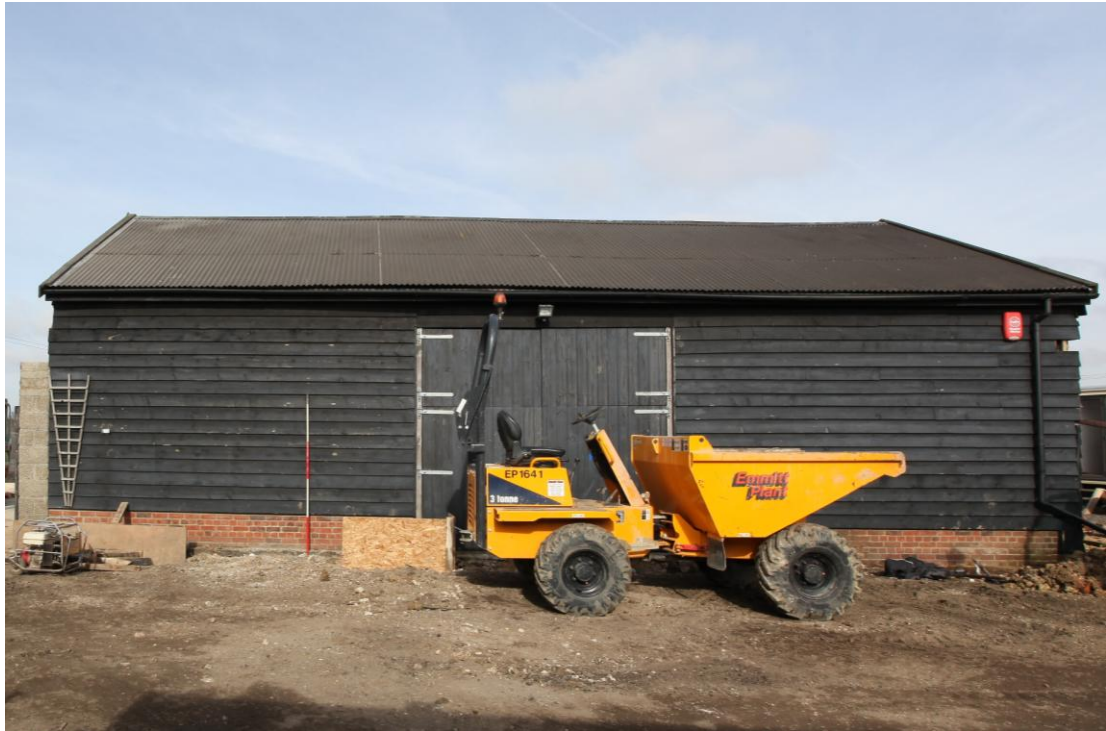
Illus. 3. The southern exterior of the barn (1) showing its modern brick plinth and stained weatherboarding. The central doors are also modern but occupy the same position as the original full-height doors which faced away from the farmhouse.

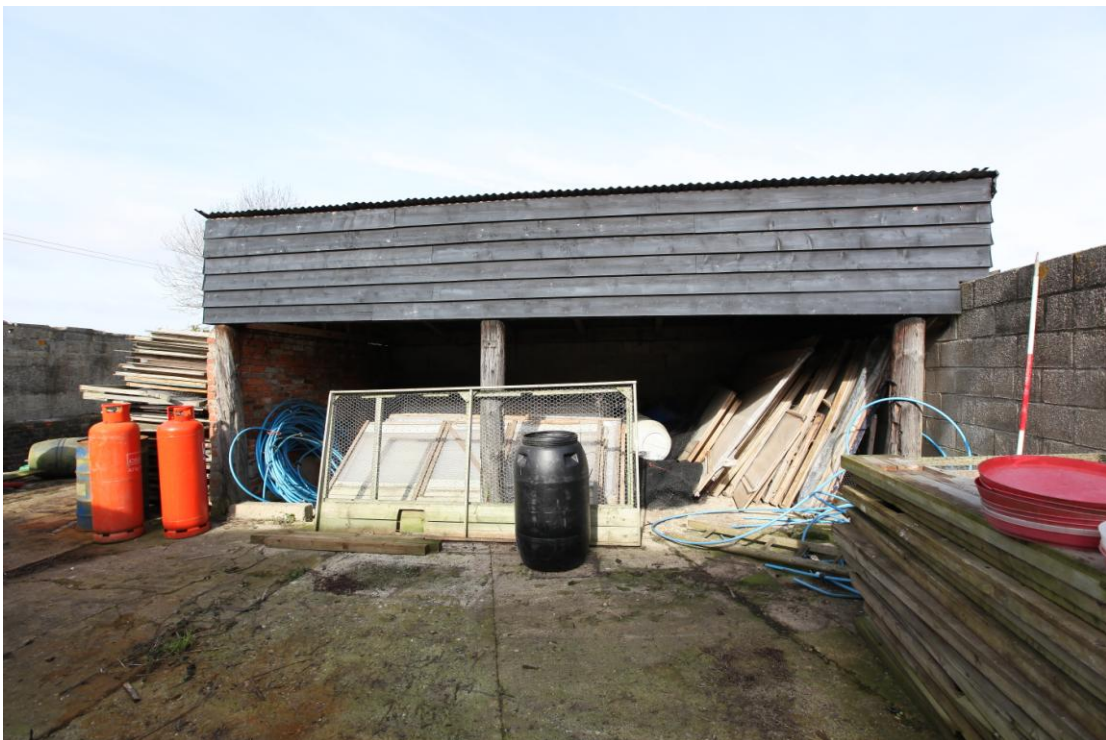
Illus. 4. The southern exterior of the open-sided shelter-shed (3) to the rear (north) of the barn (1). This is shown on the historic Ordnance Surveys but with the exception of its western brick wall (left) was entirely rebuilt in the mid-20th century with re-used telegraph poles and cement block-work.

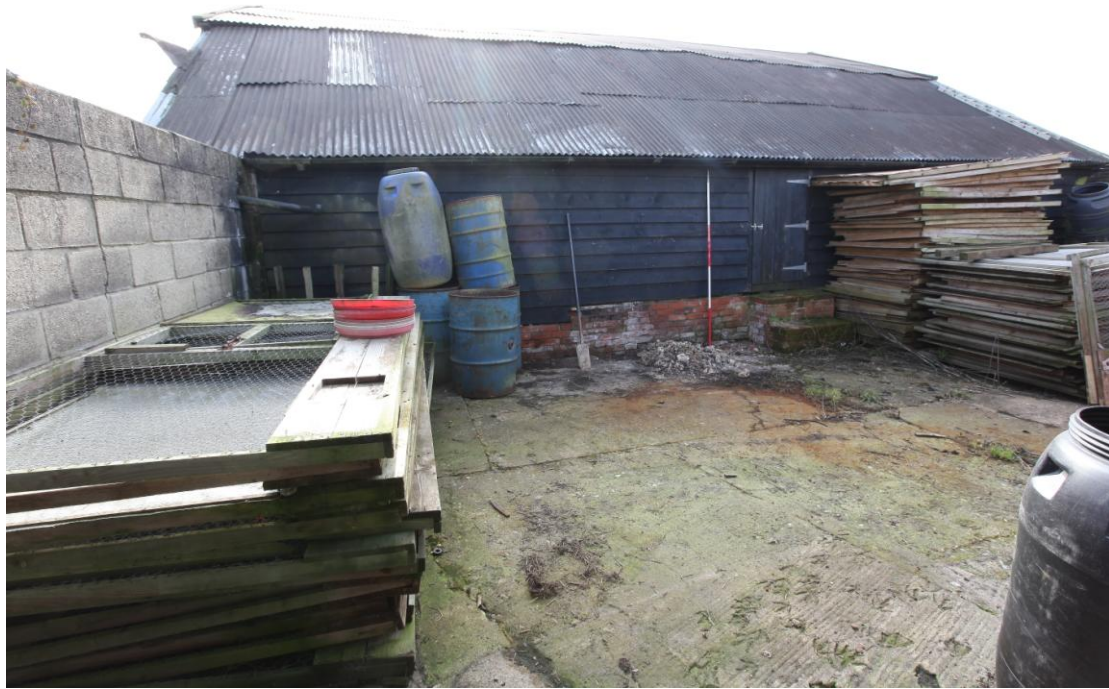
Illus. 5. The rear (northern) exterior of the barn (1) from the enclosed yard (4) showing the corrugated iron roof and recent weatherboarding of the later rear lean-to.

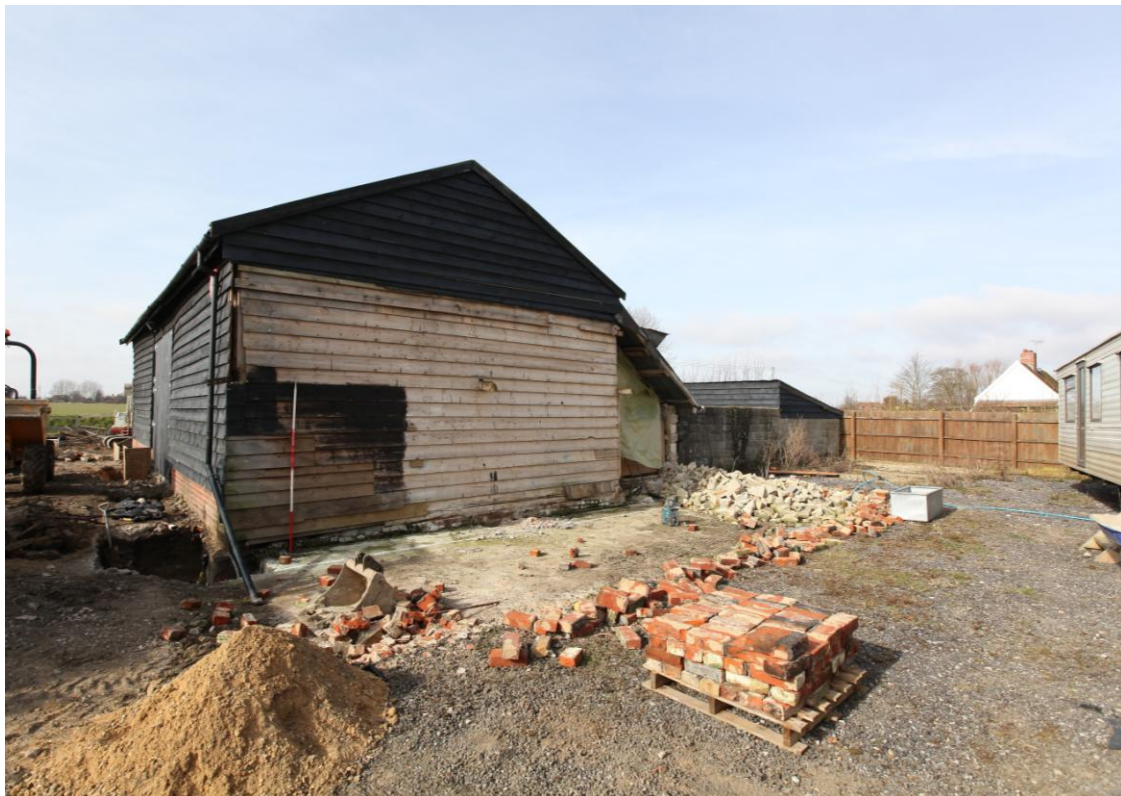
Illus. 6. The barn (1) from the east showing the scar of a recently demolished shed adjoining its gable with its rear lean-to and the shelter-shed (3) and farmhouse (5) visible to the right.

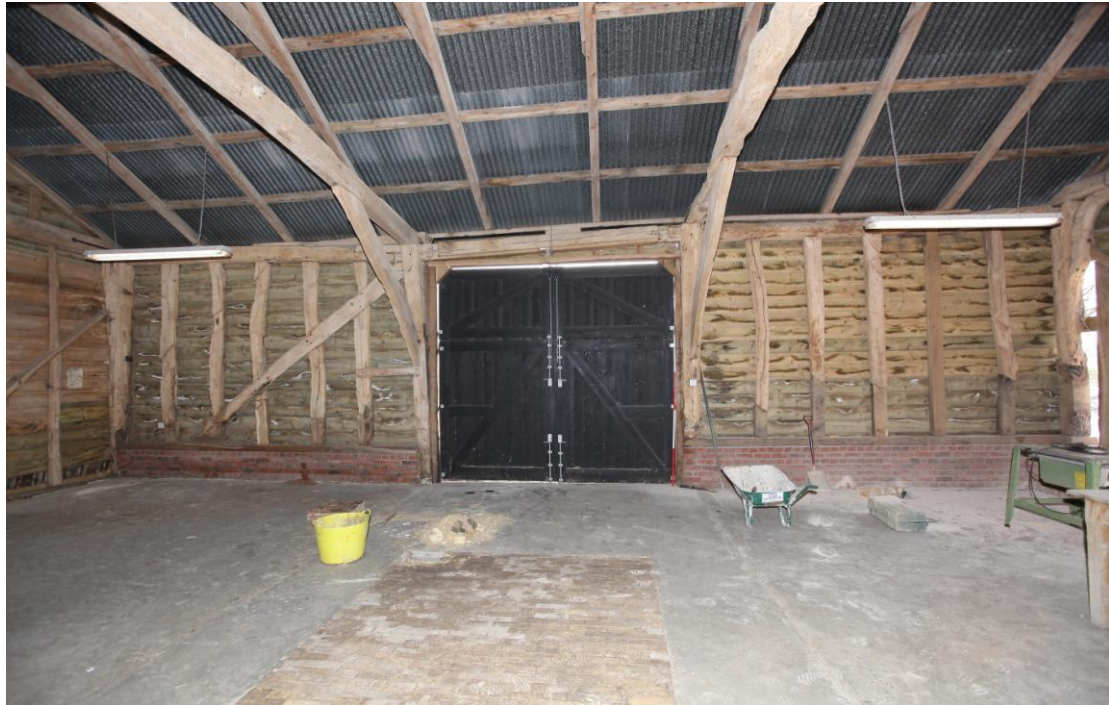
Illus. 7. The southern interior of the three-bay threshing barn (1) showing its central entrance doors flanked by original arch-braced tie-beams. The roof-plate contains mortises for the jambs of a slightly narrower original entrance. The studs of the outer bays have been truncated at their bases but with the exception of the penultimate stud on the right all are original and are trenched for missing internally trenched braces that reflected those of the northern wall. The diagonal brace on the left is secondary.

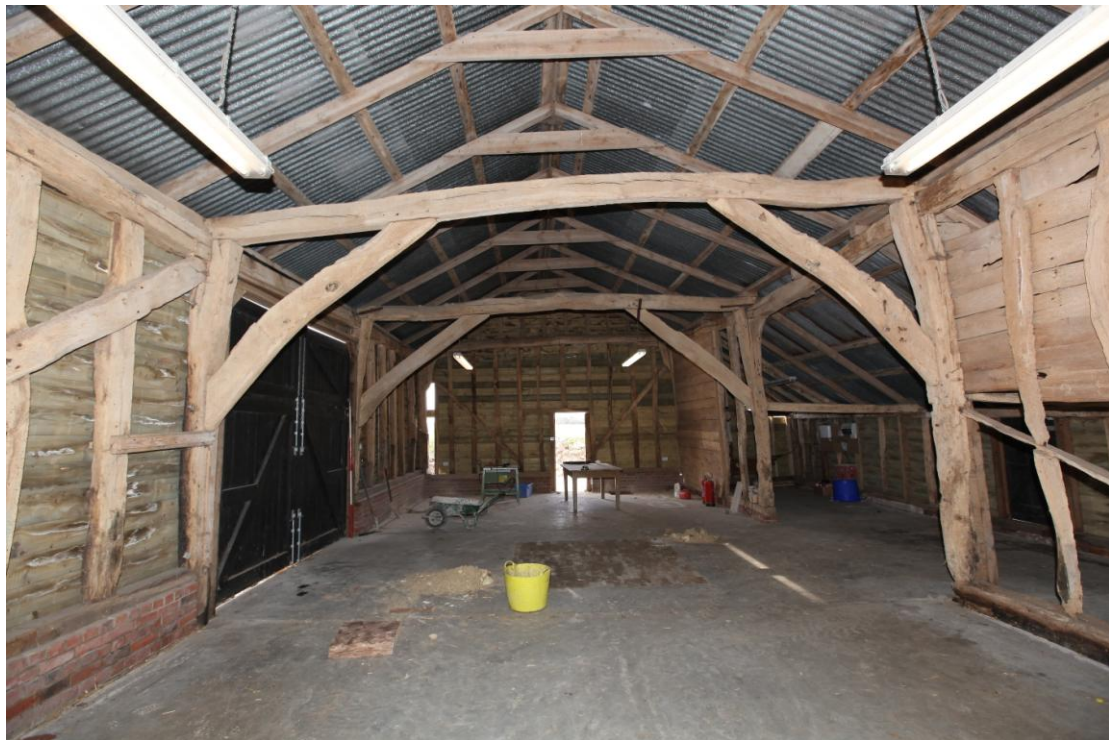
Illus. 8. The interior of the barn from the east showing the profiles of its original arch-braced tie-beams. Both gables were entirely rebuilt in the 19th century and the roof is a 20th century replacement. The original roof is likely to have been steeply pitched at 55 degrees for thatch.

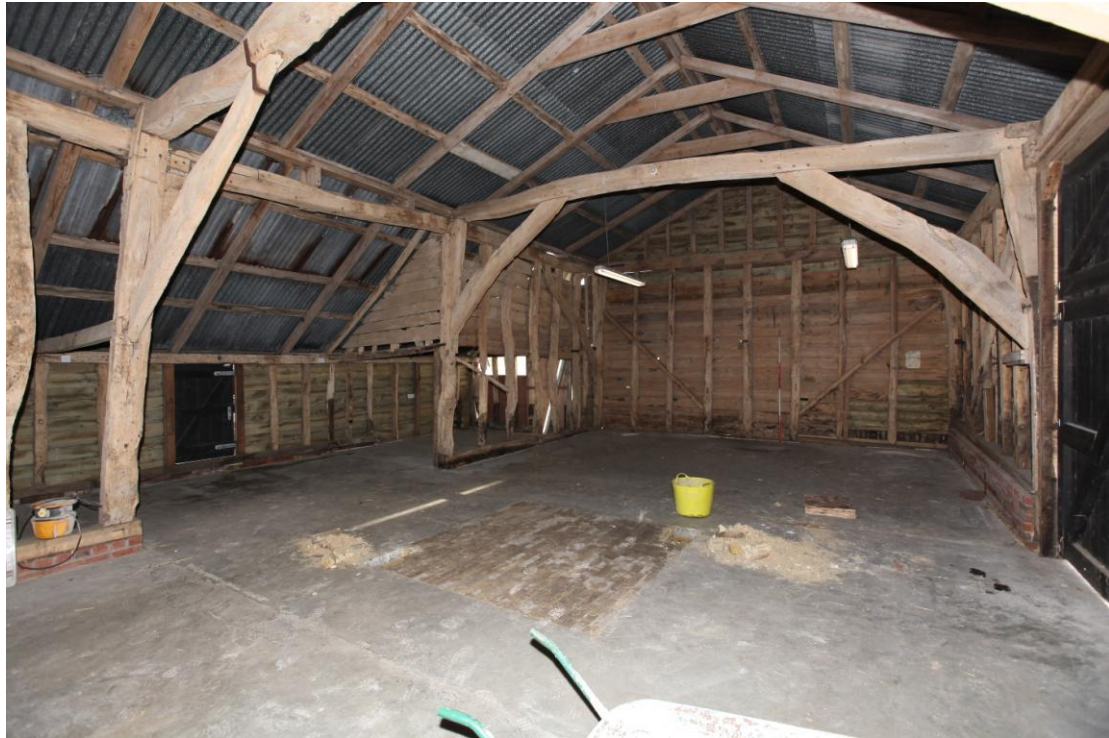
Illus. 9. The interior from the south-west showing the later rear lean-to on the left and the modern concrete floor with a central panel made from gault bricks that are understood to have been salvaged from the remains of a threshing floor.

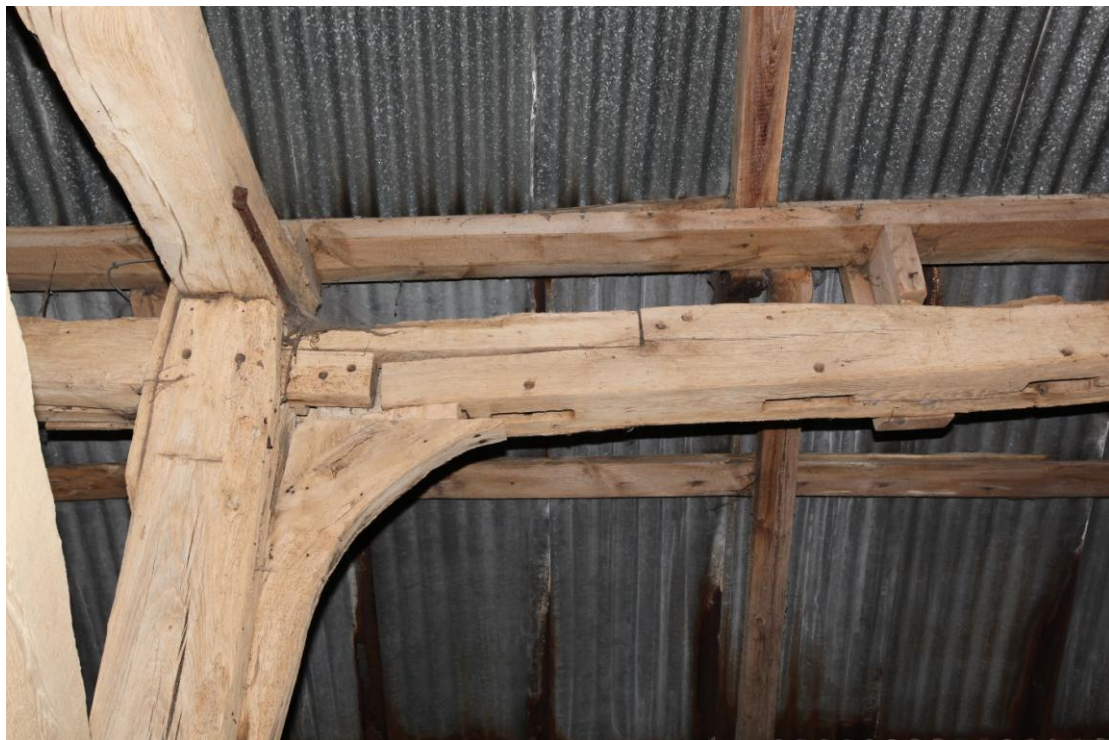
Illus. 10. A detail of the northern roof-plate of the central bay showing the 15th or 16th century type edge-halved and bridled scarf joint with double tenon pegs to the left and the studs of the removed back wall to the right. The mortise on the extreme right is central to the bay and is significantly smaller than its counterparts, having secured a short stud above the lintel of the original low, narrow rear doorway. The knee-brace on the left is a nailed insertion.

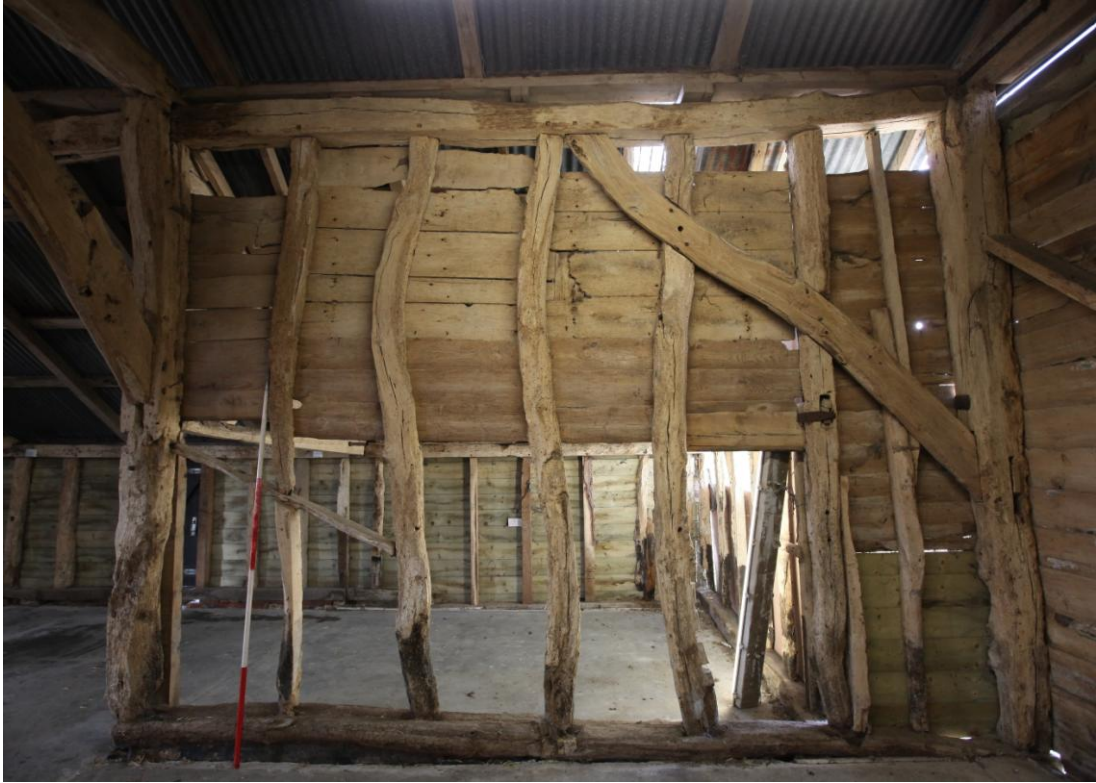
Illus. 11. The northern interior of the eastern bay showing an original ogee-curved internal brace with a mortise in the corner post for a matching brace in the rebuilt gable. Note the unusually distorted nature of the oak studs.

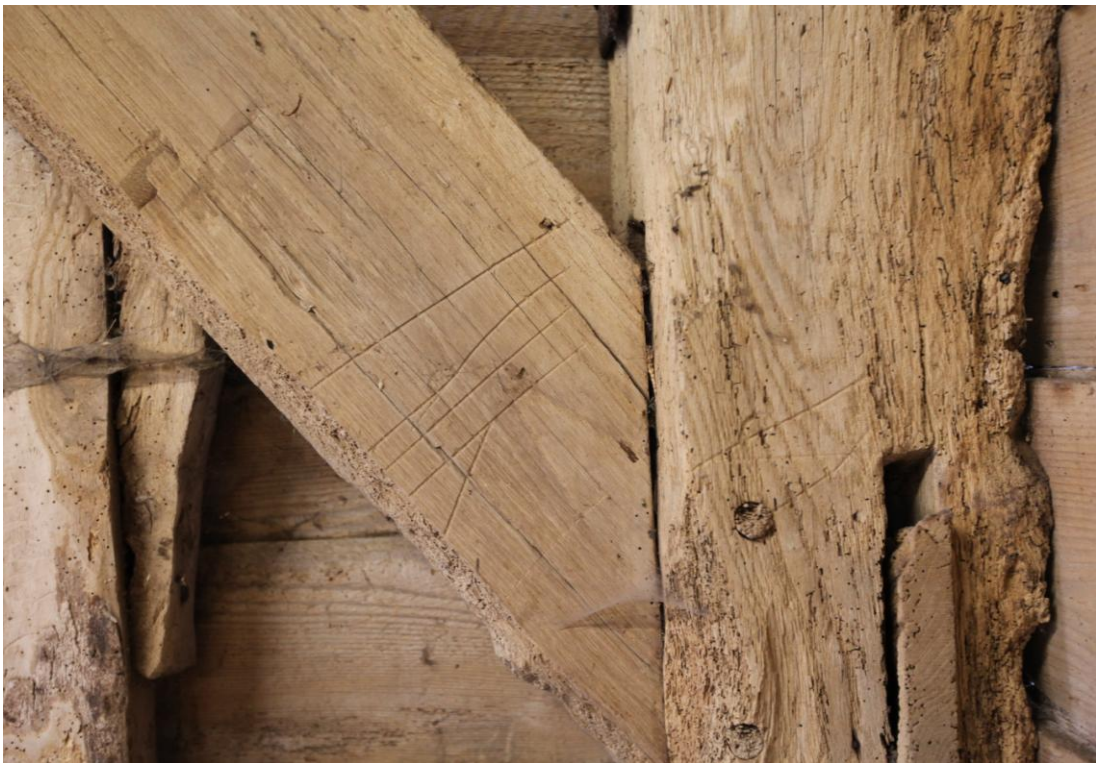
Illus. 12. A detail of an incised carpenter's Roman numeral to the northern internal brace of the eastern bay (to the right in illus. 11 above).

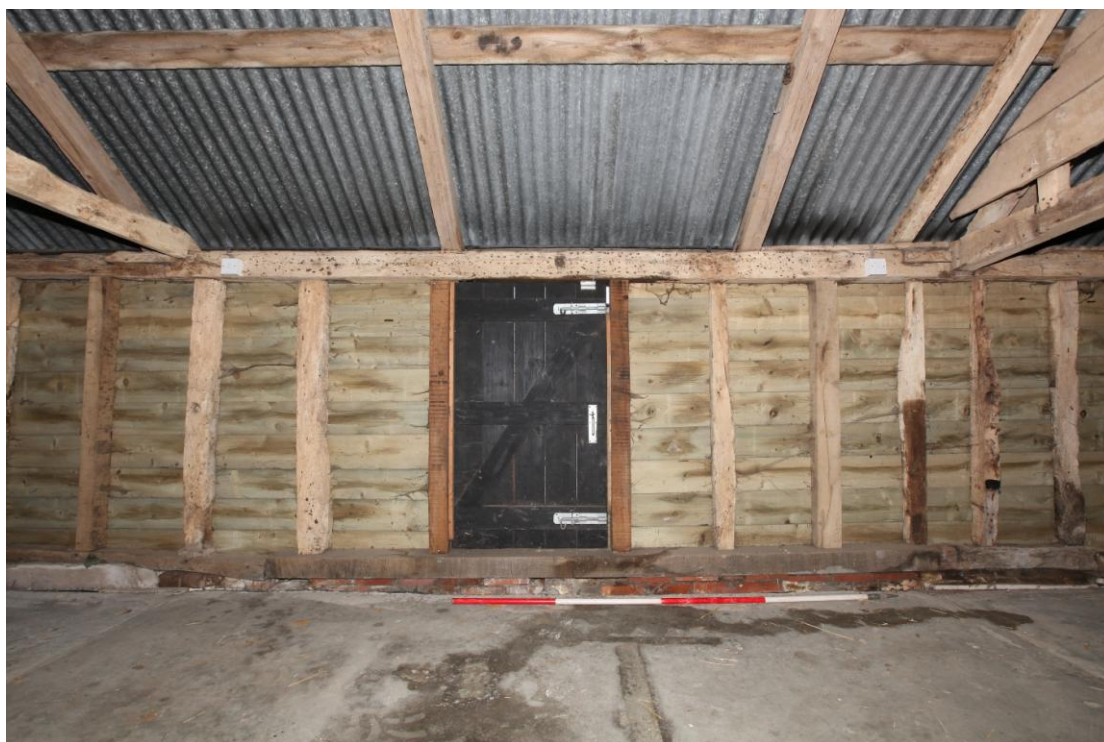
Illus. 13. The central bay of the rear (northern) lean-to with a modern door slightly to the left of the original. The roof-plate appears to belong to a 16th century structure, with edge-halved and bridled scarf joints beneath the tie-beams to left and right, but all but one or two studs have been replaced and the original lean-to was probably widened in the 19th century.

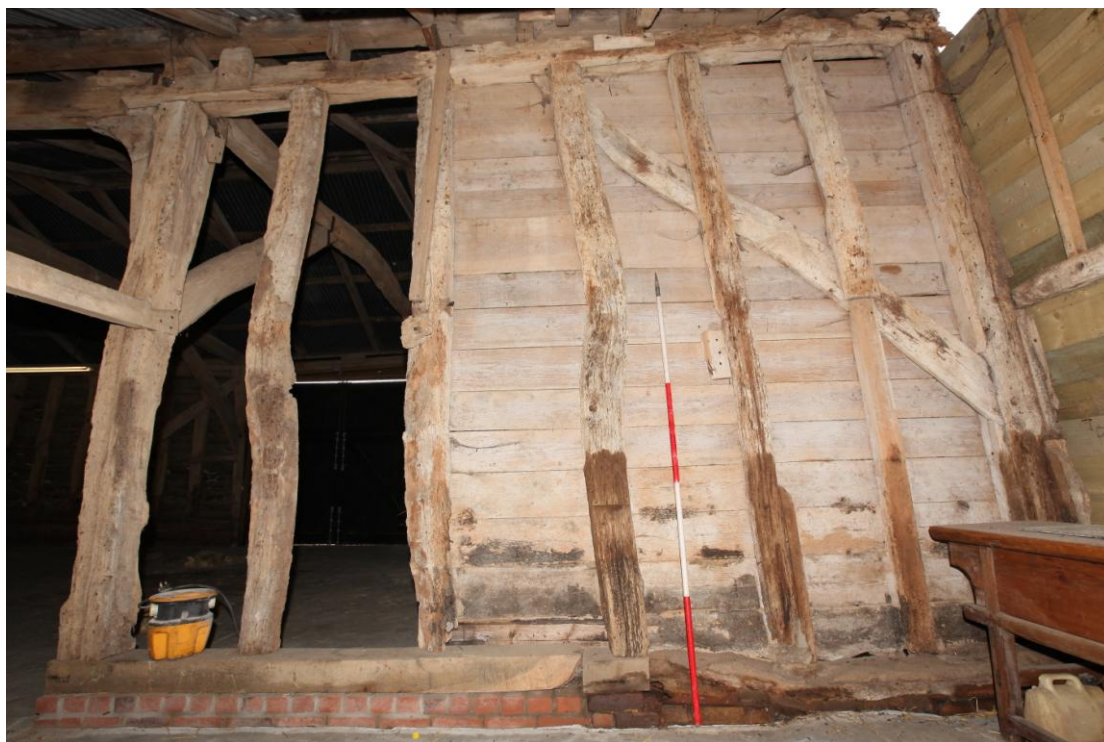
Illus. 14. The northern exterior of the western bay from the later lean-to, showing the intact original studs with an ogee-curved internal wall brace reflecting that of illus 11. The internal boarding is a 19th century addition, and the studs were formerly infilled with wattle-and-daub and rendered externally.
