**Farm Buildings at
Goldings Farm,
Sotterley, Suffolk
SOT 014**

Historic Building Record

Farm Buildings at Goldings Farm, Smiths Road, Sotterley, Suffolk

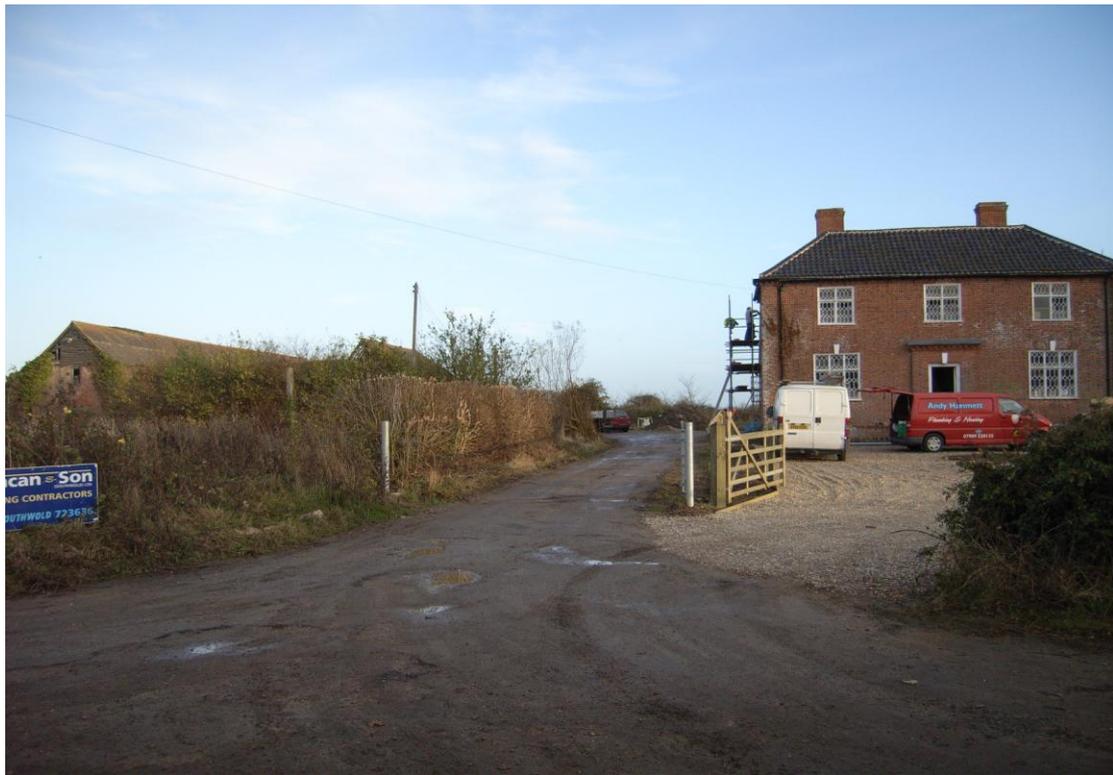
Illus. 1. The entrance to the site from Smiths Road to the west showing the grade II-listed red-brick farmhouse to the right and the farm buildings to the left.

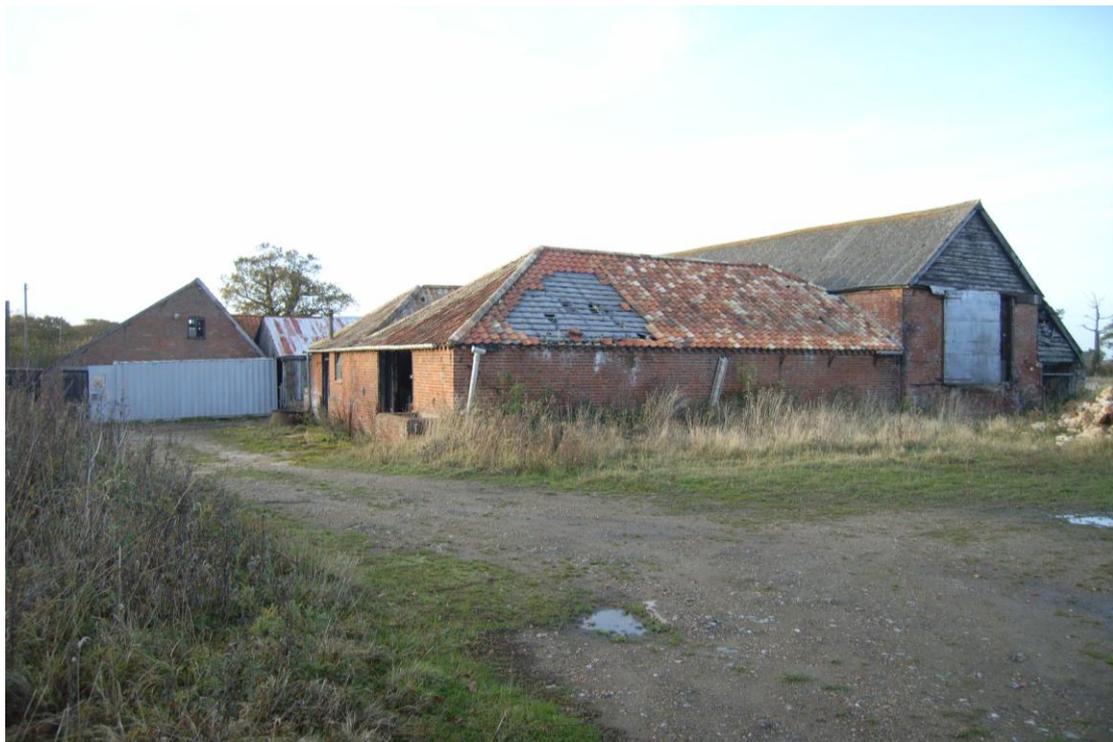
Illus. 2. A general view of the group from the south-east showing the asbestos-covered brick barn (1) in the rear to the right, the pantiled 'double-pile' cattle shed (2) in the foreground and the brick granary (5) to the left.

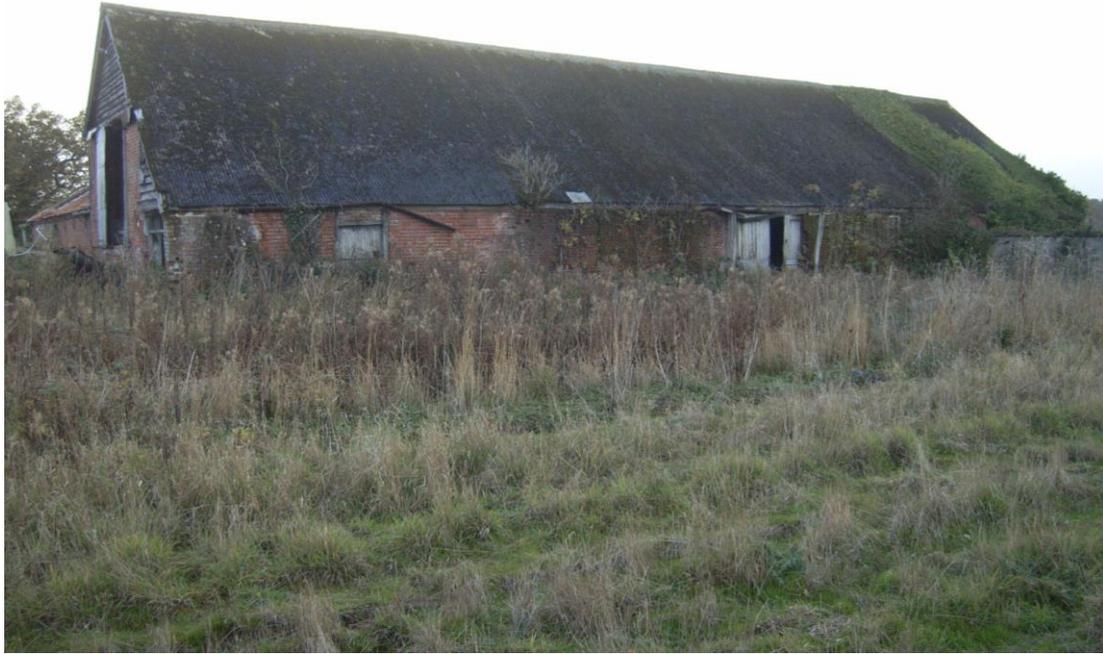
Illus. 3. The intact original rear aisle of the brick barn with 20th century doors in its eastern gable, the original door to the lean-to shed adjoining the eastern stable (1e) to the left, and the rear doors of the threshing barn (1a) to the right.

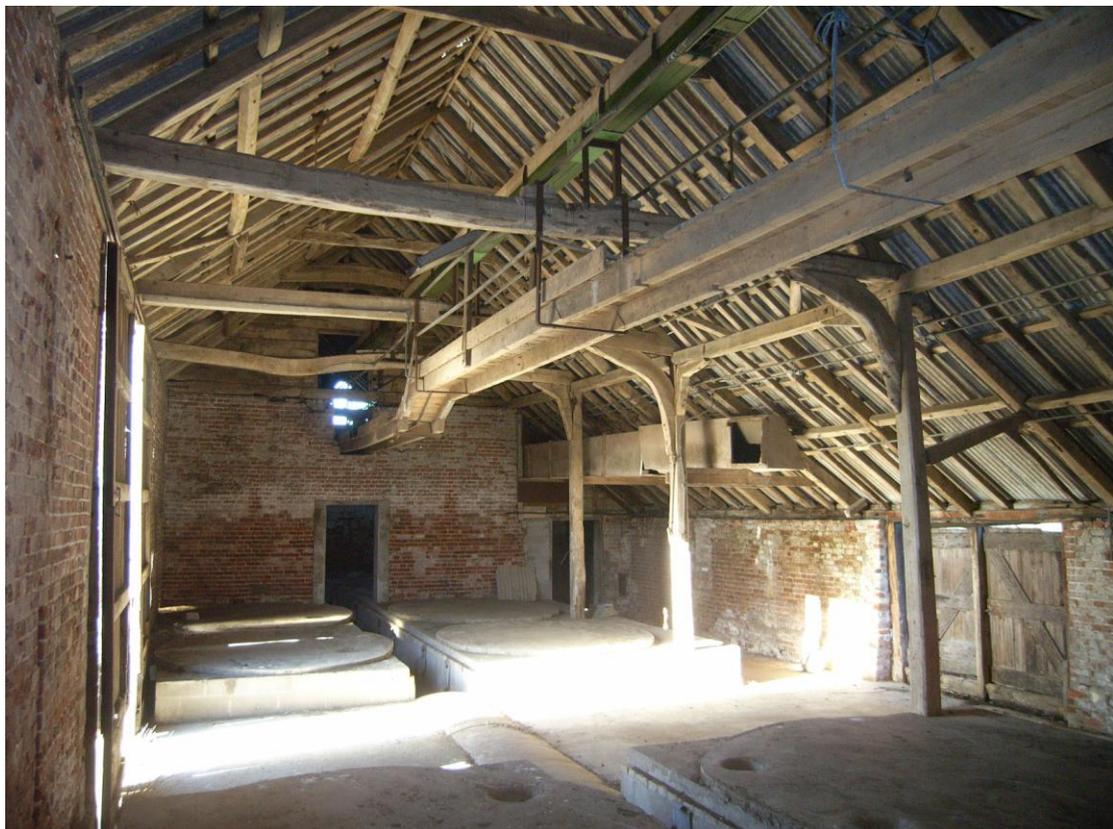
Illus. 4. The interior of the central threshing barn (1a) from the east showing its intact roof and rear aisle with the concrete bases of the 20th century grain silos that were reached by the surviving axial platform. The doors to the western stable (1b) and its rear lean-to shed (1d) are secondary insertions. The relatively shallow pitch of the roof suggests it was initially pantiled to match the house.

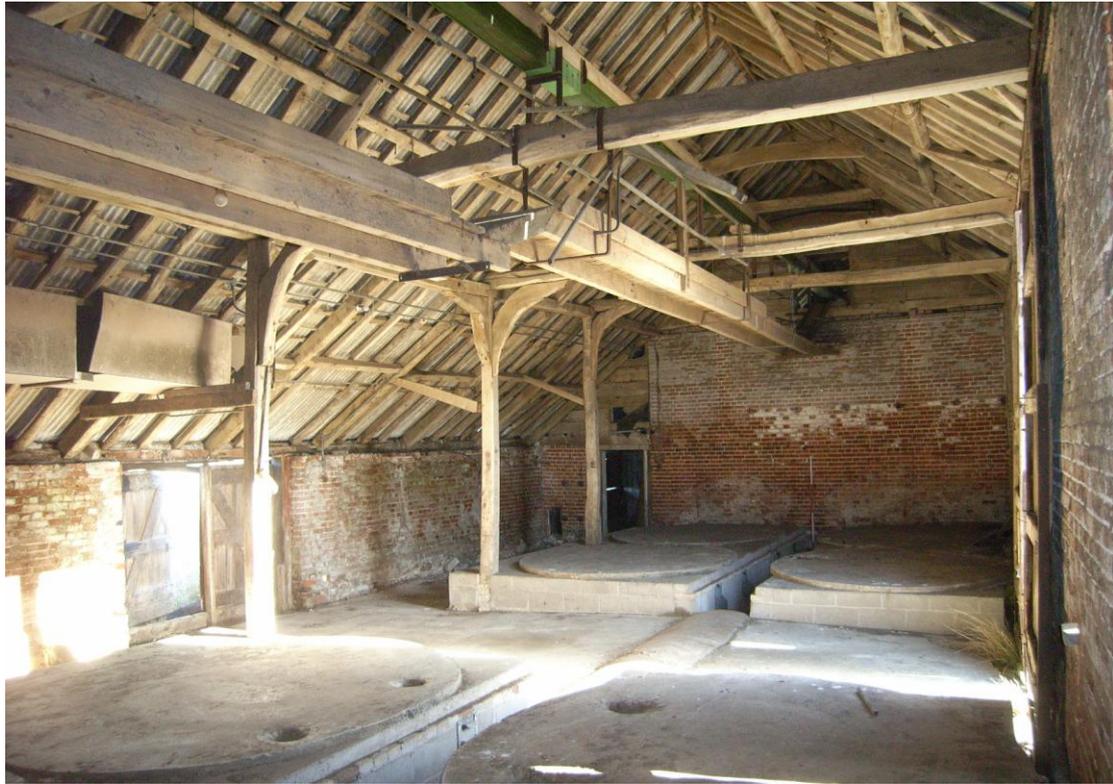
Illus. 5. The interior of the threshing barn (1a) from the west the showing intact roof and arcade posts with the rear doors of the (missing) threshing floor to the left.

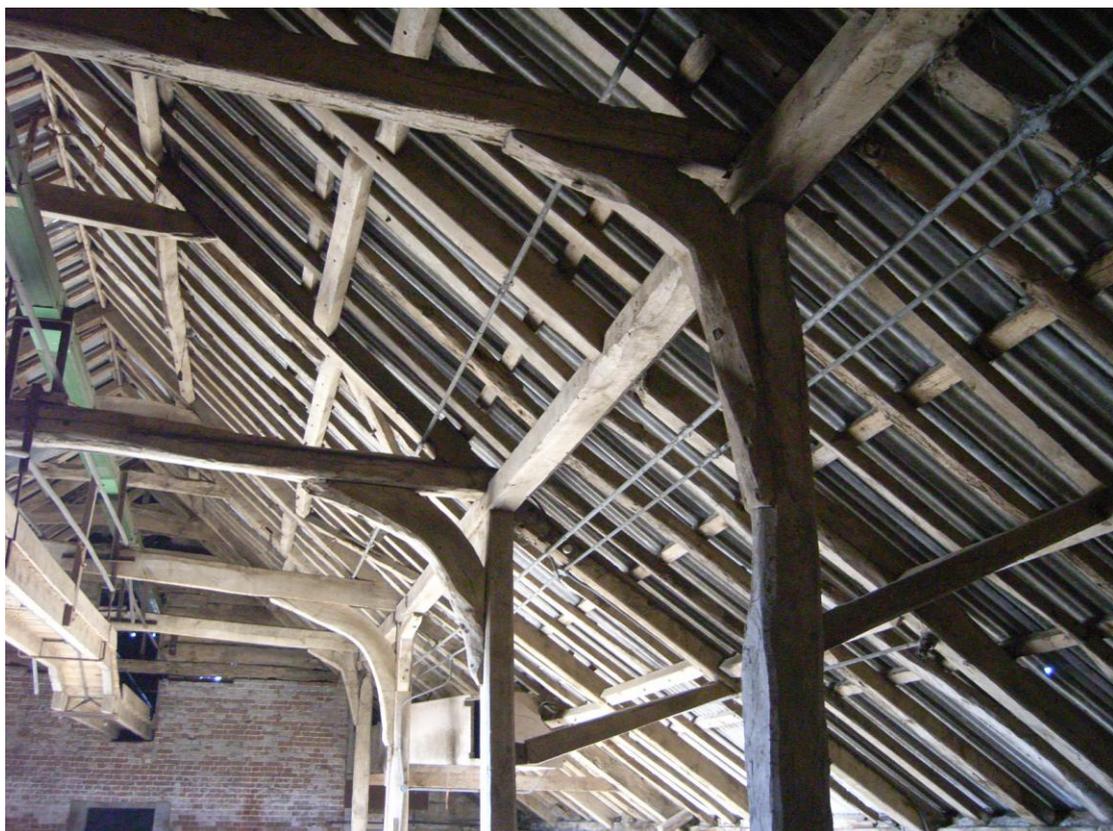
Illus. 6. The original roof structure from the east showing its impressive bolted knee-braces, raking aisle struts (tenoned to the arcade posts and the principal aisle rafters), staggered butt-purlins, pegged collars and ridge-piece.

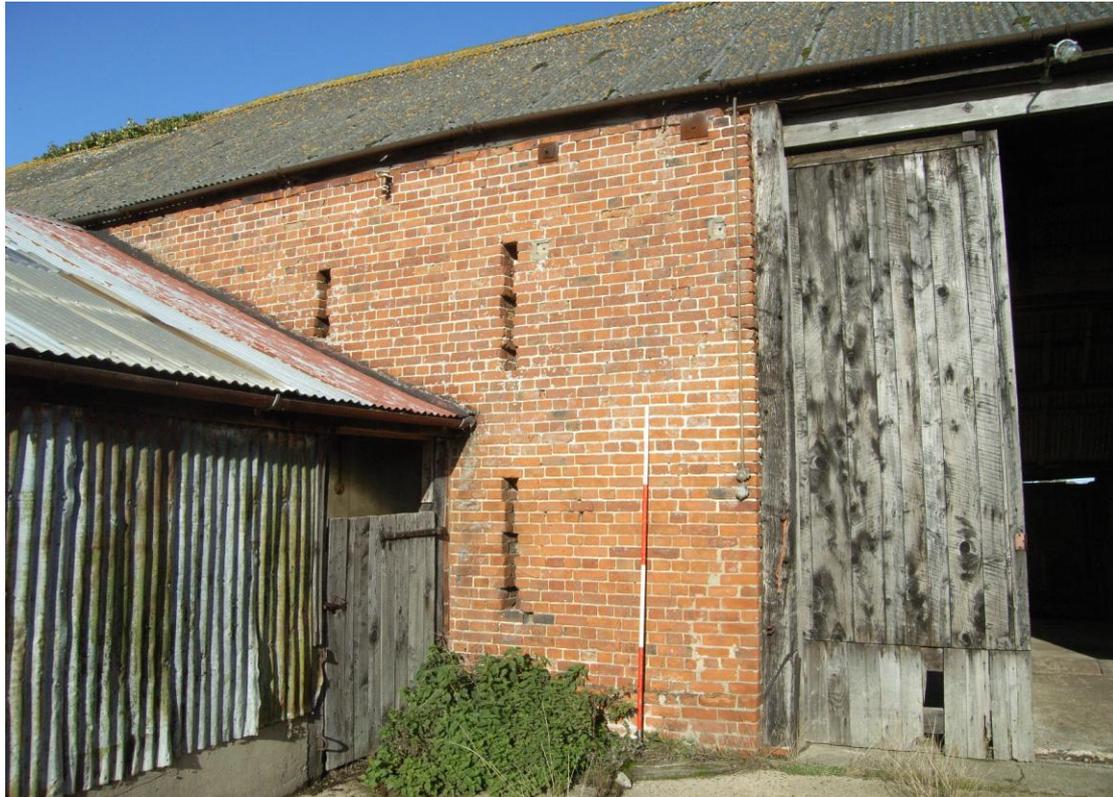
Illus. 7. The southern exterior of the two western bays of the threshing barn (1a) showing three of their six ventilation loops (the rest obscured by the 20th century covered cattle yard (4) to the left) and the original entrance to the right.

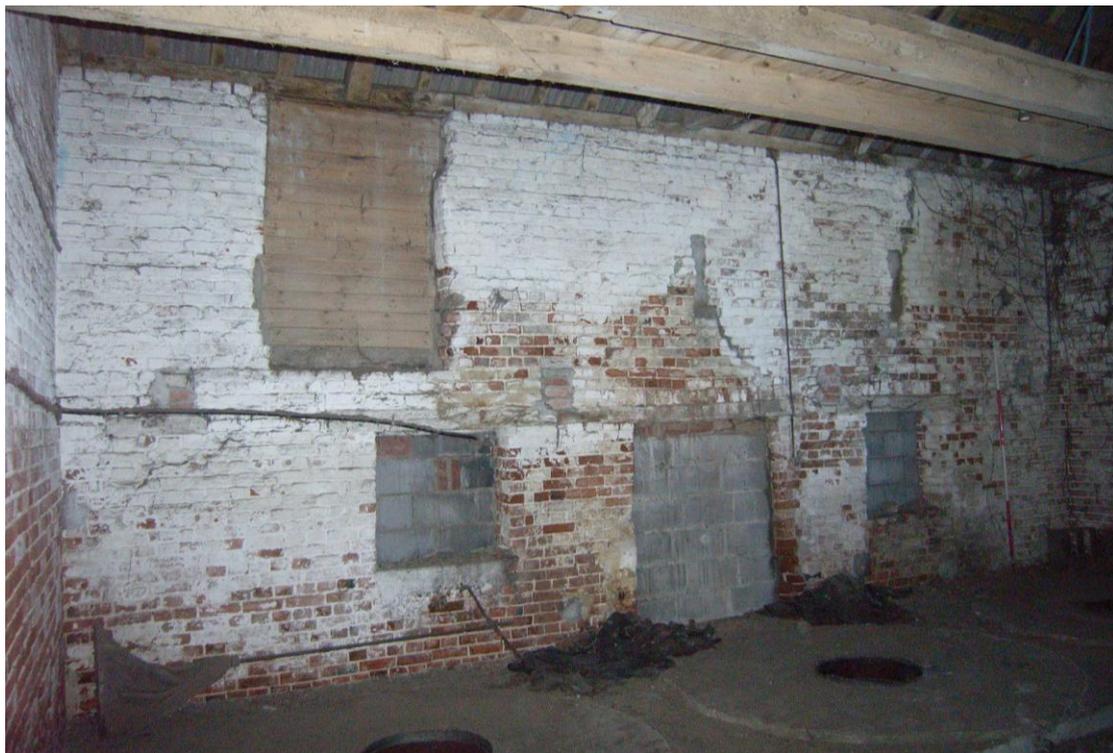
Illus. 8. The southern interior of the former stable (1b) to the west of the threshing barn (1a), showing its blocked central door flanked by windows, three ventilation loops to the missing hay loft (the easternmost enlarged to form an external door) and the scars of the removed principal ceiling joists.

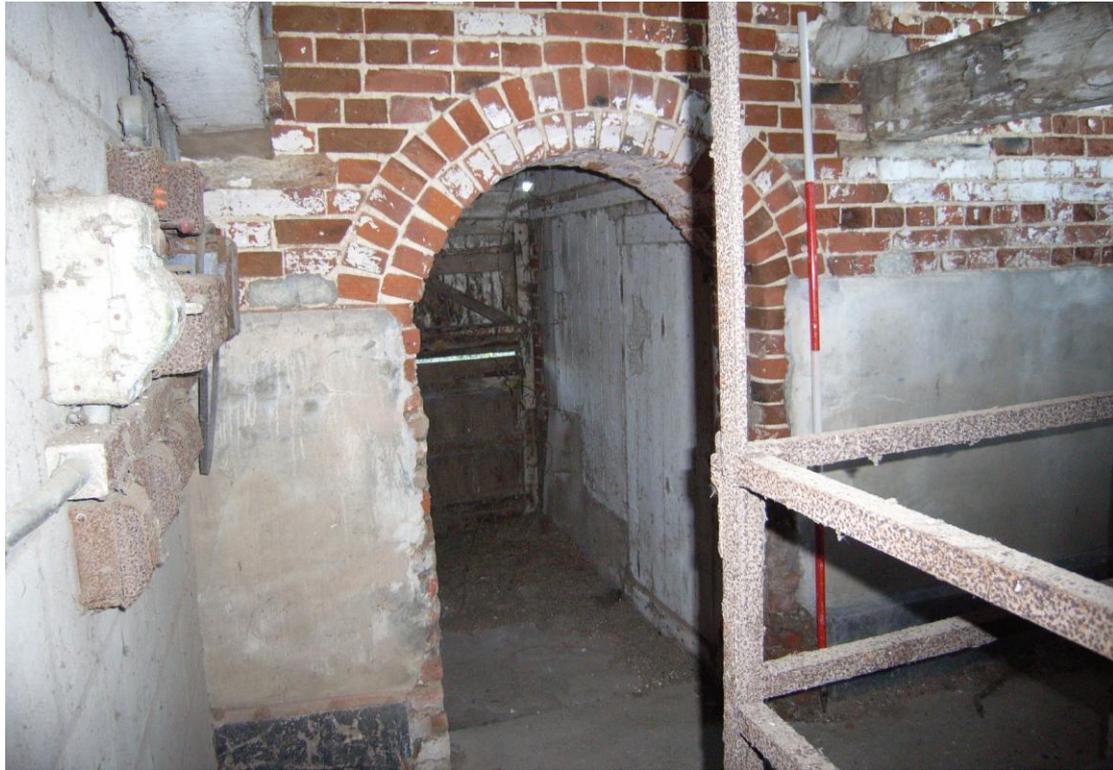
Illus. 9. The original arched doorway in the northern interior of the former stable (1c) to the east of the threshing barn (1a) with an original ceiling joist to the right. This door opens into the rear lean-to shed (1e) immediately opposite a central external door.

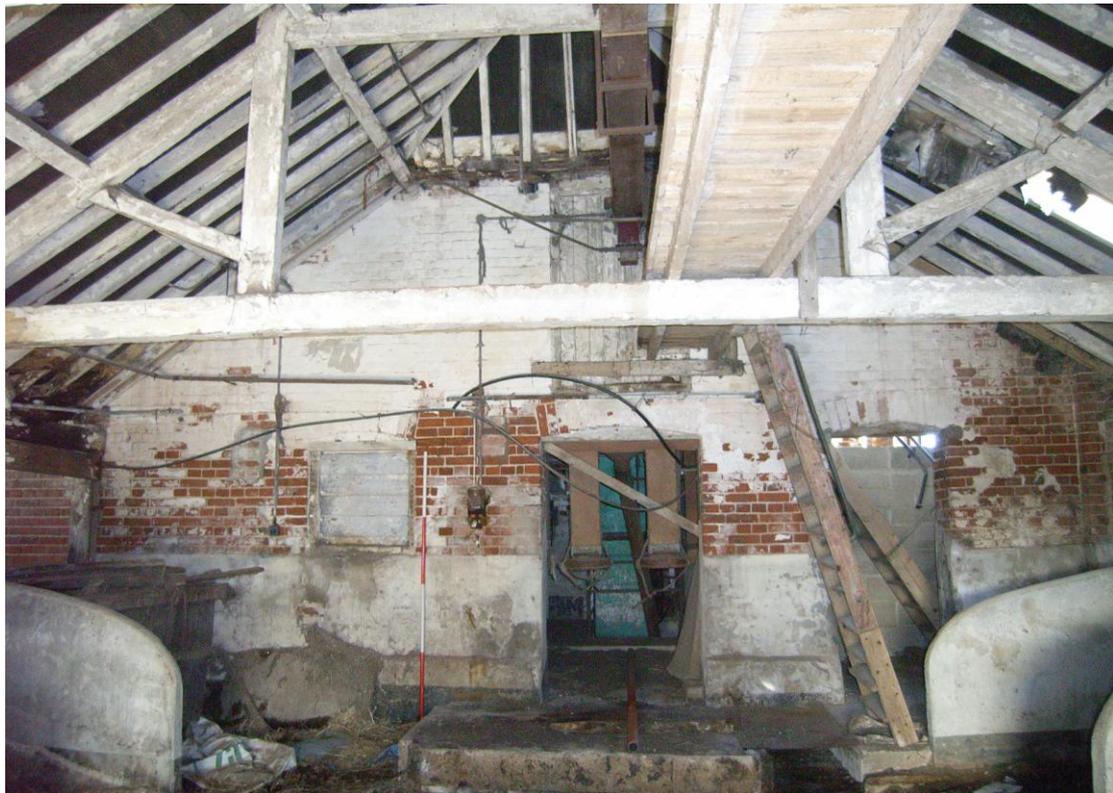
Illus. 10. The southern exterior of the eastern former stable (1c) from the later milking parlour (2a) showing its original central door flanked by windows and a later loading door to the hay loft above.

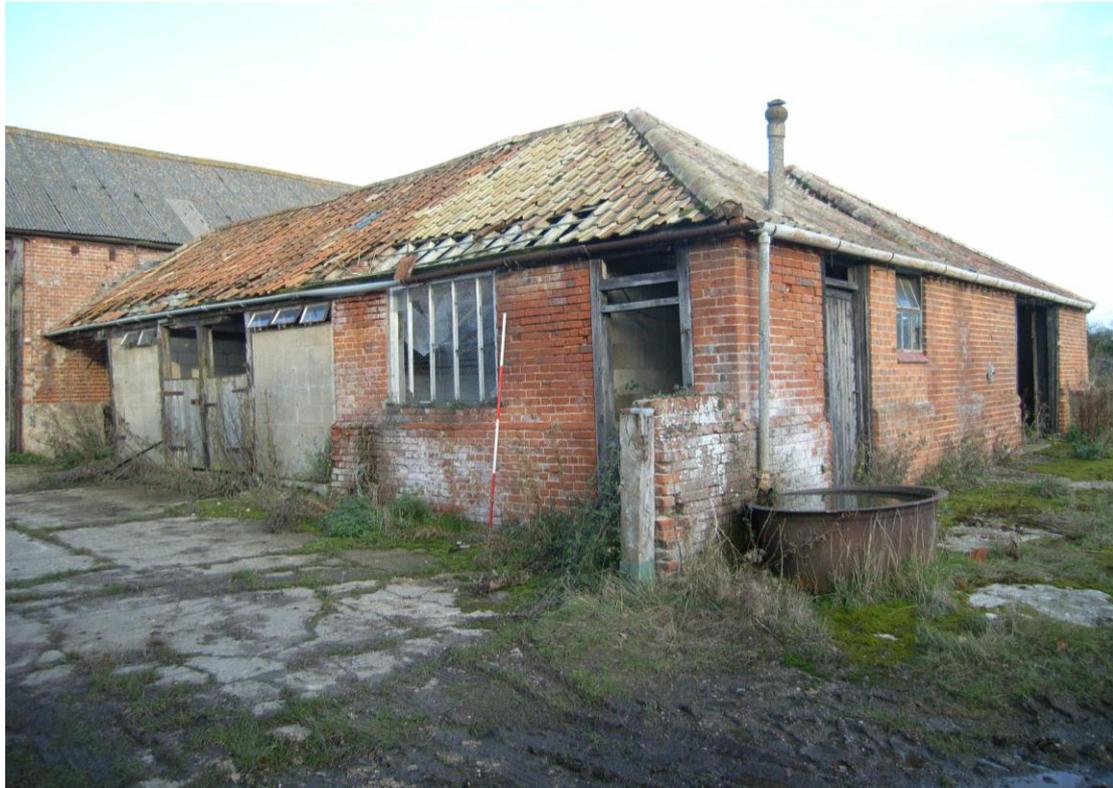
Illus. 11. The ‘double-pile’ mid-19th century cattle shed complex (2) to the east of the yard (seen from the south-west). The wide entrance to the right-hand milking parlour (2a) is original and there is evidence of a similar wide doorway in the left-hand gable. An open-sided shelter-shed (2b & 2c) to the left has been enclosed to form loose boxes.

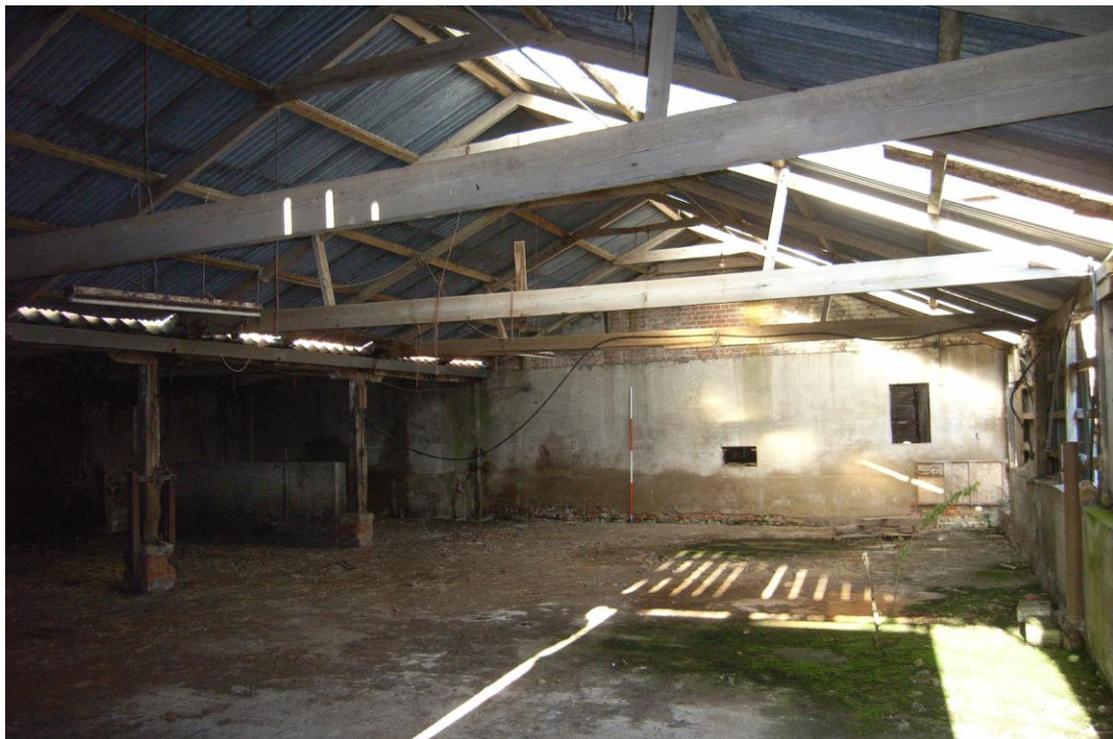
Illus. 12. The interior from the south of the 20th century covered cattle yard (4) showing the 19th century shelter-shed (3) to the left and the partly cement-rendered brickwork of the barn (1) in the rear.

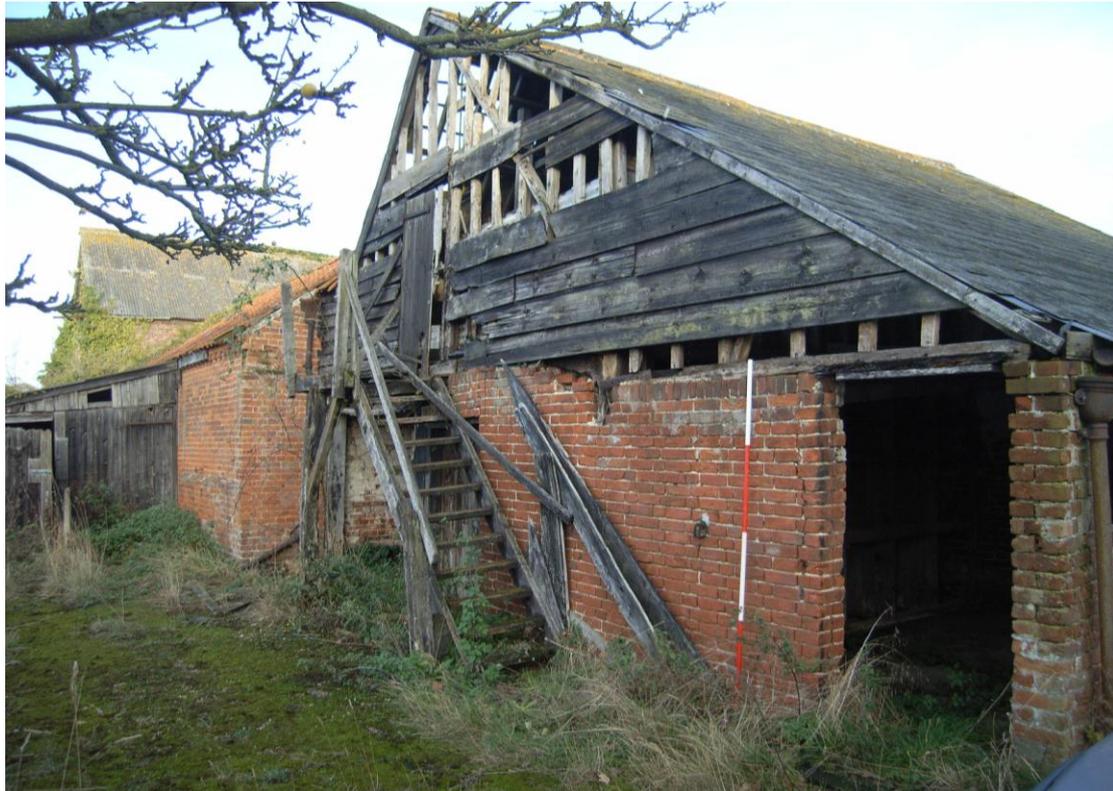
Illus. 13. The western gable of the granary (5) from the south-west showing the partly collapsed external stair to the grain floor and the entrance to the western section of a lean-to southern storage shed.

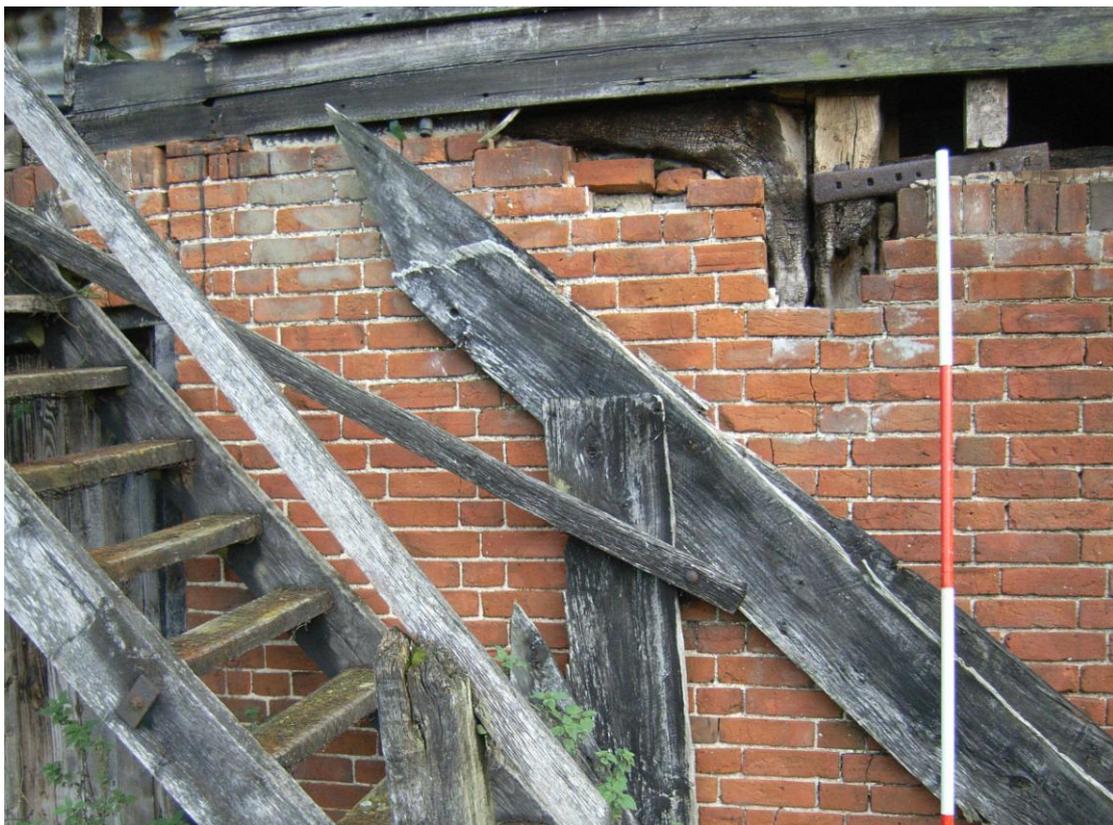
Illus. 14. The western gable of the granary (5) showing the timber post and knee-brace of an earlier timber granary and cart shed embedded in the later brickwork.

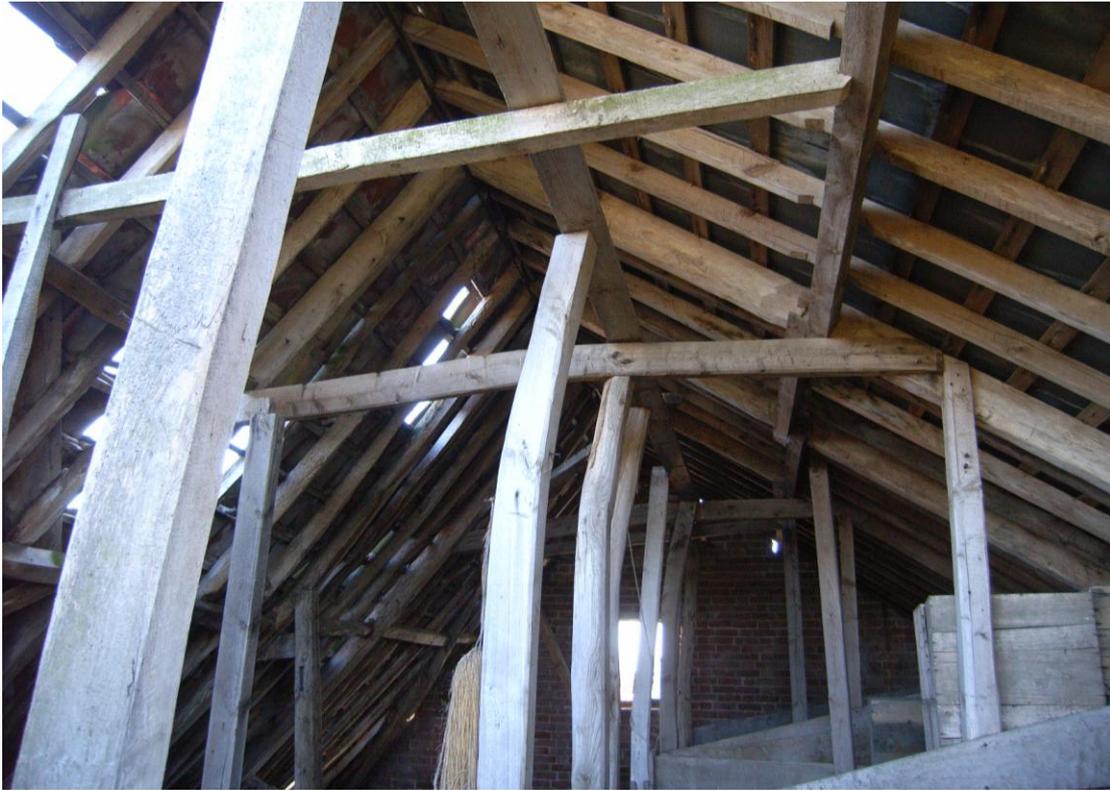
Illus. 15. The grain floor of the granary (5) from the western gable entrance showing the remains of 19th century grain bins and the difference between the northern side of the roof (left) which contains butt-purlins and appears to survive from an early-19th century predecessor, and the shallow-pitched southern half which spans the lean-to sheds and relates to its mid-19th century remodelling in brick.

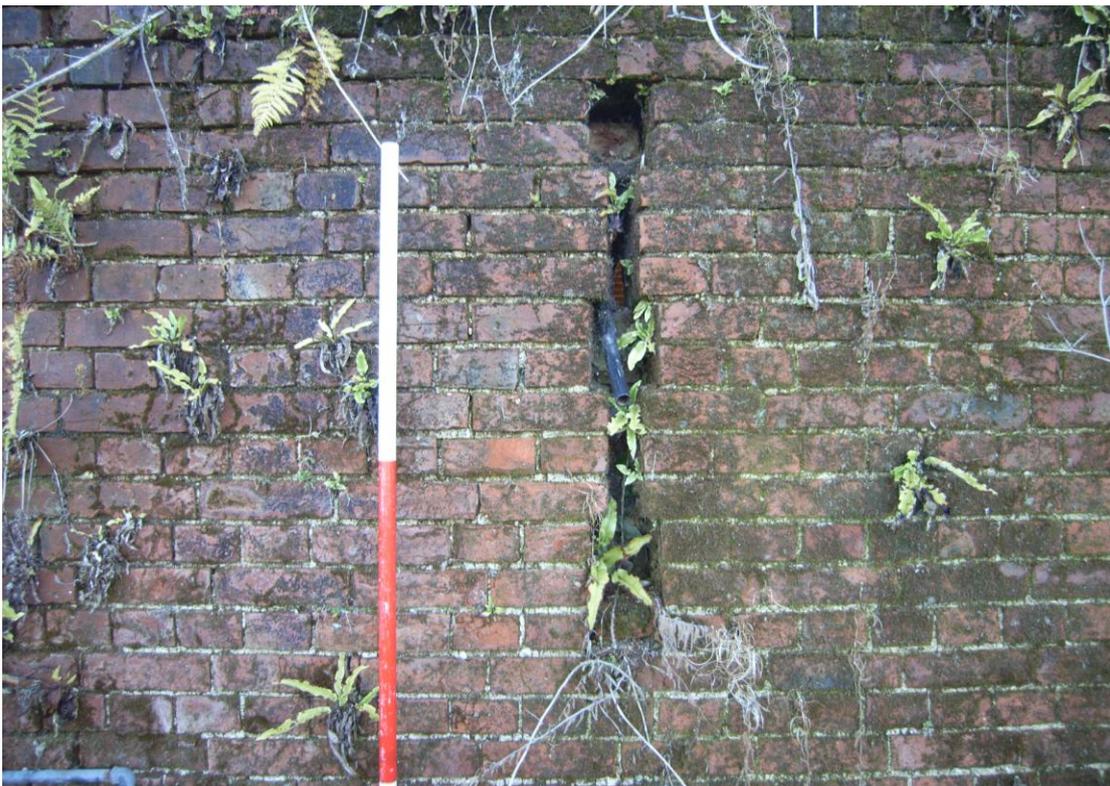
Illus. 16. Detail of a ventilation loop in the northern exterior of the threshing barn (1a).
