Clare Priory Church new extension
Clare Priory
CLA 037

Archaeological Monitoring Report

SCCAS Report No. 2013/039

Date of Fieldwork: February 2011 and November 2012

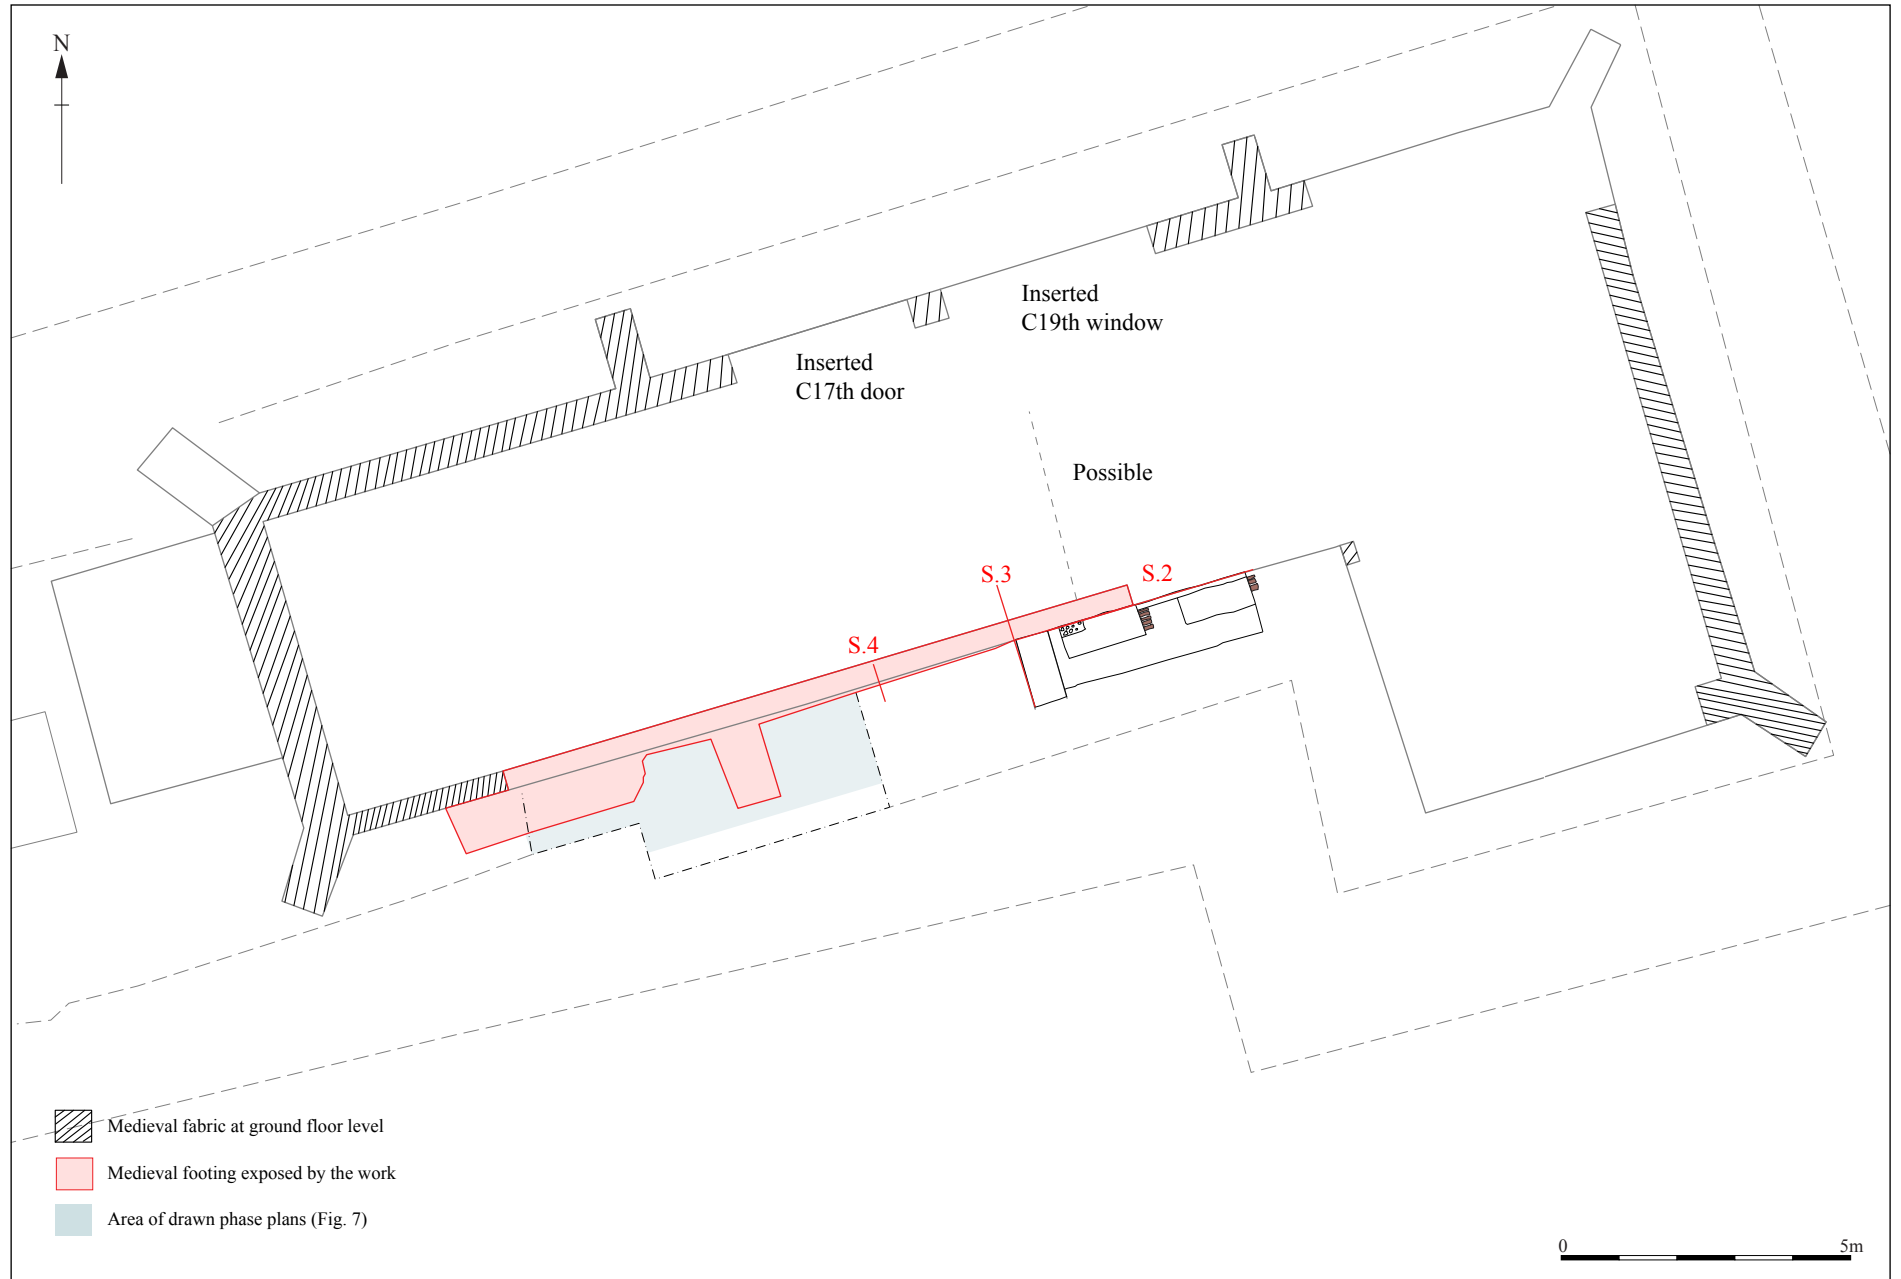
Figure 6. Plan of the Church (medieval infirmary and dormitory) showing areas of excavation and the extent of the medieval footings

Archaeological deposits included the buried foundations of the medieval infirmary, which were encountered at a depth of 350mm below the existing ground surface, and are shown in pink on figure 6. The foundations included the remains of a lost buttress and possible chimney, the respective east and west edges of which were first uncovered in the evaluation (Gill 2003) and thought to be a large, single block of masonry and (mis)interpreted as a possible base for an outshot stair. The footings for the original south wall were also found beneath the existing structure and were uncovered and recorded in a series of trenches excavated for the foundation of the new extension immediately alongside the ancient remains.

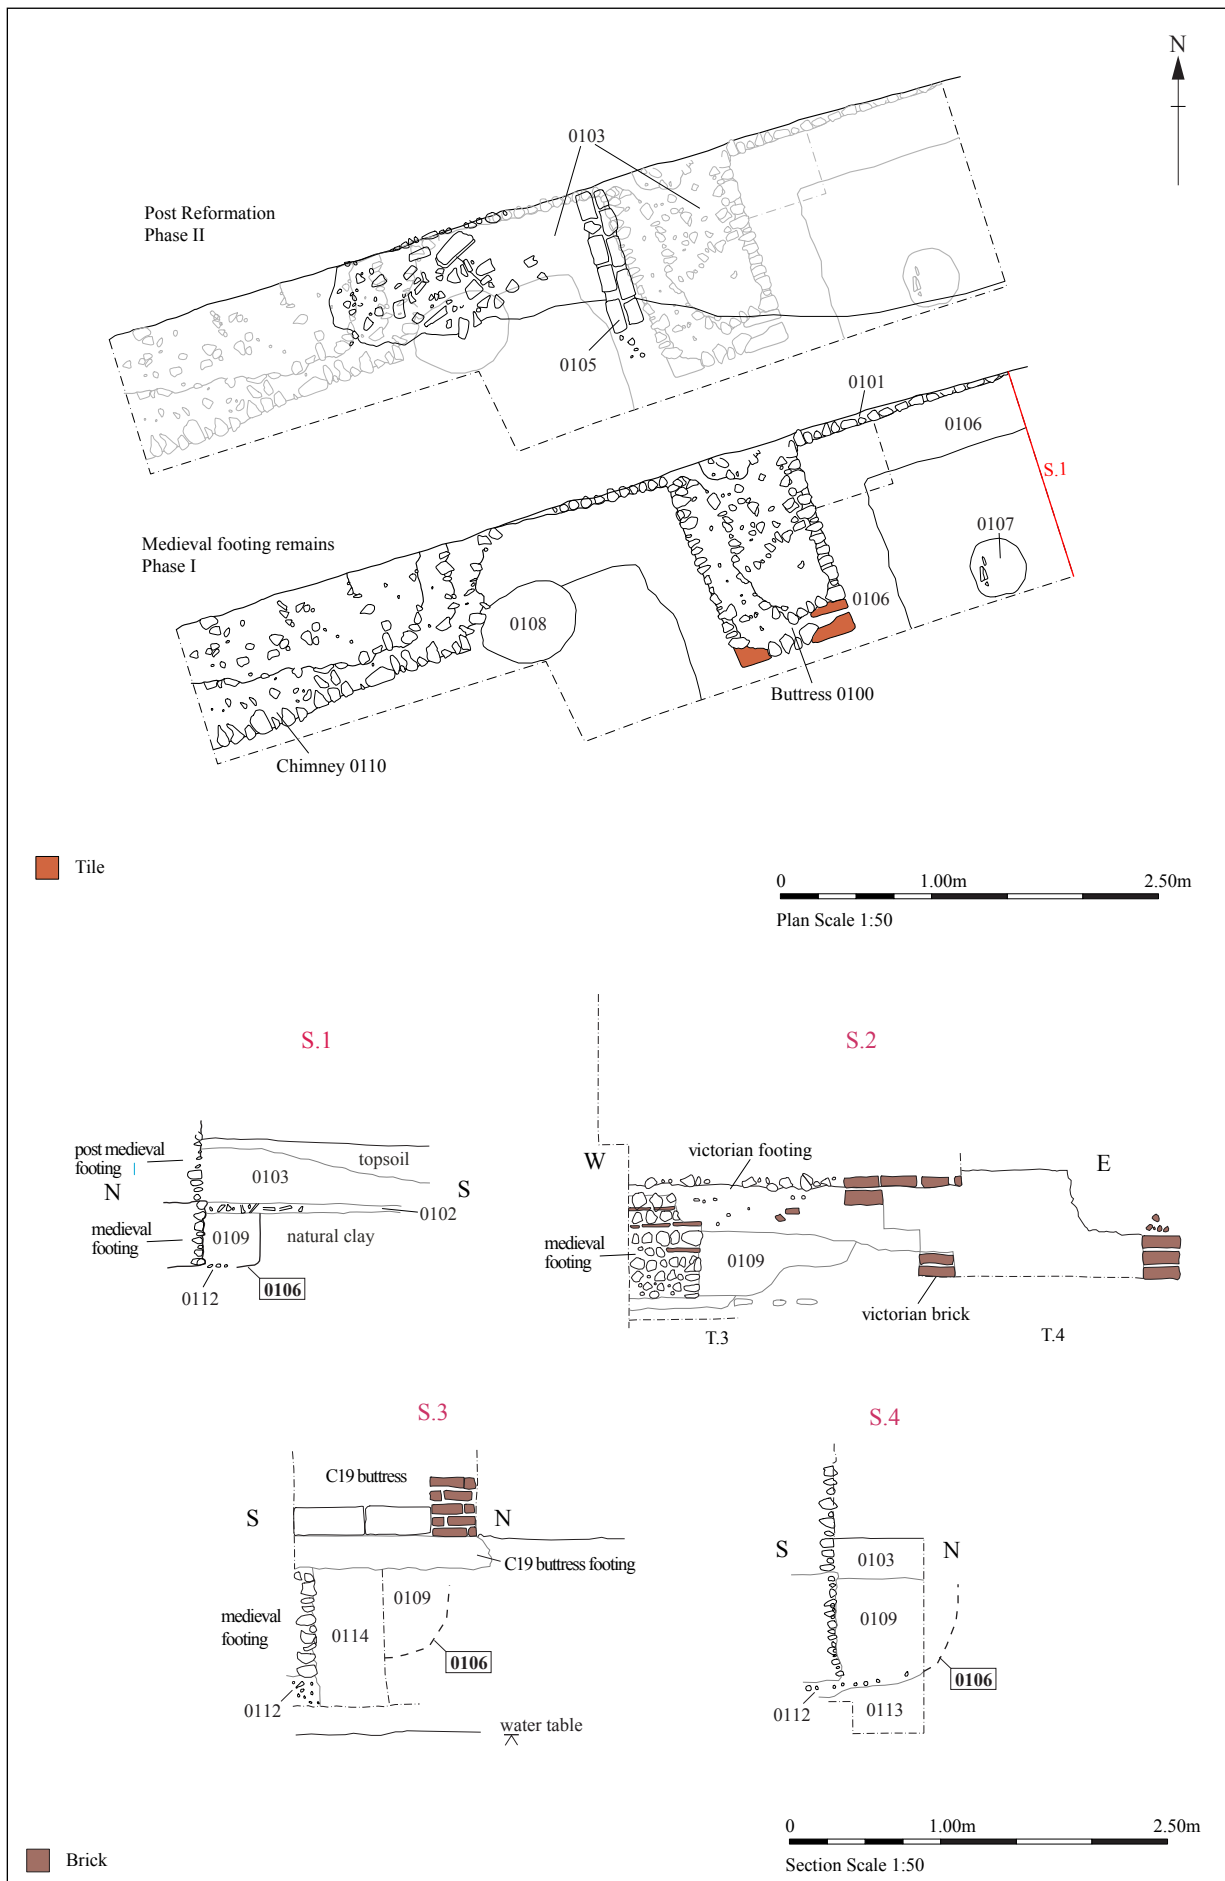
Figure 7. Detailed excavation phase plans of the south side of the church and sections through trenches

The bonded remains of the south wall footing terminated in test hole 4, 4.7m short of cross-wing at the east end of the building (Fig. 7, S4 and Pl.7). This was a deliberate end to the wall which is vertical and finished neatly with tiles and limestone fragments to form a rustic quoin. As far as it could be explored it was finished on the end; it may have been a corner and the wall continued north. The footing trench extended beyond the end of the wall terminal by at least 1m and was filled with the same type of clean clay that infilled the trench sides in front of the wall. Whether this was an 'empty' foundation trench continuing the line of the south wall or the trench for a return wall seen in cross-section was unclear and unfortunately a buried, brick and concrete-built tank obscured any potential evidence that might resolve these issues.

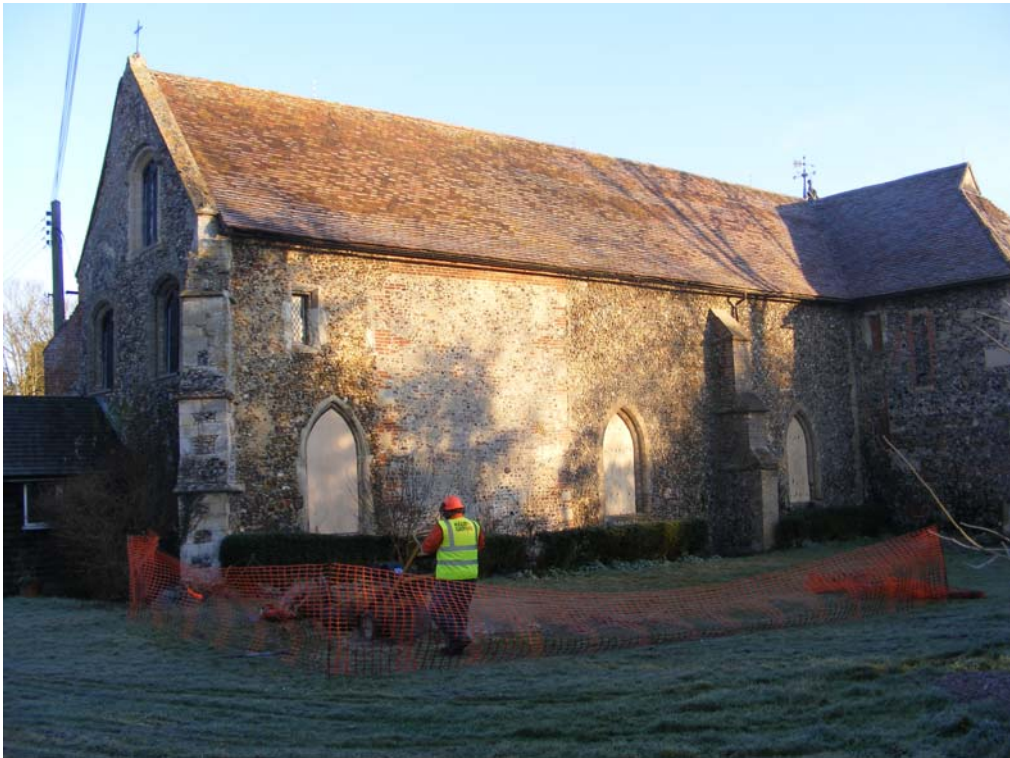
Plate 1. General view of the south side of the church prior to the start of work. The right half of the wall, including the two ground floor windows and the buttress between them, was constructed in the second half of the C19th infilling what had been an opening for full-height barn doors. The large area of paler fabric to the left of the central window is a C17th repair panel and the first and ground floor windows on the left are part of the original 14th century fabric.

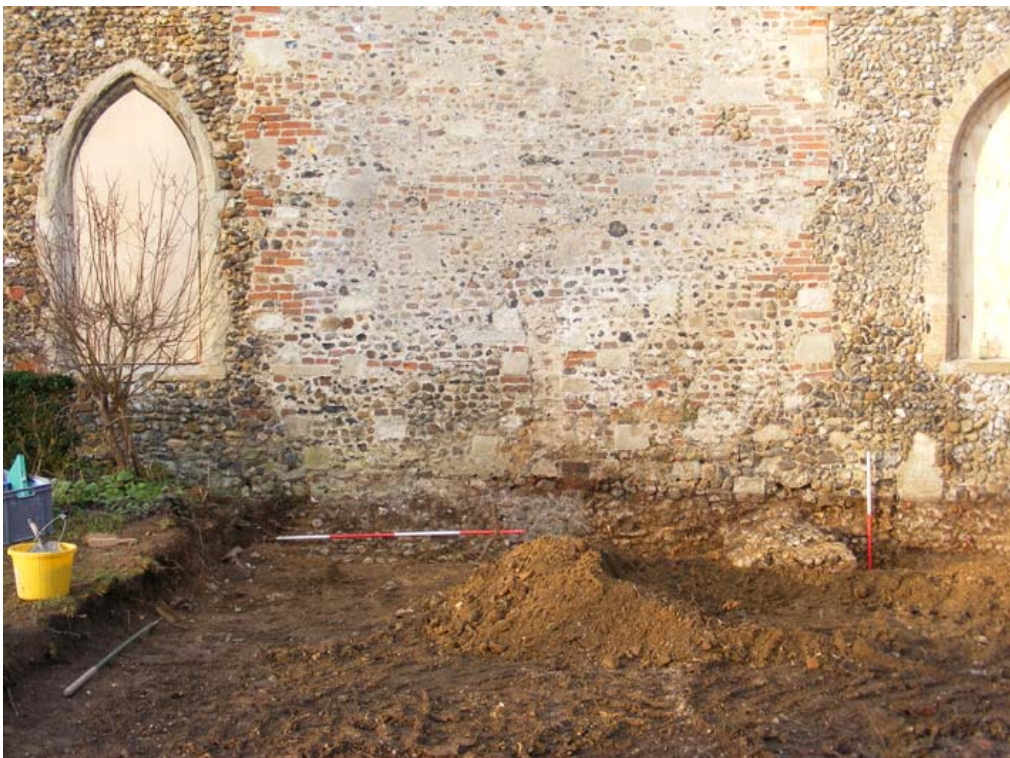
Plate 2. The below ground remains (highlighted by the scales) of a buttress (right) and chimney (left) which once projected from the face of the wall. The outer edges of the remains aligned with the limits of the repair section which was re-built after the wall containing these features was demolished. The scales are graduated in 0.5m.

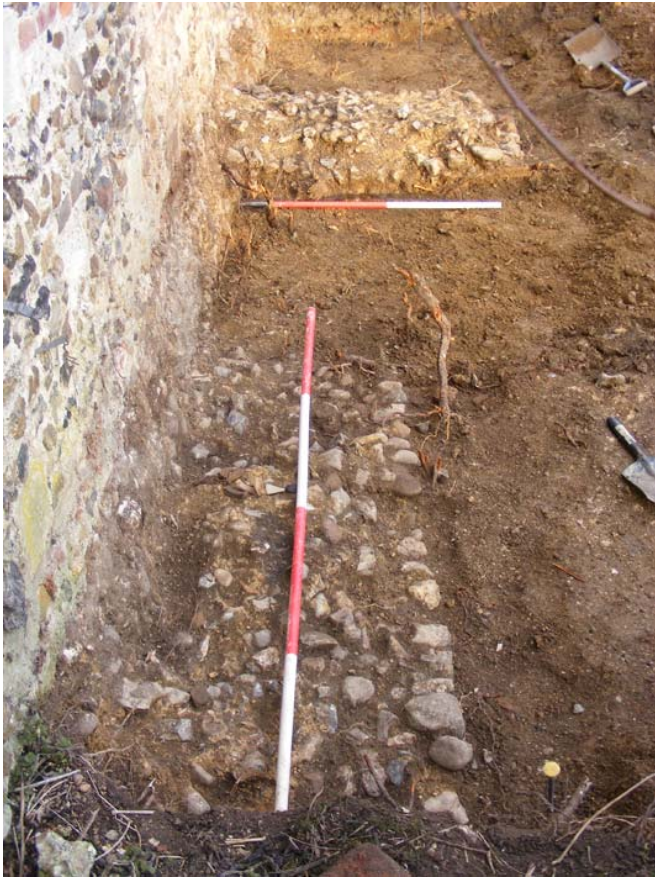
Plate 3. Truncated remains of a lost medieval chimney (foreground) and butters beyond. Both features are the same depth as, and integral with the below ground medieval footing of the south wall which survives across the whole building length.

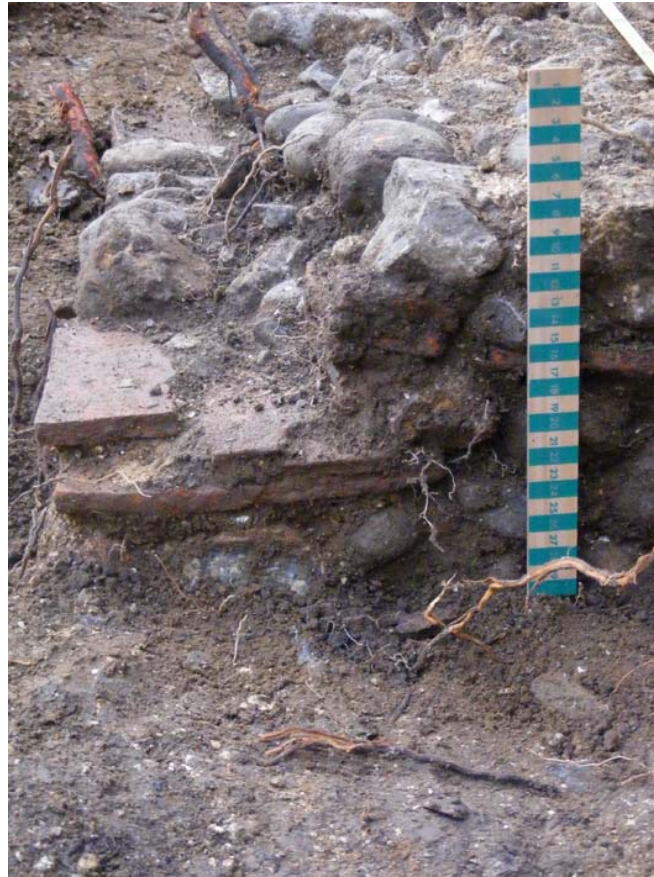
Plate 4. Detail of the corner of the butters showing its construction with re-used peg-tiles

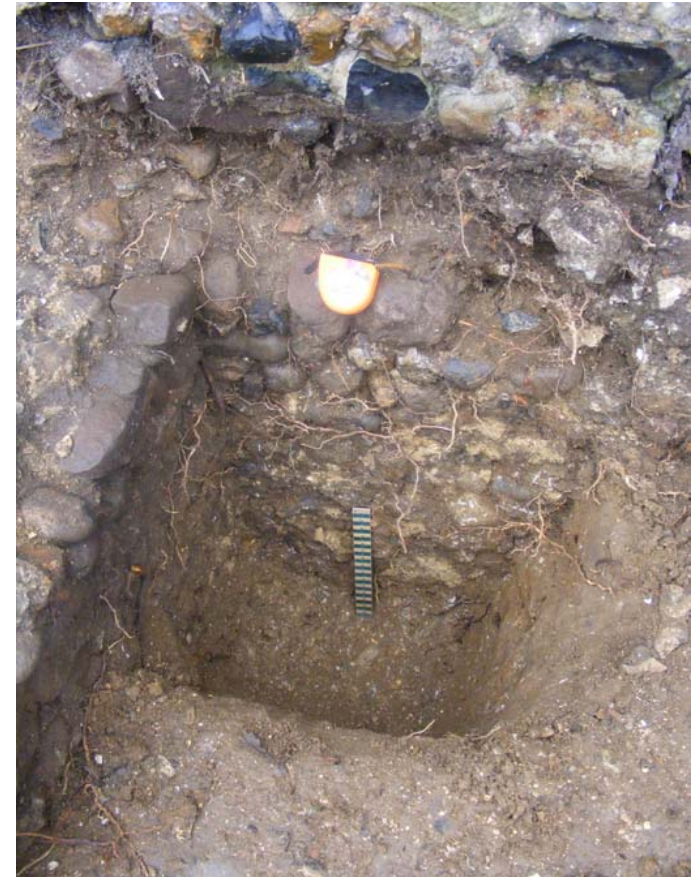
Plate 5. Excavation against the west side of the butters against the angle with the south wall showing the well-constructed foundation of the butters and south wall to the same depth.

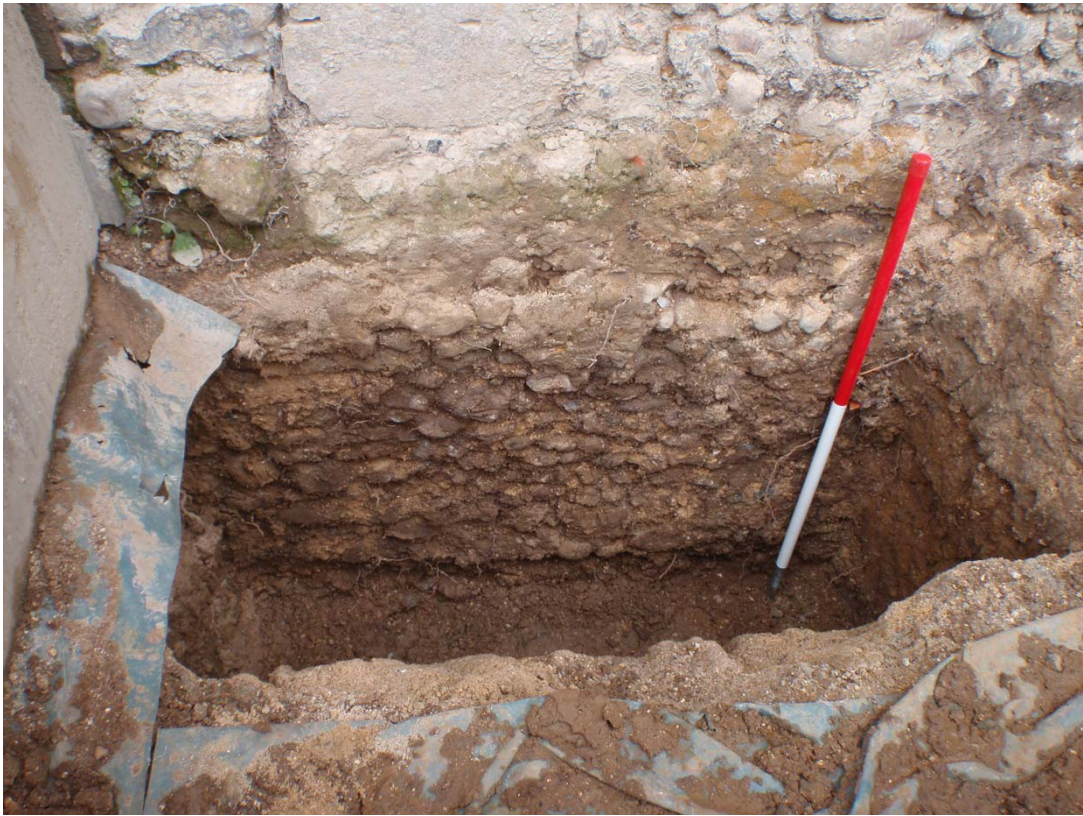
Plate 6. The medieval footing, well-constructed in bonded flint, beneath the south wall. The footing was not full length but stopped 4.5m short of the cross-wing (see below) it was built in a narrow trench, 1m deep and cut through redeposited or imported soil brought to site to raise the ground level before the infirmary was built. The top of the medieval work is at about the level of the blue plastic, the scale is 1m.

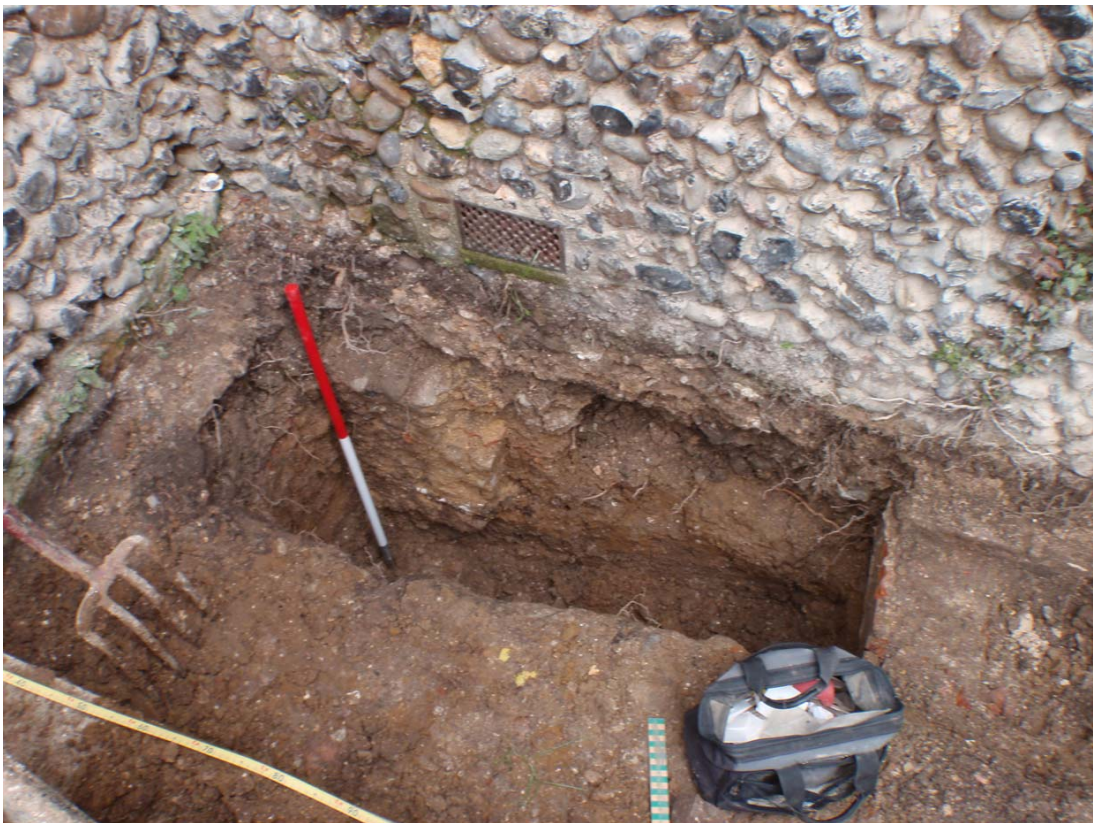
Plate 7. Eastern limit of the south walls of the medieval foundations. The end of the foundation is deliberately finished and terminates neatly using tiles to create a sharp corner similar to the buttress. The soil to east of the foundation is footing trench backfill suggesting the trench may have turned and run north at this point. The buried brickwork to the right is part of a sunken chamber dating to the C19th.

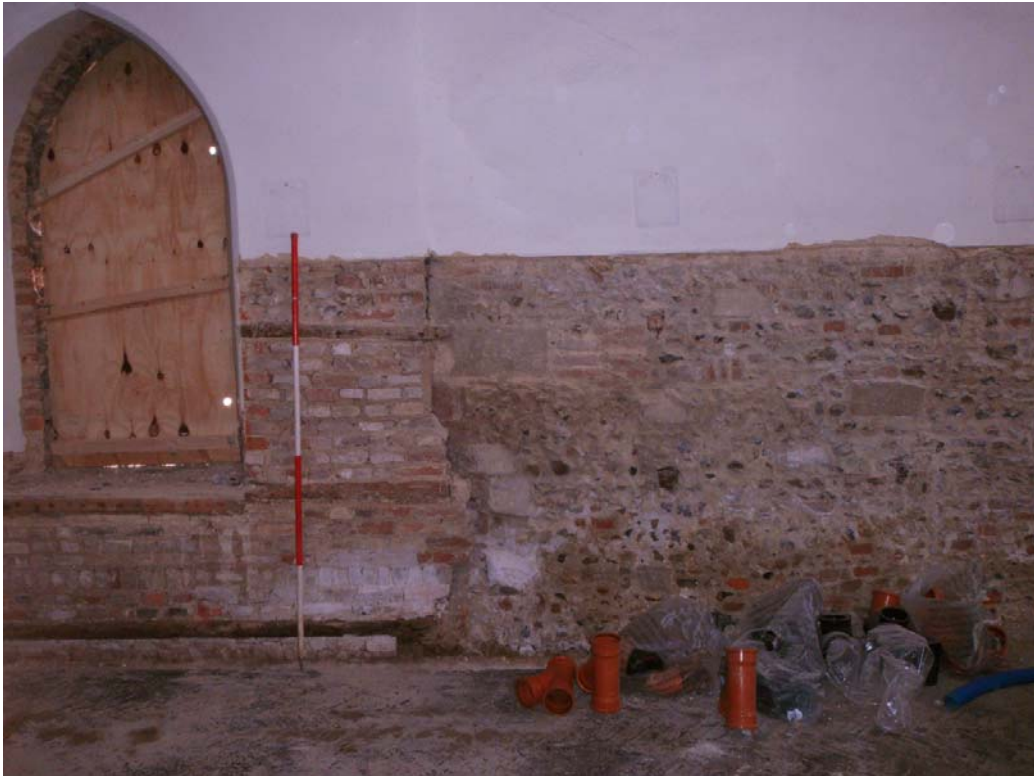
Plate 8. The inside of the church south wall after the removal of the wainscot. To the left the wall is made up of a jumble of reused brick roughly laid in a mix of stretcher/herringbone bonds as part of the C19th rebuild. Horizontal timbers contemporary with the brick and were built into the fabric to attach the wainscot. The 'rubble' wall to the right dates to the c.17th century and is part of the remedial work following the removal of the buttress and putative chimney from the outer face.

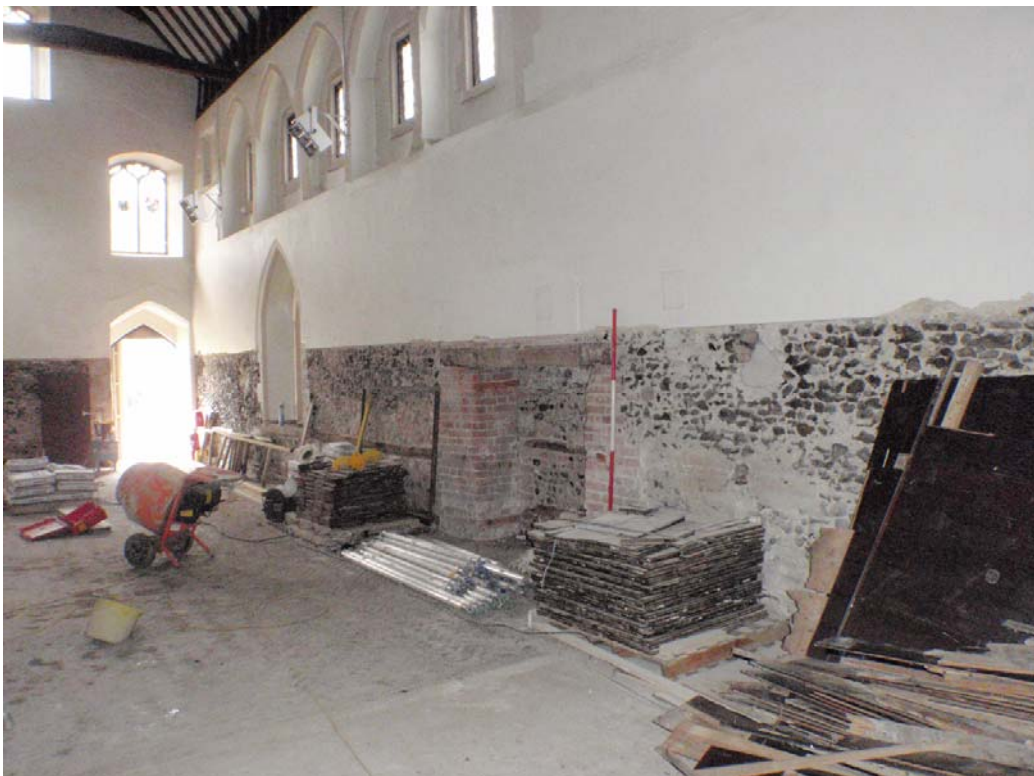
Plate 9. Interior of the north wall with the exposed remains of the brick-built jambs of the central door which was inserted in the 18th century; graffiti scratched into the bricks dated 1811. To the right of the door is the vestiges of wall plaster which carry apotropaic (evil averting) marks inscribed its surface. In-built horizontal timbers for the wainscot identify where the wall surface was re-built in the C19th; where the earlier wall face survives the wainscot was held on with inserted small wooden plugs. The blackened face of the flints is caused by sooting from the C19th heaters.

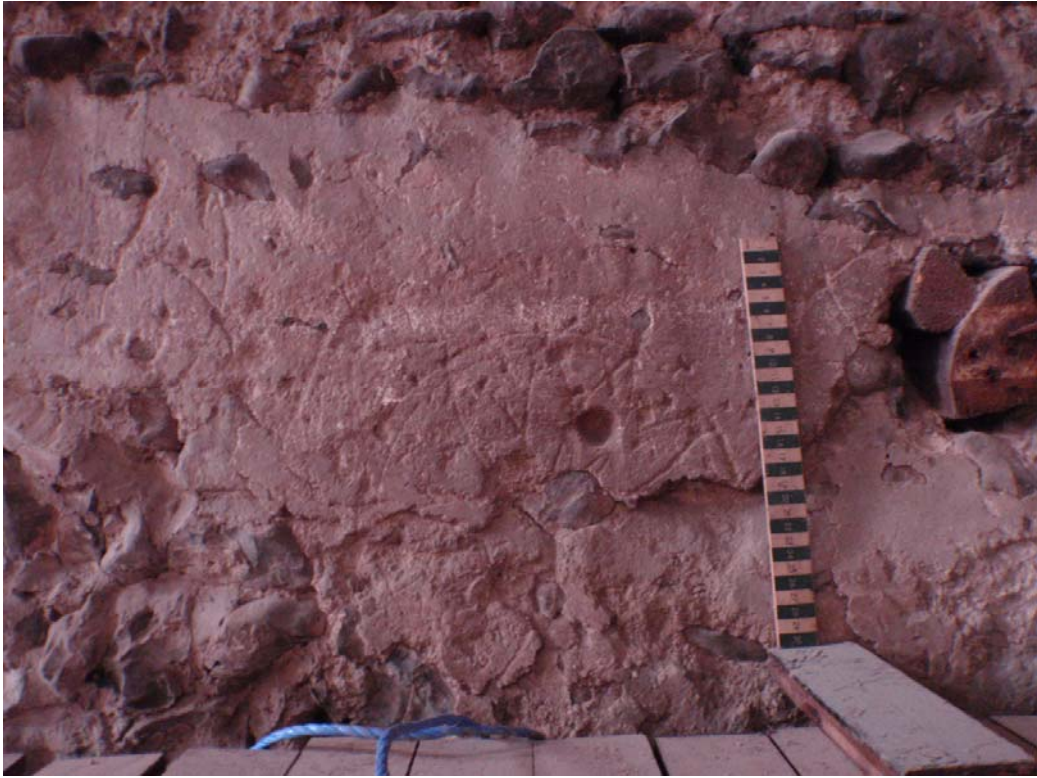
Plate 10. Apotropaic marks. Daisy wheel patterns were inscribed into the surface of the plaster on the north wall; these were numerous and occurred wherever the fragments of plaster survived (the remains of three wheels are shown here).

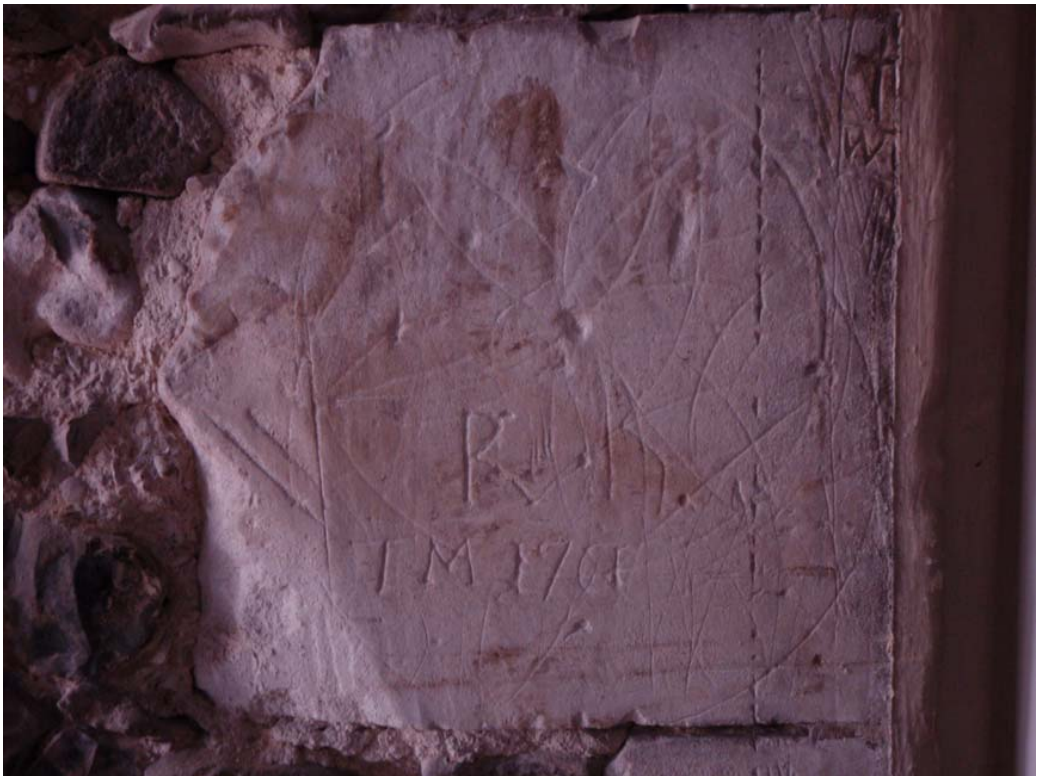
Plate 11. Detail of apotropaic marks and graffiti scratched into the soft clunch stone surround the one remaining original window at the east end of the north wall. The inscription by 'TM' in 1701 was thought to overlie the daisy wheel pattern suggesting a *post terminus quem* for when the building was safeguarded by this symbol.

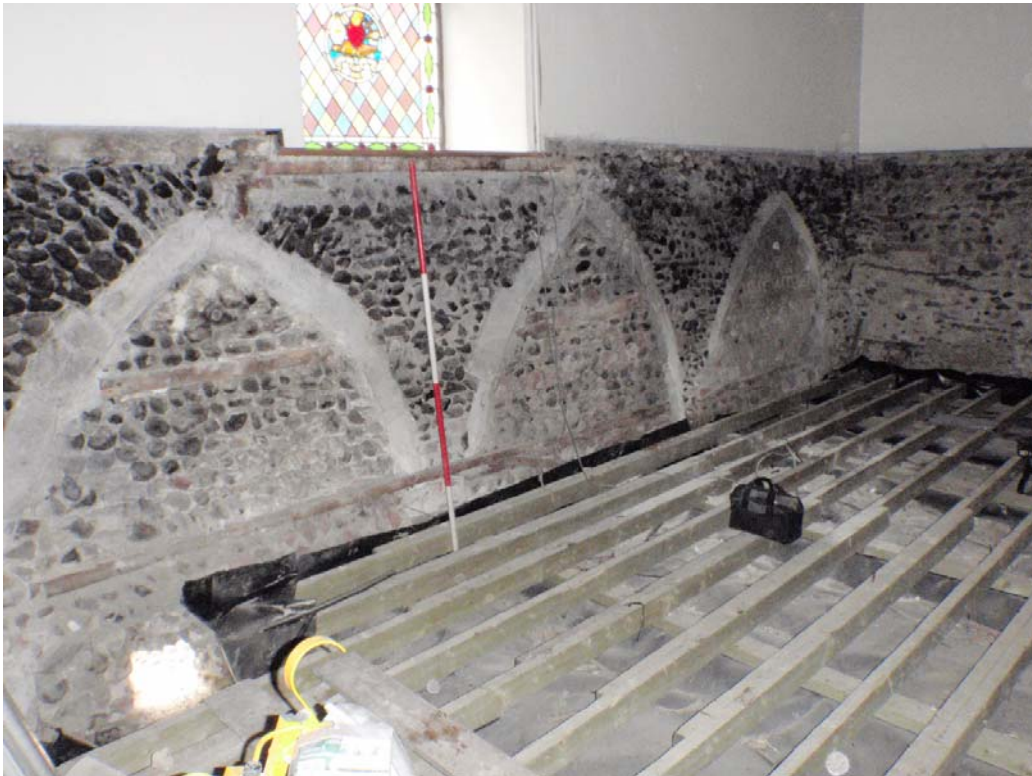
Plate 12. The interior of east wall of the cross-wing after the removal of the wainscot which revealed the arches of the reredorter. The reredorter was flushed through by water from the Stour brought to the building in a channel shown on the tithe map (Fig. 2 and Pl. 14). The arches came together at the current ground level but there was no opportunity to examine how the arches were supported below this. The presence of the horizontal timbers built into the arch infill suggests that they were not blocked in until the C19th.

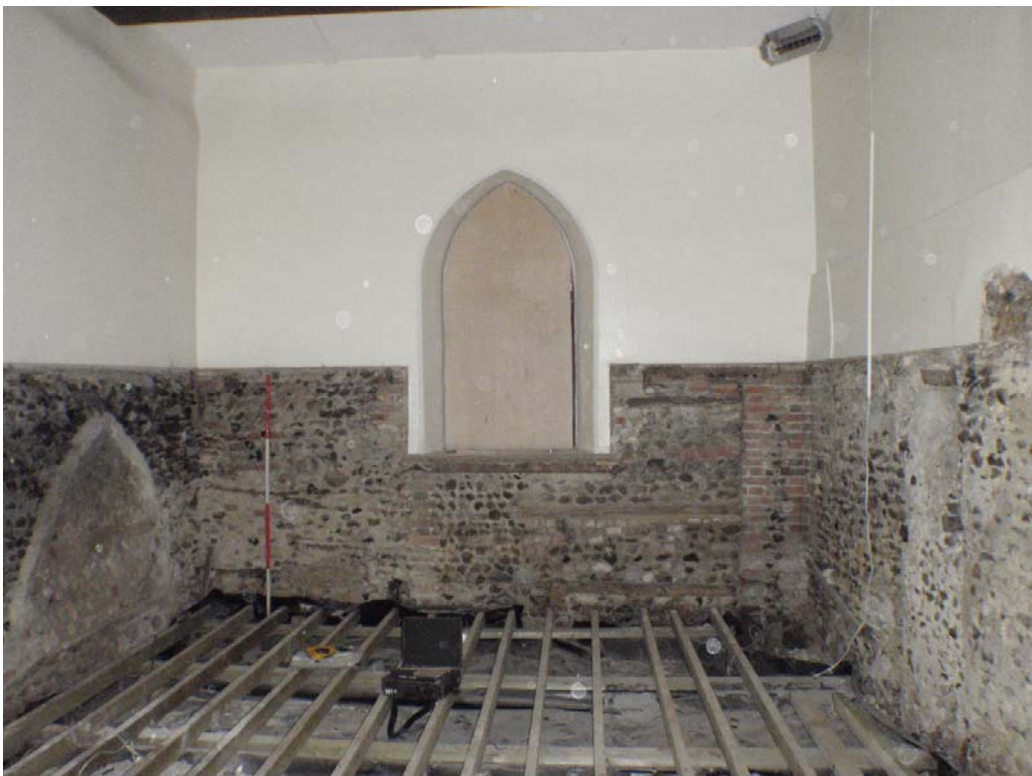
Plate 13. The exposed fabric of the north end of the cross-wing. The flints are mixed with reused bricks and timber over the entire area of the wall suggesting that it has been largely rebuilt.

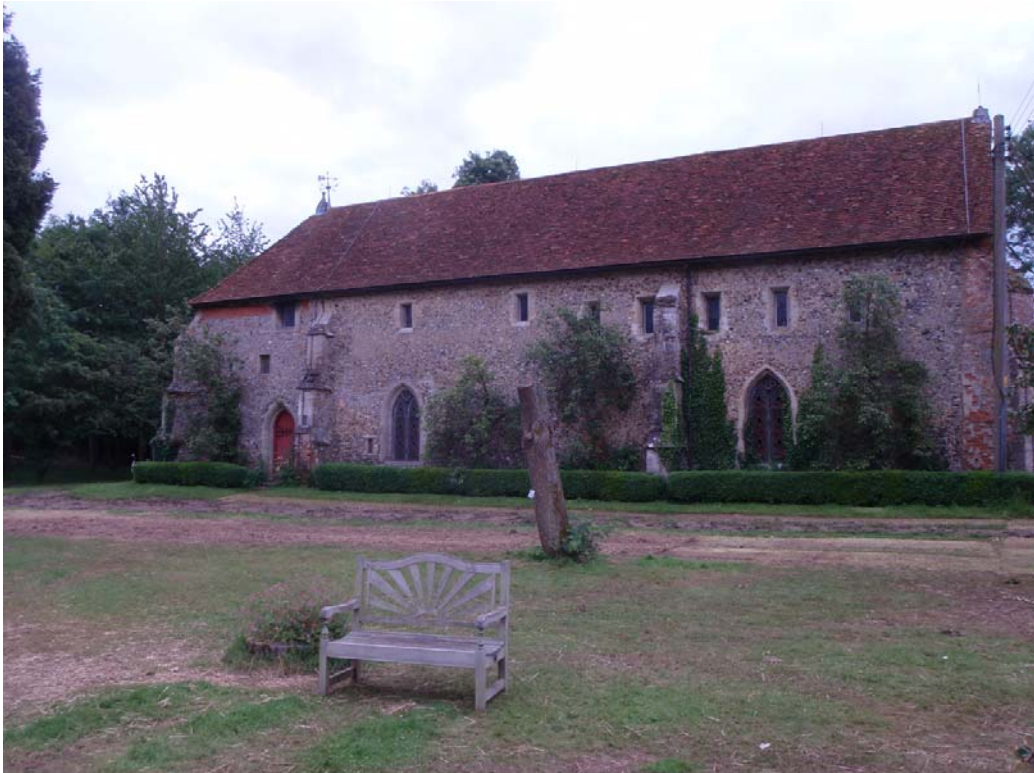
Plate 14. General view of the north side of the church. Note the first floor windows are at different levels suggesting that the central internal space may have been separated from the one within the west end (right) and which necessitated separate entrances (via the outshot stair on the south side and the west gable end door). On the ground floor the westernmost window is the only other original opening and together with its opposing window the only indication of how the ground floor was lit. The C19th arched window at the east end cuts a possible small square window at high level in the central area.

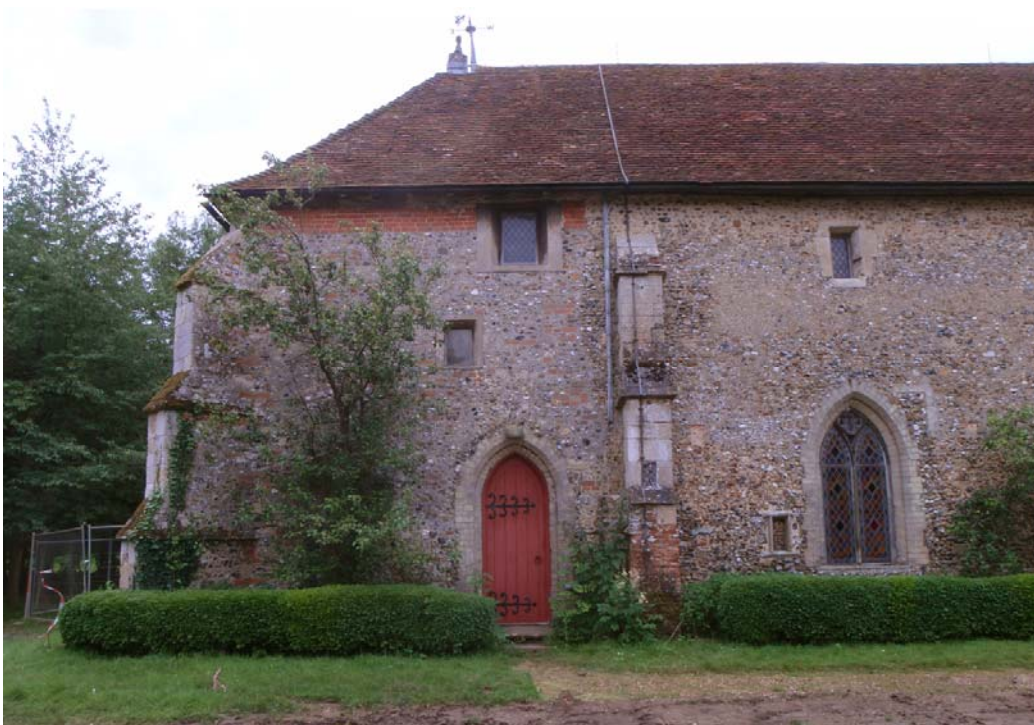
Plate 15. The east end of the church north side appears to have been re-built from a point just to the left of the buttress in the middle of the picture. Only the small first floor window on the right is the only original opening with all of the others being later inserts. The end of the footing on the opposing north face aligns with the right side of the large ground floor (C19th) window but there is no indication the building stopped here and the medieval fabric continues to the east (left) beyond this point

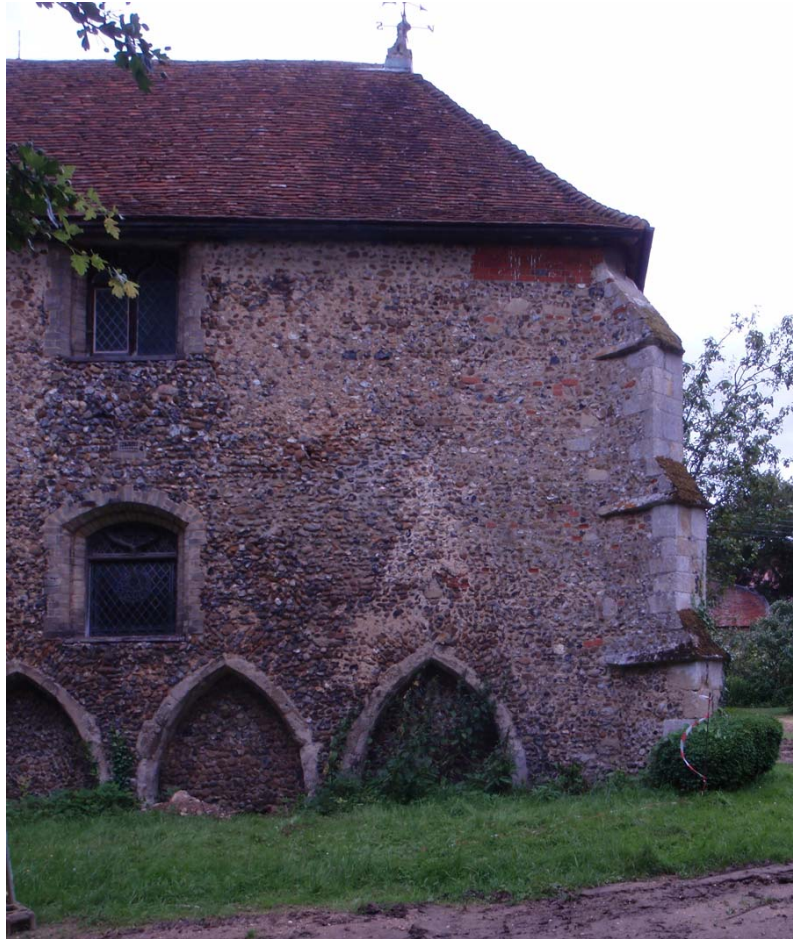
Plate 16. Exterior of the reredorter east wall showing extensive refacing or rebuilding in the north east corner

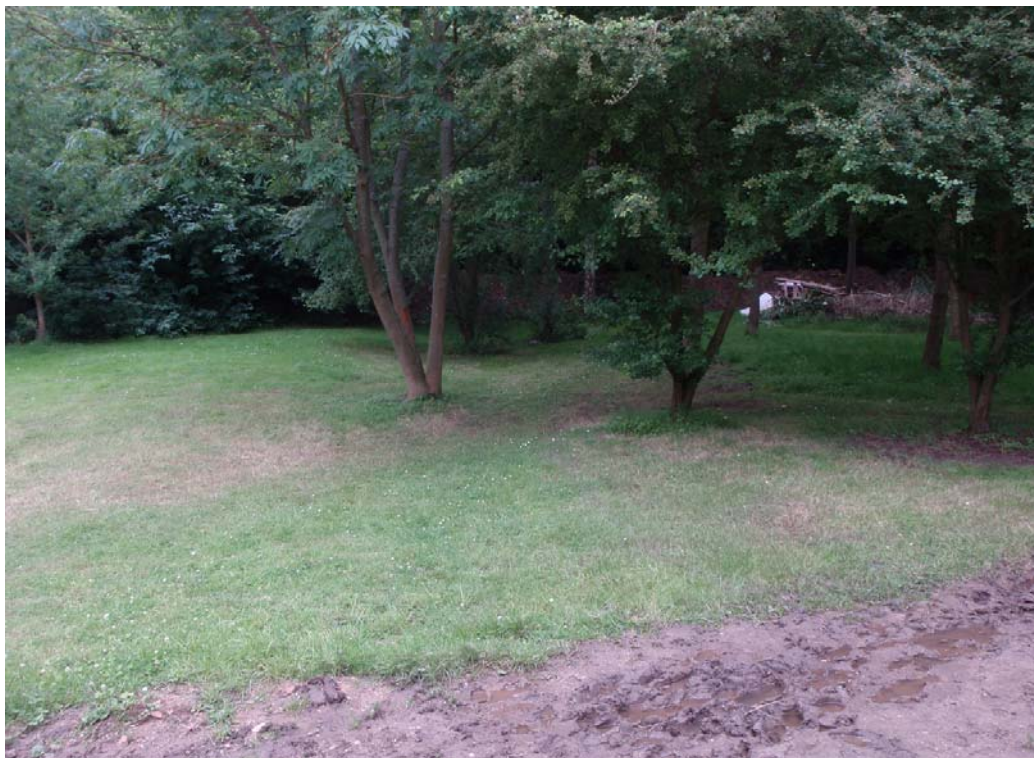
Plate 17. Linear hollow east of the church on the line of the water channel that once served the reredorter
