ARCHAEOLOGICAL MONITORING REPORT

SCCAS REPORT No. 2013/112	Parish: Clare
Assessing the effects of building contractors, potential damage to the Clare Priory grounds	Planning App No: SE/08/0398
	SAM consent ref: HSD 9/2/8757
	HER Event No: CLA 037
Address: Ashen Road, Clare, Suffolk CO10 8NX	Grid Reference: TL 7699 4500
	Number of site visits: 1
	Date of visits: July 2013
<p><i>Background</i></p> <p>An archaeological monitoring visit was made to Clare Priory to assess the impact of construction traffic tracking through the designated area of the Scheduled Ancient Monument. Deep wheel ruts had been created within the area of the priory's medieval cloister as a result of vehicle (dumper truck) movements relating to building work for the extension to the priory church. The visit was prompted by an instruction from John Ette, English Heritage's regional Inspector of Monuments who had identified the damage to the monument's landscape during a site inspection. This document is an addendum to the monitoring report already completed for the monitoring of the ground works of the church extension (SCCAS report no 2013/039)</p>

Plates: Clare Priory, monitoring construction works damage

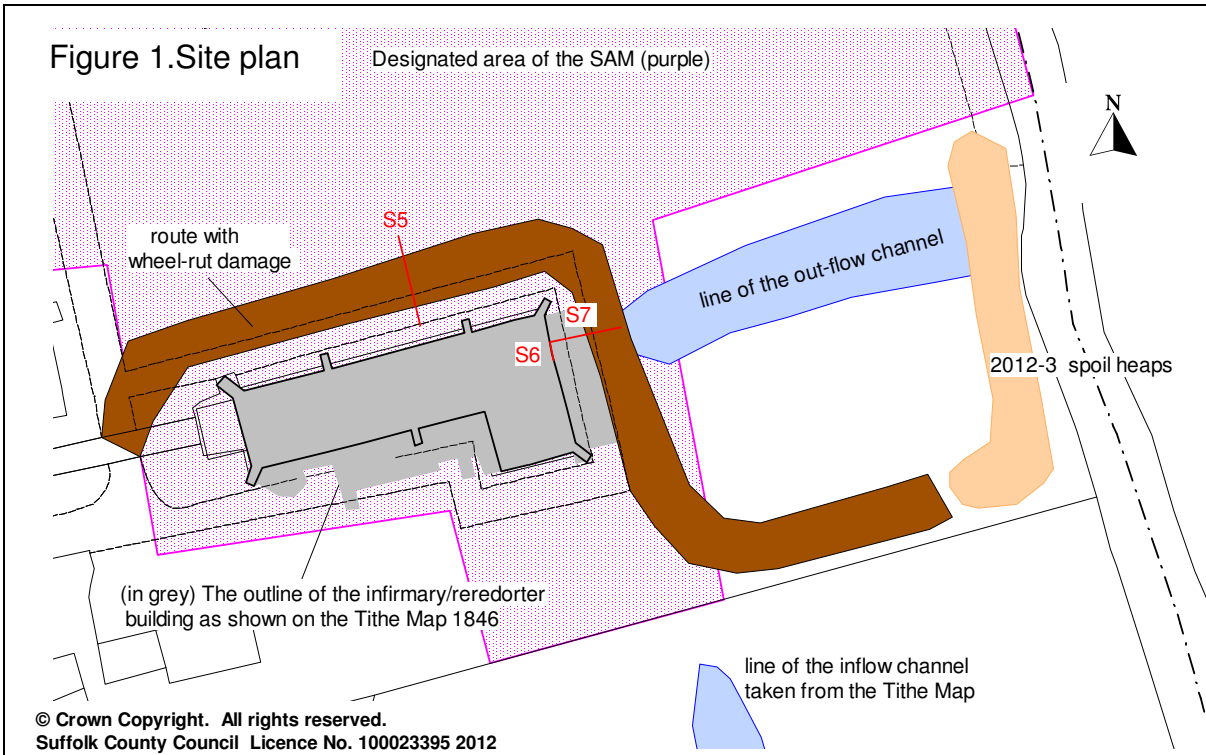
<p><i>What was seen - nature of the work, condition of trenches etc.</i></p> <p>The wheel ruts encircled the north and east sides of the church en route to a linear spoil heap that was being created on the east edge of the site (Fig.1). The spoil was being used to create an embankment alongside the river to alleviate the flooding of the grounds that frequently occurs. The river's channel is a man-made cut (presumably medieval in date) which carries the River Stour and formed part of the boundary of the priory precinct.</p> <p>A machine cut trench was excavated across, and to the full depth of the ruts, in the presence of the monitoring archaeologist to access the potential damage to any underlying archaeological deposits. A service trench was re-excavated at the east end of the church which had been missed due to an oversight in the original monitoring.</p>

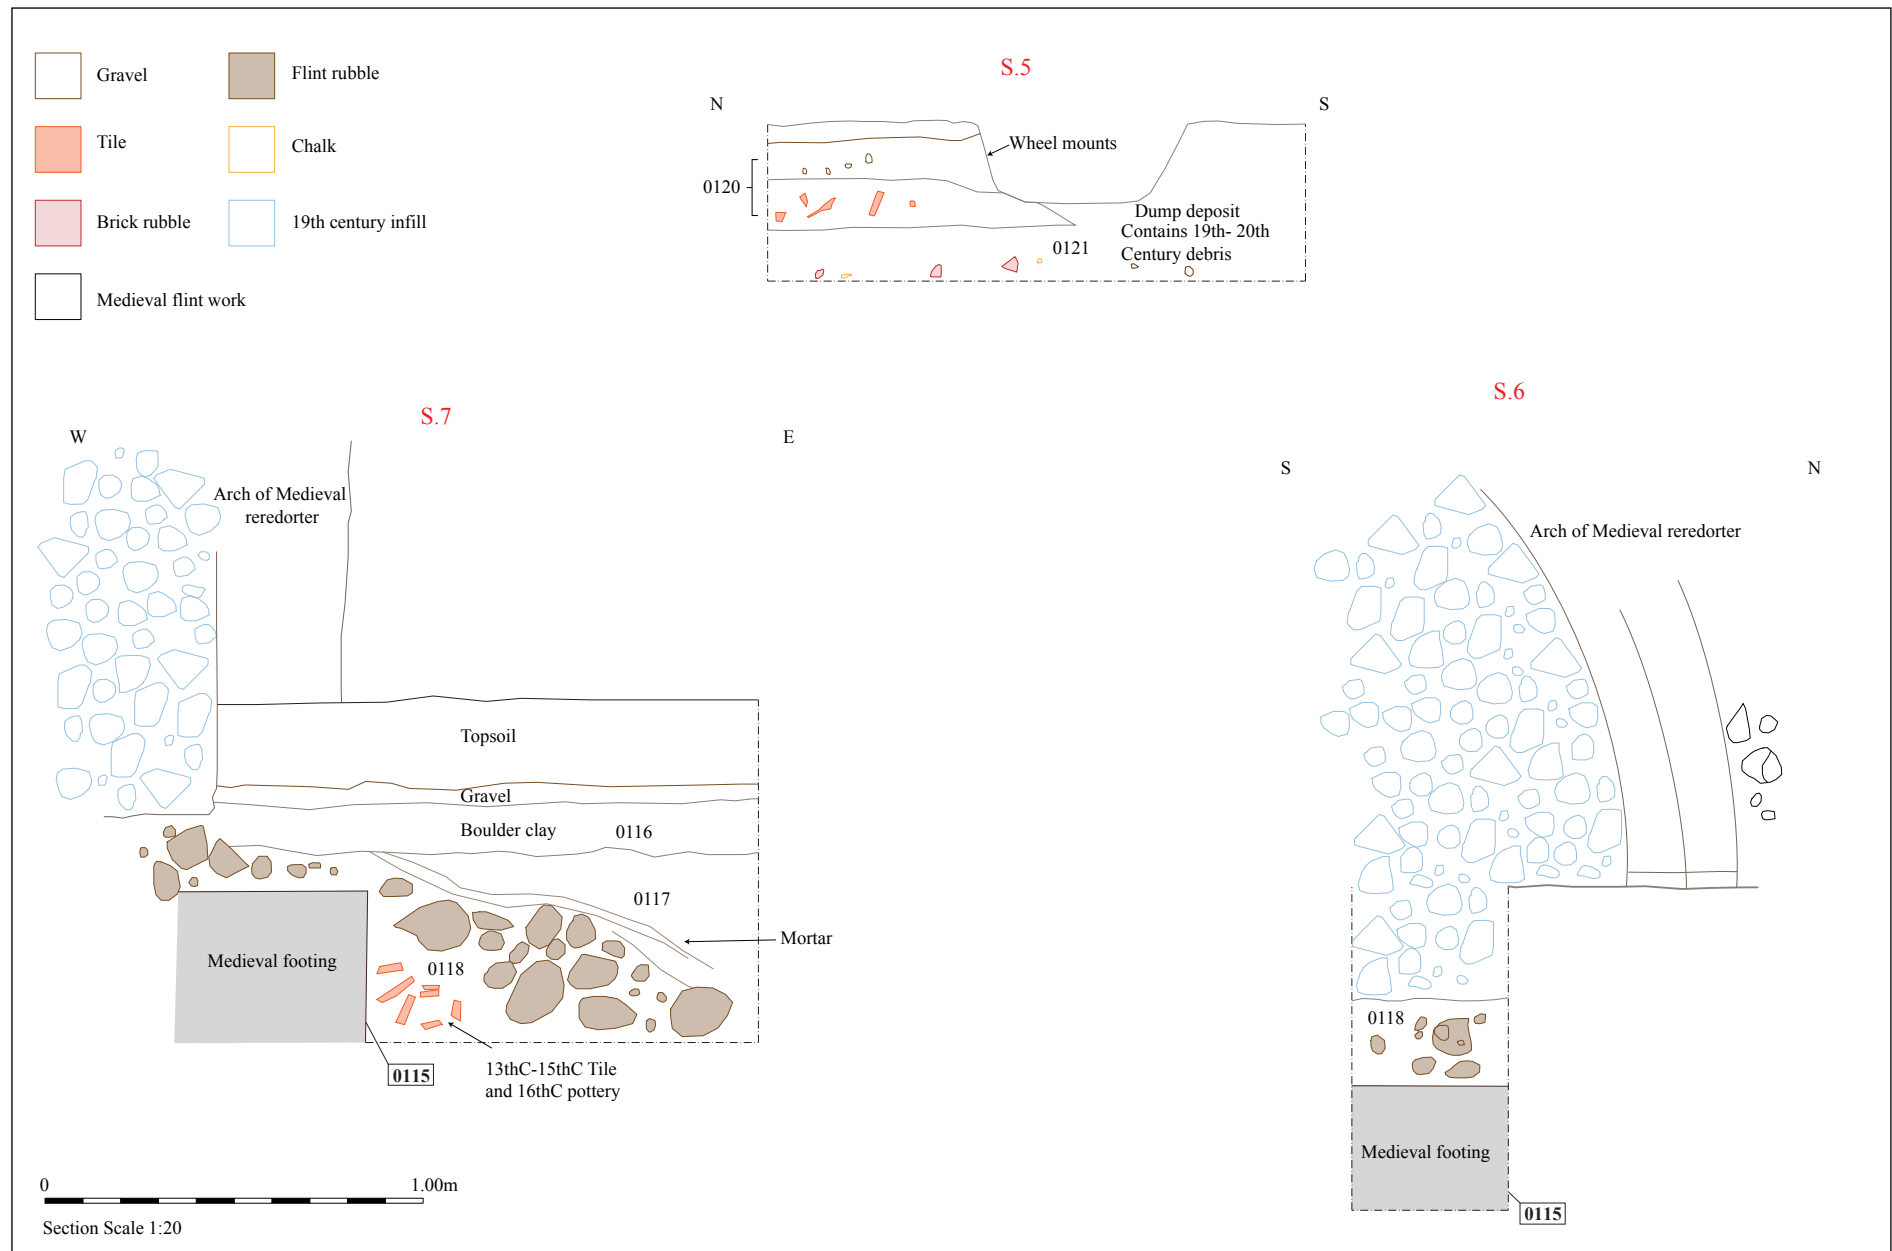
Figure 2. Trench sections

Wheel ruts (see plan above and Fig. 2, S5)

The soil profile within the excavated section showed that the ground here was made up of relatively recent deposits; these were more than 500mm deep and in excess of the depth of the excavated section. The deposits included the remains of the gravel path which once lead to the north door, and its rubble sub-base (0120) laid over a homogenous layer of re-worked dark soil (0121). Layer 0120, possibly a dumped imported soil, contained modern detritus including broken glass, china, brick fragments and coal. The date of this material indicated that it had been re-worked or imported since the beginning of the 20th century; possibly as the result of previous construction works or landscaping associated with the return of the Priory to the Order of Friars in the 1950's. The dumper's wheels had sunk into the ground by as much as 300mm but this was wholly within these late deposits and no archaeological horizon had been affected. A programme of remedial work was agreed with the main contractors to restore the ground to its previous level and condition.

Drains (see Fig. 2, sections S6 and S7)

The excavation exposed a well-made footing (0115) beneath the arch; identical in form to the one seen below the south wall of the building (SCCAS report no 2013/039). The top of the footing was 500mm below the current ground surface and demonstrated that a bonded footing ran in a continuous, unbroken line between the arch openings. The footing was buried under a tumble of Dissolution rubble (0118) made up of large building flint and tiles. The fact that the rubbles lies directly on top of the footing suggests that at the Dissolution, when the reredorter was functioning, this seemingly below ground wall was exposed and therefore must have formed a revetment to the west end of the outflow channel. The rubble had spilled over the footing and into the end of the channel, which was still an open feature at this time and at least 900mm deep. The rubble is not closely dated, but the age-range of tile and pottery collected from beneath the flints includes the end of the medieval period and they are likely to be contemporary with the monastic use of the building. The pottery which was dated broadly to 1480-1600AD was coated with, what is possibly, limescale. This implies that the vessels were once water containers and potentially directly related to the functioning of the reredorter (see finds report below).

Sealing the rubble and infilling the channel to the east of the building was a muddy silt backfill (0117) that produced medieval and post-medieval brick and glazed floor-tiles together with large sherds of glazed earthenware pottery. The assemblage dates to the 16th-18th centuries and included ceramics imported from the low countries representing the most fashionable style of the period. The cut-off date for the finds strongly suggests that the segment of the channel nearest to the building was infilled before the beginning of the 19th century and this is supported by the tithe map evidence (SCCAS report no 2013/039, Fig. 2) which shows the otherwise open E-W channel terminating about 10m short the building in 1846.

At the top of the section was a horizon of green clay (0116). This layer was flat and level suggesting the ground had been prepared once this section of the channel had been filled in. The top of the clay coincided with the base of the flint infilling the arch suggesting that the two may have been contemporary. A layer of similar clay was recorded on the south

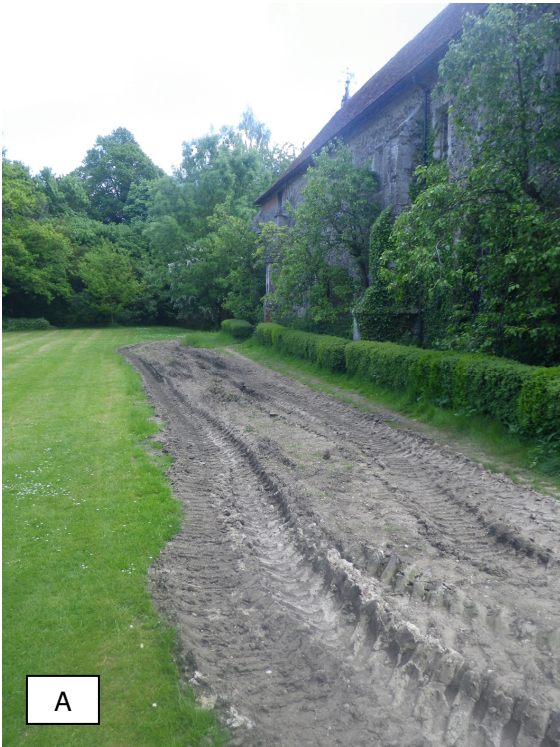
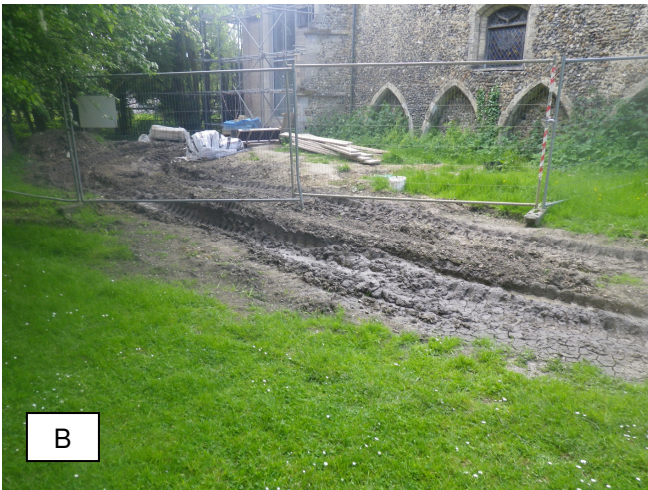
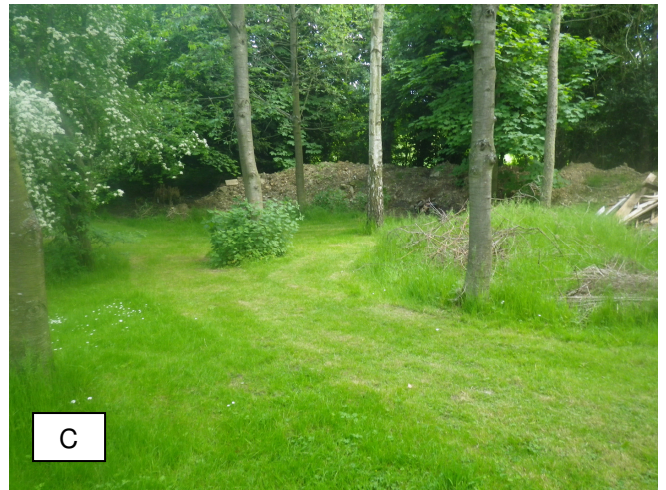
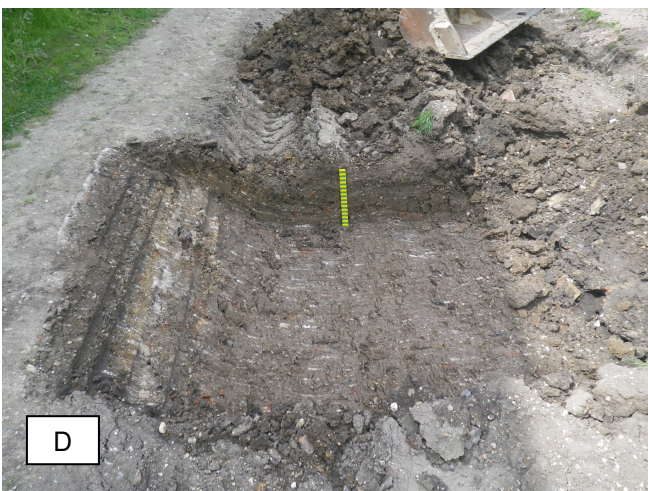
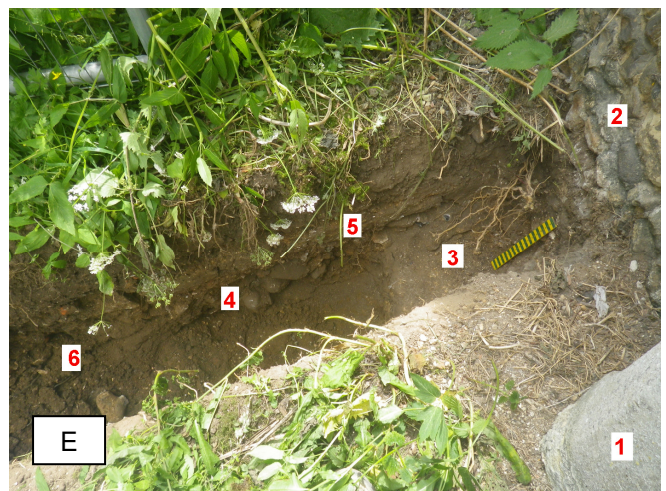
- A) Wheel ruts running across the area of the former cloister north of the church (medieval infirmary/reredorter)
- B) Wheel ruts at the east end of the building crossing the line of the channel with the arches of the reredorter seen behind
- C) Spoil heaps along the east side of the site (behind the trees). The edge of the channel is the un-mown grass in the foreground
- D) Section 5 across the wheel ruts north of the church. The banded soils on the left are the former path and the dark soil at the base of the trench contained material from the first half of the 20th century.
- E) Section 7 in the line of the outflow channel alongside the arch of the reredorter 1) Lime dressing, haunch of the reredorter arch 2) C19th flint blocking of the arch 3) Medieval footing 4) Dissolution rubble 5) Clay layer 0116. 6) Infill of the channel 0117
