ARCHAEOLOGICAL MONITORING REPORT

SCCAS REPORT No. 2013/137	Parish: Polstead
St Mary's Church, Polstead. Installation of an extension to the drains drain to the west of the	Planning Application No.: N/A
	OASIS No.
	HER Event No.: PLS 044
Address:	Grid Reference: TL 9888/3808
	Number of Site visits: 2
	Date of visits: 22-23 October 2013

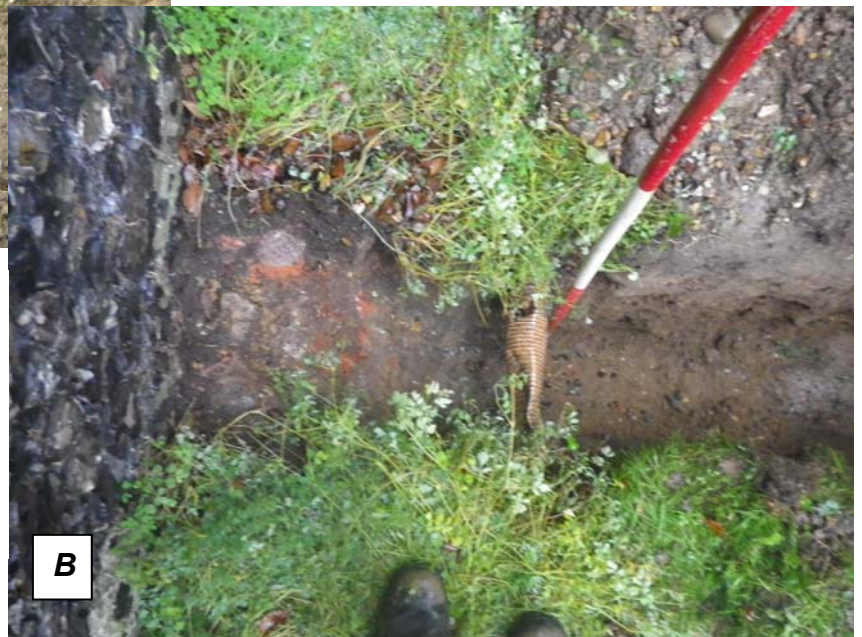
At the base of north aisle wall the trench uncovered a substantial buried footing (S3 Figs

1-2 and Pls. A-B), this was made from small and medium-sized brown flint cobbles, tightly packed and bound with a sandy mortar. The flint type contrasted with the decorative large, black, knapped flint which made up the lower part of the above ground wall. The face of the footing projected 700mm forward of the line of the aisle west wall and, because of this together with the change in the character of the flint and its general robust nature, the footing was initially interpreted as possibly the remains of an earlier wall. Examination of the footing's core in the hole cut through the wall however, indicated that aisle wall and the footing were a single phase of construction. The surrounding soil up to the face of the footing was disturbed and there was no indication of a cut trench into which the footing was built.

A) Footing beneath the west wall of the aisle. The base of the footing was c.1m below the existing ground surface and sat on natural sand; the whole depth of the footing was exposed within the trench footing. The orange pipe is part of the *french drain* that surrounded the church at the base of the wall and cut into the top of the footing
