ARCHAEOLOGICAL MONITORING REPORT

LANDGUARD FORT, FELIXSTOWE, SUFFOLK (Suffolk SMR ref. FEX 064)

A REPORT ON THE ARCHAEOLOGICAL MONITORING OF GROUNDWORK ASSOCIATED WITH THE INSTALLATION OF AN ELECTRIC CABLE DUCT WITHIN THE FORT COMPLEX

Suffolk County Council Archaeological Service Report No. 2006/121

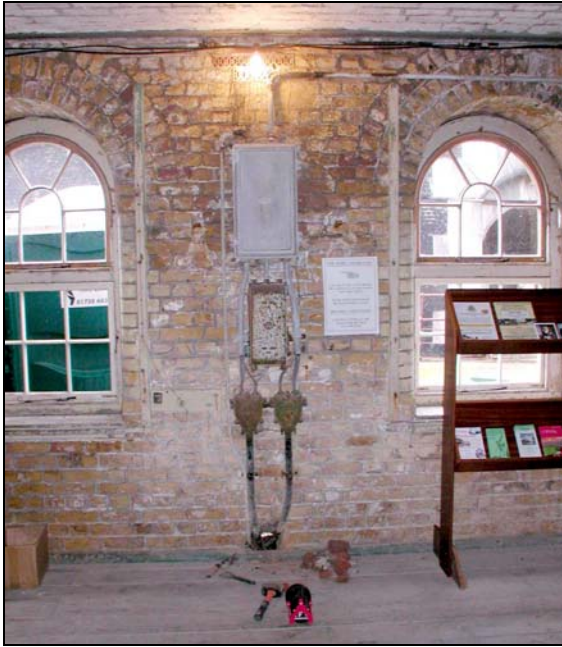
electrical cabling (Plate IV). Both continued into the guardroom where one was cut flush with the wall whilst the other continued up the wall before terminating at a point where it turned to run horizontally (Plate I). Two further cables were noted in this trench. Each was armoured with steel ribbon and sealed with a tarry substance. Both had been cut at a point c. 0.6m from the brick wall.

Plate I: View inside Guardroom. The new electrical box is to be fitted in the location of the white notice adjacent the window

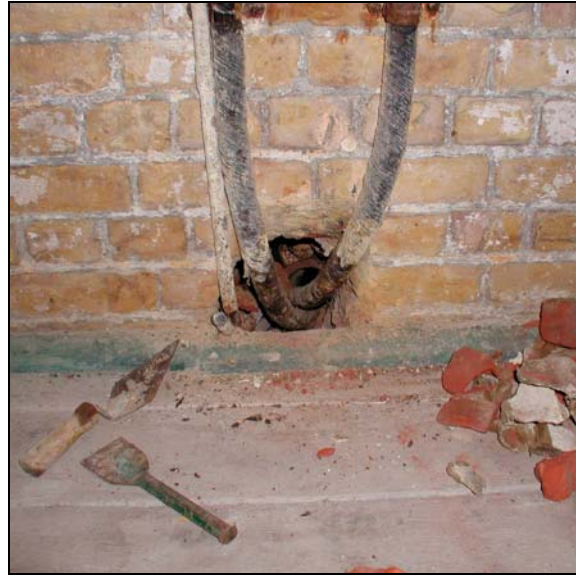
The existing services seen in the trench passed into the guardroom via a hole cut through the wall of the guardroom. This had been sealed by a thin skin of cement on the inner face of the wall and, as the hole was inclined at an angle running down to the southwest, it was below ground level upon reaching the outer face of the wall. An iron (?steel) grating of similar dimensions to a single brick was present on the outer face of the wall immediately above the hole suggesting an existing vent may have been utilised to fit the earlier cables although probably with some alteration as the vent was likely to have originally been to allow air to circulate under the floor space in the guardroom. A small fragment of a broken grating was located within Trench 1 (not retained) which could be remains of a further section of vent removed to allow the earlier service cables to pass. The new cable was installed by passing it through this hole and into the existing duct in trench 1.

Plate II: View of hole through wall from within Guardroom

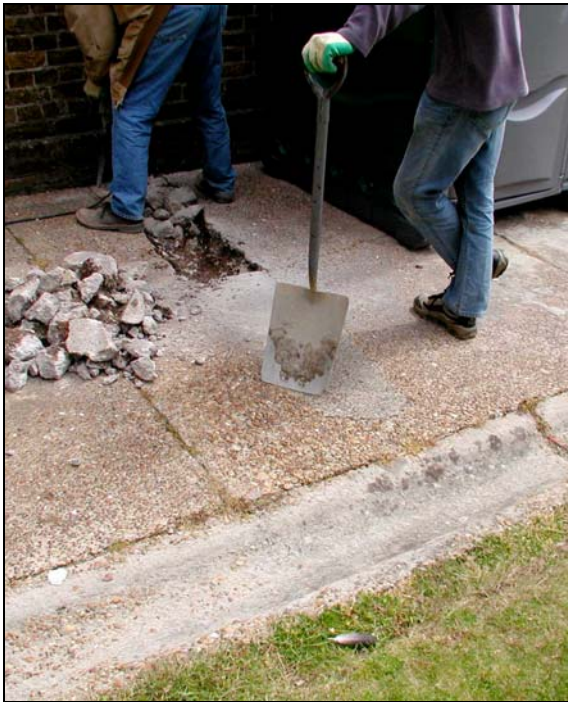
Trench 1 was excavated from the rear wall of the guardroom south of the fort entrance. It measured 0.3m in width, was cut to a depth of *c.*0.25m and ran to a point some *c.* 2.2m to the southwest. In order to excavate this trench it was necessary to break out a small portion of the concrete pathway. A scar was visible where the concrete had been previously broken out, presumably to install an earlier service (Plate III), and the trench was excavated at this location.

Plate III: Site of Trench 1
Illustrating 'scar' from previous excavation

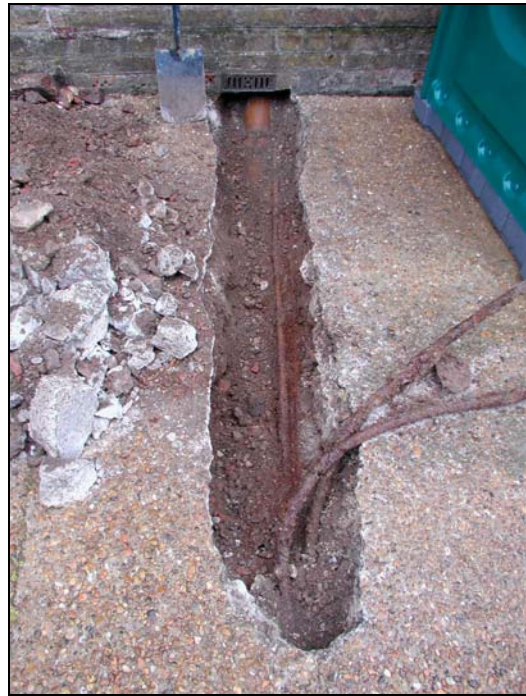
The concrete surface was relatively thin at only *c.* 65mm thick and immediately overlay a brown sandy shingle. Located within the excavated trench was a cable duct, *c.* 90mm diameter and formed from ceramic pipes, within which were two thick cables. Running alongside the duct were two ?steel pipes, *c.* 25mm across, which were believed to contain

Plate IV: Trenches 1 after excavation

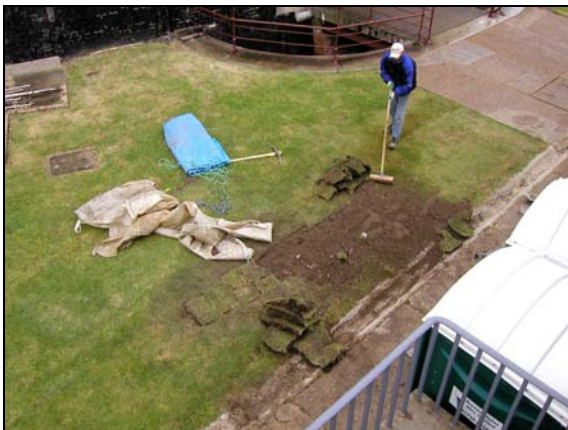
Trench 2 was excavated in order to locate a cable duct seen during previous cable installation in 2004 (SCCAS Report No. 2004/94). Unfortunately the duct was not immediately located and consequently it was necessary to excavate an irregular, but roughly rectangular, shaped hole approximately 2.7m in length and 0.8m wide to a depth of approximately 0.6m, before it was found. No obvious layering was noted in the material removed and it would appear that this trench was excavated entirely within an area previously disturbed during the installation of earlier services, primarily the existing cable duct and a similar duct running alongside. An existing hole in the duct, created during cable works in 2004, was used to pass the cable into the duct, which ran to an existing access point sealed beneath concrete slabs some 8.6m to the southeast.

Plate V: Trench 2, backfilled

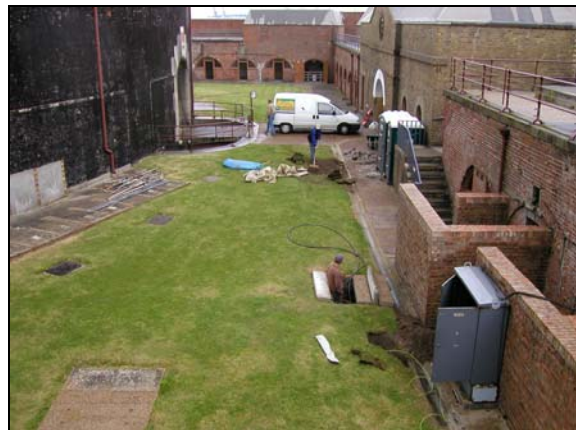
Plate VI: General view of Trenches 1 and 2
