**Barn at Mill Hill Farm,
Darsham, Suffolk
DAR 029**

Historic Building Record

Barn at Mill Hill Farm, Westleton Road, Darsham, Suffolk

Heritage Asset Assessment

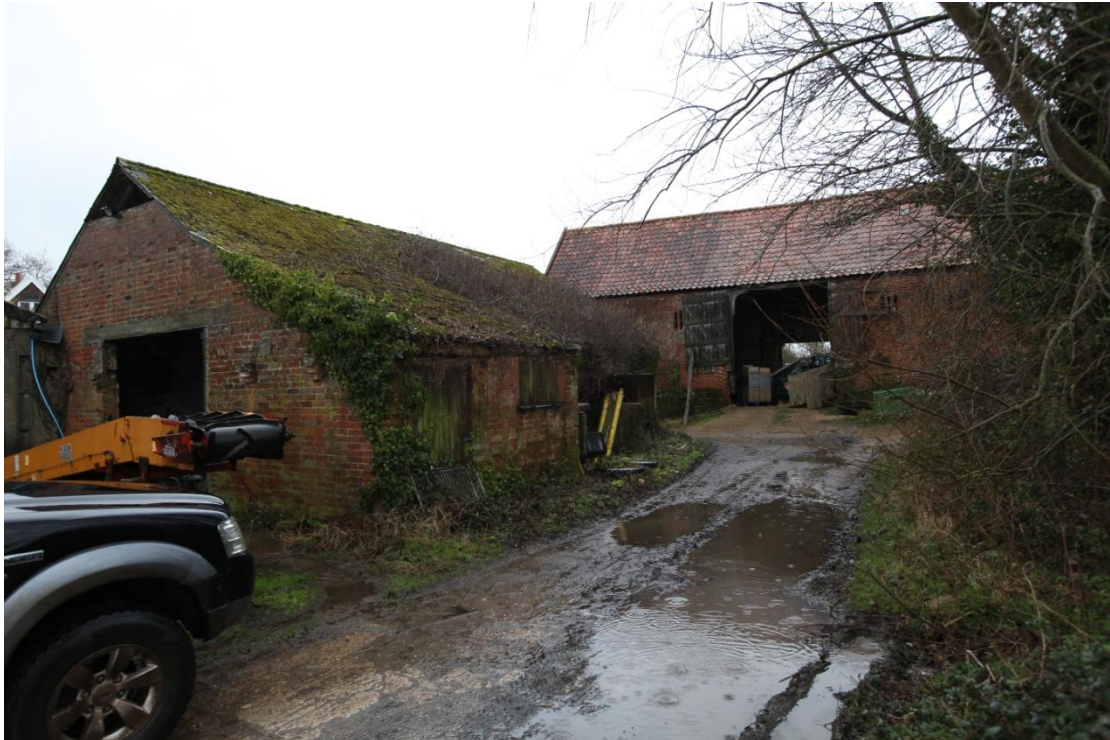
Illus. 1. A general view of the site from Westleton Road to the south showing the much altered 19th century brick shed to the left with the barn in the rear.

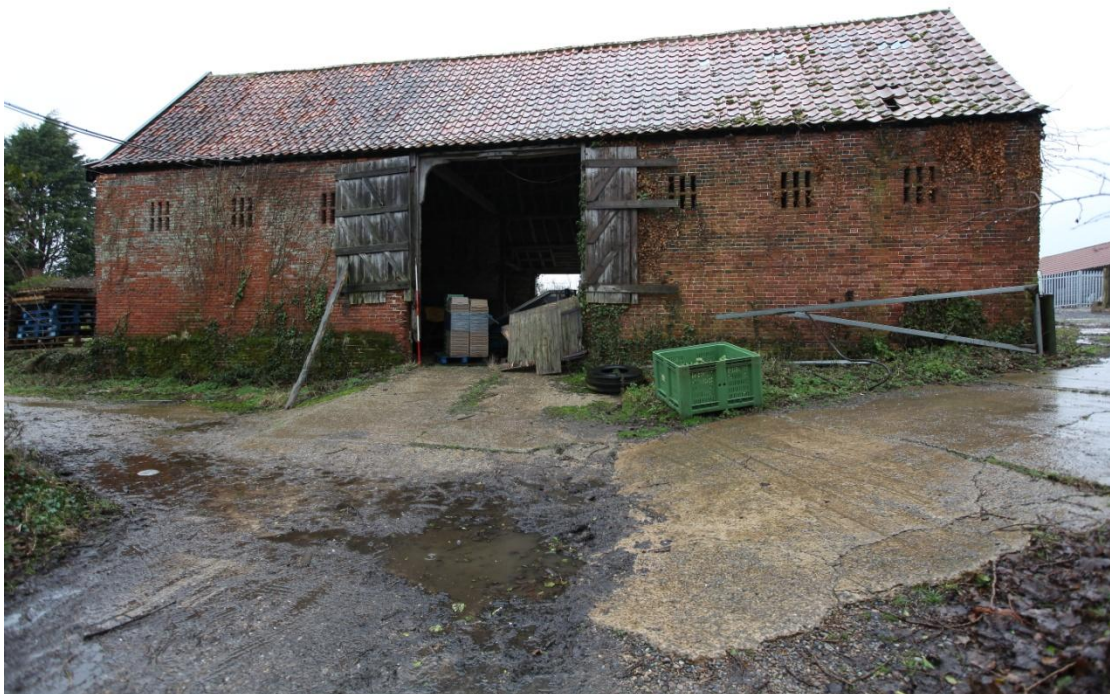
Illus. 2. The barn's well-preserved southern facade with three groups of original ventilation loops on each side of the central entrance. The fragmentary half-hung doors are replacements of the late-19th or early-20th century.

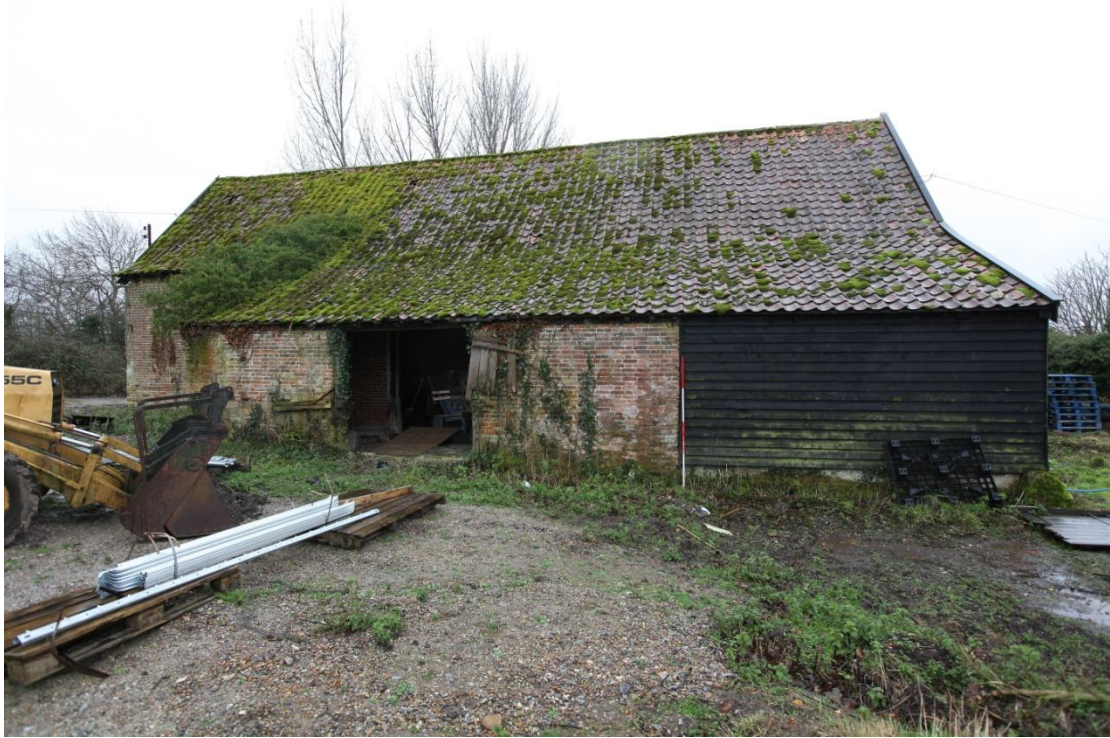
Illus. 3. The rear (northern) exterior showing the central lean-to brick porch added in the mid-19th century to increase the length of the threshing floor and provide grain storage bins on each side. The weatherboarded studwork to the right was renewed in the 20th century.

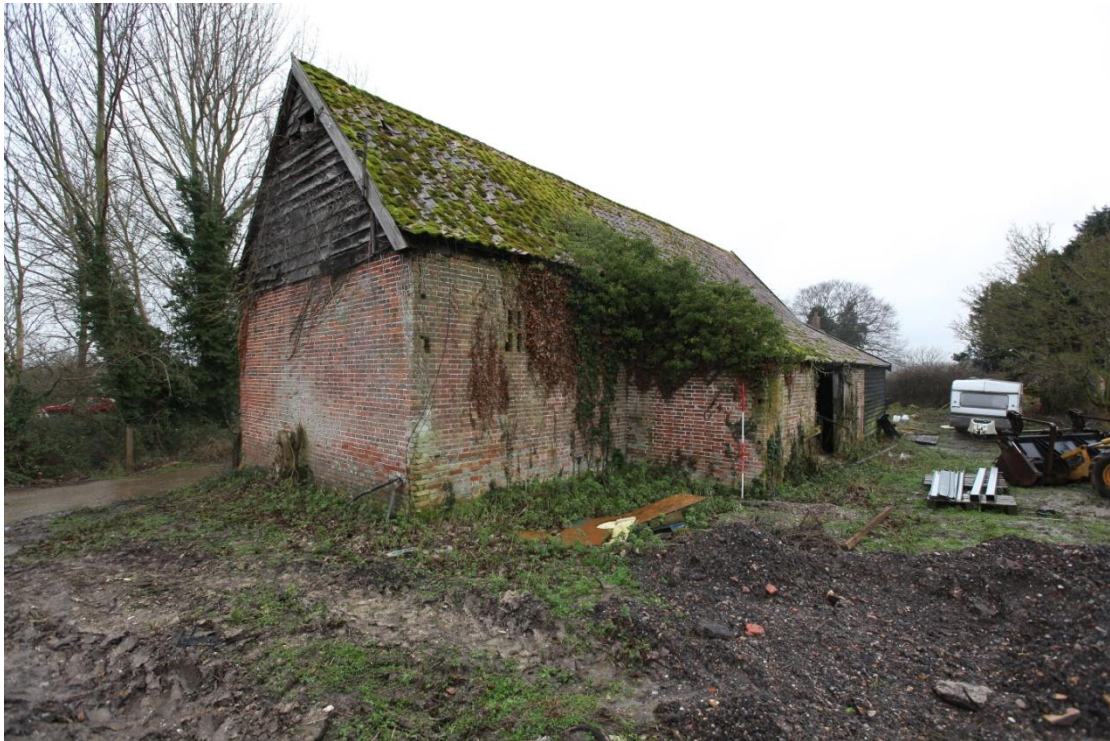
Illus. 4. The barn from the north-east showing the original weatherboarded studwork of the roof gable. An aperture in the brickwork of the northern elevation is likely to have secured the tie-beam of a second weatherboarded lean-to shed as depicted on the historic Ordnance Surveys but subsequently demolished.

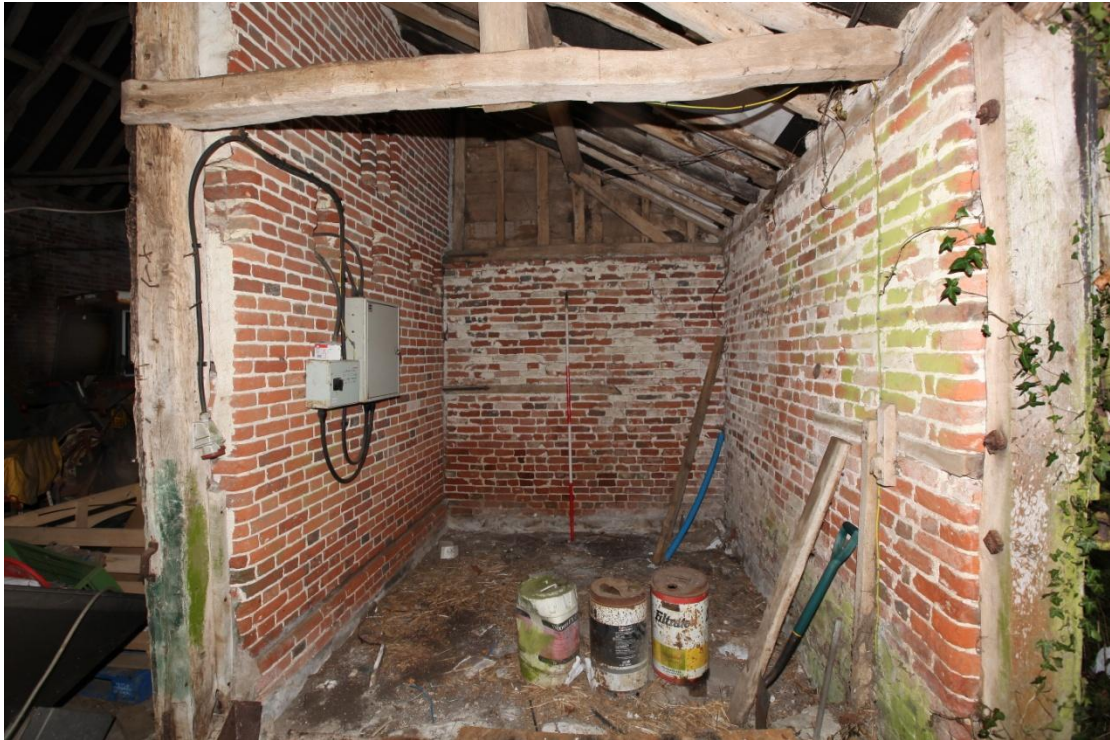
Illus. 5. The western half of the secondary lean-to rear porch, with the grooved wooden post of a grain bin still attached to the northern wall on the right. The entrance to the barn on the left has been cut through the brickwork and is secondary, having replaced a smaller original back door.

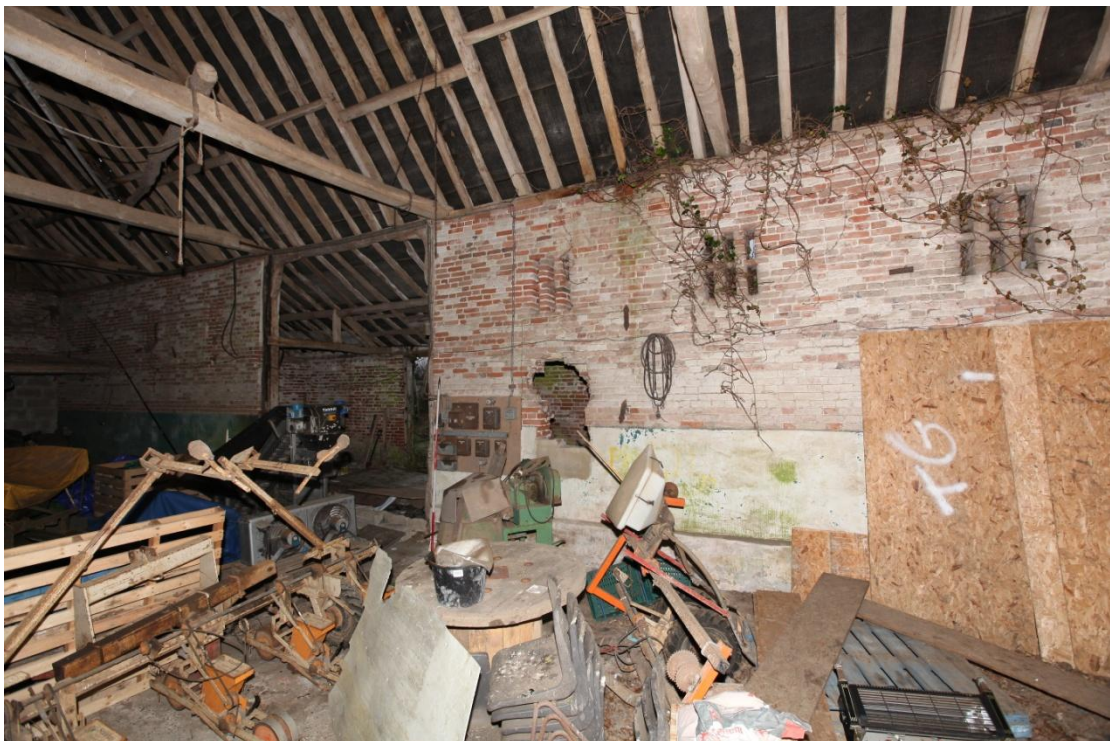
Illus. 6. The northern (rear) interior of the original threshing barn showing the secondary central aperture adjoining the rear porch with three groups of ventilation loops on each side. A hole has been cut through the wall to the right of the porch in recent years, perhaps to accommodate a drive shaft.

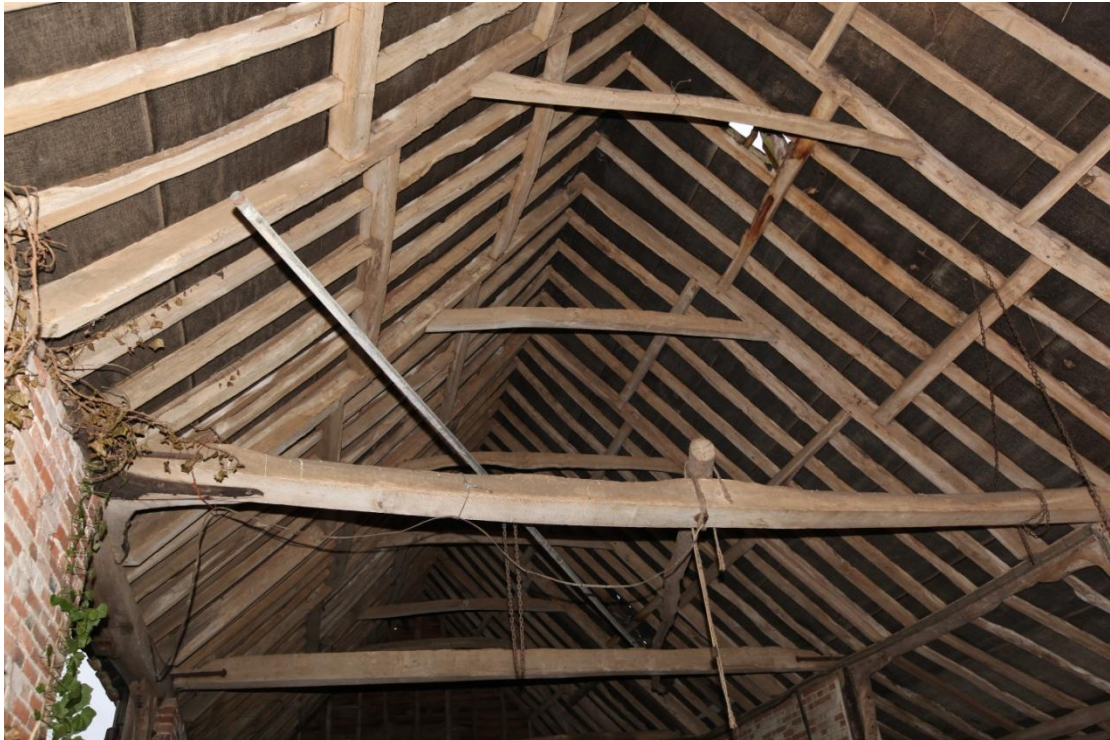
Illus. 7. The intact, original oak roof structure consisting of two tiers of staggered butt-purlins with pegged collars. This form of roof is typical of the late-18th and early-19th centuries in Suffolk.

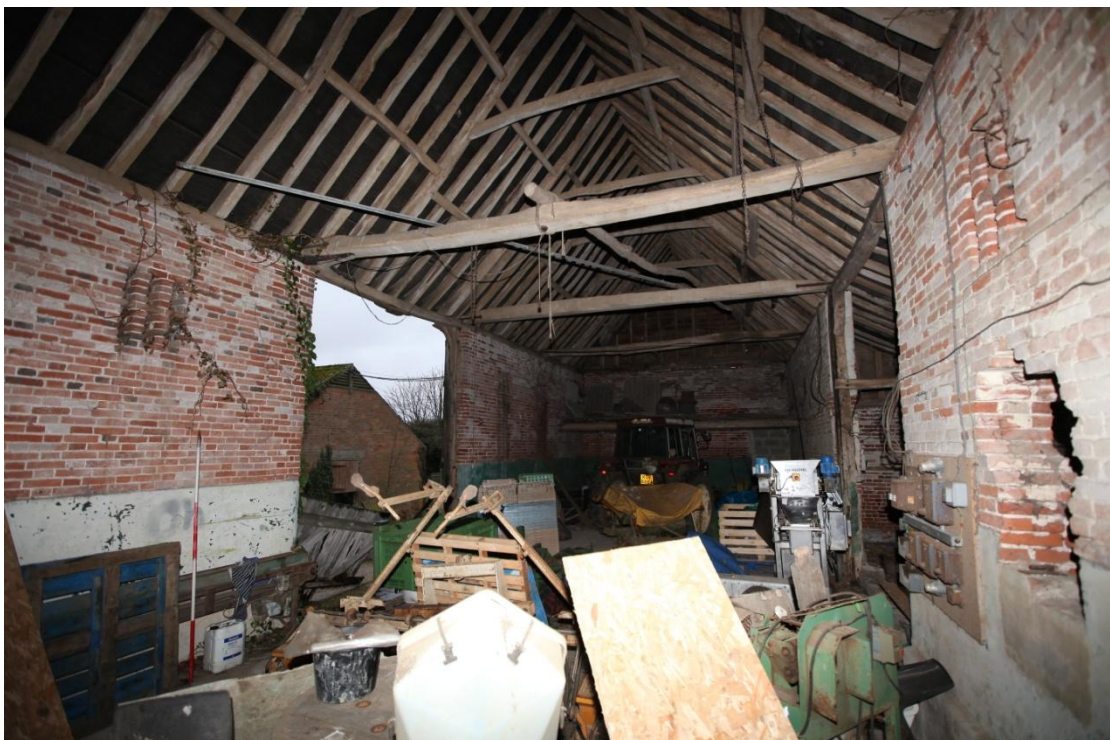
Illus. 8. The interior from the east showing the original central entrance to the threshing bay on the left and the later aperture to the porch on the right.

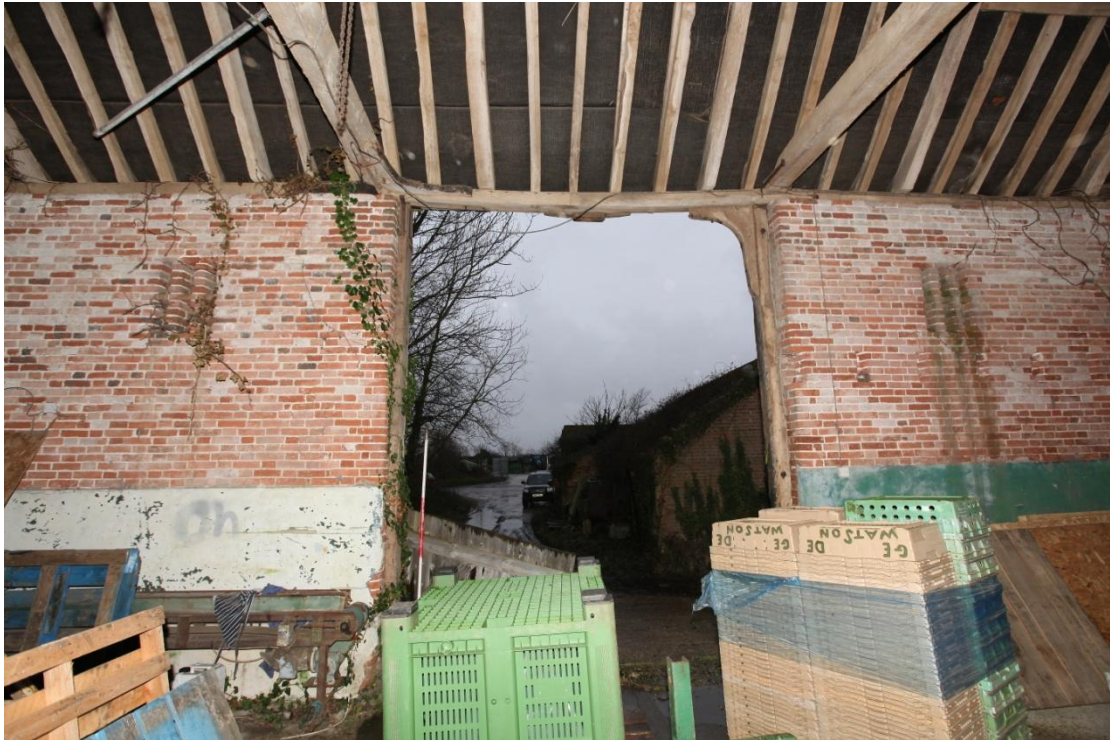
Illus. 9. The southern entrance flanked by ventilation loops arranged in groups of three over three. The right-hand (western) door jamb and bolted knee-brace appear to be original, but the left-hand jamb is a replacement and its knee-brace has been removed. There is no evidence of a threshing floor but it may survive beneath modern concrete.

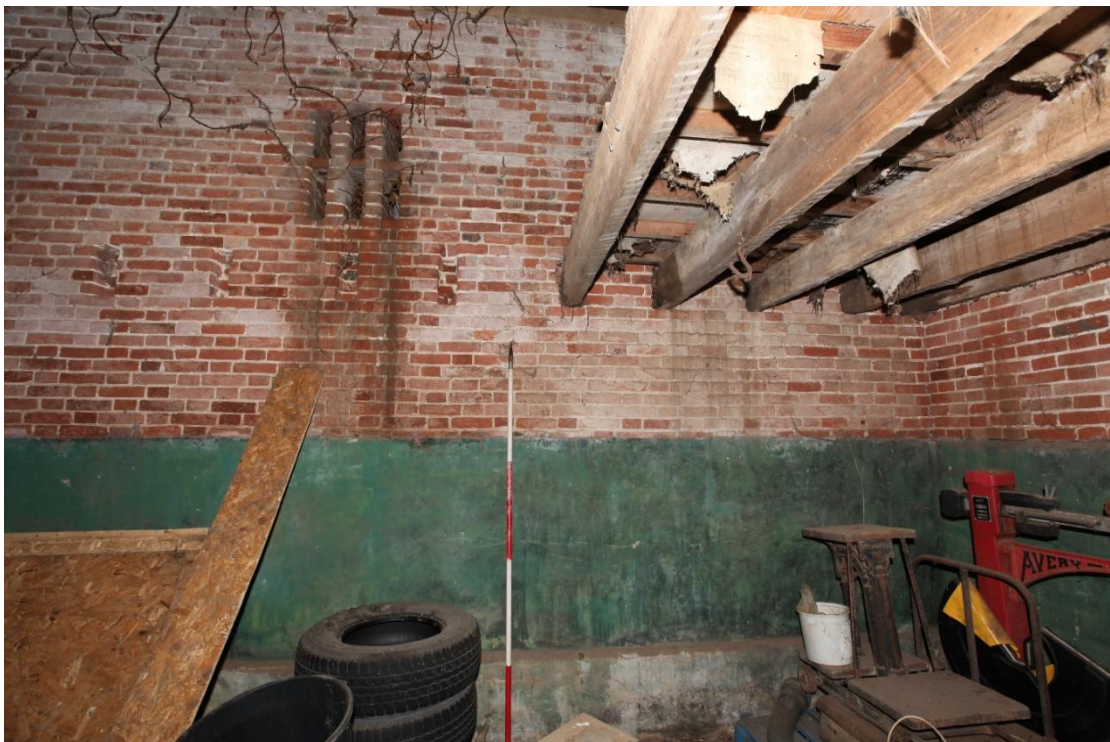
Illus. 10. The western end of the southern interior showing the remnant of a late-19th century loft adjoining the western gable on the right. A series of crudely cut apertures for missing joists can be seen in both the front and rear walls of the entire western half of the barn. A new floor of 20th century axial softwood joists is visible above the 19th century lateral joists.

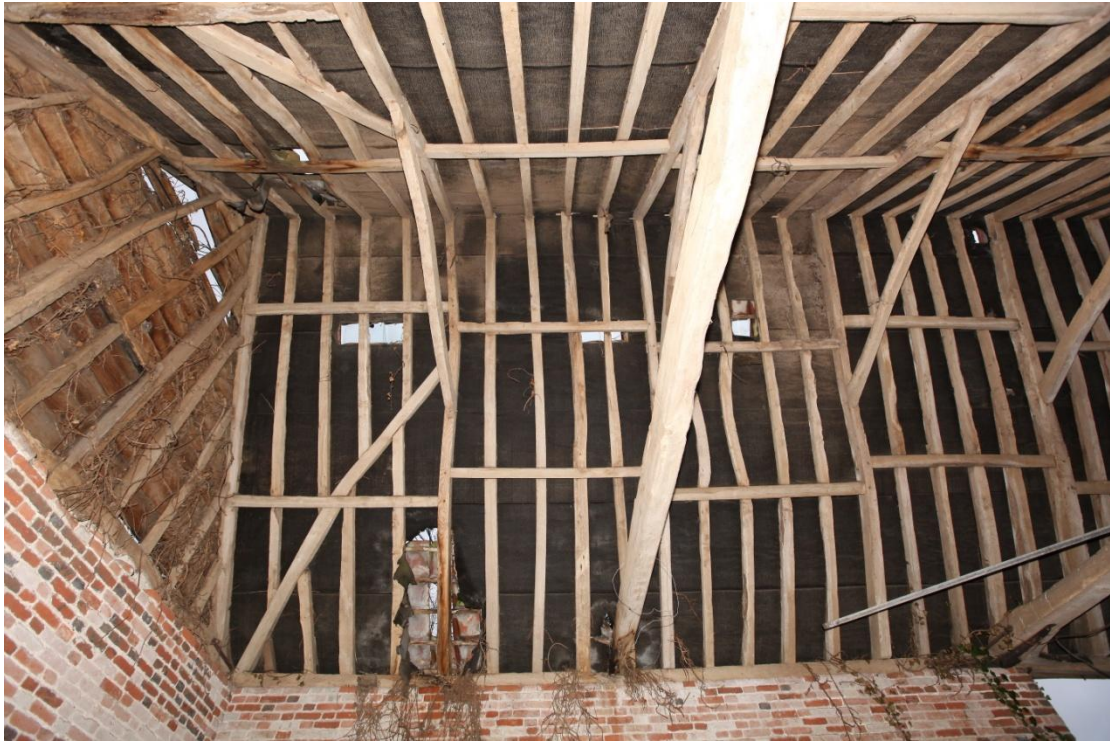
Illus. 11. The unusually intact staggered butt-purlin roof structure in the eastern half of the barn, looking south, with original primary braces interrupting the rafters in the end-bay to the left. The roof of the western half is identical.

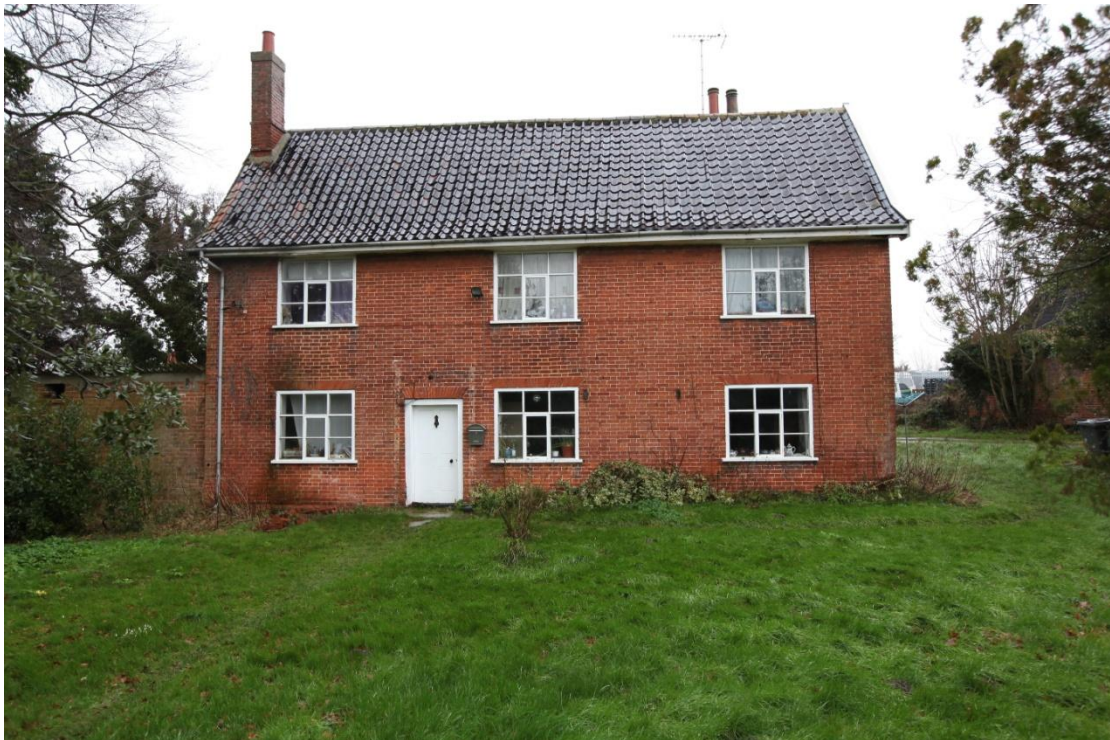
Illus. 12. The former farmhouse to the west of the barn, viewed from Westleton Road to the south. This building is reported to contain the date 1780 incised into its brickwork and may well be contemporary with the barn – although its asymmetry suggests the brick facade may conceal earlier fabric. Included for site context.
