# BUILDING SURVEY REPORT

## ST MARGARET'S CHAPEL, WENHASTON with MELLS HAMLET WMH 003

A REPORT ON THE BUILDING RECORDING AND SITE  
INVESTIGATIONS, 2007

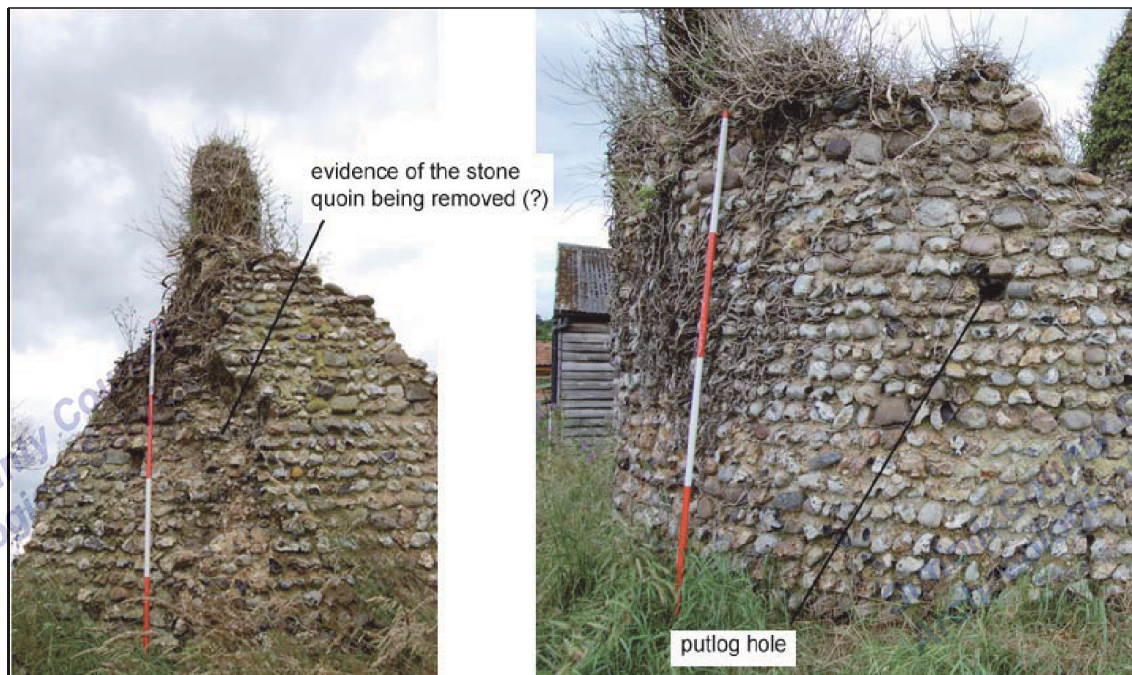
The nave walls have been demolished to within a few courses of the ground leaving little in the way of details of the building. The external corners of the nave, at the west end and at the junction with the chancel, have been damaged suggesting that the building has been robbed of its

Figure 3. Building details, showing horizontal coursing of the flint, missing quoins and putlog hole

limestone quoins (Fig 3). There are breaks in both the nave north and south walls, these are almost opposed and likely to be what remains of the doors.

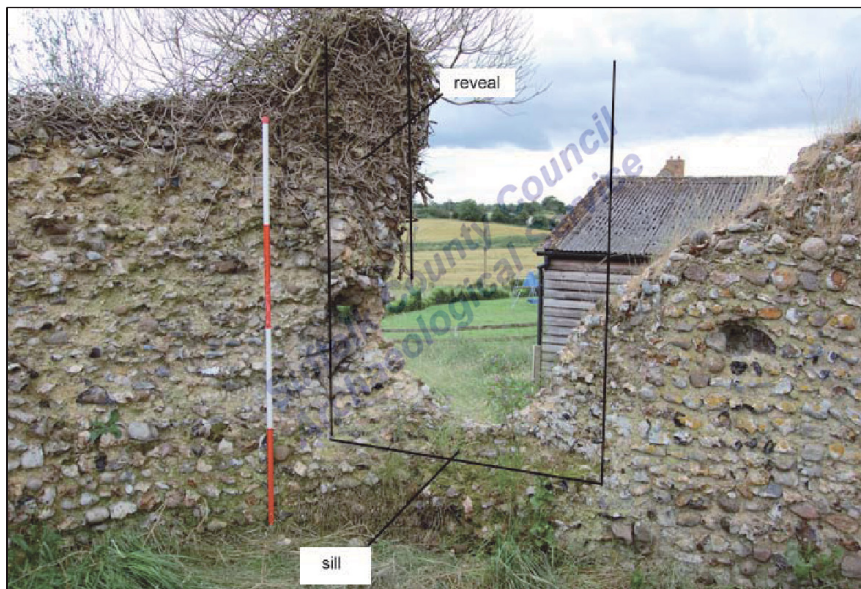
The chancel is better preserved and in places survives to a height of *c.*2m. There is a small window at the apex of the curve at the east end, and on inside of the south wall there is a reveal for a recess. This extends close to present ground level to form a low sill and at this level is blind (Fig.4). Where the reveal is most apparent the wall is completely pierced but whether this actually an opening or the result of collapse is unclear, but a large window in a chapel of this date is unlikely. The wall on the north side is in too bad a state of repair to determine if there was an opposing recess or window but W.R Gowers describes a possible window here in his essay on the building in 1894 (PSIA Vol VIII pt.3). A small vaulted niche (Fig. 5) is built into the south wall at the junction with the cross wall, its position is shown on the plan (Fig. 2) and its profile on the east facing elevation drawing (Fig. 8)

Figure 4. Recess/window south wall of the chancel

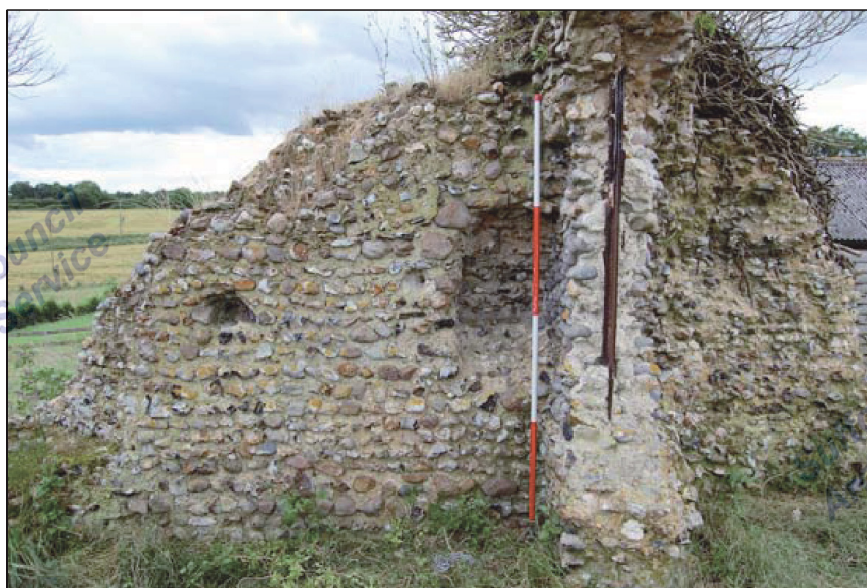
Figure 5. Niche in the chancel south wall also repair to chancel arch using an iron bar.

There has been an extensive loss of flintwork at mid-height of both responds and notably the outline of the break is mirrored approximately on each side of the arch. It is unclear whether this is due to an architectural feature having been removed or simply the pattern of arch collapse. The south side has been infilled with a repair in grey granite pebbles and edged with an iron bar; the repair has underpinned the arch preventing the whole cross-wall from falling down.

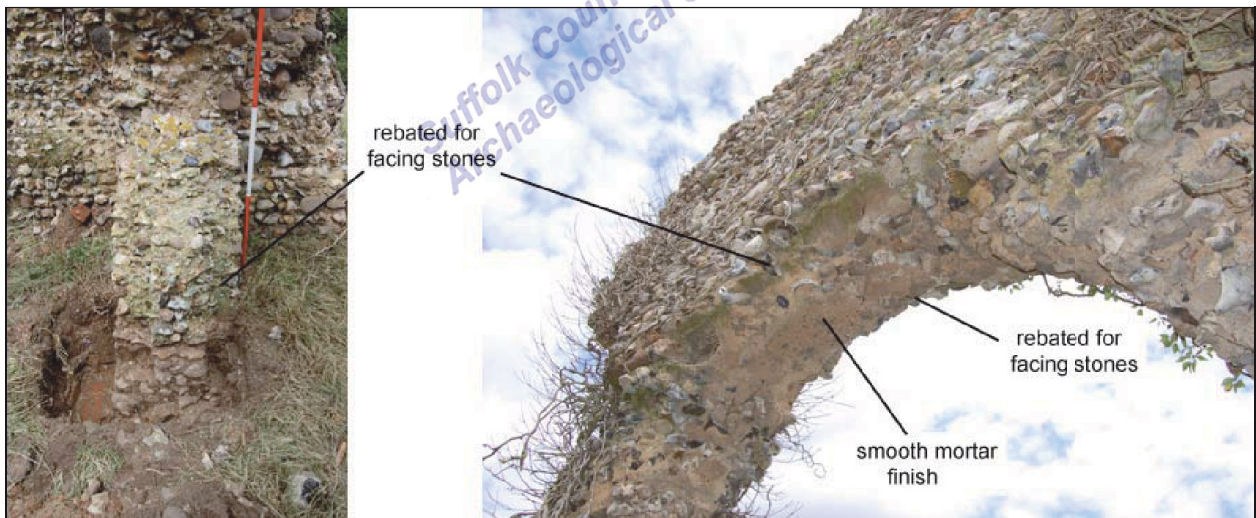
The arch itself has been removed leaving only the opening but evidence enough survives to suggest the original dimensions of the arch and indicate from where dressed stones have been robbed. The arch was a round-headed type, typical of the Romanesque style of architecture of the early Norman period. Between the responds the opening would have been *c.*2.1m but at the base of the head of the arch it is slightly wider suggesting the arch itself was built off an *abacus*. The test hole excavation identified the probable original floor level and this gives the full height of *c.*3.75m. The cross section of the edge of the opening was recorded at the base of the north respond and shows a rebate where the stone blocks and voussoirs, which once faced the arch, were set (Fig.6 and 11). The rebate could be seen on both faces of the north haunch and to a lesser extent on the east face of the south haunch; where best preserved this suggested that the blocks were 220mm wide by 200mm deep. The stone blocks seem to have been only on the two leading edges of the opening and not on the flat face of the *intrados* or responds. The inner face of the arch appears to have been finished in flint, on the underside of the haunches the face of the flint is projecting but is well laid, at the apex this was covered with a smoothed mortar suggesting that there may have been a render. A similar use of stone, only on the edges of the arch, can also be seen in the ruins of the Abbey church at Bury St Edmunds.

Figure 6. Chancel arch details

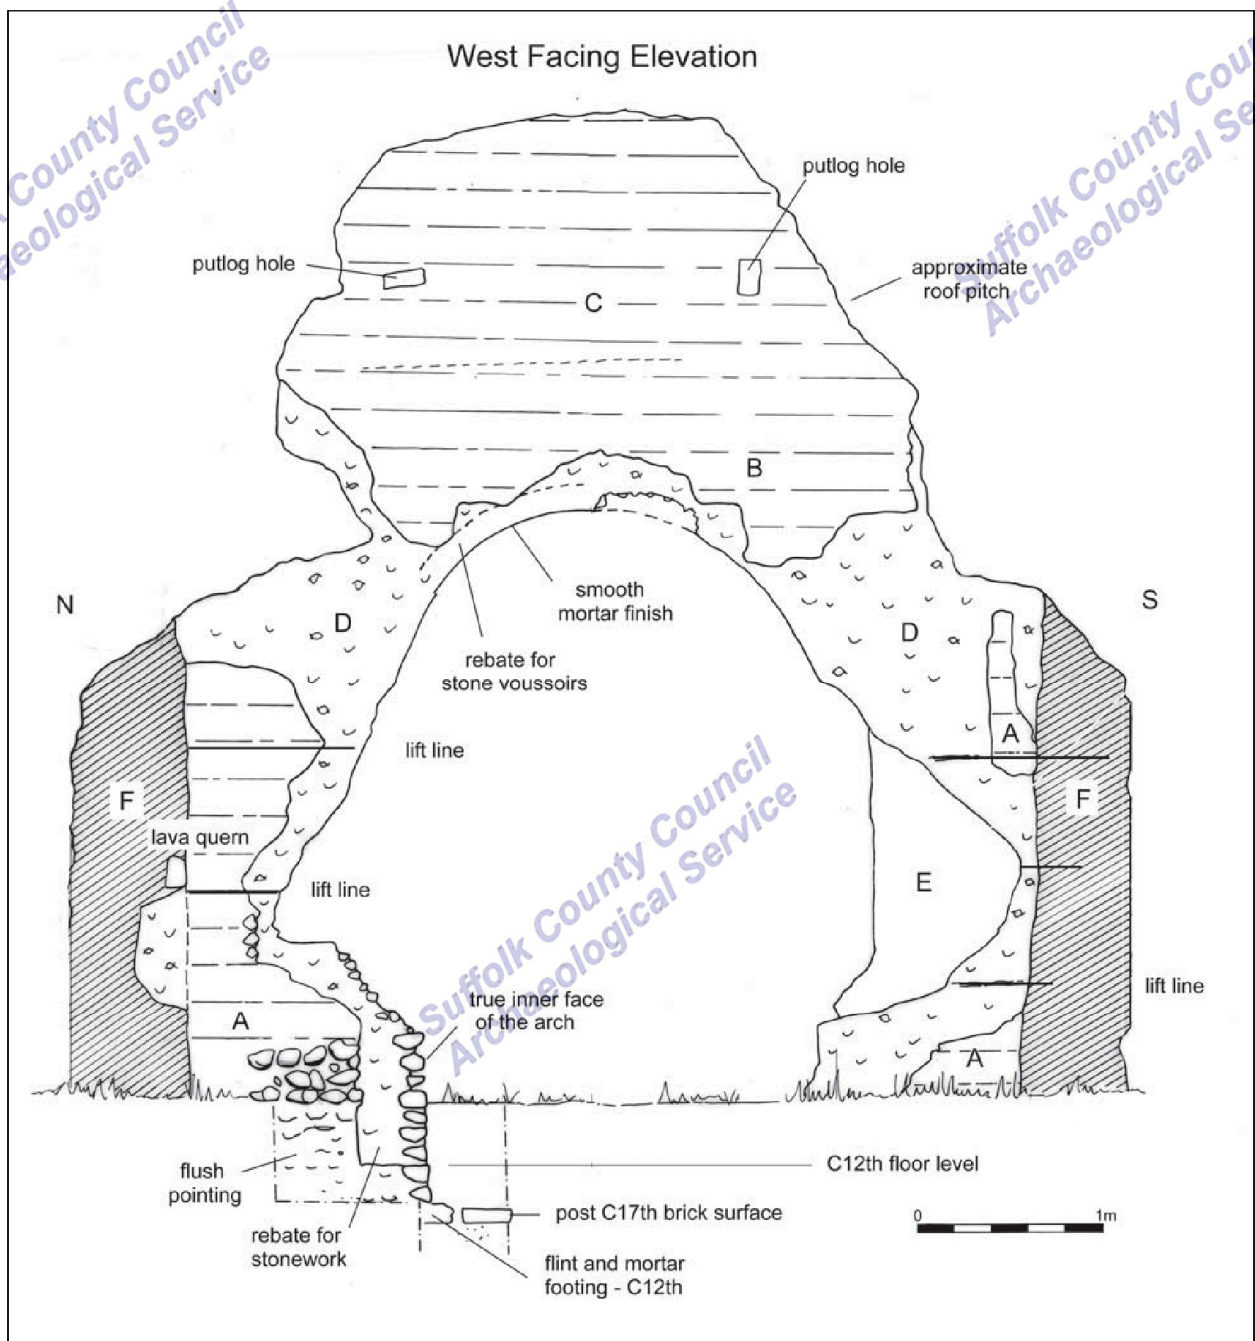
Figure 7. West facing elevation of the chancel arch

- A. Flint facing: Large rounded flint cobbles and brown sandstone pebbles. Generally well coursed, but coursing a bit uneven at bottom lift due to variety of stone sizes. Most of the pointing weathered so that flints project 3-4cms
- B. Pattern of coursing over arch continuous with that below springing point
- C. Mixed large flints closely spaced good coursing, some flush pointing.

- D. Exposed core. Core fabric - pale brown, fine sand, mortar with large chalk inclusion. Mortar mixes distinct from lift to lift. Smaller flints than facing stones, but laid vaguely in courses.
- E. Modern repair
- F. Cross section of nave walls

NB lift lines continuous across nave and cross walls.

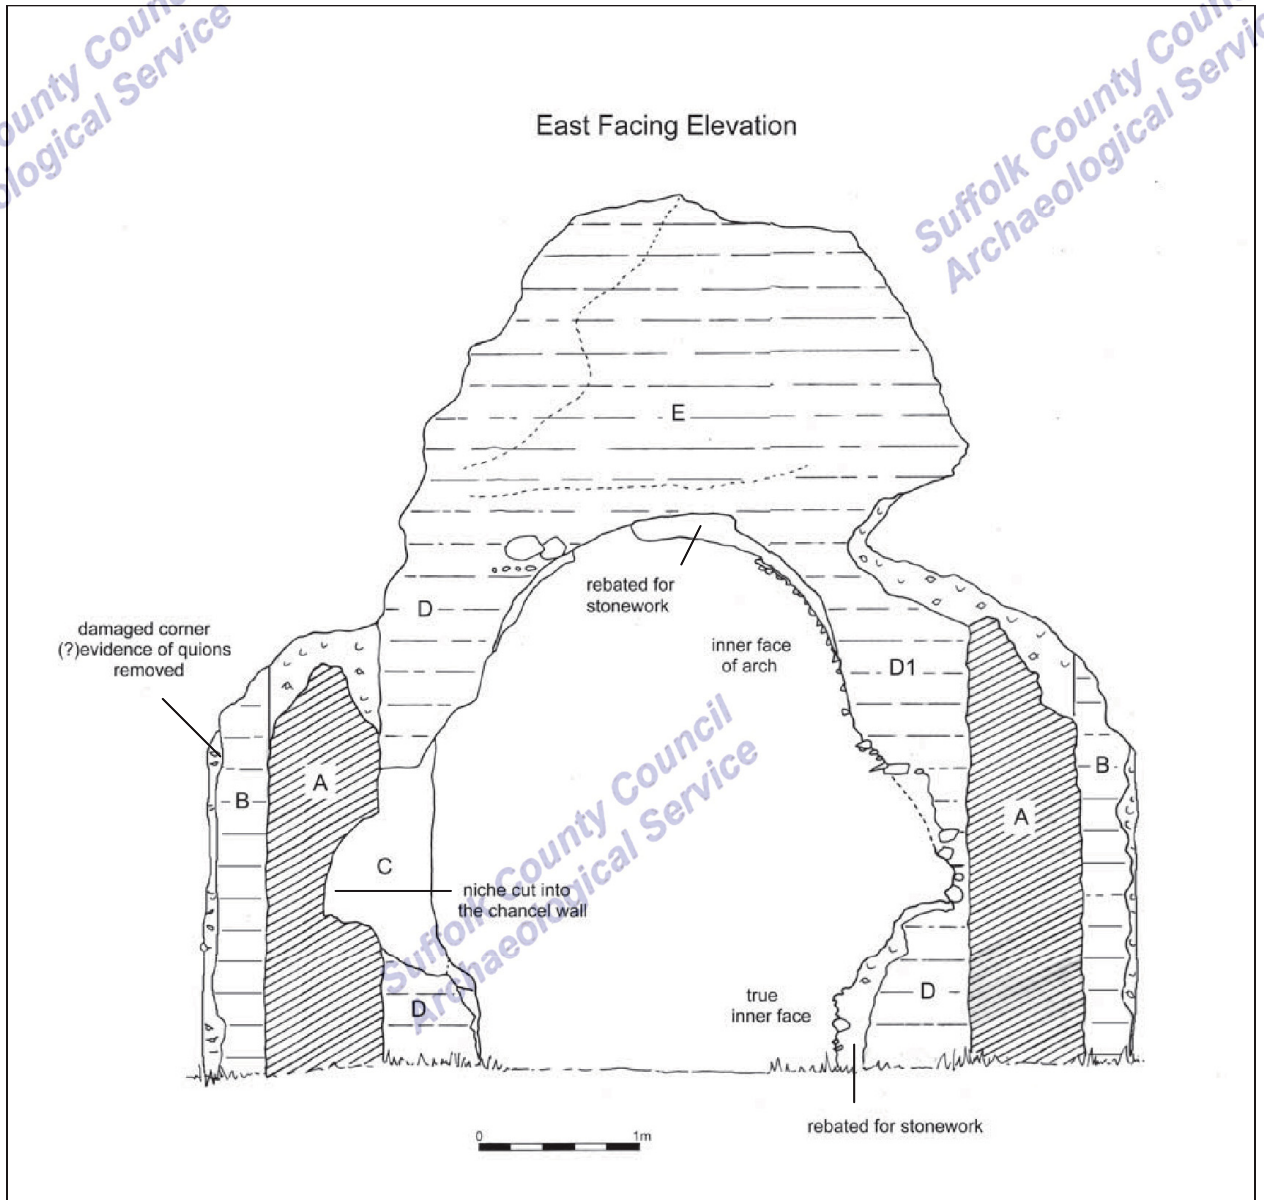
Figure 8. East facing elevation of the chancel archaeological

- A. Cross-section of the chancel walls
- B. Nave walls, projecting beyond the line of the chancel
- C. Repair section
- D. Flint facing: large, rounded flint cobbles and sandstone pebbles. Pale

- brown, fine sand mortar with large chalk inclusions. D1 includes many large elongated flints laid horizontally.
- E. Point flush with the face of the flints.

The outline of the ruin above the arch has been eroded and the apex has gone, but although difficult to survey because of the remains of the ivy cover, the sloping side particularly on the south side is indicative of the angle and line of the roof.

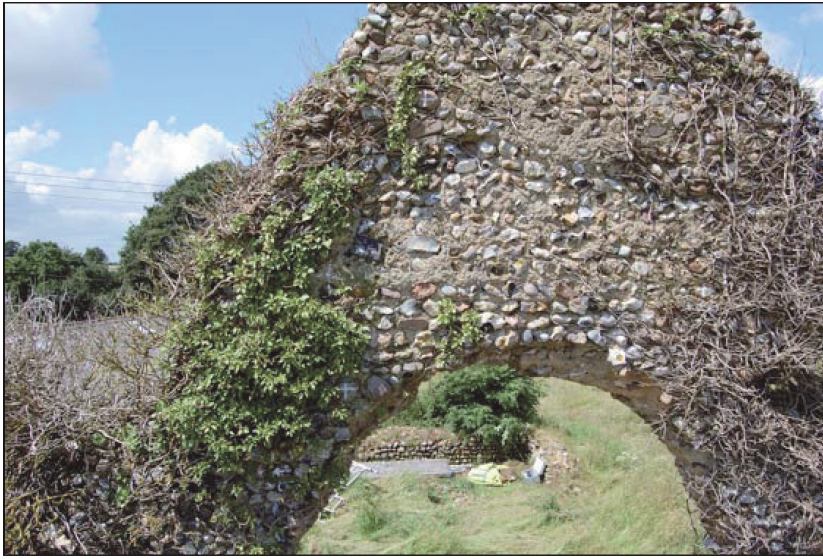
Above the arch on both elevations the pointing of the flints is almost flush with the face of the flints, the mortar is lime based and thought to be original. The shape of the arch is not reflected in the pattern of flintwork that surrounds it and the rhythm of the horizontal coursing which exists below the springing point is unbroken. This contrast with other buildings (Abbey Church, Bury St Edmunds) where a strainer arch constructed of flints laid in radial bands contribute to the load bearing over the openings.

Figure 9. East elevation: Flush pointing and horizontal coursing

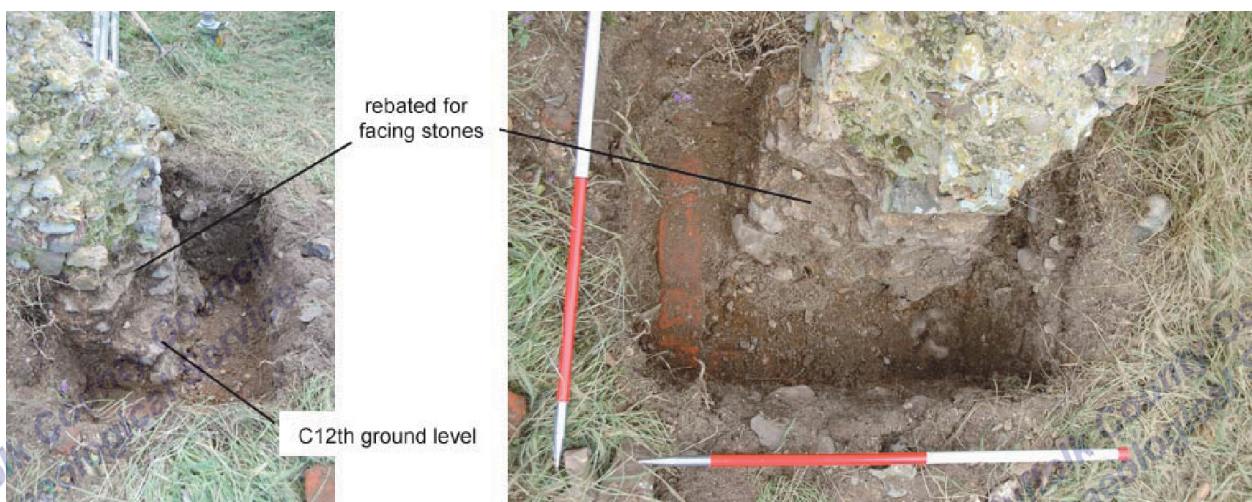
Figure 10. Test hole

Inside the chapel there is a build-up of flint and fine crushed mortar rubble, which has raised the ground level by 400-500mm. A testhole was excavated alongside the northern respond down to the surface of the undisturbed subsoil. The results are shown on the main elevation (Fig 7) and in plan and photographs (Figs 10 and 11). Below ground level the wall surface had been protected and was not weathered revealing the original full depth of pointing. The rebated bed for the limestone blocks continued and a ledge for the bottom block was recorded at 240mm below the present ground surface. The position of the base of this block is probably a good indication of the Norman floor level but there was no evidence of the original floor surviving. The bottom of the wall was at 550mm, and was built off a shallow footing comprising a mortar and small stone mix; this was laid directly onto the subsoil surface. The footing projected beyond the line of the

respond slightly but did not extend across the opening of the arch. At the base of the test-hole was a surface of bricks, laid dry in stretcher bond. The bricks were plain, handmade, soft reds measuring  $9\frac{1}{2}'' \times 4\frac{3}{4}'' \times 2\frac{3}{8}''$  and could date to the mid-16th century. The bricks had old mortar adhered to them so in this context were re-used and were laid directly onto the natural sand.

There were no definable layers in the soil overlying the bricks suggesting that this had accumulated or been deposited in a single event.
