**Hill Farm,
Swefling,
Suffolk**

Archaeological Record

Farm Buildings, Hill Farm, Swefling, Suffolk

An Archaeological Record

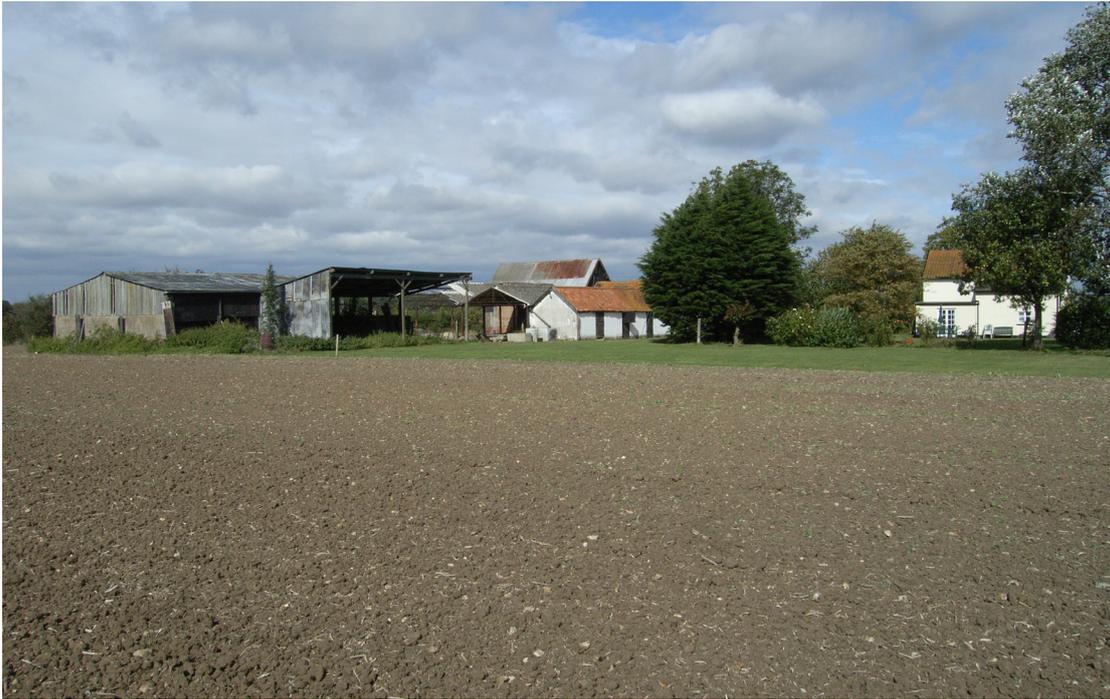
A2.1 General view of hilltop site from south showing farmhouse to right and redundant farm buildings to left

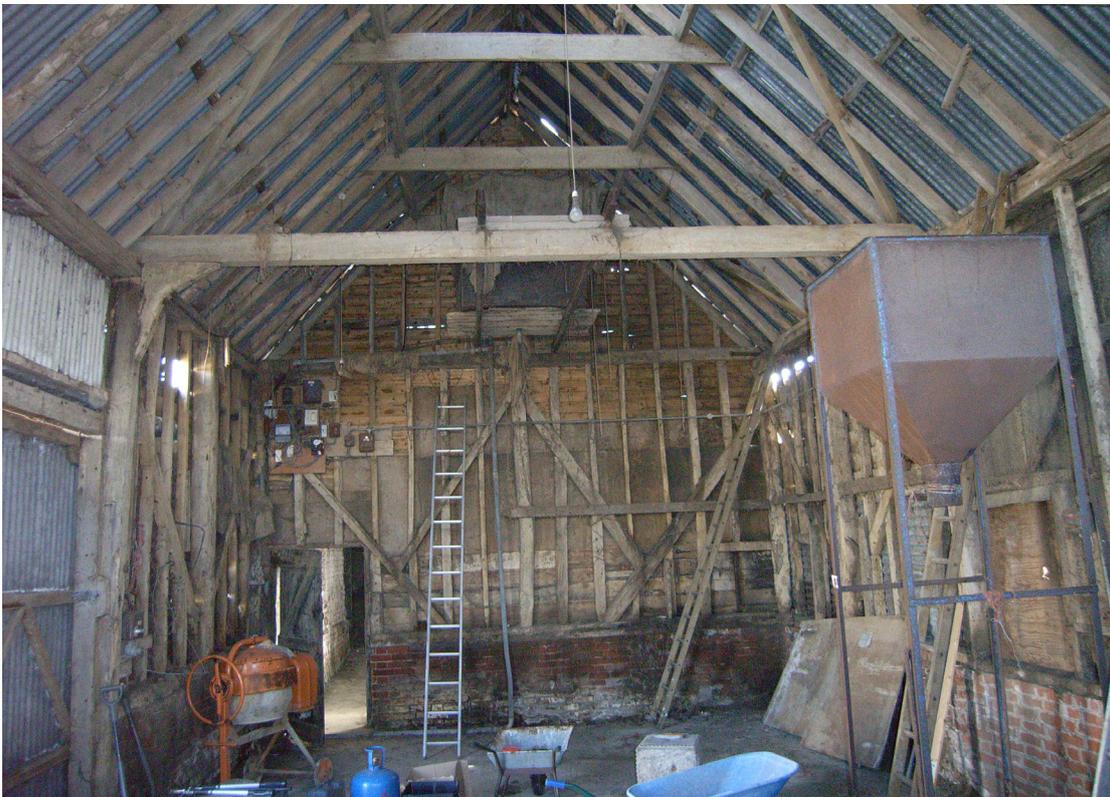
A2.2 Interior of barn from west with inserted door to cattle shed in rear and 20th century grain hopper to right.

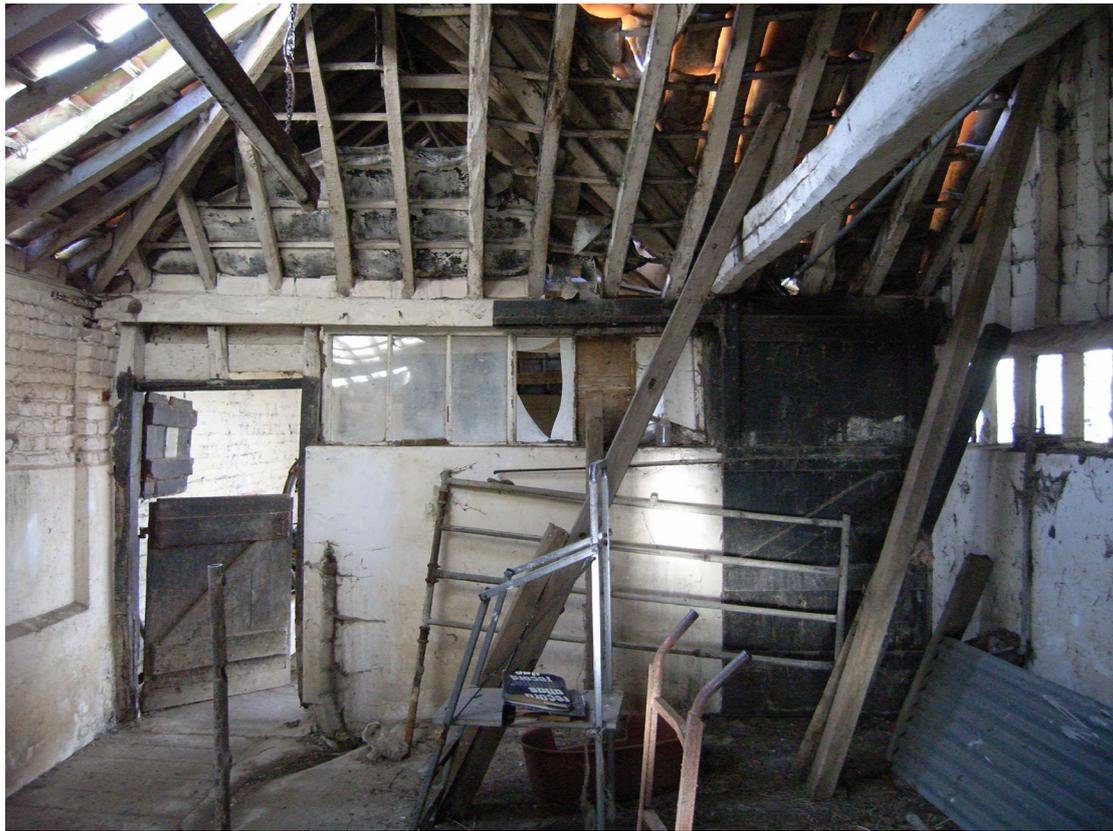
A2.3 Interior of 19th century shed (4) looking south to open area (7) in corner of covered yard (wall rebuilt in 20th century). This shed operated until recently as a milking parlour with stalls for four animals facing the wall to the right with floor drain and entrance passage to left.

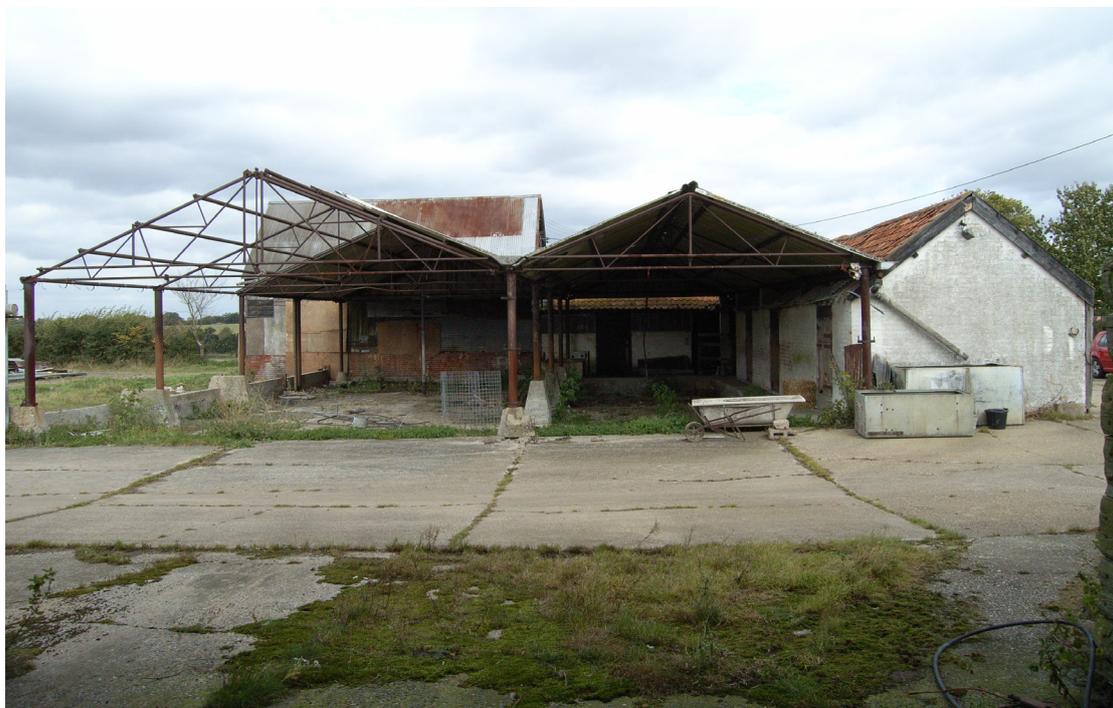
A2.4 Exterior of covered cattle yard from south with 20th century loose boxes for cattle to right which replaced the open-sided shelter indicated on the Ordnance Survey of 1928. A similar open-sided shelter lay to the left in 1928 but has been demolished.

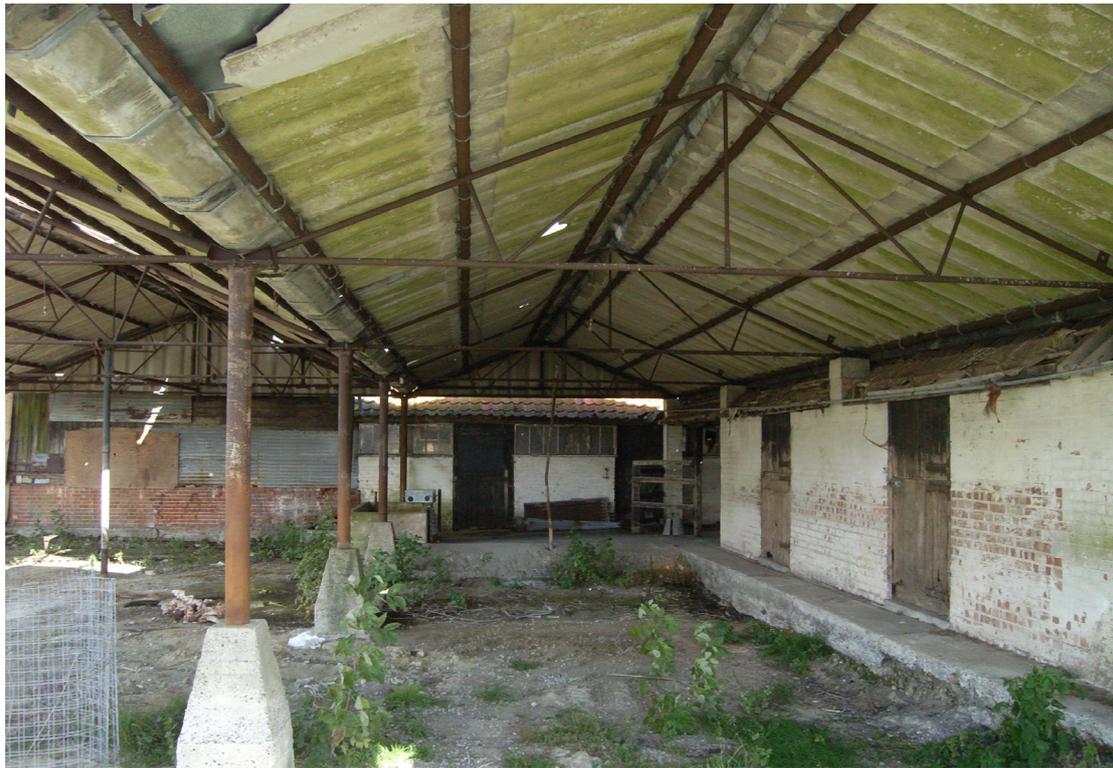
A2.5 Interior of covered cattle yard from the south with mid-19th century barn and shed in background.

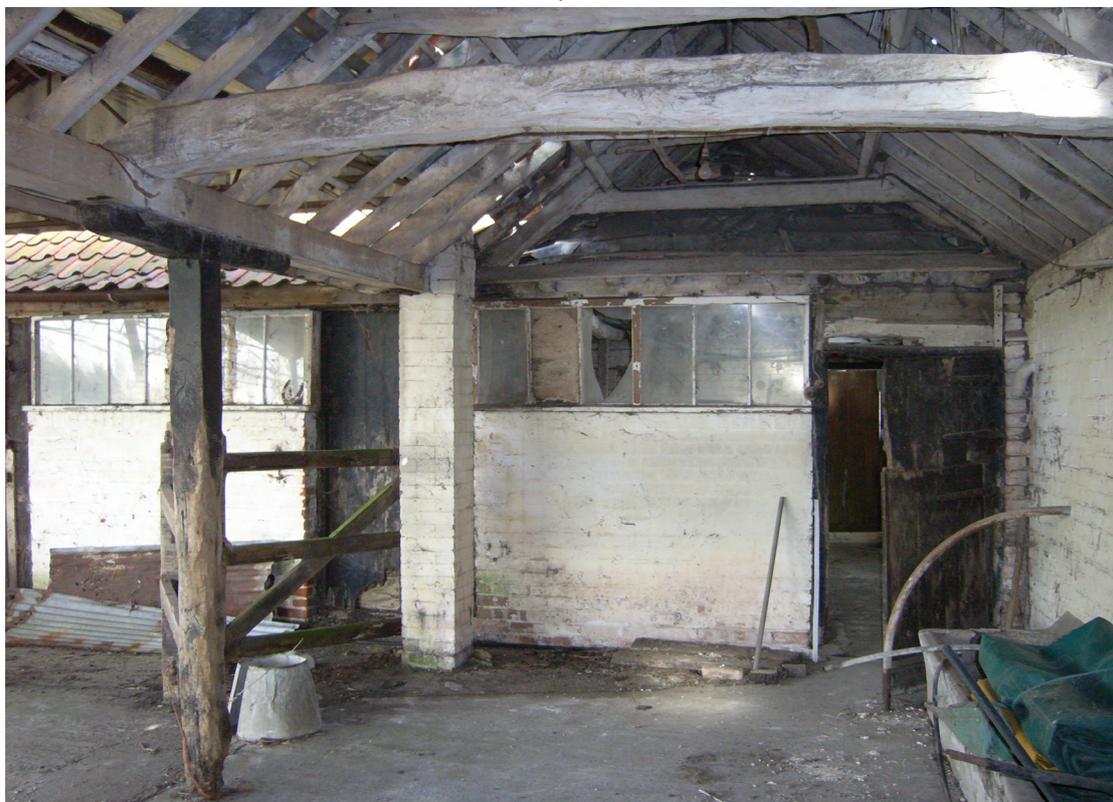
A2.6 Interior of open area (7) in north-eastern corner of covered yard with entrance to shed (4) recently used as milking parlour to right. The gate to left was used to control the passage of cattle. Note concrete trough to right.
