Wixoe Barns Wixoe, Suffolk

Archaeological Record

An Archaeological Record

This report provides a written and photographic record at English Heritage (2006) Level 2 of an unlisted barn and adjoining stable known as Wixoe Barns. It has been prepared to a brief designed by the Archaeological Service of Suffolk County Council (Dr Jess Tipper, 30 March 2007) and is intended to fulfil a condition of planning permission for domestic conversion (St Edmundsbury Borough Council Application SE/07/0333).

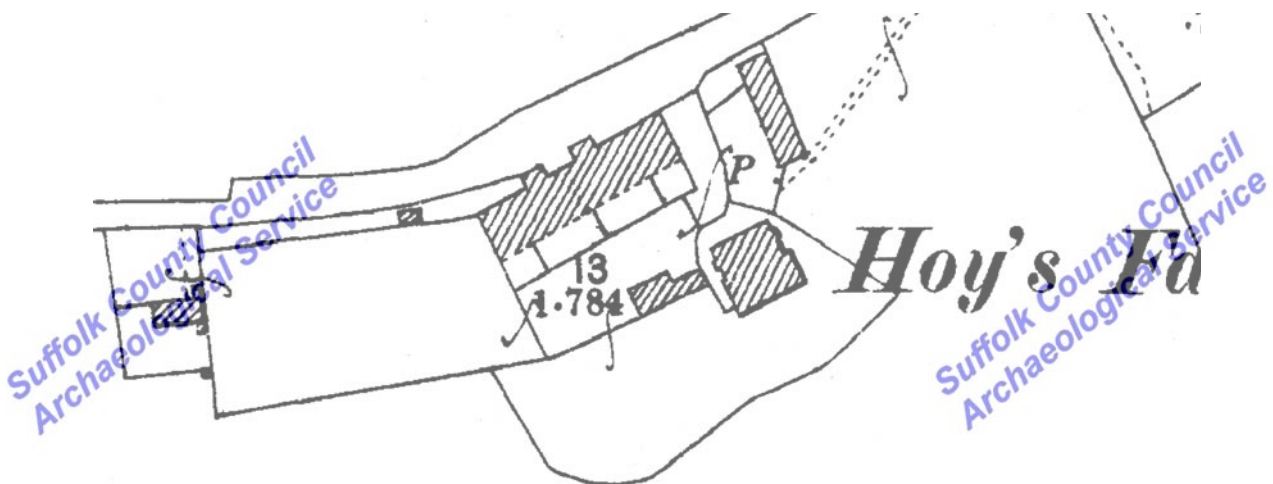
Plan of Site in 1902 (Second Edition 25 inch Ordnance Survey)

The empty walled enclosure to the left is now occupied by Hoys House, but the farmhouse and all other buildings shown here have been demolished. Only south-western angle of the flint farmyard boundary wall now remains.

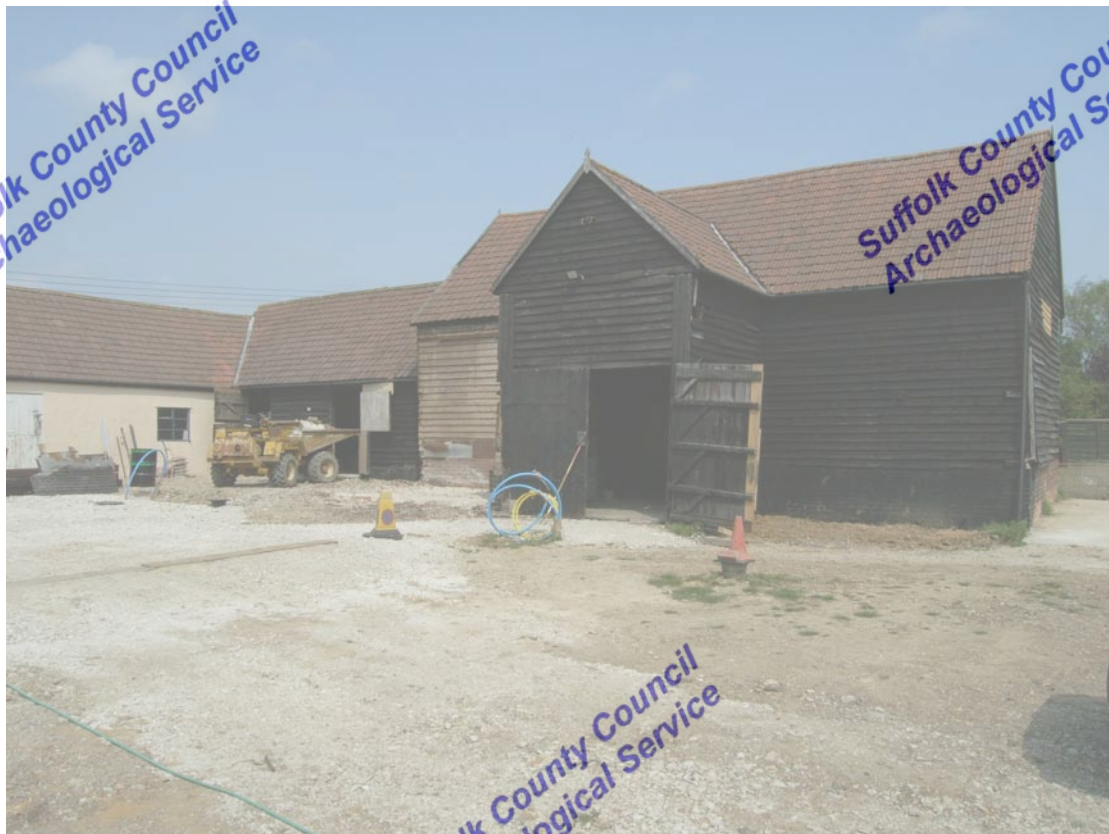
A2.1 The eastern side of the yard from the south-west, showing from left-to-right the 20th century buildings marked on the Block Plan as Shed D, Stable A and Barn B.

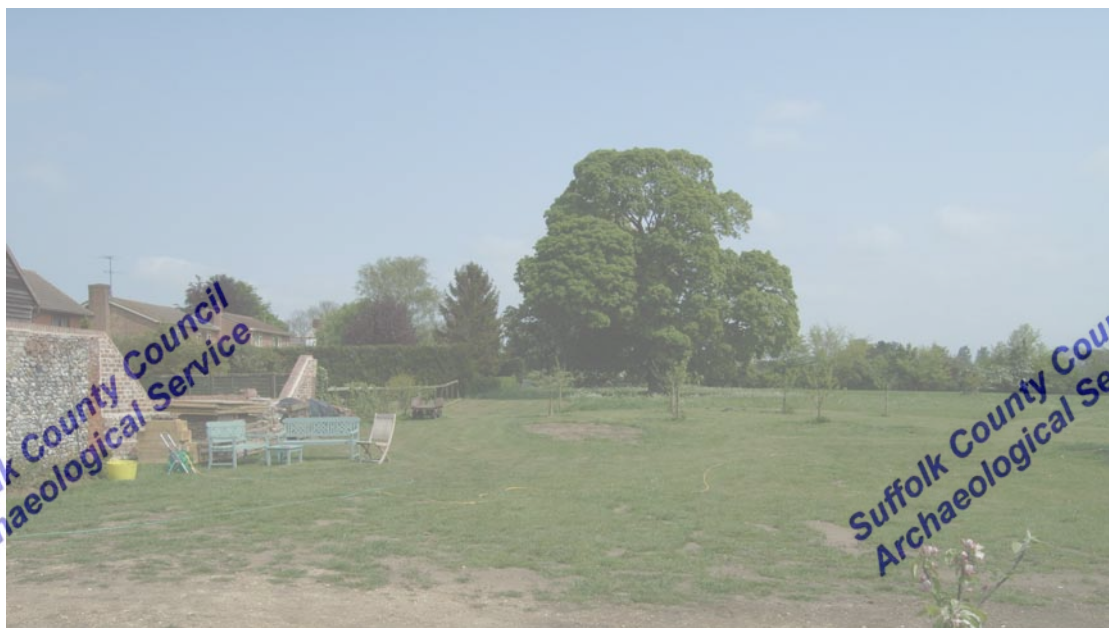
A2.2 The probable site of the demolished farmhouse shown on the 1902 ordnance Survey seen from the west with the existing barn and stable yard to the left (the site is marked by a raised platform recently planted with saplings).

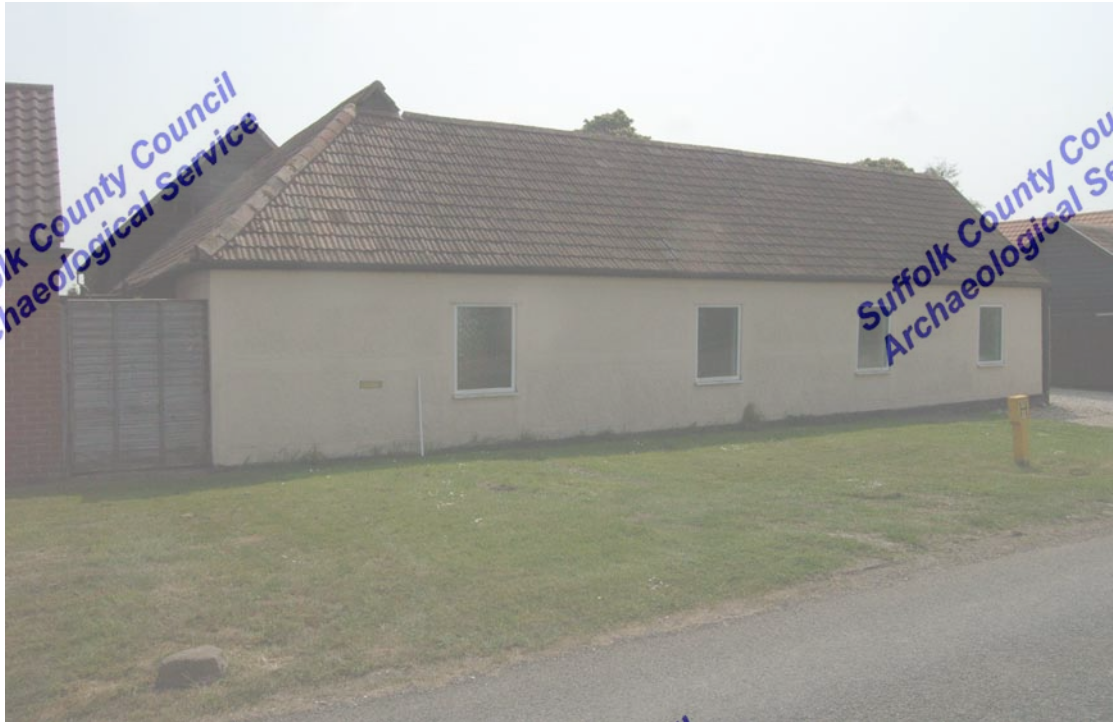
A2.3 The northern gable of Stable A (left) and Shed D seen from the lane to the north, with late-20th century render and windows relating to an earlier phase of partial conversion. The gable of the slightly taller Barn B is visible in the background, and the modern entrance to the yard to the right.

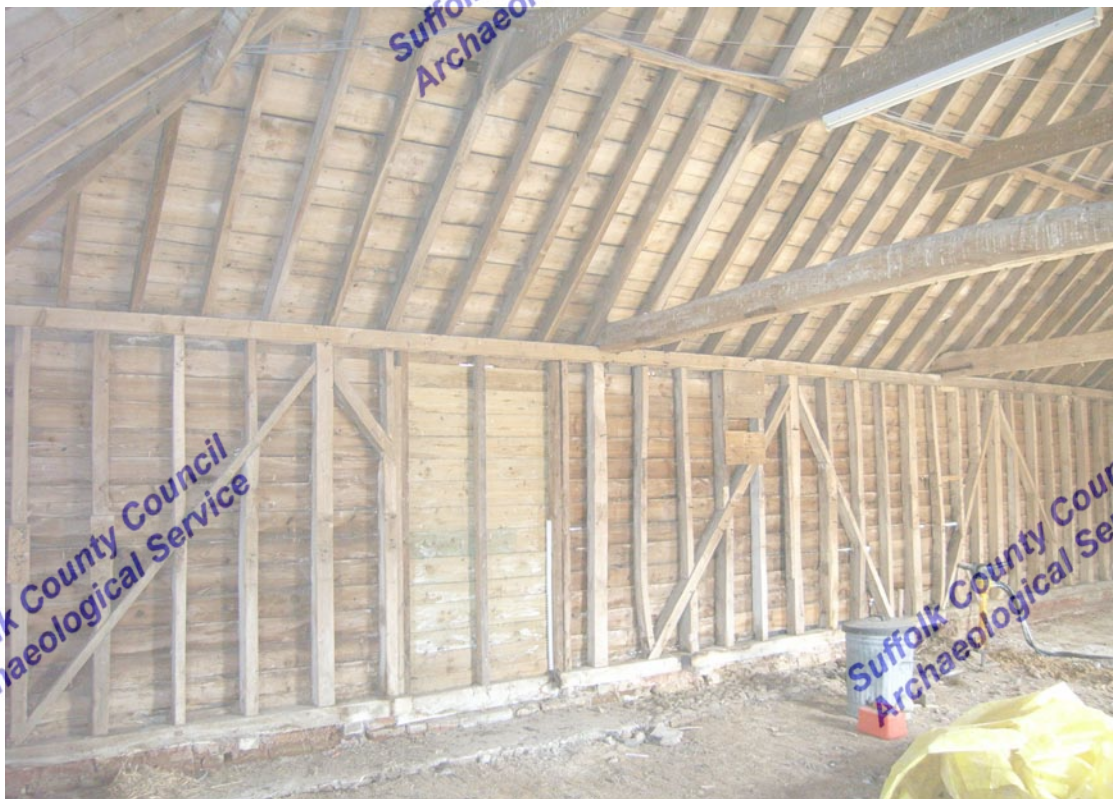
A2.4 Stable A. Interior of the eastern elevation showing a secondary blocked door and a small section of original cobbles. The machine-cut softwood framing is typical of the early-20th century.

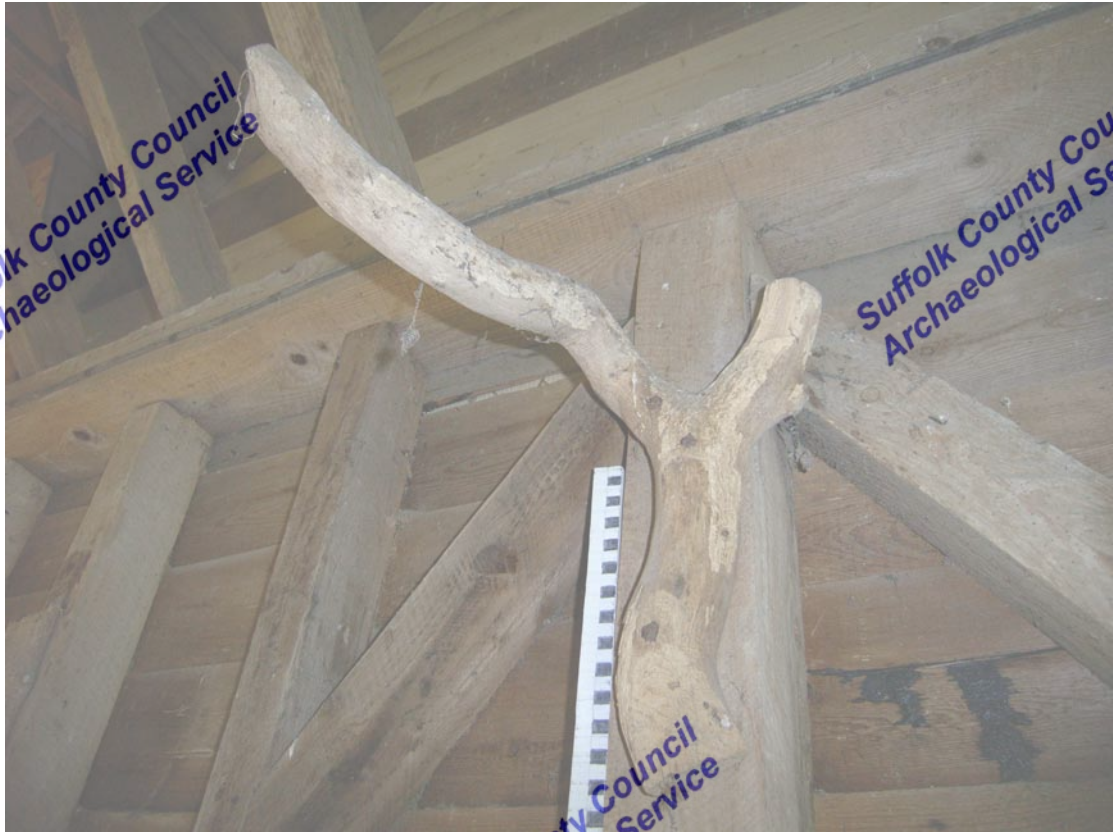
A2.5 Stable A. Detail of the southernmost of two bentwood harness hooks nailed to the western wall at its northern end.

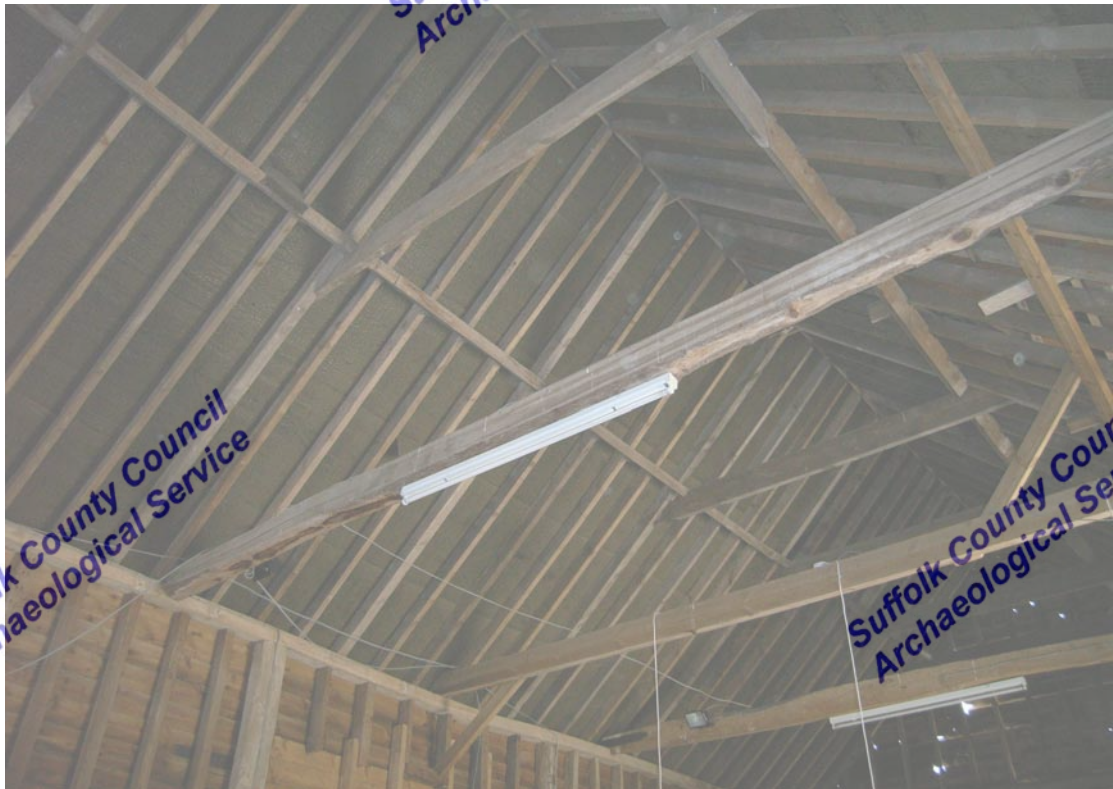
A2.6 Barn B. The original roof structure of the 20th century barn with its southern gable to the right. The roof has been re-felted.
