**The Willows,
South Elmham All Saints,
Suffolk**

February 2008

**The Barn,
The Willows, The Common,
South Elmham All Saints,
Suffolk**

Archaeological Record

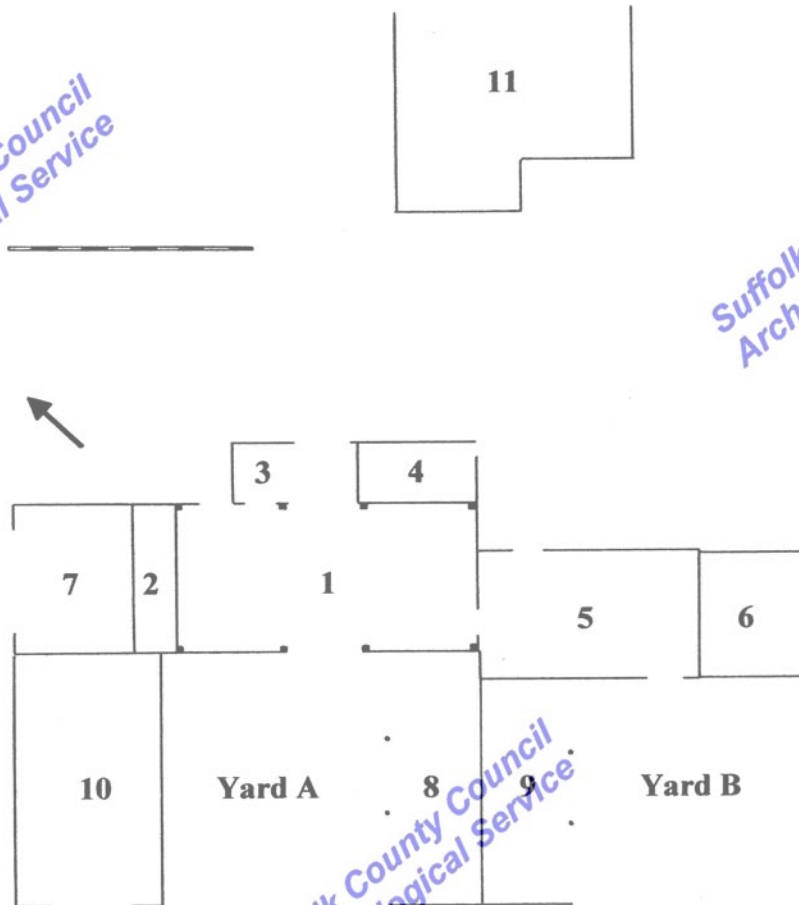
Figure 6. Block Plan of Site (showing the original extent of the barn with reference to its various surviving extensions and additions). Scale in metres.

1. The Barn. Late-16th or early-17th century timber-framed and weatherboarded barn of three bays with original central entrance facing gable of farmhouse to north-east. Formerly thatched and externally rendered.

2. Extension of 6 feet (1.8m) to main barn, removing original north-western gable studs. Early-19th century.
3. Lean-to addition to north-eastern elevation forming open shed adjacent to entrance. Early-19th century.

4. Lean-to addition to north-eastern elevation forming enclosed shed entered from stable yard to south-east. Possibly a tack room. Early-19th century
5. Brick stable with hay loft or granary against south-eastern gable of barn. Early-19th century (probably 1820s or 1830s).

6. Small brick shed added to south-eastern gable of stable. Much altered and partly demolished. Probably part of a missing structure which projected towards the farmhouse.

7. Lean-to extension to north-western gable of barn. Early-19th century
- 8/9. A pair of open-sided timber-framed shelter sheds with brick gable and studwork axial partition, built as one structure but serving opposing yards (i.e. Cattle Yard A and Horse Yard B).

10. Modern shed on the site of an open-sided shelter shed shown in figures 3-5.
11. Farmhouse (aligned at right-angles to barn). Listed as late-16th or early-17th century and probably contemporary with barn. Now in separate ownership and not inspected, but apparently oriented with service gable towards barn

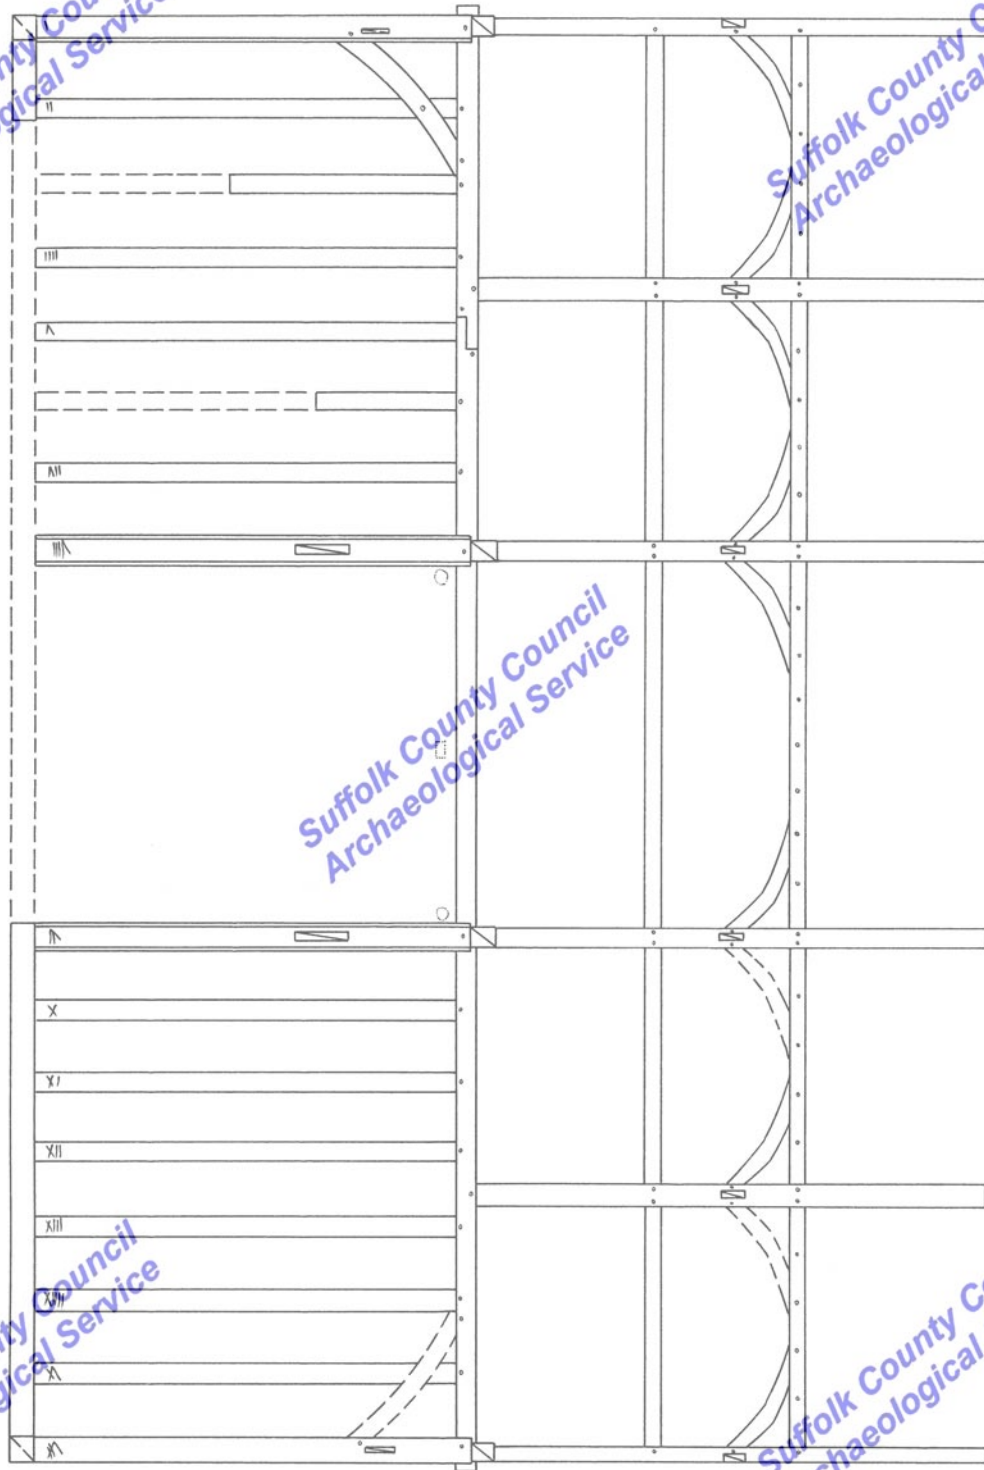
Figure 7

Internal elevation of north-eastern façade with principal roof timbers
Note evidence of original central door, with circular housings in roof-plate soffit

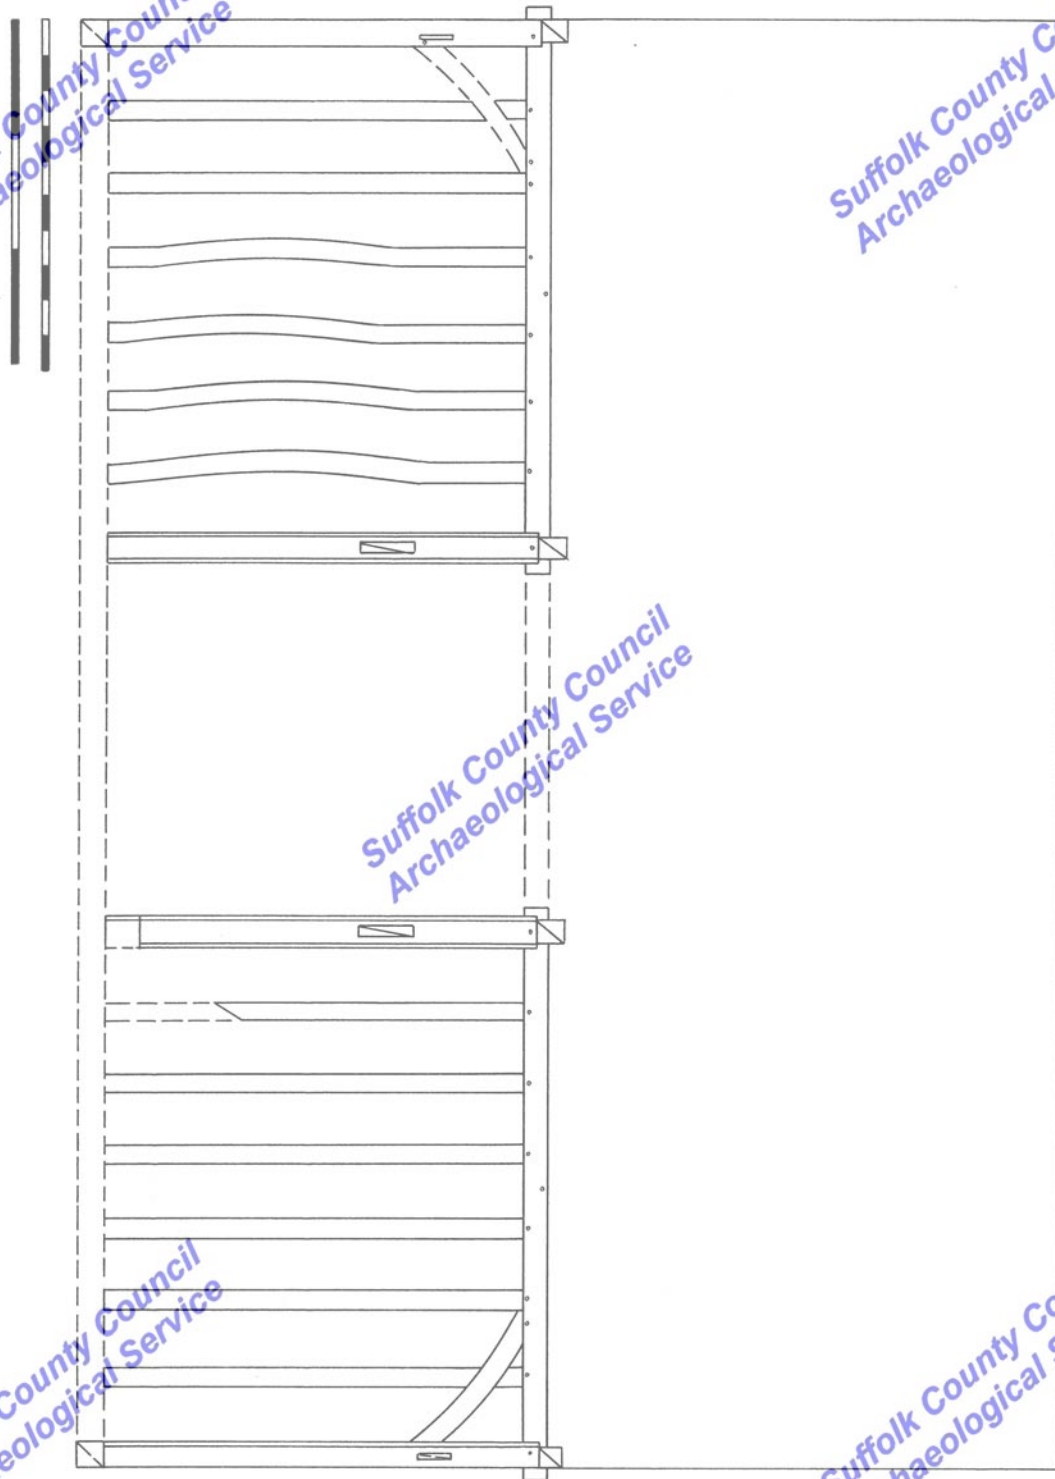
Figure 8
Internal elevation of south-western rear elevation
Framing of central bay destroyed by insertion of secondary entrance to Yard A

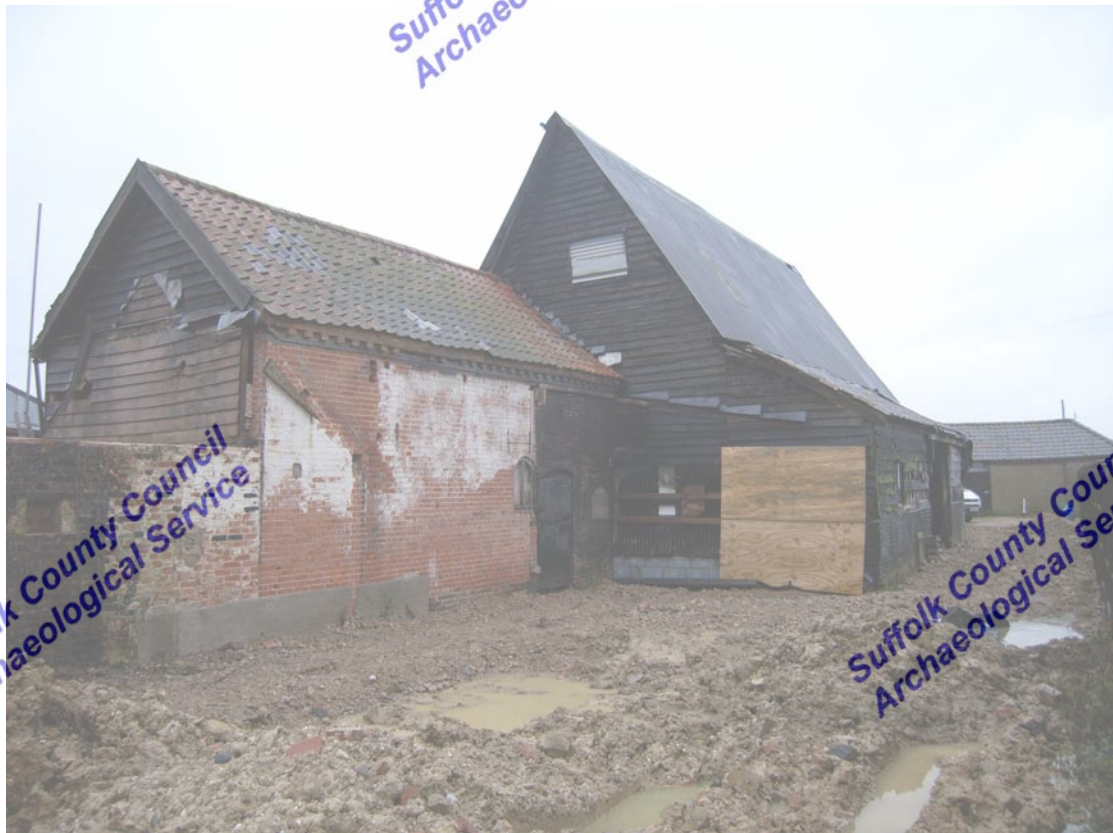
A2.4 Exterior from east showing Stable (5) to left with barn in rear. Note scar of demolished building which projected to north-east

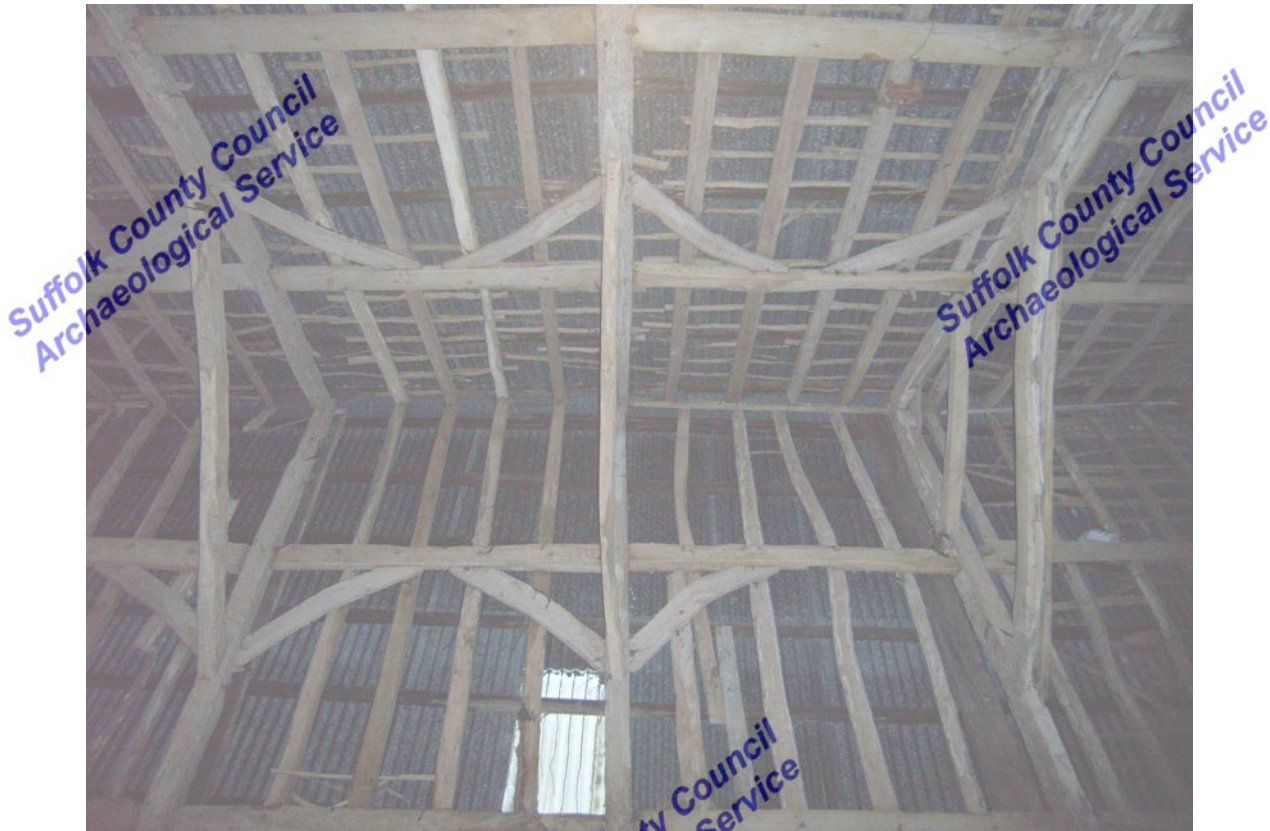
A2.5 roof structure of barn (double butt-purlin with wind braces). Western half showing original north-western gable to right (studwork removed)
