MONITORING RECORD – SCCAS**SXM 019****Grid Reference:** TM 3881 6298**Parish:** Saxmundham**Address:**
Church Bridge,
Saxmundham.**Planning app. no.:** N/A**Report number:** 2008/255
OASIS ID: 48274**Number of visits made:** 3**Date of visit/s:** April 2007*(What was seen)*

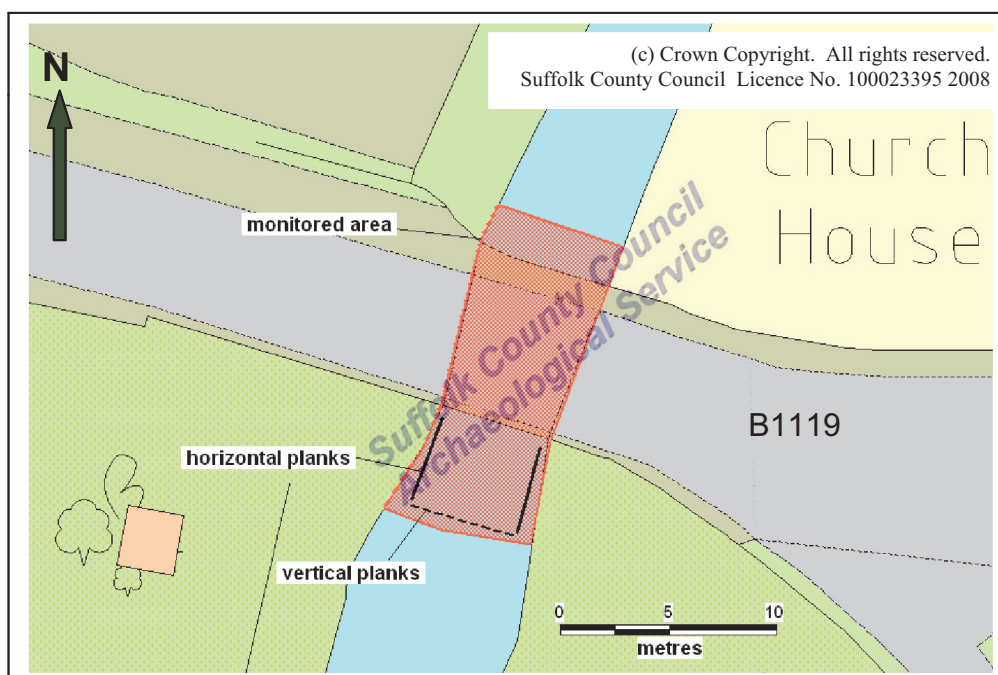
Sketch Plan: *(location of trenches – e.g. front or back of house etc)*

Brick facing associated with former phases of bridge survive against either bank. These comprised c.3 courses of red brick from the 19th century bridge under white bricks from the bridge built in 1922. Where the river bank was exposed, the only deposits revealed comprised layers of modern made up ground/topsoil (dark brown sandy loam).

No features were observed within the river bed which could be associated with earlier bridge structures. Wooden structures to the south of the bridge consisted of two narrow horizontal planks, each c.50mm thick x 4m long against each side of the river bank, with a series of upright planks c.50mm thick x 125mm wide, the tops of which had decayed somewhat. Whilst the function of these timbers was unclear, they did not appear to be of any great age and they were not in an environment conducive to wood preservation. These timbers will be sawn to the level of the river bed and buried under stone cages as part of the new build.
