**The Barn,
Pear Tree Farm,
Rumburgh,
Suffolk
RMB 014
Historic Building Record**

**Barn at Pear Tree Farm,
Aldous's Corner,
Rumburgh, Suffolk
(TM 339 810)**

An Archaeological Record

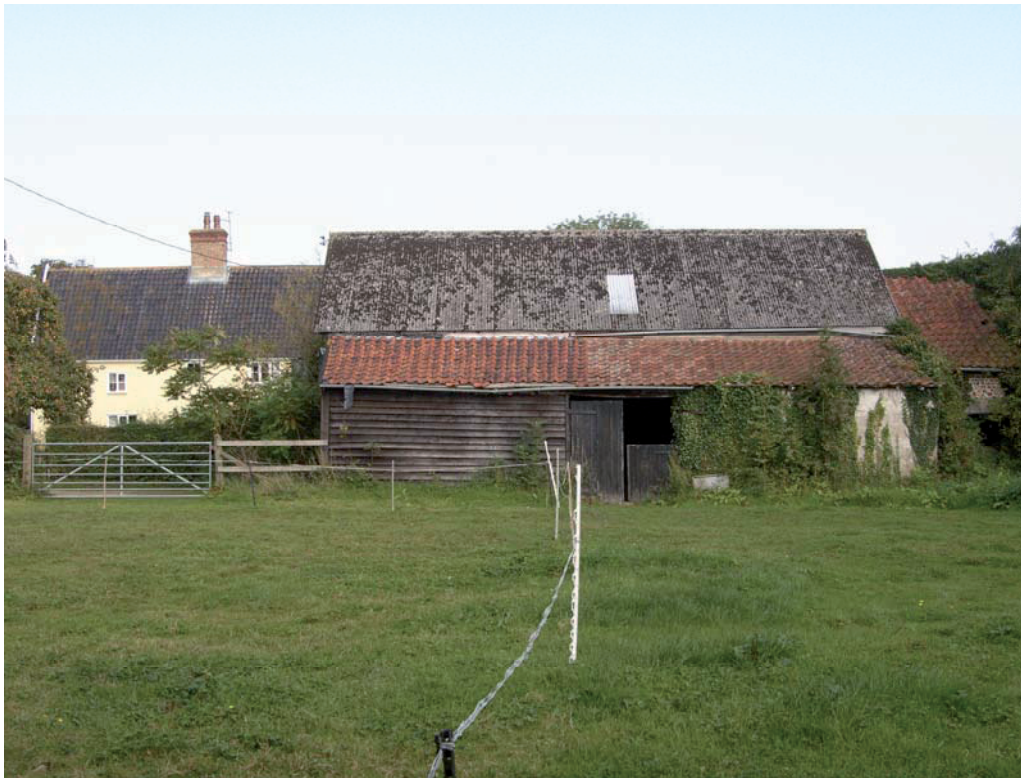
A2.1 General view of site from west showing barn (1) in centre with later lean-to in foreground; brick stable (2) to right and listed farmhouse (4) to left

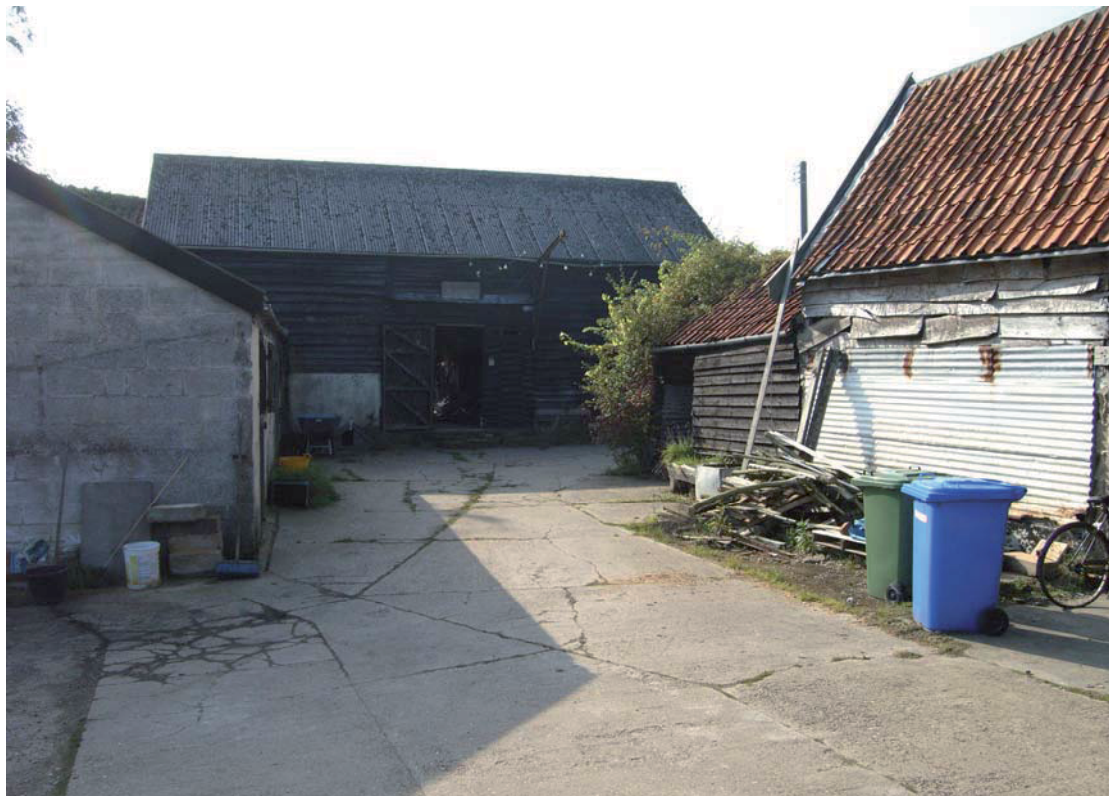
A2.2 Exterior of barn (centre) from yard to east showing timber-framed stable (3) to right & modern block-work stable to left

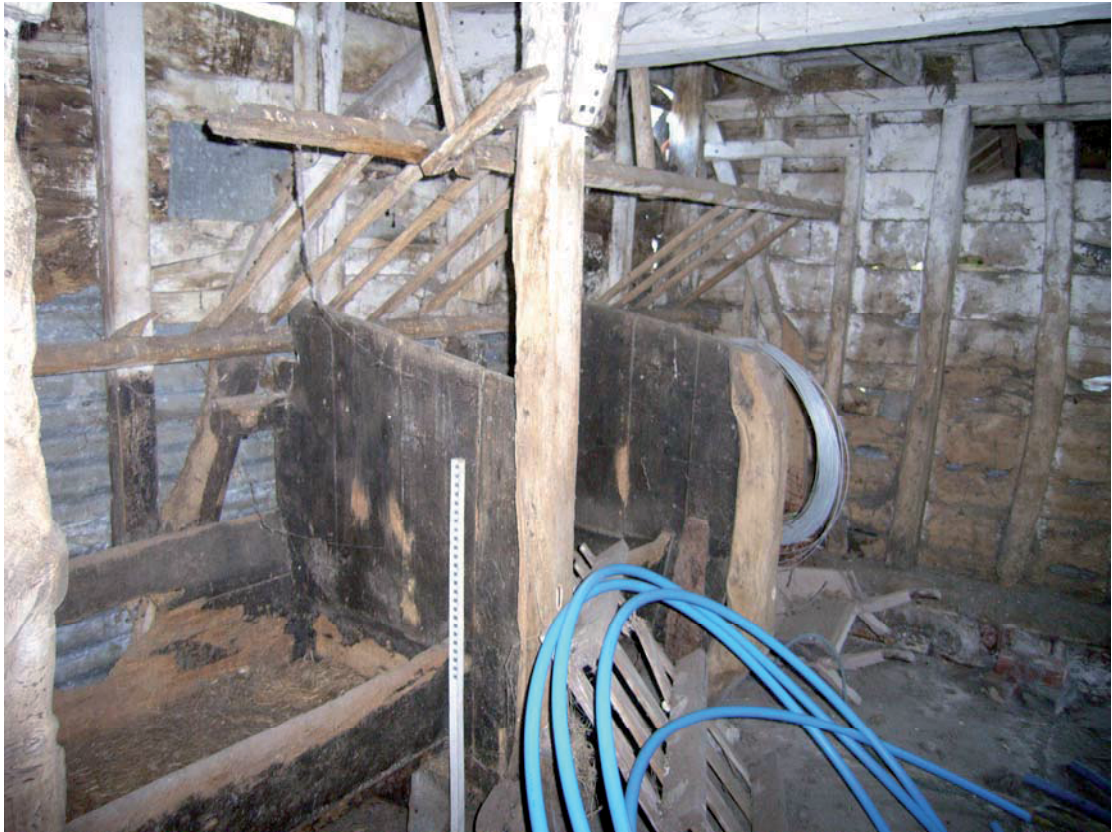
the hay loft above, and a door opens onto the northern paddock. While the presence of the hay loft is normally associated with stables rather than neathouses, the low height of both the mangers and rack suggest they were designed for cattle (at 58 cm and 1.1 m above the ground respectively – instead of the 1 m and 2 m found in typical working-horse stables). The building may have been converted into a neathouse, either wholly or partly, when the brick stable was built in the mid 19th century, but whatever their origin the low fittings are rare and interesting survivals.

A2.3 Interior of timber-framed stable (3) showing low hay rack and manger with western gable to right

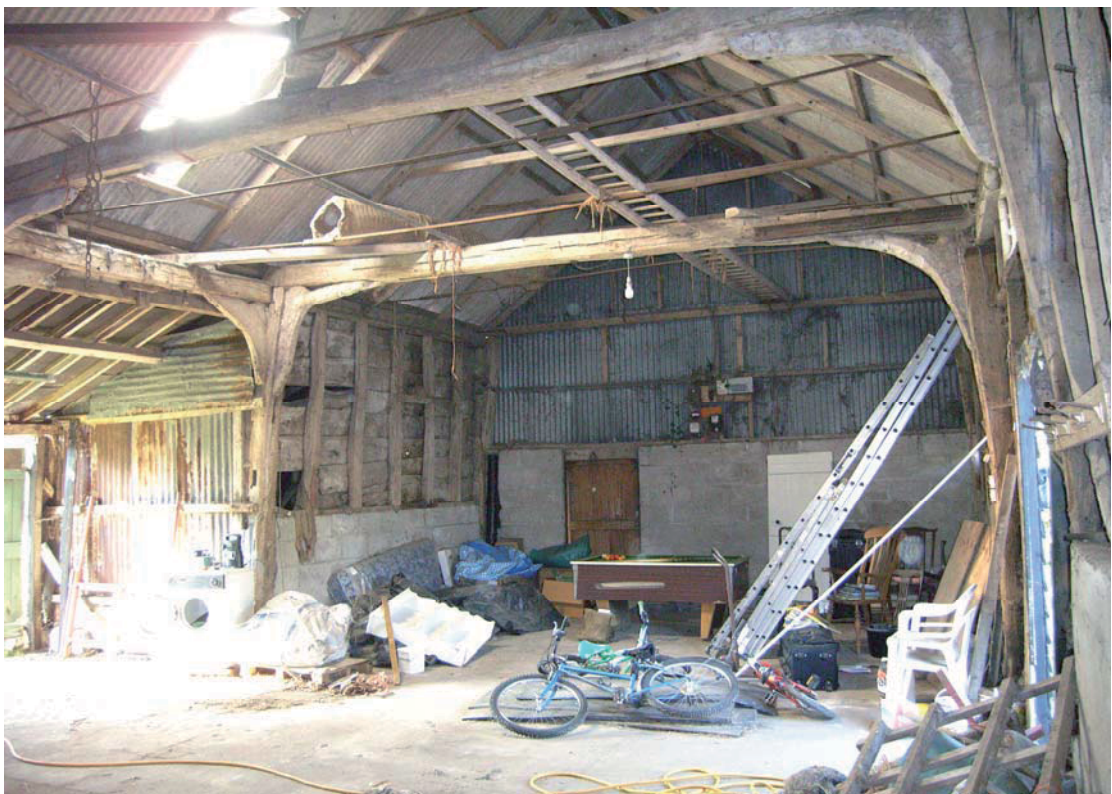
A2.4 Interior of Barn. General view from south showing rebuilt northern gable with western lean-to shed to left

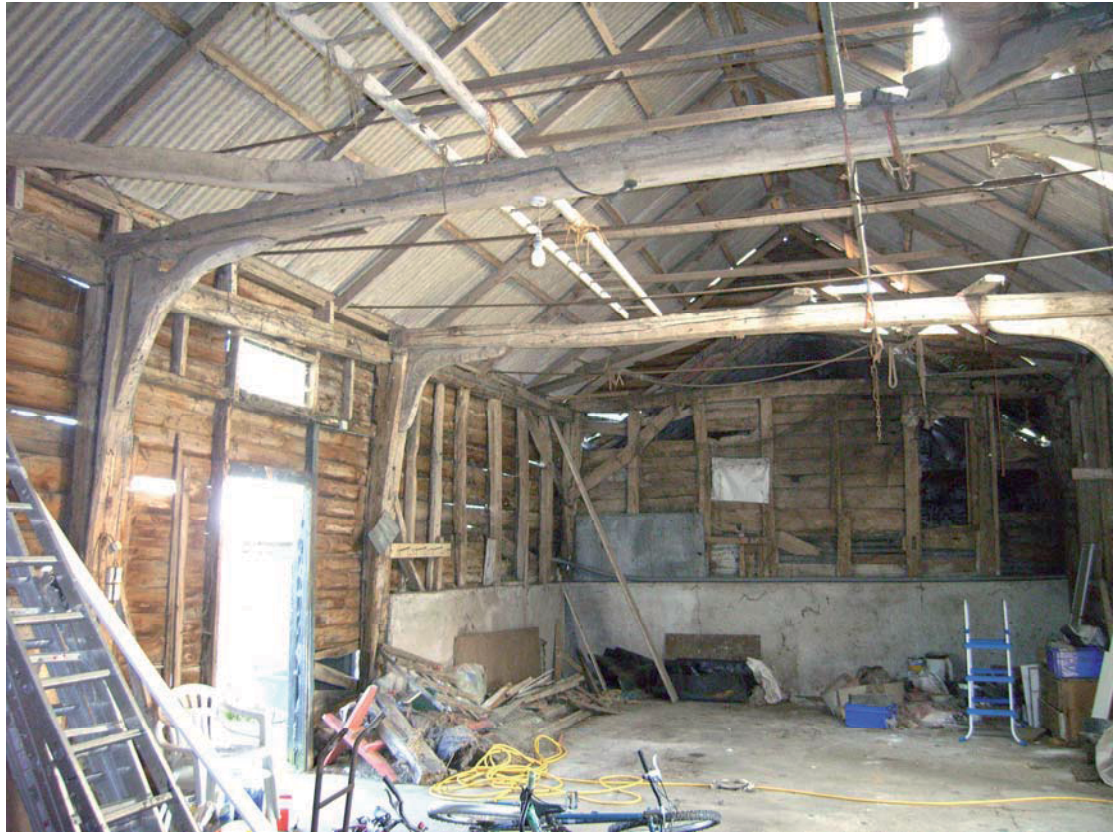
The wall framing is reasonably complete, and contains all the necessary evidence to reconstruct the barn's original arrangement as described above. As usual, the arch-braces of both open trusses were replaced with bolted knee-braces in the 19th century to increase headroom, and the studs and doorway of the central, western bay were removed to permit vehicle access. The present eastern entrance is considerably smaller than the original, which spanned the entire length and height of the bay. The entire northern gable was rebuilt in softwood and concrete blocks during the mid-20th century, and the roof structure was entirely replaced at the same time. A tall plinth of shuttered concrete was also inserted, and this is likely to have destroyed any ground sills and framing buried within it. With a small number of exceptions the original studs of the southern gable and outer bays are intact, but the internal braces survive only in the eastern wall and in the eastern corner of the southern gable; their former positions are indicated elsewhere by empty trenches in the studs.

A2.5 Internal eastern elevation of barn from north showing original entrance in central bay to left and southern gable to right. The knee-braces replace original arch-braces

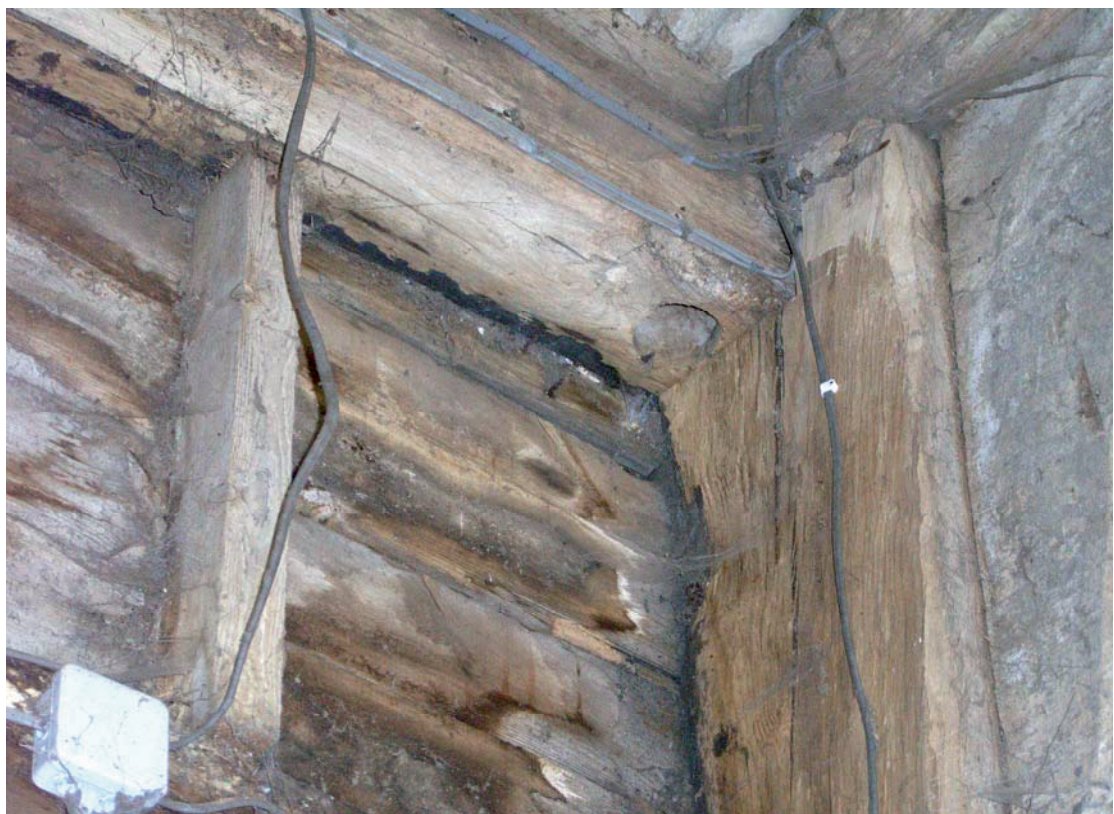
A2.6 Detail of roof-plate at southern end of central eastern bay showing circular housing for pin hinge of original door

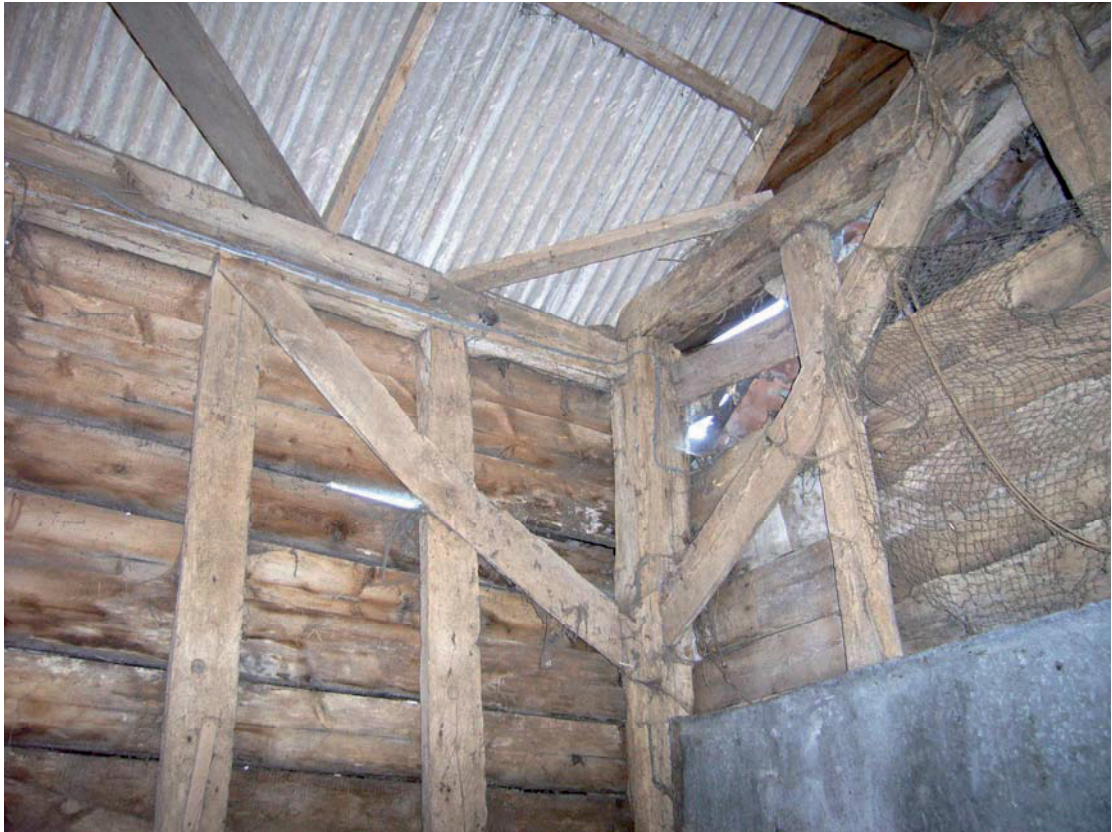
A2.7 Detail of original internally trenched wall braces in south-eastern corner of barn, showing southern gable to right

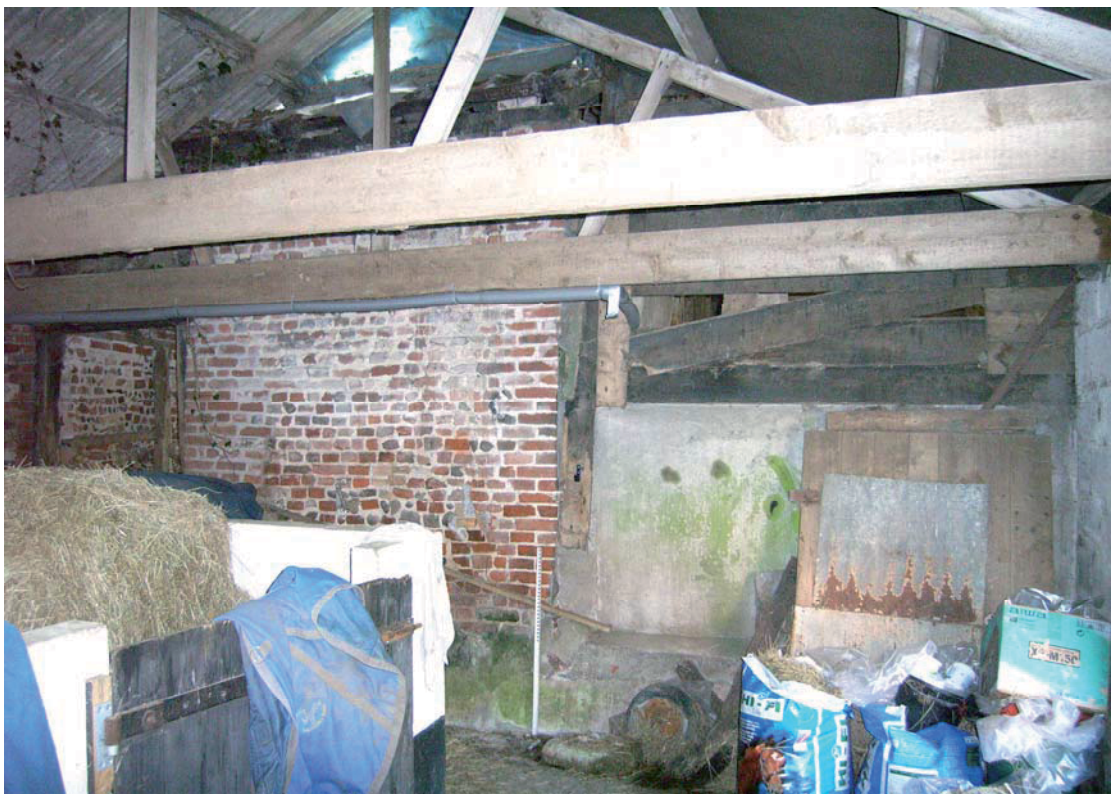
A2.8 Eastern external elevation of brick stable (2) from block-work stable showing original entrance door to left & southern bay of barn to right

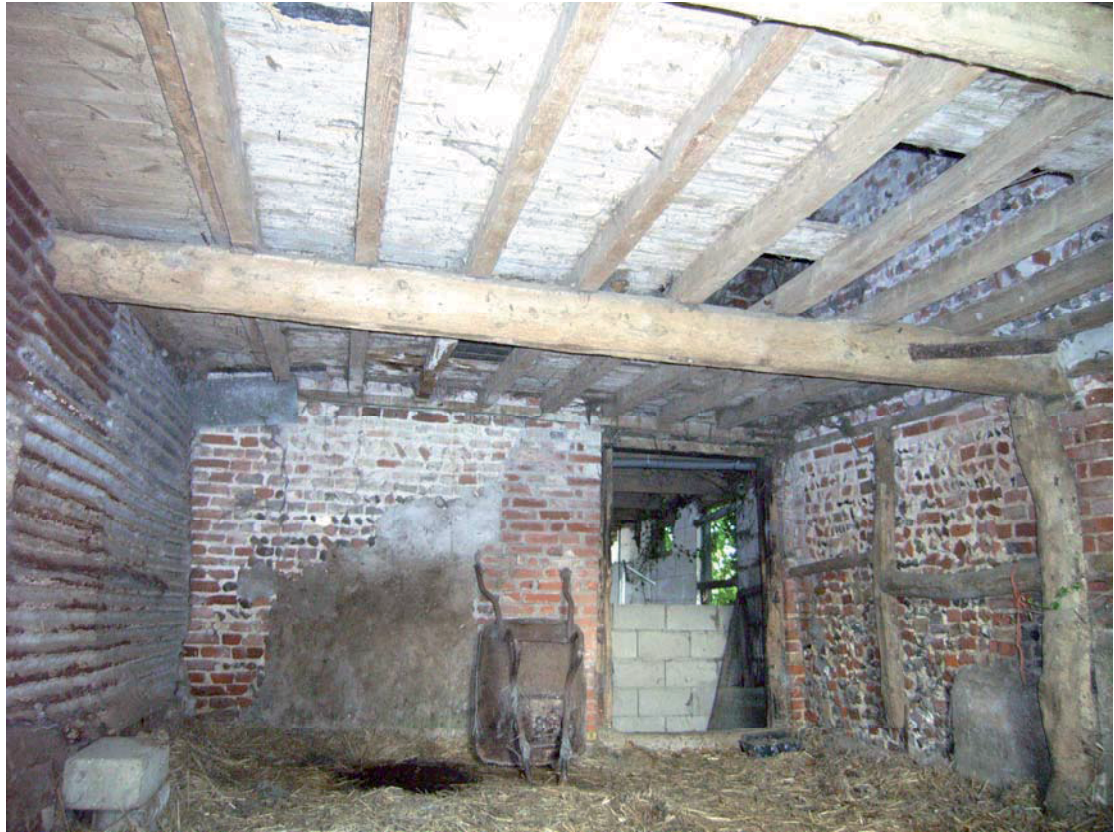
A2.9 Interior of brick stable from west showing hay loft ceiling and eastern entrance to right. The southern gable of the barn is shown to the left

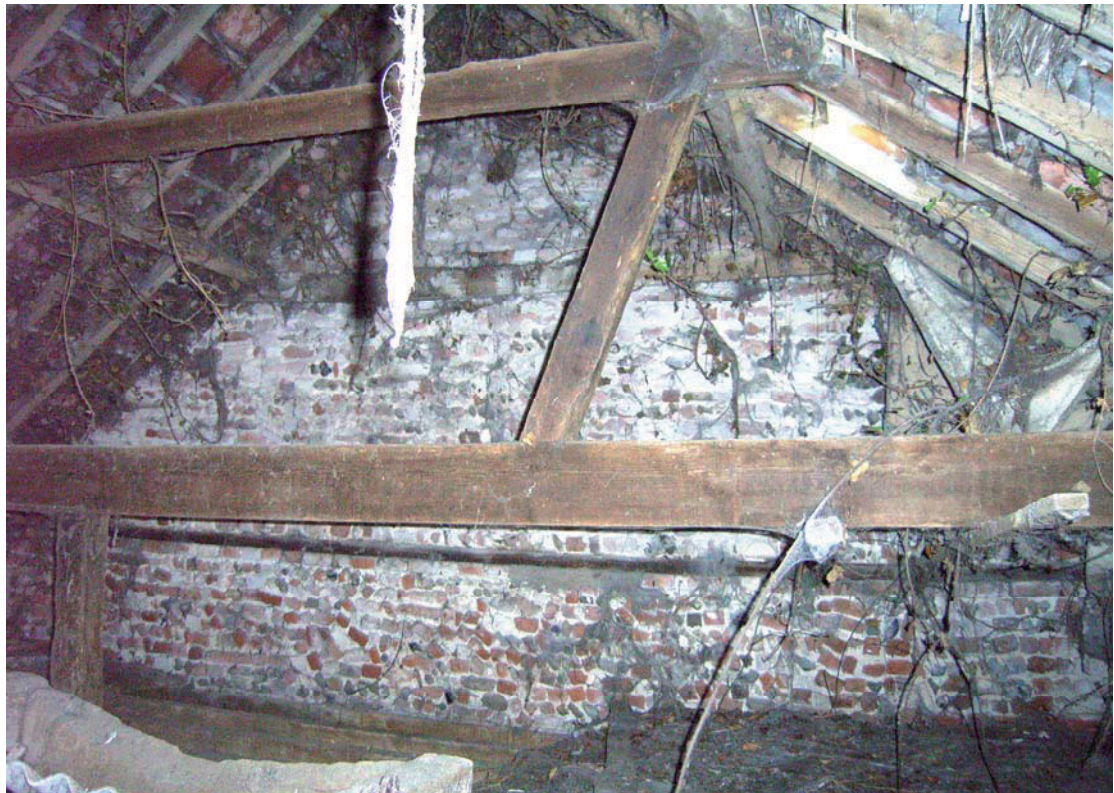
A2.8 Internal southern gable of brick stable (2) from hay loft showing softwood roof-structure
