Church Farm, Thornington, Suffolk

Archaeological Record

**Church Farm,
Thorington Road, Thorington,
Suffolk**

An Archaeological Record

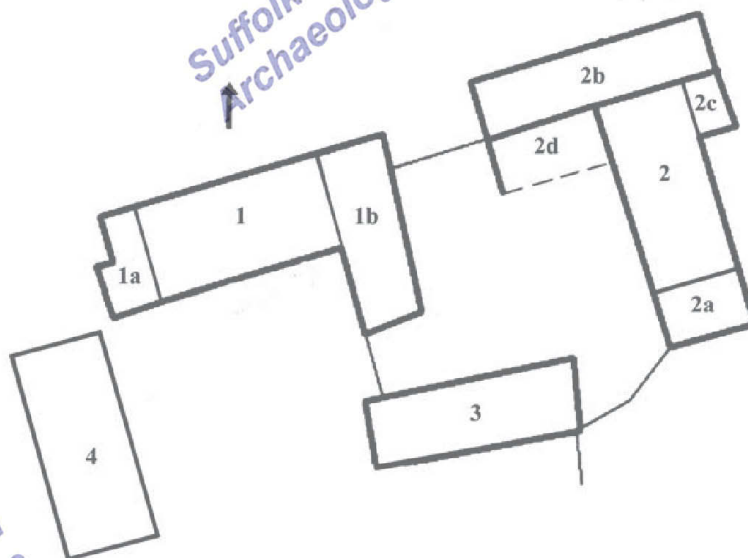
Figure 5
Schematic Plan of Historic Buildings, based on figure 1

1. Bakehouse. Early-17th century timber frame with brick chimney to western gable. The external walls rebuilt in brick during 18th century and extended to east in early-19th century. 1a: Three 19th century lean-to sheds including a two-seater privy to rear. 1b: 19th century brick and flint animal shed, partly demolished at the time of inspection
2. Barn (2) & Stable (2a). Early-17th century three-bay timber-framed and rendered barn with central entrance to west. 2a: Early-17th century stable and hay loft with door to west, originally open-framed against barn but both re-

- roofed in early-19th century. 2b: Early-19th century flint and brick open-ended lean-to shed. 2c: 18th century lean-to shed. 2d Early-19th century open sided animal shelter, largely collapsed at the time of inspection
3. Neathouse. Late-18th century timber-framed neathouse with loft and evidence of hay rack to rear (northern) wall. Formerly with yard range to south of which only collapsed fragments remained at the time of inspection
 4. Site of historic farmhouse, demolished *circa* 1960, as shown on tithe map and Ordnance Surveys until 1951

N.B. A number of structures shown on the Ordnance Surveys no longer survived at the time of inspection, having apparently collapsed or been demolished when the site was cleared of vegetation.

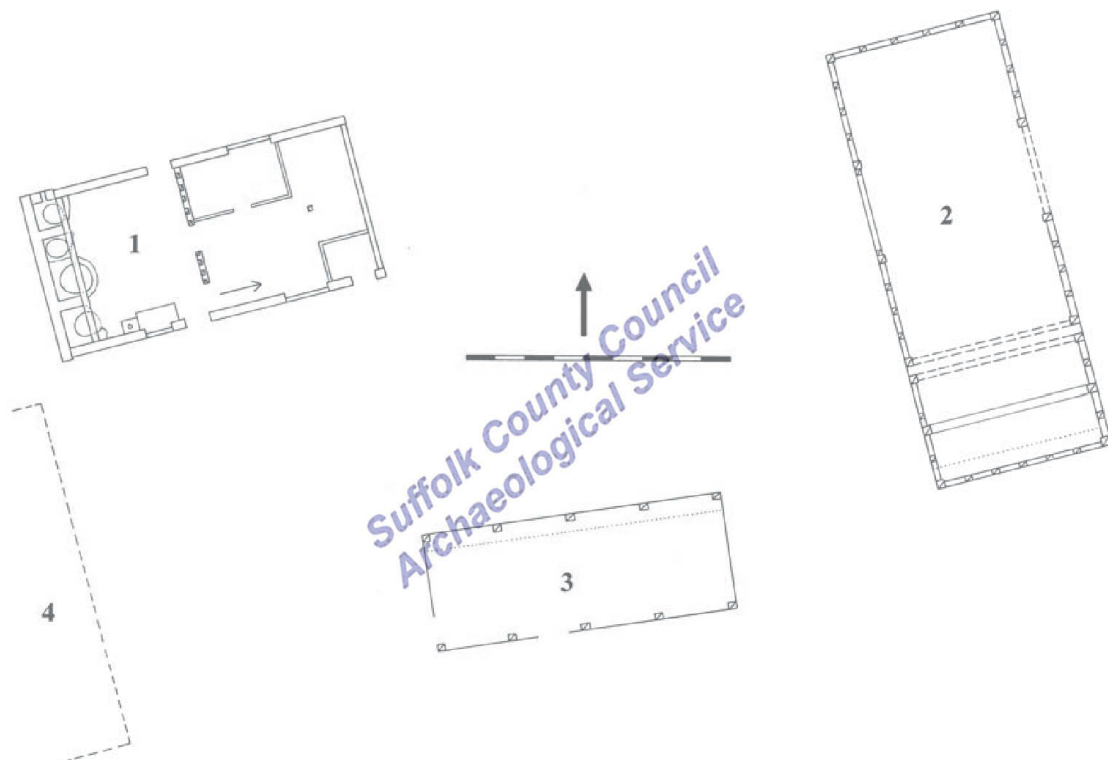
Figure 6
Ground Plans of Historic Buildings, as numbered in figure 5

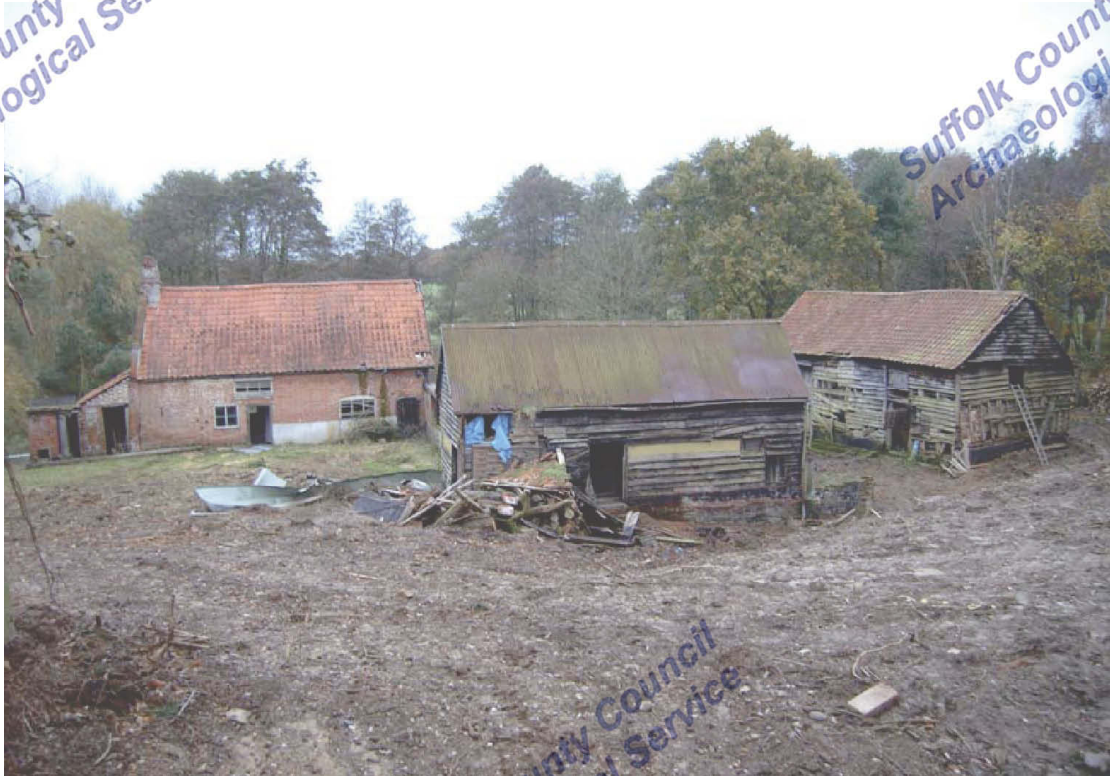
A2.1 General view of site from ridge to south showing bakehouse to left, neathouse in centre and barn to right

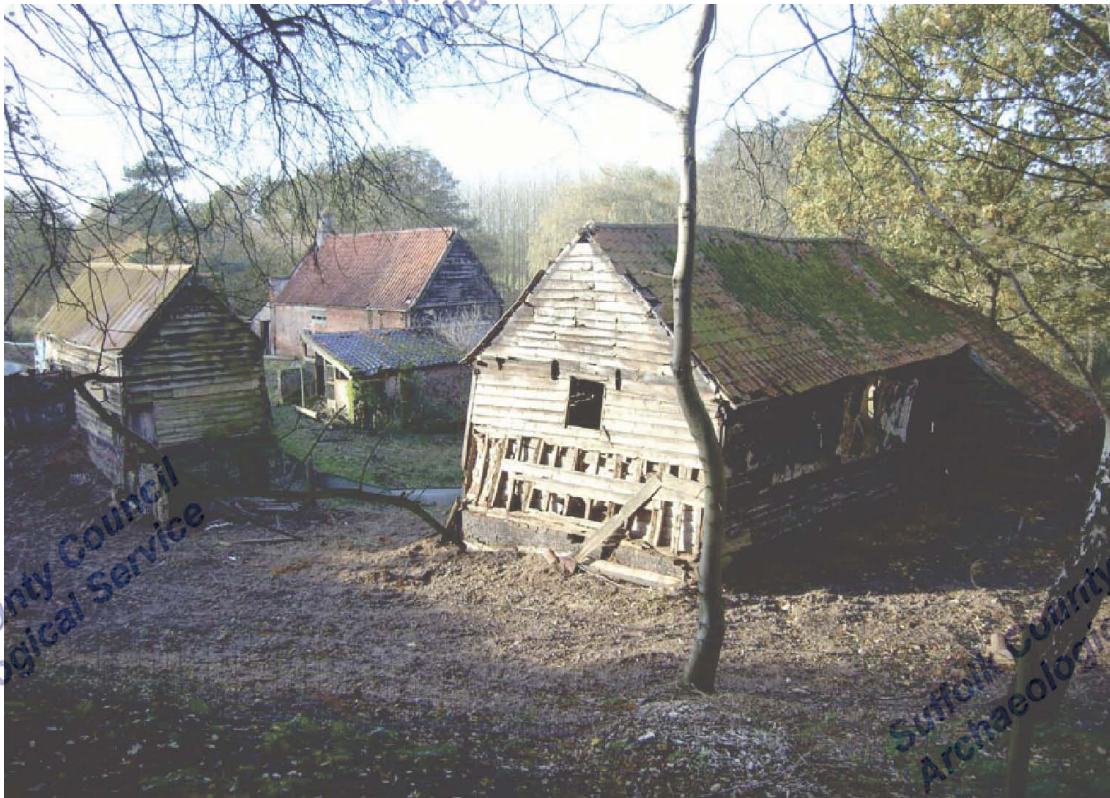
A2.2 General view of site from south-east showing barn to right (with attached stable in foreground), bakehouse in centre and neathouse to left

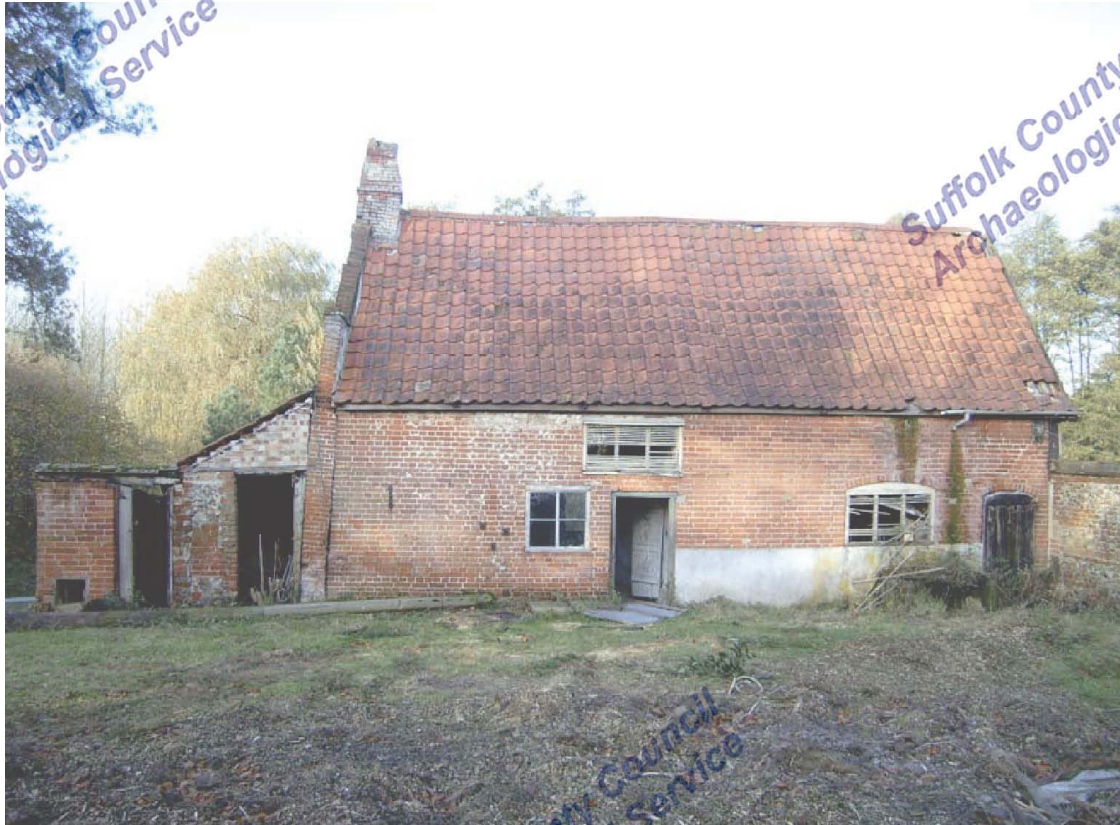
A2.3 Bakehouse. Southern external elevation with secondary brick façade showing central cross-entry with brick gable and integral chimney to left

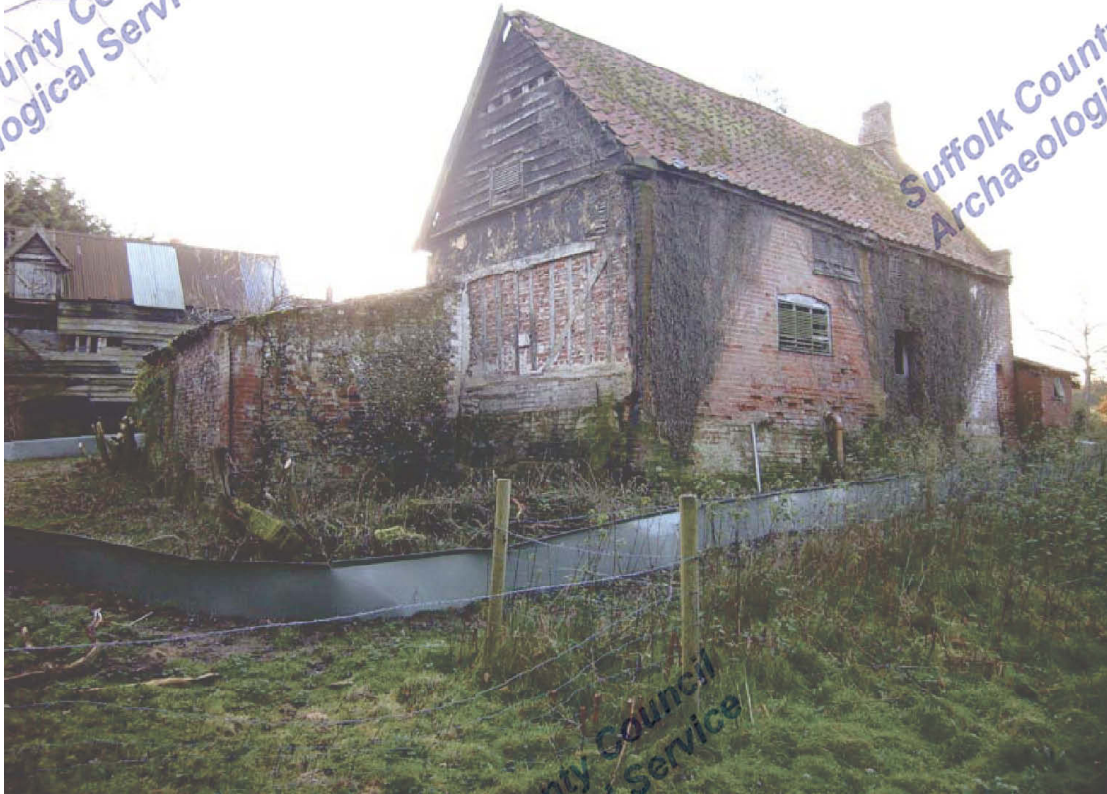
A2.5 Bakehouse. Exterior from north-east showing timber-framed eastern gable to left

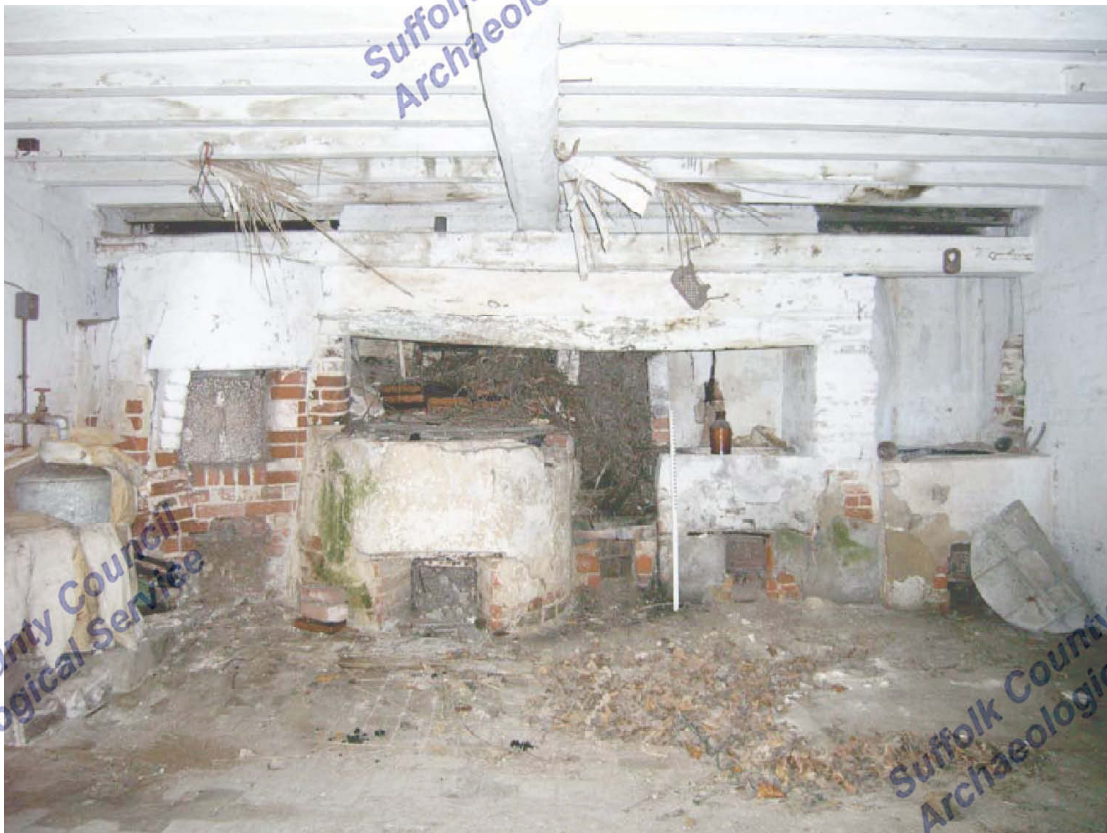
A2.6 Bakehouse. Interior of western gable showing chimney beam & three coppers to right with oven to left

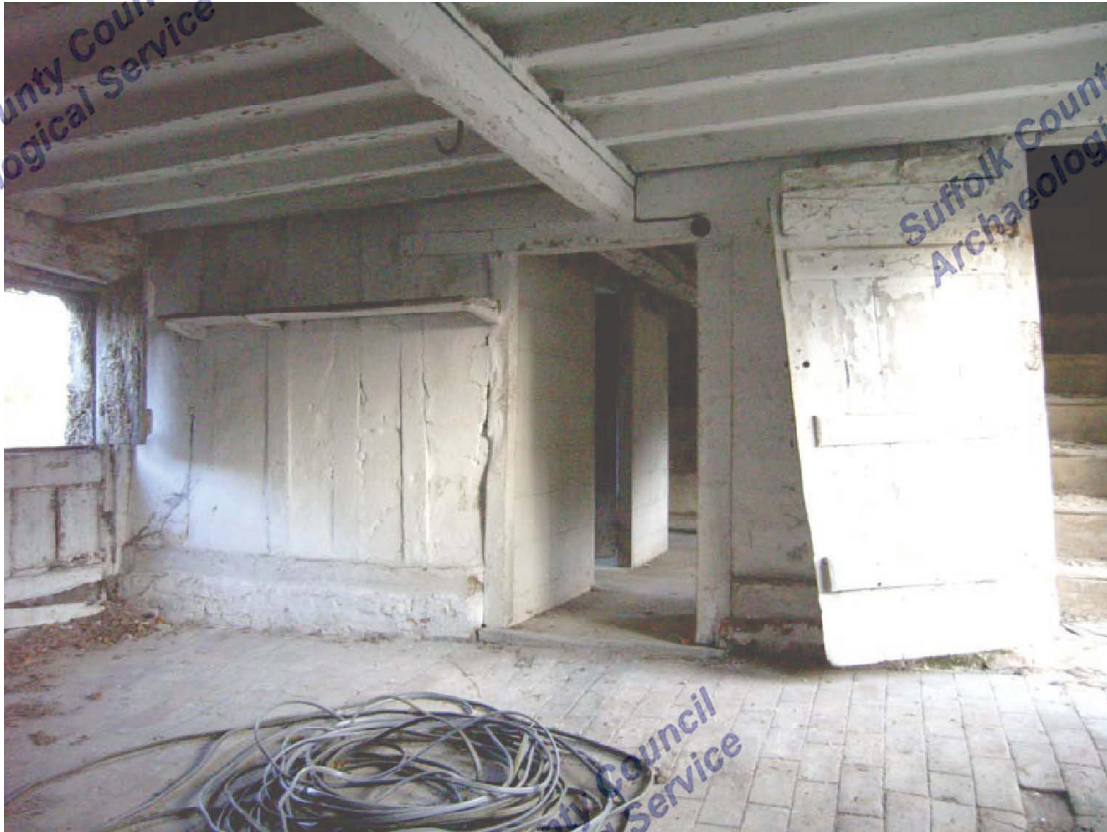
A2.7 Bakehouse. Interior from west showing timber-framed partition with central door to eastern storeroom, rear external door to left and stair door to right

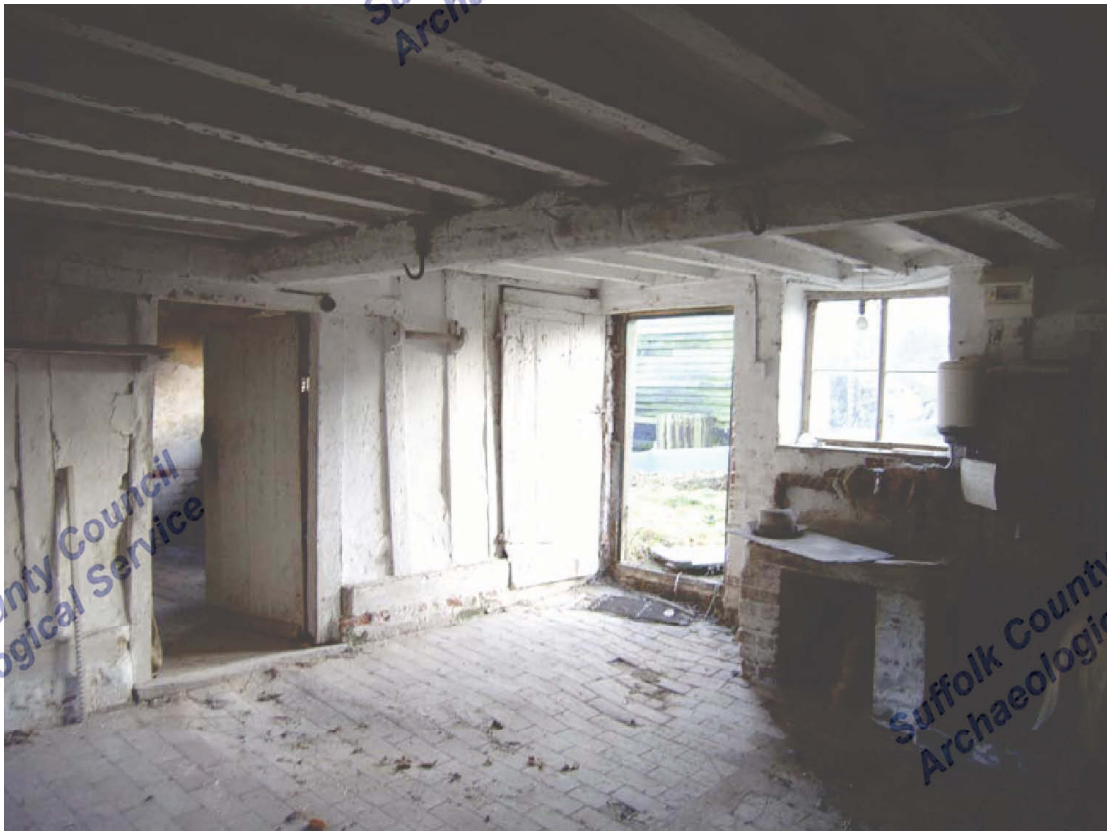
A2.8 Bakehouse. Interior from north-west showing southern entrance and worn floor bricks

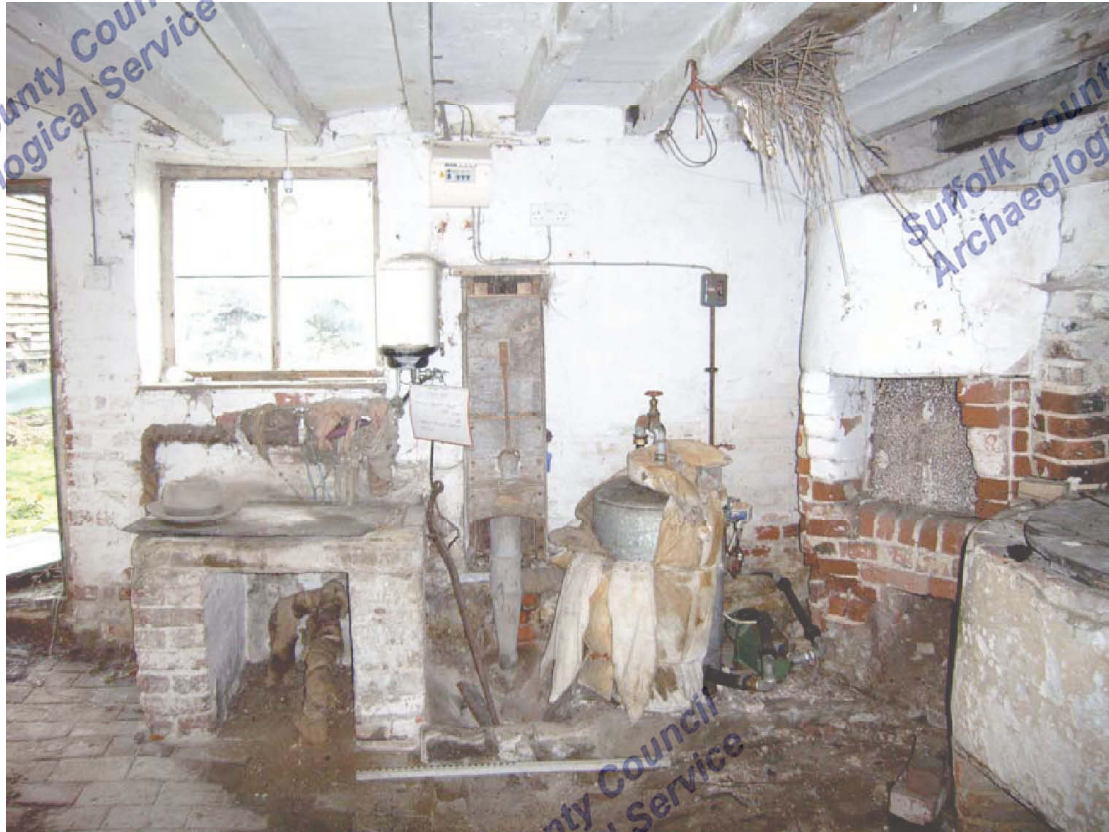
A2.9 Bakehouse. Interior of southern elevation showing stone sink to left, boarded pump in centre and oven to right

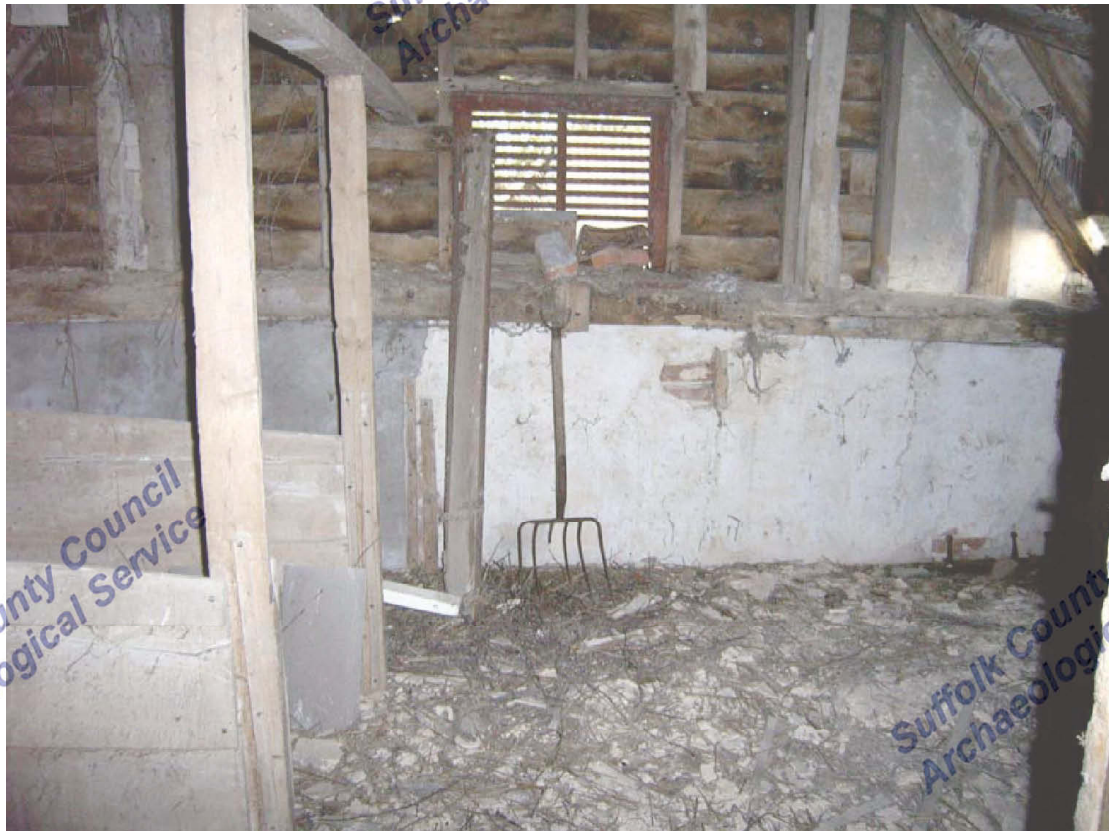
A2.10 Bakehouse loft. Eastern granary chamber from west showing grain bins to left

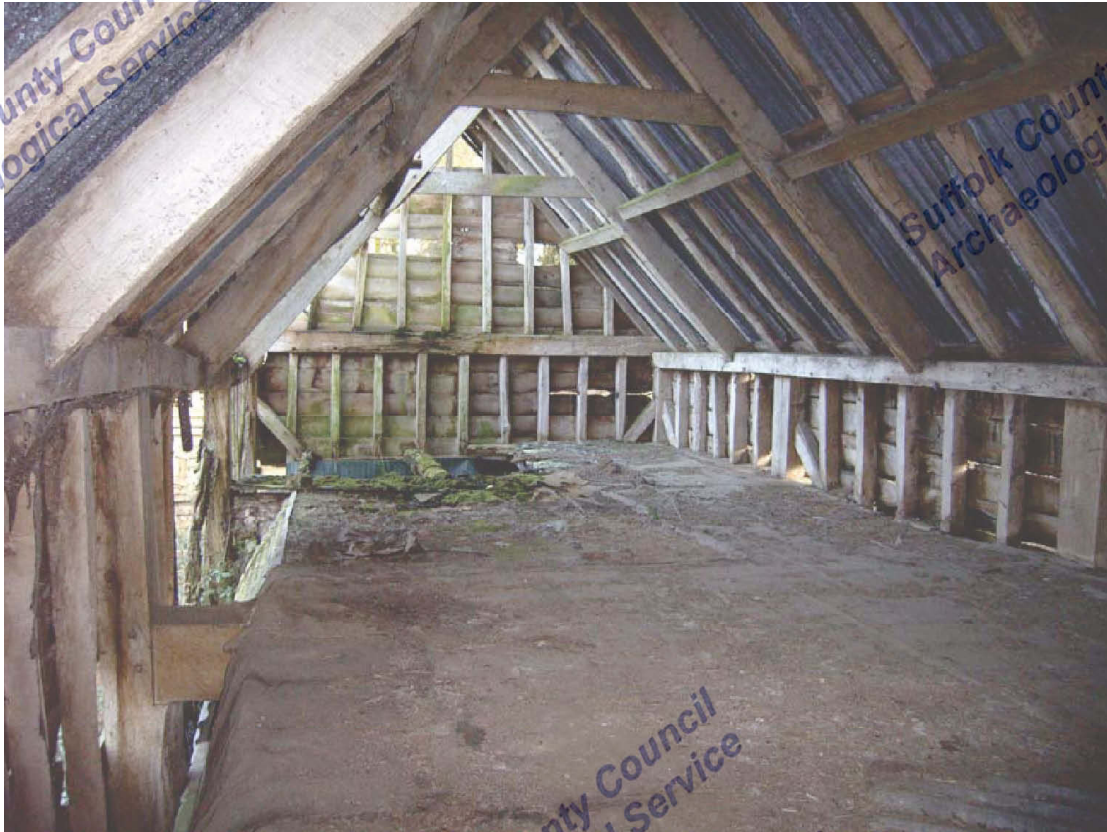
A2.11 Neathouse. Loft from west showing butt-purlin roof structure and loading vent above former hay rack against northern elevation to left

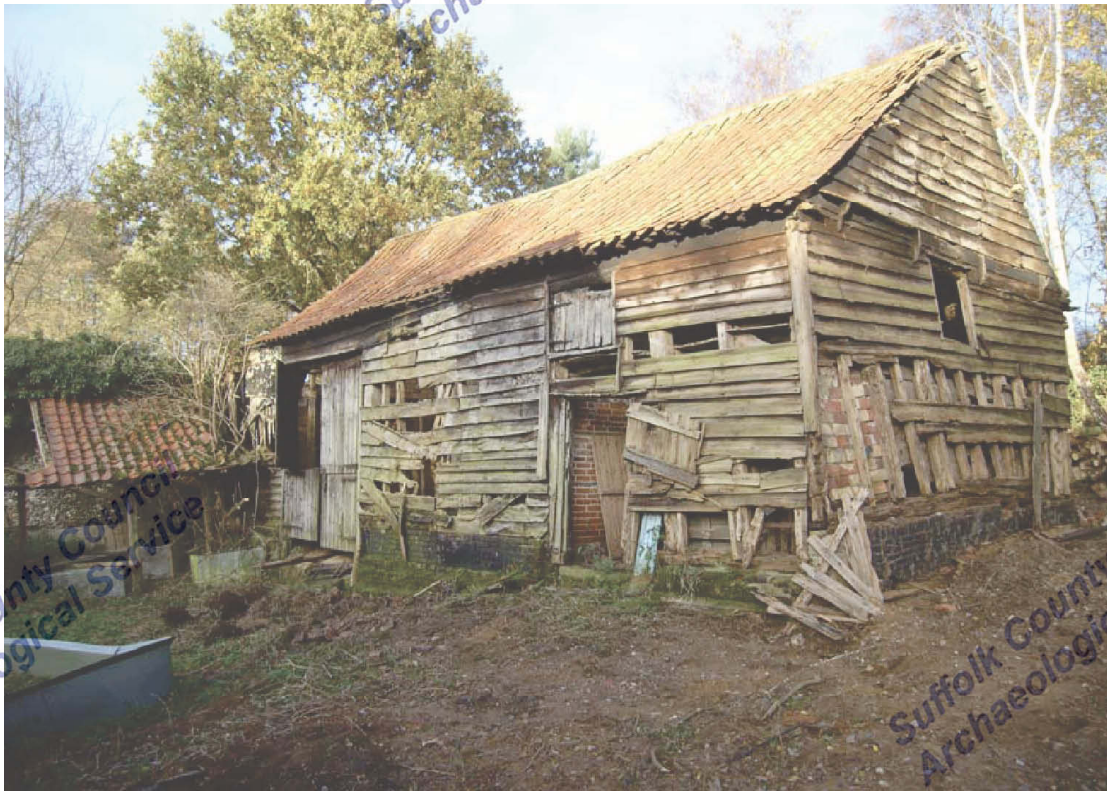
A2.12 Barn. Exterior from south-west showing original barn entrance to left and stable door to right

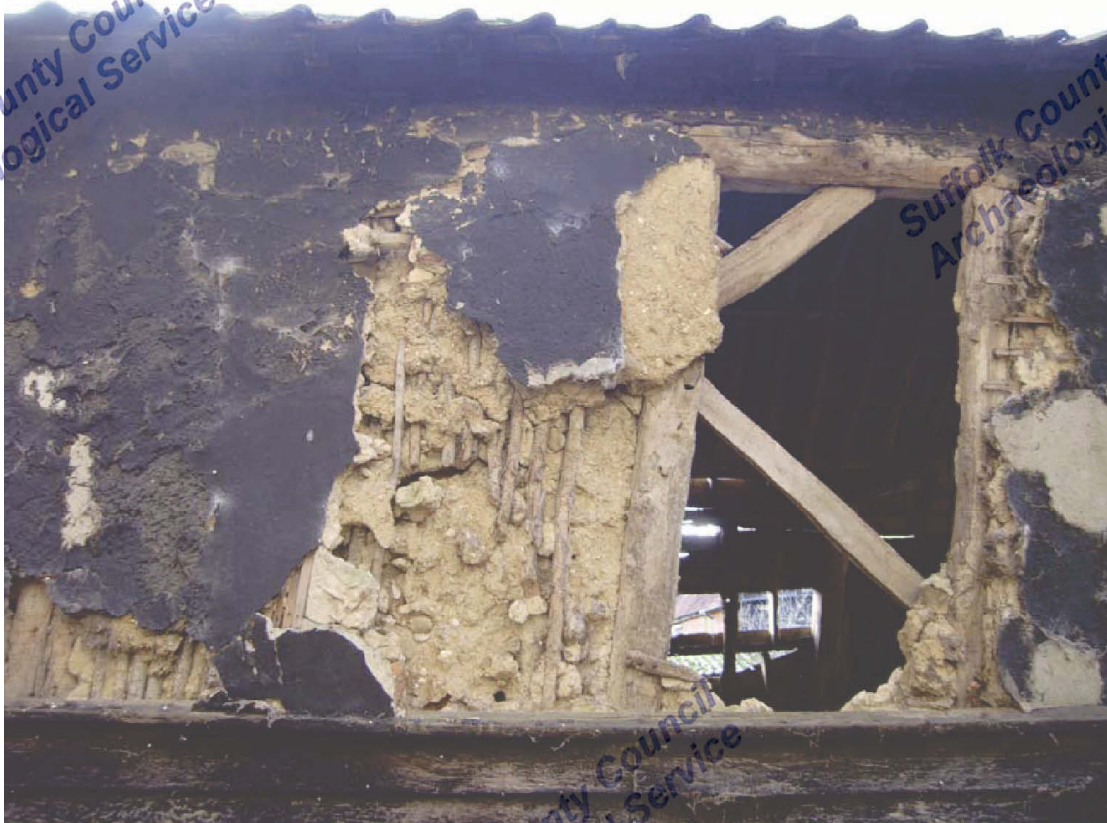
The building is currently clad with 19th century tarred weatherboarding to its gabled western elevation, but retains substantial areas of tarred wattle-and-daub to the east. The daub is secured by vertical coppice poles between the studs and horizontal split-laths nailed to their outer surfaces. The daub does not respect the division between the two timber frames and is probably secondary, although some elements may be original. A substantial section of

external daub to the northern bay is of particular historic interest as it is protected within a lean-to shed and was not tarred in the 19th century; its whitewashed surface extends from the roof-plate to the ground sill and is textured with roughcast pargeting. This daub offers a rare insight into the external appearance of many local barns in the 17th century.

A2.13 Barn. Detail of tarred external wattle-and-daub to eastern elevation

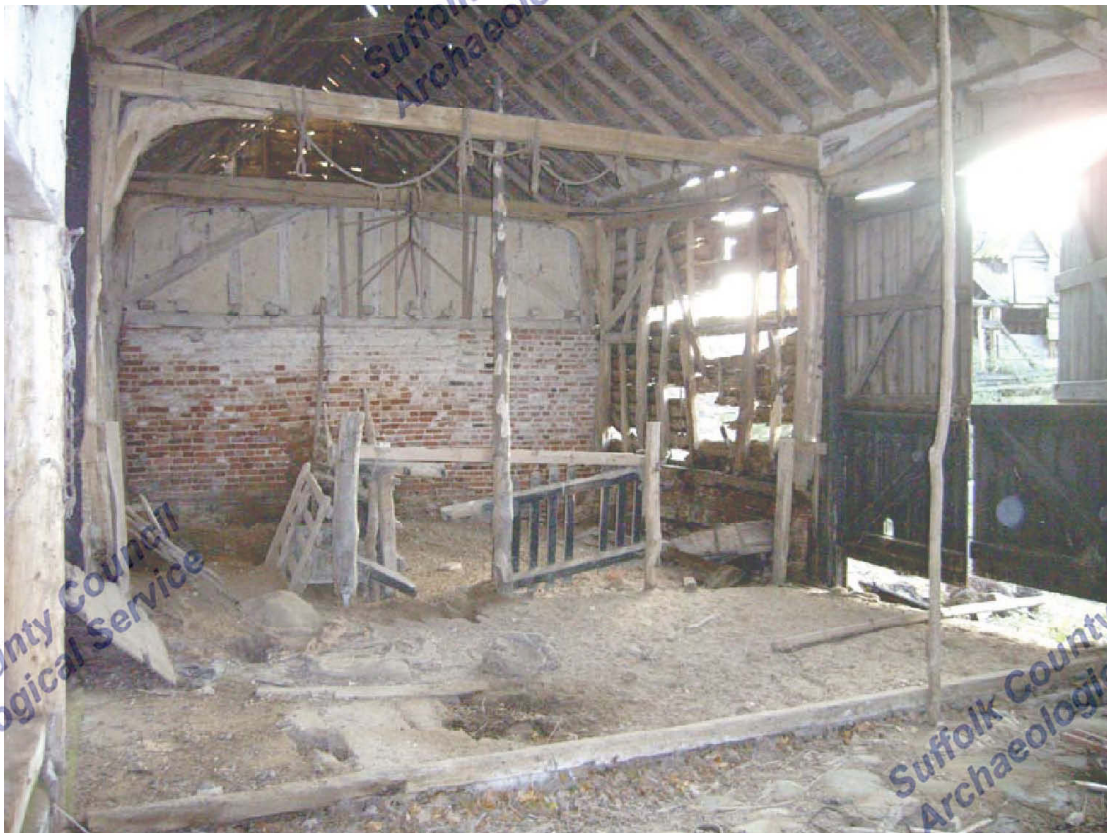
A2.14 Barn. General view of interior from north showing boarded threshing floor in central bay and secondary brick partition to stable in rear

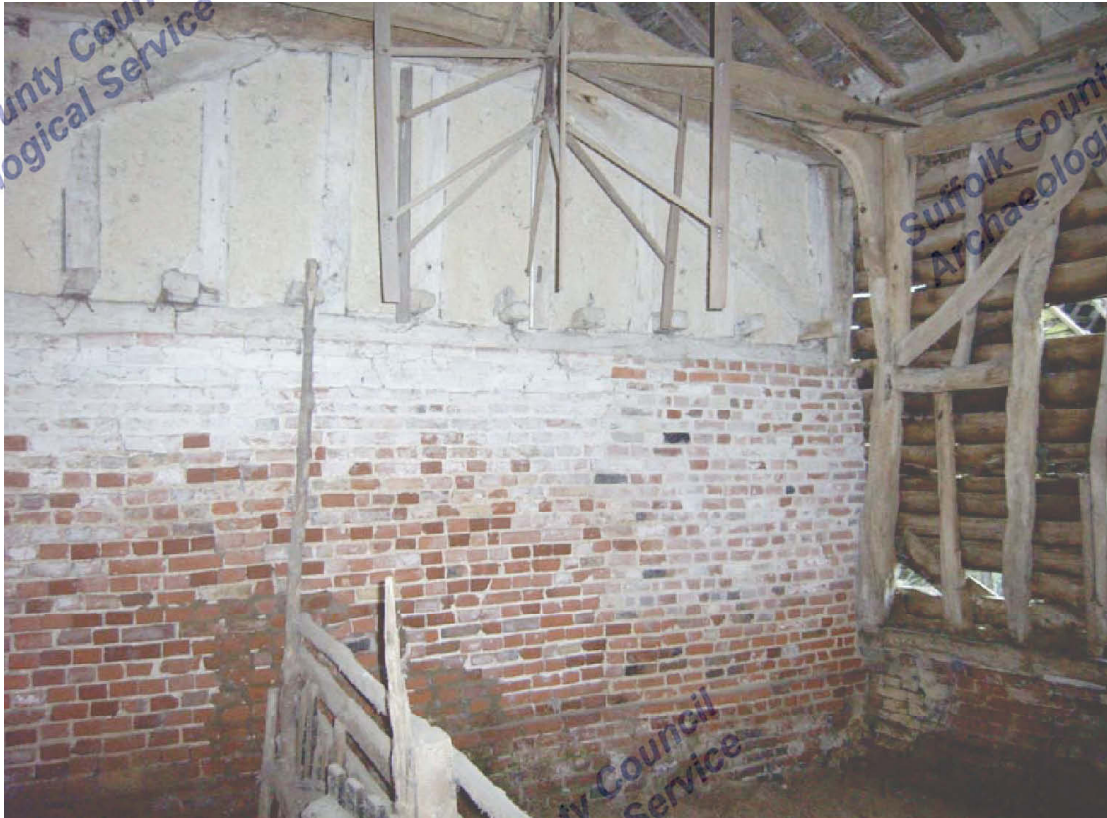
A2.15 Barn. Position of removed southern gable showing secondary brickwork to stable and original framing of three-bay barn with lintel of secondary door to right. The blades of a mechanical harvester hang from the tie-beam above

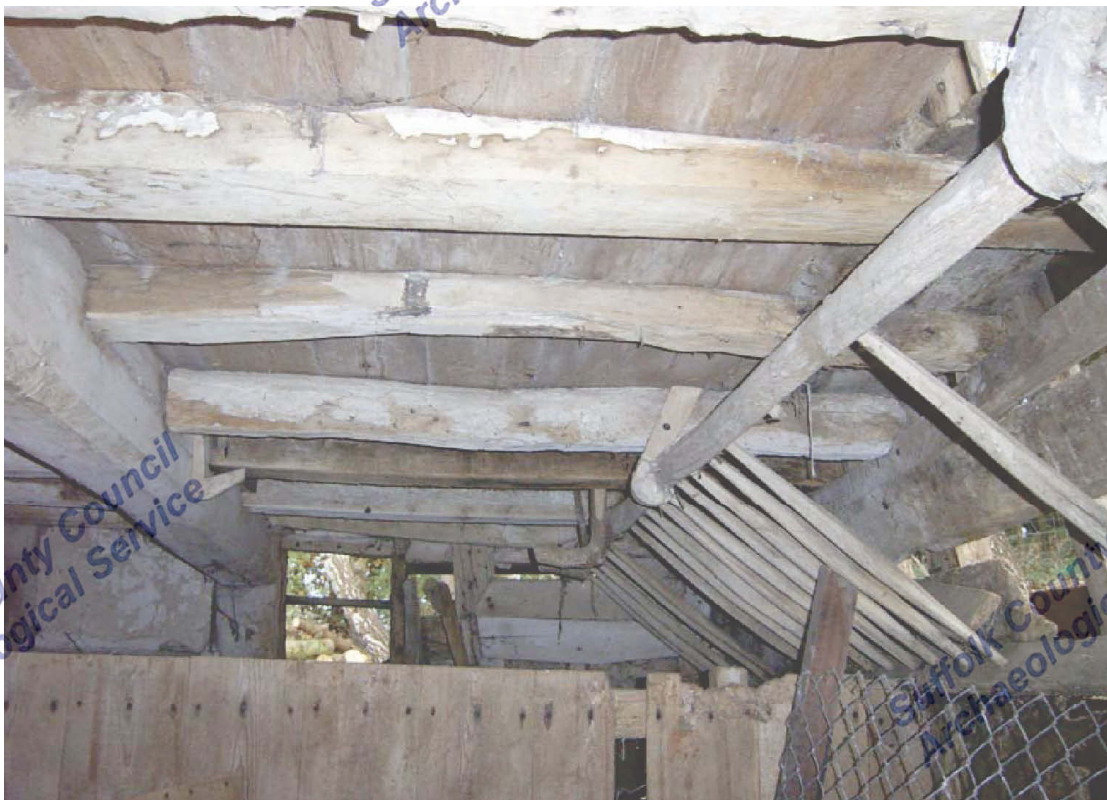
A2.16 Barn. Detail of stable ceiling from west showing hay rack against southern gable

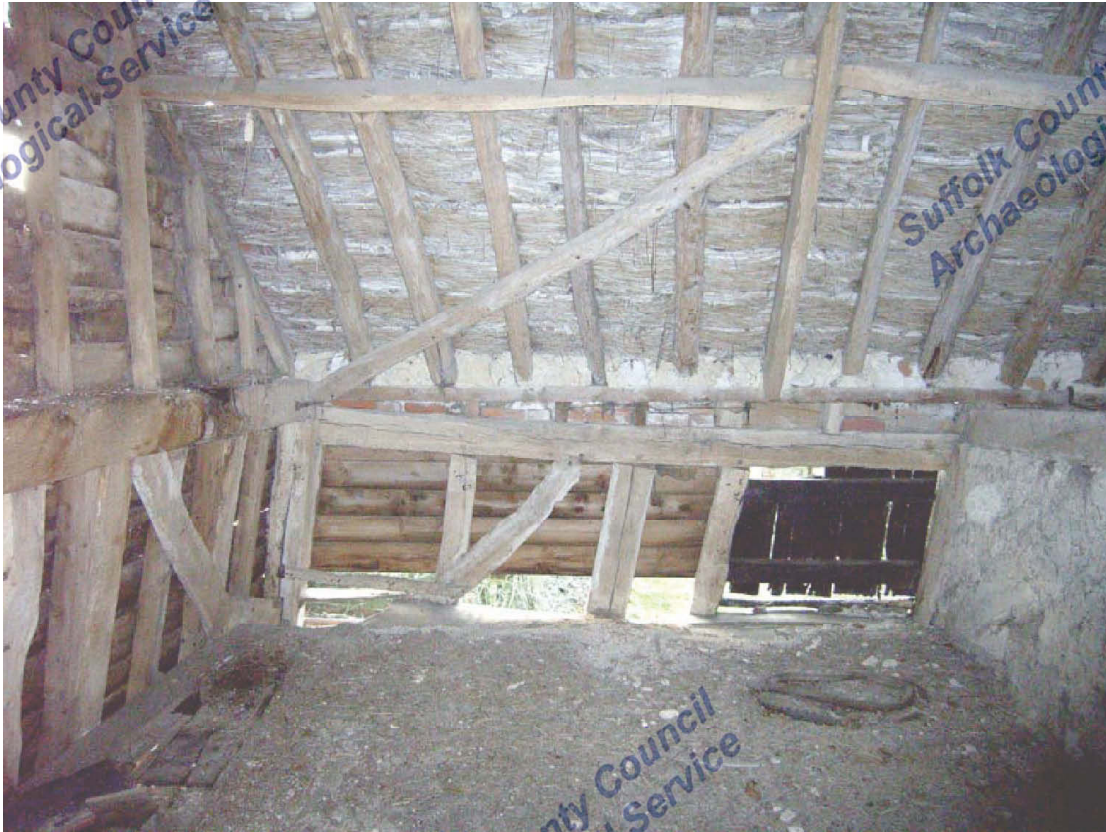
A2.17 Barn. Western internal elevation of stable loft showing original framed loading aperture to right
