HISTORIC BUILDING RECORD

SUBMARINE MINING ESTABLISHMENT PIER LANDGILADD FORT **FELIXSTOWE**

(HER Ref. FEX 064)

SCCAS REPORT No. 2009/001

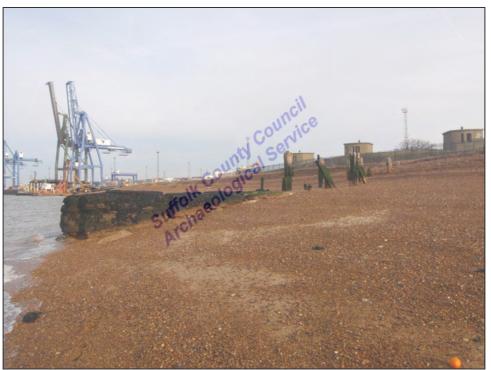
General view of the pier remains, camera facing north

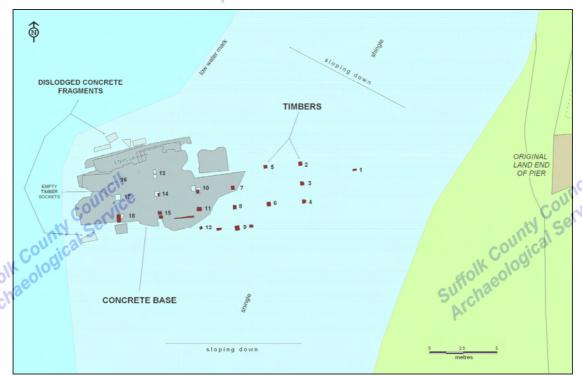
Figure 4: Results of the GPS Survey of the Pier Remains (A larger scale version is available as Appendix 2)

The majority of the timber uprights were heavily weathered and had lost their most of their upper surfaces. Three timbers, numbers 2, 5 and 11, still retained a finished surface on the top of the post at an elevation of 2.64m OD. Evidence for jointing indicated that further timbers, which were presumably horizontal beams to support the deck, were fixed at this point and a possible height of the deck has been extrapolated and presented in the longitudinal section (figure 5)

The results of the measured GPS survey of the pier remains have been processed and are presented below. Figure 4 consists of the surface plan whilst figure 5 comprises a West to East profile.

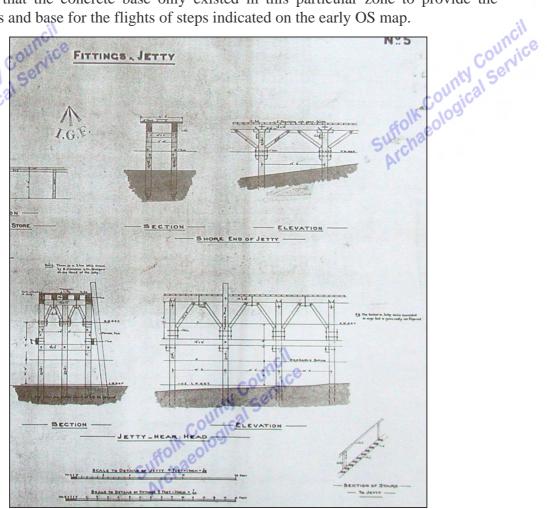
Figure 6: Extract of drawing titled 'Submarine Mining Establishment Fittings & Jetty' (PRO ref. and date not known by the author)

There are numerous plans of Landguard Fort and associated structures held in the Public Record Office (PRO) and it is likely that detailed plans of this pier survive, either as plans from its original construction, details of alterations or later record plans. A plan of the pier titled the 'Submarine Mining Establishment Fittings & Jetty' was given to the author along with other Felixstowe plans which probably originated from the PRO but unfortunately it came without any references or dates but is included above as it shows some interesting detail. It illustrates a pier constructed with diagonal braces butting against timber blocks affixed to the uprights as seen on the surviving remains. It also shows horizontal timbers running longitudinally along the pier at a lower level which is consistent with the timber encased in concrete west of Timber 11. What it does not show is the concrete base which could be seen as confirmation of its later addition.
